Pyestock Testing Facility, Cody Park, Farnborough, Hampshire: Walkover Survey, Historic Building Record and Watching Brief

Planning Application: 09/00746/MAJOR

AOC Project No: 30839

Date: September 2012

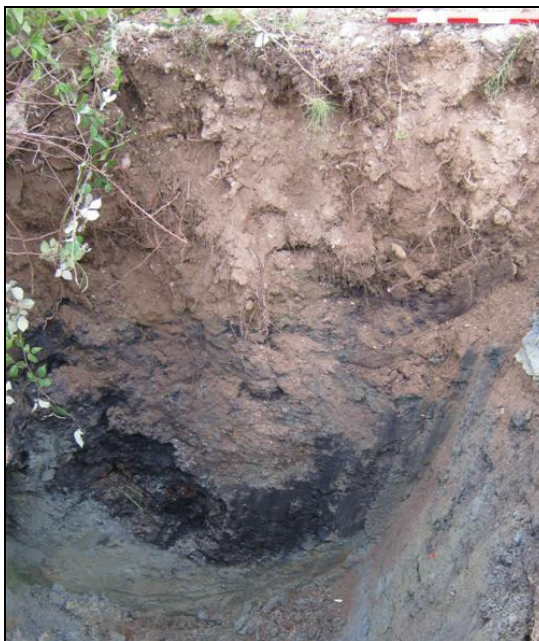
Plate 1: Made Ground Deposits

lenses of dark greyish brown sandy silt. A maximum depth of 2.7m of made ground was seen by Building 8 (Plate 1). It is possible that the made ground derives from landscaping of the site.

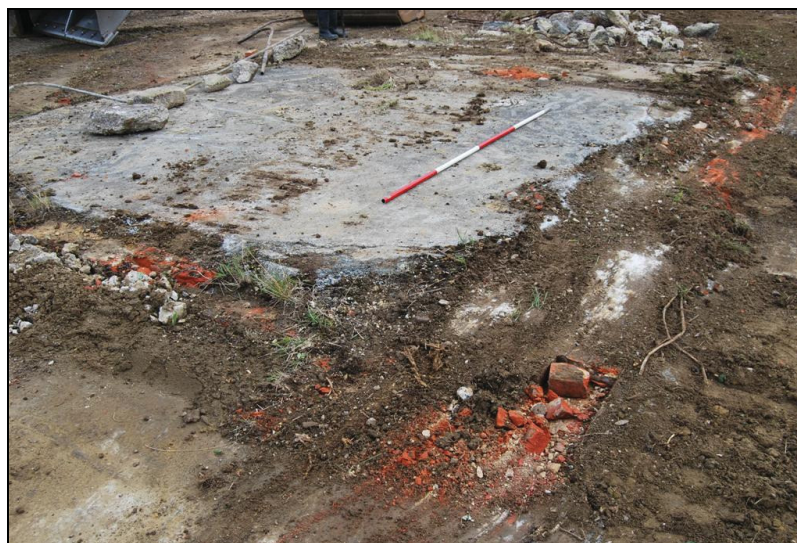
Plate 2: Building 1, Looking East

6.3.1 Building 1 is an almost square block, measuring 5.7m by 5.3m, represented by a concrete floor within brick footings standing two courses higher than the surrounding concrete hard standing. The bricks are orange-red, measuring 230mm by 112mm by 68mm, and laid in English Bond. The bricks are slightly frogged, and the bonding material has cement. The foundation is 0.23m wide, suggesting a building without reinforced walls. The concrete floor is 0.25m deep, and has no features. This is not depicted on any available plans of the site, so its function is unclear.

6.3.2 The lack of any details, including a threshold or evidence of lost fittings in the floor reduces the understanding of the form and function of this building.

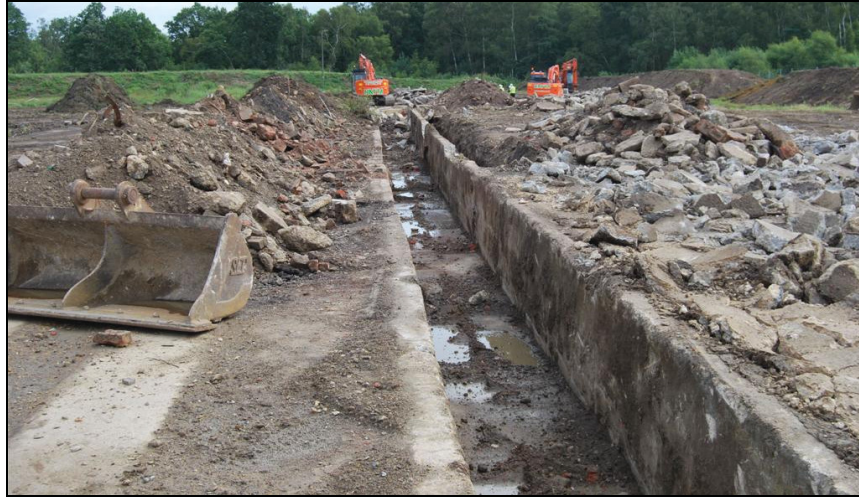
Plate 3: Building 2 Looking Southwest

6.3.1 A long channel with reinforced concrete sides and base marks Building 2. It runs northeast-southwest, for a distance of 54.8m, and is 1.20m wide internally, and 1.15m deep. The walls and floor are concrete, the walls being 0.17m wide and reinforced with steel bars. The channel slopes downhill slightly to the northeast. The northeastern end is somewhat damaged, and widens out towards the northeast, where there are scant remnants of flanking brick structures each 1.11m wider than the channel. The bricks appear slightly more modern than those used for Building 1, being 220mm by 110mm by 70mm, and less-regularly well fired.

- 6.3.2 The channel is probably a duct for pipework: It has a cruciform southwestern end, which may indicate that pipes within led to/from different locations. Two offshoots from the duct run northwest and southeast; both have brick ends which appear to be blocking events. However, there was no evidence for the duct continuing beyond the bricks. The addition of the bricks indicates a change in use or reduction in scale of the operations carried out in relation to this duct. Again, such poorly preserved remains reduce interpretation, but the building appears to be related to Buildings 3-6. Overlaying its location on the historic map (Figure 3) shows that this duct runs between a garage and a test bed.

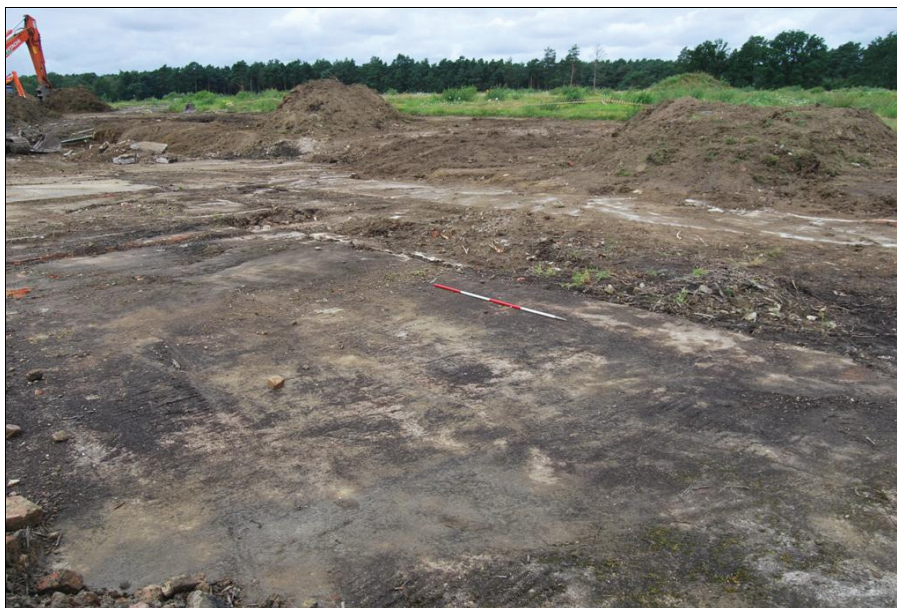
Plate 5: Building 6 Looking North

- 6.7.1 2m west of the Artificial Load Pond are the remains of a building, parts of which appeared to have been reduced to below ground level, with fragments of brick lying in short sections above concrete footings 1.1m deep, and a spread of concrete 22m long and 6m wide representing the floor surface of the former test bed. The brick walls are just 0.25m wide, and may have held a lightweight structure other than a solid building. The lines of the walls are only traceable for a limited distance.

The limited survival of building remains may indicate that it was taken down before final closure of the facility.

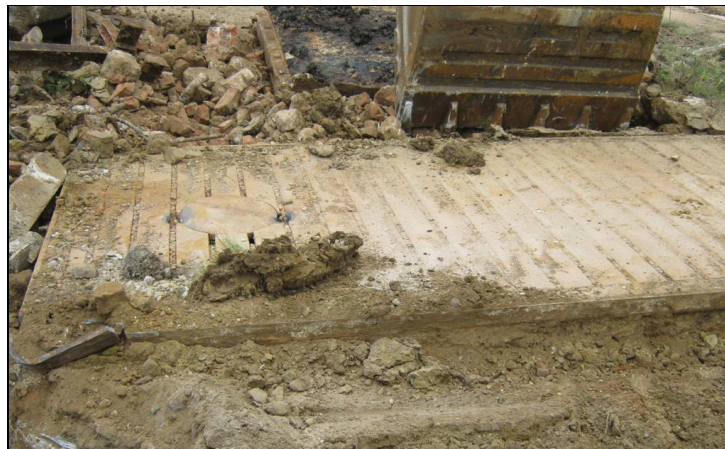
Plate 6: Iron Plate, Building 8

- 6.9.2 The western side of the block has a cast iron ridged plate measuring 4.6m by 1.5m, set within a bed of concrete 0.40m thick, again with an outer wall footing 1.20m deep. The iron plate was 0.22m thick,

with a circular plate towards the western end. As part of the testing facility, this clearly had a slightly different function to the elements of the other remaining test beds.

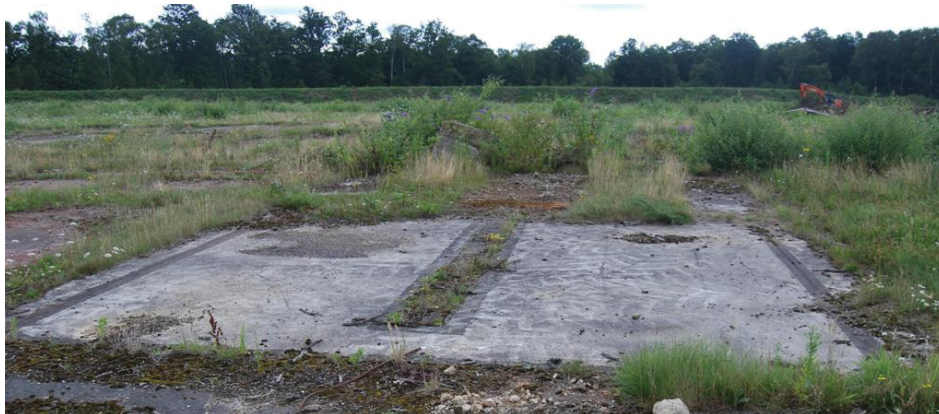
Plate 7: Building 8, Looking Northeast

- 6.9.1 The building is represented by a rectangular footing on the edge of the flat plateau in the centre of the site. It measures 9.9m by 6.4m east-west. This is the southern part of one of the test beds (Building 239), and has two parts of different character. The western part of the building foundation has a concrete footing 0.25m wide which may represent the line of a wall. On the north and south sides are thick reinforcing I-beams across the length of the block. These are set into the concrete footings, which are 1.20m deep. The floor surface of the block is formed on a concrete slab 0.30m thick, with a concrete-lined duct in the centre, running eastwards. This presumably held pipework associated with the testing facility. It seems that the substantial concrete foundations and ironwork provide an immobile frame for mounting engines for testing.

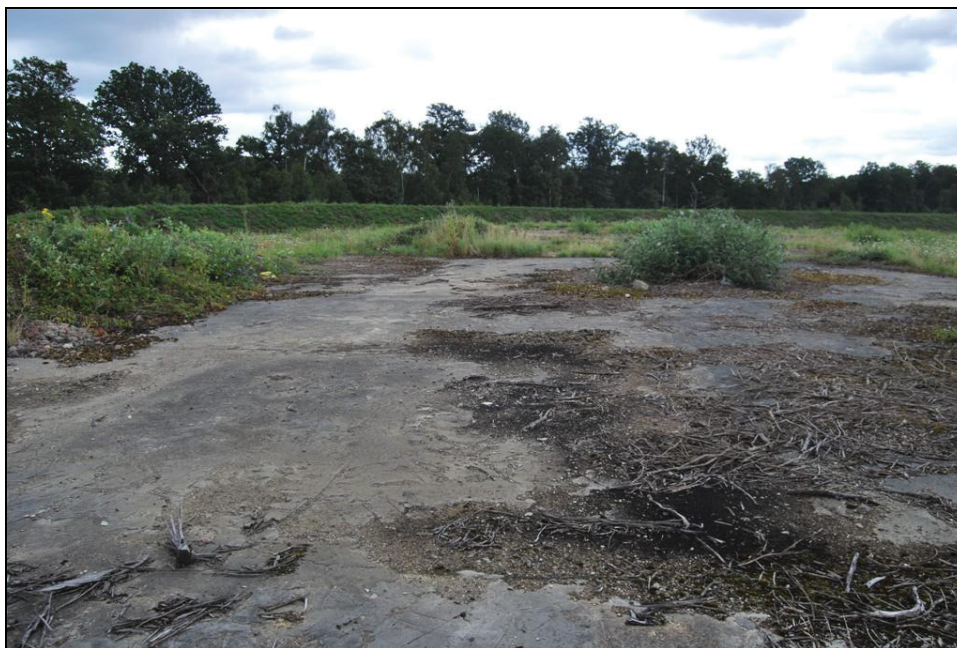
Plate 8: Concrete of Building 10, Looking East

- 6.11.1 This large expanse of concrete overlooks the northern edge of the central mound at the Pyestock site. The concrete had no defined footings associated with it. It is L-shape in plan, 21.3m northeast-southwest 29.1m southeast-northwest. There is a ramp of tarmac running downhill northeastwards. The lack of any structural evidence suggests that this may have been an open area of hardstanding. If it was covered, it may have been an area of impermanent structures. Building 11 lies at its western end. It is shown on the 1970s plan as a dotted outline rather than an active building, indicating that what was present had been removed by that date, perhaps in conjunction with the expansion of the new Pyestock site.

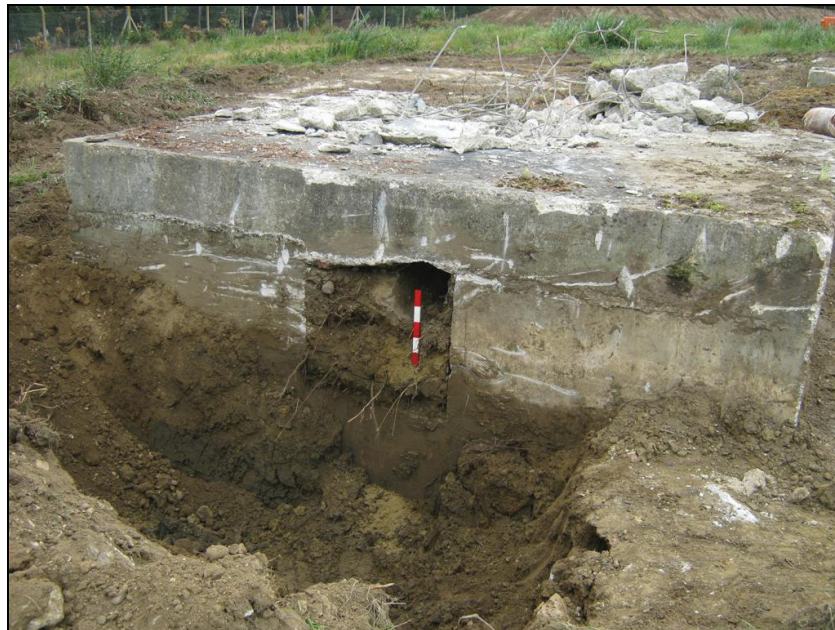
Plate 9: Building 12, Looking Northwest

- 6.13.1 This is a small concrete block at the northern edge of the building mound, lying 6.1m north of Building 11. It is not shown on the plan from the 1970s. The block is built on a bed of concrete 0.75m thick, with a footprint of 4.75m east-west and 5.2m north-south. This lies at 74.88mOD. It was unclear whether the base was cut into the made ground, or if the ground was added only after the block was built. The walls of the block rise by 1.75m, and are 0.45m thick, reinforced with steel rods. The concrete appears to have been poured into shuttering. There is a 0.9m square opening in the eastern and western walls, and these are the only openings into the building. The roof of the block is a concrete slab 0.5m thick. The reason for this structure is not clear: there are no internal fixtures or fittings that indicate a function. Equally, the square holes in the walls are not easily accessible.

- 6.13.2 The block was almost fully filled with mixed clayey sand, and a fibreglass pipe runs through it, between the openings. Possibly, this is a solid base, and rather than using solid concrete, clay was used as infill. However, the clay was uncompacted.

- 7.6 Building 12 is a small concrete block approximately 5m square with openings in the sides through which a pipe passes. Next to it, a partially enclosed walkway seems to have run along the northern edge of the made ground forming the mound upon which the structures were founded. The square block itself is an odd feature. The openings through which the pipe passes are formed as part of the building, yet are not access points. The structure is filled with silty sand, yet it is uncompacted, as if it were a later addition. This, may be a large platform for heavy plant, but the surface is smooth with no fixings. If it were a shelter for safety, then an access would have been expected. It is not shown on the 1970s plan, so had fallen from use.

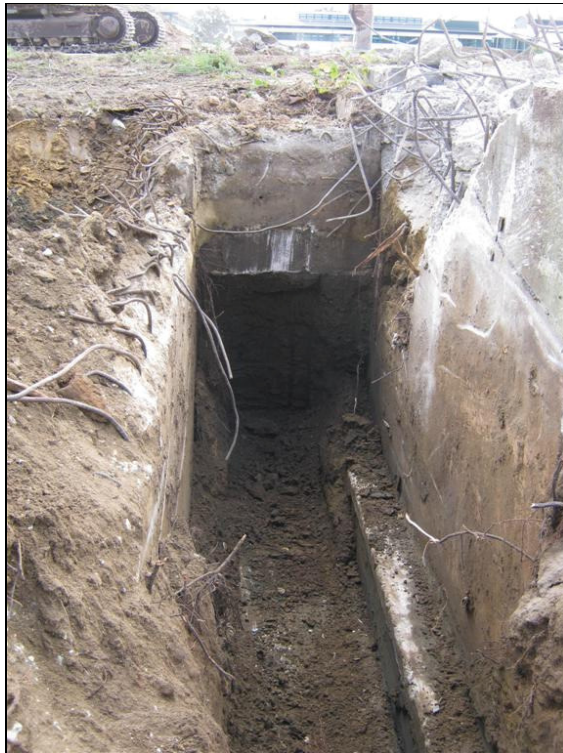
Plate 10: Passage Around Building 12. Looking Southeast

- 6.13.3 Along the eastern side of the block is a passageway 1.20m wide, the outer edge formed of 0.17m thickness of reinforced concrete, standing to 77.08mOD. Four projecting corroded iron bars on the wall of Building 12 may mark the height of a wooden walkway. It runs north, where it appears to have opened onto the slope made by the made ground. Southwards, it was accessed from next to Building 11. There is a supporting arch across the passage at the rear of the block, which is 0.6m deep.

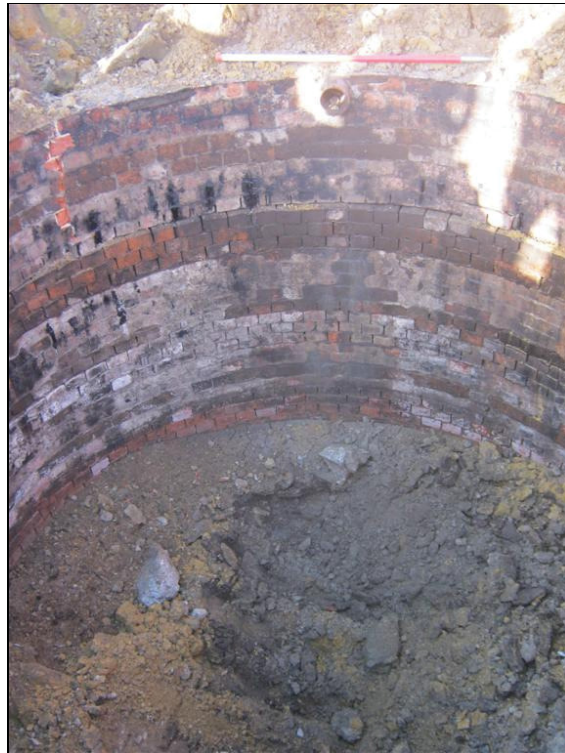
Plate 11: The Soakaway

- 6.14.1 A circular brick soakaway was recorded during a watching brief, to the south of the site near building 3. It was constructed of red bricks, each 220mm by 110mm by 72mm, and header coursed. The top was domed, and sealed with a concrete slab 1.5m across. The soakaway was fed by a ceramic pipe of 0.14m diameter in the west side. This is not marked on historic maps, but being of 20th century date, must be part of the Pyestock testing facility infrastructure.

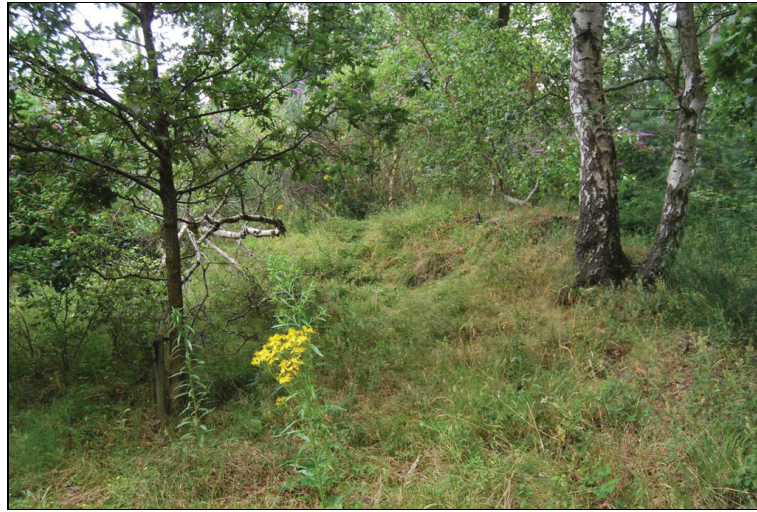
Plate 12: Overgrown Backstops

- 6.15.2 The shooting stand is yet to be located, but the Ordnance Survey plans indicate a length of some 100m. There is no extant northwestern boundary to the range: it is presumed lost to modern fencing, general dereliction, and the creation of the bund around the current development area that derives in part from the demolished buildings of the testing facility. The southeastern side of the range is marked by a low fence of chestnut paling in poor condition. Towards the end is a gate that states 'Danger Rifle Range Keep Out' on a wooden board. This is adjacent to the southern of two backstops. The backstops are rounded mounds of sandy silt and gravel 7m by 3m in plan with a concave face towards the shooting stand. A space of 7m between the mounds would have been the location for a target or series of targets. The mounds are now overgrown, yet still stand up to 1m high.

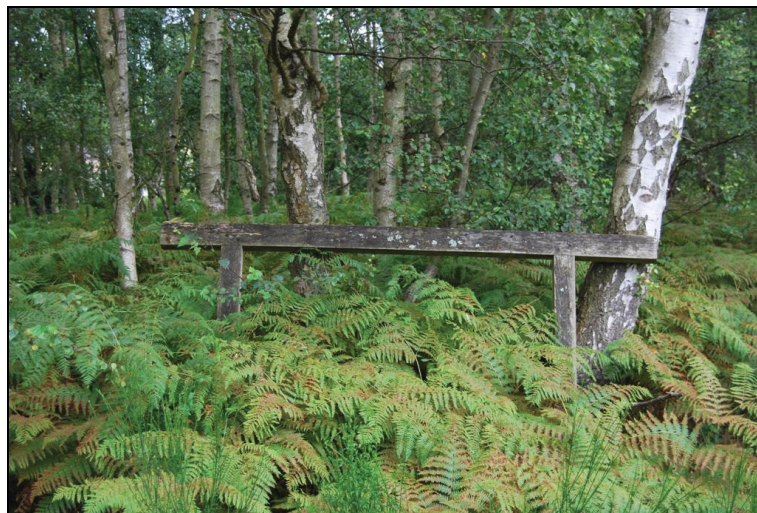
Plate 13: Mid Target

- 6.15.3 Approximately 50m southwest of the backstops is a wooden frame comprising two uprights and a crossbeam. This is likely to be a mid-target. It currently leans against a semi-mature birch tree.
