Crammag Head Lighthouse Watching Brief, Dumfries & Galloway: Data Structure Report

AOC 21291

On Behalf of: Northern Lighthouse Board
84 George Street
Edinburgh
EH2 3DA

AOC Project No: 21291

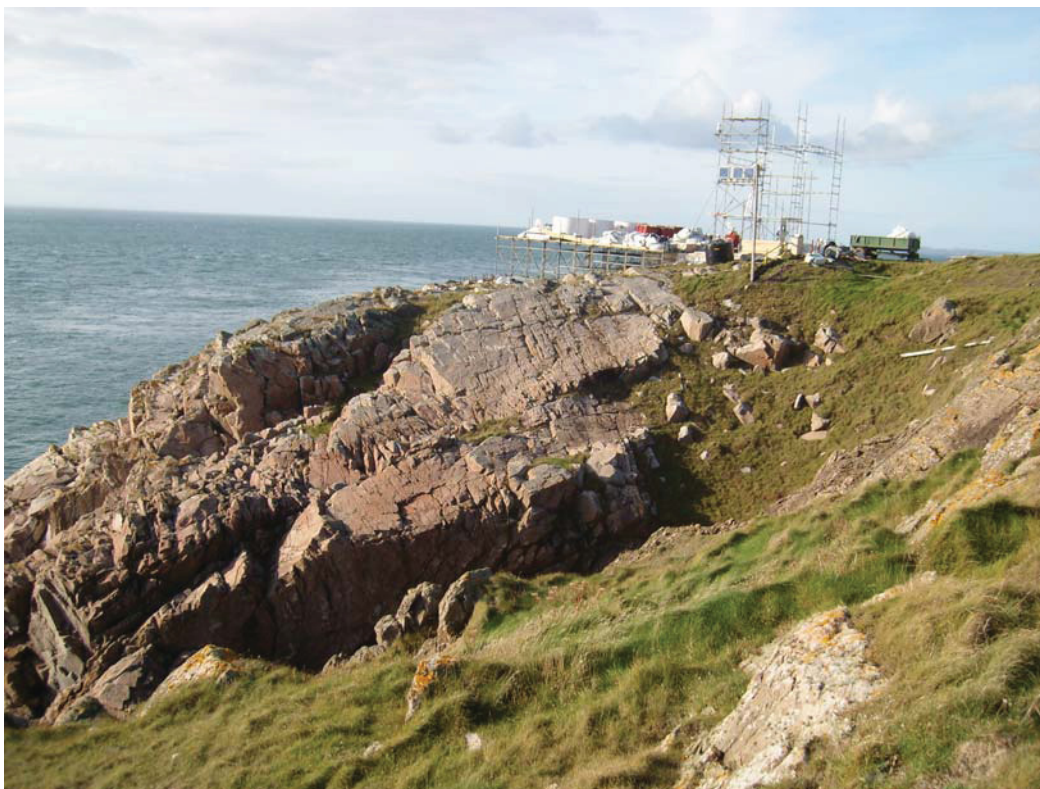
Plate 1: Crammag Head from south

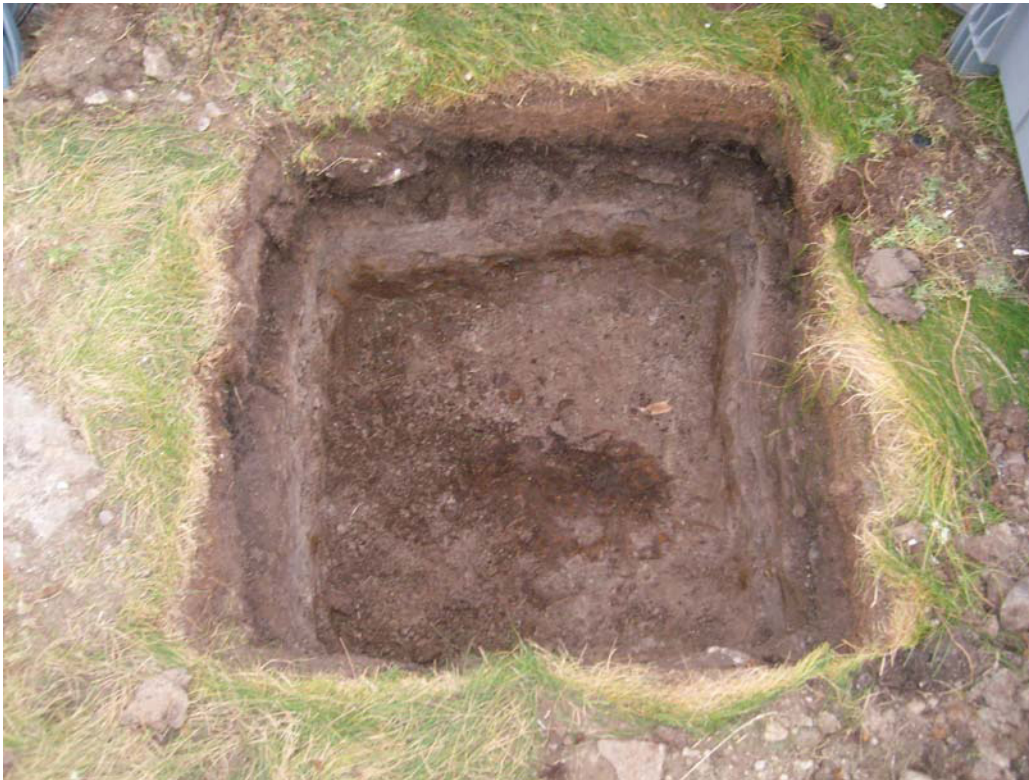
Plate 2: Pit 2 from east

| | Dimensions | | | Summaries | |
|---|---|---|---|---|---|
| Pit 2 | 0.8 N/S | 0.8 E/W | 0.6 | Turf and Topsoil Compact dark brown sandy silt Frequent inclusions of small and medium sized angular stones | 0.3 |
| | | | | Subsoil Compact light grey sandy silt | 0.27 |
| | | | | Natural Compact orange clay sand | |

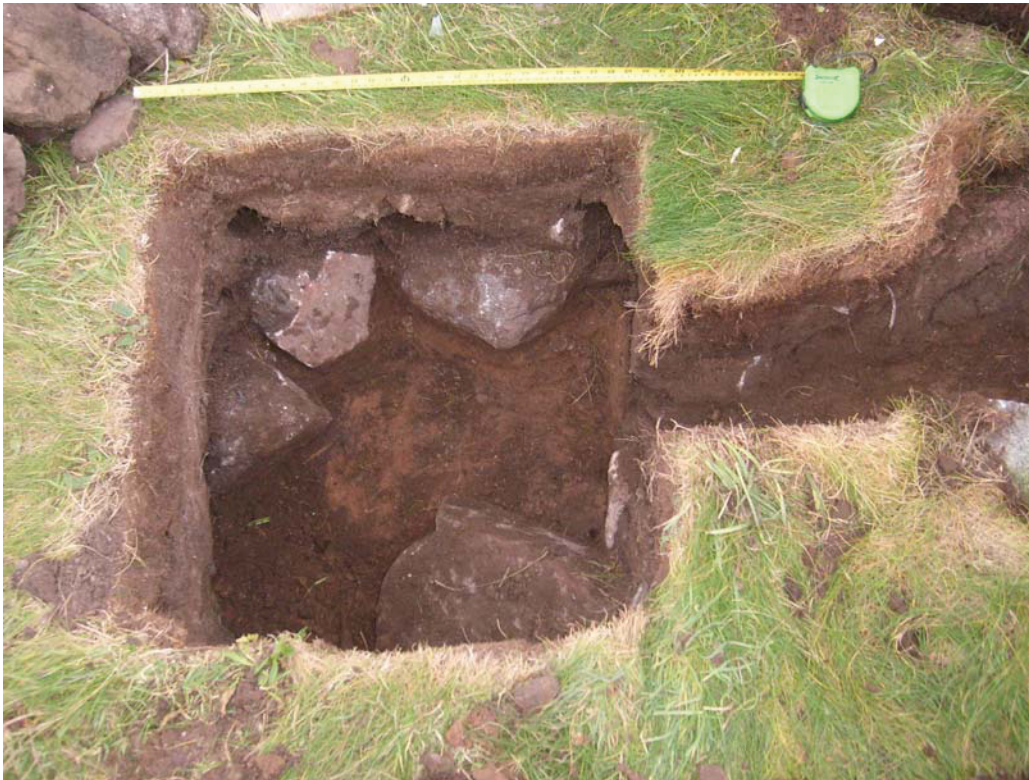
Plate 3: Pit 1 from south (tape is extended to 1 m)

- 5.1 Apart from the possible tumble seen in Pit 1, no features, deposits or artefacts of any archaeological significance were recorded or disturbed during the watching brief.

| | Dimensions | | | Summaries | |
|---|---|---|---|---|---|
| Pit 1 | 0.7 N/S | 0.7 E/W | 0.6 | Turf and Topsoil Compact dark brown sandy silt Frequent inclusions of small and medium sized angular stones | 0.14 |
| | | | | Subsoil Compact dark grey clay sandy silt Frequent inclusions of large rounded and angular boulders, loosely packed. Not believed to be deliberately placed. Possible tumble or clearance. | 0.27 |
| | | | | Natural Compact orange clay sand | |
