# Newhouse Farm Evaluation, Kilbirnie, North Ayrshire: Data Structure Report

AOC 21339  
February 2010

### Data Structure Report

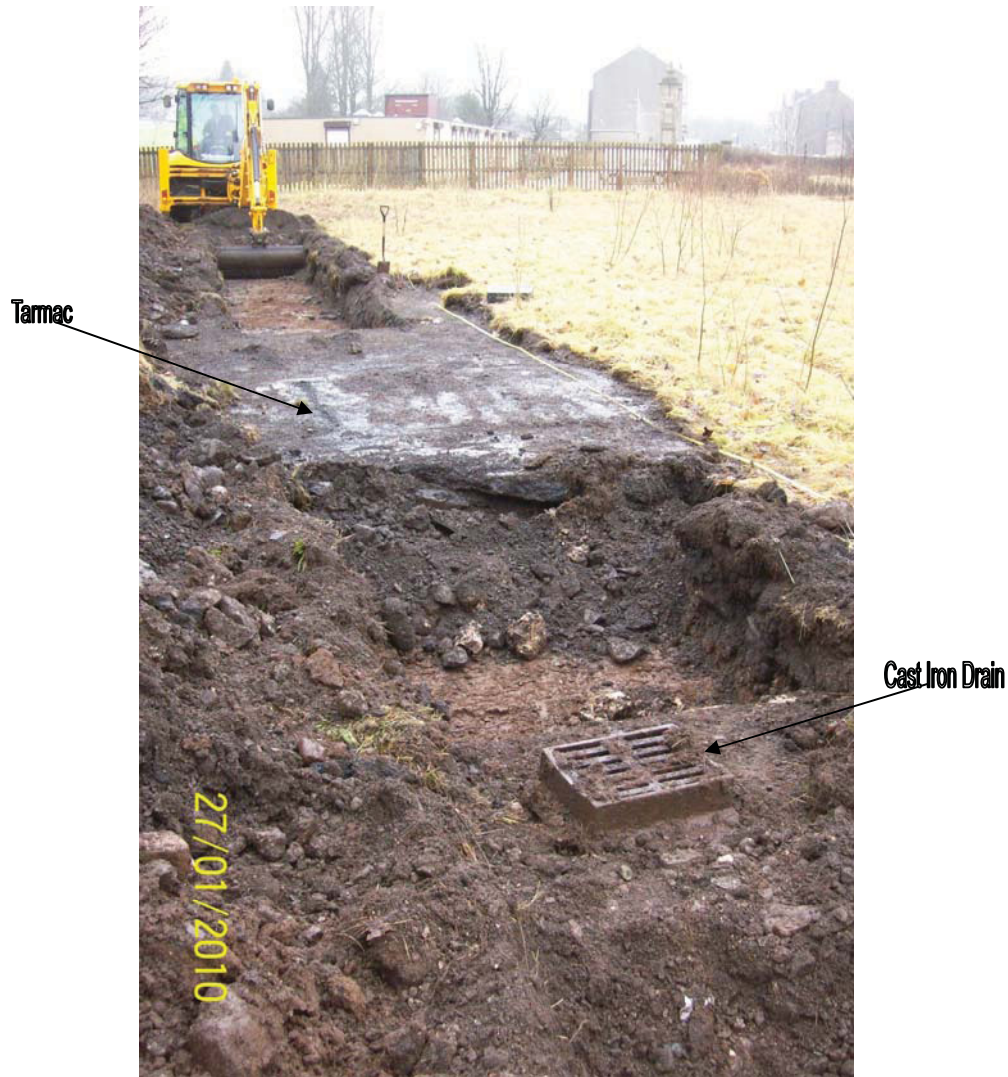
**Plate 1: Trench 1 showing cast iron drain and tarmac**

- 4.2.2 There were a number of obviously modern features cut into the natural geology. Trench 1 contained a rubble drain, a cast iron service pipe and cast iron drain (see Plate 1), whilst Trench 4 was crossed by water and gas service trenches supplying the derelict property in the north-east corner of site. Both Trench 1 and Trench 6 contained modern pit features, square in plan, similarly sized at approximately 1.0 m<sup>2</sup> and both containing brick, glass and mortar.
