Dumfries House Adventure Playground, Archaeological Works: Data Structure Report

AOC 21411
August 2009

On Behalf of:	Dumfries House Trust Dumfries House, Cumnock, Ayrshire KA18 2NJ
National Grid Reference (NGR):	NS 5415 2122
AOC Project No:	21411
Prepared by:	Lindsay Dunbar
Illustration by:	Douglas Park
Date of Fieldwork:	July 2009
Date of Report:	August 2009

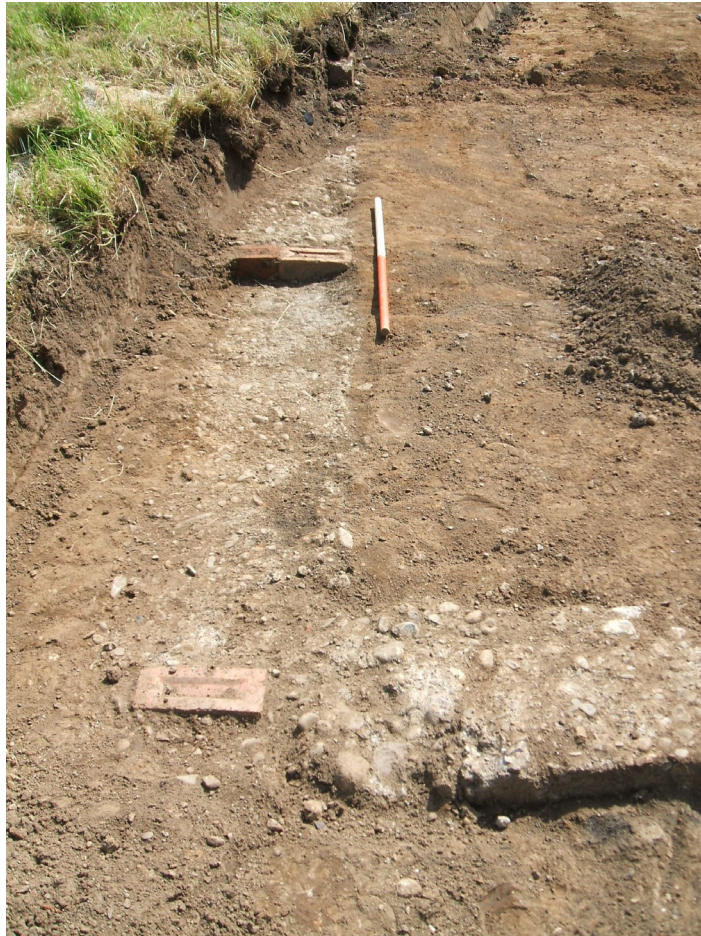
Plate 1 Building 2, north-west corner of building showing stepped foundations

- 4.2.4.2 The concrete foundation was between 0.50 m and 0.70 m wide by a few centimetres thick on which the brick walls had been constructed. The natural slope of the ground drops in height across the site predominantly from north to south but also to a lesser extent from east to west. This is reflected in the concrete foundations which were stepped to accommodate the slope.

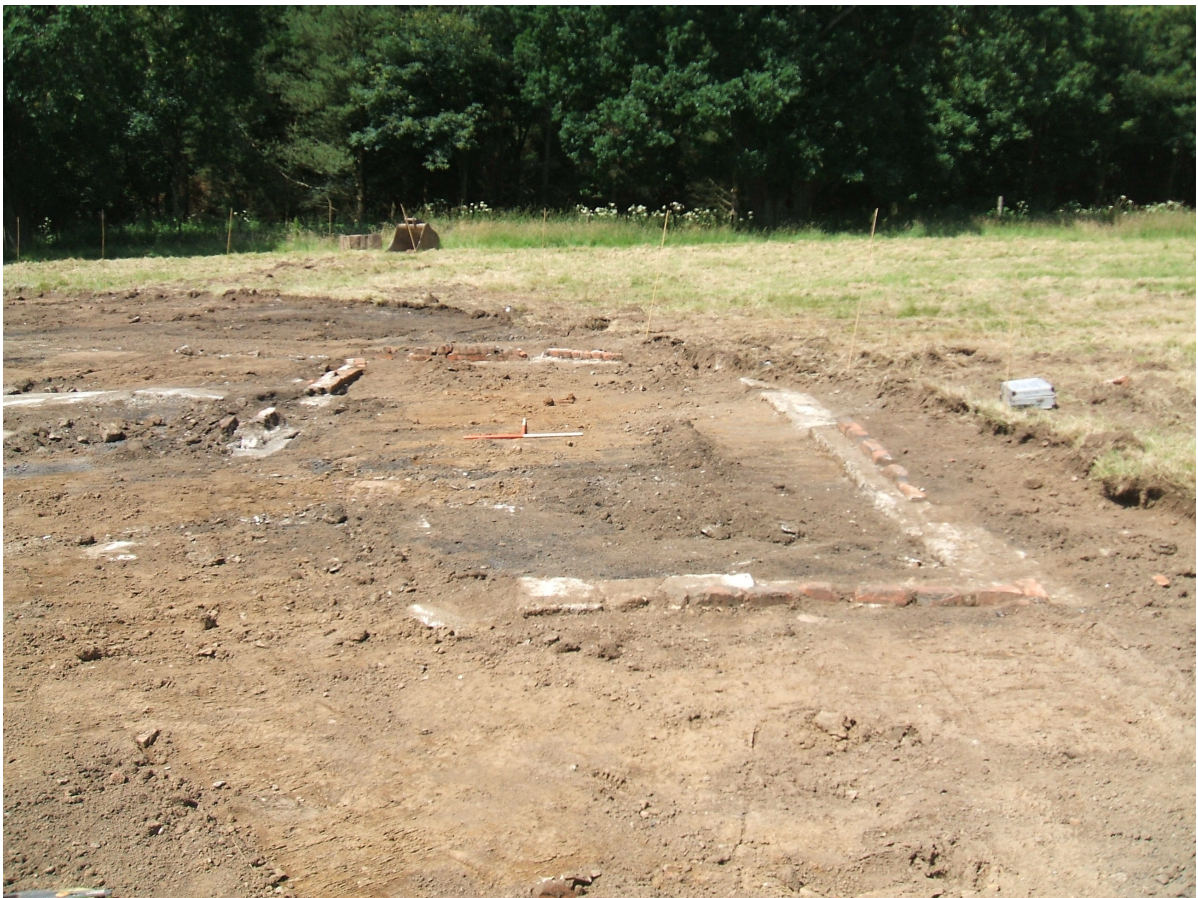
- 4.2.4.3 On these foundations were then set the brick bases of the walls to buildings. In both Building 1 and 2 the first course of brick was laid perpendicular to the foundations. This was then followed by a single course of brick laid at 90° to the first course, parallel to the foundations and on the outside edge of the first course of bricks.

- 4.2.4.4 The south-eastern corner of Building 1 had been completely removed by the demolition process and the north-eastern corner of Building 2 fell beyond the extent of the excavation area. However from the portions of the buildings surviving it was clear that they had all been reduced by the demolition to the last two courses of brick.

Plate 2 Building 1 from east

- 4.2.4.5 Building 1 was approached by a concrete path passing by the western end of Building 3 and it corresponded with an appropriate break in the brick work suggesting the entrance to the building. From the south-western corner of Building 1 ran a ceramic drain.

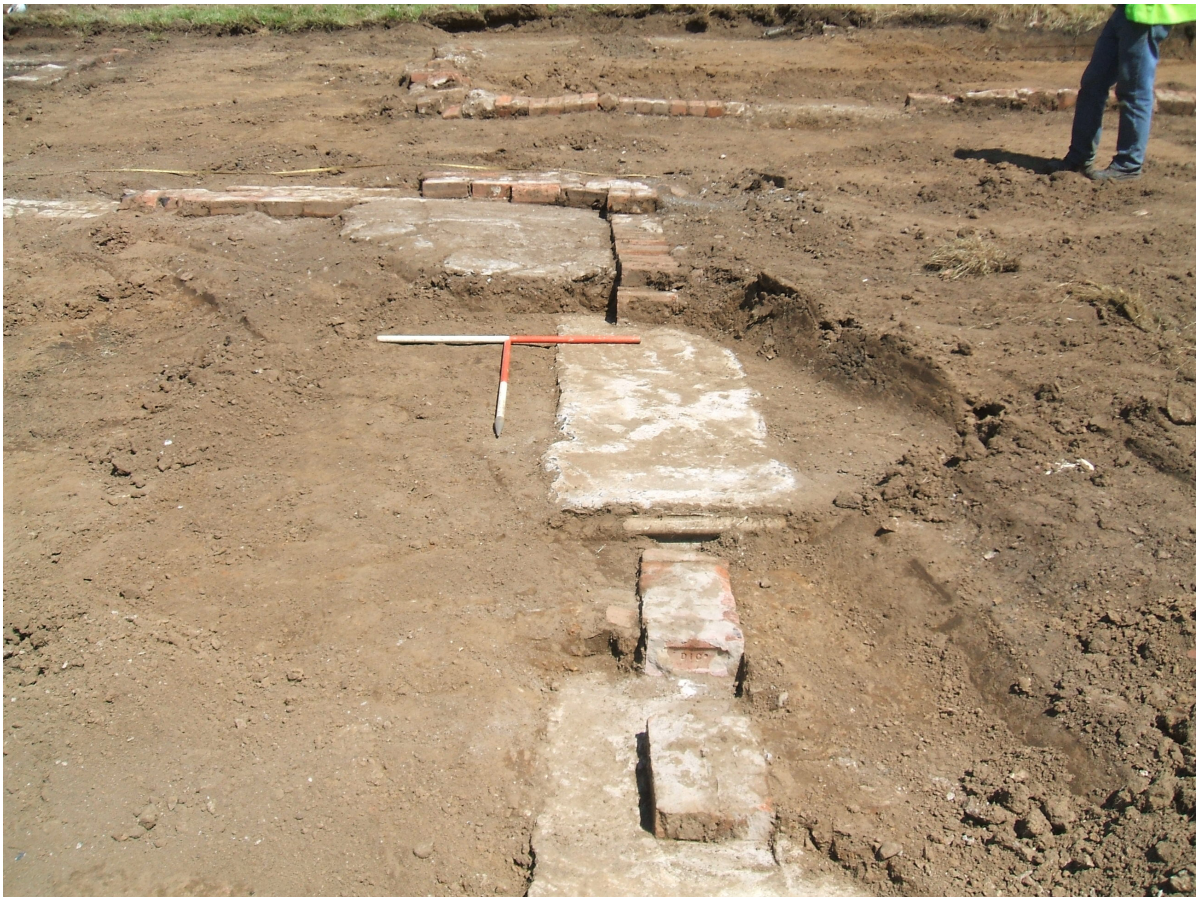
4.2.5.2 The concrete pad foundations were slightly thick and wider at nearly 0.10 m thick and up to 0.85 m wide. The foundations were stepped east to west and north to south. The surviving brickwork also displayed the more substantial aspects of this building with the north to south gable walls having double brick thick first courses. As with Buildings 1 and 2 this first course was perpendicular to the foundations. The east to west walls were identical to those in Buildings 1 and 2, a single course perpendicular to foundations.

Plate 3 Building 3 from south showing floor & stepped foundations

4.2.5.3 In the north-east corner of the building lay a remnant of a thin concrete layer which abutted the brick works and overlay the concrete foundation. This was interpreted as the remains of an internal floor surface to the building.

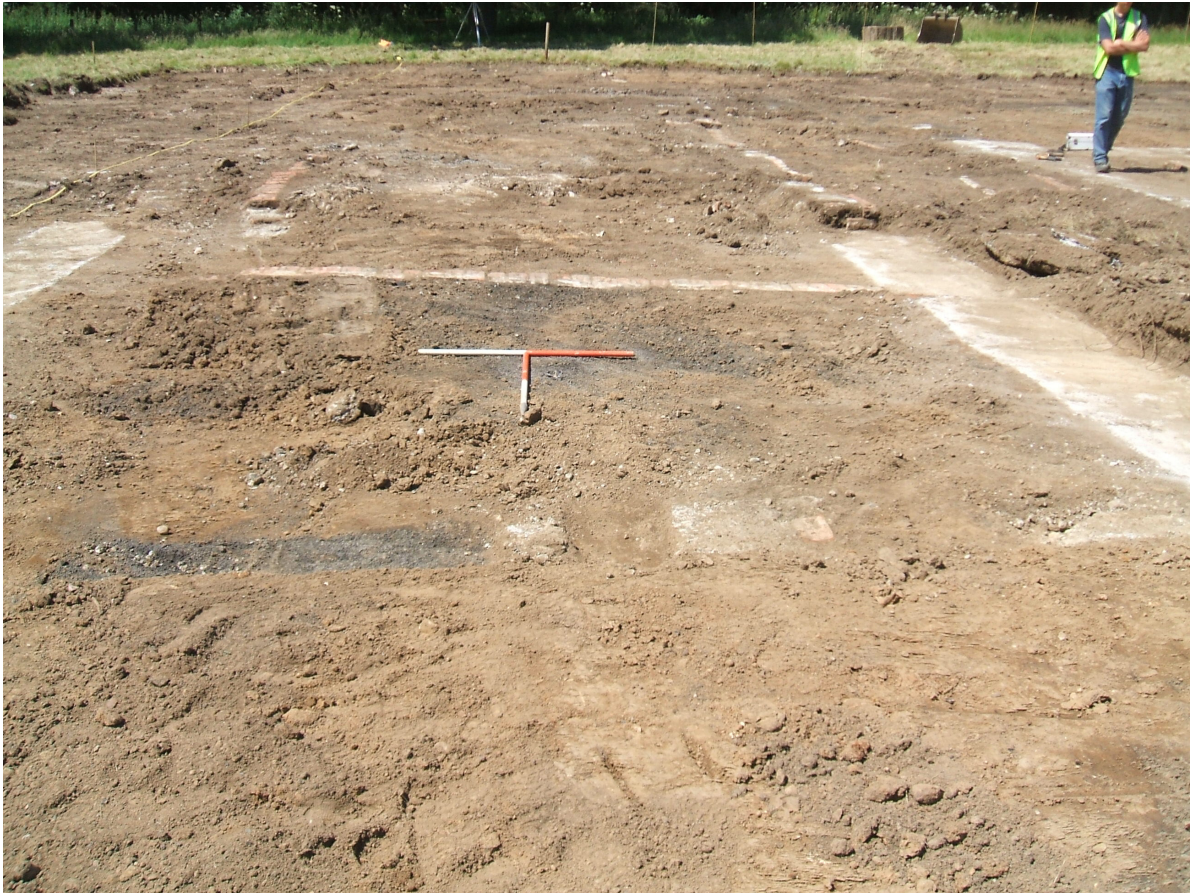
- 4.2.6.4 Building 4 was subdivided by two north to south walls, creating two equally sized rooms at the eastern and western ends, at 11.3 m long and a much smaller almost square middle room at about 6 m long (which the concrete path suggests had its own entrance on the north side of the building). The two inner walls appear to be of a slighter construction to the gable and side walls, though the brick was still present along the length of the western inner wall and it didn't show any sign of a break for a doorway.

Plate 4 Building 4 from east showing two internal walls

- 5.1 The buildings that were exposed form a clear pattern that can be easily identified on the APs. The remains correspond very well, but for Building 4 which on the APs looks like two separate rectangular buildings. As mentioned in the description of Building 4, the better preserved of the 'dividing walls', the western wall does not show a gap in the brickwork. It is possible that this is a gable wall. Along the north and south long walls of Building 4 there was a lot of brickwork surviving; however the middle sections contained no brick. It is possible that the foundations were poured as a continuous line but that the middle section was never built upon leaving two separate buildings matching the AP image.
