# Newbridge Fire Training Centre Evaluation, Edinburgh: Data Structure Report

AOC 21466  
November 2009

## Data Structure Report

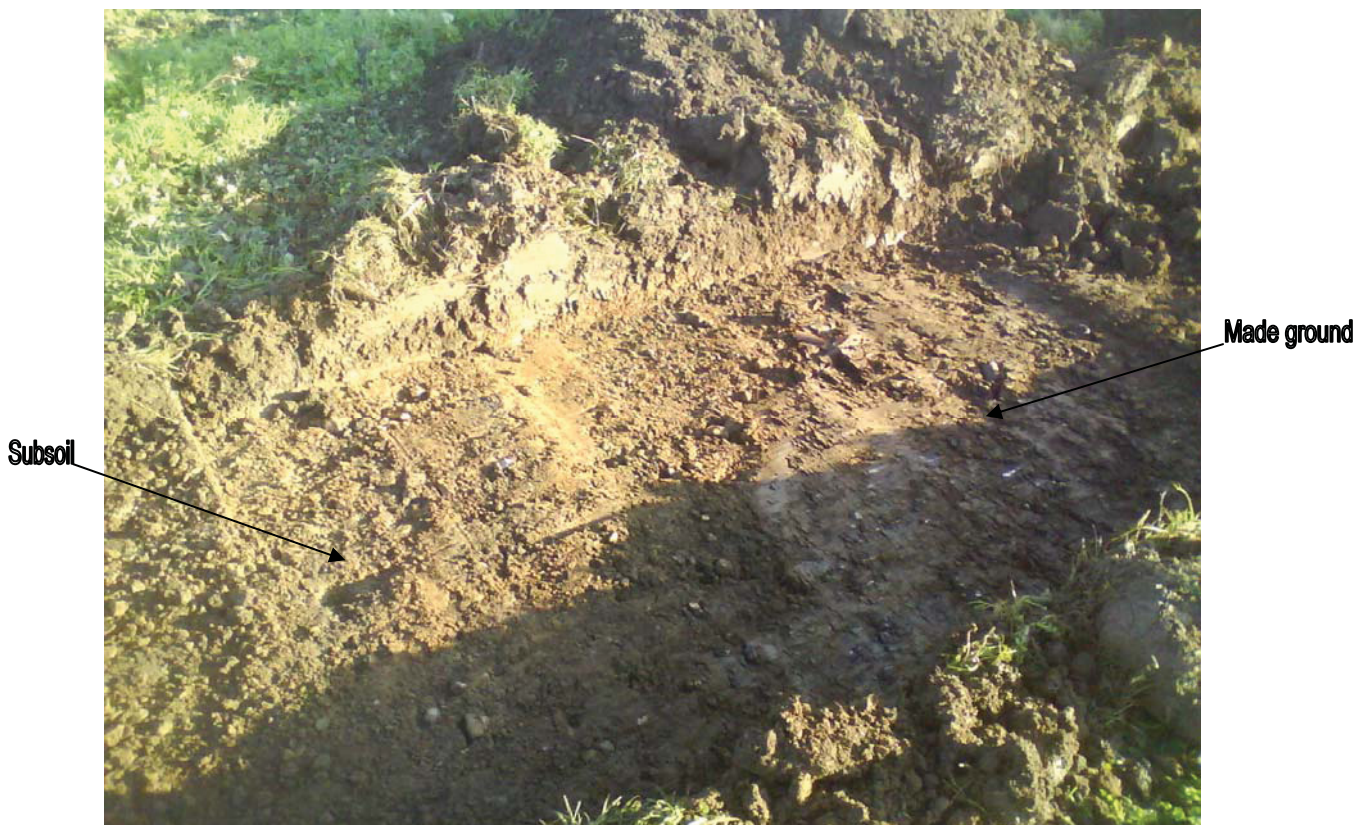
**Plate 1: Trench 11 showing cut of made ground**

- 4.2.3 Given the general topography of the site rising slowly from the south to the north, before falling away slightly towards the railway, it is difficult to reconcile this with the depth of made ground present across the southern half of the site, which is in excess of 2.0 m. However, Trenches 5, 6, 8 and 11 suggest that the site may have been subjected to a degree of

excavation with infill then dumped into the resulting excavations. In these trenches the edge is sharp and steep between the *in situ* natural geology of orange clays and the dumped, mixed infill material. Where it survives, on the highest point of the site, the natural geology of orange clay is crossed by agricultural ceramic field drains and is covered with 0.30 m of quality topsoil giving a glimpse of the soil profile at the beginning of the 20<sup>th</sup> century.

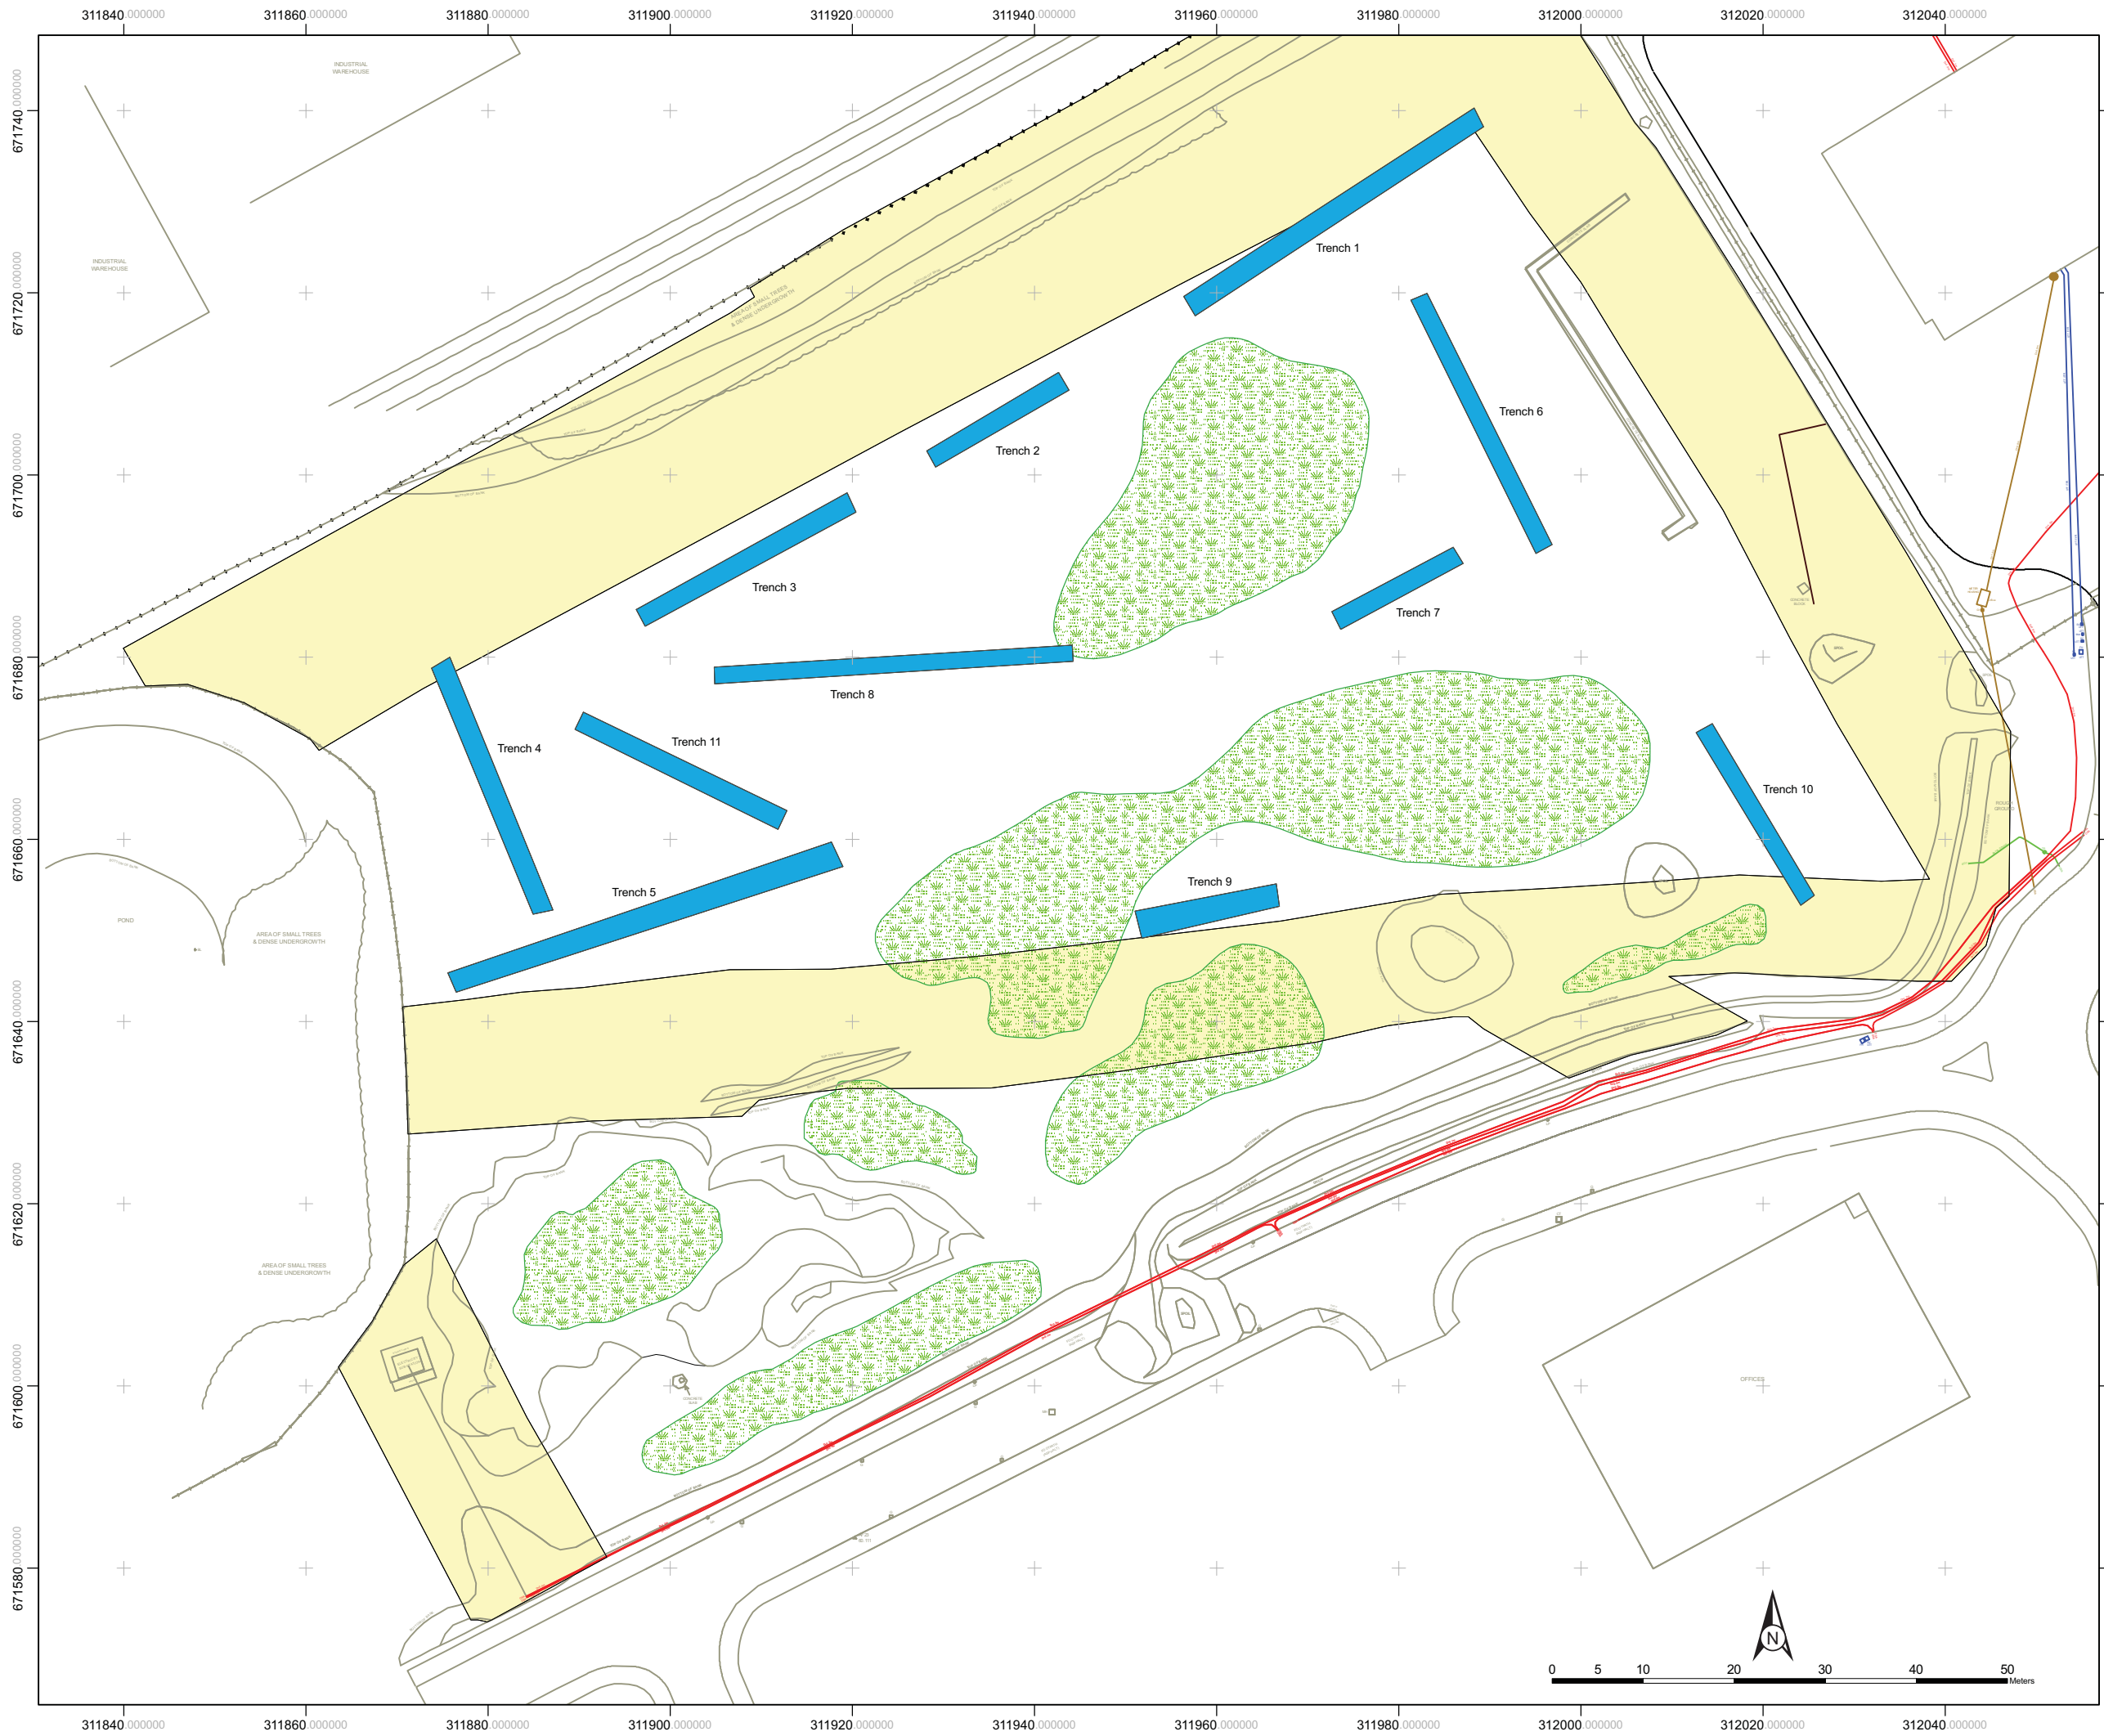
Figure 2: Site Plan and Trench Locations

- 3.1 The Written Scheme of Investigation (Dunbar 2009) proposed the excavation of trenches equating to a 5% sample of the development area, with a further 3% contingency to be invoked if requested by Mr. Lawson, if archaeology was uncovered during the initial 5% sample evaluation. The site covered approximately 2.34 ha resulting in evaluation trenching with a total basal area of 1170 m<sup>2</sup> (Figure 2).

- 3.2 The presence of a number of utility services, coupled with very extensive areas of standing water, reduced significantly the area that could be feasibly evaluated, resulting in total evaluation trenching of 700 m<sup>2</sup>. An on-site meeting with Mr. Lawson on 12<sup>th</sup> November, to discuss the evaluation findings, concluded that the contingency trenching was not required and that the evaluation, though less intensive than stated in the WSI, had fully assessed the archaeological potential of the site.
