# Whitehill Road, Kinnaird South, Newcraighall Excavation:

## Data Structure Report

# Whitehill Road, Kinnaird South, Newcraighall: Excavation Data Structure Report

**AOC Project No:** AOC 21226

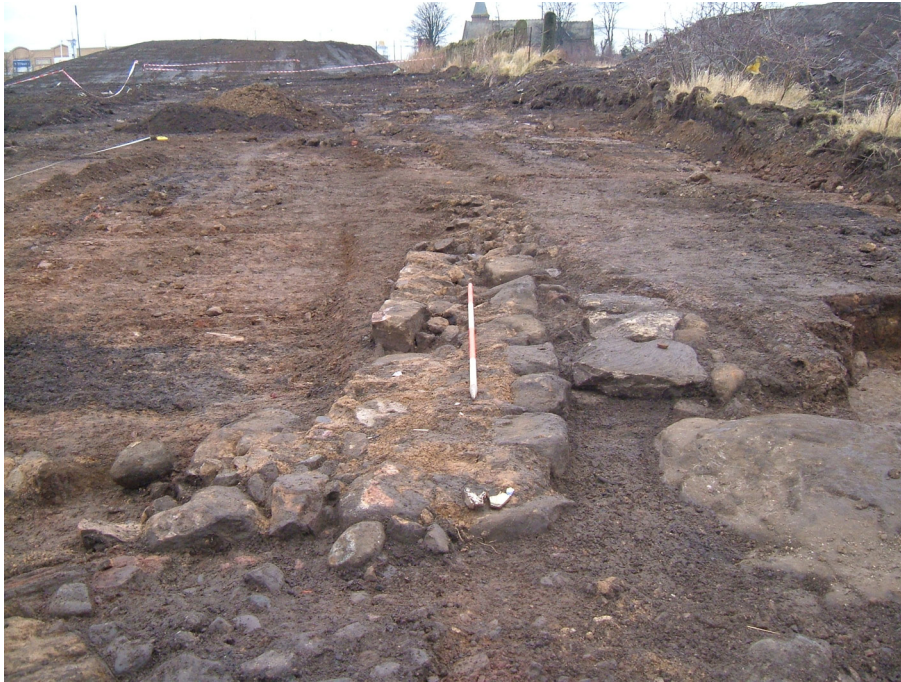
PLATE 1: WALL [007], FROM SOUTH-EAST

4.1.2 The principal feature unearthed was a poorly preserved stone-built structure with three extant walls. The long axis of Structure [003] was aligned approximately north to south, with an internal width, east to west of approximately 4.75 m . Each wall was set within a shallow foundation cut [010]. The eastern wall [007] at c.0.9 m wide with a traceable external cut length of 9 m was the best preserved but still only survived to a single course in height. Its construction, undressed stone outer faces with a rubble infill bonded by a lime mortar, was shared by the other walls. The southern wall [008], the most poorly preserved, was cut by a red ceramic field drain. The western wall [009] possessed a 0.70 m wide gap, interpreted as a possible entrance, at some 6 m from the southern end of the building. The northern

wall appears to have been effectively removed by ploughing together with the northern areas of walls [007] & [009]. No interior floor surfaces were present.

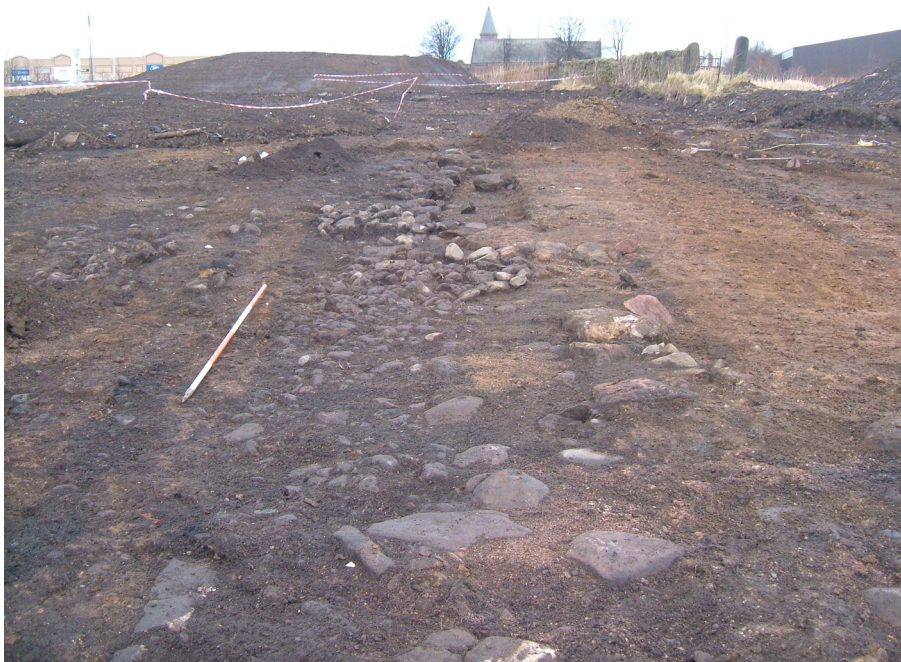
PLATE 2: COBBLES [011] ALONG WESTERN SIDE OF STRUCTURE [003], FROM SOUTH-EAST

4.3.1 The western wall, [009], and southern wall, [008], of Structure [003] were abutted by a cobbled surface comprising contexts [011], [012] and [006]. This area of hard-standing was composed of small to medium-sized sub-rounded cobbles, tightly packed in some areas, [006] and [011] immediately to the west of wall [009] and more diffuse in others, for example to the south of wall [008]. In the less immediate area of building [003] the presence of disperse scatters of cobbles to the west, [021], and south-west, [020], hints at originally a much more extensive area of hard-standing which has subsequently suffered from a higher degree of plough attrition. Modern (probably 20<sup>th</sup> century) white ceramics were recovered from the surface of cobbles [006] and [011].

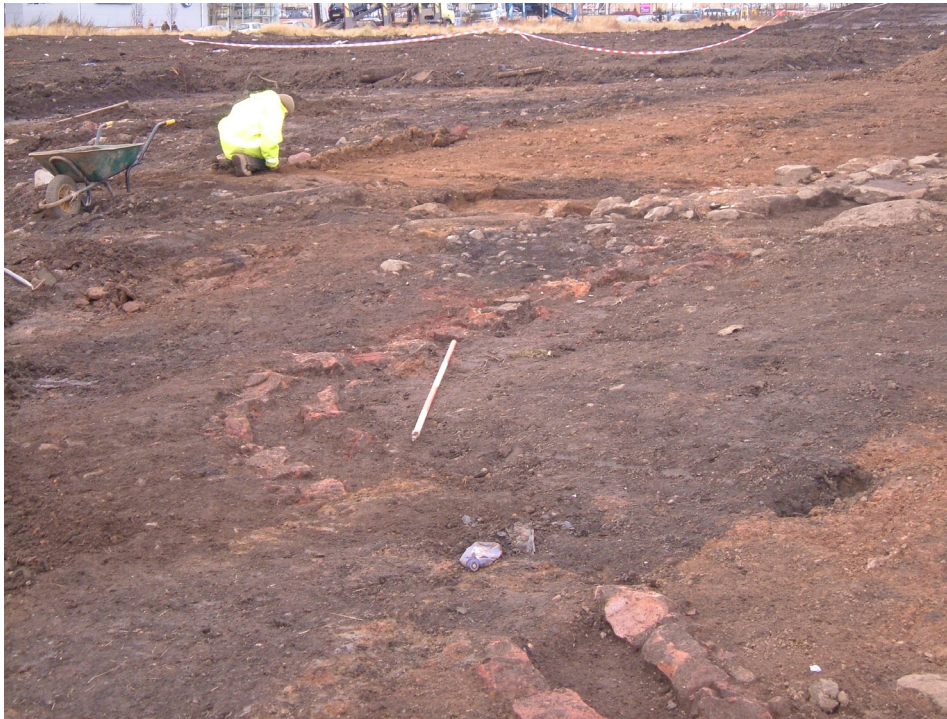
PLATE 4: CULVERT [005] WITH STRUCTURE [003] IN BACKGROUND

4.4.1 A curvilinear sandstone culvert [005] ran along the eastern wall [007] of Structure [003]. Approximately 20.0 m in length with sandstone cap-stones visible alongside Structure [003]. The culvert was 0.50 m wide and 0.30 m in depth. The culvert was overlain by cobbles [011] and curved to the east upon passing Structure [003] directing water away from the cobbled area to the south of the structure.

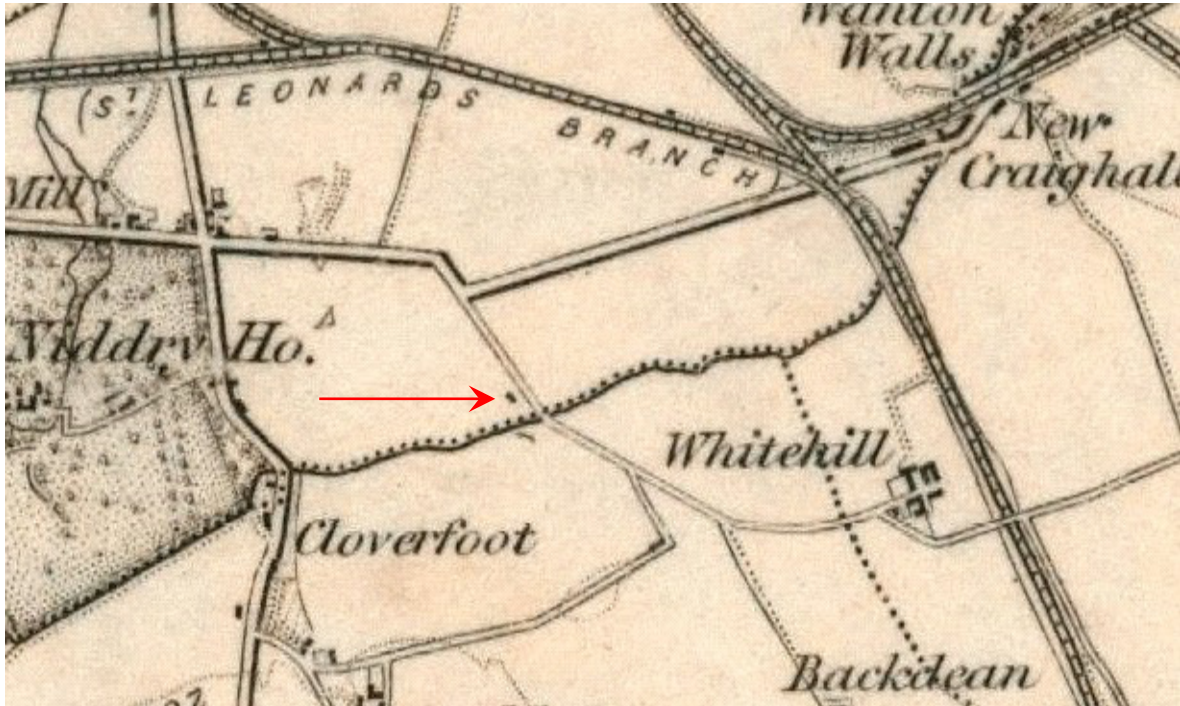
PLATE 5: EXTRACT FROM ORDNANCE SURVEY (1857) SHOWING BUILDING MARKED

- 5.1 Cartographic evidence appears to show Structure [003] as deriving from a single rectangular building lying on the western side of the old line of Whitehill Road. Shown on Sharp *et al* (1828) the building as depicted on the First Edition Ordnance Survey (1857; surveyed 1851-56) (Extract shown as Plate 5) illustrates the structure lying in the corner of a field between the policies of Niddrie House and Whitehill Farm. With an origin in the late 18<sup>th</sup> or early 19<sup>th</sup> century, it subsequently disappears from the cartographic record sometime between the OS 1904 and 1924 editions. After this date the building's sub-surface elements have suffered greatly from plough damage, with only fragmentary single wall courses surviving and no internal floor architecture.
