KINGS TROOP RHA, WOOLWICH, HA-HA ROAD SITE, LONDON BOROUGH OF GREENWICH BUILDING RECORD AND ASSESSMENT

AOC Project No: 30782

Date: January 2011

Building Record and Assessment

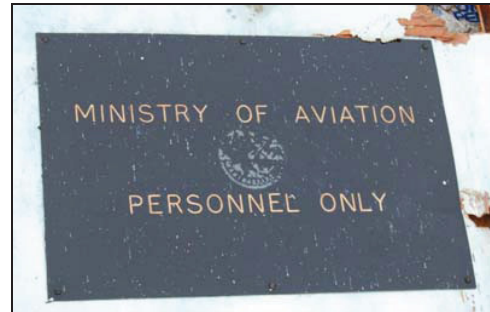
Plate 2: Sign on Door, Eastern Shelter

- 7.1.7 A door lying broken at the base of the eastern stair displays the sign "Ministry of Aviation Personnel Only" and a worn print with the word 'Radioactive' still visible

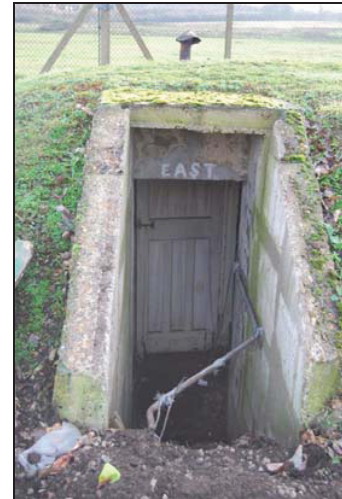
Plate 4: Eastern Entrance To Eastern Shelter

- 7.1.3 Both ends of each shelter have a stair leading in from the north, with a small antechamber at the base, and a small room to the south. Doors at the foot of the stairs and at the entrance to the shelter proper give some blast protection and may also be a gas trap, but the doors and fittings were in poor condition.. There are six steps, and the floor of the shelters lie 1.38m beneath the ground surface outside. The entrance to the stair has an angled concrete wall, reflecting the angle of the earth mounded over the top.

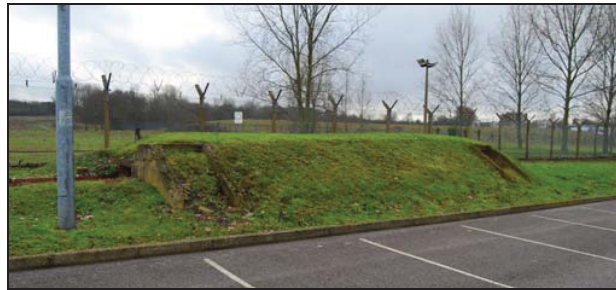
Plate 7: Western Bunker, Looking Southwest

- 7.1.9 The western shelter has been modified, perhaps repaired, with a new stairway in the eastern end with a brick stairwell. The original eastern stair has been blocked and backfilled. The shelter contains wooden decking on the floor, but this does not appear to be original. The fittings are more extensive than the eastern shelter, with all light fittings in place. The fuse box attached to the eastern wall may be an original feature: the cover has a sunburst motif that may be of late 1930s or 1940s date.
- 7.1.10 A sondage excavated at the eastern end of the shelter revealed that a section of corrugated galvanised iron was still extant over the concrete of the body of the structure. A single deposit of gravel-rich brown silty sand (107) formed the mound, 0.33m deep over the roof, and this was sealed by topsoil and turf (106)

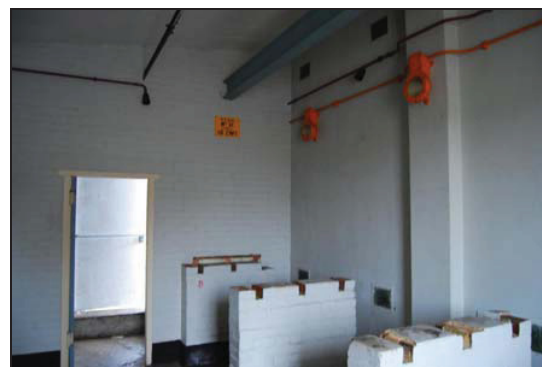
Plate 17: Internal View of Chemical Store.

- 7.2.8 Next to the eastern entrance is a CO₂ station, with fittings for three bottles, and an advertising plaque for Pyrene. CO₂ is a fire retardant, and this may have been present due to the storage of volatile chemicals. A string of reinforced lighting runs along the walls, manufactured by Holophane.

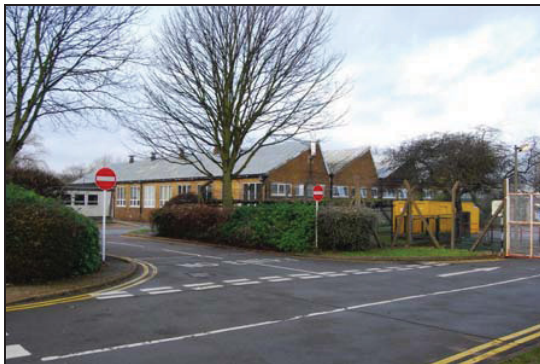
Plate 19: Building 10/8 Looking Northwest.

- 7.2.12 The third extension is a twin of the first phase: an identically sized block with a twin northlight roof. The first and third phase builds can be identified by subtle difference in the details, specifically continuous window lintels of the gable ends on the older part, and individual lintels on the newer. This part of the block has been subdivided into offices, whereas the rest is more open plan, recently in use as workshops.

- 7.2.13 The roof trusses for the northlight roof were partially visible: a girder construction with a kingpost to the ridge and triangular half trusses supporting the long side. The roofing material contains asbestos. Entrance was not possible due to this, but a plan of the building was copied from the paper archives, which shows the layout, but not function of the rooms and the activities carried out within.

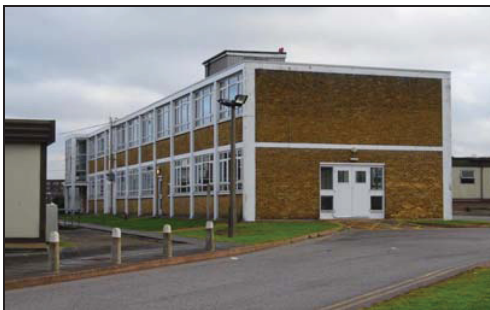
Plate 23: Building 10/10 Looking Southeast.

- 7.2.14 Building 10/10 is a long thin building of two storeys in the centre of the site. It has a girder frame infilled with yellow bricks, and is a well-proportioned building with extensive windows along both sides of both floors. The roof is flat, with an additional plant room. The 1965 Plan denotes it as Workshop Wing Less Pubs & W/Study and notes 'occupied 1st January 1965'.

- 7.2.15 The building measures 41.4m by 8.75m in plan. Access was not possible due to the presence of asbestos, but a plan in the paper archives gives the function of some rooms, including Reprographics, Stores and Post-Room, plus toilets and First Aid on the Ground Floor. There is a staircase towards each end of the building. There are also a set of double doors on the ends at ground floor level. Inspection of the interior through windows appeared to show that most signage and fittings that indicate the use of rooms has been removed, but basic fixtures such as pipework and services remains.

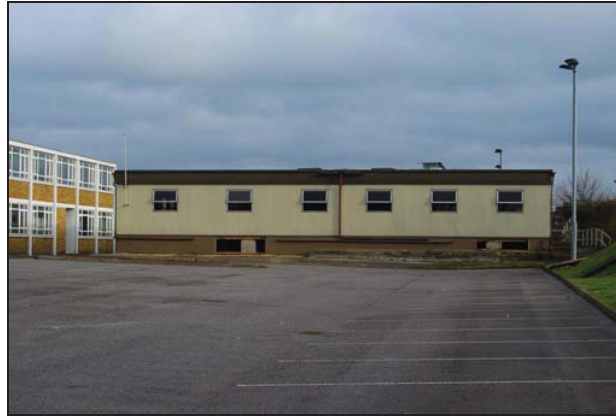
Plate 25: Building 10/12 Looking East

- 7.2.16 One of two modern blocks on the site; Building 10/12 is a rectangular building with multiple rooms inside. There are plans of this building in the paper archive. The building is typical of modern (post 1990) buildings, with prefabricated walls, floors and ceilings. It is constructed to provide a rapid solution for the office needs, with a lightweight building which may be classed as temporary, although these has been on the site since 1991.
- 7.2.17 The building is single storey, with step and ramped access, with windows on all sides. A door in the north is the principal entrance. Small skylights towards the centre of the building provide natural light for internal rooms. The building stands on breezeblock piers.

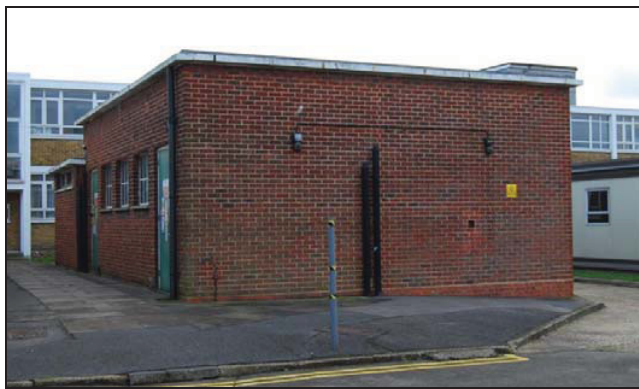
Plate 26: Building 10/13 Looking Southwest

- 7.2.18 This small red brick building houses CO₂ and gas and electricity supplies, with a small addition on the southern end with a Gents toilet. There is no plan of this building in the paper archive, and there was no access because the services within were still active. The building is of single storey, has a flat roof and is of functional design. The few windows are Crittal windows and the sills concrete.
- 7.2.19 The door to the CO₂ store is covered with signage, dominated by a CO₂ sign with a logo for the Pyrene Company Ltd, on the Great West Road, Brentford,

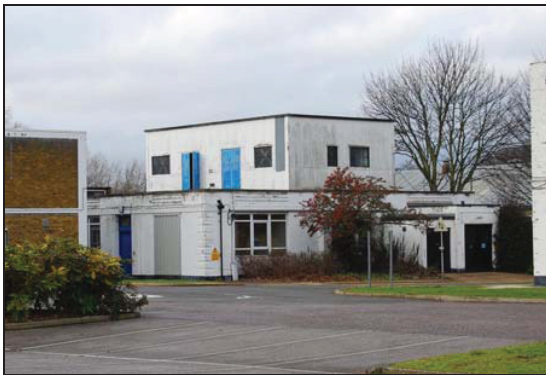
Plate 29: Building 10/14, Looking Northeast

- 7.2.20 This structure is depicted on the 1938 map, and stylistically suggests an art-deco influence. Although quite plain and utilitarian, the building has well-lit internal rooms with large windows, while the exterior brickwork is adorned with almost rusticated quoins and each long side, facing east and west has a central bay flanked by squared brick pillars. The pillars have tile and bricks on end at the tops, giving a hint of the ornate. The historic map describes the rooms of this building as 'Battery Room' and 'Power Switch', where legible. The rooms are accessed off a central north-south corridor.

- 7.2.23 The partial first floor part of the building is clad in corrugated galvanised iron (CGI), with hints of army green showing through. This may be a later addition or repair to the building, since it contrasts strongly with the building materials of the ground floor.

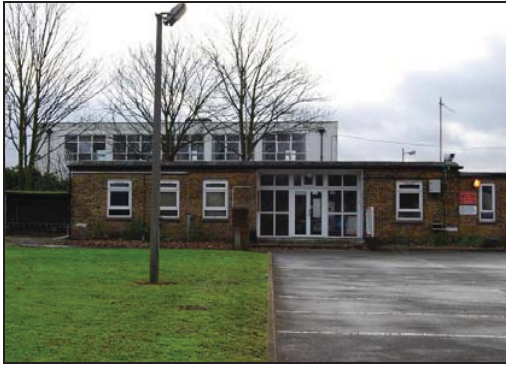
Plate 31: Front of Building 10/15, Looking South.

- 7.2.26 The main entrance to the building is across an apron of tarmac, and this was also the entrance for the site. The doors open onto a fairly large room with a reception desk towards its rear. A corridor leads east to a group of four rooms: two offices and two toilets. A second corridor leads south to more toilets and kitchen areas, as well as to two 1960s extensions: one is a store; the other is of unknown function. To the west of the reception area are two offices.

- 7.2.27 The interior is in good condition, with floor and wall surfaces undamaged. What is notable is the lack of signage designating functions of each room, or the personnel who may have worked there.

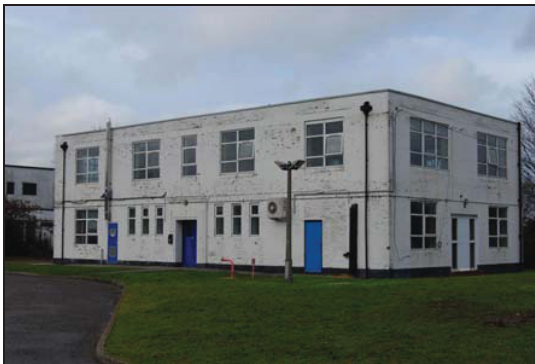
Plate 33: Building 10/17, Looking Northeast.

- 7.2.28 Directly east of Building 10/14 is a rectangular two-storey structure first depicted in 1939, and therefore slightly later than Building 10/14. It is well-proportioned and appears to be in good condition. The map describes this as a drawing office, but also telephone exchange and 'Libra club'.

- 7.2.30 The external aspects are plain yet attractively proportioned, and the large windows give adequate light to all internal spaces. The sills are brick, the lintels concrete. The tops of the walls have concrete wall plates with a low parapet wall above. The exterior is painted white with black paint below the damp course, and makes an attractive group with Building 10/14. It should be noted that this white colour was not suitable for camouflage during the Second World War, the site being a potential target for bombing raids, therefore a post-war paint scheme.

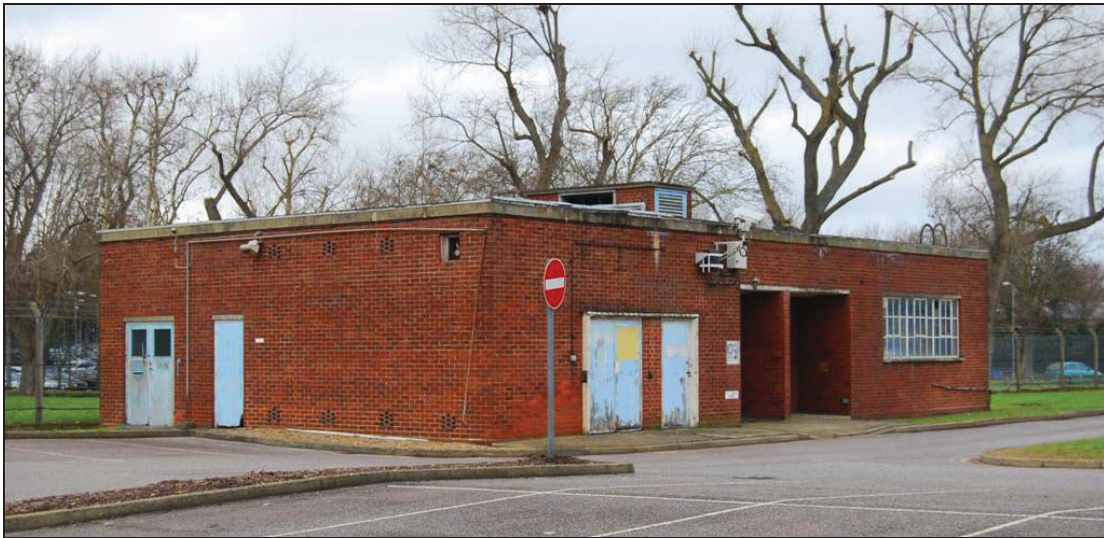
ORIGINAL FUNCTION: Chemical research laboratory CURRENT FUNCTION: Store/ Abandoned

The building is a single storey building constructed in red brick laid in stretcher bond with a concrete roof supported on iron beams. An air conditioning unit lies towards the north, above the roof level. Doors in the south, west and north lead to internal rooms. A central passage provides access to all rooms, many of which are partitioned with metal and glass screens. Three units of Crittal windows on the east side and one unit on the west side provides light to the former laboratories. A central hipped skylight provides light to the middle of the block.

Internal floors are concrete. Internal surfaces are painted. The entire building is suffering from gradual failure of the flat roof.

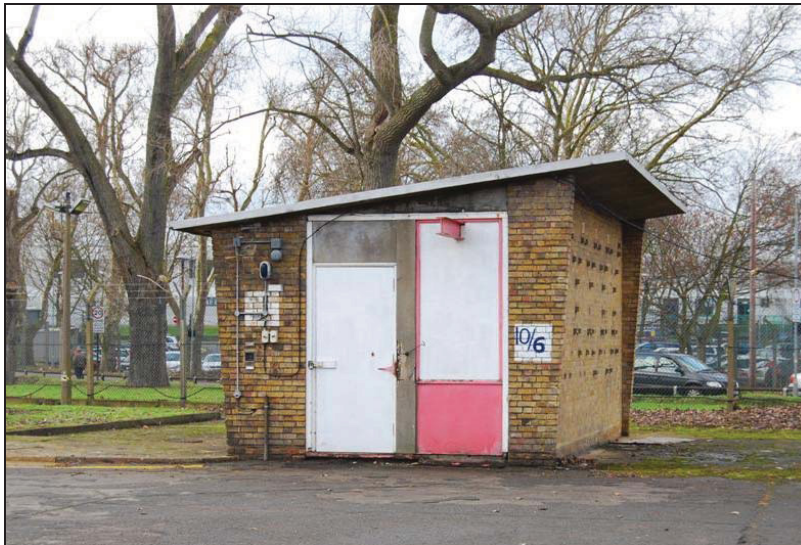
ORIGINAL FUNCTION: Oil and Spirit Store CURRENT FUNCTION: Chemical store/ abandoned

CONSTRUCTIONAL TYPE: Brick DIMENSIONS: 8.05m by 4.02m

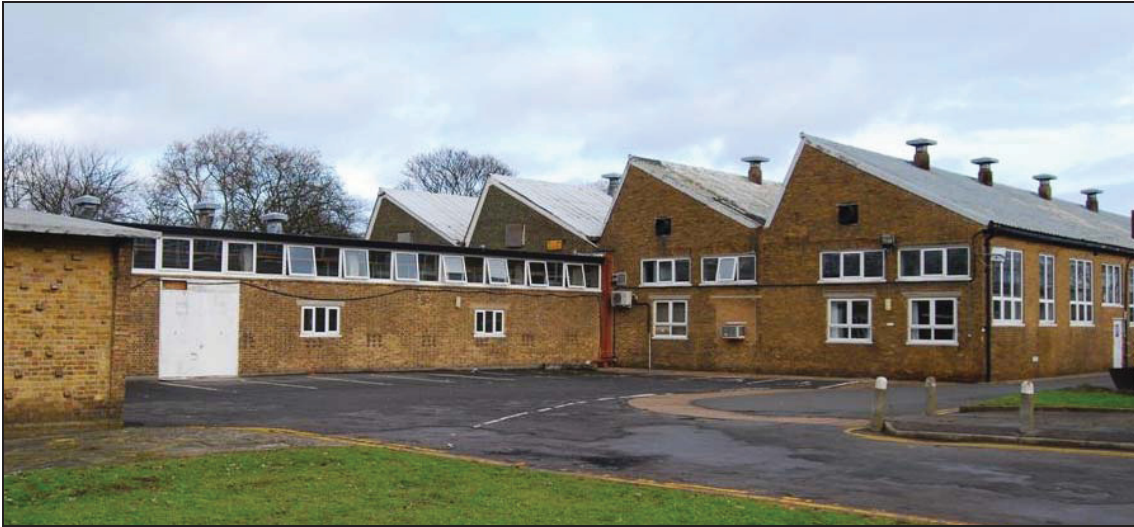
ORIGINAL FUNCTION Offices and Workshops CURRENT FUNCTION: Offices and Workshops/
Abandoned

CONSTRUCTIONAL TYPE: Brick, DIMENSIONS: Maximum 70.3m x 30.2m

The windows are recent replacements of assumed Crittal windows. Some reorganisation of personnel flow is shown by a blocked door in the eastern elevation.

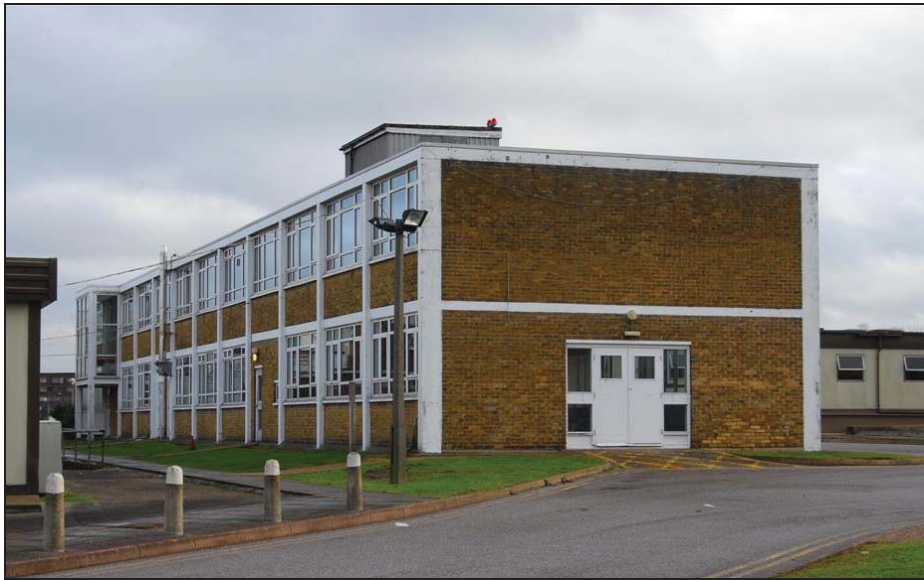
ORIGINAL FUNCTION Workshops and offices CURRENT FUNCTION: Office/ Abandoned

CONSTRUCTIONAL TYPE: Brick with girder frame DIMENSIONS: 41.4m x 8.75m

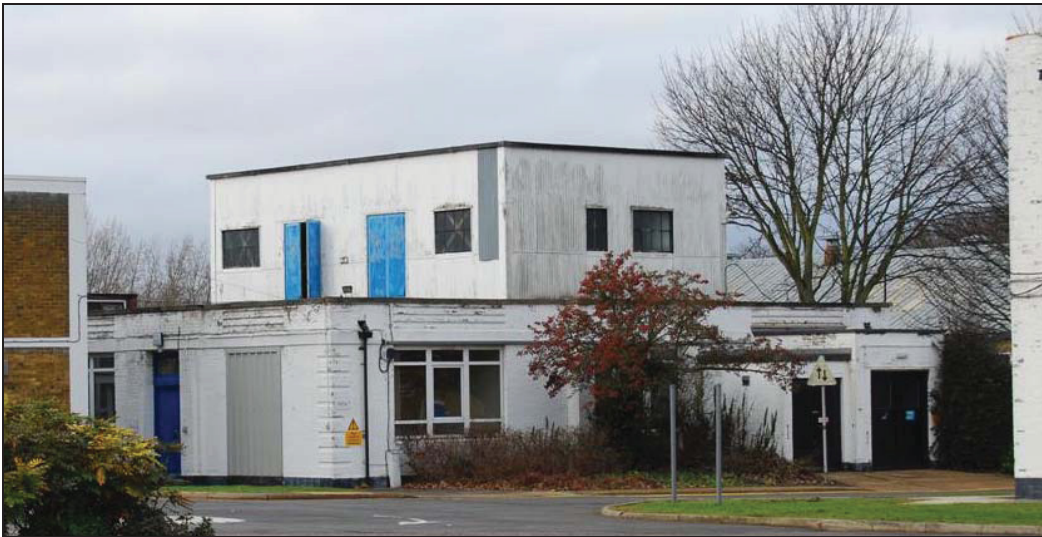
ORIGINAL FUNCTION: Battery House

CURRENT FUNCTION: Workshop/ Abandoned

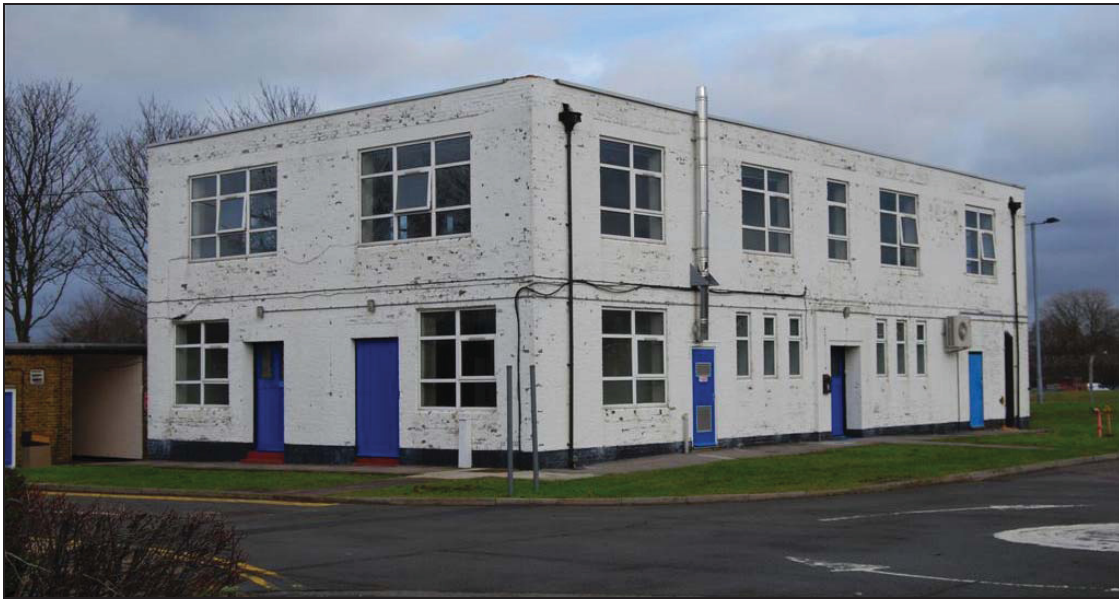
ORIGINAL FUNCTION: Drawing office and Telephone Exchange

CURRENT FUNCTION: Office
