Strood Riverside, Sustainable Transport Link, Strood, Kent: A Historic Building Record and Watching Brief

Planning Application Number: MC/09/0933

AOC Project No: 30927

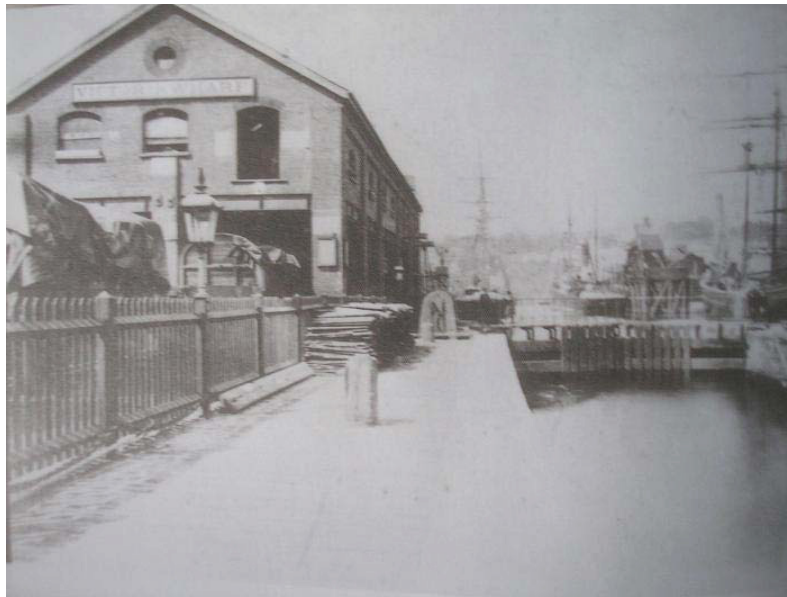
Plate A: The Strood Lock, Looking Towards the River Medway.

Photograph taken c. 1910.

- 4.20 The canal inlet with curving brick seawall is still present leading into the outermost portion of the lock chamber with the much decayed twin sets of outer lock gates. The majority of the landward section of the lock chamber has now been infilled and lies under 1980s housing. In addition to the lock chamber and gates, various fixtures and fittings including chains, ladders, shackles and a capstan were present.
- 4.21 There are a number of other heritage features close to the route of the new link road, including Strood pier and 19 WWII pimples (anti-vehicle obstacles); however these will not be affected by the development (Mott Macdonald 2010).

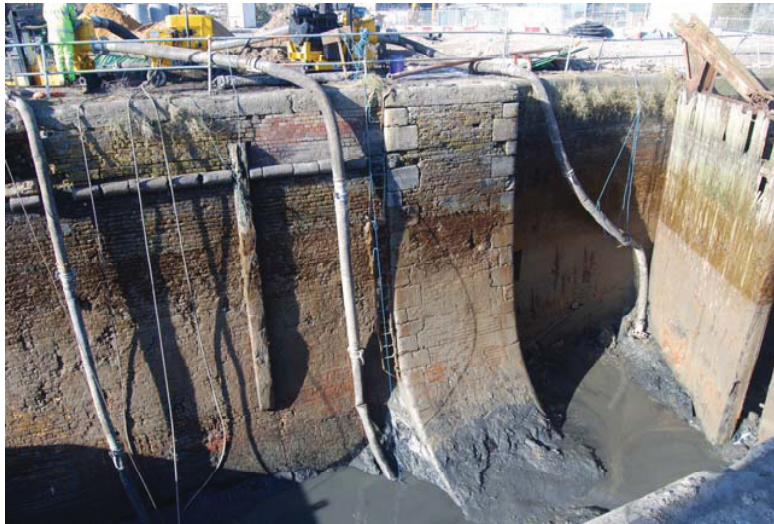
Plate B: Basin walling and buttress curving into base

- 8.6 The canal basin comprises several sections. To the northwest is a short area between the modern steel plating and the inner gates, which has vertical walls, dropping to a base sealed by concrete. Two hollows in the brickwork mark the location of sluice equipment that is no longer present. The two sets of gates stand either side of an area slightly set in, by 0.25m, with stone quoins. One of the stones on the northeast side next to the outer gate is inscribed with the number '16'. Between the gates is a second pair of square hollows, also once the settings for equipment related to the working of the gates. Outside of the second pair of gates, the canal has a flat base within their area of swing and has vertical sides that are slightly concave in plan. Beyond this a principal brick buttress with an inverted arch at the base rises to each side of the canal, the buttress having stone quoins. The coping is formed of regular rectangular blocks with a bullnose curve and are 0.48m thick. The base of the buttress is at -3.14mOD.

- 8.7 Strickland reports generally on lock walls that they are 'generally founded on a hard natural bottom, but frequently on a system of piles well-driven and bound together. A flat segment or inverted arch, is sometimes laid on the wooden bottom.' (Strickland 1826, p8). This arch is present at Strood. Strickland also describes the lock chamber at the Thames and Medway Canal as 'a beautiful and substantial piece of work', and the inverted arch as a 'stone torus...which serves as a fender and protection to the brickwork (Strickland, 1826, p8).

- 9.2 The canal walls and base are in good condition, with occasional patches of rebuild, which show that the canal was kept in a good condition of repair until its fall from use. The original condition has been much altered by the addition of a metal wall at the landward end of the site and the addition of a concrete base. The stonework and yellow stock bricks that form the basin walls are all original. The two sets of gates hang from a block that projects slightly from the mainline of the wall. The end of the masonry at the base of the basin is marked by a large buttress. There is no brickwork base to the riverside of this buttress, just rammed chalk and retaining beams.

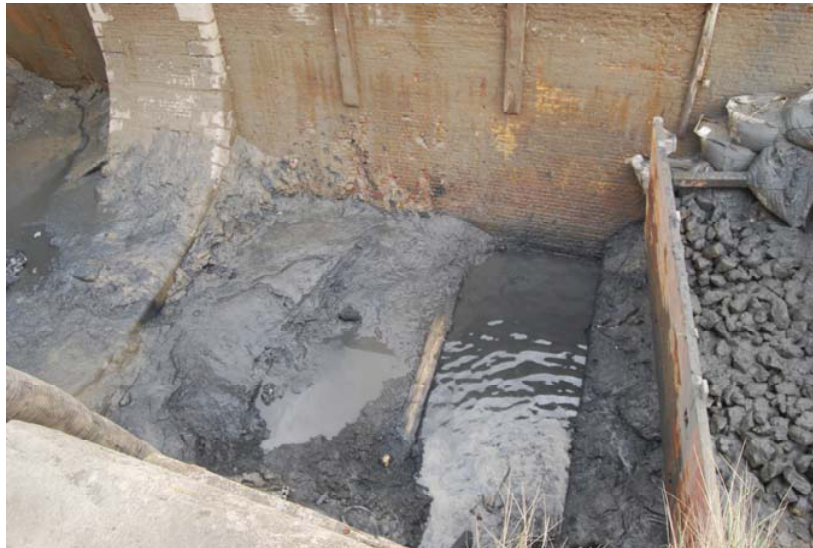
Plate C: Base of basin showing timber compartmentalisation

- 8.7 Outside the buttress towards the river, the canal does not have a masonry base. The base of the canal entrance is formed of rammed dark brown silty clay and chalk rubble to a depth of over 0.6m. This lies within timber compartments that span the base at intervals of 2.43m. The canal entrance is 7.4m deep from the coping stones to the base of rammed chalk in its base at -3.25mOD. This is 0.1m lower than the buttress.

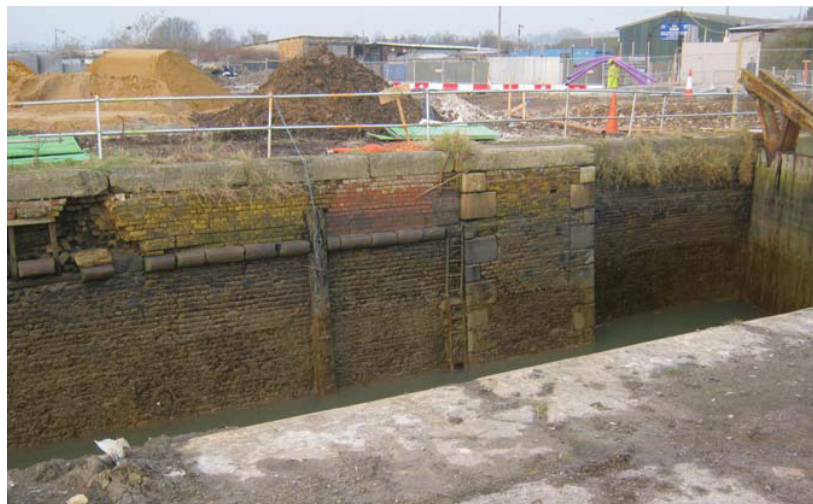
Plate D: Basin wall showing coping, rubbing fender and ladder

- 8.8 Rubbing fenders along the curved entrance to the basin are rectangular in profile, made of box halved pine, and are eroded below -0.85mOD. The outer curve also features a course of projecting rounded stone blocks at 3.40mOD. This corresponds to the high water mark. One ladder is present, made in short sections and attached to the wall just outside the buttress. This is the only fitting of this nature that is present within the basin.

- 9.3 The use of rounded stones near to high water level is likely to be a measure to prevent barges or boats from catching and tipping with the rise or fall of the tide. The use of rubbing fenders prevented some damage to the lock walls, but scars and dents were still clearly apparent.

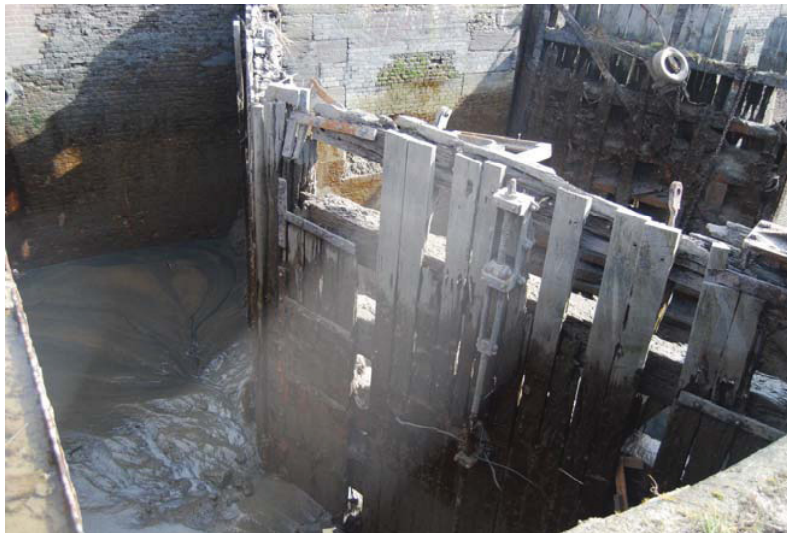
Plate E: Inner Lock Gates

- 8.9 Strickland's report of 1826 records the lock gates as cast iron with hollow coins and mitres, the ribs eighteen inches apart (Strickland 1826, p9). The gates are also recorded as curved. Neither pairs of gates correspond to this description, indicating both are replacement features. The inner pair of lock gates are constructed in the same way as each other and are therefore probably contemporary in

date. These gates are faced with regular planking on the northwest, landward, face, the planks 0.22m (8½") wide and 0.05m (2") thick. These are nailed to the frame with what were originally square headed nails, which are now heavily corroded to shapelessness.

- 8.10 The frame of each gate is formed of large boxed beams 0.40m square. The visible part of each of the gates had six cross members between uprights, 0.61m apart. Three lower cross members were also visible, which lie directly upon one another with no spaces in between; this conjoined planking contained the gate sluice. On the planked side, the sluice lies below the level of modern concrete. The beams are assumed to be attached to the uprights with mortice and tenon joints. Additional support is given by large L-straps on the corners and T-straps below, bolted on with hexagonal nuts passing directly through the beams to twin straps on the opposite side. The straps were added after the planking and clearly continues behind the strapwork.

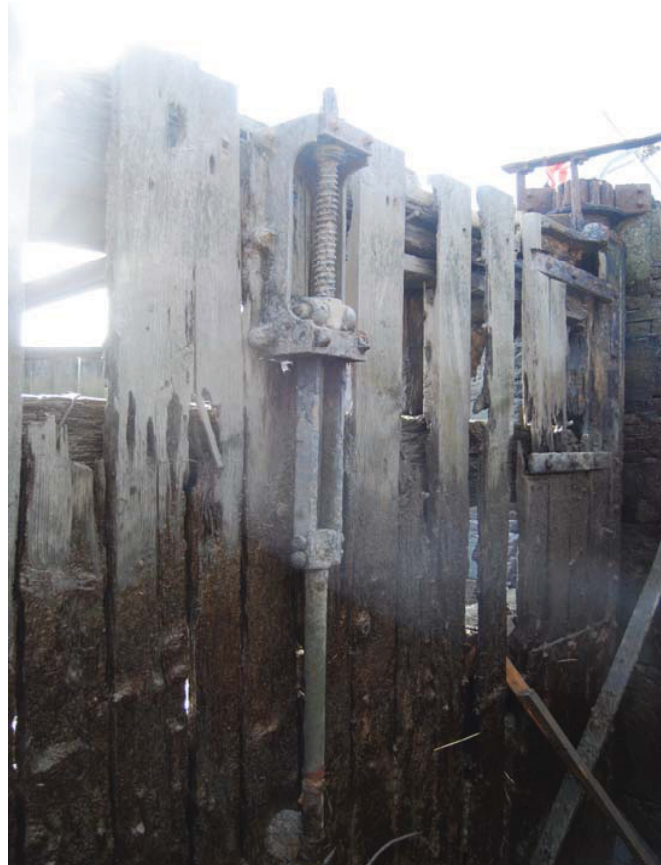
Plate F: Detail of sluice mechanism on inner lock gate

- 8.12 The furniture and equipment associated with these gates is largely missing. The surviving equipment includes iron rings, one walkway strut from the top of Gate A1, hinges, and one partial paddle rod, also on gate A1. Two iron rings are bolted to the top beams of each gate. These may have held chains to help close the gates. The walkway strut is cast iron, and has fallen from its original position, but is the only survival of a walkway across the gates. This strut has a T-shaped profile, and appears to be a later addition. The paddle rod on gate A1 has an upper and lower housing bolted onto the planked surface. A section of the rod at the top has a screw thread, and engages with the upper housing. The paddle itself is missing, as is the bottom end of the rod. The paddle sluices have iron frames. Two square plates with hoops at low level on the landward side contain chains that disappear into the concrete below. Strickland describes these as valves, and offers a similar description of the original paddle mechanism as that used here, although the gates are not original (Strickland 1826, p.10). These may have once held chains that helped open the gates. However, so much of the basin furniture is missing or sealed below more recent concrete that the exact

mechanics of operation were unclear. Strickland illustrates runners at the base of the gates, affixed by chains to capstans on the lock side (Strickland, 1826, Plate 12).

- 9.5 The workings of the sluices and paddles are mostly missing from the gates. This does not enhance the archaeological record, or an understanding of the technology. However, the location of the paddles is present, so the potential height difference for raising and lowering the water level is revealed. The exact method for opening and closing the gates will in part have been eased by water pressure. The inner gates may have used chains, the outer gates may have had balance beams. Stricklands report (1826) mentions that the gates were operated by chains attached to wharfside capstans, and the low level chains may be a remnant of this technology. However, the loss of the capstans has removed evidence for whether this method was used for the later gates. Possibly, the motors failed. The balance beams may be additions to the tops of the gates following failure of the chain method.

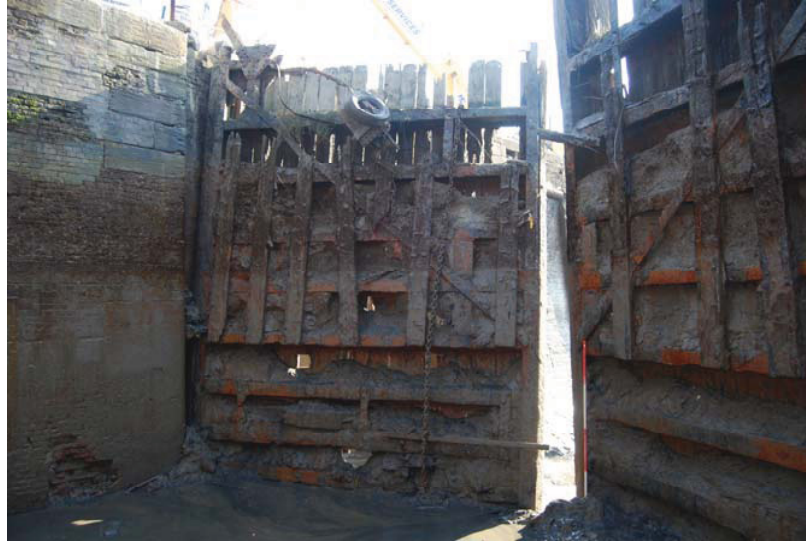
Plate G: Landward side of outer lock gates showing framing

- 8.14 The outer pair of gates have a planked external face bolted to an iron frame. The iron frame is made of I-beams 0.38m wide with 0.08m wide flanges at intervals of 0.92m near the top, narrower to the base, where remains of paddle housings remain. It is assumed that the iron frame is bolted together. The paddle rods and paddles themselves are missing. The planking on these gates is wider than that on the inner pair: in this instance each plank is 0.075m thick (3") and 0.28m wide (11"). Both gates have paddle frames near the base, formed of a cast iron frame with two bars. Part of a rod rises for 1.5m from gate B2.

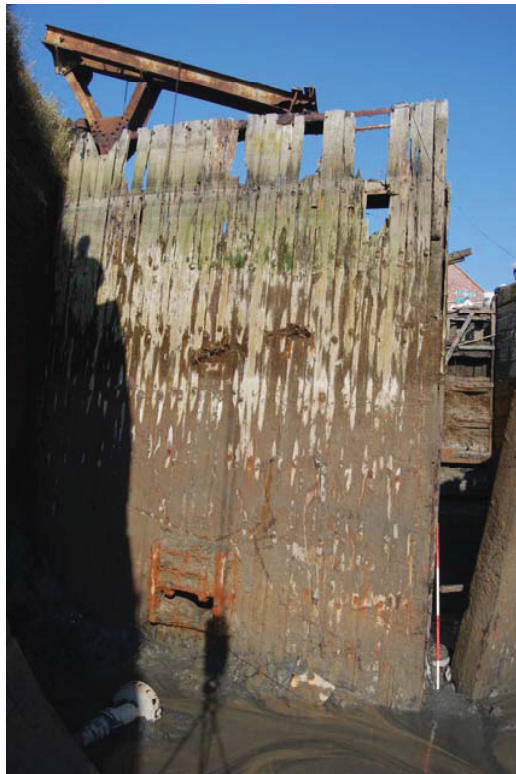
Plate H: Seaward face of outer lock gate showing planking and sluice

- 8.15 The gates' hinges are strapped to the coping blocks on the side of the quay, and are clearly later additions. The different form of these gates to that of the inner pair is particularly noticeably in their

opening technology: a pair of I-beams are bolted with a curved bar to the top beam with a trapezoidal plate holding an inner pair of struts. This strongly resembles the beginnings of a balance beam for manual opening. The struts are attached to a lower beam by an iron bar. The metalwork on Gate B2 is heavily corroded and less well preserved than Gate B1

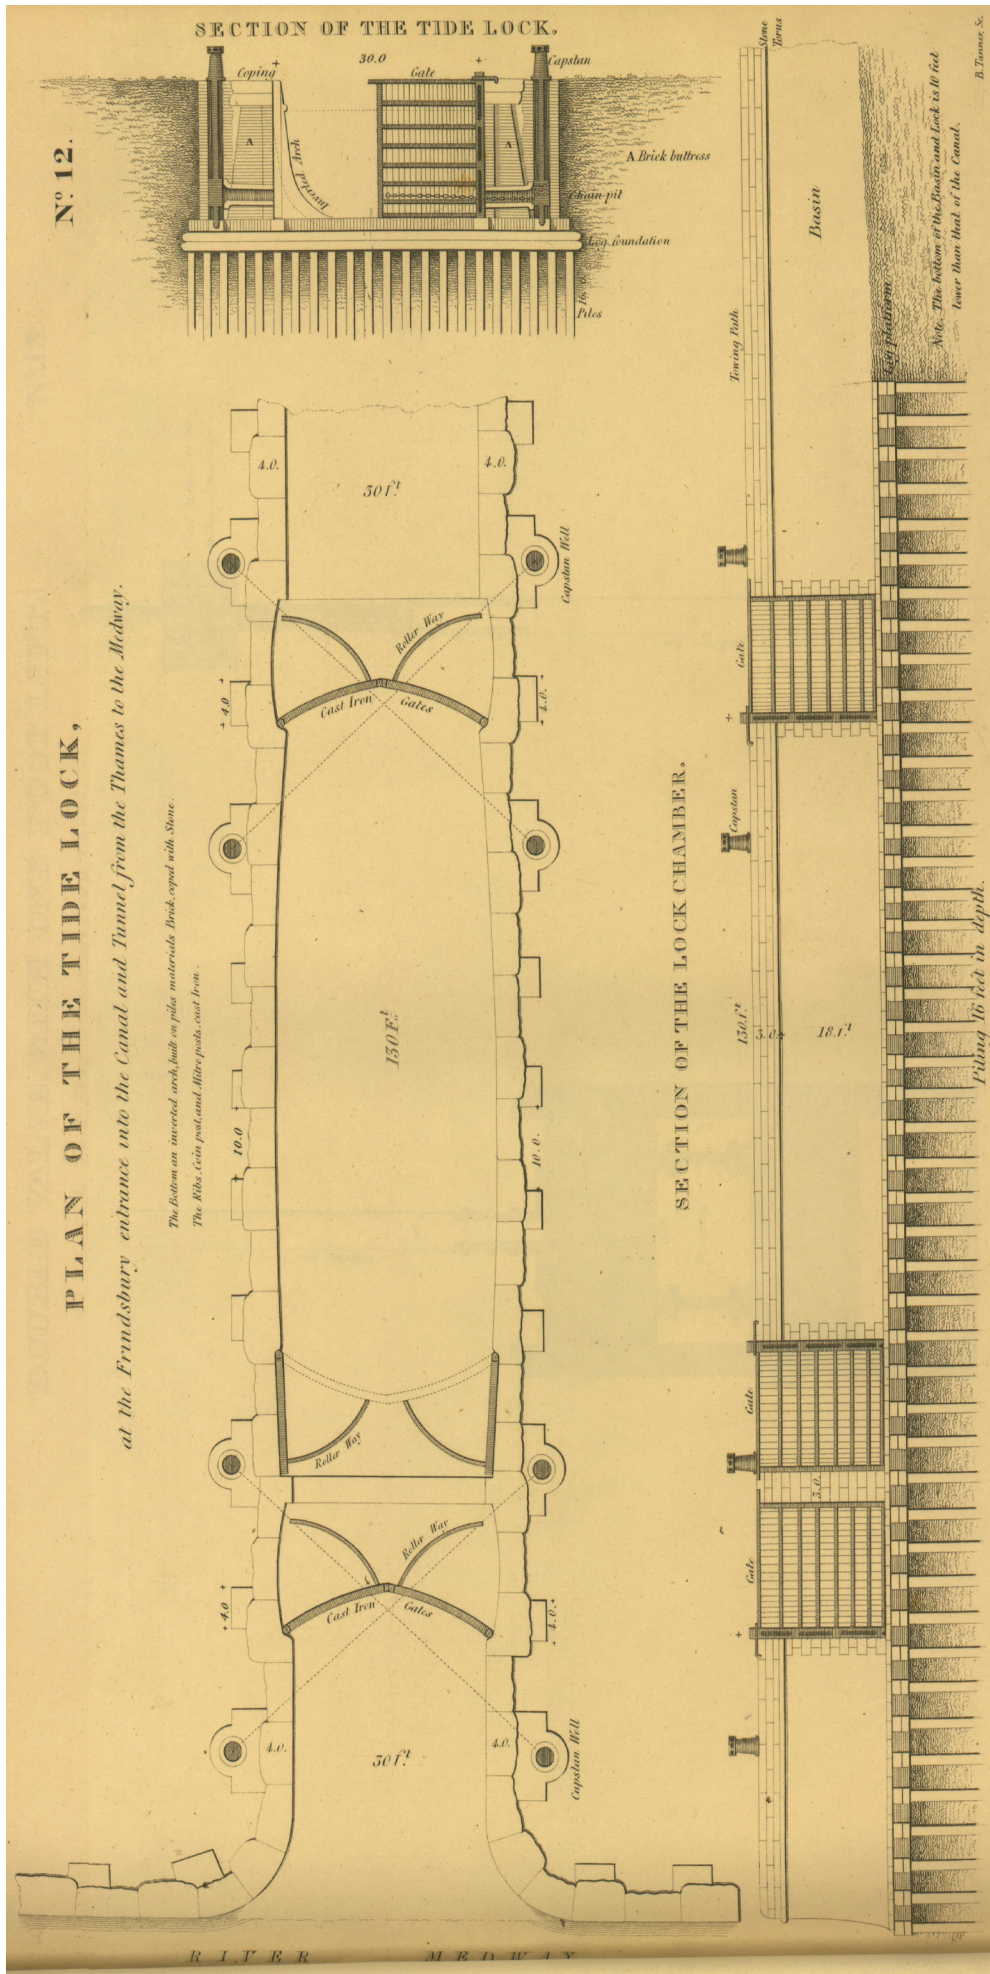
Figure 10: Plan and Sections Showing Lock Design

- 4.18 The base of the lock chamber was curved in section to conform with the shape of seagoing vessels hulls and again fashioned from red brick. The lock base rested on log decking which itself was laid over a dense piling of timber uprights sunk 16' into the underlying alluvium (Fig. 11); the lock and basin at Frindsbury was fully 10' deeper than the canal itself, which had a maximum depth of 7' (Figure 10).

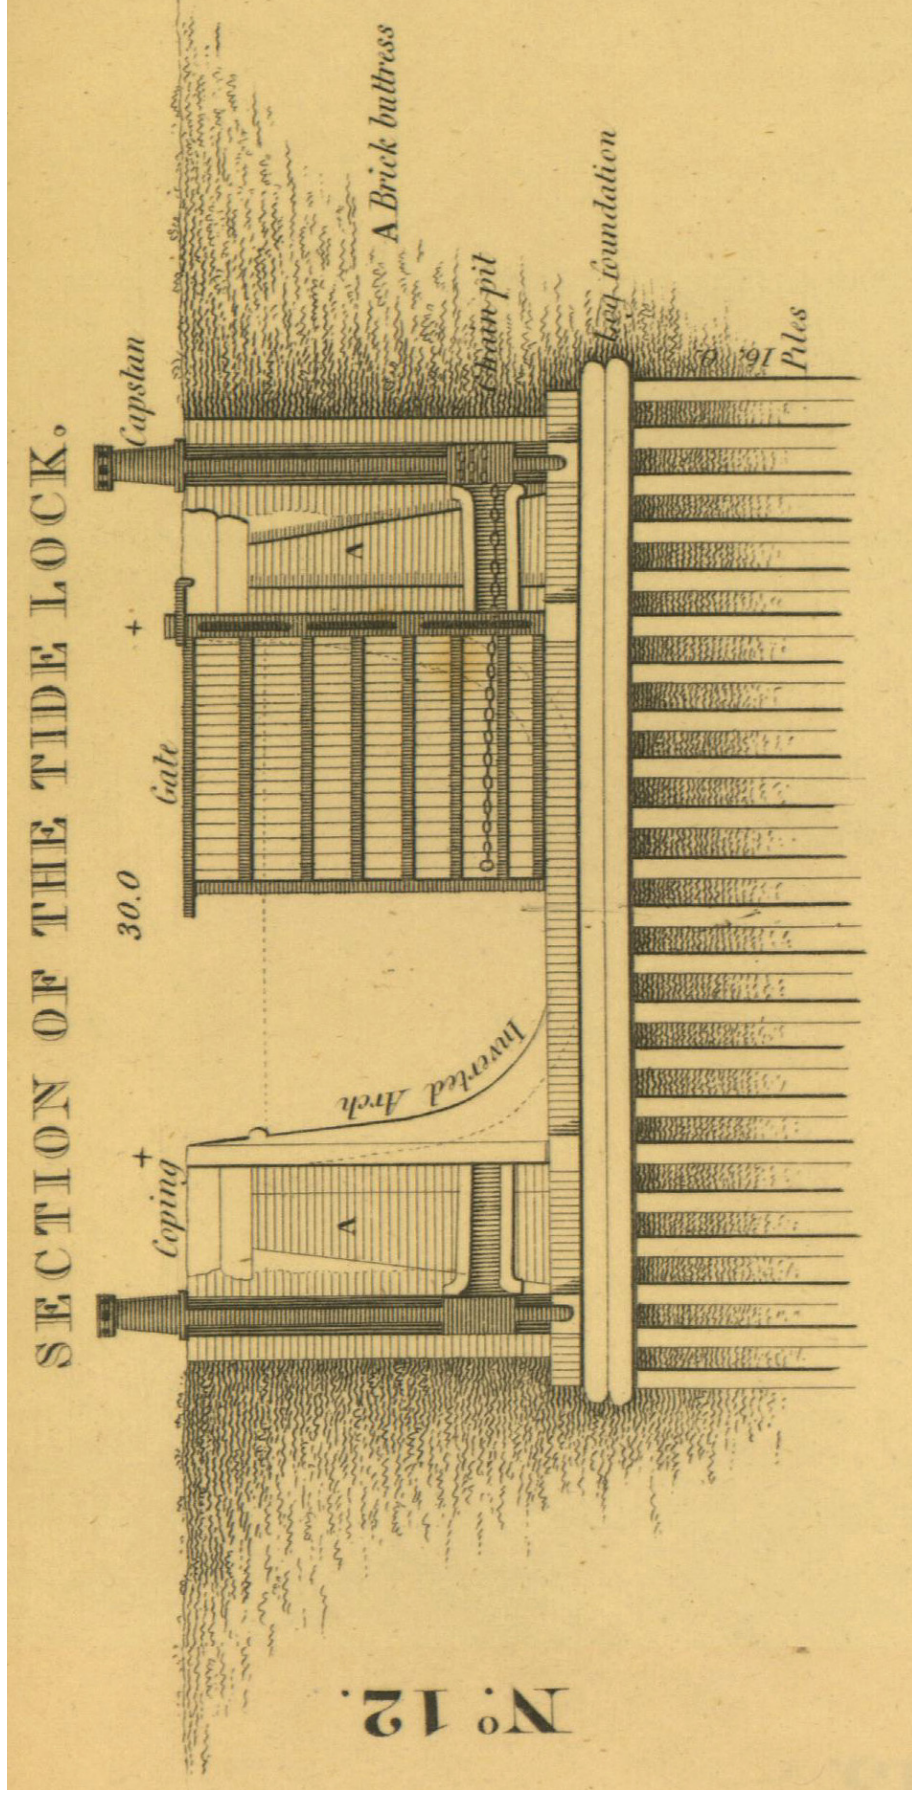
Figure 11: Section Showing Lock Design

- 4.15 The basin and lock at the Medway end of the canal was actually completed in 1822 and was known as the Frindsbury Basin. In design the lock was almost identical to the earlier lock constructed 1799 – 1801 at the Gravesend junction of the canal with the Thames. The principal difference was that the Frindsbury Lock was larger and could accommodate vessels of up to 300 tons compared with only 200 tons for the Gravesend Lock. Strickland’s report of 1826 claimed that the Frindsbury Lock was one of the largest lock chambers in England and offered “accommodation for loading and ballasting vessels of every description, with the greatest despatch.” The earliest available drawings of the lock are to be found in Strickland’s report on the canals and railways of England (Strickland 1826); these are reproduced as Figures 10 – 12 of this report.
