Bleachingfield, Dunbar, East Lothian: Evaluation Data Structure Report

AOC Project 21807
4th February 2011

On Behalf of:	East Lothian Council John Muir House Court Street, Haddington, East Lothian EH41 3HA
National Grid Reference (NGR):	NT 6753 7873 (centered)
AOC Project No:	21807
OASIS Project No:	archaoc1-92995
Prepared by:	Lindsay Dunbar
Illustration by:	Stefan Sagrott
Date of Fieldwork:	1st – 2nd February 2011
Date of Report:	9th February 2011

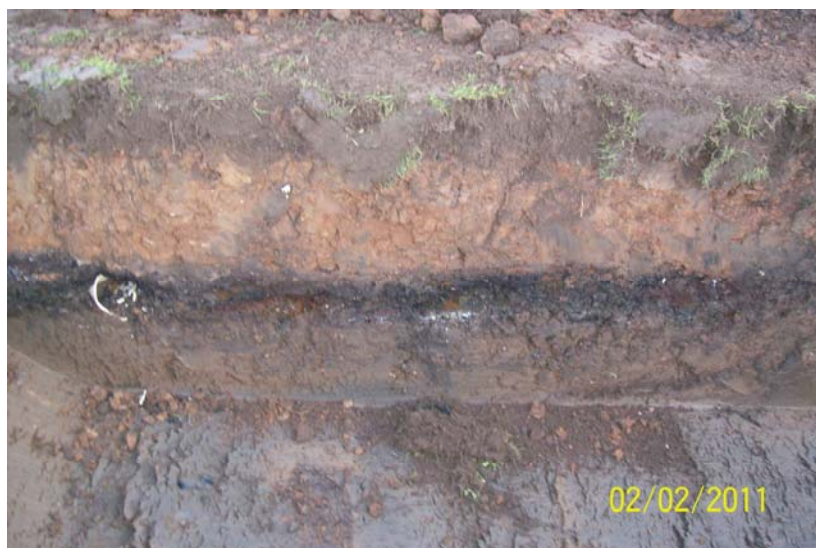
Plate 1: South-facing section of Trench 4 showing extent of made ground

- 4.1.2 The generally flat development area was a mixture of carpark, hardstanding, footpaths, play park and grassed areas. Trenching showed that across the development area there was at least 1.1 m of made ground, which in places extended to a depth of 2.0 m. The excavation of the trenches revealed a very similar stratigraphy across the entire site suggesting that the area was built up in a concerted and planned effort to create a flatter area, smoothing out natural hollows and rises.

- 4.1.3 The madeground consisted of two main layers. The basal layer present in all trenches varied from 0.2 m to 0.6 m thick and consisted of a dark sandy matrix which contained modern white glazed ceramics, oyster shell, bone, glass and large amounts of burnt material such as ash and cinder. Overlying this layer was a thick deposit of relatively clean redeposited pink/orange clays and sands. Again this layer was present in all trenches, though in Trench 7 it appeared to be truncated and replaced with crushed sandstone and mortar rubble. The trenches with hardstanding (Tr.1) and those in the carpark (Tr.7 and Tr.8) have additional layers of tarmac, bedding gravel whilst the trench within the playpark (Tr.6) had modern rubber matting, tarmac and bedding gravels but in general these two layers of madeground existed across the site.

<i>Depth of Excavation</i>	Up to 1.2 m
<i>Trench Stratigraphy</i>	Turfed surface, with up to 0.15 m thick topsoil lying over a mixed dump deposit of a redeposited natural red/orange clays and sands. This deposit was between 0.4 m and 0.5 m deep and overlay a dark sandy matrix which contained modern white glazed ceramics, oyster shell, bone, glass and lenses of ash/cinder. This deposit was between 0.3 m and 0.4 m thick and lay over a possible buried topsoil deposit. This brown sandy matrix was only up to 0.2 m thick and lay over the natural geology.
<i>Subsoil</i>	Orange/Red clay with red/grey sand in patches
<i>Significant Features</i>	None
<i>Finds</i>	Modern ceramic and glass noted within redeposited made ground.

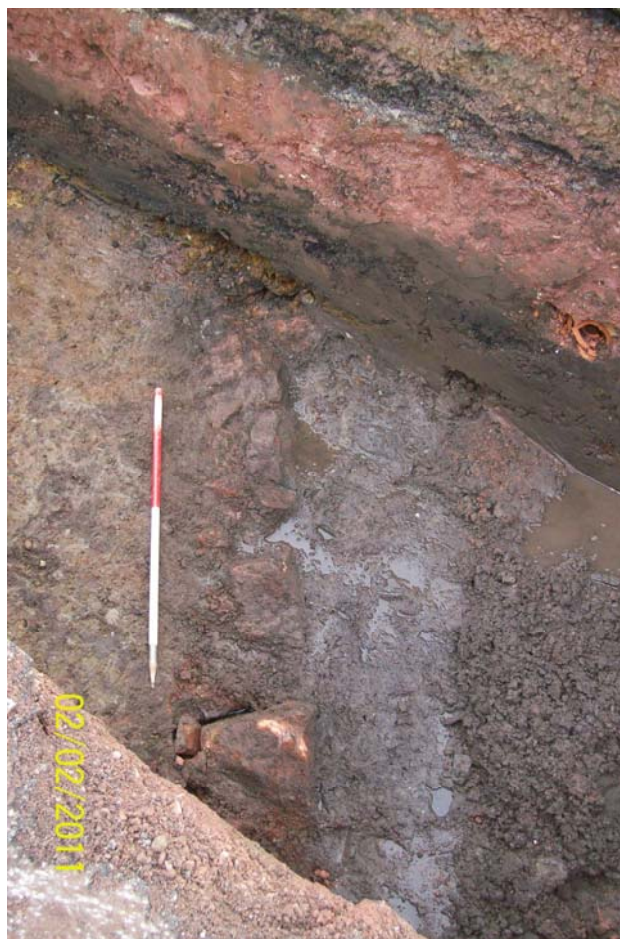
Plate 2: Wall [801] viewed from north, Trench 8

- 4.1.6 In Tr.1 and Tr.8 lay the remains of two sandstone walls cut into the natural geology and underlying all of the dumped material. They were on similar NW-SE alignments and both were unmortared. In Tr.1 sandstone wall, [101], measured c.0.6 to 0.7 m wide with two courses of stone present whilst sandstone wall, [801], measured c.0.35 to 0.45 m wide with only one course of stone present. In Tr.8 wall [801] was directly overlain by a spread of modern white glazed ceramic sherds within the base of the ash/cinder layer immediately overlying the wall.
- 4.1.7 No significant archaeological features or artefacts were identified during the evaluation. The only artefacts (ceramics and glass sherds) noted during the evaluation were modern in date, the majority dating from the latter part of the 19th Century and early part of the 20th century.

- 5.2 The significance of the two sandstone walls is difficult to ascertain. Their form was not much more than seen in a rubble drain, though given the size of the stones and closeness of the positioning they are believed to be wall bases rather than drains. No finds were derived from the cuts of the walls. It is unlikely that the new development will impact upon these features given their location in relation to the new buildings to be erected on the site and more importantly the depth of made ground covering these features.

Subsoil Orange/Red clay with red/grey sand in patches
Significant Features Unmortared sandstone wall, [801], aligned NW-SE. Cut into natural, c.0.35 to 0.45 m wide with only one course of stone present. A spread of modern white glazed ceramics directly overlay the wall.
Finds Modern ceramic and glass noted within redeposited made ground.
