Linlithgow Sports Club: Watching Brief Data Structure Report

AOC Project 21763
Oasis ID: acoarcha1 94333
June 2011 Revision

This report represents the results of an archaeological watching brief on ground reduction works associated with the construction of a new car park and associated access roads and drainage by AOC Archaeology Group at Linlithgow Sports Club, Linlithgow.

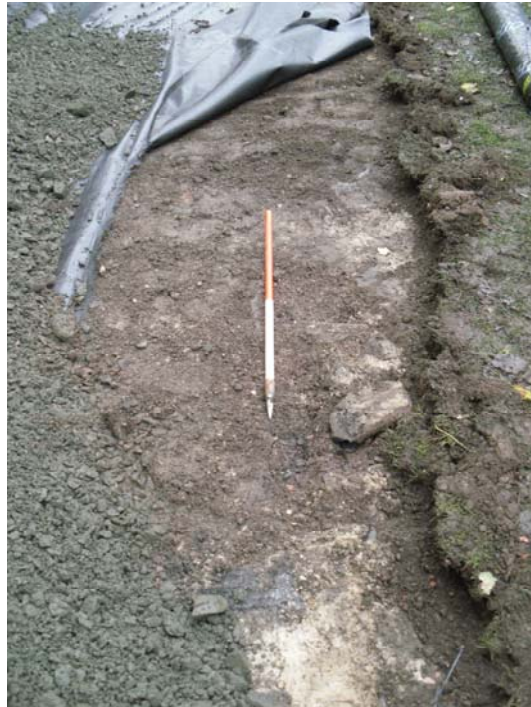
4.2 During the excavation of the western road the remains of a stone-built wall or surface [02] were found directly below the topsoil (Plate 1). This was constructed from irregularly shaped, flat stones and extended 2.9 m east to west with a width of 0.9 m. The feature was found in association with loose light yellow sand believed to be degraded lime mortar. As the stones are generally flat it is believed that they are more likely to be the remains of a surface. A small fragment of 19th-20th century pottery was found on the surface of these remains. Further stone remains [03] were also found directly below the topsoil during the excavation for this road in the form of a short alignment of

Plate 1: Wall/surface remains [02]

- 5.2 With regard to the stone features (02) and (03) the 3rd edition Ordnance Survey map shows a football pitch which has an access track on its northern side. The remains are located in this area and are likely to be the remains of this track or walling associated with the track. The track does not appear on the earlier 2nd edition map of 1896.
- 5.3 Plate 6 also illustrates the supposed site of St. Magdalen's Hospitium or Hostillarie. No evidence relating to this site was found during the watching brief.

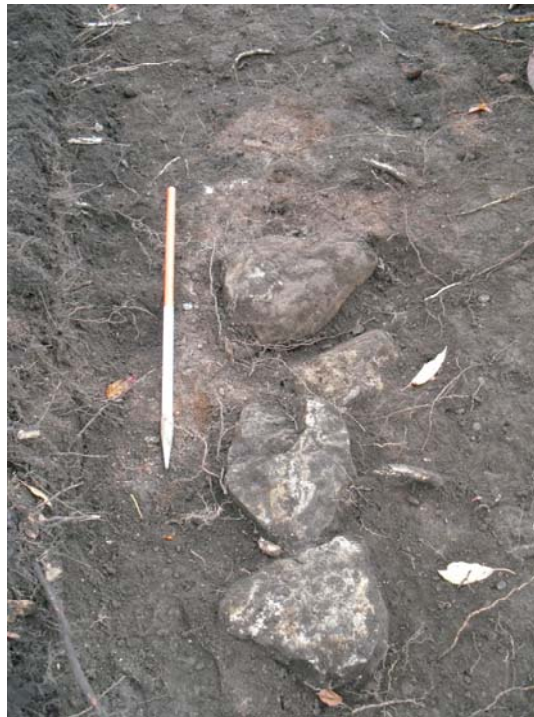
irregular shaped stone again surrounded by a degraded lime mortar (Plate 2) on approximately the same alignment as [02]. Both these features were left *in situ* and buried below the new road (Figure 1).

Plate 2: Wall remains [03]

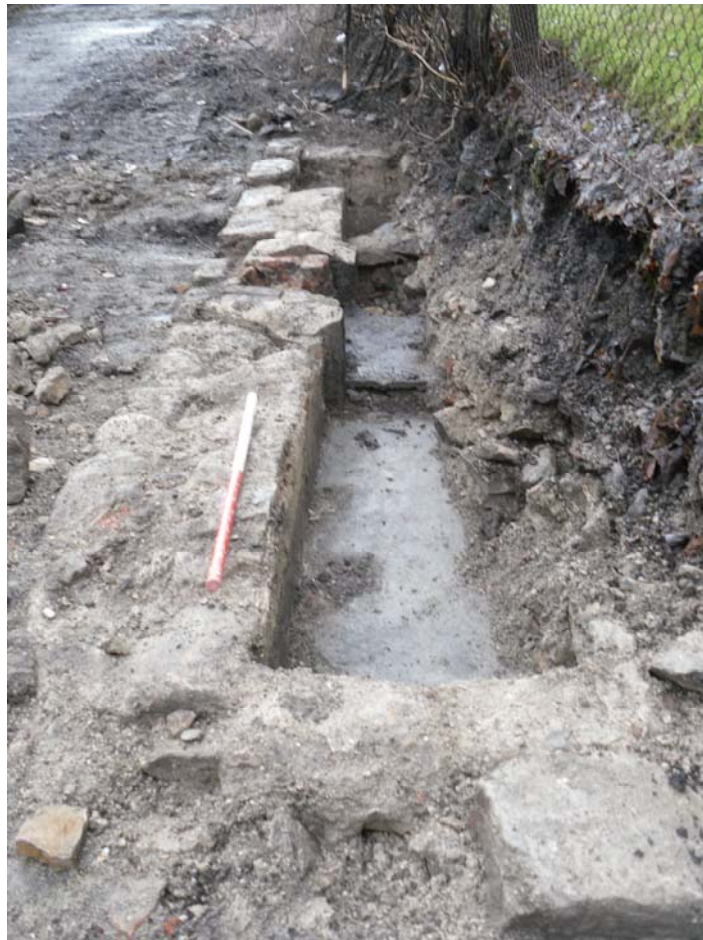
- 4.3 The only other remains found were on the route of the southern access road (Figure. 1). The work involved the cutting back of a steep bank so that a new retaining wall could be built down the western side of the road. Directly below the bank constructed from Type 1 hard core were the gable remains of a building (Figure 2; Plate 3). The remains extended out from the bank for a distance of 2.7 m and had a width of 6.2 m north to south. The walls of the building [07] were constructed from roughly worked and faced stone blocks of varying size, but typically 0.5 m by 0.2 m by 0.2 m. The remains were bonded with lime mortar and were laid in up to four random courses surviving to a height of 0.5 m and a width of 0.55 m. The upper courses had been built above a foundation of large, rounded, unworked and mortared boulders 0.2 m in height (Figure 3). Internally the walls had been rendered with plaster on which a green paint could still be seen.

Plate 3; Building remains [07] from the south

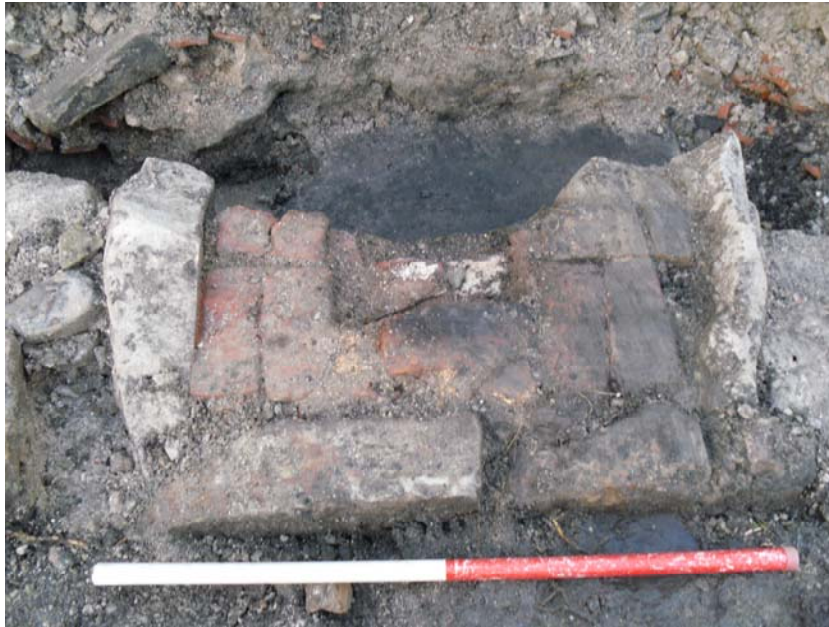
- 4.4 At a distance of 2.2 m from the southern end of the building and set within wall [07] were the remains of a hearth [08]. This had been constructed by using large narrow stone slabs set on edge surrounding a central in-fill constructed from hand-made and unfrogged bricks stacked as headers and stretchers and bonded with lime mortar (Plate 4) lying above a hearth stone [11] which was raised above the surrounding floor remains.

Plate 4; Hearth [08]

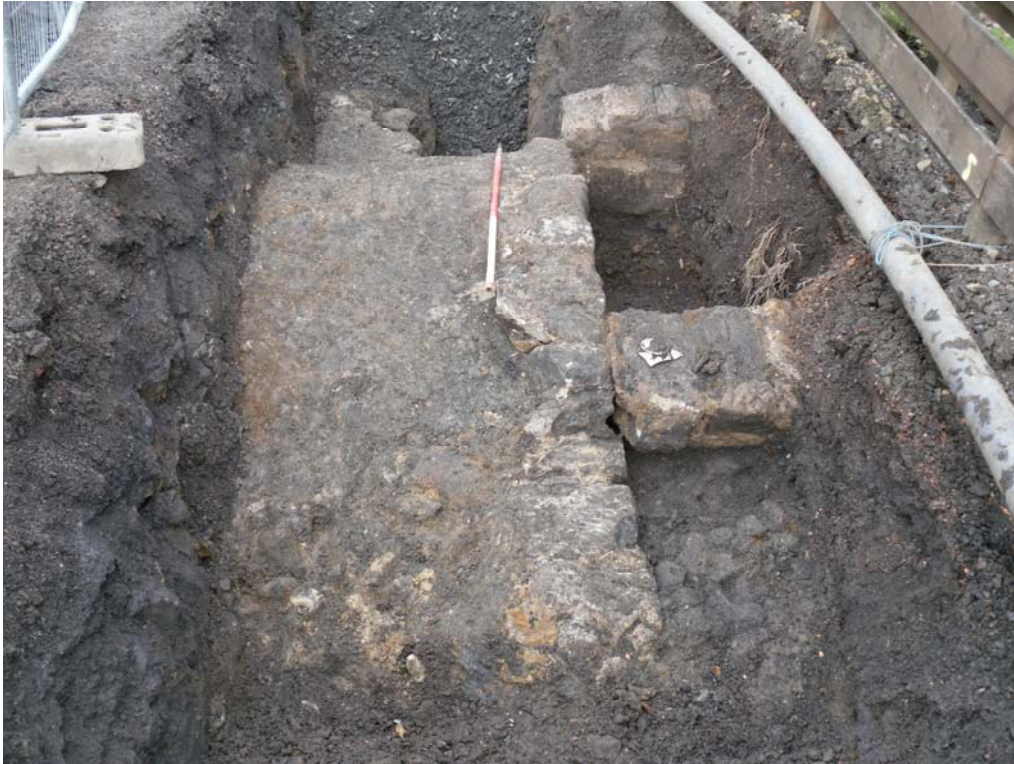
- 4.6 At a distance of 3.21 m to the south-east of this building and located on the eastern side of the road further structural remains were found during the excavation of a pipe trench. These remains (Figures 4 & 5; Plate 5) consisted of a filled-in water channel which crossed the road from east to west and was bounded by two stone built walls [18] and [19] forming a culvert which was traversed by a small bridging structure [20]. Both walls were built of a mix of regular and irregular stone blocks with bricks also seen in the construction of wall [19]. The foundation course of wall [19] consisted of a single course of large rounded stones similar to the foundation of building [07]. Above the foundation course the walls remained to a height of three courses or 0.73 m and were separated by 1.3 m.

- 4.7 The bridging structure [20] was constructed from roughly rectangular blocks bonded with a cement mortar and consisted of a single flattened arch bridging the width of the channel with a maximum height of 1.0 m. Both walls butted up to the bridge [20] and were not tied into its structure. The feature had a total length of 3.2 m N-S and width of 1.35 m E-W. It overlay a cobbled road surface [22] (an earlier road surface?) at its northern end and further cobbles [21] were seen to abut its SE

edge and the southern face of wall [19]. The upper surface of [20] was partially covered by a layer of concrete [23].

Plate 5; General shot of water channel and bridging structure (from the north)

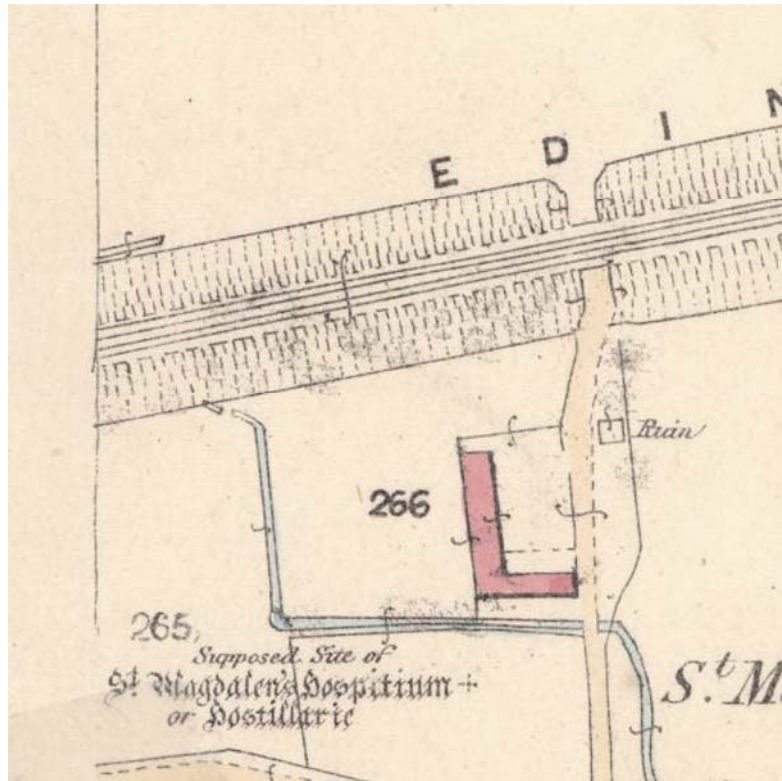
Plate 6; Extract from OS 25 inch 1st edition 1856

- 5.1 The vast majority of the development area has proven to be archaeologically sterile. Where features have been located these are of recent date. The 1856 town plan map of Linlithgow (OS 1856a) and the first edition OS map (OS 1856b; Plate 6] clearly shows an 'L' shaped building aligned with its gable end in the same location as these building remains and called St Magdalens which appears earlier and later as a farm name (Hugh McBrien pers comm.). Magdalens can also be located on the Great Reform Map of 1832 (Great reform 1832; Plate 7) but on this map the building is shown with a north-eastern wing which has disappeared by 1856. Given that the hearth (08) was of a domestic type it is safe to assume that these remains represent the part of the domestic range of the former St Magdalens Farm steading. The map evidence suggests that the farm was constructed some time before 1832 but how much earlier is unknown. It is shown on maps up to 1926 (OS 1926). Also of note on this map is the burn which is shown to run northwards past the eastern side of the building. By the time of the production of the 1856 map the burn has been canalised and runs past the southern side of the building and confirmed by the excavations. However it is not known when the farm was first built.

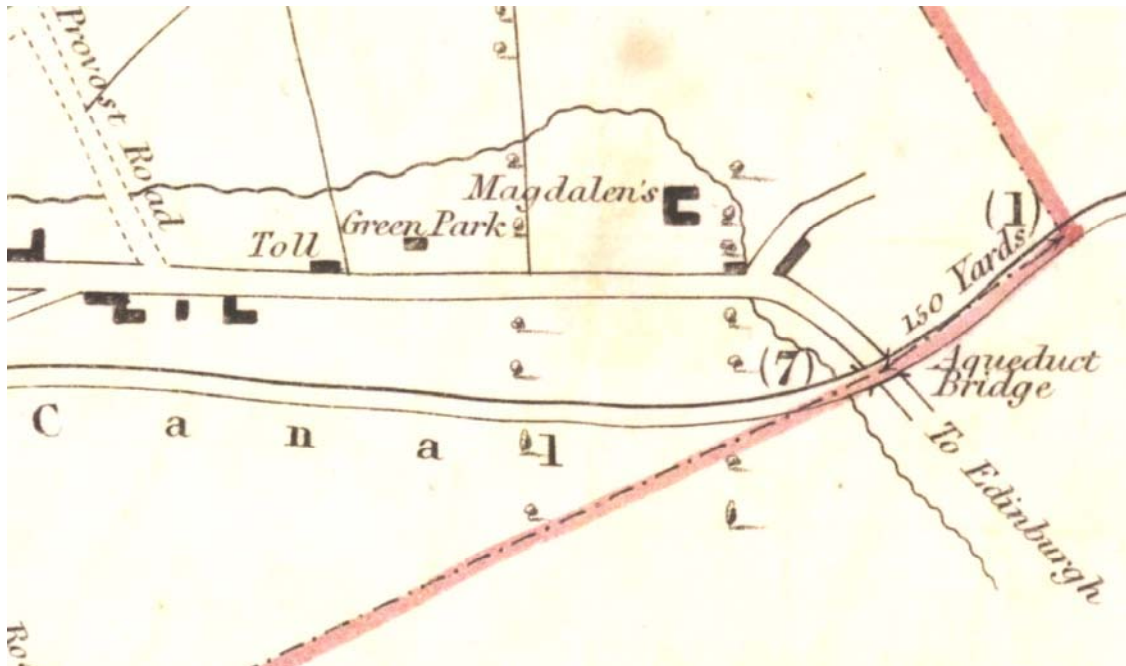
Plate 7; Extract from the Great Reform Act plans and reports 1832, Map 48

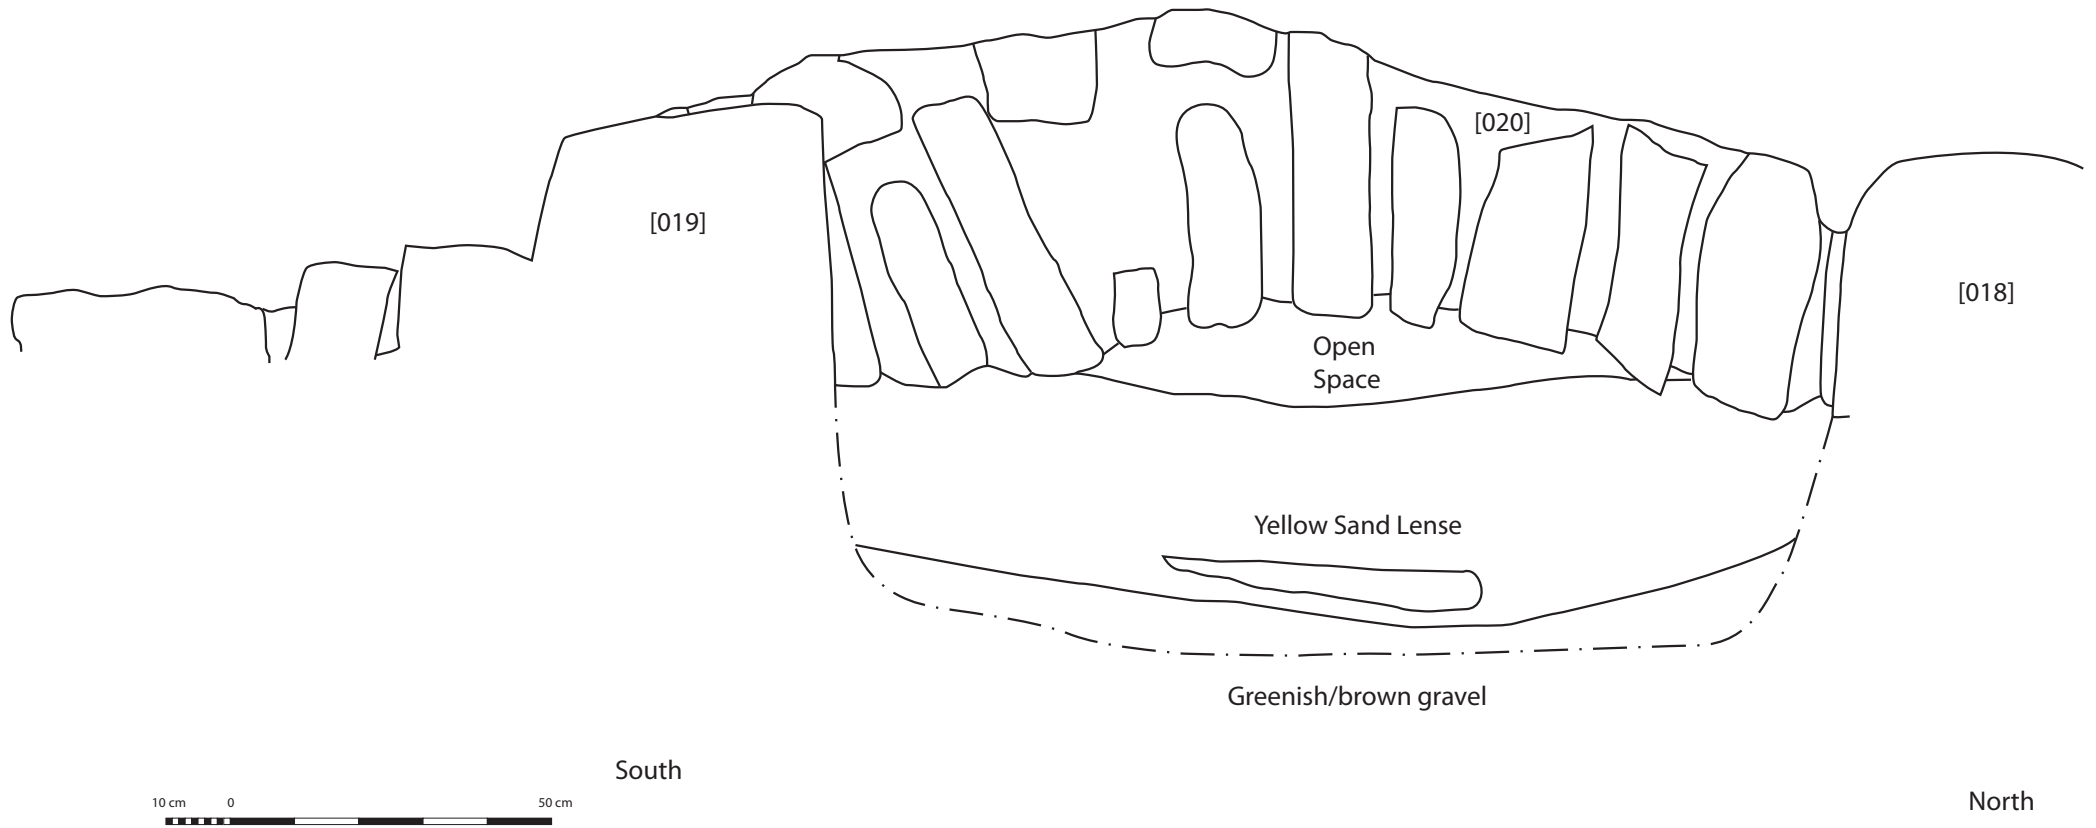
Figure 5: Elevation/section through water channel
