57-63 Wharfdale Road and the Printworks, Regents Quarter Area D, Kings Cross, London Borough of Islington A Historic Building Appraisal

Planning Consent : P090206 Condition No 45
National Grid Reference Number: TQ 3010 8331

AOC Project No: 30910

Date: March 2011

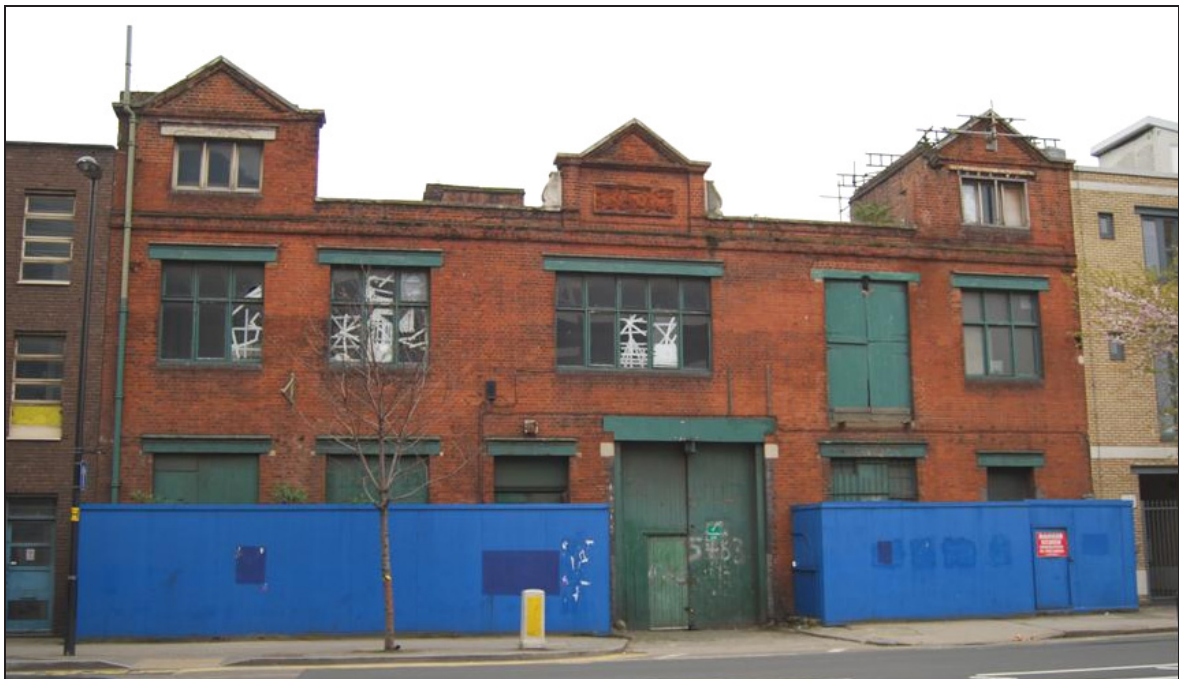
Plate 1: 57-63 Wharfdale Road: North Elevation

- 7.1 57-63 Wharfdale Road is a red brick warehouse building of three storeys, including a basement. There is a pair of extra gables at roof level, flanking a central pediment with a terracotta panel displaying the date 1901. The building is a good example of the decorative properties of red brick and terracotta to provide a building with architectural merit instead of a bland façade. The structure has a slightly irregular five bay frontage facing north on to Wharfdale Road. There is a principal vehicular doorway in the front wall, with pedestrian access to one side. The vehicle door has two doors with an inset pedestrian access; these are formed of planks with a wide bottom rail attached to a wooden frame with angled braces. An unusual feature is a group of iron bars attached over the planks and bottom rail, but these are probably signs of repair rather than design.

- 7.2 A third door to the west now only provides access to the first floor. Three large metal framed windows on the ground floor provide light to a pair of offices and a store, and these have steel lintels and stone sills.

- 7.3 The first floor has four large metal-framed casement windows, all with steel lintels and stone sills; a fifth opening is a hoist door in poor condition, with the remains of I-beams projecting north from it, suggesting a hoist floor had once been present.

- 7.4 The façade is surmounted by a low parapet wall with a gable at each end with a metal framed window in each. One contains stairs to the roof, the other a water tank, A third central gable with the date plaque is built in a similar way, with elements of classical order, including a plain brick architrave and a pediment with stone coping. The terracotta date stamp in the frieze of the central gable is stylised with floral motif to the corners. The gable is flanked by stone pilasters.

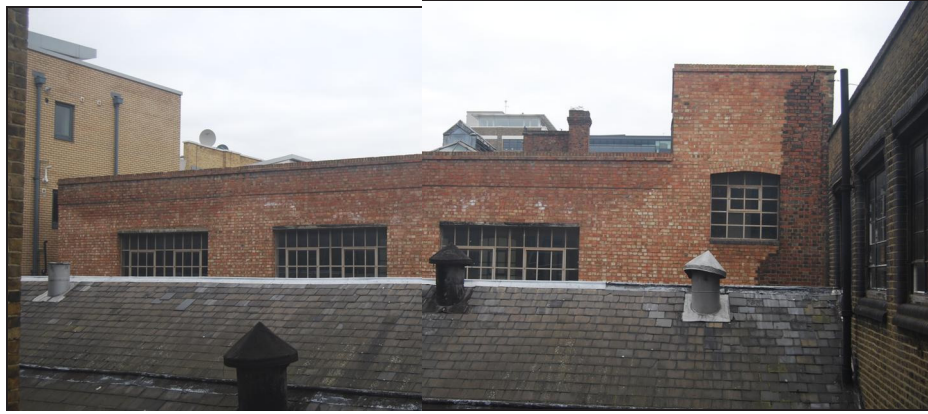
Plate 2: Rear View of Building Showing Repair.

- 7.5 The rear of the building is constructed of less regular, paler bricks, not in keeping with the high quality materials of the front. However, the rear staircase is partially enclosed in red bricks, strongly suggesting that the rear of the building has been rebuilt, possibly following wartime bomb damage.

- 8.2 Not all of the warehouse building is original; the first floor rear wall is a post – World War II repair, and the ground floor may have also suffered extensive damage.

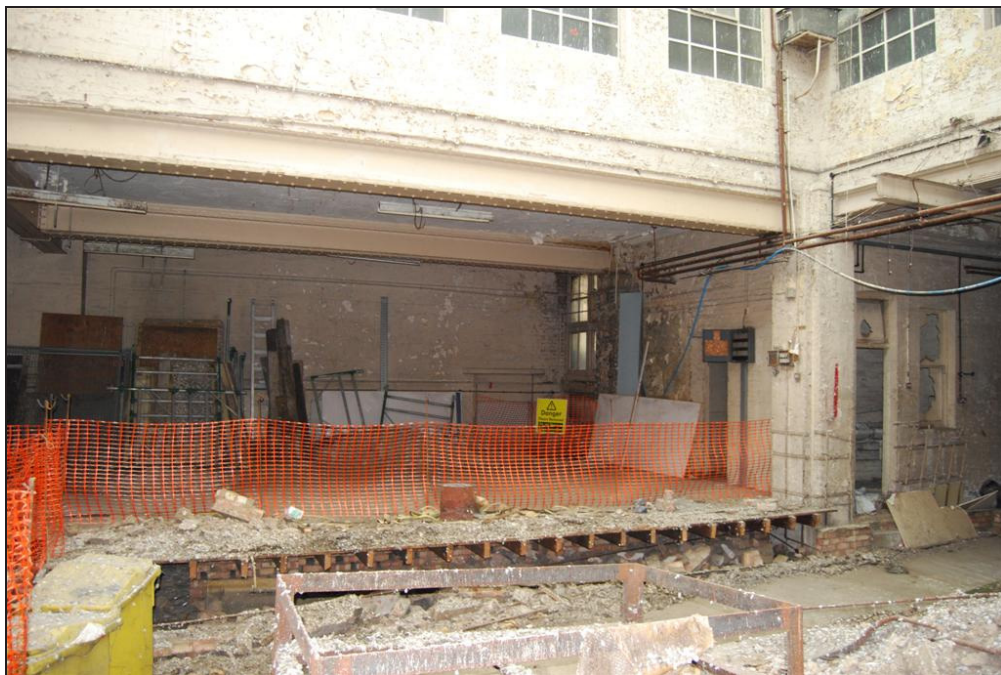
Plate 3: Overview of Warehouse Space, Looking East

- 7.6 The vehicular access at the front of the building has a stone cobbled surface. This surface leads into a central loading bay in the body of the building, which is a warehouse space measuring 21m by 19m. A staircase in the southeast corner of the room provides access to the first floor and roof. The floor is lit by a lightwell from the roof, with a glazed canopy.

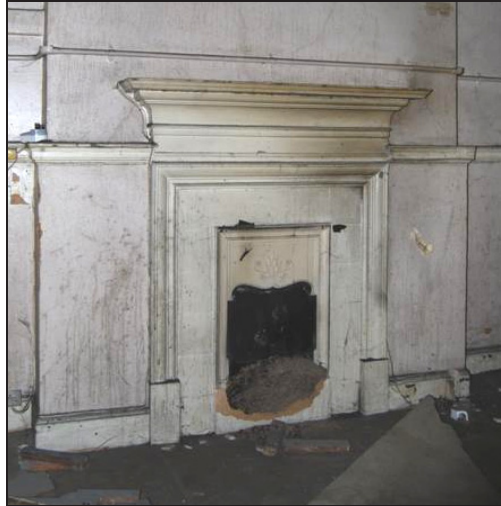
Plate 4: Fireplace in Office

- 7.8 To the right of the double doors are a pair of offices and a reception area, which were once furnished to moderately high level, as befitting rooms for clients rather than storerooms. The reception room has been partitioned, to form corridor access. Both offices feature architectural details not apparent in the rest of the building: they have herringbone-patterned parquet floors, bead-moulded skirting, a high level picture rail with a wide frieze and complex moulded cornice above. The steel beams that

form the frame of the building are boxed in with panelling in both of these rooms, and there is panelling to dado height on the southern of the two. Both rooms have chimneystacks rising up the eastern wall, with original surrounds. The surrounds have an incised moulding rising from rectangular plinths, and are surmounted by a plain frieze with moulded flat cornice above in the Tuscan style.

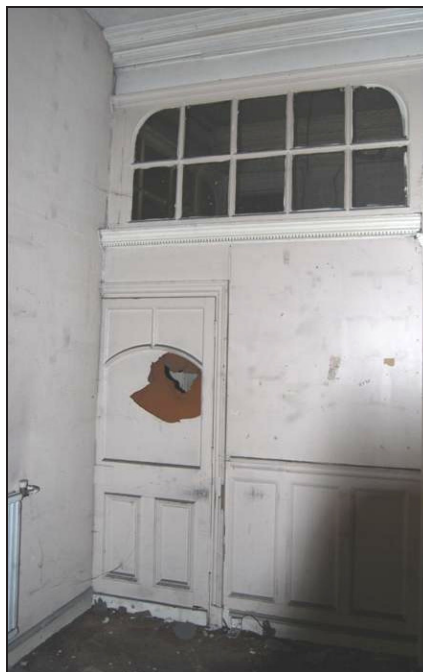
Plate 5: Detail of Partition in Office

- 7.9 The walls between the offices are lightweight, but original. These are characterised by panelling to dado height, with semi-glazed doors and a dentil courses below a wooden-framed fanlight. The doors are probably original features, but only exist as one painted over (Plate 5), and one off its hinges, the glazing broken. The original glazing bars show a segmental arch in a square frame and a central mullion.

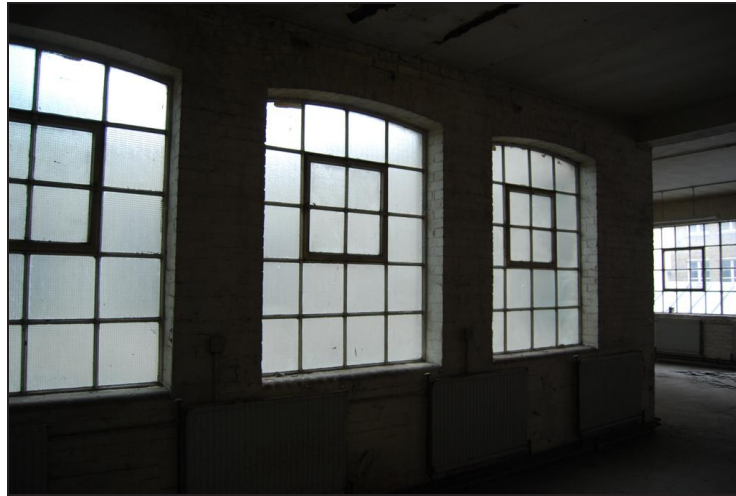
Plate 6: Original Windows

- 7.10 The first floor is accessed from either staircase, or a lift rising up the centre of the building that no longer functions. Both stairs are separated from the working space by a pair of doors, both with original hinges and bolts. The first floor is mostly one open space, well lit by rows of metal-framed windows at the north and south, and by a central lightwell with glazed canopy. The inner walls of the

lightwell are brick, with metal windows of a type common to the north wall. These have bull-nosed brick sills internally, and segmental-arched lintels. In comparison, the rear (south) wall contains wider windows with squared reveals, which may be of later date.

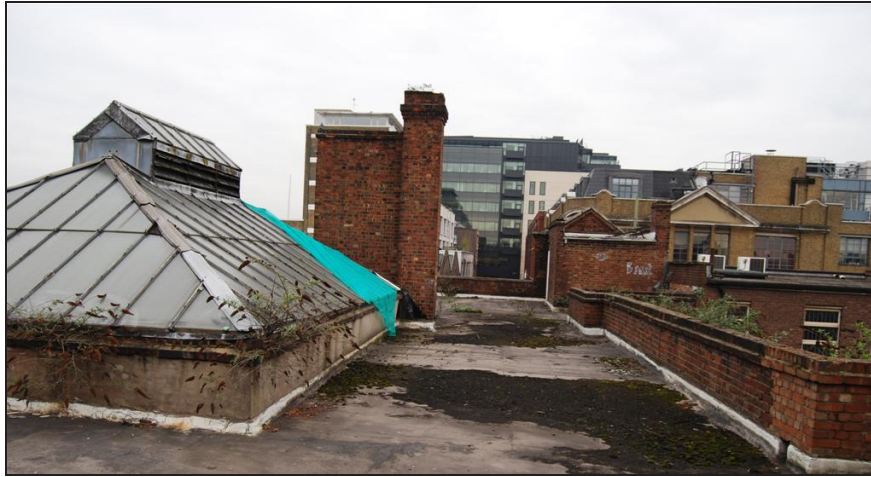
Plate 8: View of Roof Looking North

- 7.13 The roof is flat with a low parapet wall. It features three brick structures: two stairwells open onto the roof, and there is one building housing a water tank. These are in generally good repair, except for the northwest stair.

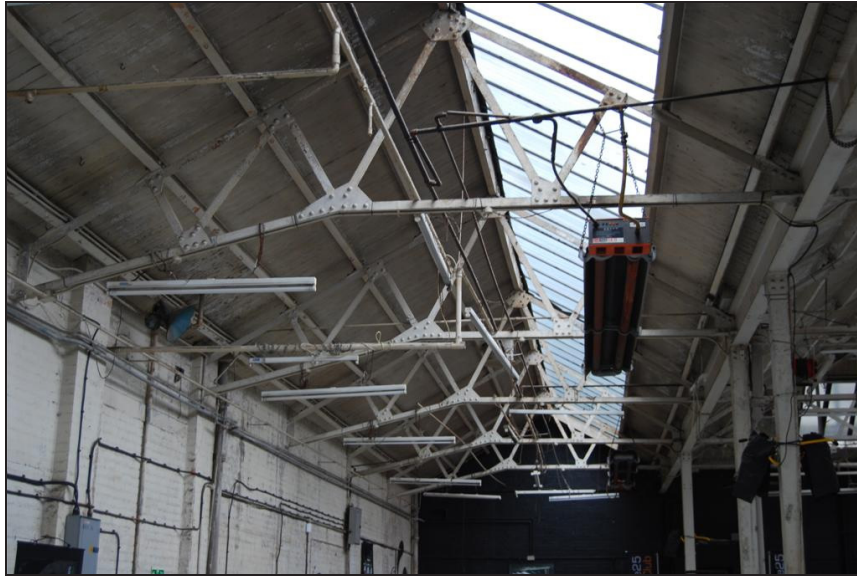
Plate 9: View of Girder Frame, Southern Section Looking West

- 7.18 The most visible part of the buildings construction is its roof, which is a double pitched roof, formed of girders in two sections comprising a single build; that to the north is wider. The girder frame is typical of a form in use since the 1920s. The valley between the roofs is formed of steel beams with the makers name in relief: 'DORMAN LONG & CO, MIDDLESBROUGH, ENGLAND', who were the principal manufacturer of I-beams for much of the 20th century. The valley also carries rain water from the roof through pipes adjacent to the upright beams.

- 7.19 The girders of the roof do not spring from buttresses, instead, they are attached to the exterior walls of the adjacent properties, indicating that the building may not have been constructed as an individual structure, but is the result of a covered yard space. It may be noted that the wider section of the roof has a hipped western end.

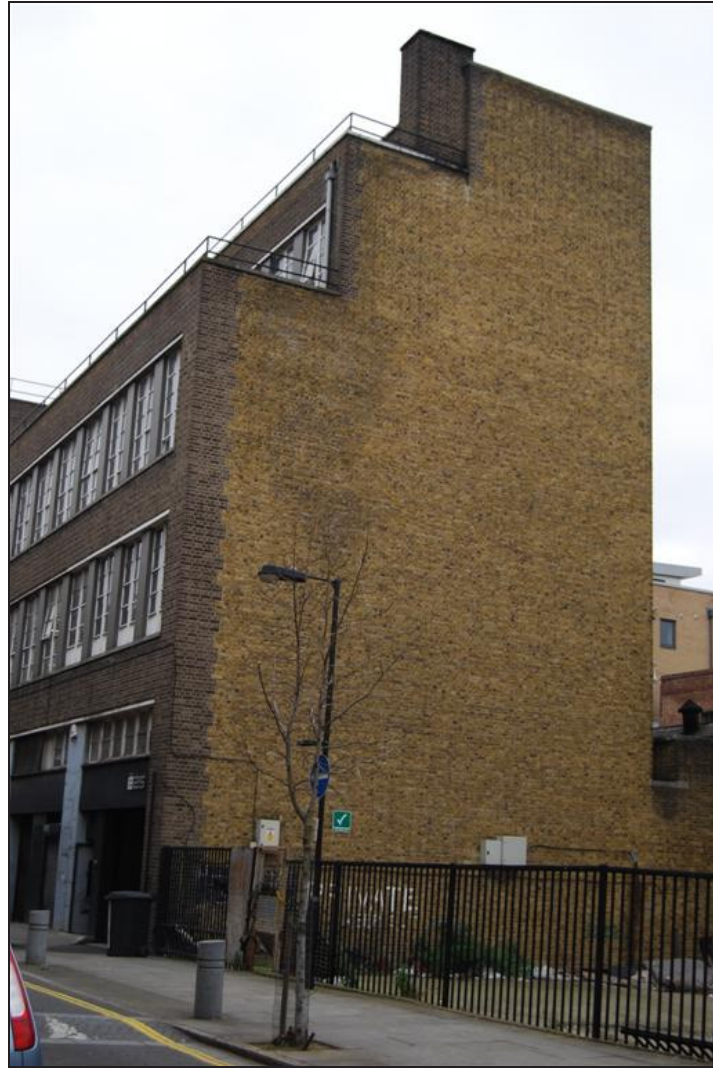
Plate 11: External View of Building on Railway Street, Looking Northwest.

- 7.20 The company using the Printworks space is a car dealership, with offices in an adjacent building which overflies the entrance. The offices are plain functional spaces, with architectural details that do not seem to be of great age. This may be the result of refurbishment and rebuilding of the south face onto Railway Street. The fittings include parquet floors and sycamore panelling, and the door frames are generally simply moulded. The windows have metal frames, and are plain.
- 7.21 The majority of the building is of yellow stock bricks, but the face onto Railway Street is of brown brick that does not have an aspect suggesting a pre-World War II date. The facing material is joined very cleanly, so this may be evidence that the visible east-facing side wall is contemporary.
