# New service run, Bruisyard Hall, Bruisyard BUD 007

## **Archaeological Monitoring Report**

**SCCAS Report No. 2011/076**

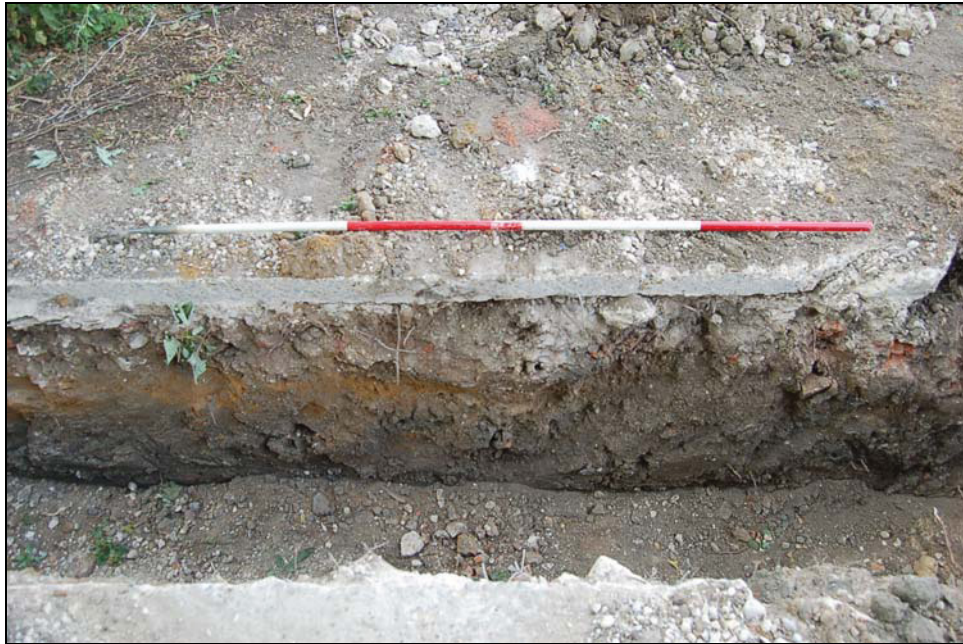
Plate 1. Trench 1, near to infilled pond, facing south-west (2m scale)

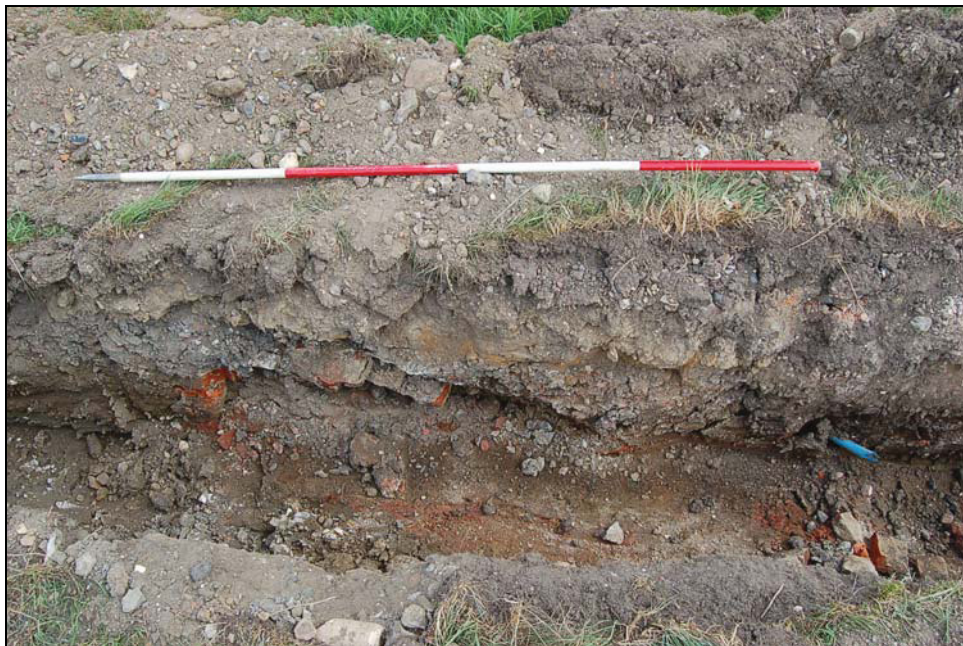
The service trench observed was c. 100m long, with some 90m open and available for inspection at the time of the site visit. The trench was 0.6m wide, and varied in depth slightly though was generally approximately 1.0m deep. The geology observed generally consisted of 0.5m or more of a mid/dark brown clayey silt topsoil with frequent ceramic building material fragments and small-medium irregular-shaped flints and stones. Occasional scattered animal bone fragments were present (less than 10 pieces along the whole trench), as well as oyster shell fragments. The further down the slope towards the old pond the trench went, the deeper the topsoil deposit became, apparently due to both intentional deposition as well as colluvial deposition with tip lines, dumps and spreads of modern material visible in the section of the trench in places. Modern plastic water pipes were encountered in four places at depths of between 0.6-0.9m below surface level and the remains of two brick wall footings were noted. One ran parallel and adjacent to the service trench at its northern end, while the other crossed the trench to the south of the outbuilding and to the west of the access road. The bricks were reddish brown, approximately 0.21m x 0.10m x 0.07m in size and similar to those present in the standing structures nearby (such as the outbuilding the trench comes from to the north which dates to the mid-late 19th century). No frog was visible, although most of the bricks observed were broken and potentially a small frog could have been obscured by mortar remnants.

The southern of the two walls may relate to a structure noted on an early 19th century estate map (visible on appendix 2, west of 'G') although the lack of any other structural remains such as the opposite or end wall leaves questions about the potential form of this structure – it may have been open sided on one or more sides, for example. The northernmost wall probably dates to the construction of the building, some time in the

Plate 2. Trench 1, wall remains near access road, facing northeast (2m scale)
