**Stables and Granary at
Wolsey House Farm,
Yoxford, Suffolk
YOX 022**

Heritage Asset Assessment

May 2011

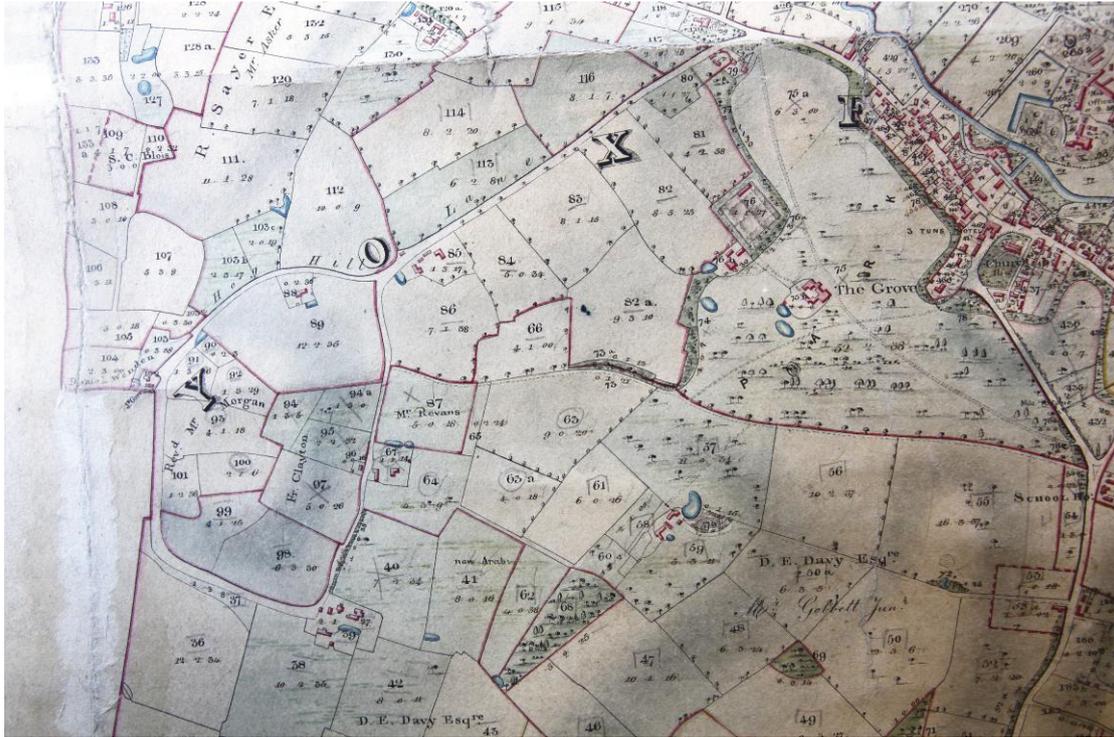
Figure 2

The 1839 tithe map of Yoxford parish (Suffolk Record Office) showing Yoxford Street to the right and Wolsey House Farm at the south-eastern corner of an oval-shaped block of land to the left that may represent an enclosed medieval wood or green.

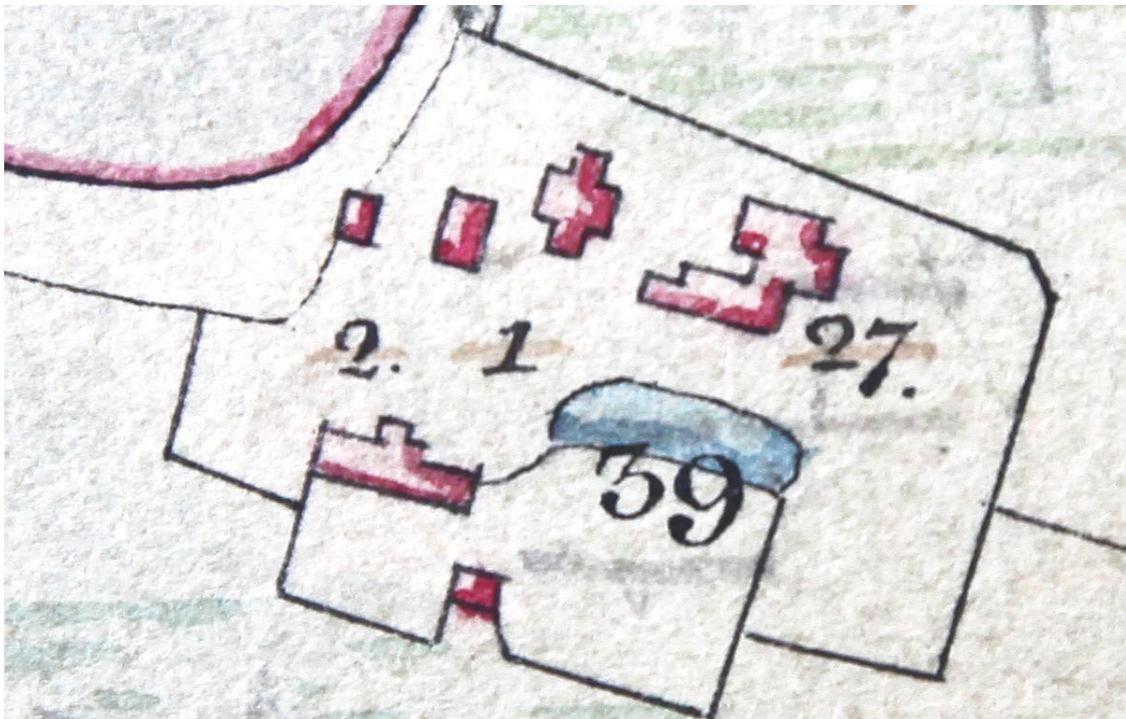
Figure 2a

Detail of the 1839 tithe map showing the irregular outline of the farmhouse (right) before its extensive alteration in 1840. A group of earlier outbuildings occupy the site of the existing granary and stable to the west, which had yet to be built. The 17th century barn is shown with its central porch to bottom left.

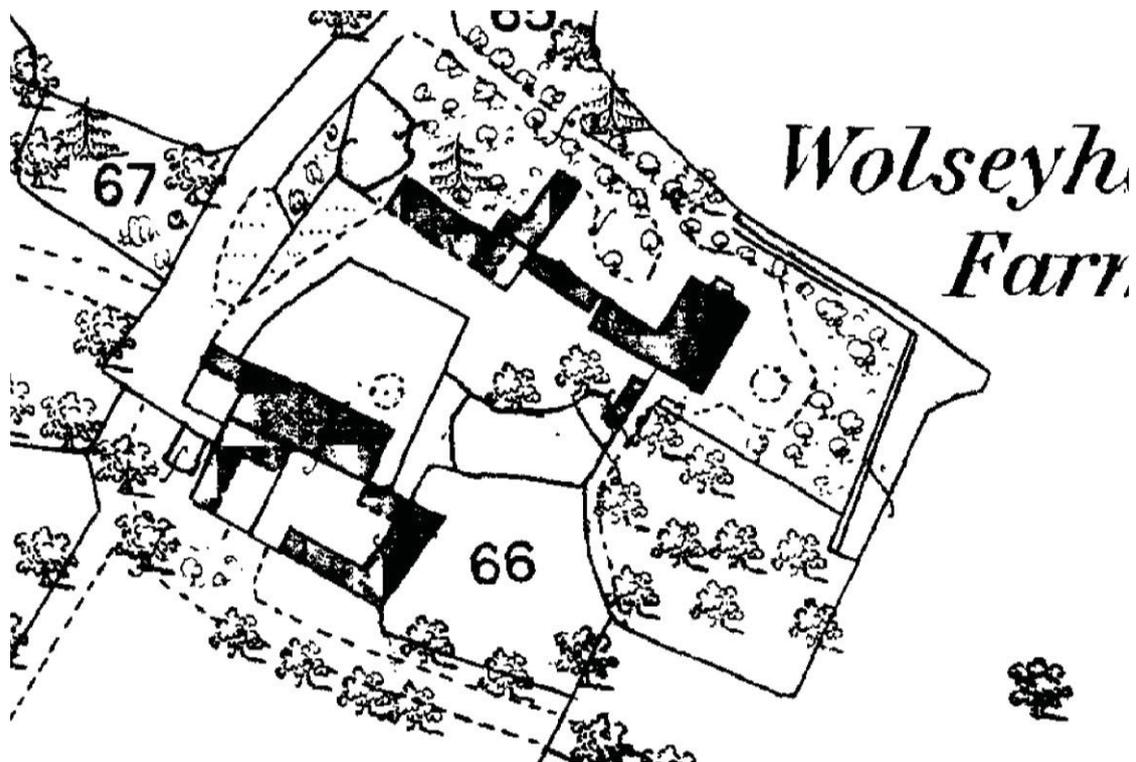
Figure 3

The First Edition 25 inch Ordnance Survey of 1884, showing the unified profile of the farmhouse of 1840 with its western dairy wing and the L-shaped outline of the granary and stable (buildings 1 and 2 in figure 6). The latter, however, consists of several different structures. Note the circular horse engine outside the newly unified barn.

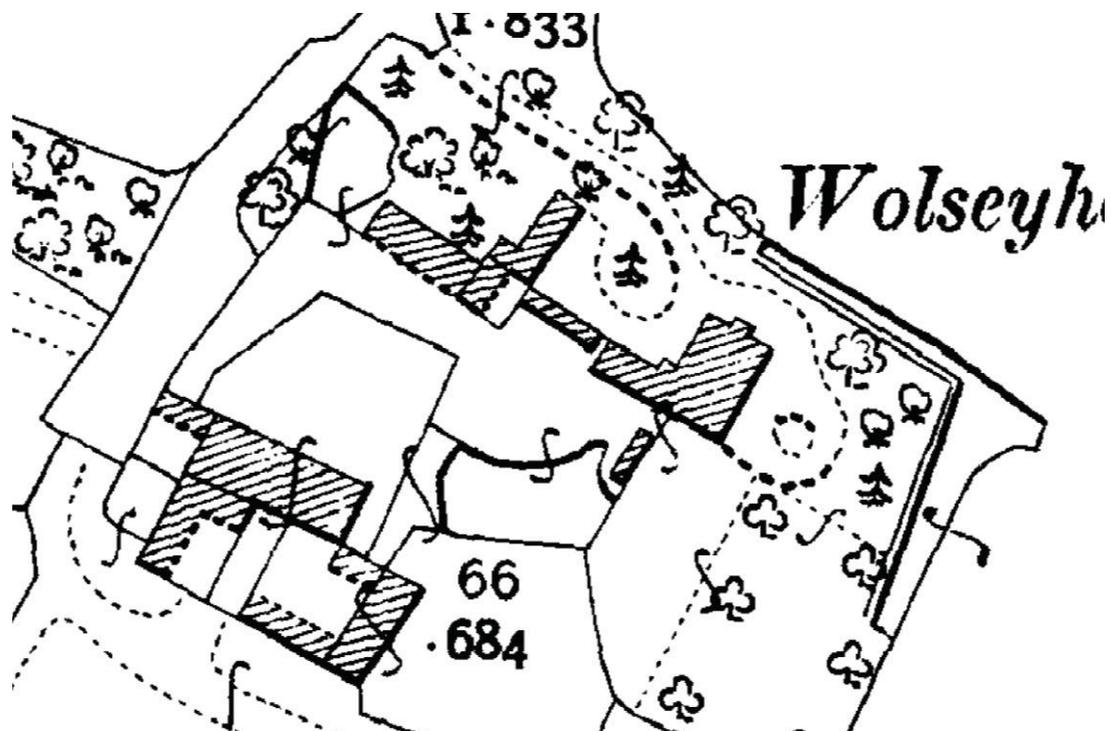
Figure 4

The Second Edition 25 inch Ordnance Survey of 1904. The open southern elevation of the ground-floor cart lodge beneath the granary is indicated by a broken line. A second open-sided structure serves a small yard adjoining its eastern gable.

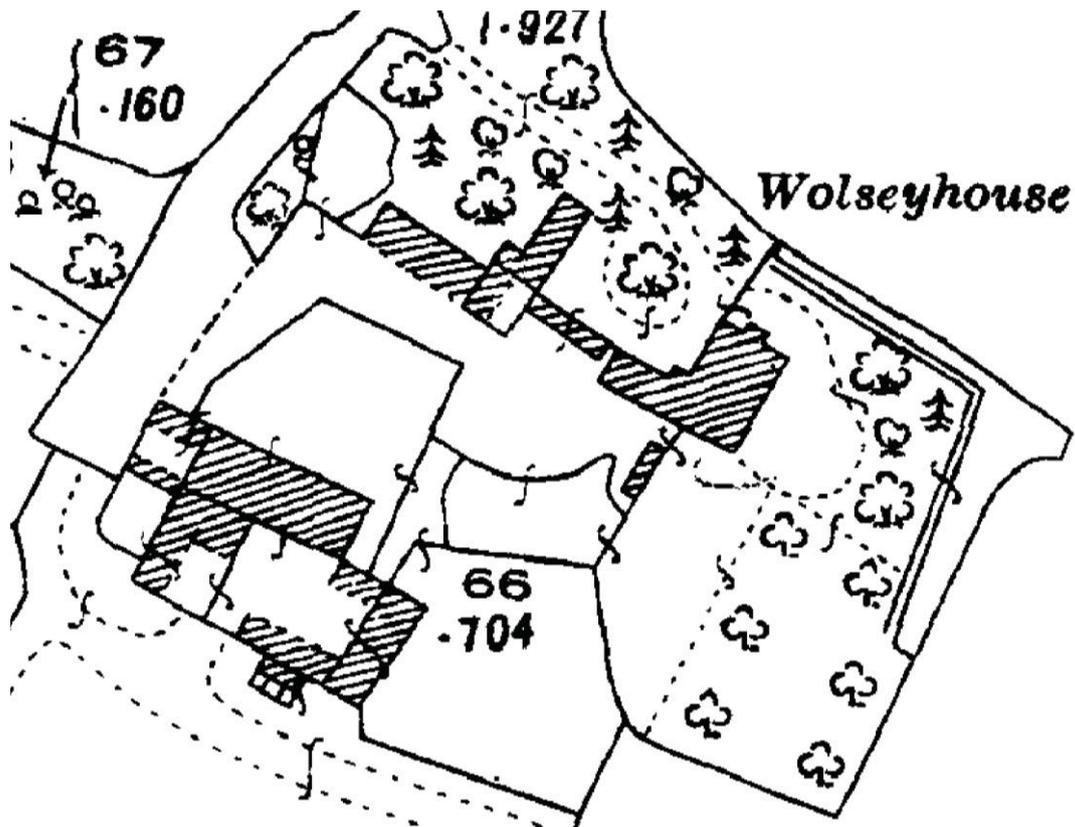
Figure 5
Third Edition 25 inch Ordnance Survey of 1927, showing little change since 1884. The buildings adjoining the granary's eastern gable have since been demolished and replaced with the present stable. The dairy wing projecting from the south-western corner of the farmhouse has also been lost.

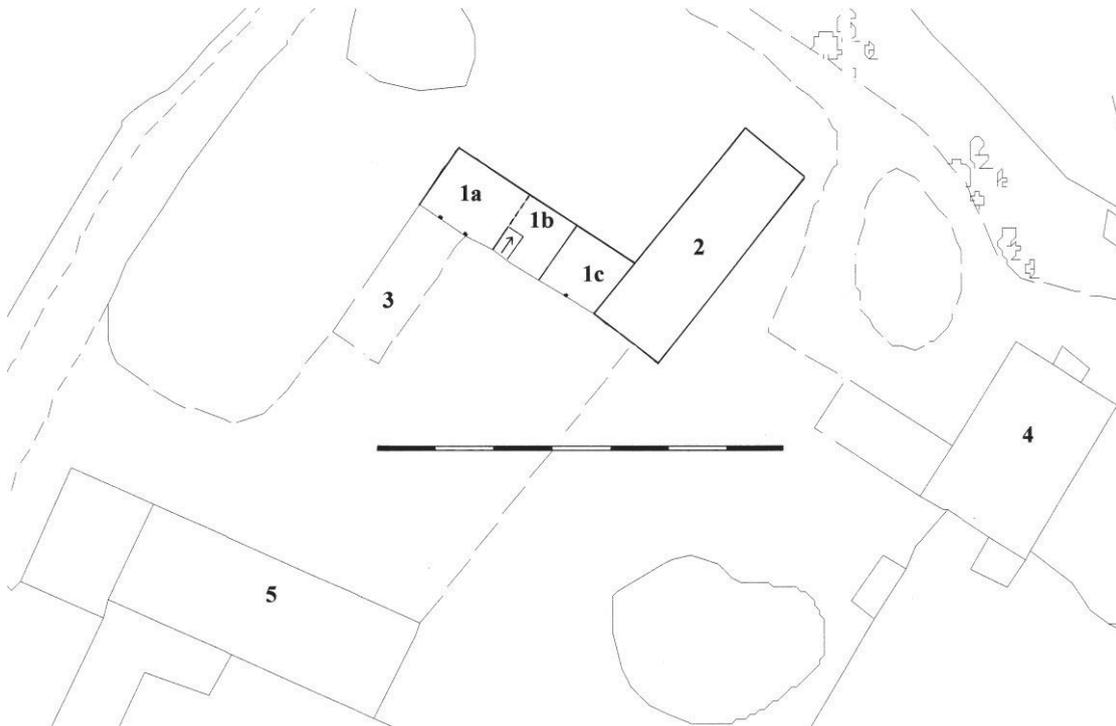
Figure 6

Schematic block plan of the site, numbering the key elements for ease of reference in the text and photographs. Scale in blocks of 5 metres. Based on Ordnance Survey

1. A mid-19th century red-brick and slate open-fronted cart lodge with first-floor granary. The lower storey divided by brick partitions into three compartments as indicated, and the grain floor reached by a central stair from the southern exterior.
2. A newly built single-storied stable range of re-used 19th century red-brick, cement blocks and slate. Late-20th or early-21st century on the site of several earlier buildings.
3. A mid- or late-20th century shed of cement blocks of which only the western wall and concrete base survived at the time of inspection.
4. Grade II-listed 17th century timber-framed farmhouse with brick facades and extensive remodelling of 1840 by Robert Barker. Not inspected.
5. An early-17th century timber-framed threshing barn of four bays originally entered from the south. Extended to the west, re-roofed and partly rebuilt in brick during the mid-19th century.

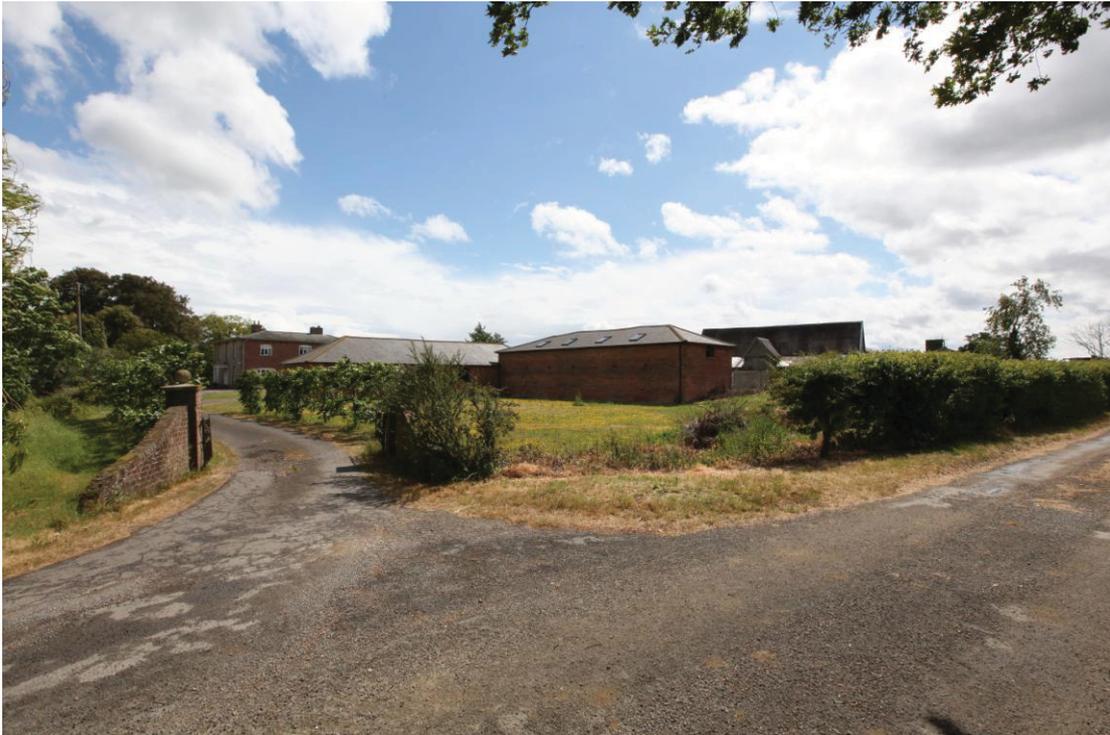
Illus. 1 General view of site from the north showing the entrance to the farmhouse to the left with (from the left to right) the grade II-listed 17th century house (4), the recently rebuilt stable (2), the 19th century cart lodge with first-floor granary (1) and the 17th century barn (5).

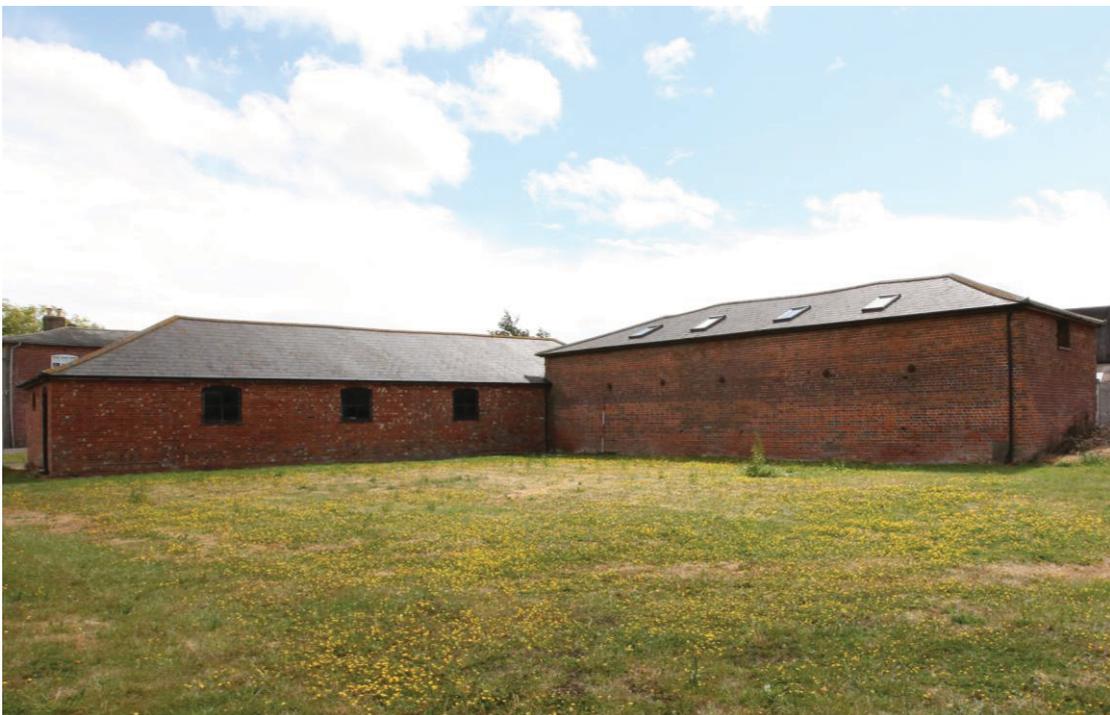
Illus. 2 The northern (rear) exterior of the granary (1) showing its 20th century roof lights and iron ties with an original window in the western gable to the right and the recently rebuilt stable (2) to the left.

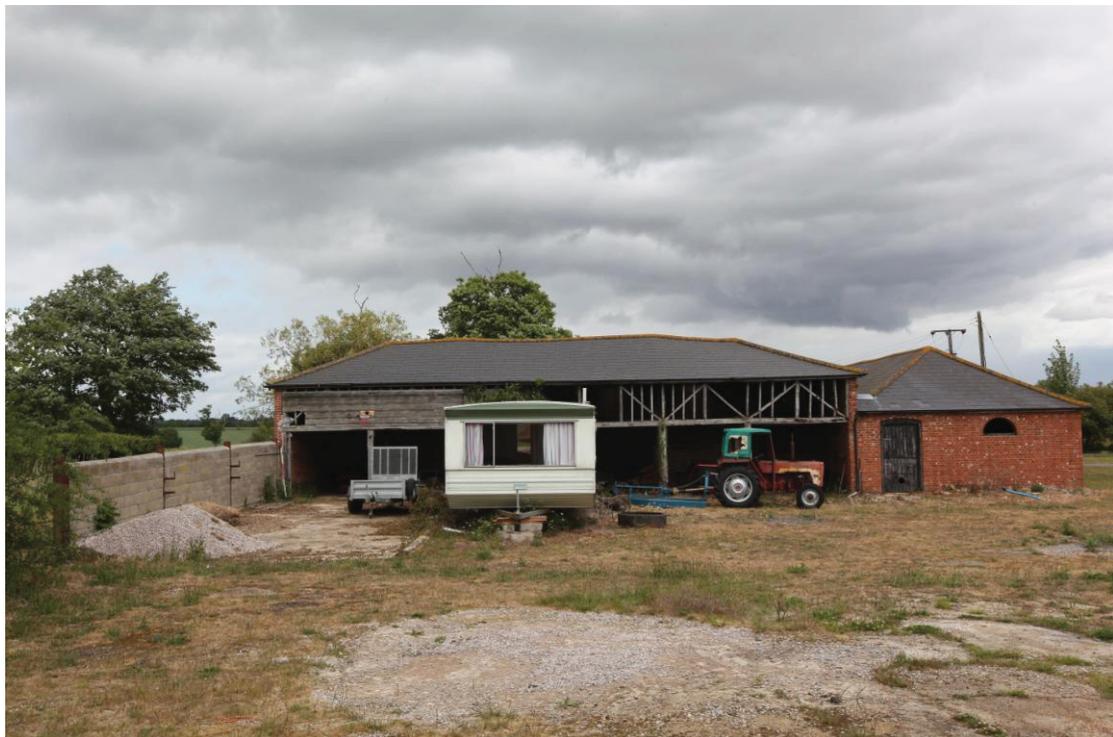
Illus. 4 The southern exterior of the granary (1) showing the concrete base of a demolished 20th century cement-block shed (3) to the left and the recently rebuilt stable (2) to the right. The lower storey is an open-sided cart lodge and the stair to the first-floor granary is concealed by the caravan.

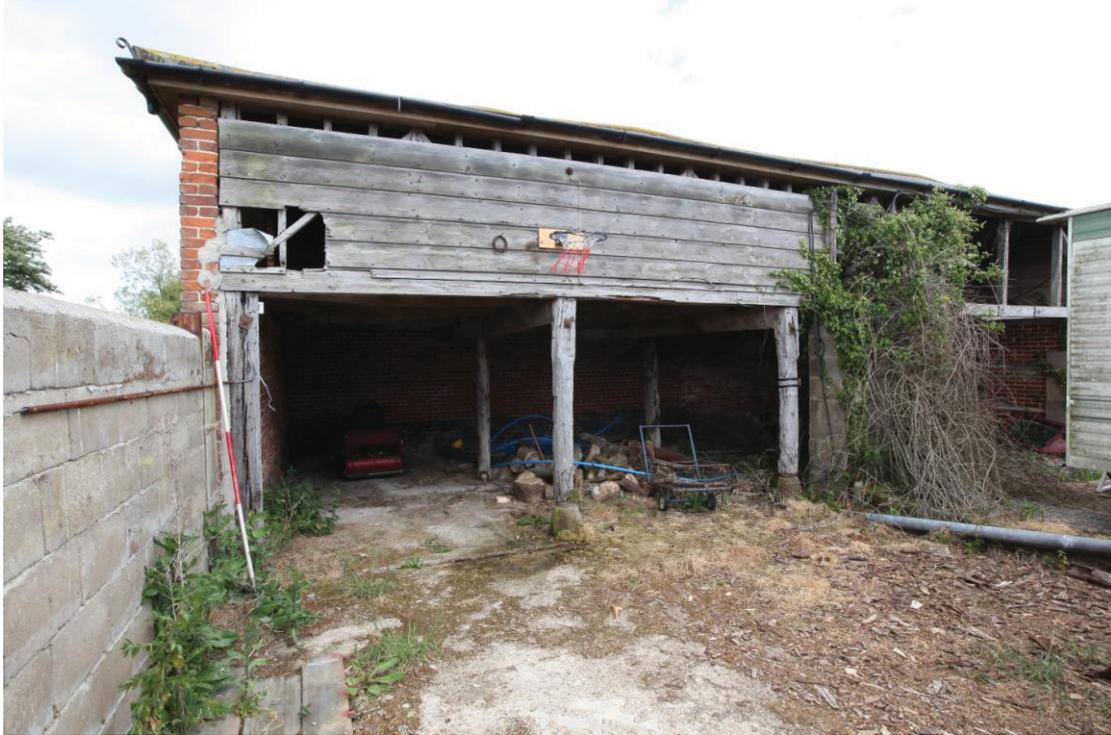
Illus. 5 The southern exterior of the granary's three-bay western compartment (1a) showing the surviving section of boarded cladding to the grain floor and the octagonal oak arcade posts of the ground-floor cart lodge.

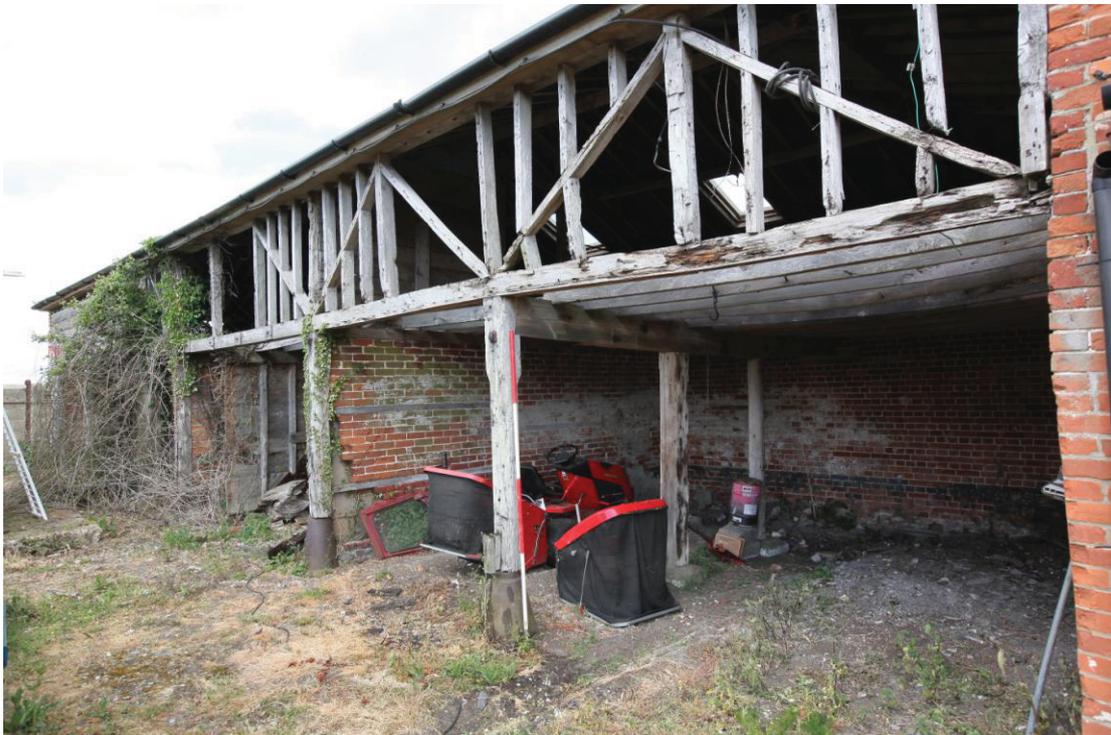
Illus. 6 The southern exterior from the south-east showing the two-bay eastern compartment (1c) to the right with the boarded eastern side of the stair in the central compartment (1b) to the left.

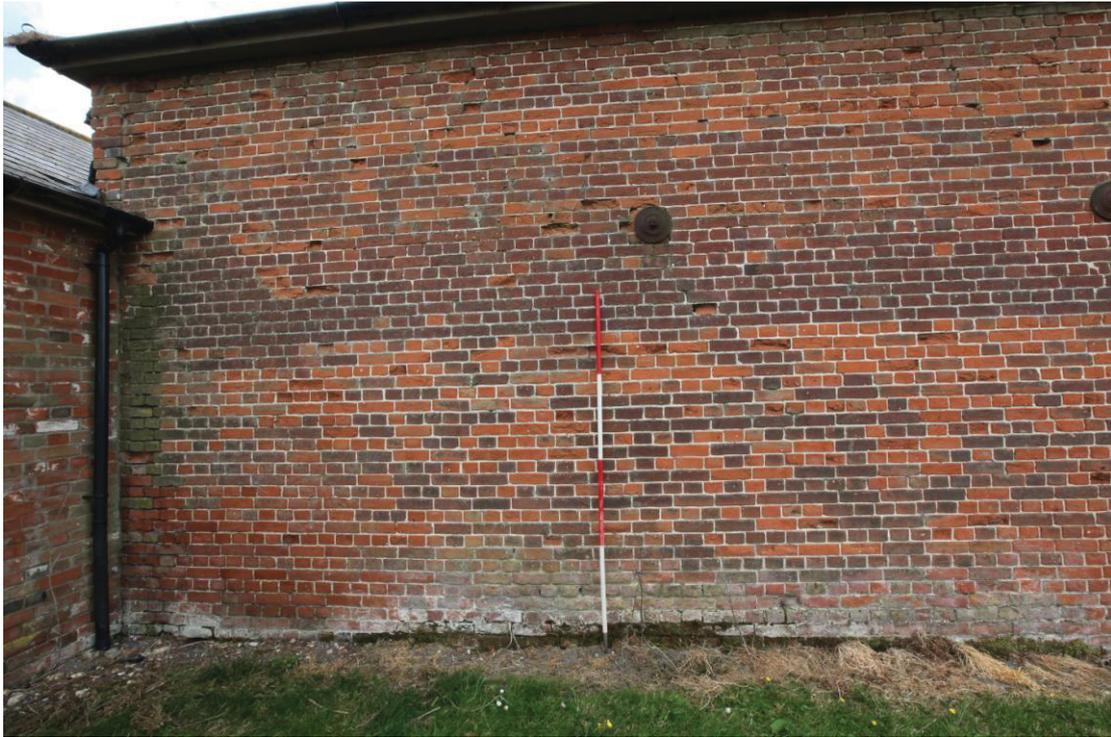
Illus. 7 Detail of the English bond brickwork of the northern exterior of the granary (1) showing an iron tie and the recently rebuilt stable (consisting entirely of re-used brick) to the left.

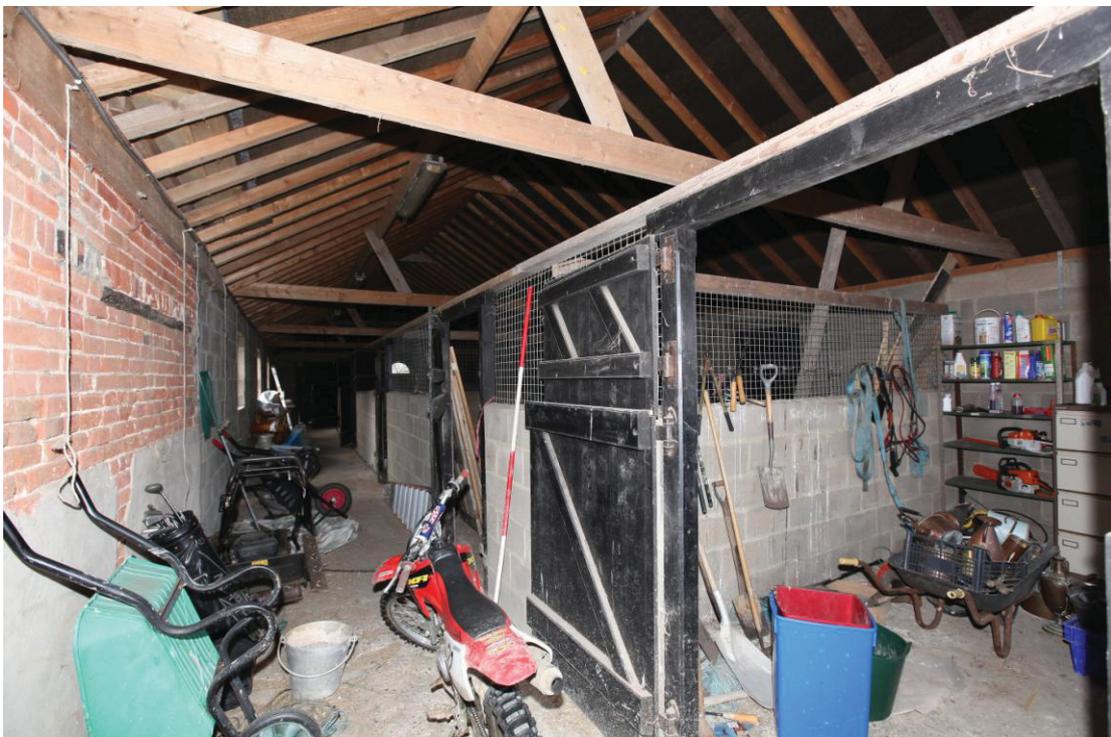
Illus. 8 The interior of the rebuilt stable (2) from the south showing its modern softwood roof and block-work inner walls with the eastern external gable of the granary (1) to the extreme left.

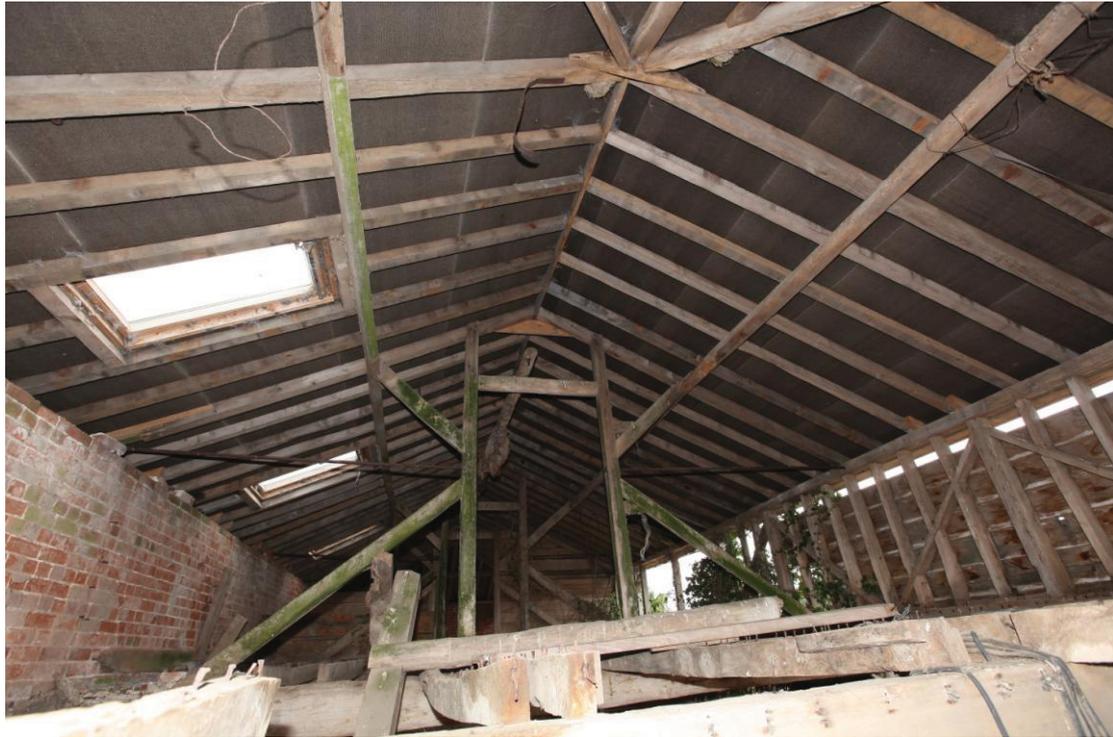
Illus. 9 The interior of the grain loft from the west, showing the door frames of an axial passage and the rebuilt 20th century softwood roof structure with roof lights to the north (left). The floorboards and cladding have been removed and there is no trace of any grain bins.

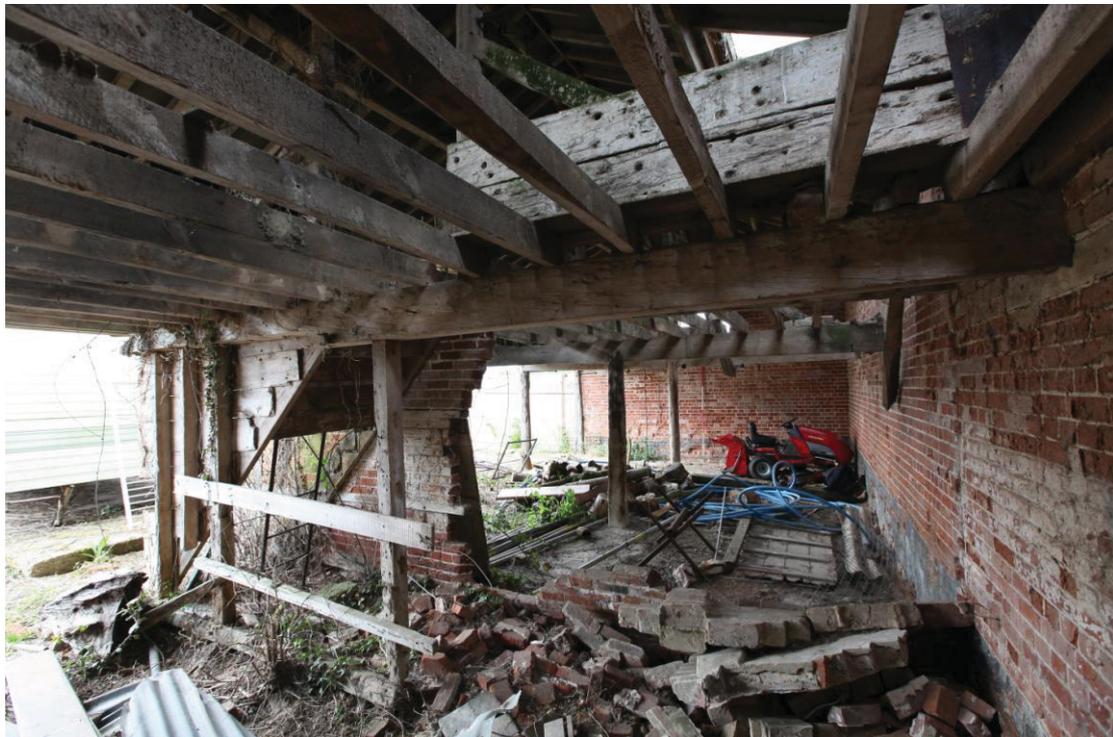
Illus. 10 The interior of the central compartment (1b) from the east showing the original stair rising from the southern yard to the left and the collapsed original brick internal partition to the western compartment (1a).

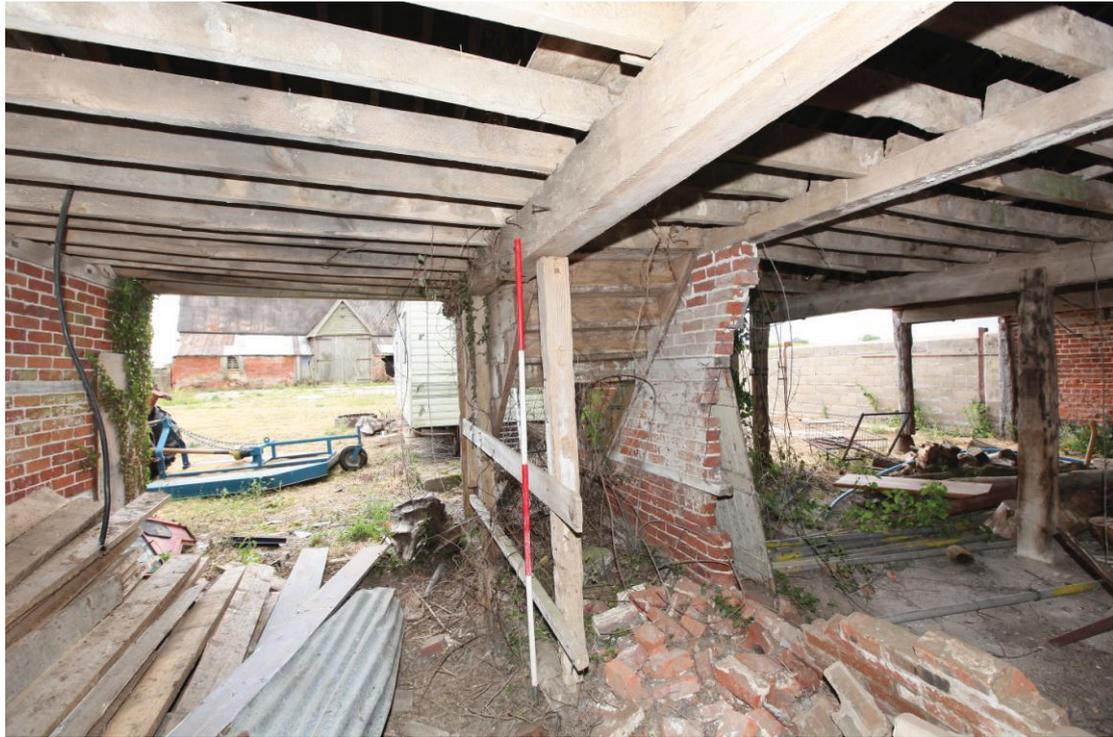
Illus. 11 The southern interior of the granary from the central compartment (1b) showing the underside of the stair with a boarded partition to its left and a partly collapsed internal brick partition to the right. The barn (5) is visible in the rear.

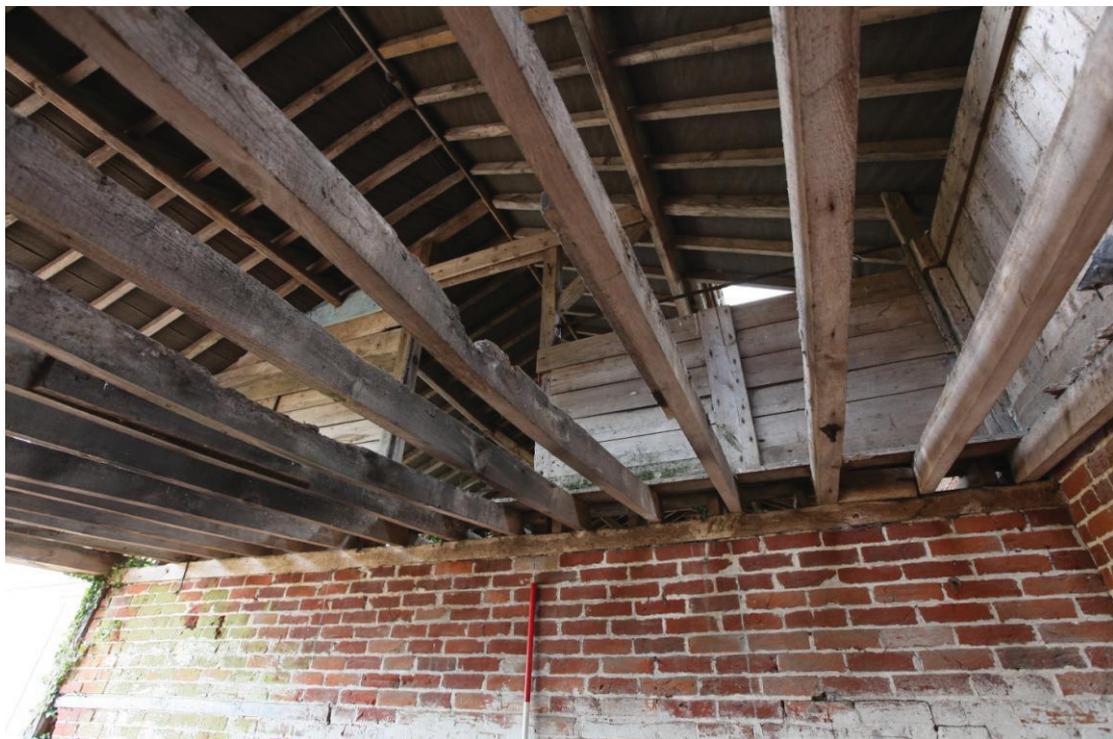
Illus. 12 Detail from the eastern compartment (1c) of the boarded first-floor partition and doorway to the central compartment of the grain floor.
