ARCHAEOLOGICAL MONITORING REPORT

SCCAS REPORT No. 2011/090

**Cable Ducts, Shire Hall Carpark, Bury St Edmunds
BSE 364**

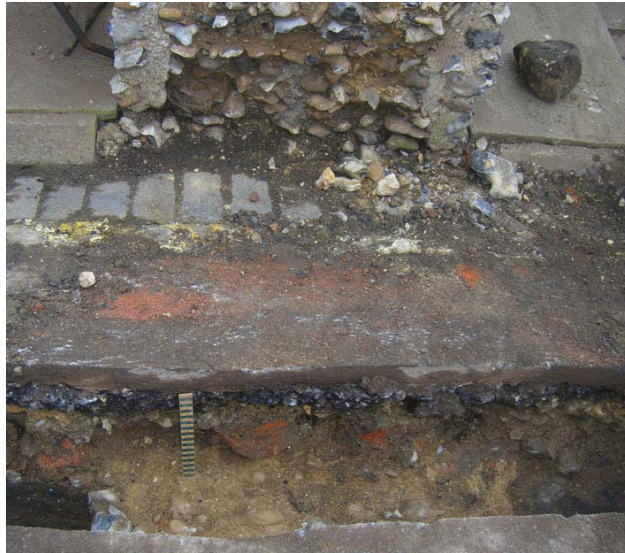
Plate 1. Southern Precinct wall (0025)

Precinct wall 0025 was found directly in line with the known standing wall (Fig. 2) and at a depth of 0.4m from the road surface (Fig. 3). The soil was hand excavated around the wall to record it and the cable conduit was raised to be laid over the wall so that none of the wall fabric was removed. Wall 0025 had a very similar make up to the standing wall but did not have the facing flints. It consisted of very densely packed mixed black and brown flints bonded with a pale yellow brown mortar. The mortar was made from a coarse gravel sand with large grits, measuring <1.5mm. The wall was sealed beneath the modern road surface, a layer of hogging and concrete 0020 and a layer of 19th century brick rubble 0021 (Fig. 3). Deposits 0020 and 0021 both reached a depth of 0.1m and appear to be hard core for the road

surface. To the south of the precinct wall was brown silt 0022, and to the north there was a layer of black silt 0023, containing coal dust, china and flower pots. These are probable garden soils, the difference in colour probably stems from differing cultivation practices on either side of the wall.

The monitoring confirmed that the southern most precinct wall of the Abbey of Bury St Edmunds survives under the modern road surface at a depth of 0.4m and that these remains are very well preserved.
