Former Methodist Chapel and Boys Brigade  
Hall, Bury Road, Hargrave  
HRG 010

**Building Recording Report**

SCCAS Report No. 2011/149

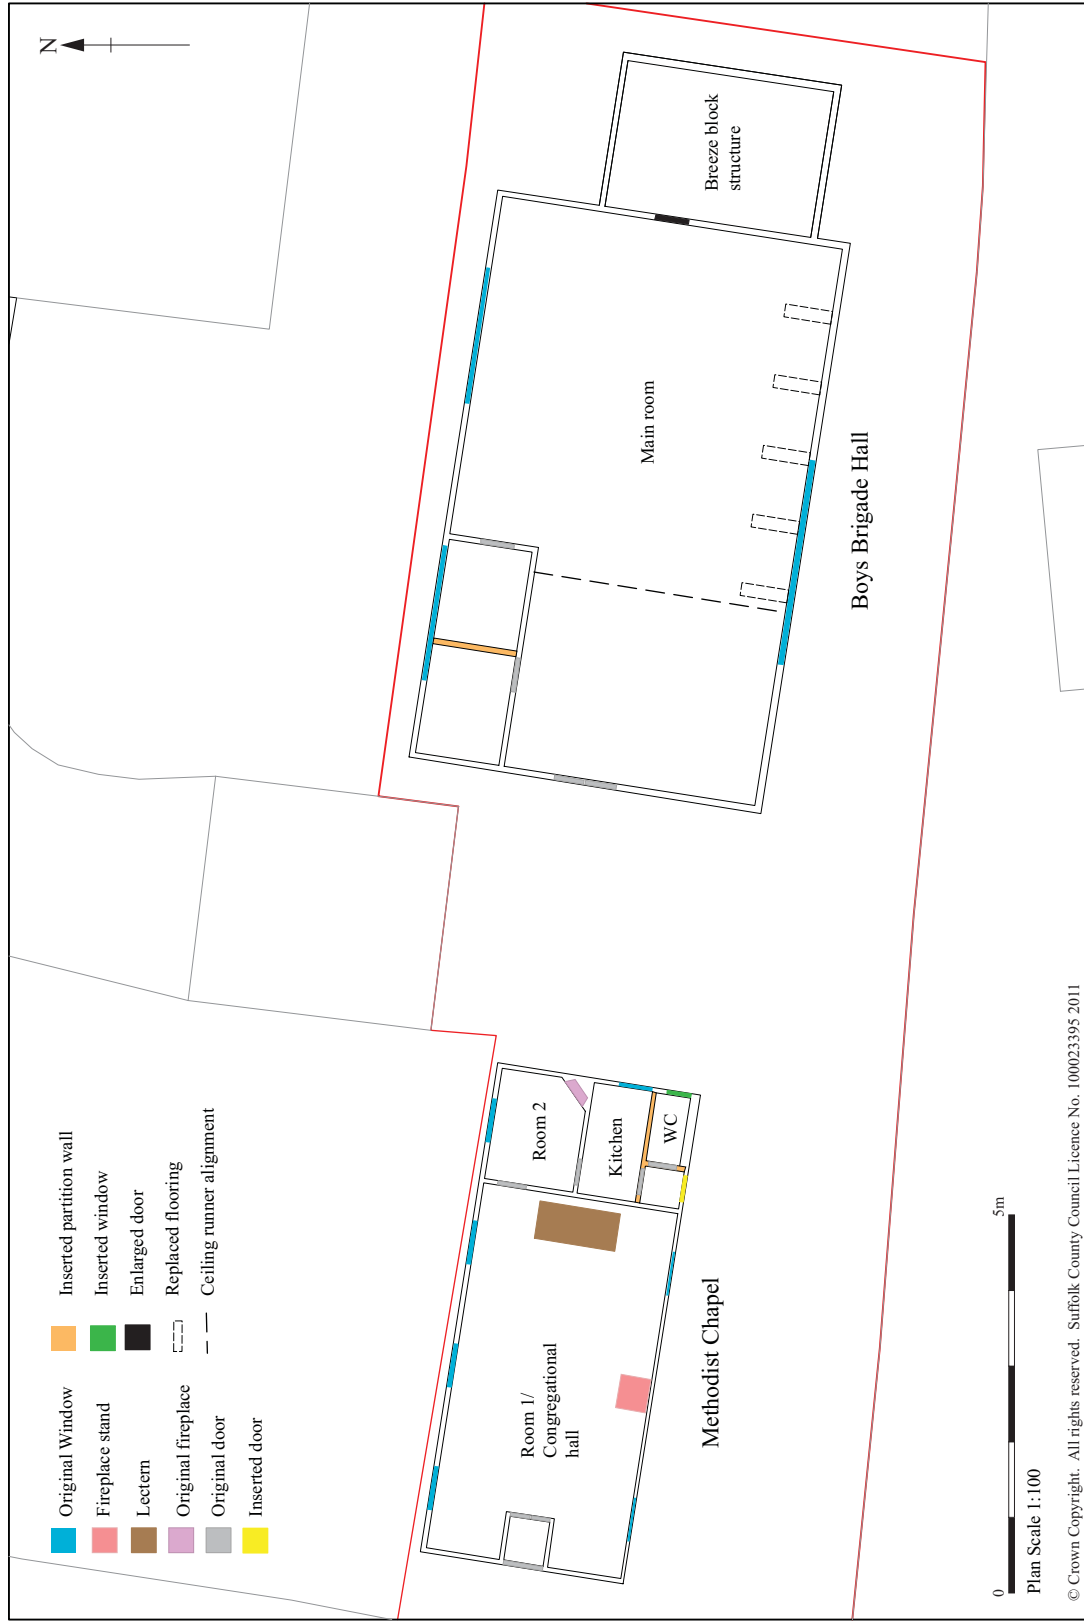
Figure 2. Building plans

The chapel was rectangular in plan, aligned ESE-WNW and built of brick; the exterior being rendered with 'pebbledash' concrete, leaving certain brick details showing, comprising the intricate main doorway, gable end roof detail and two chimneys (Fig. 2). It was 13m long (ESE-WNW) x 5.45m wide (NNW-SSE). The original windows were wood, painted white. The roof was covered with slate tiles and to the rear/east, with the roofline dropping where three rooms led off from Room 1. On both sides of the main doorway were memorial plates, with that to the left of the door reading:

The Nissen hut was rectangular in plan, aligned ESE-WNW, measuring 15.15m long x 9.4m wide (Fig. 2). The east and west walls were constructed from brick (painted white) and the whole structure was covered by corrugated metal sheeting, painted black and riveted to the girder structure underneath. Single concrete chimneys emerged from the eastern and western wall, which were thought to be original, although the example on the eastern end had largely been removed. On the southern side of the hut a single long window emerged. This had a white wooden frame, with black wooden boarding on each

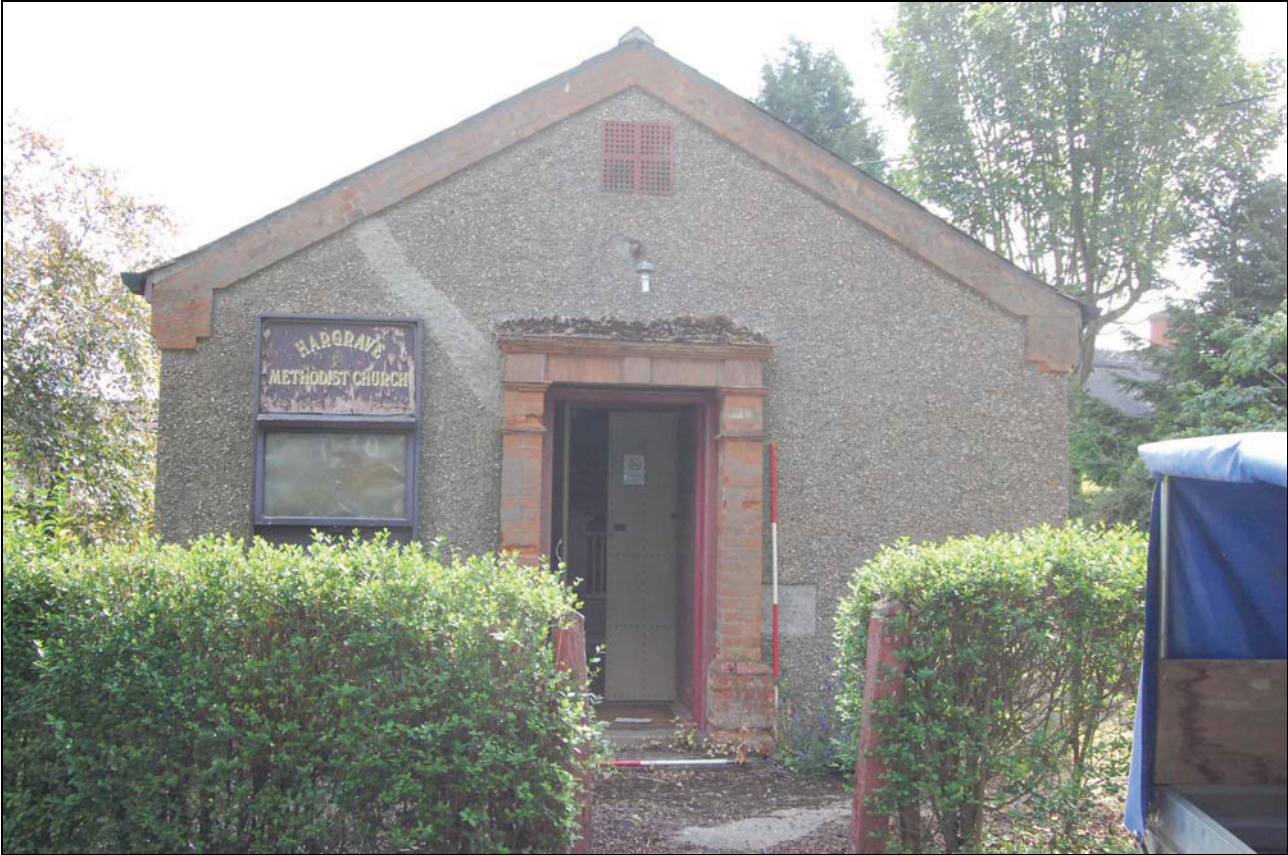
Plate 1. Methodist Chapel, front elevation leading onto Bury Road

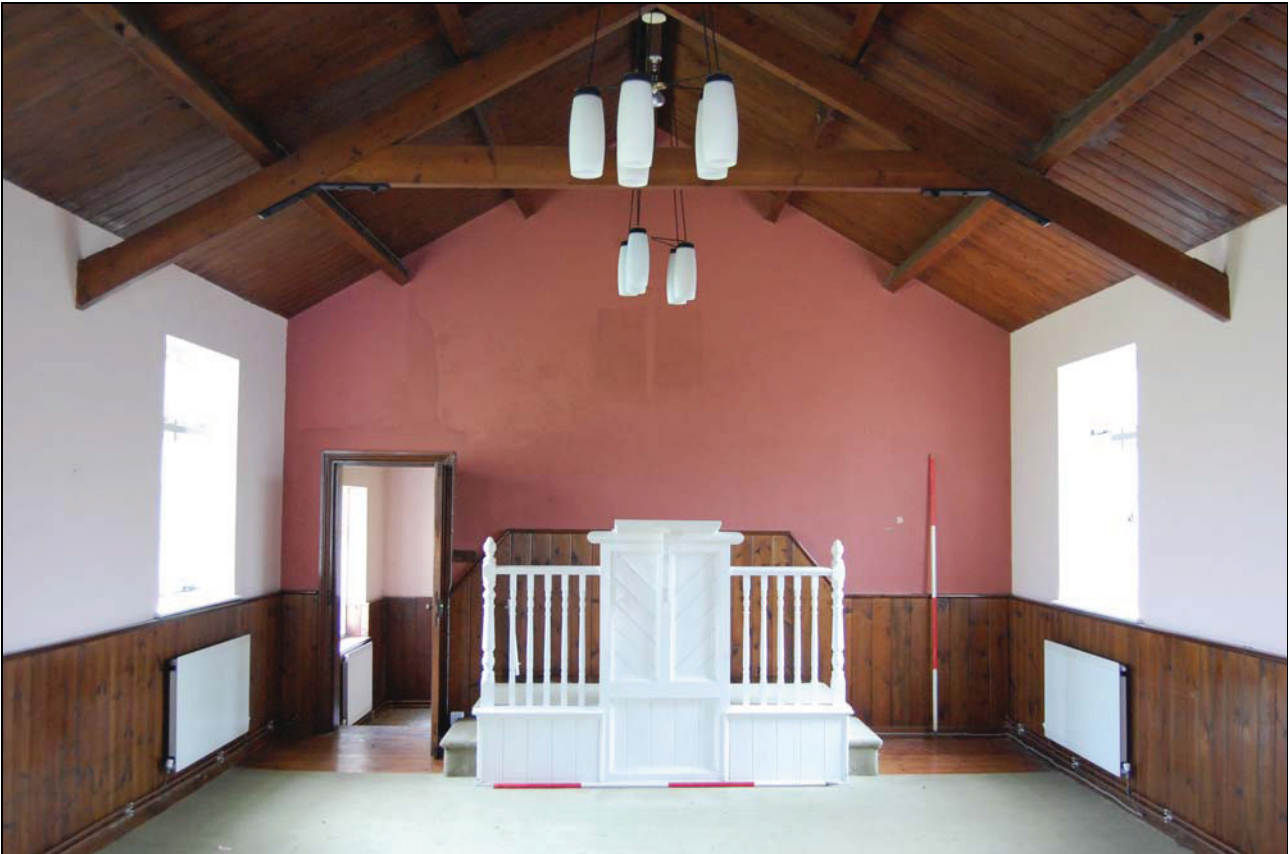
Plate 2. Methodist Chapel, Room 1/congregational hall, facing ESE

Entrance to the chapel was via the doorway off Bury Road, leading immediately to a small entrance porch with two padded doors. This led to Room 1, the main congregational hall, which had wooden flooring and wooden wall cladding to the base of the windows. The roof construction was not enclosed and consisted of wooden trusses with metal fixings. There were three windows in the northern elevation and two in the south. The space for the third, central window in this elevation was taken up by a concrete block in the floor, which used to be the base for a fireplace, since replaced by central heating. In the eastern end of the hall the white painted wooden lectern stood.

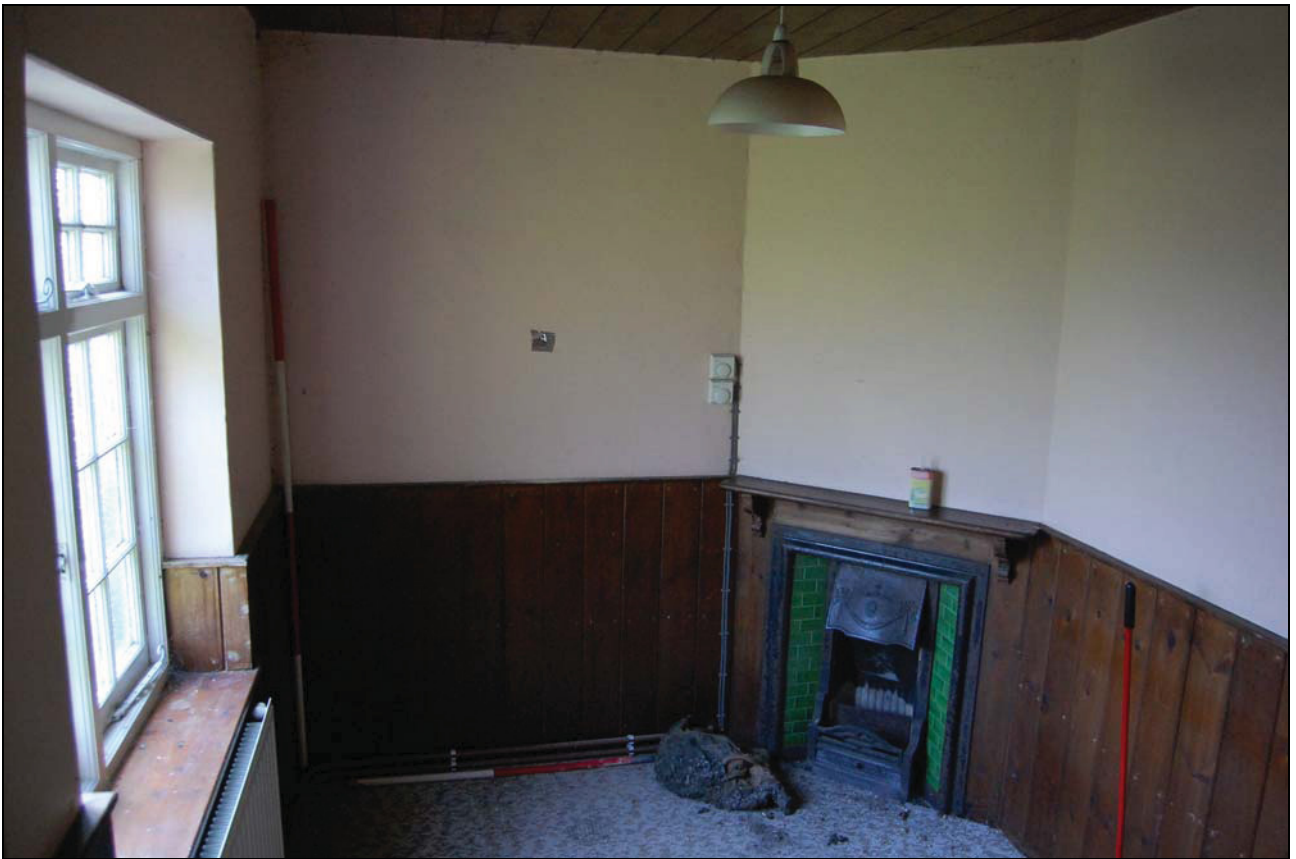
Plate 3. Methodist Chapel, Room 2, facing ESE

A single door to the north of the lectern led into Room 2. This was a small room, but it had one full-sized window and had not been heavily altered. The floor was carpeted, the walls also had the wooden cladding seen in Room 1 and the ceiling was wooden planking. There was a fireplace in the south-eastern corner of the room.

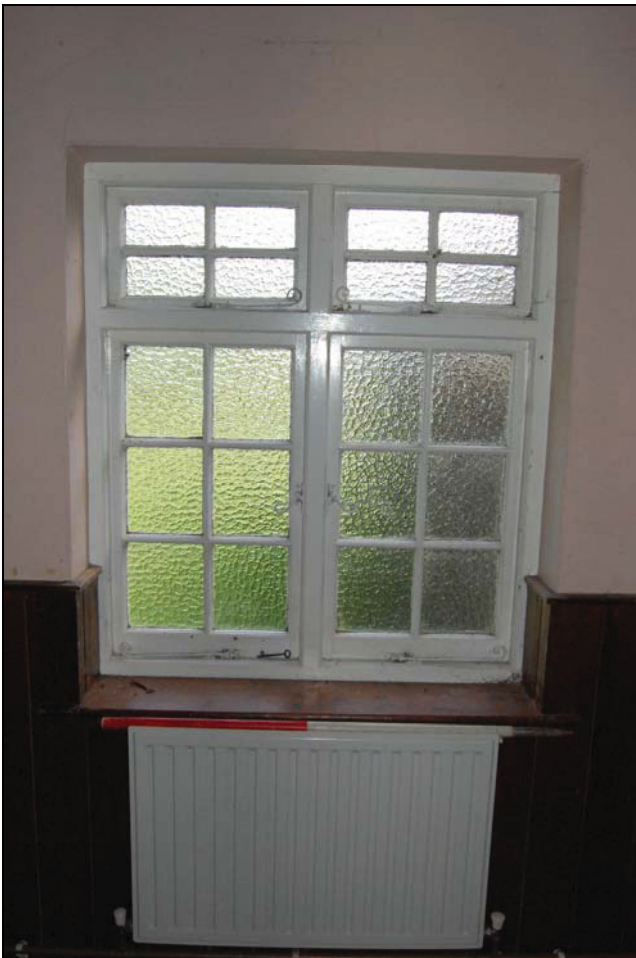
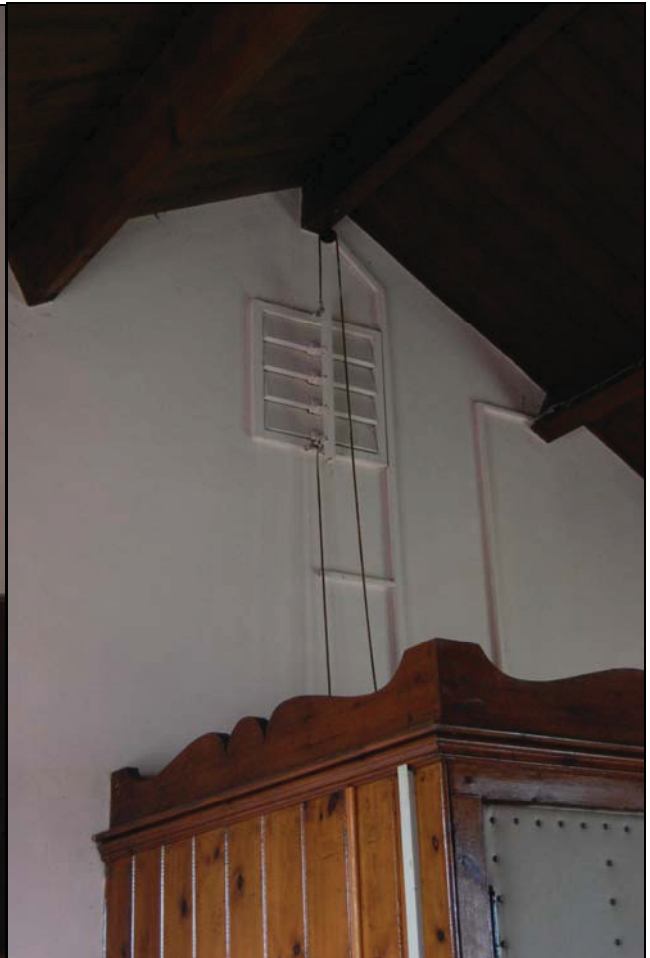
Plates 4 and 5. Methodist Chapel, left- unaltered window frame in Room 2, right- vent mechanism above main doorway

None of the original seating was present. A string-pull operated vent was recorded above the main doorway.

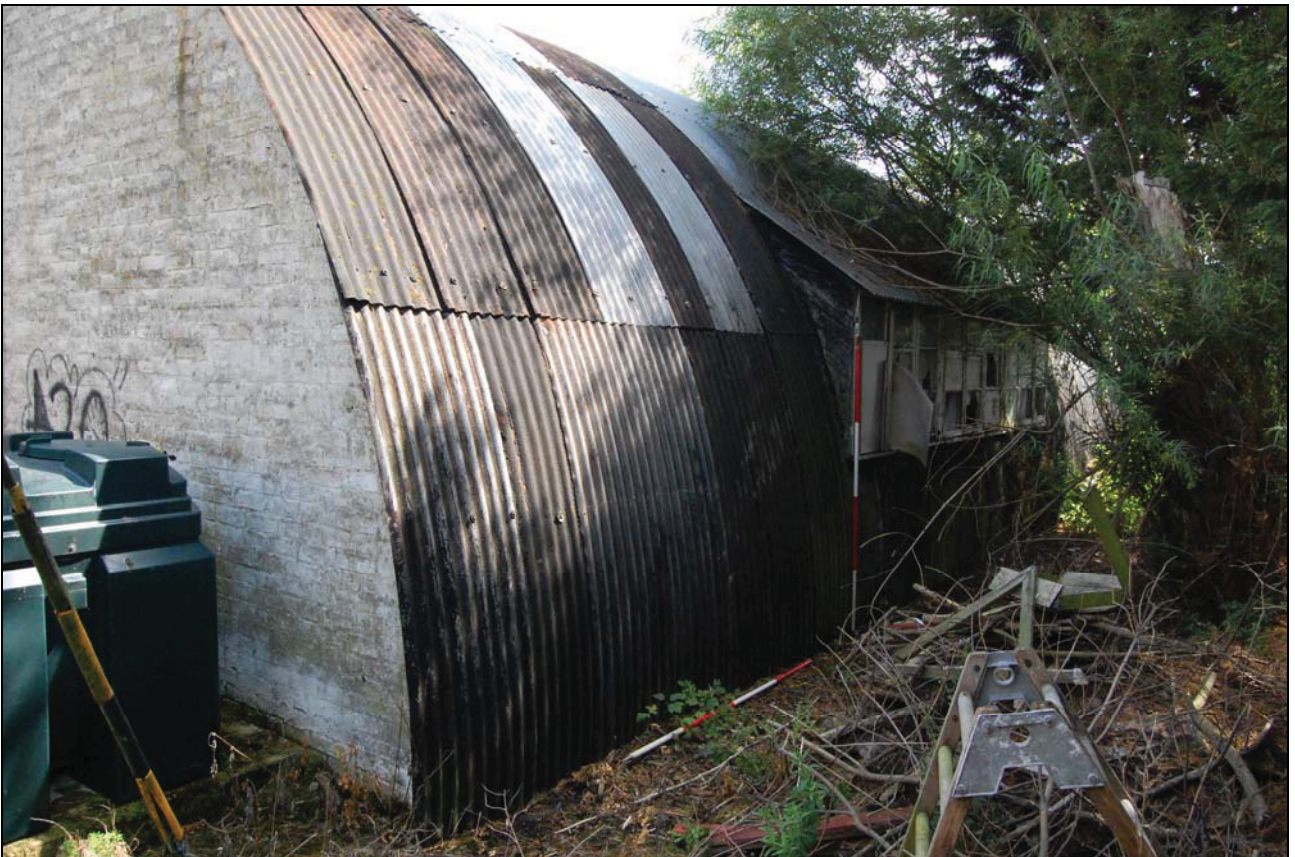
Plate 7. Nissen hut, facing NE

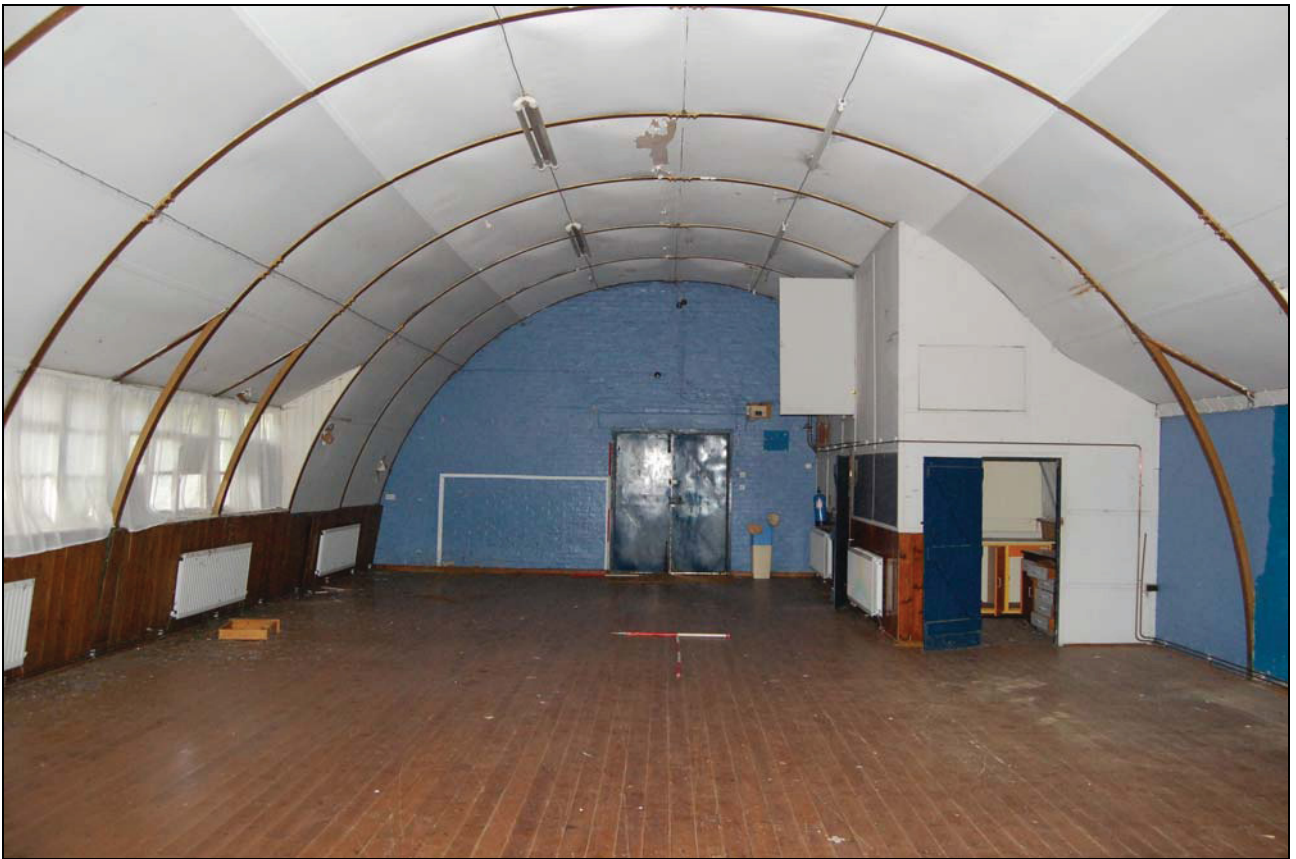
Plate 8. Nissen hut, looking towards entrance and internal rooms, facing WNW

The flooring was made up of wooden boards, with wooden wall cladding up to just below the windows. A chipboard-type material made up the roof between the metal girders. In the north-west corner of the main room were a further two rooms. These were currently used for shelving, cupboards, etc. and the gas boiler, which was a later addition. It was clear that the dividing wall between these two rooms was also a later insertion as it met the external wall midway along the length of the window and the woodwork used here was clearly not original. The floor in these rooms was slightly lower than in the main hall, and carpeted. The space above the ceiling of the rooms and the main structure roof was used for storage. In the eastern elevation of the main hall a doorway led to the breeze block structure. This opening had clearly been widened as the lintel was only as wide as the doorway.
