### ARCHAEOLOGICAL EVALUATION REPORT

SCCAS REPORT No. 2011/112

# Land South of Church Street, Saxmundham SXM 024

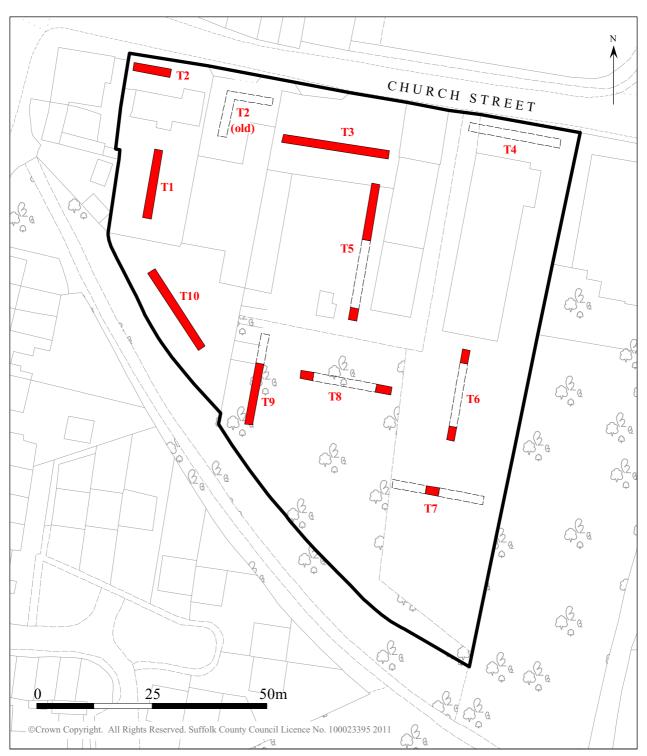
Figure 2. Trench location plan

Figure 2 indicates the locations of the excavated trial trenches. The areas blocked in red denote where the natural subsoil was exposed and the black dashed lines mark the lengths of trench that were not attempted.

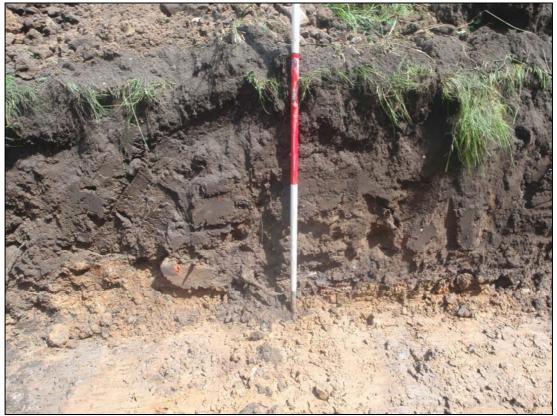
Plate 1. Trench 1, camera facing east (photo ref. HLE01)

<u>Trench 1</u> - ran approximately north to south across the rear garden of the house in the north-west corner of the site and measured 15m in length. The natural subsoil, which comprised a pale orange silty sand, lay at a depth of 0.9m (Plate 1), rising slightly to 0.8m at the southern end. The overburden consisted of a brown silty garden soil with very occasional fragments of 20th century brick. No features were noted cutting the natural subsoil but a number of small pits were cut into the overburden; all contained mid to late 20th century glass and general household debris.

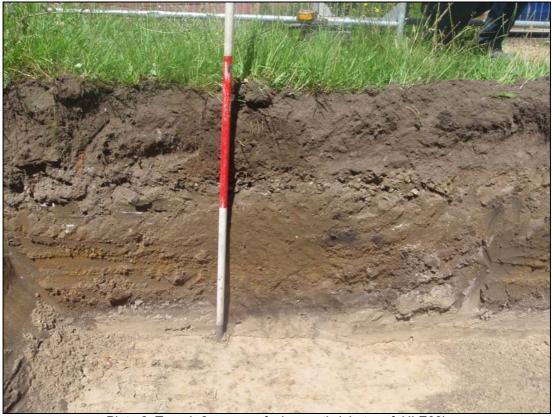
Plate 2. Trench 2, camera facing north (photo ref. HLE03)

Trench 2 - It was originally intended to excavate an 'L' shaped trench in the forecourt of a former garage but this was abandoned due to the presence of numerous live services. To mitigate the loss of this trench an additional trench was excavated in the front garden of the house, an area slightly closer to the street frontage and Saxmundham High Street. In this trench the natural subsoil, which comprised a pale yellow sand, was located at a depth of 0.8m (Plate 2). It lay beneath an overburden of 0.3m of dark rich topsoil, over 0.4m of compact grey silt and sand with occasional fragment of 20th century brick, which in turn overlay a thin spread of dark grey/brown silt. The interface between the natural subsoil and the overburden was relatively sharp suggesting previous truncation.

In Trench 2, close to the street frontage and relatively close to the High Street and an area with the greatest potential for archaeological evidence to be present, the natural subsoil appeared to have been truncated which has removed any early evidence. This truncation is probably related to the demolition of 19th century buildings and the construction of the present house.

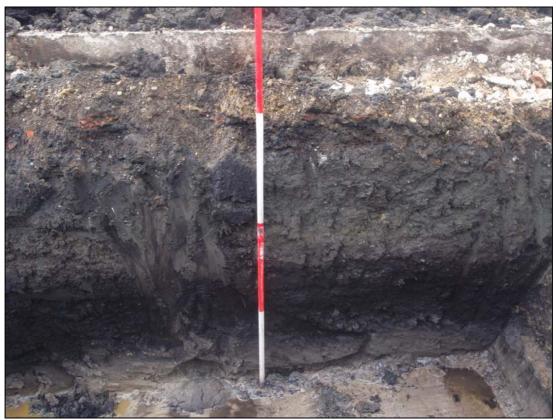
Plate 3. Trench 3, camera facing north (photo ref. HLE05)

<u>Trench 3</u> - was excavated parallel with Church Street, approximately 11m back from the road edge. The natural subsoil consisted of a pale grey/yellow, waterlogged sand at a depth of 1.8m below the present ground surface. The revealed stratigraphy comprised: 0.5m of concrete slab and a sub-base of brick rubble and crushed chalk; over 0.6m of

dense grey alluvial silt; 0.4m of dark peaty material; and 0.3m of grey sandy silt (Plate 3). Other than a known sewer, no archaeological features were encountered.

Of interest is the fact that in Trench 3, which ran close to Church Street, the natural subsoil lay at a depth of 1.8m beneath layers of peaty material and alluvial silt with no indication that the level of the subsoil would rise significantly. This would suggest that Church Street lies on an artificially raised causeway linking the site of the church to medieval Saxmundham. This is likely to consist of a substantial earthwork but may have originally comprised a raised wooden trackway.

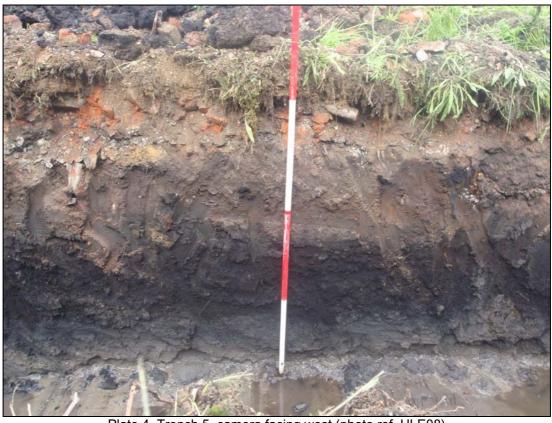
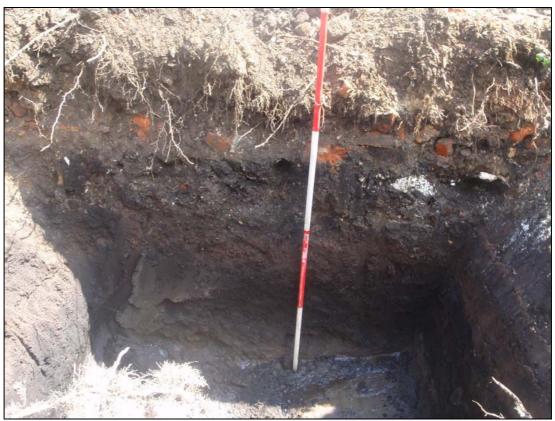
Plate 4. Trench 5, camera facing west (photo ref. HLE08)

Trench 5 - was excavated perpendicular to Church Street, starting approximately 19m back from the road edge. At the northern end the natural subsoil consisted of a pale grey/yellow, waterlogged sand at a depth of 1.5m below the present ground surface (this does not represent a rise in the natural subsoil as the ground surface was c. 0.25m lower than the area of Trench 3). The revealed stratigraphy comprised: 0.4m of brick rubble; 0.4m of brown silty clay; 0.4m of dark peaty material; and 0.3m of grey sandy silt (Plate 4). The natural subsoil dipped down gently towards the south reaching a depth of 1.7m (because of a thicker deposit of the 20th century rubble). This occurred 12m from the northern end of the trench at which point excavation of the trench was abandoned. To confirm there was no great change in the stratigraphic layers a test hole was machine excavated at the southern end of the proposed trench (Plate 5). This revealed that the natural subsoil had dipped to a depth of 1.9m below the present ground surface. The lower silt and peaty layers remained unchanged but an additional layer of material was present between the rubble and the brown silty clay consisting of grey brown clay containing crushed chalk and a substantial amount of modern debris.

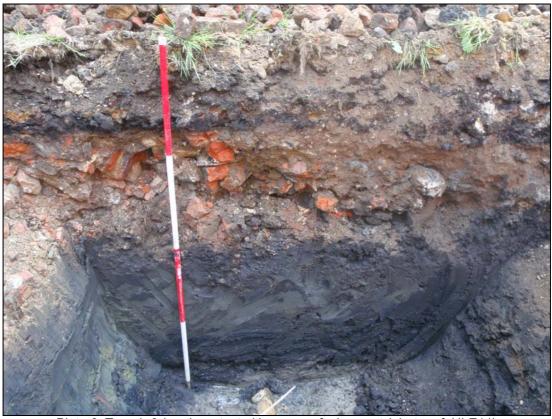
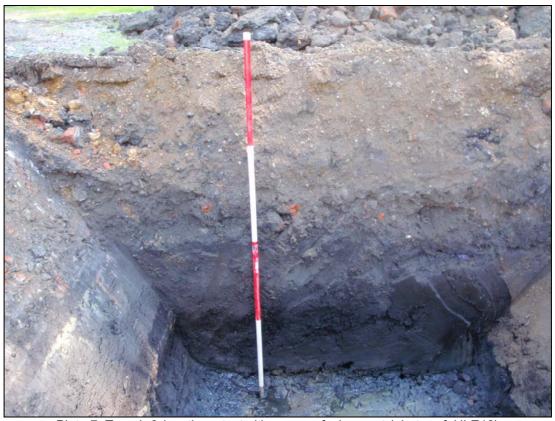
Plate 6. Trench 6 (northern test pit), camera facing east (photo ref. HLE11)

<u>Trench 6</u> - This was intended to be a north-south trench measuring 20m in length. Excavation started at the northern end and revealed a stratigraphic sequence comprising: 1m of modern concrete, hardcore and brick rubble; 0.8m of dense grey alluvial silt; and 0.2m of peaty material over a natural subsoil of pale grey sand at a depth of 2m below the present ground surface (Plate 6). Due to the extreme depth this trench further excavation was abandoned in favour of a test pit at the southern end of the proposed trench. This revealed a similar stratigraphic profile but with a thicker peaty deposit and a corresponding thinner layer of alluvial silt (Plate 7).

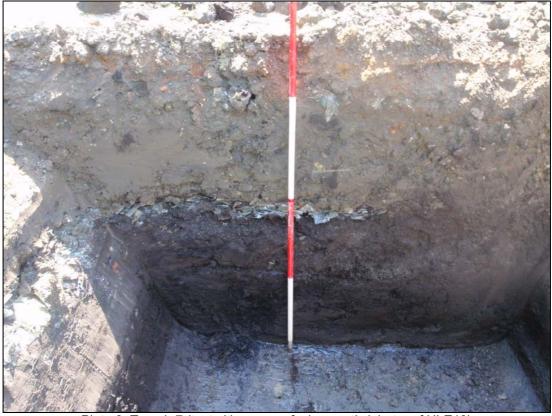
Plate 8. Trench 7 (test pit), camera facing south (photo ref.HLE13)

<u>Trench 7</u> - Reduced to a single test pit due to extreme depth and the presence of Japanese knotweed in the locality. Excavation revealed a stratigraphic sequence comprising: 0.9m of grey silty clay with modern debris overlying a layer of broken glass which in turn overlay 0.8m of peaty material with occasional lenses of grey silt (Plate 8).

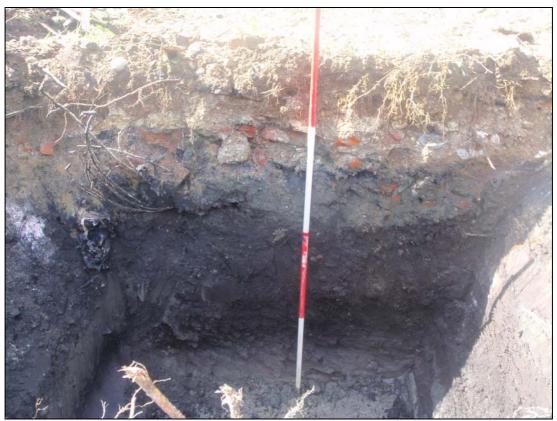
Plate 9. Trench 8 (western test pit), camera facing north (photo ref. HLE14)

<u>Trench 8</u> - This was intended to be an east-west trench measuring 20m in length but was reduced to two test pits. Both revealed a similar stratigraphic sequence consisting of 1m of modern debris (rubble, concrete etc.), over 0.5m of dense grey alluvial silt and 0.3m of peaty material over a natural subsoil of pale grey sand at a depth of 1.8m below the present ground surface (Plate 9).

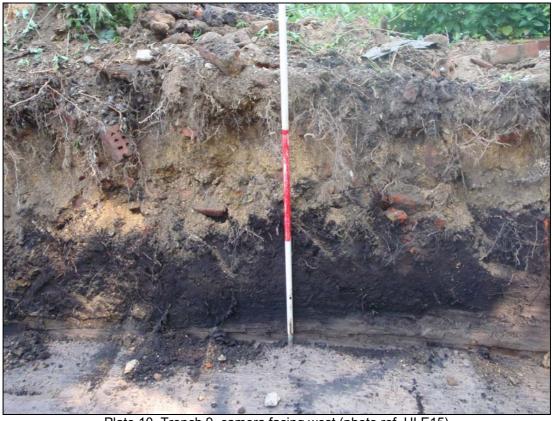
Plate 10. Trench 9, camera facing west (photo ref. HLE15)

<u>Trench 9</u> - A north-south trench which revealed a stratigraphy comprising 0.6m of modern overburden (rubble etc.) over 0.5m of dark peaty material over 0.1m of grey silt which in turn overlay a natural subsoil of mottled pale grey and yellow sand (Plate 10). This trench was intended to be 20m in length but was abandoned after 13m due to the presence of a substantial concrete ?footing cutting into the surface of the natural subsoil.

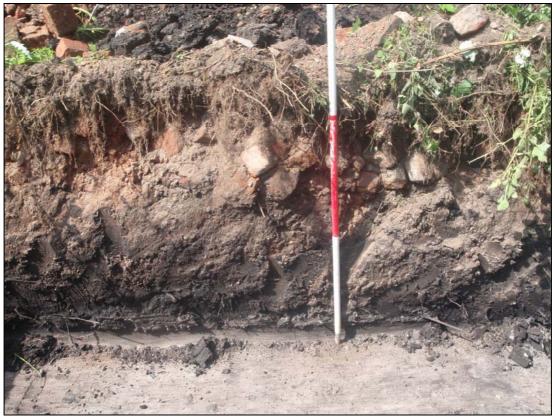
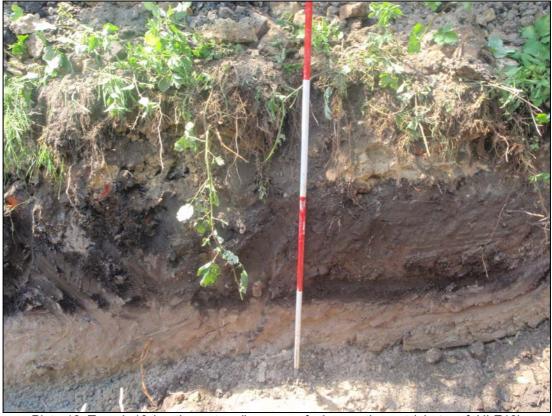
Plate 11. Trench 10 (south-east end), camera facing south-west (photo ref. HLE17)

<u>Trench 10</u> - A north-west to south-east trench. At the south-east end the revealed stratigraphy consisted of 0.7m of modern overburden (rubble etc.) over 0.6m of dark peaty material which in turn overlay a natural subsoil of pale grey sand (Plate 11). The natural subsoil sloped up gently towards the north-west end where it lay at a depth of 1m below an overburden of 0.4m of topsoil over 0.5m of dense grey silt over a 0.1m thick layer of dark peaty material (Plate 12).
