**Abbey Gardens Play Area,
Bury St Edmunds
BSE 366**

Archaeological Monitoring Report

SCCAS Report No. 2011/132

Client: St Edmundsbury Borough Council

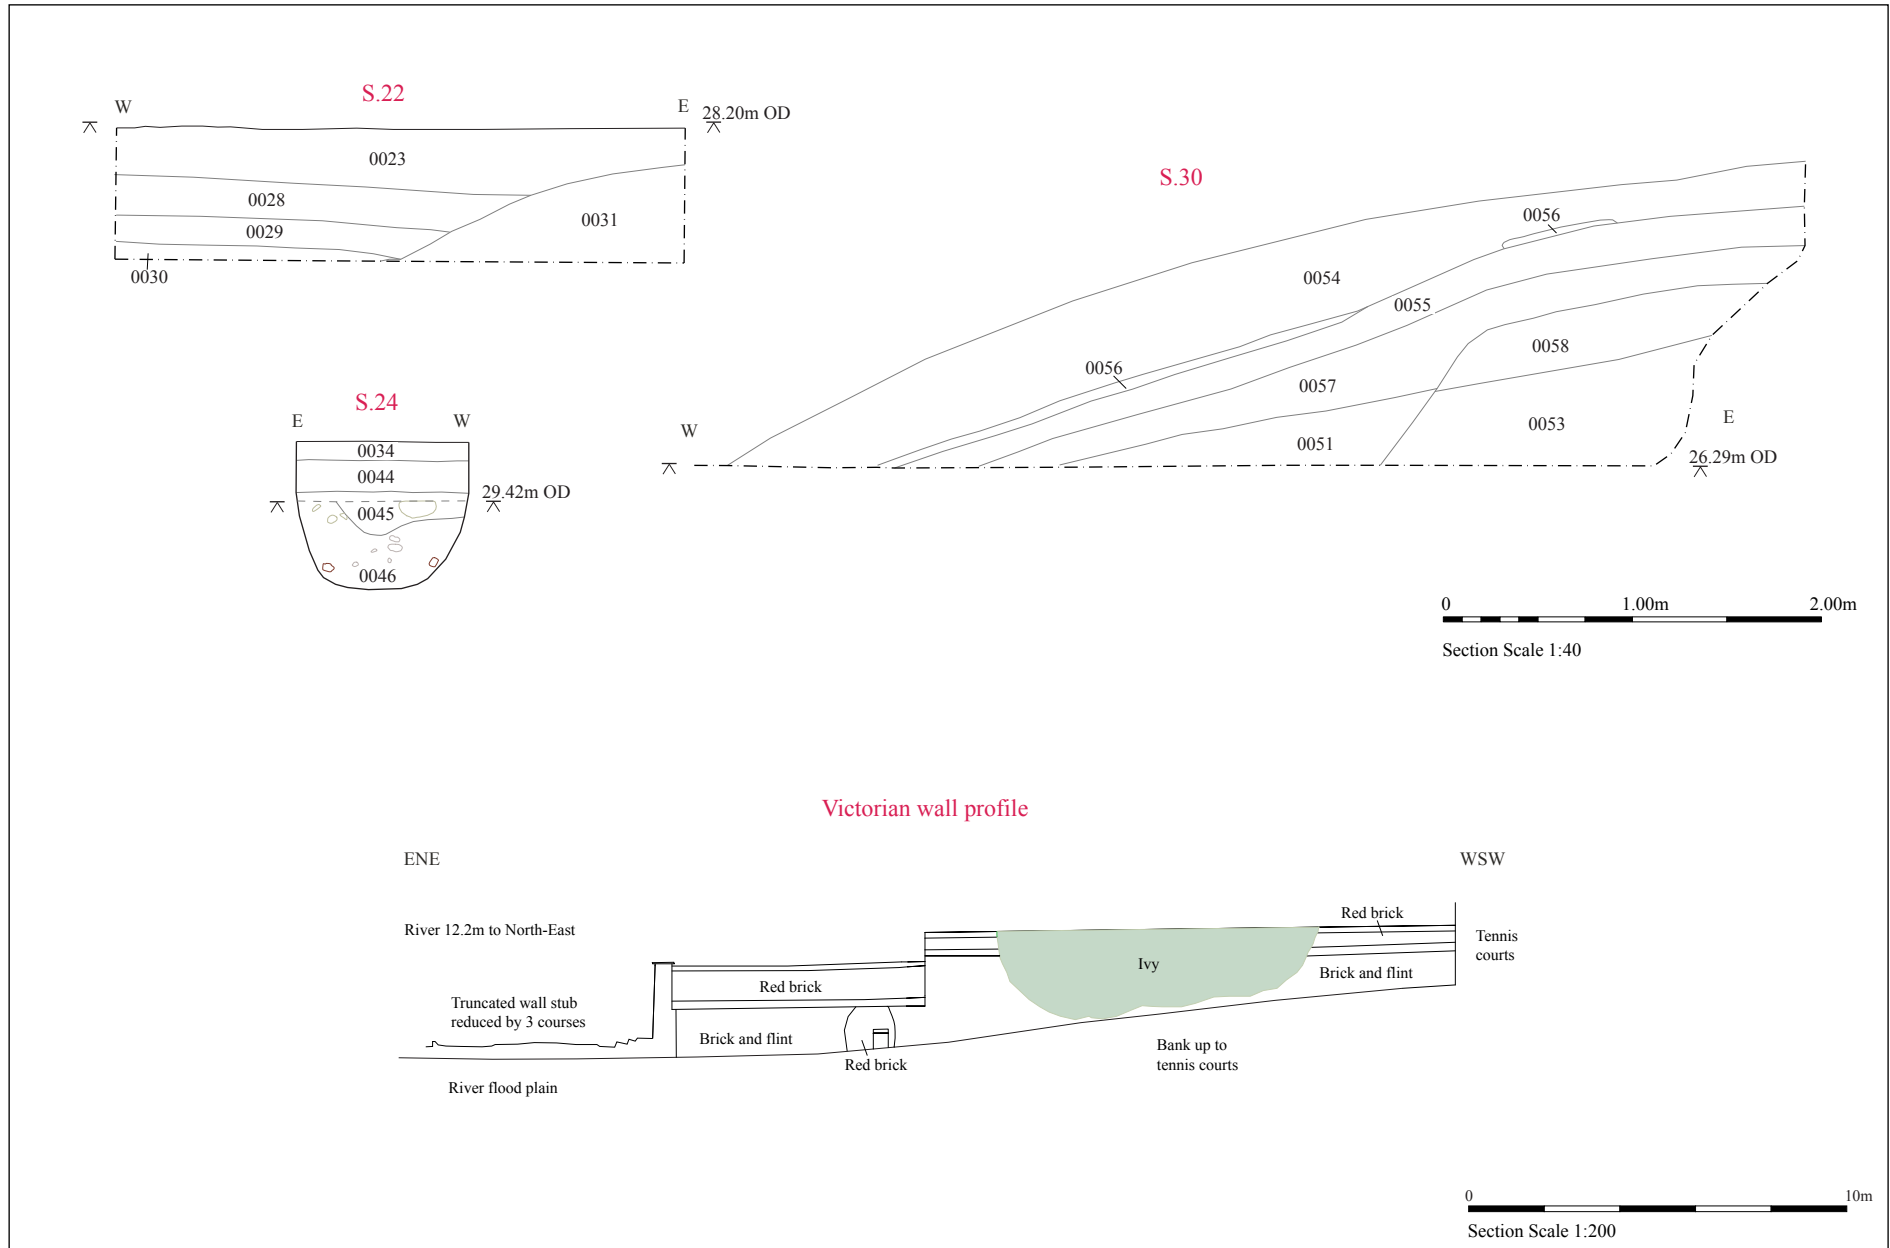
Figure 3. Sections and wall profile

The trenches revealed what appeared to be the buried eastern bank of the River Lark's former channel (Fig. 3, S.22) rising as contexts 0027, 0031, and 0035. The three trenches had similar profiles, with the upper layers thinning as the lower ones rose to the north. No dating evidence was recovered from these fills.

The west side of the River Lark was unremarkable (see Table 1), but the trench dug into the east bank showed several layers of deposition and the possible cutting through of earlier layers, either by the action of the river itself or through human intervention (Fig. 3, S.30).

Beneath topsoil 0054 was a thin, intermittent layer of fine gravel, context 0056, covering buried topsoil 0055. Beneath this, layer 0057 covered and possibly cut through layer 0058, a gravelly sand which contained two fragments of a late 12th to 14th century jug. Layers 0051 and 0052 sat on top of river clay 0053, which became less black-streaked as it rose to the east, possibly representing an older riverbank approximately 3.5m back from the current river edge.

Also of interest is the east bank of the River Lark, as exposed in the trench for the rope bridge footings. The old riverbank, seen in contexts 0053 and 0058, was 3.5m back from the modern one, and contained pottery dating to the late 12th through 14th century. The medieval remains of the bridge abutment to the south and those of the former vineyard respect the current bank and indicate a stable water course, however. Whether this means the river widened between them or used to follow a more curving

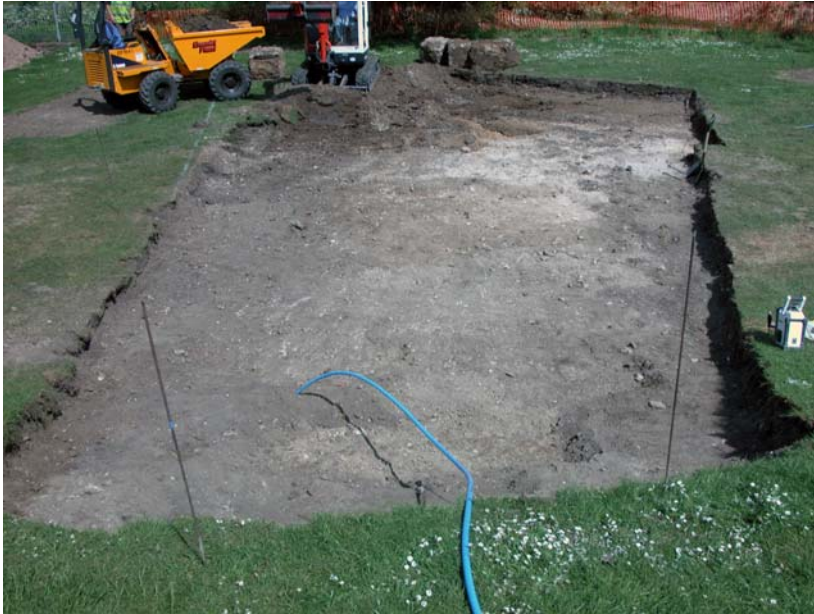
Plate 1. Sand and water area, facing east. The pale soil to the top is layer 0045

A 208m² area of soil was stripped adjacent to the bank covering the remains of the Prior's House, as shown on the first edition OS map (Fig. 2), to near the edge of the River Lark, revealing layer 0044, which was filled with fragments of flint, brick, and oyster shell, dating to the late 17th to the 18th century. This layer continued throughout the stripped area, apart from the northeast corner, where it mixed with and possibly covered layer 0048, a more sterile silty clay. The exact relationship between these layers was unclear due to a mixed horizon.

Beneath layer 0044, two extents of yellowy crushed mortar, possibly the same layer, were partially revealed. Layer 0047 was just below the bank and held occasional fragments of brick and flint. Layer 0045 was similar, but further down the bank where the ground levelled out, and was more fully revealed in profile by the removal of the concrete base of a piece of playground equipment (Fig. 3, S.24). No bonded material was identified in either layer, and they may have been spoil dumps, possibly from earlier excavations of the area around the Prior's House, which took place in 1849 and 1933-4 (Whittingham 1951). These deposits lay over the infill of the River Lark's former channel, and must therefore post-date 1791. A partial human radius was found in layer 0045 and is almost certainly redeposited.

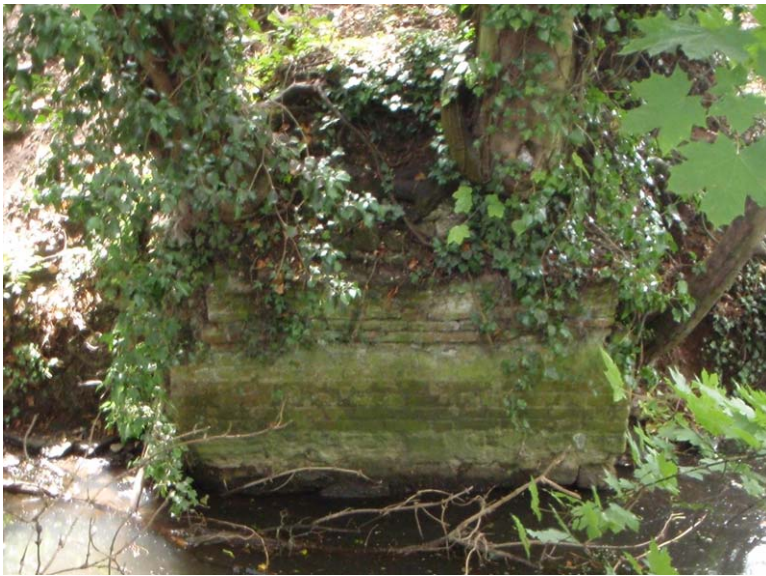
Plate 2. Bridge remains, woodland area, facing west

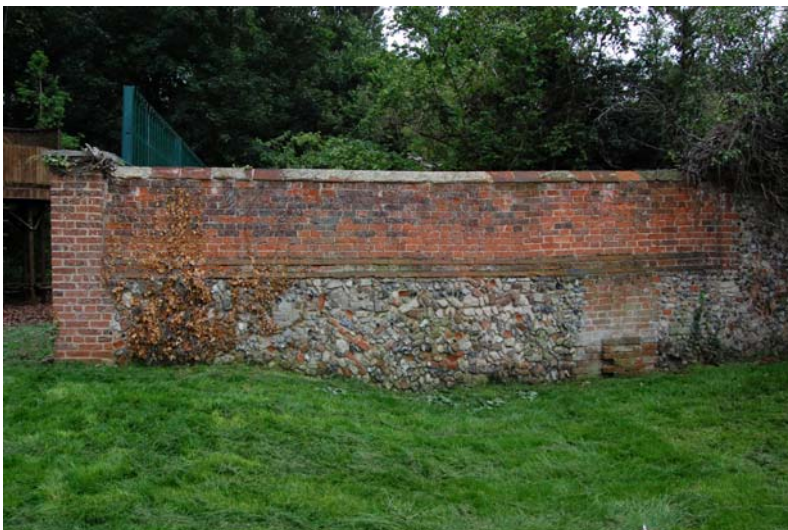
Plate 3. Victorian wall recording, facing south

| Wall Recording | 04/05/2011 | The remains of a Victorian wall that separated the Woodland Area from the rest of the Abbey Gardens were recorded by photograph and survey prior to the removal of the top three courses of bricks to allow for the creation of a smoother bank between the two. The reduced section of wall was made of bricks and does not reflect a medieval boundary, instead being constructed over the infilled River Lark channel sometime after 1823 and before 1886, when it first appeared on the first edition OS map. |
