**Gardeners Cottage at  
Grundisburgh House,  
Grundisburgh, Suffolk  
GRU 040**

**Heritage Asset Assessment**

**August 2011**

## **Heritage Asset Assessment**

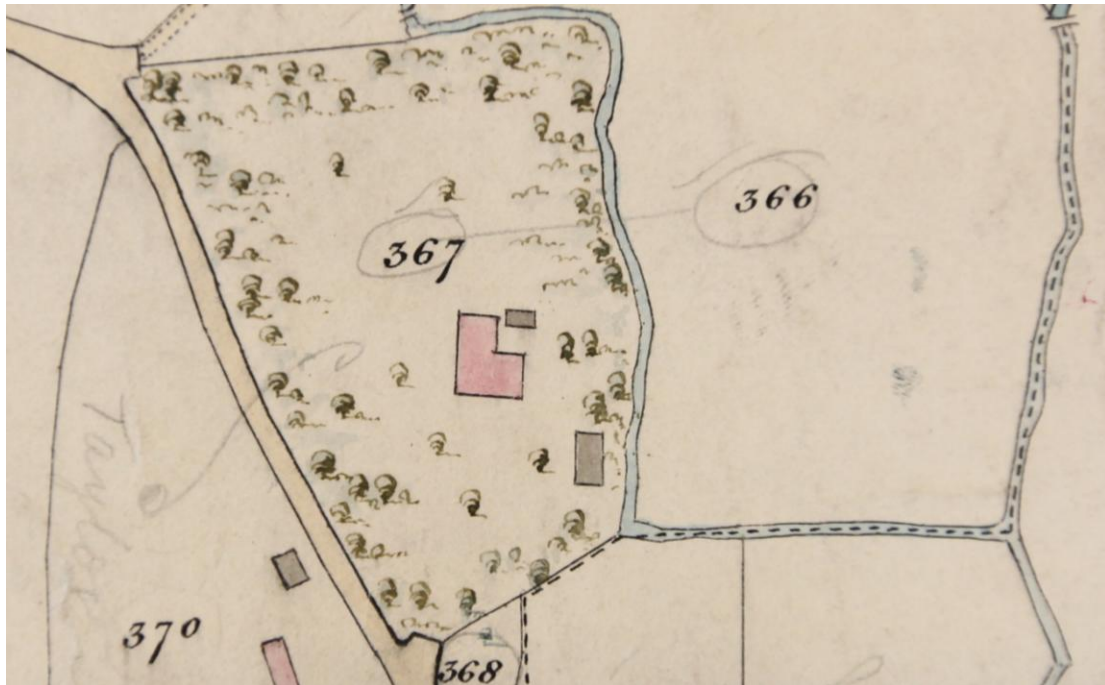
**Figure 2.** The 1841 tithe map of Grundisburgh parish (Suffolk Record Office) showing north towards the top right-hand corner. Grundisburgh House has an L-shaped outline (in red) while a building on the site of Gardeners Cottage is shown in grey as a simple rectangle. The boundary with Burgh parish is indicated by the broken line to the right.

The 1841 tithe map shows a detached structure with a rectangular outline on the site of the building now known as Gardeners Cottage which flanks the approach to the main house. Its depiction in grey rather than red ink may indicate a timber-framed and boarded structure as opposed to one built of brick, but conventions vary and this may simply reflect its status as an outbuilding.

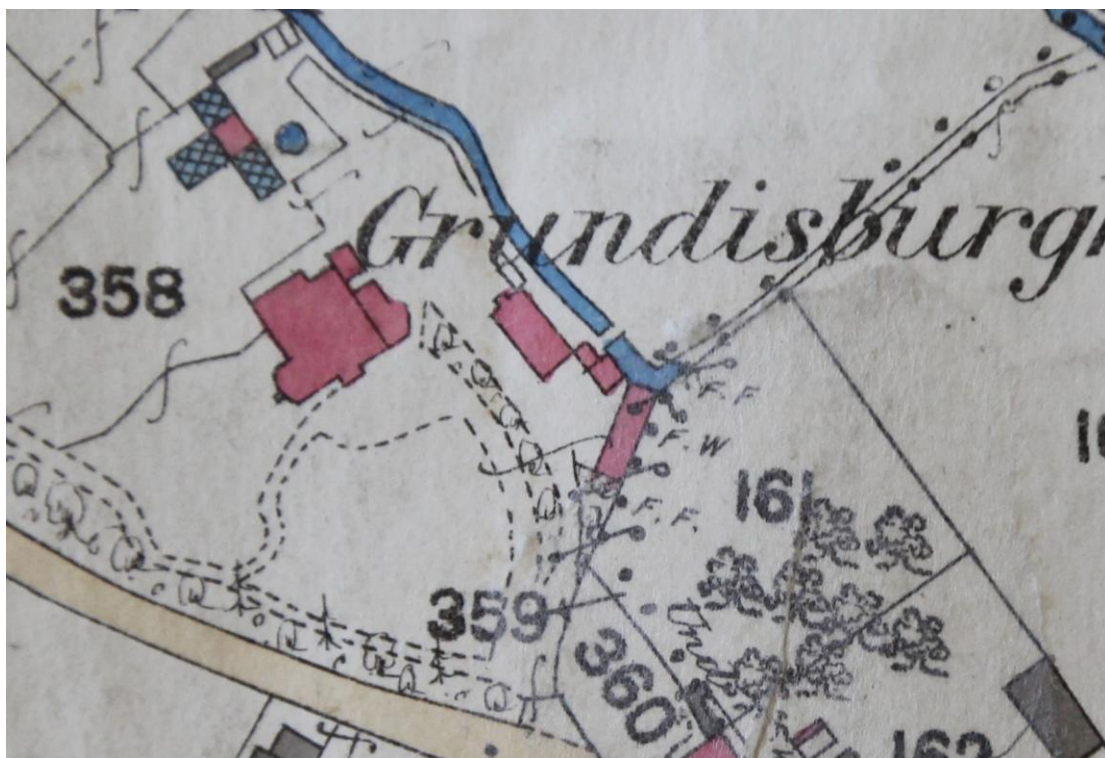
**Figure 3.** First Edition 25 inch Ordnance Survey of 1881. Gardeners Cottage is still shown as a rectangular structure with what appears to be a chimney or possibly an external stair projecting from its north-western gable. Its red pigment indicates brick rather than studwork. A new range of outbuildings, including the present red-brick stable, had been added to the south-east since 1841 and the main house had been considerably enlarged to form a square with its present porch and semi-circular wings.

By the time of the first edition 25 inch Ordnance Survey of 1881 the main house had acquired its present facade with canted wings and large extensions had appeared to the rear along with a series of detached greenhouses. Gardeners Cottage still retained its simple outline but new sheds had been attached to the north and east (including the surviving single-storied red-brick shed (building 2 in figure 6) and the detached stable with integral shelter-shed to the east). Yet another substantial gault-brick rear extension had been added to the house by 1904, presumably by the Round-Turners. Between 1904 and 1927 Gardeners Cottage was extended to the north-west to create its present outline, and the attached eastern sheds were replaced by the surviving red-brick shed which overlaps its south-eastern gable (figures 4 and 5). These changes are said by a local resident now in her nineties to have adapted a stable to create a dwelling for a chauffeur alongside a garage (information from current owner). Kelly's Suffolk Directory of 1912 names the Reverend Robert Fetzer Taylor as the resident of Grundisburgh House with Mrs Round-Turner living at 'The Cottage', but this probably refers to a separate property elsewhere in the village. The building's current name suggests it was later occupied by a gardener.

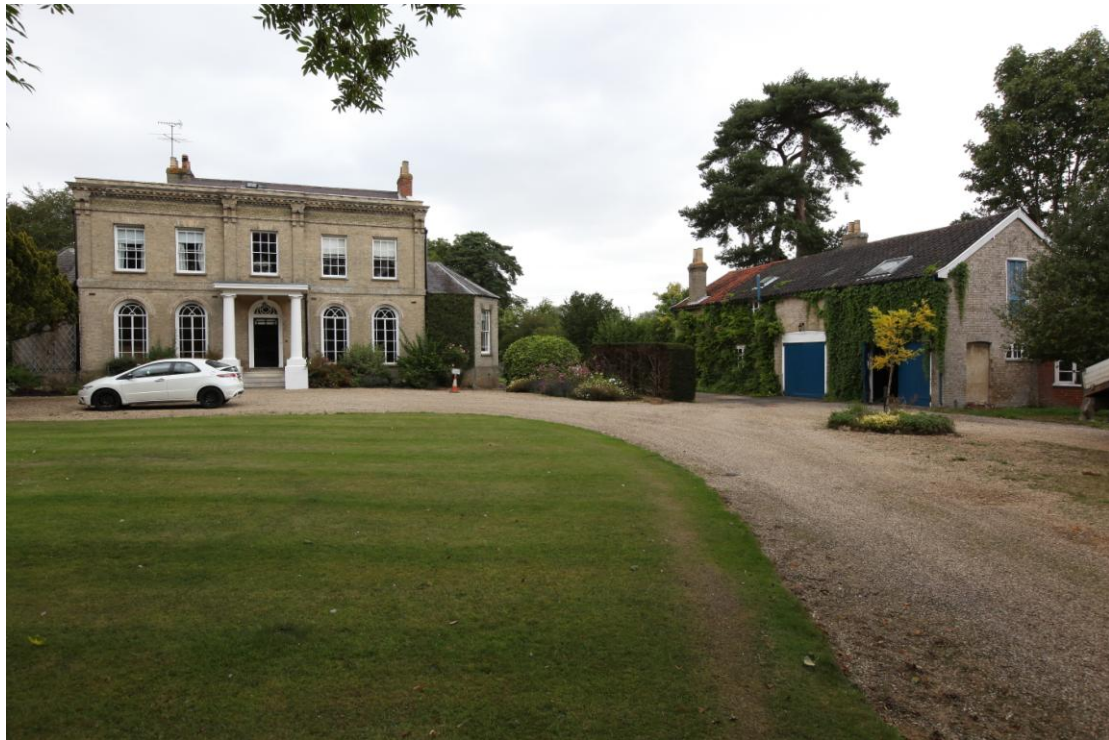
**Illus. 1** Gardeners Cottage from the south (right) showing the manner in which it flanks the approach to Grundisburgh House. The latter's impressive grade II-listed facade consists of matching gault brick.

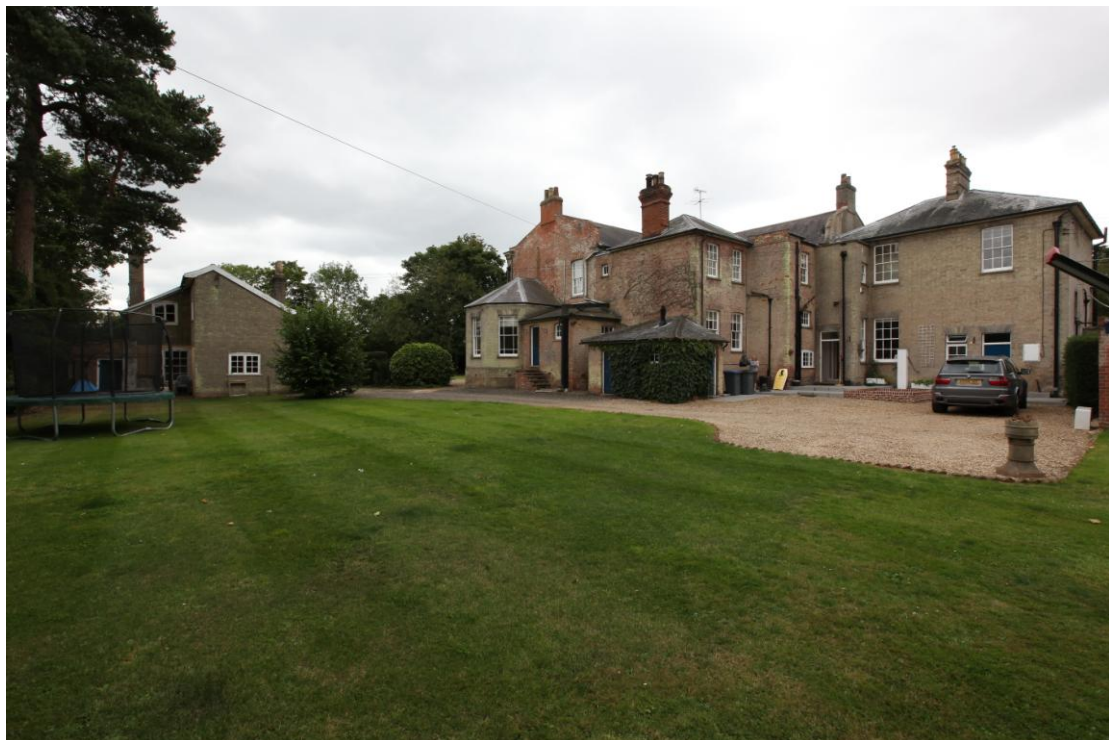
**Illus. 2** General view of the site from the north west showing the later rear service range of Grundisburgh House to the right and the domestic quarters of Gardeners Cottage to the left.

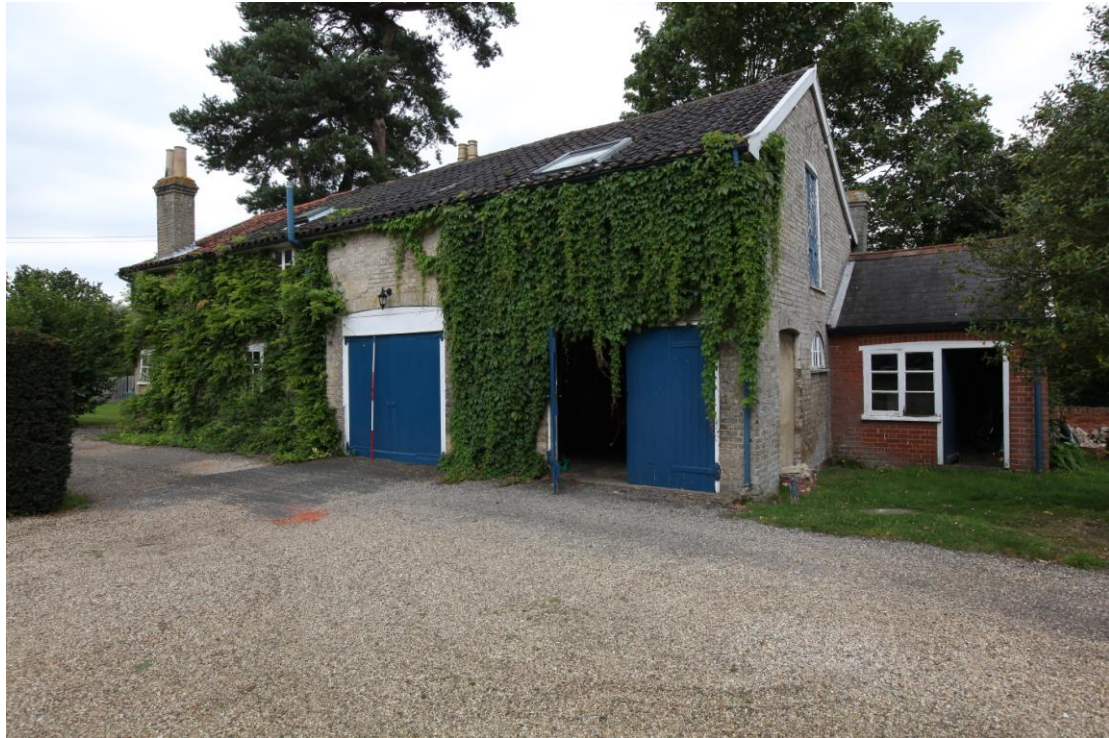
**Illus. 3** The south-western facade of Gardeners Cottage showing the doors to the two sheds (1c & 1d) to the right and the domestic cottage windows (1a & 1b) to the left.

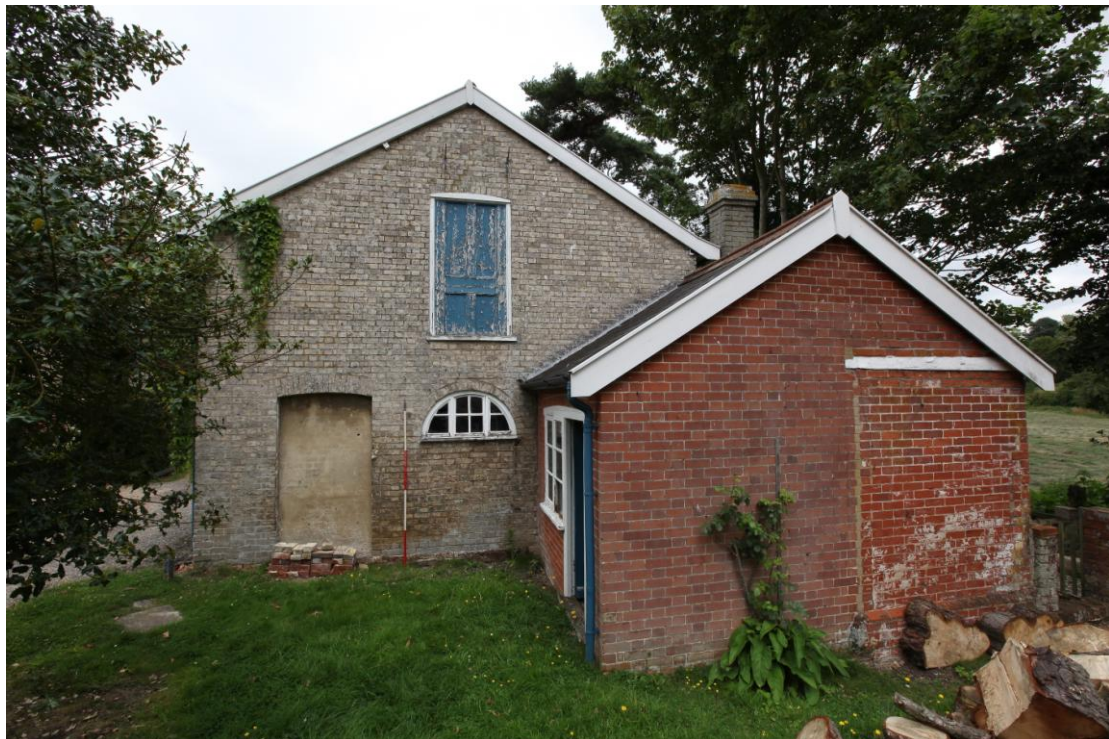
**Illus. 4** The south-eastern external gable showing the external loading door to the first-floor loft with the blocked original entrance to the probable former stable (1d) to the left. The arched window is also original and reflects the ground-floor windows of the house. The red-brick structure (3) to the right is a later addition which was probably built as a groom's shed at the beginning of the 20<sup>th</sup> century.

The eastern section of the building (1d) survives from the structure shown on the Ordnance Survey of 1881 and probably the tithe map of 1841. It appears to have formed a stable with an entrance passage against its gable and a first-floor hay loft or granary reached by an external door (via a missing set of steps). The original floor of gault brick preserves a shallow drain between the passage and the north-western section of the interior where the horses would have been stalled. The ceiling of moulded joists retains original lath-and-plaster with evidence of a blocked trap for an internal ladder in its eastern corner. The rear wall preserves an arched window and a door at the end of the passage, but the front wall has been destroyed by the insertion of 20<sup>th</sup> century vehicle doors beneath a horizontal concrete lintel. A similar window and door survive in the gable, but the door has been blocked by internal wainscoting of vertical stained pine boards which appear to date from the early-20<sup>th</sup> century and retain the scars of two axial partitions with curved top-rails. The present entrance presumably post-dates the removal of these partitions. The loft has been partly converted but preserves some original whitewashed softwood rafters beneath the present unpainted timbers which have a slightly steeper pitch. It is possible that the building was originally covered with slate to reflect the house.

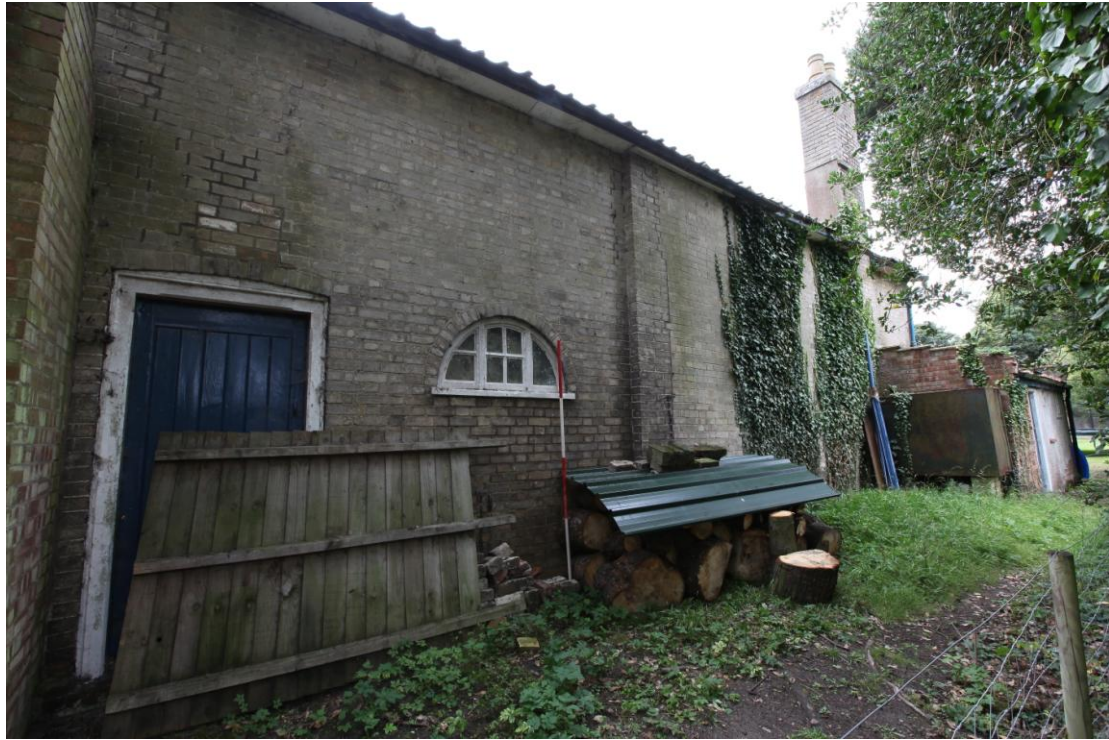
**Illus. 5** The rear (north-eastern) exterior showing the original door and arched window to the probable former stable (1d) to the left and the projecting central bay to right. The straight vertical joint in the latter's brickwork suggests the right-hand half of the structure has been remodelled (i.e. the domestic cottage 1a and 1b).

The brickwork of the front elevation is largely concealed by a creeper, but the exposed rear elevation contains a straight vertical joint in the brickwork at the junction of sections 1d and 1c. The brickwork to the east differs in colour and texture from the rest of the elevation and is clearly the earlier of the two phases, but there is nothing to indicate the original structure terminated at this point. The narrow domestic kitchen (1a) is conspicuous by its absence from the Ordnance Surveys of 1881 and 1904 (but was present by 1927), yet its fabric is fully integral to that of the sitting room (1b) and the rear elevation of the central shed (1c): It would therefore appear that much of the mid-19<sup>th</sup> century structure of which the eastern shed (1d) formed a small part was rebuilt when the present cottage was created between 1904 and 1927. The present pantiled roof may have been added at the same time.

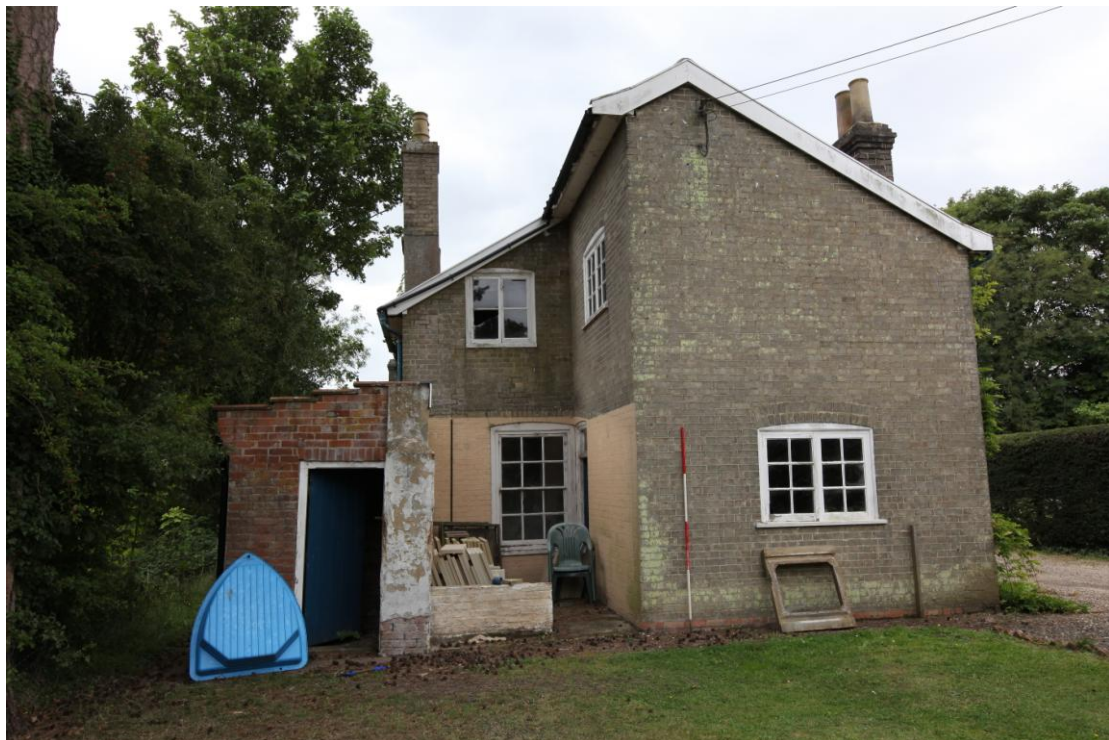
**Illus. 6** The north-western external gable showing the unusual configuration of the domestic cottage (1a and 1b) with a narrow yard dividing the kitchen (1a, right) from a single-storied red-brick shed (2) to the left.

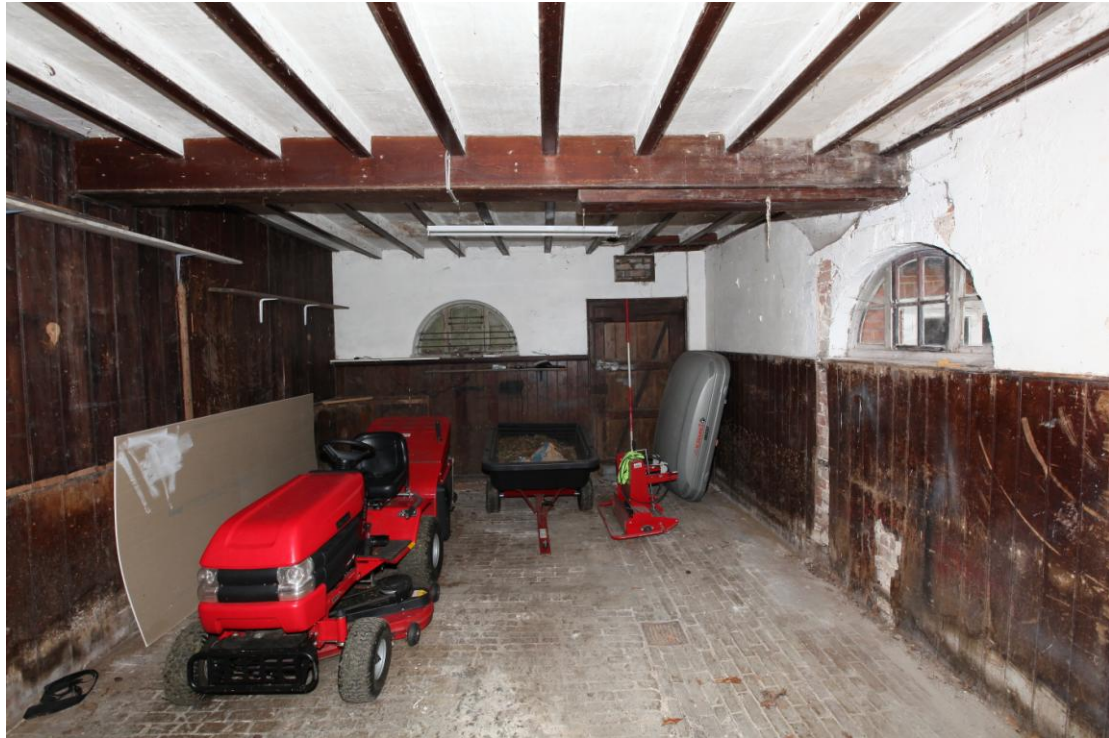
**Illus. 7** The interior from the south-west of the eastern shed (1d) showing the later wainscot of stained vertical boards and the original gault-brick floor with evidence of a lateral drain and passage to the right. The wainscot blocks the original door in the south-eastern gable (extreme right) and bears the scars of two axial stall partitions. Note the original whitewashed lath-and-plaster between the stained ceiling joists.

d. Vehicle shed entered by double doors from the south-west. The present entrance a 20<sup>th</sup> century insertion beneath a concrete lintel, and probably built as a stable in the mid-19<sup>th</sup> century with a gault-brick floor, arched windows reflecting those of the main house and a lateral passage against its south-eastern gable. First-floor hay loft or granary with external loading door (now partly converted). An original ground-floor gable door now blocked by internal wainscot which bears the scars of two axial stall partitions.

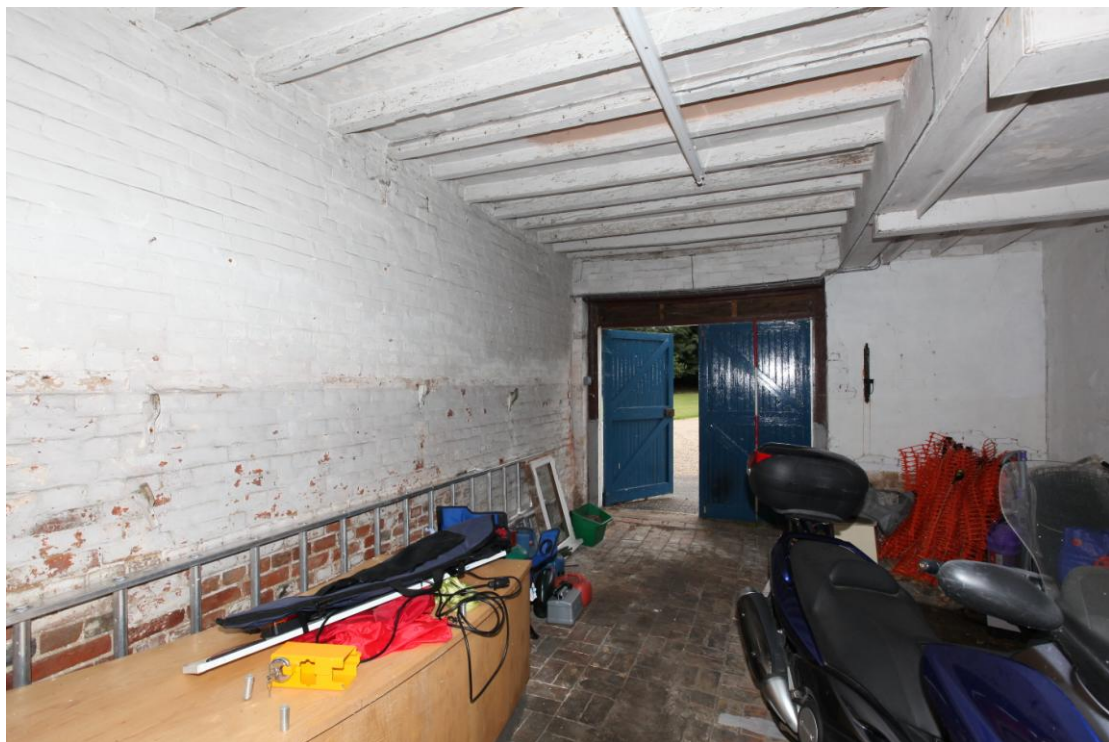
**Illus. 8** The interior from the north-east of the central vehicle shed (1c) showing its south-western entrance doors and the lower section of ceiling beneath the domestic bedroom to the right.

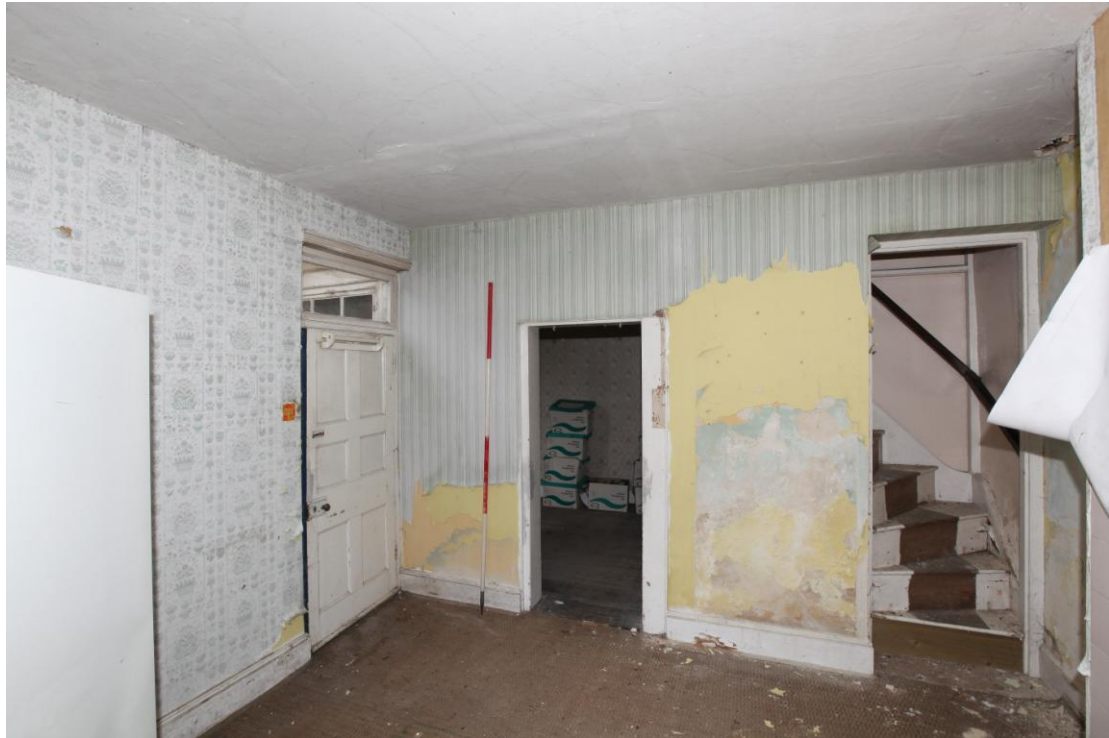
**Illus. 9** The interior of the cottage kitchen (1a) from the north-western gable showing the external entrance door to the left with the internal doors to the sitting room (1b) and stair to the right.

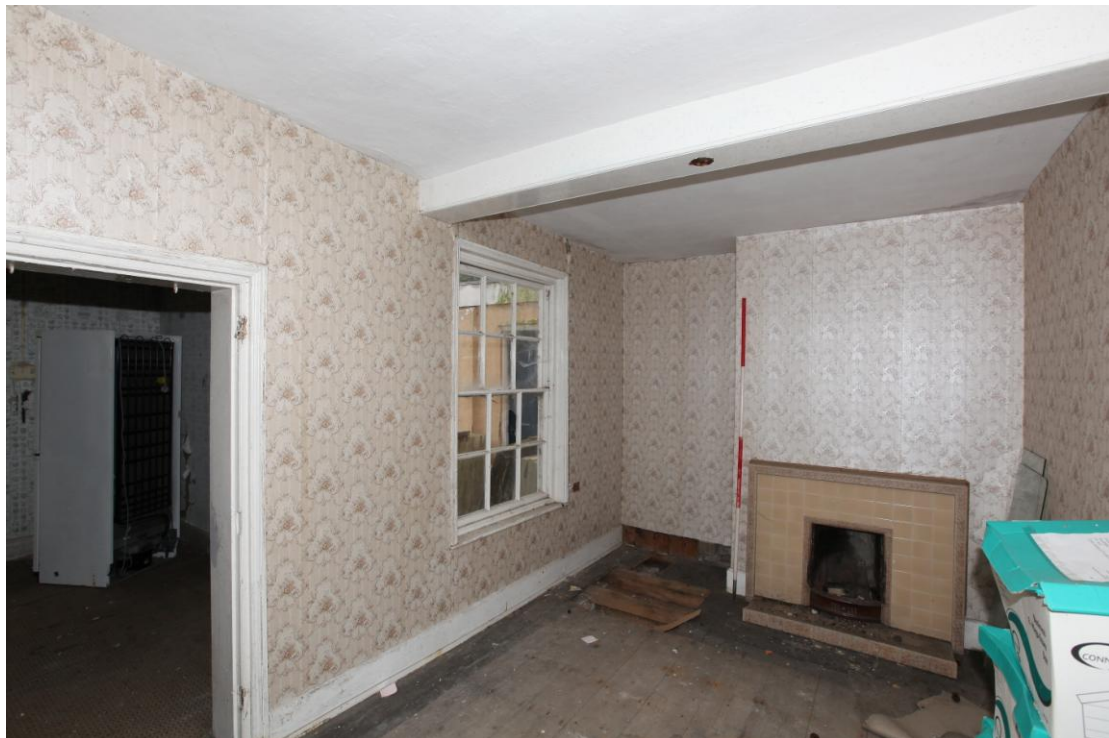
**Illus. 10** The interior of the cottage sitting room (1b) from the south-west showing its mid-20th century tiled fire surround with the yard window and kitchen (1a) to the left.

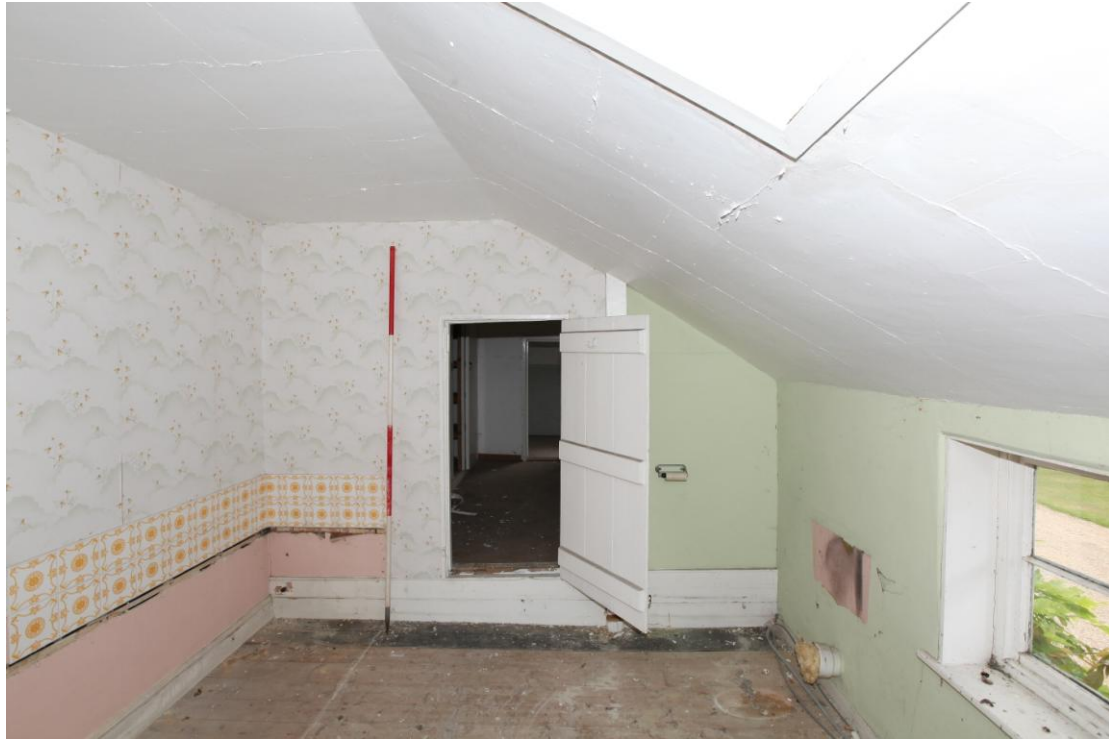
**Illus. 11** The front (south-western) bedroom above the cottage sitting room (1b) showing the door to the raised area above the central shed (1c).

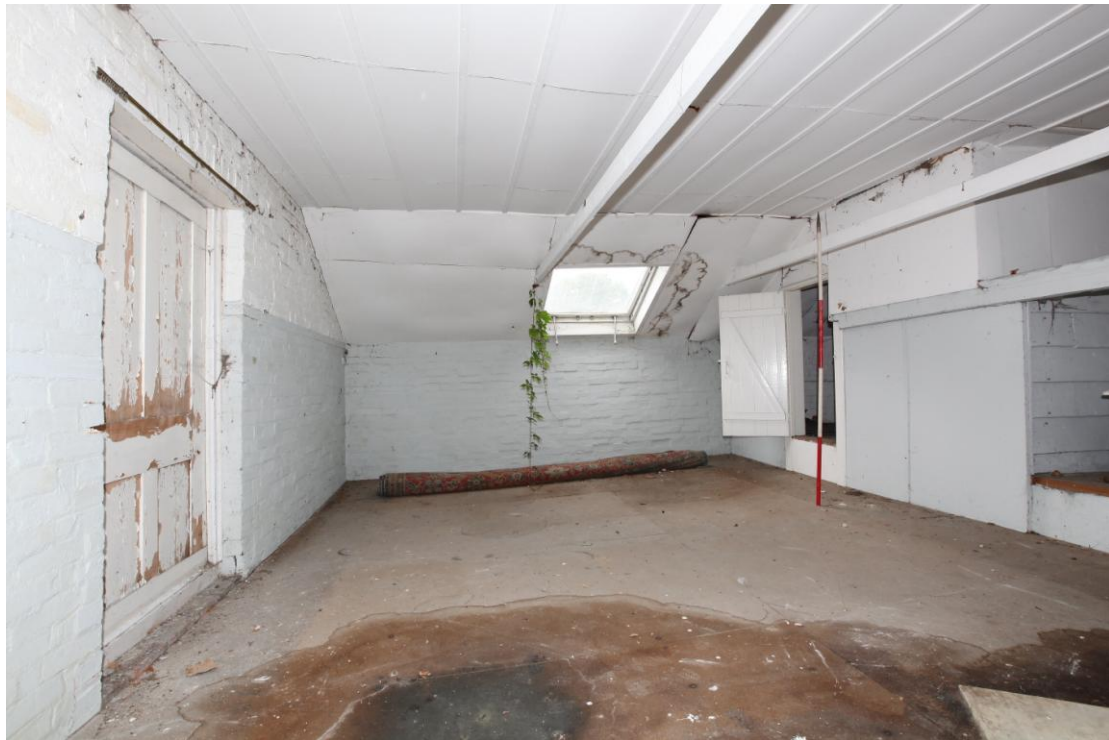
**Illus. 12** The partly converted eastern loft above the probable former stable (1d) seen from the rear (north-east). The external loading door in the gable is visible to the left with the raised section above the central shed (1c) to the right.
