**Cart Lodge at Moat Farm,
Fressingfield,
Suffolk
FSF 067**

Historic Building Record

Cart Lodge at Moat Farm, Storey Lane, Fressingfield, Suffolk

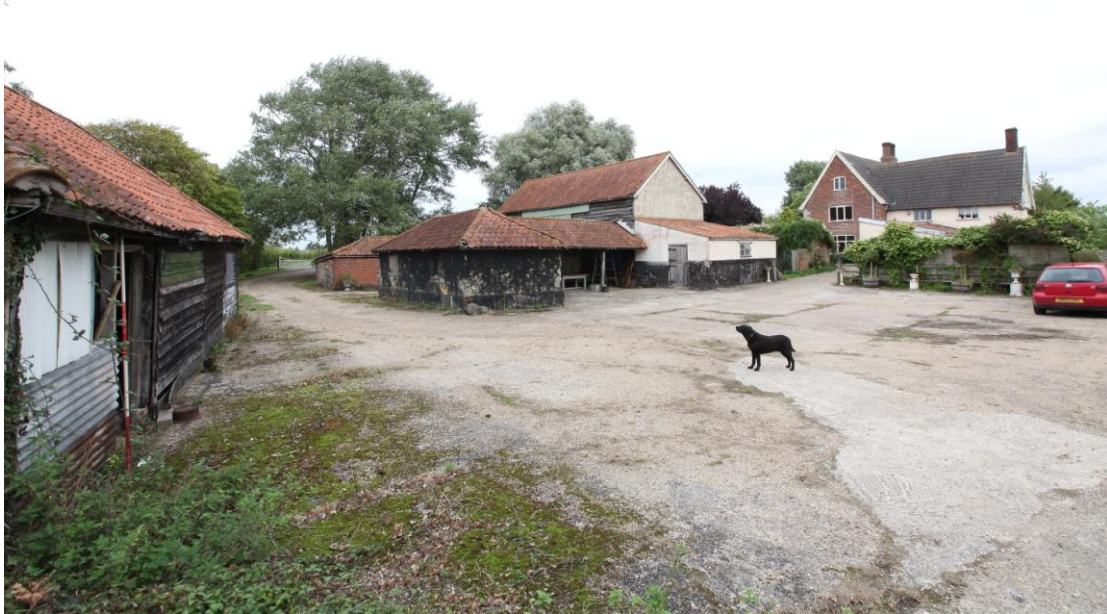
Illus. 1. General view of the site from the south showing the cart lodge facing an open yard to the left, the early-19th century barn and single-storey yard sheds in the centre and the grade II-listed farmhouse to the right.

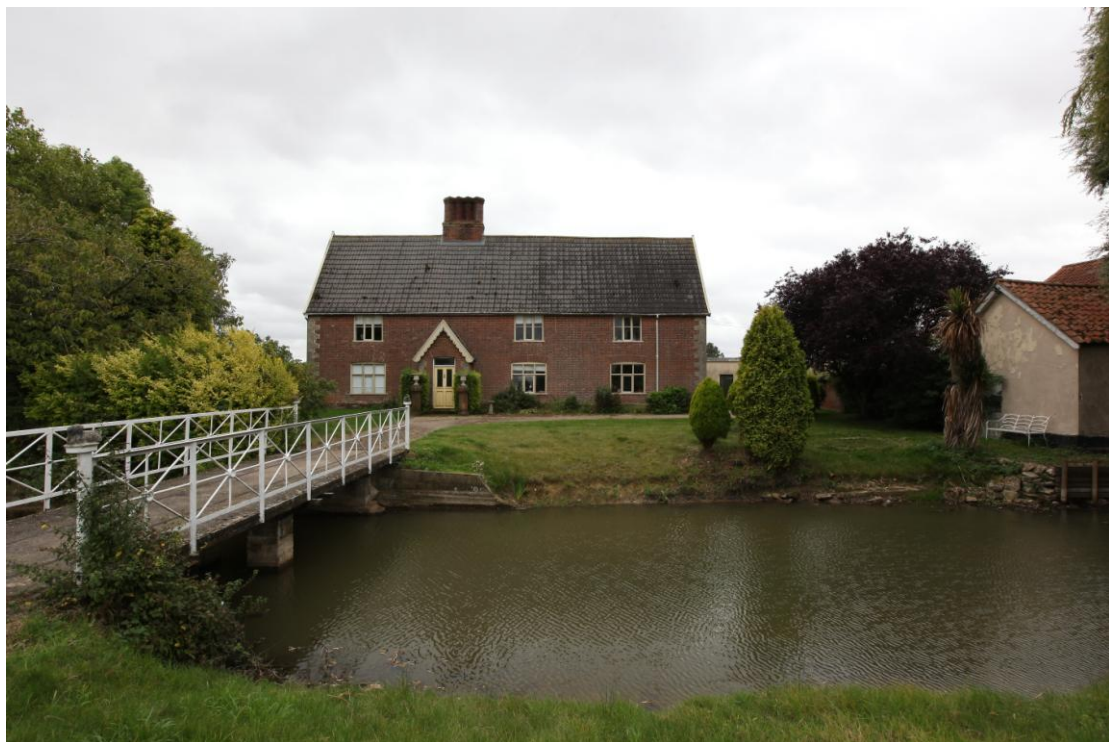
Illus. 2. The grade II-listed farmhouse of *circa* 1600 with its 19th century brick facade seen from across the moat to the north. Included for site context.

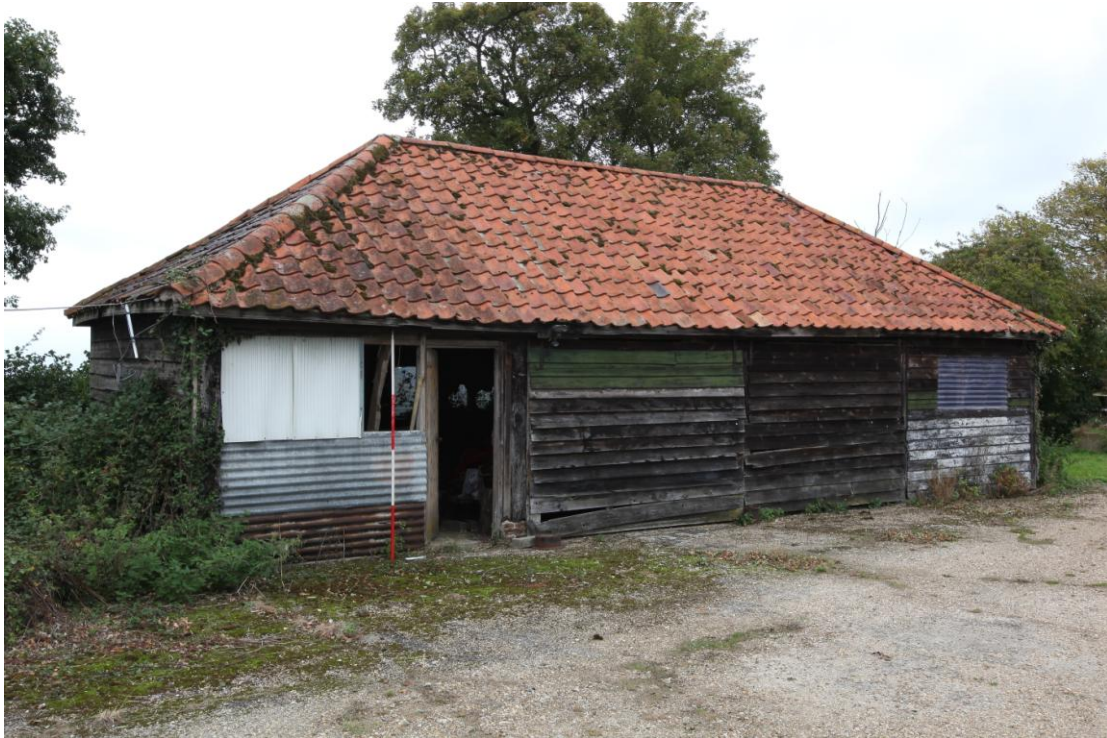
Illus. 3. The exterior of the cart lodge from the south-east showing its originally open eastern elevation (now enclosed by 20th century boarding) with the weatherboarded southern gable to the left.

The front (eastern) elevation is now enclosed by 20th century boarding but was originally open to the yard along its entire length. The roof-plate is supported by three oak posts on brick plinths with crudely chamfered lintels which are nailed from beneath as shown in illustrations 9 and 10 below. The posts are roughly hewn and may have been re-used from an earlier structure. The south-eastern corner post contains an empty mortise that may have secured a post-and-rail fence defining the southern edge of the yard as shown on the Ordnance Surveys.

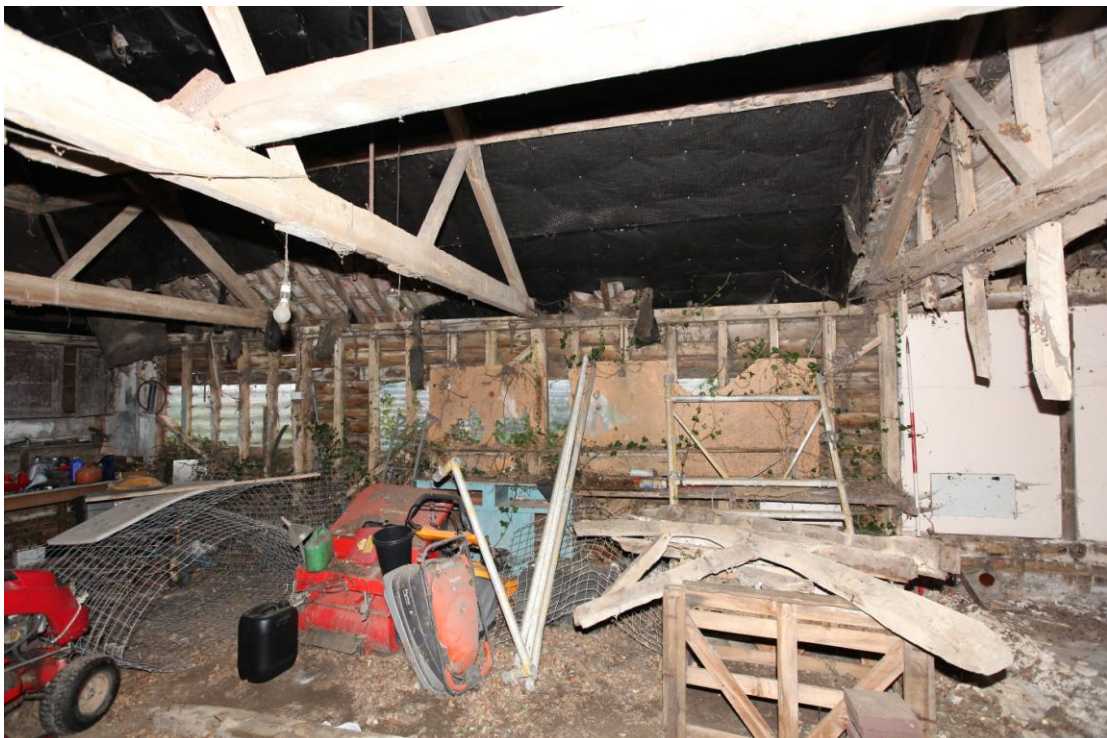
Illus. 4. The rear (western) internal elevation showing its narrow studs with nailed primary braces and deal roof-plate. The remains of the original boarded partition on a brick plinth to the northern bay are visible to the right.

The fabric of the enclosed gables and rear (western) elevation consists of narrow oak studs with deal (softwood) roof-plates and prefabricated roof-trusses with central iron bars bolted to the tie-beams. The studs are interrupted by primary diagonal braces that are nailed rather than pegged to the principal timbers. These features are characteristic of the latter part of the 19th

The northernmost of the cart lodge's four bays was divided from the rest by a boarded internal partition with an integral brick plinth but the partition had been largely removed by the time of inspection. The eastern elevation of this northern bay was later infilled with narrow softwood studs to form an enclosed shed and a new entrance door inserted into the northern gable. The floors are of 20th century concrete throughout.

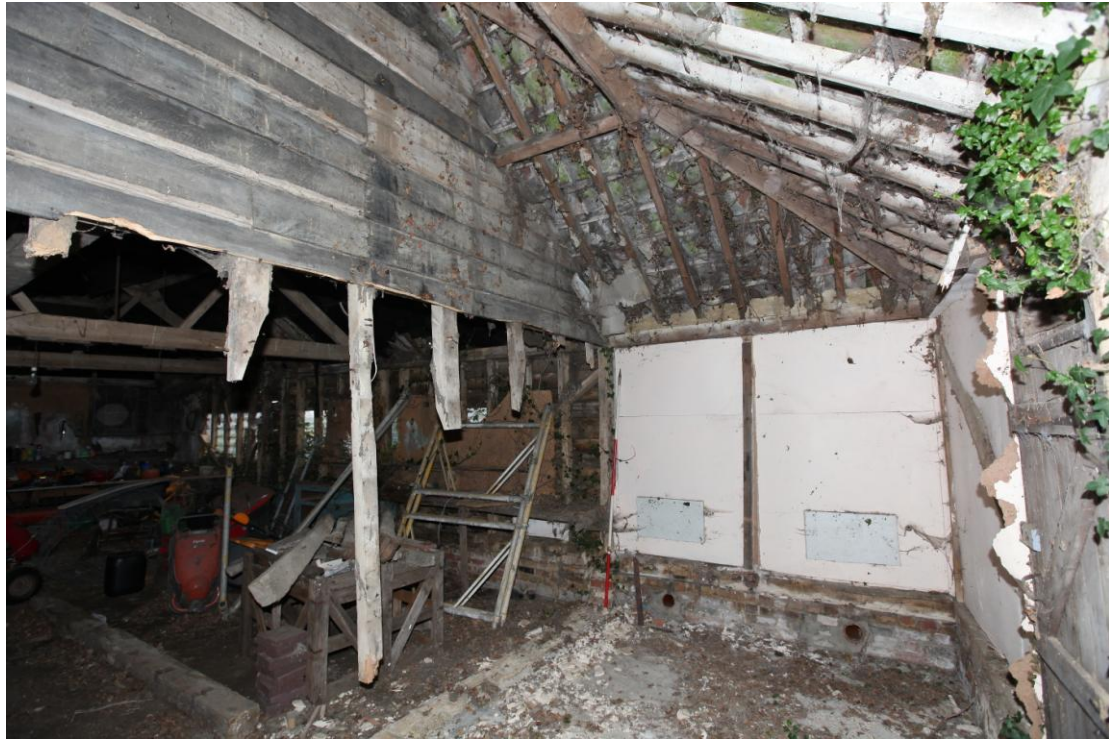
Illus. 5. The interior of the northern bay from the east showing the remains of the boarded internal partition to the left and the northern gable to the right.

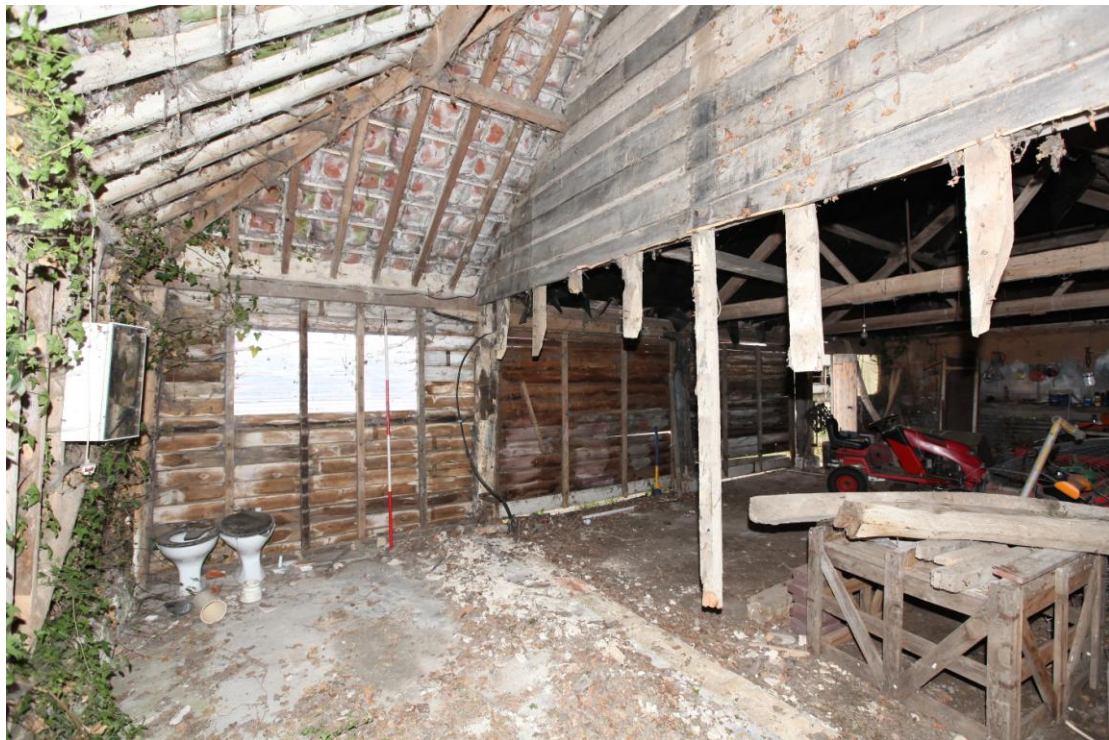
Illus. 6. The northern bay from the west showing the narrow inserted studs without a brace to the formerly open eastern elevation, and the remains of the original internal partition to the right.

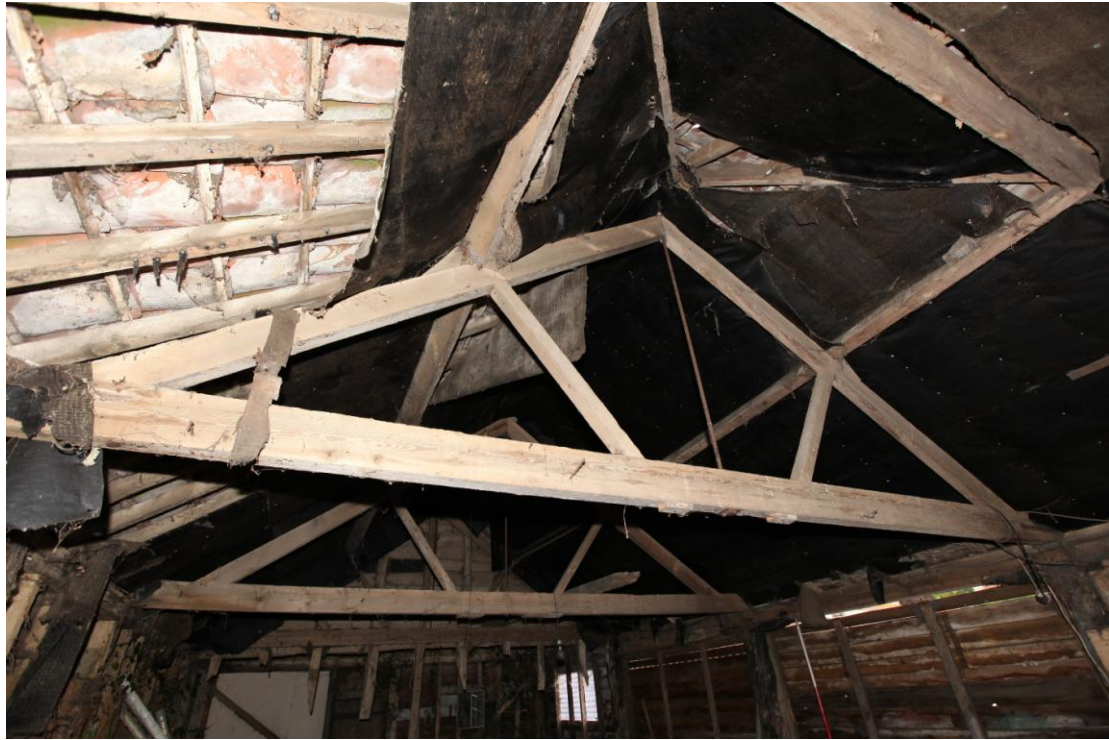
Illus. 7. Detail of the pre-fabricated softwood roof trusses from the south showing a central iron suspension bar.

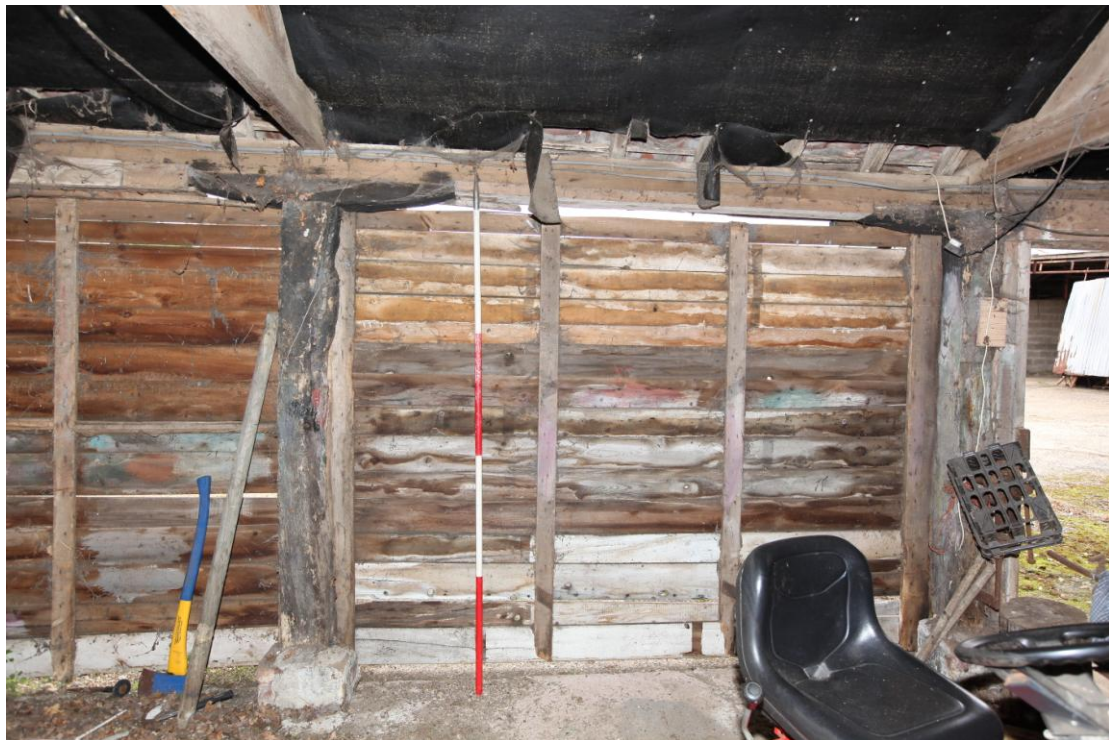
Illus. 8. Detail of the black-painted arcade posts and lintels to the original open eastern interior.

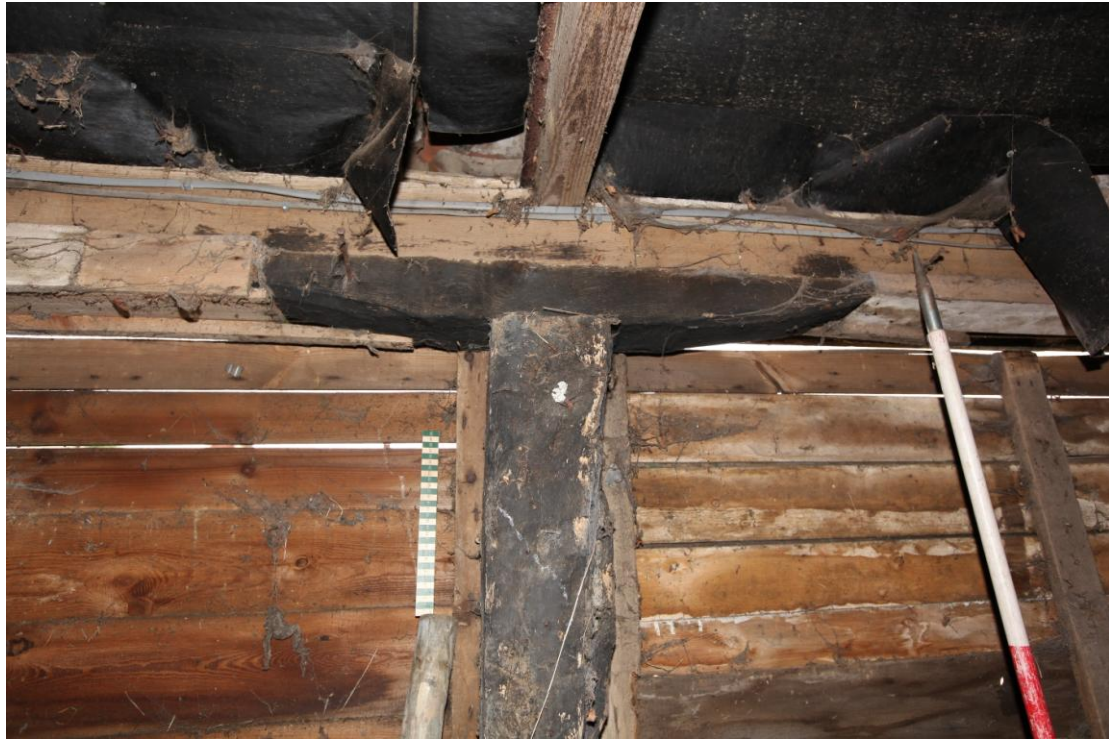
Illus. 9. Detail of the chamfered and nailed lintel to the northern arcade post of the eastern interior.

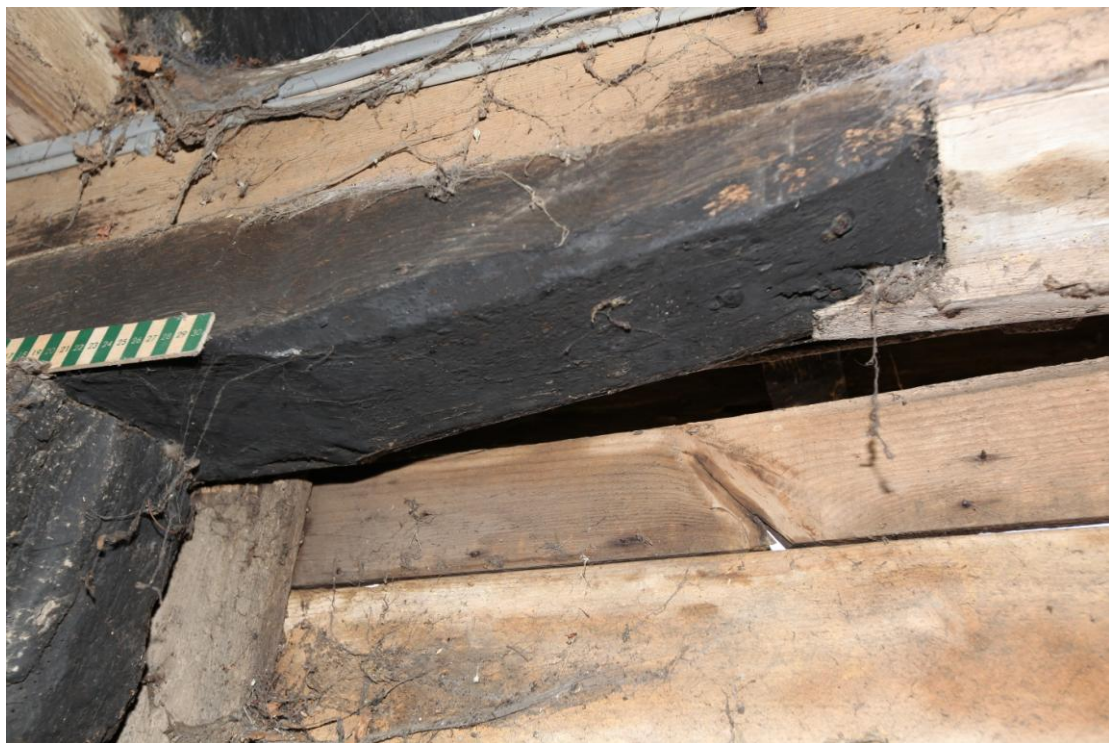
Illus. 10. Detail of the northern chamfered arcade post lintel of the eastern interior showing the heads of the iron nails which secure it to the roof-plate.
