**The Mission Hall,
Pettaugh,
Suffolk
PAU 011**

Historic Building Record

The Mission Hall, Ipswich Road, Pettaugh, Suffolk

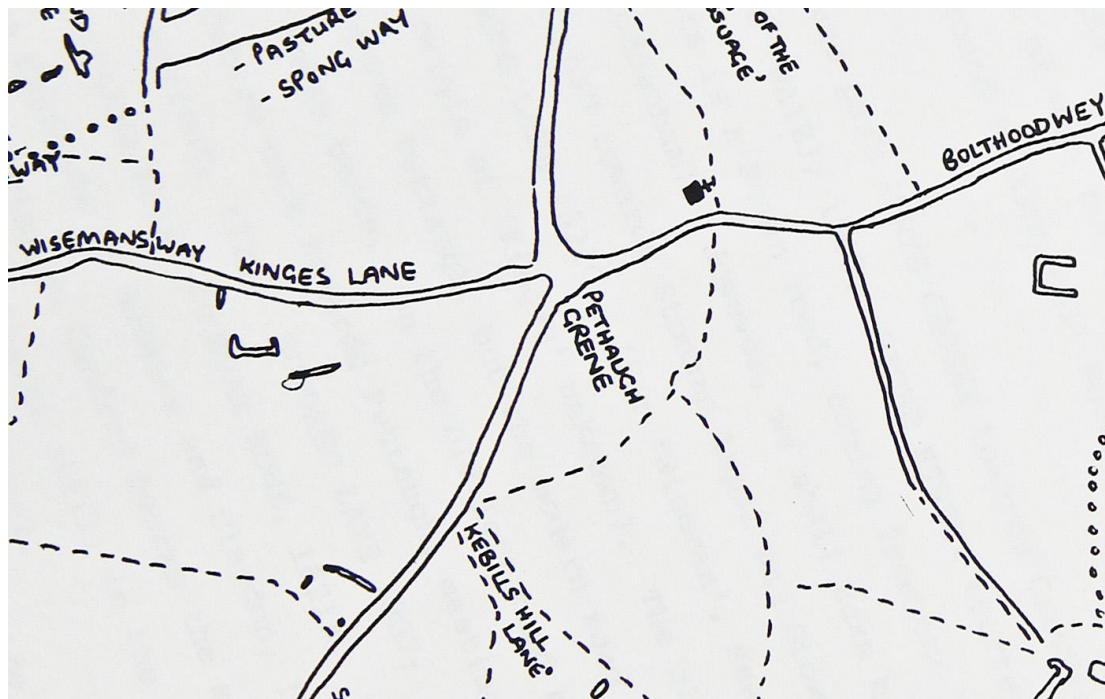
Figure 2

A plan of Pettaugh based on surveys of 1562 and 1621 showing the area of ‘Pettaugh Grene’ east of the junction between Ipswich Road and the A 1120 as described in 1621.

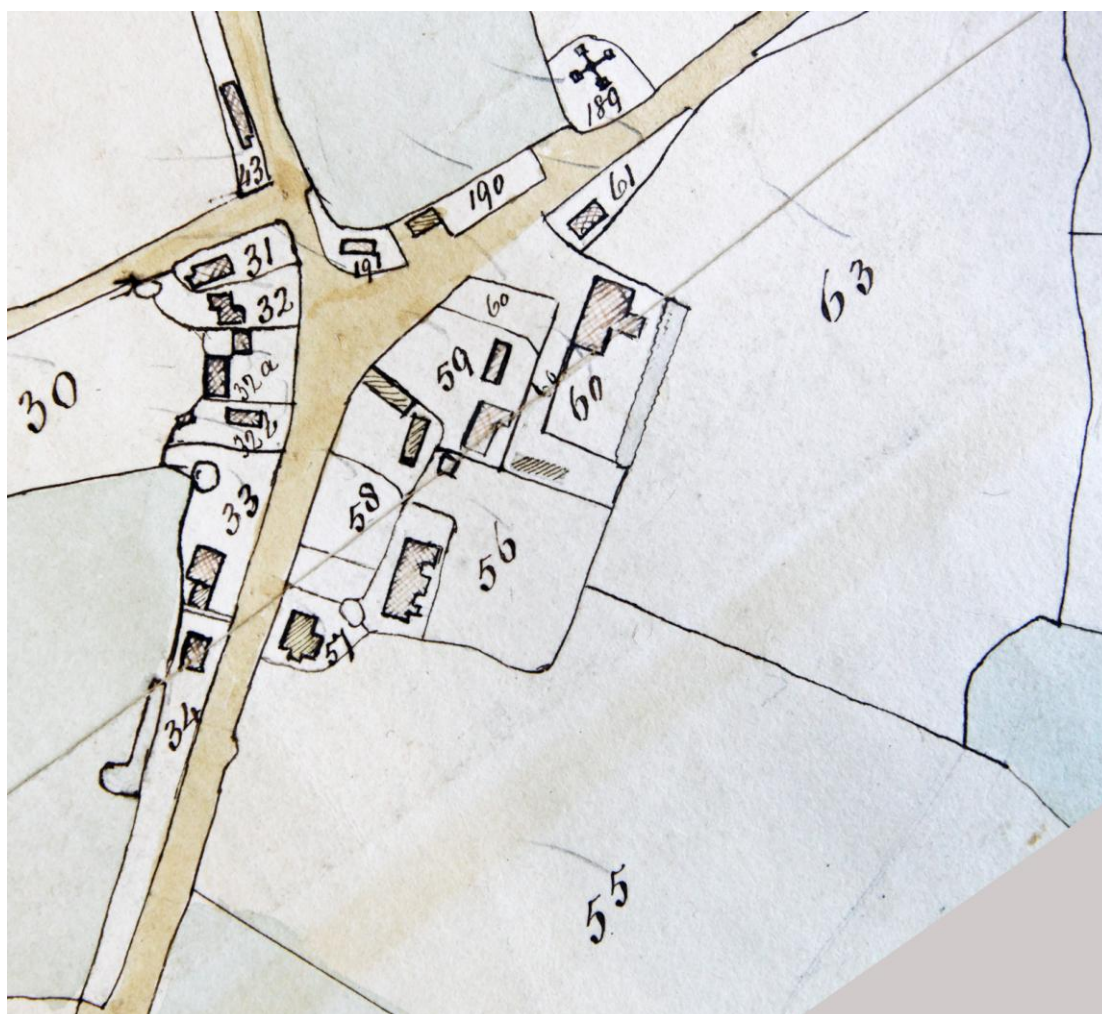
Figure 3

The site on the Pettaugh tithe map of 1839 showing the area of the former green to the east of the road junction. Its triangular outline is clearly indicated by the alignment of the cross-hatched houses to both the right and left of the present road, and the two outbuildings at right-angles which formed the yard into which the Mission Hall was later inserted (plot 58) were clearly encroachments built on the green in the 18th or early-19th century. They belonged to the grade II-listed house to the south and the whole plot was named as: 'House, shop and yard'. Their owner also leased the windmill to the north (indicated by a cross). The predecessor of the present Bull Inn, which adjoins the A1120, lies further from the road in close proximity to the linear pond which probably defined the green's medieval boundary.

The site of the Hall lay in the empty south-western corner of an enclosed yard defined by outbuildings on the north and east and belonging to a house immediately to the south (plot 58 in figure 3). The timber-framed house still survives, divided into three cottages that are listed at grade II and described in the Schedule as ‘probably 17th century with a possible earlier core’. The building is set back from the road and undoubtedly fronted the green when first built. Remarkably, a good early-17th century thatched house which defines the opposite side of the green (plot 32a), is not listed at all. Plot 58 was described as ‘house, shop and yard’ owned by Lionel Pepper, who also owned the small field to the east (56) together with two other houses in the parish and was the tenant of the windmill (plot 189). He was said to ‘occupy’ all three of his houses and it is unclear where he lived. The neighbouring house on the north (59) was a ‘house and garden’ owned and occupied by Joseph Chilvers and the building to the south was a blacksmith’s shop (57). The nature of Lionel Pepper’s shop is not specified but White’s Suffolk Directory of 1844 describes him only as a corn miller and it seems likely that it was leased to a third party – possibly William Cooper, a wheelwright who is not mentioned in the tithe apportionment. Joseph Chilver (sic) was named as a tailor. The T-shaped building beside the linear pond on the tithe map was the ‘Bull Inn and yards’ (plot 60), which had been rebuilt closer to the present road by 1885 (figure 4). The link between William Cooper and the site of Chilver’s shop is reinforced by White’s edition of 1855 which describes him as a wheelwright and shopkeeper, while by 1874 he had diversified to become a miller, shopkeeper, wheelwright, blacksmith and ‘agent for Ransomes ploughs, etc.’

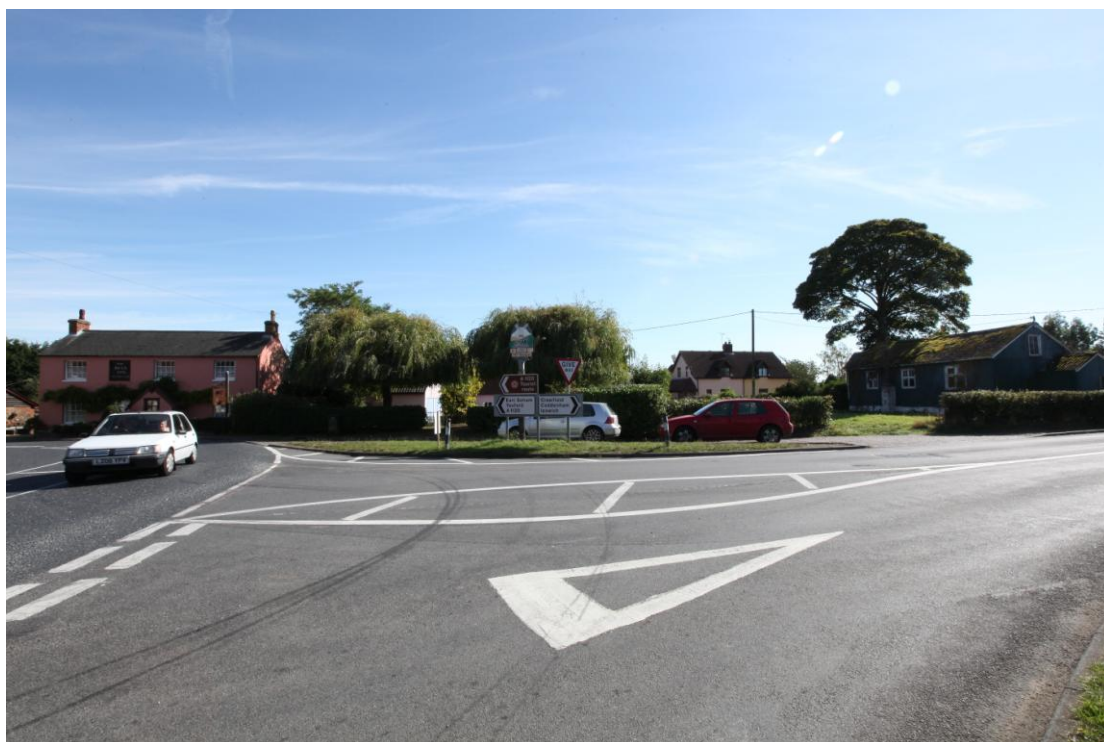
Illus. 1. General view of the site from the north, showing its conspicuous location on the junction of the A1120 (left) and the Ipswich Road, with the remains of the medieval green in the rear, the Mission Hall to the right and the Bull Inn to the left.

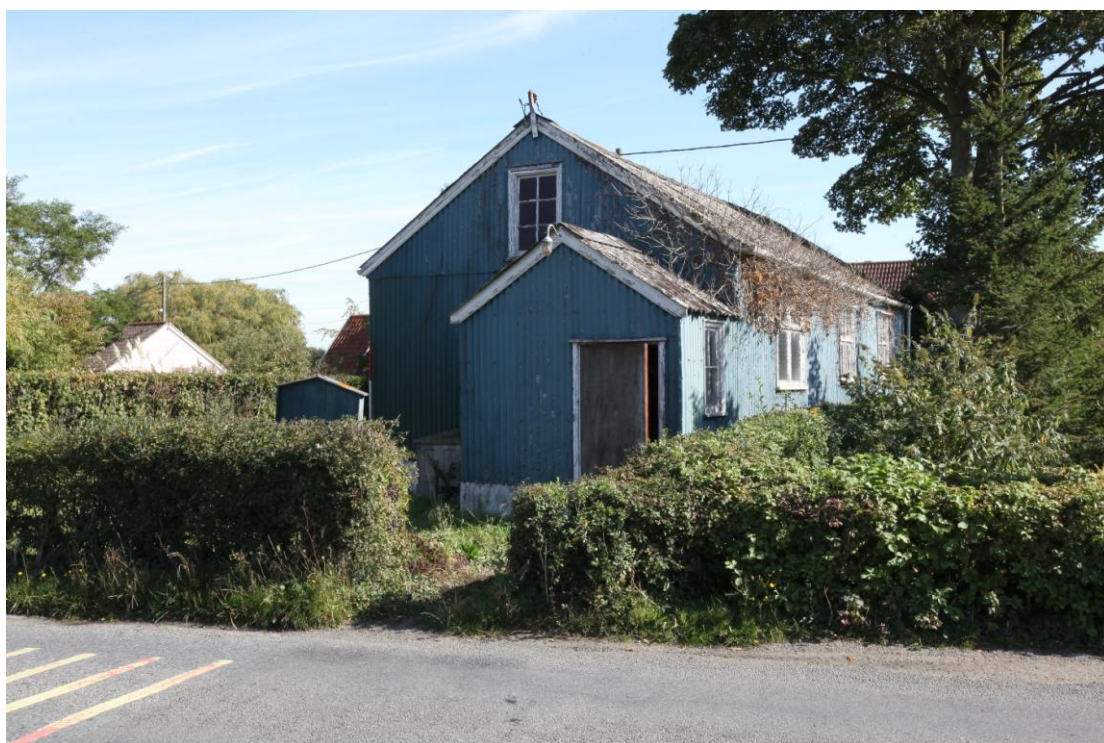
Illus. 2. The western exterior from the Ipswich Road showing the porch and site entrance in the hedge with the notice board to the left.

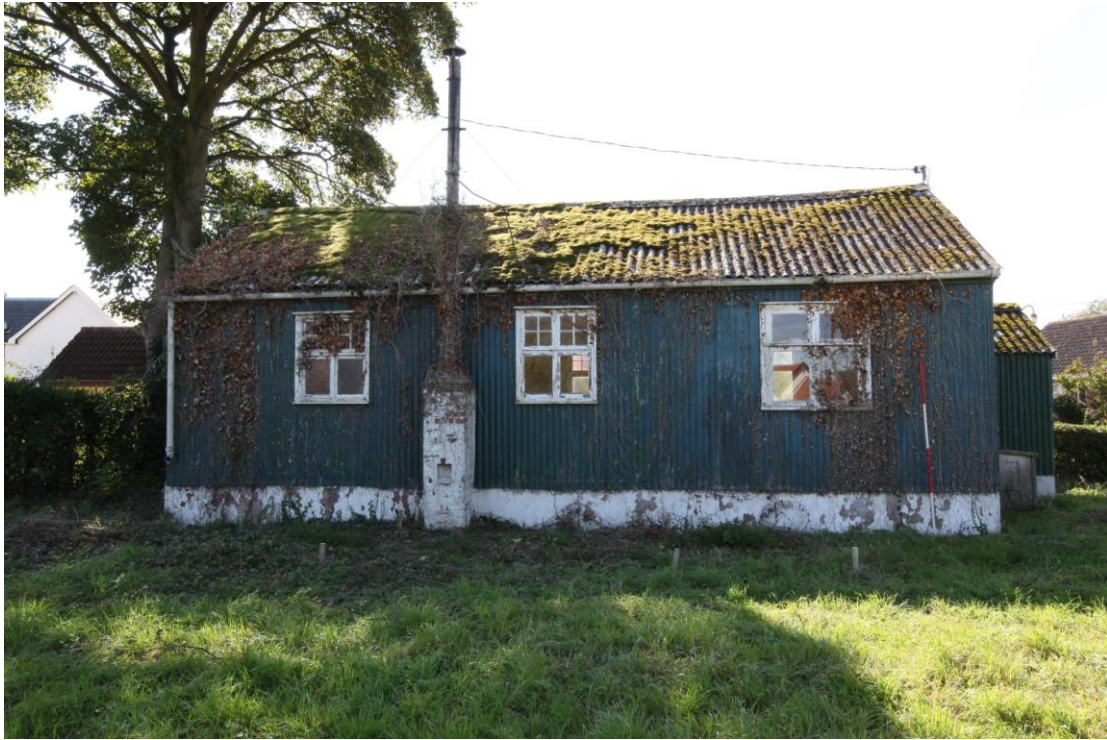
Illus. 3. The northern exterior from the remnant of medieval green showing the chimney with two ostensibly original window apertures to the left and the later, larger window to the right.

The documentary evidence indicates the hall was erected in the corner of a wheelwright's yard at the end of 1888, and opened on 2nd January 1889, but was extended by 10 feet in 1893. There is no obvious physical evidence of this extension, presumably because the new materials were identical to the old, but the nature of the fenestration suggests it may have been added to the front (west) rather than the rear as might otherwise have been expected. The roof trusses are more closely spaced at this end of the building, and the two western windows are significantly larger than their counterparts to the east (which are identical to the south, with vertically hinged upper lights, but also differ to the north where the central window is a 20th century replacement).

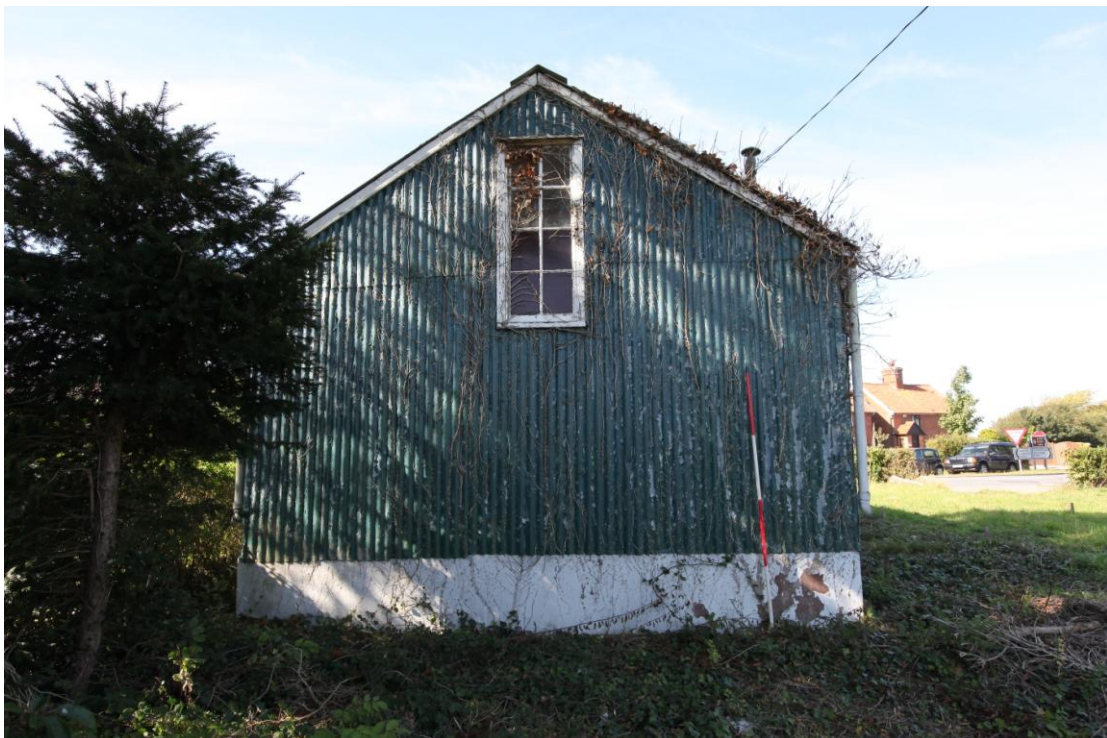
Illus. 4. The eastern external gable showing the original eight-pane rectangular window and the narrow strips of corrugated iron on a plinth of shuttered concrete.

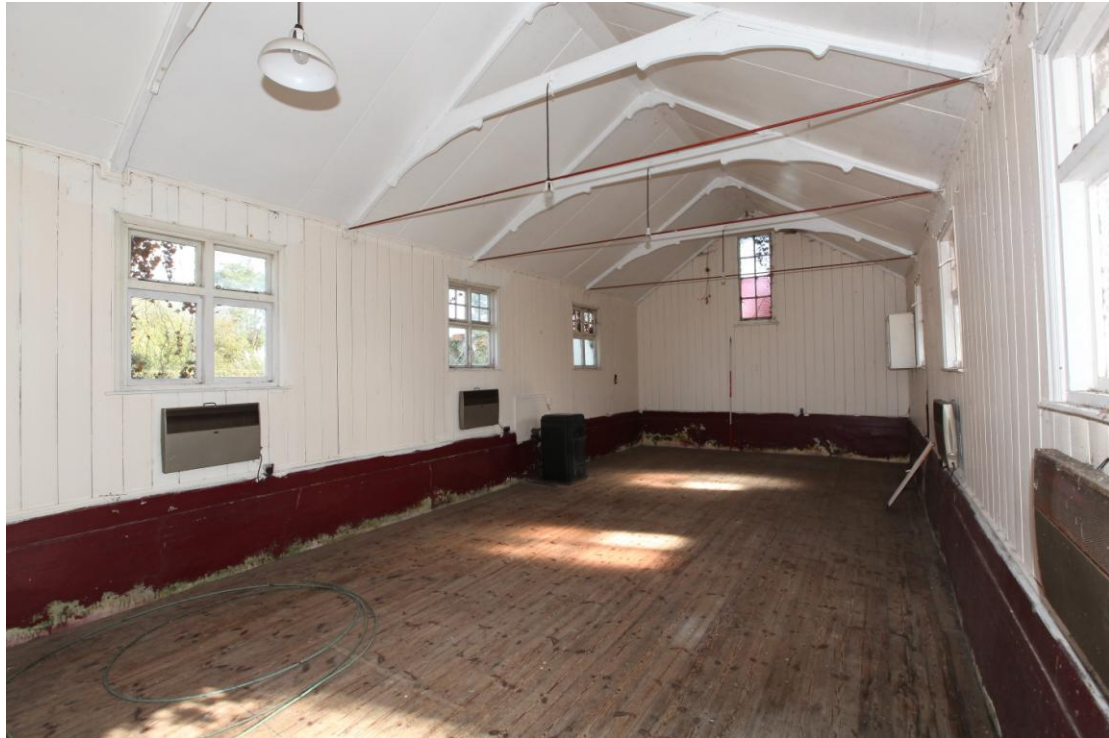
Illus. 5. A general view of the interior from the west showing the shaped wooden roof trusses and painted vertical deal boarding to the wall fabric.

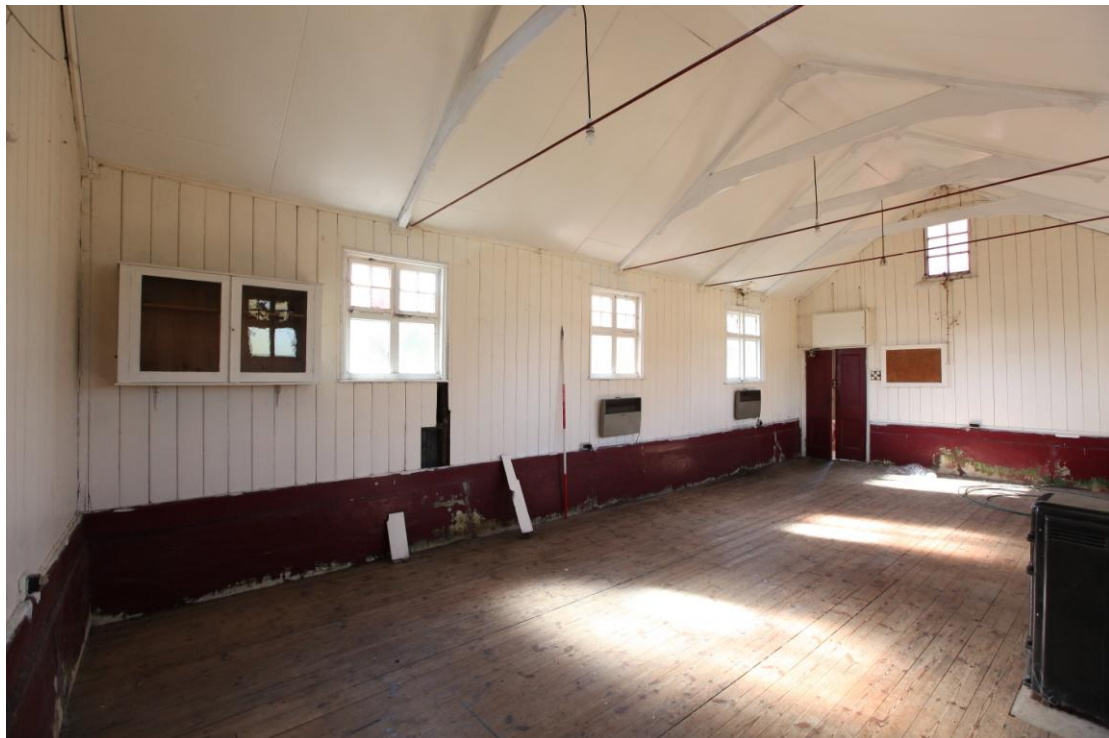
Illus. 6. The southern interior showing the apparently original identical windows to the left and a larger probably later window by the entrance doors to the right.

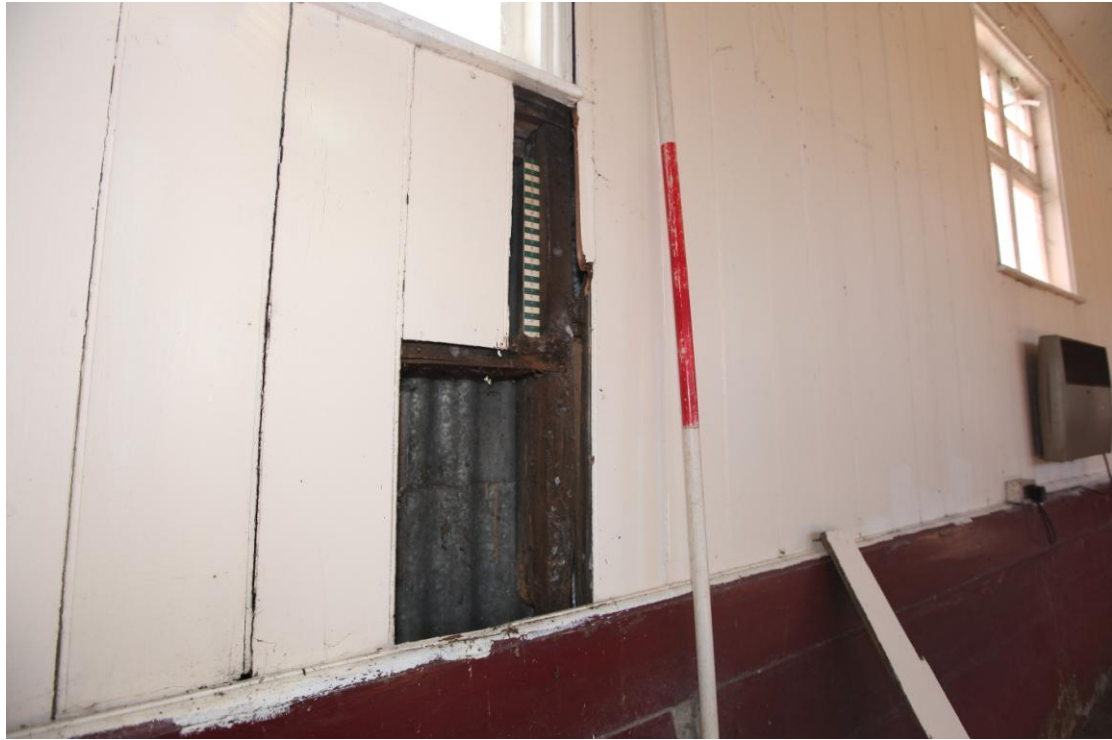
Illus. 7. The section of exposed timber wall fabric to the southern interior showing the nailed junction between a horizontal rail and a vertical stud with the shuttered concrete plinth beneath. Scale in centimetres.

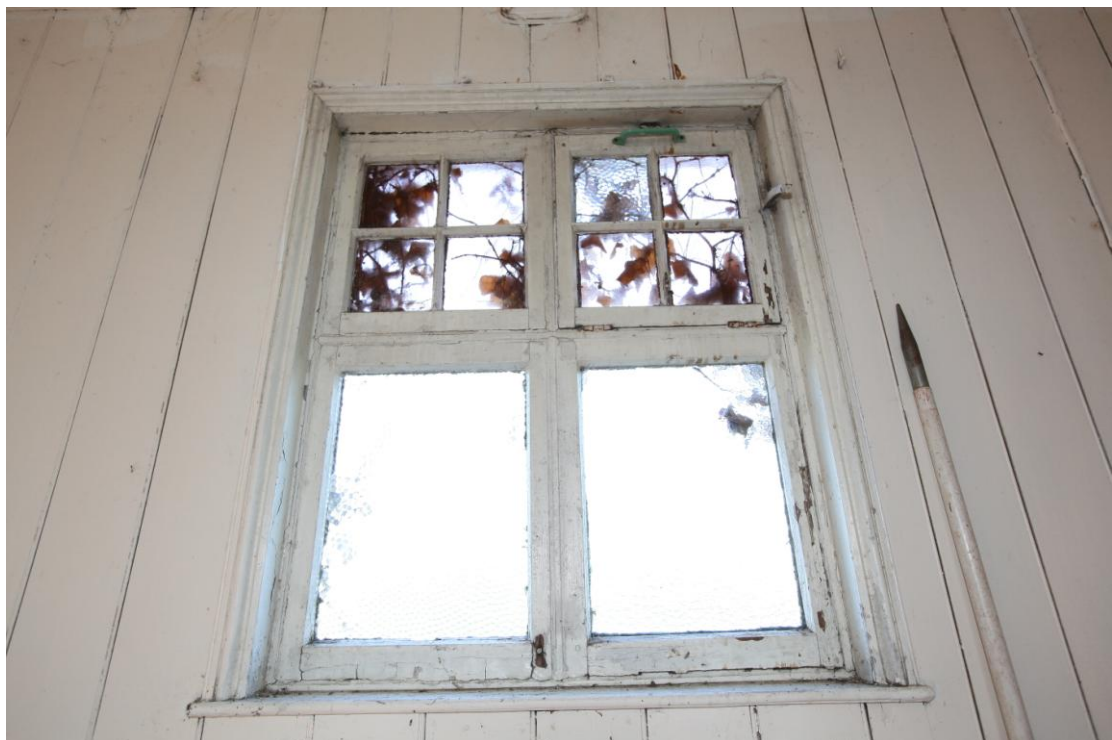
Illus. 8. A detail of the ostensibly original eastern window of the northern interior with fixed lower lights and vertically hinged casements with iron stops above.

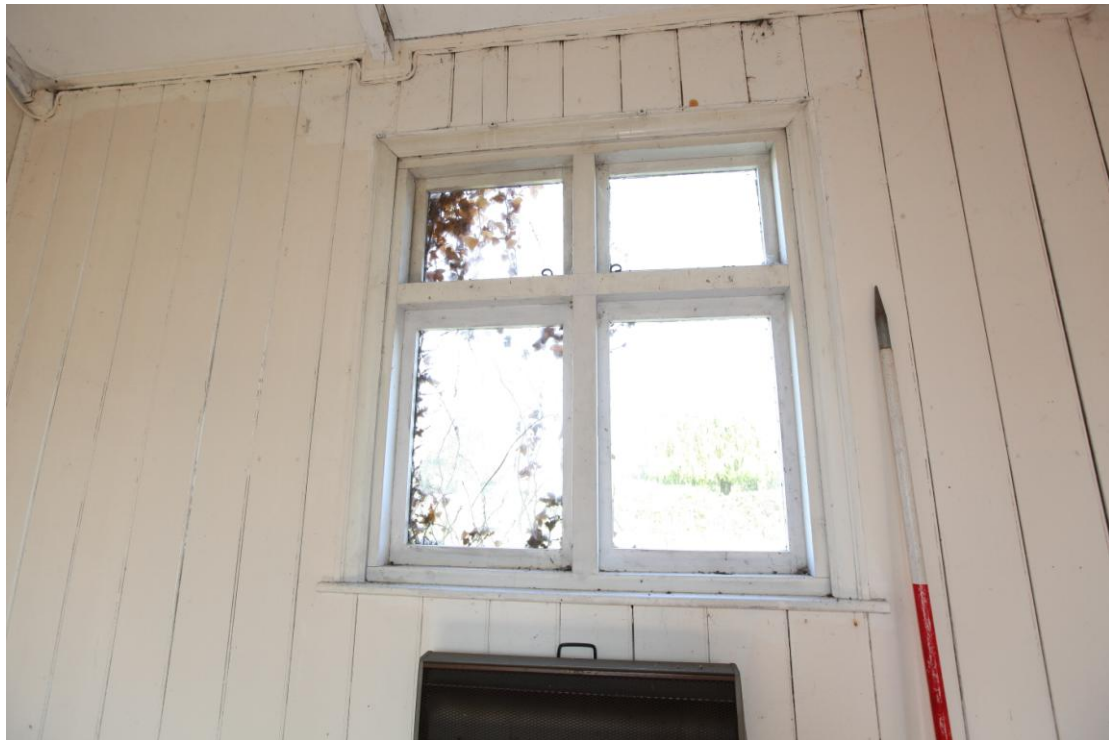
Illus. 9. A detail of the larger and ostensibly secondary western window of the northern interior.

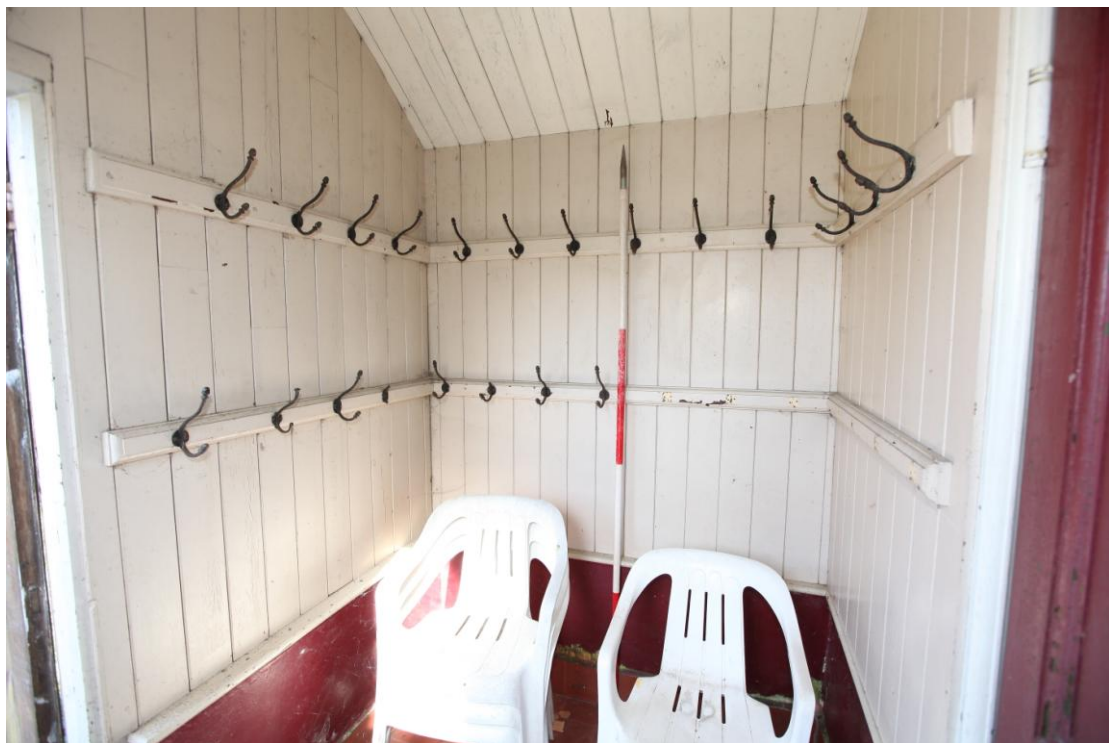
Illus. 10. The interior of the western porch or lobby from the south showing two ranks of iron coat hooks with acorn terminals with the external entrance to the left and the hall doors to the right.

the ostensibly original deal floorboards. A small gabled porch of 2.4 m in width (8 ft) projects by 1.7 m (5.5 ft) from the southern end of the western gable where a pair of original double doors with fielded panels opens into the hall (now coloured red but with green paint beneath). Two ranks of black-painted iron coat hooks, each with two acorn finials, line the interior of this porch as shown in illus. A2 10 below.
