Land adjacent to Chapel Cottage,  
Wickhambrook  
WKB 041

**Archaeological Evaluation Report**

**SCCAS Report No. 2011/208**

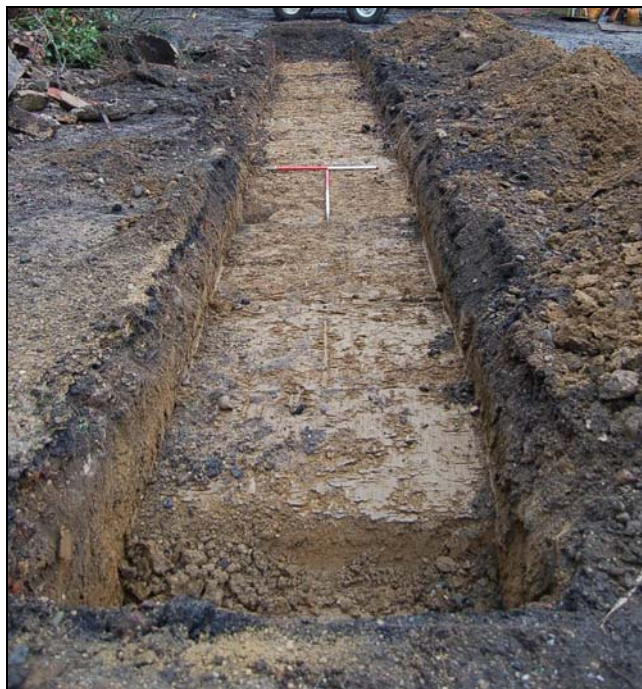
This trench was 13.2m long, 1.6m wide and approximately 0.3-0.4m deep, orientated northwest-southeast towards the north-eastern end of the site. The stratigraphy encountered consisted of 0.13m of heavily disturbed mid-dark greyish brown clay-silt topsoil above a mid-brown silty clay subsoil with occasional chalk flecks up to 0.2m thick. This sealed mid/pale brown natural chalky till, visible towards the south-eastern end of the trench. The edge of a natural watercourse was visible in the north-western end of the trench, which was filled with a dull brown slightly silty clay with slight marbling visible. A test-pit excavated at the end of the trench located the base of this feature at 0.9m below surface level. A single modern feature was observed on the north-eastern edge of the trench, containing modern ceramic building material (CBM) fragments. This was not recorded further and the artefacts were discarded on site.

Plate 1. Trench 1, facing south-east (2 x 1m scales)

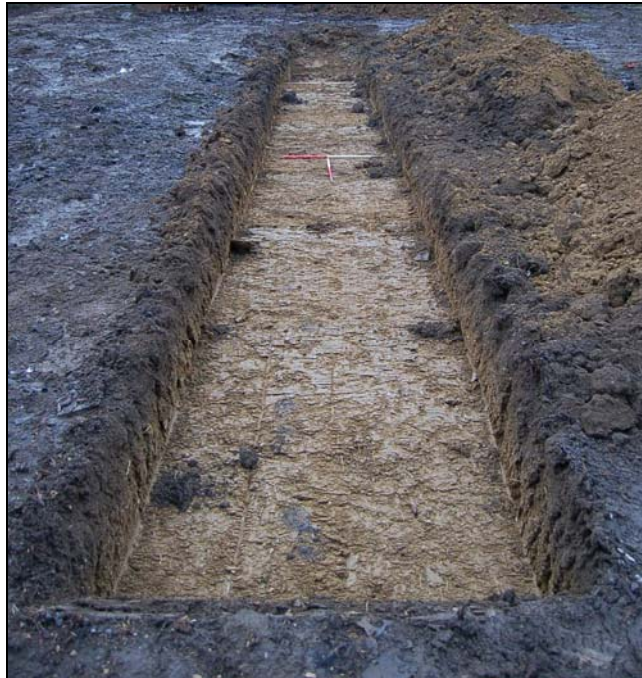
This trench was 14.9m long, 1.6m wide and approximately 0.5m deep, orientated northeast-southwest towards the centre of the site. The stratigraphy encountered consisted of 0.28m of topsoil above 0.22m of mid-brown silty clay subsoil. The majority of this trench appears to be within the watercourse noted in Trench 1, and a test-pit at

the southern end of the trench was excavated to a depth of 0.85m below surface level. No finds or features of archaeological relevance were observed.

Plate 2. Trench 2, facing south-west (2 x 1m scales)

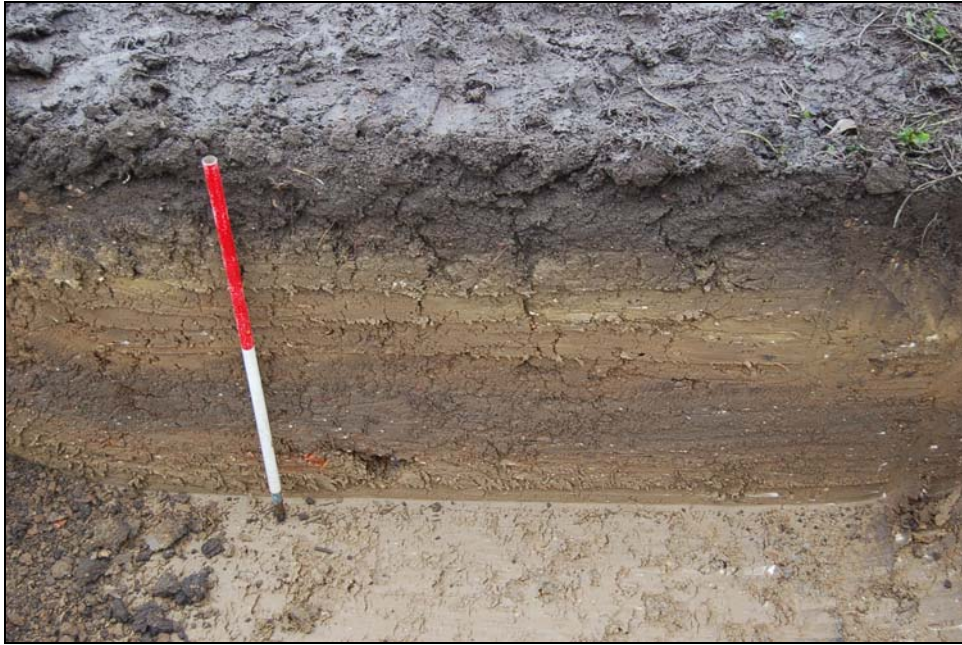
This trench was 10m long, 1.6m wide and approximately 0.5m deep, orientated northwest-southeast towards the south-western end of the site. The stratigraphy encountered consisted of 0.25m of topsoil over a layer of redeposited subsoil 0.41m thick containing occasional CBM fragments and pieces. This sealed a buried topsoil layer, 0.26m thick, of mid/dark brown silty clay, with occasional CBM fragments present. Below this was a mid greyish brown subsoil layer, containing a defunct ceramic field drain at a depth of 1.1m below the surface. No natural geological layers were observed in this trench. Due to the depth of the trench and the poor surface ground conditions the central portion was stepped up after 3m, to the level of the buried topsoil at 0.5m below the surface and a test-pit excavated at 9-10m along the trench. This confirmed that the already observed stratigraphy continued and a decision was made to terminate the trench early since no archaeologically relevant deposits were likely to be reached in the final 5m.

Plate 3. Trench 3 showing buried soils, facing southwest (1m scale)
