# ARCHAEOLOGICAL EXCAVATION REPORT

## Henry Watson's Potteries, Pottery Hill, Wattisfield WSF 056

A REPORT ON THE ARCHAEOLOGICAL EVALUATION, EXCAVATION  
AND MONITORING, 2005 - 2006  
(Planning app. no. OL/201/03)

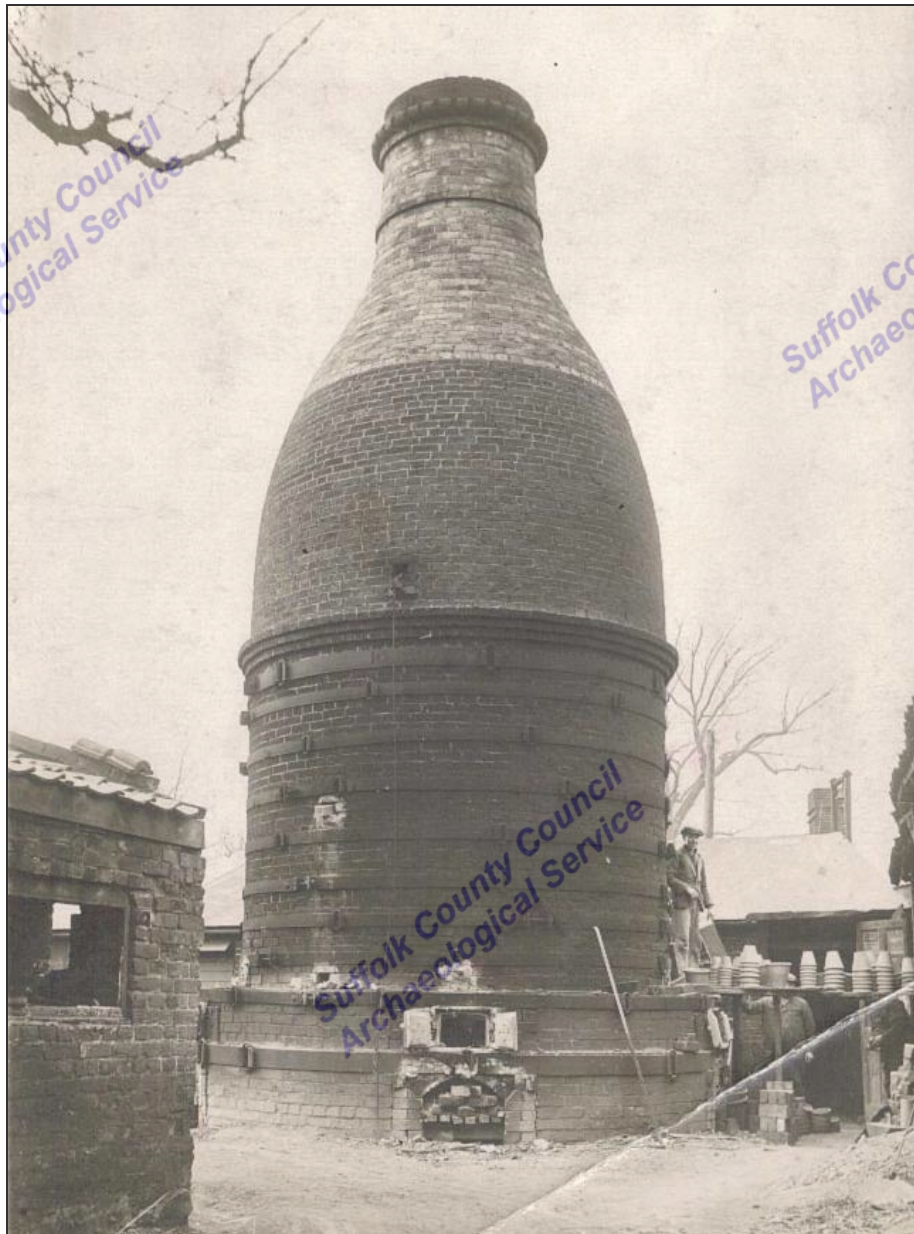
Figure 5. The bottle kiln in 1934

A later photo of the bottle kiln (Fig. 5), taken in 1934 from an uncertain viewpoint, clearly shows it standing as a broadly separate structure within the central yard.

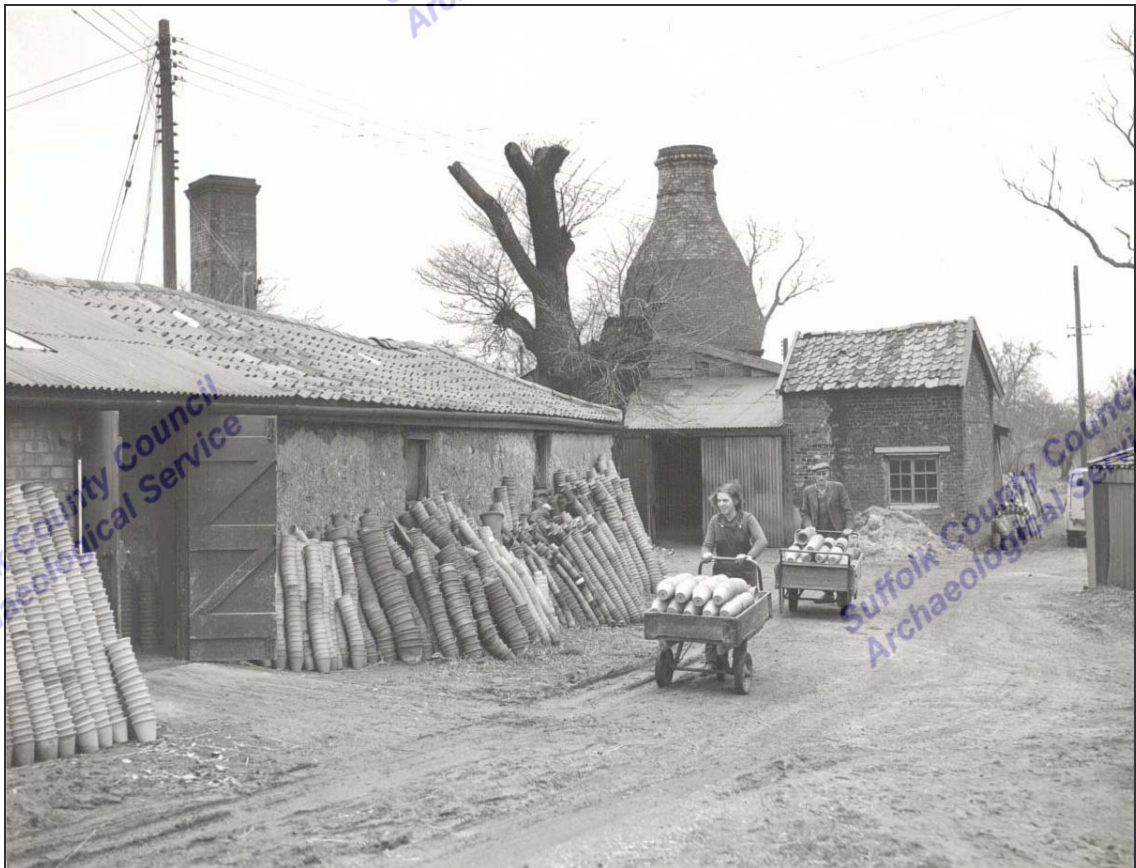
Figure 7. The site, seen from the south, c.1950's

Two other photos from the c.1950's (Figs. 7 and 8), are taken from vantage points to the south alongside the clay lump potting shed which is seen on the left hand side. Both photos show the 19th century yard surrounding the bottle kiln being infilled with buildings with corrugated roofs and the surviving 19th century brick and tile building on the righthand side. Figure 7 clearly shows the chimney associated with the 1940/41 kiln on the left hand side while in Figure 8,

which was taken from a slightly higher vantage point, the very top of the dome of the new 1940/41 kiln can just be seen behind the tree and potting shed.

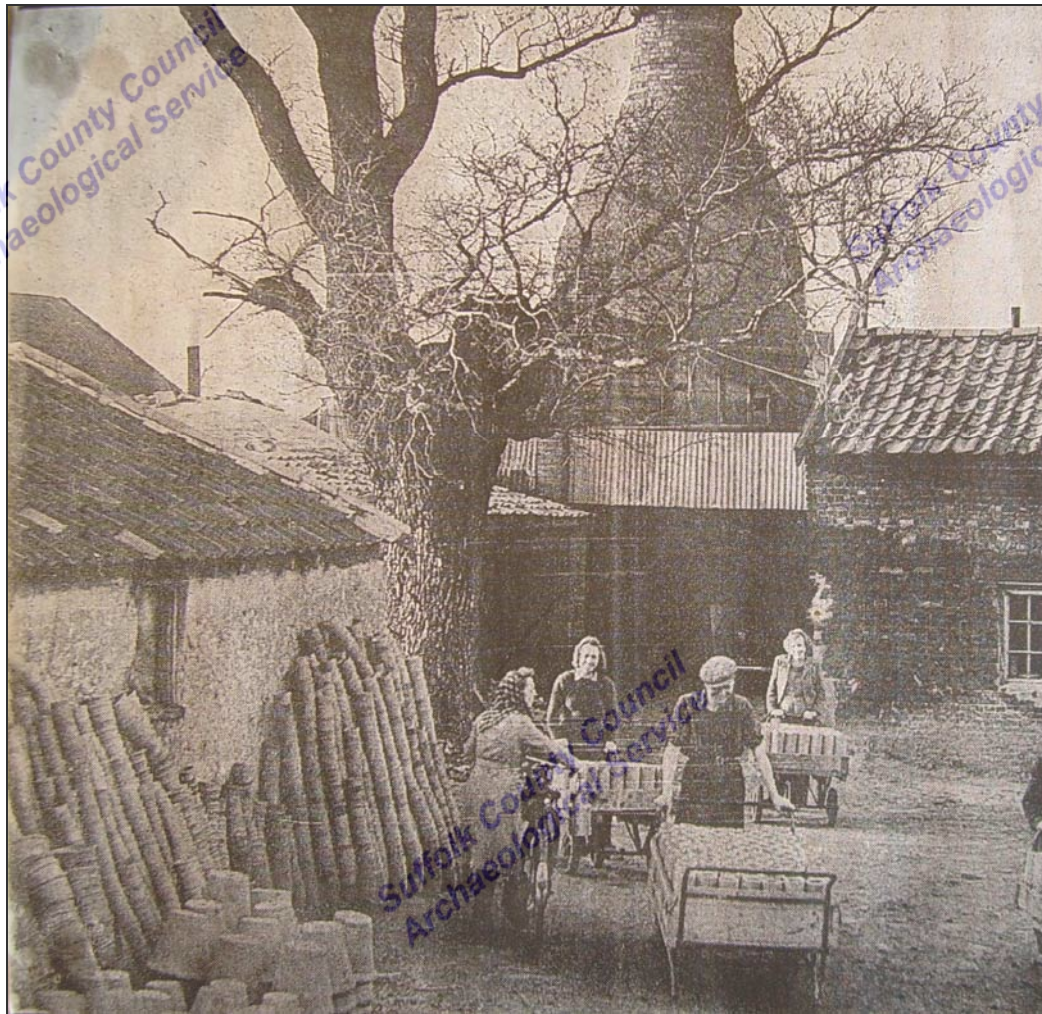
Figure 8. The site, seen from the south, c.1950

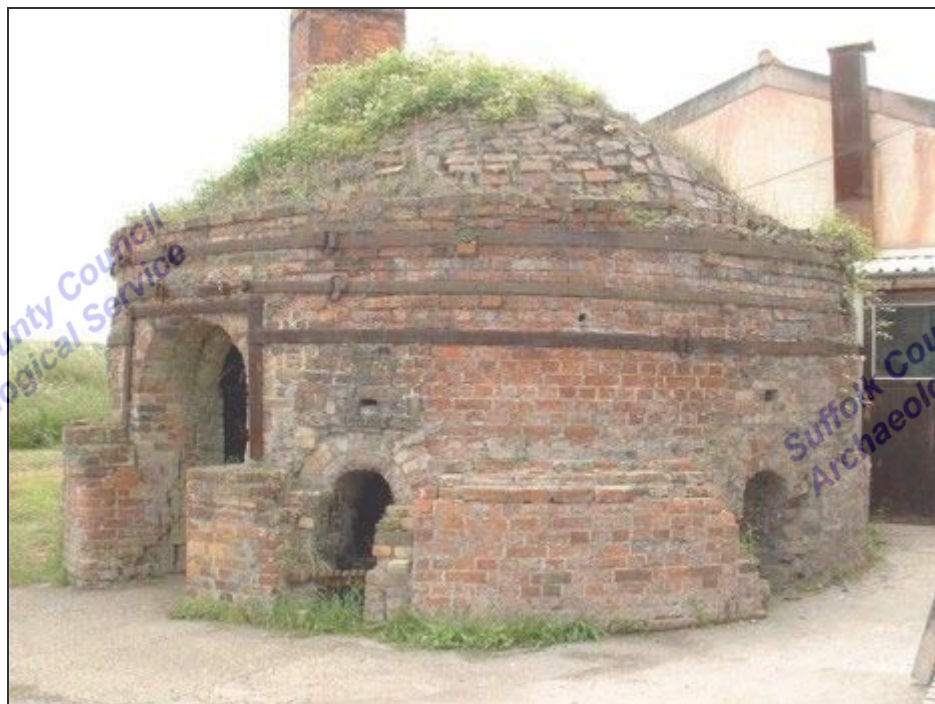
Figure 9. The down-draught kiln and chimney constructed in 1940/41, seen from the NE

The 1940/41 kiln and chimney, still stand upon the site (Fig. 9) and have been renovated during the housing development. Built by the workforce with self-manufactured brick, it is a circular structure with a domed roof, some c.6.5m in diameter. The kiln had two entrances and was capable of holding 50,000 flowerpots. The kiln was fired on a weekly basis with seven furnaces above ground level around its perimeter. Heat was drawn down through the centre of the kiln and vented through a flue to the chimney stack to the south which also still stands.

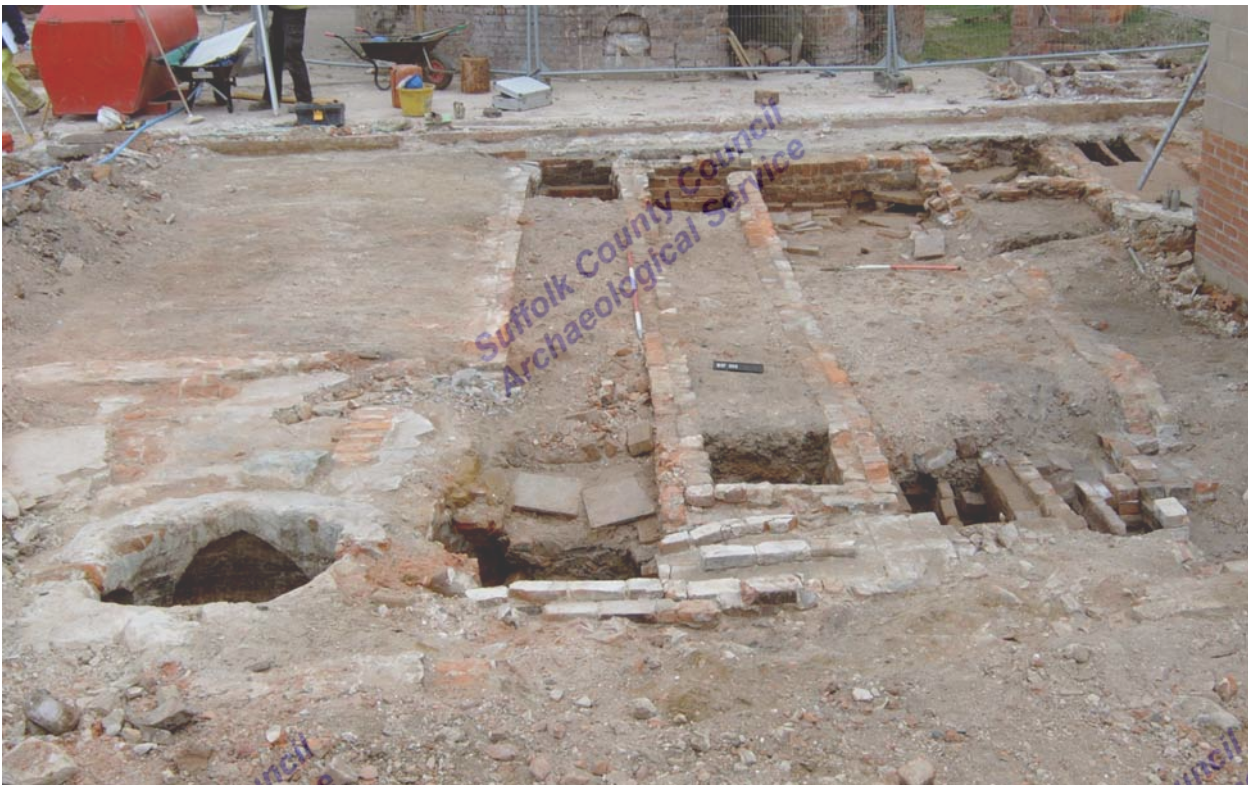
Figure 16. Area 01 looking NE to 1940's kiln

The 1st and 2nd flues systems were identified and recorded as 0008 and 0011 respectively where they left the firebox and adjacent channel and initially ran parallel along the northern side of the site before both turning 90° and heading southeast. The brickwork 0017, which sits above the channel and the terminus of flue 0011, appears to be a later phase of construction.

0008 was seen in section where it left the deeper channel and contained three thin basal fills, 0005-0007, of soot, ash and charcoal. Within this section the roof of the flue had been destroyed or removed, allowing the flue to be infilled fully. Lying above 0005 was an almost pure deposit of broken pottery sherds and complete vessels, 0004, which was finally sealed by 0.2m of brick rubble. Deposit 0004 partially slumped from the flue into the void under brickwork 0017 and selections of the pots from this fill were retained as a sample. A sample brick, numbered as 0008, was retained from the central wall dividing the flue. To the north of flue 0008 the site strip exposed a hard and dense mid grey/green clay/silt, which was thought to be the top of the trampled natural subsoil.

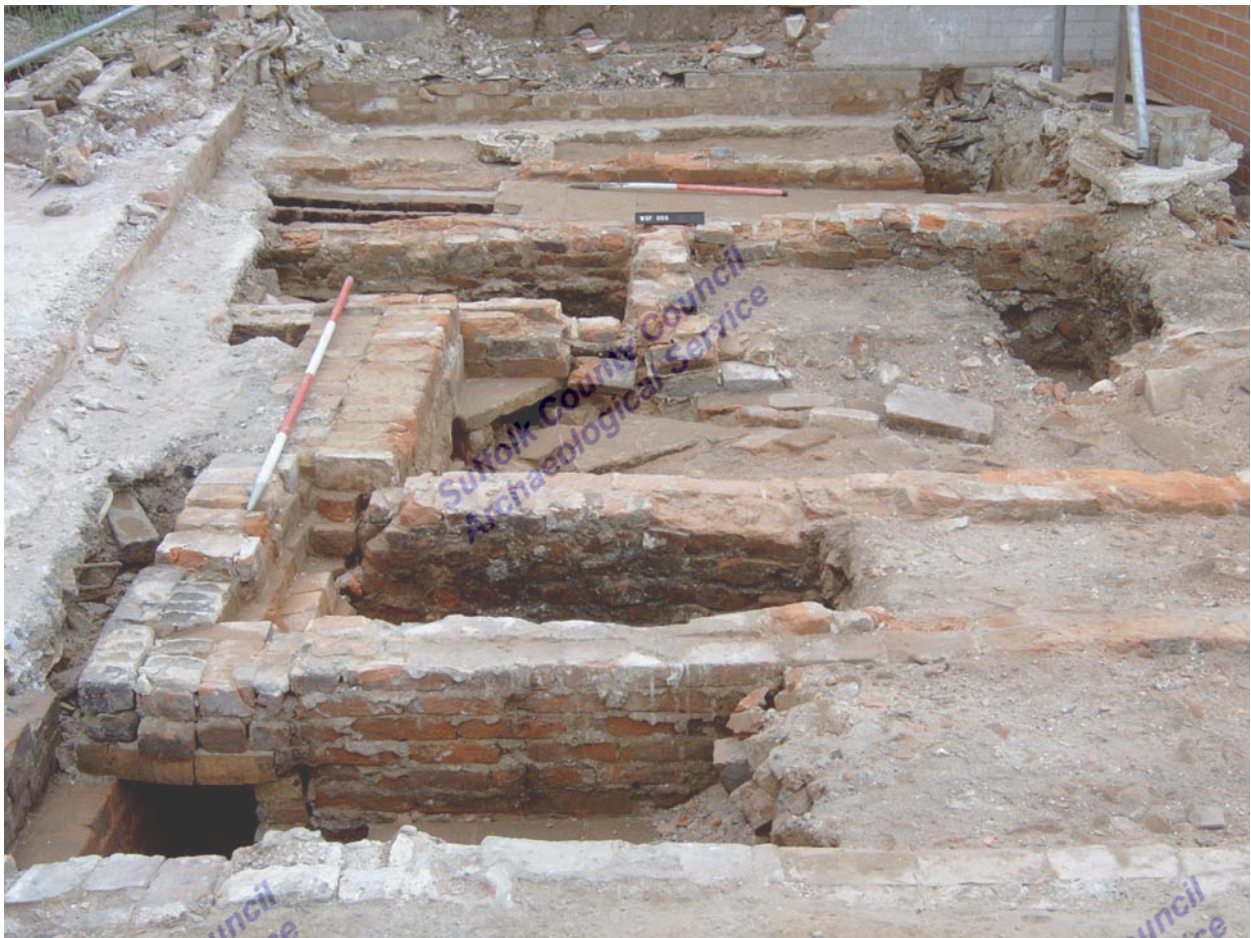
Figure 17. Eastern end of site looking SE

Meanwhile flue 0011 emerged from beneath flue 0008 and continued southwest, heavily disturbed, as 0013, into evaluation trench 05. A basal fill, 0014, of soot and ash was seen in flue 0013. Within Trench 05 flue 0013 turned 90° and headed northeast back towards the chimney stack, emerging onto the site as 0015. It was this section of flue that was seen in section during the evaluation.

0015 was a very well preserved section of the flue system, despite running at a higher level than the other parts. Where the roof was missing basal charcoal deposits, 0016, were present beneath an infill of mixed earth and rubble.

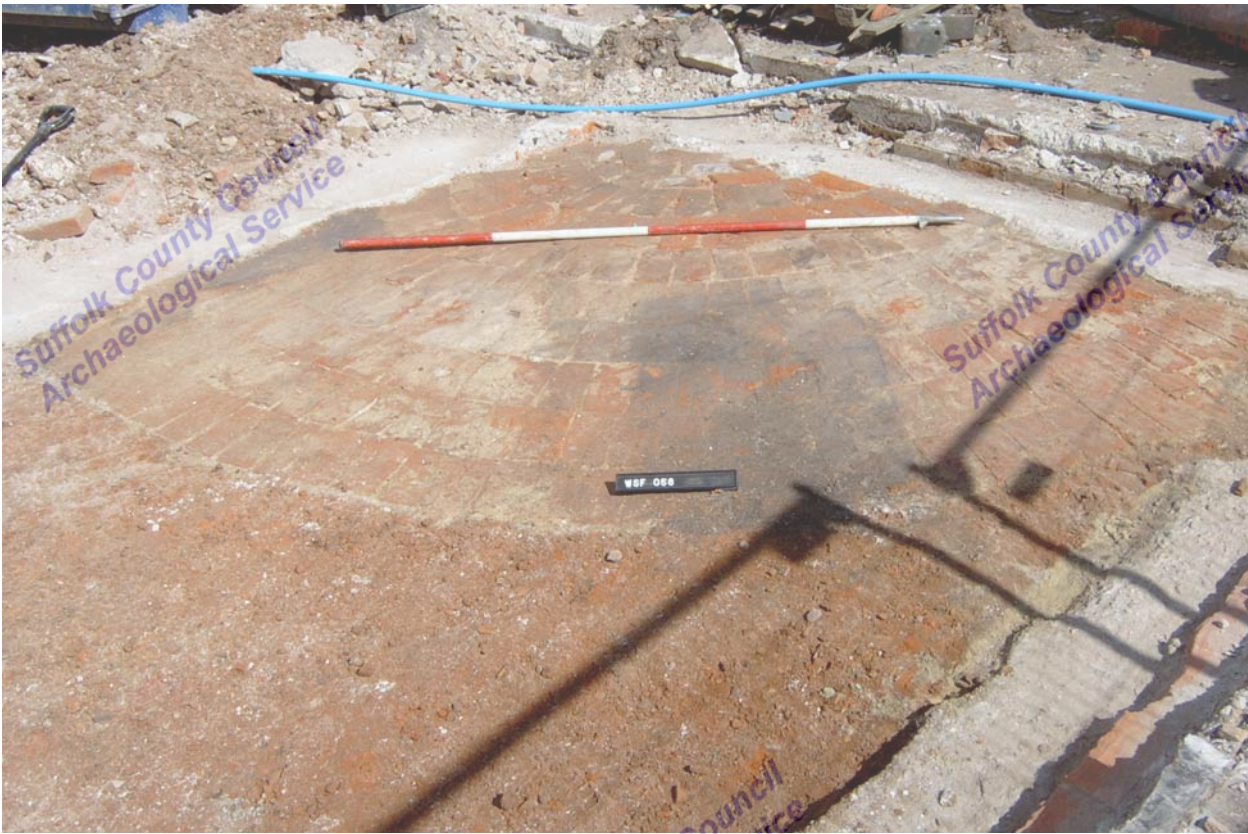
Figure 20. Brick platform 0003, looking north.

Of particular interest was the rectangular black stain upon the surface of the bricks (Fig 20), measuring c.1.2m by 0.7m. Formed from soot or charcoal it extended from the outer edge of the feature in towards the centre and the edge of a second stain was just visible on another edge of the truncated brickwork. There was no indication of the underlying bricks having been directly subjected to heat.

The suggestion is that 0003 may have been the basal floor of a similar kiln, with the blackened areas resulting as staining from the above ash pits. The shape of the illustrated ash pits closely match the complete blackened area. If 0003 was once a full circle it would have been slightly larger than the example illustrated and would have had five of these ash pits if they were evenly spaced. The standing 1940 kiln is larger still with seven flues and two entrances so it is feasible that 0003 may be the remains of a kiln of a size between these two examples. The apparent lack of any real foundations to the possible kiln may also be explainable, as some of these structures may have had relatively short lifespans, probably being constantly rebuilt or replaced to suit business needs and would not have required substantial, long term foundations. However if this pad formed the floor for the ash pits it would also have underlaid the flues, in which the waste heat would surely have affected the brickwork. There was no sign of any such burning or vitrification within the visible area of the pad but it is just possible that any flues may have been entirely contained in the missing 75% of the structure. If it is a kiln base then, according to the Watsons recollections, it was probably in use relatively early in the business history during the 19th century.

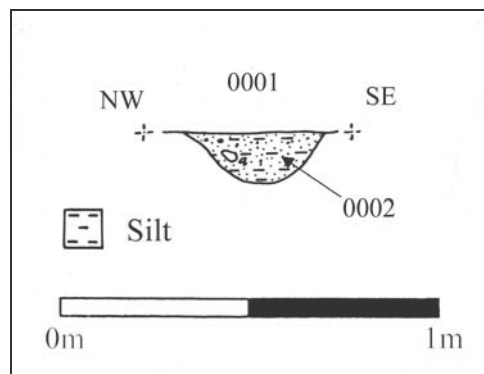
Figure 21. 0001 section

In this area removal of the concrete floor showed only a thin layer of hardcore overlying the natural clay. A single ditch, 0001, aligned south-west to north-east and parallel to the track to the south, was identified on the edge of the site (Fig. 14), cutting the natural subsoil. A single section (Fig. 21) was excavated showing it to be 0.8m wide and 0.3m deep with moderate sloping sides and a concave base. Its fill was a compact, mid brown, silty/clay. No finds were recovered.

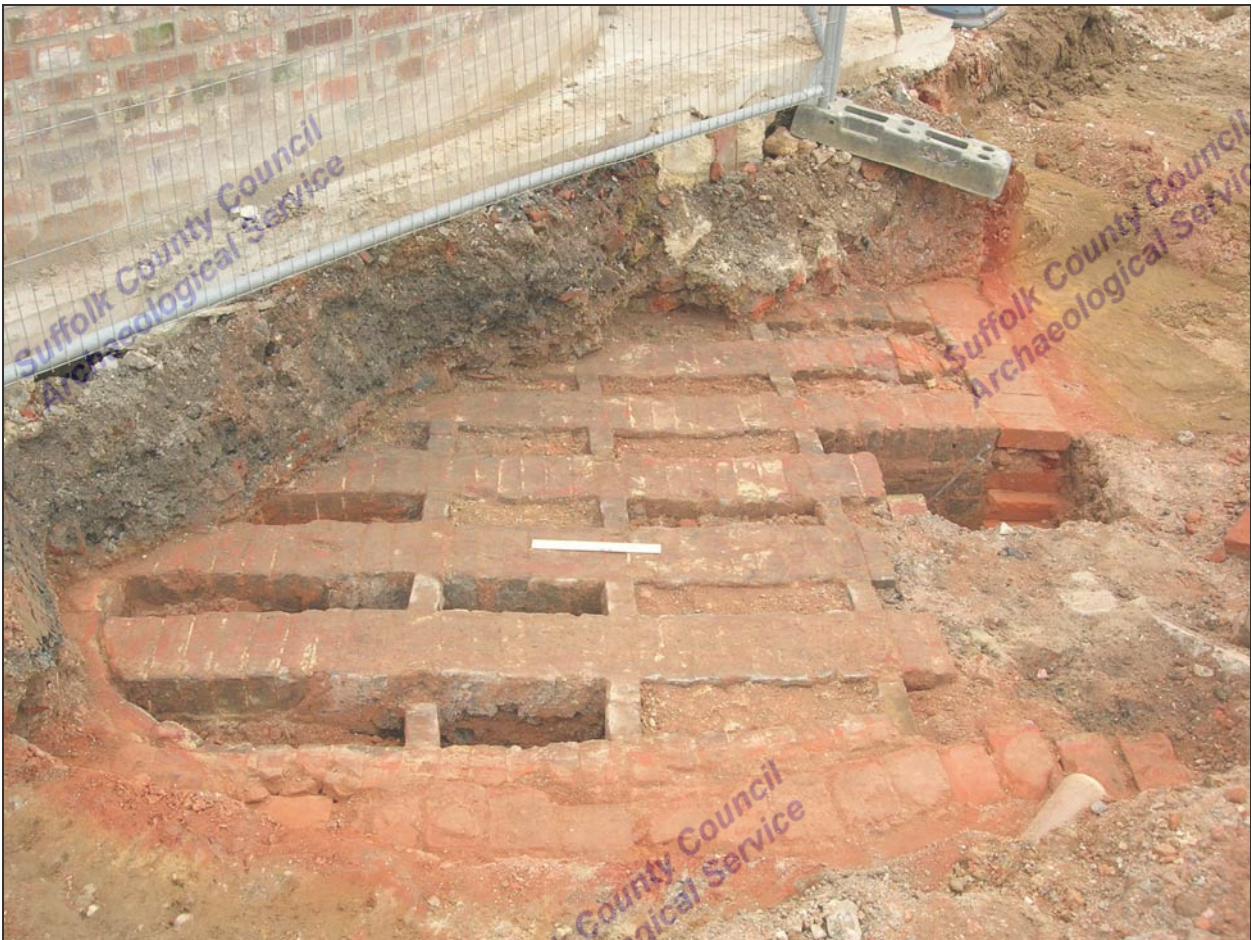
Figure 25. 0024, looking SW

A c.20m wide band of the natural clay subsoil around the exterior had been burnt to a dark red/orange colour by heat conducting from the structure.

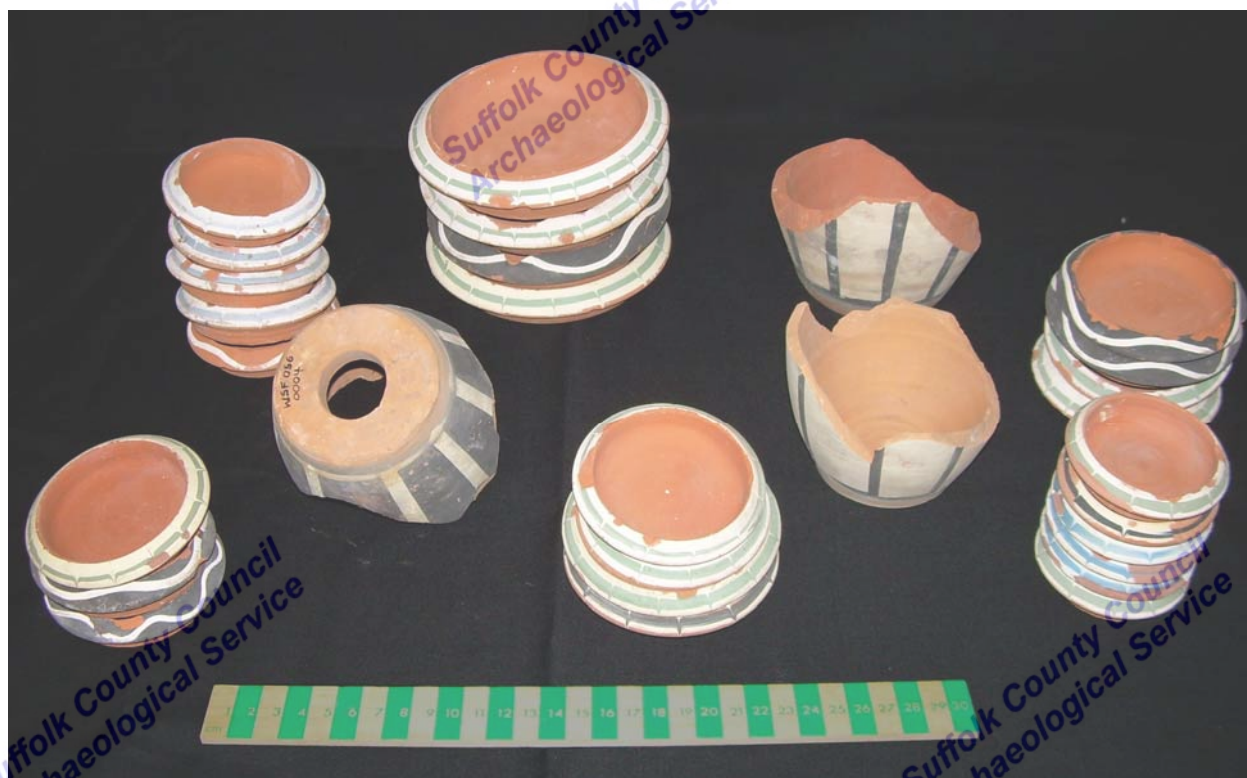
Figure 26. 0004 pottery

A representative sample of post-medieval ceramics was recovered from 0004, the final backfilling deposit over the double-flue 0008. The assemblage comprises a total of 42 individual vessels, weighing 4.576kg. The group is made up of a number of flower and plant pots, both plain and decorated, and plant pot saucers in a range of coloured slipped decoration (Fig. 26).

Only one actual waster was identified, the burnt and misshapen base of a flowerpot with a drainage hole. Three complete small unglazed ridged flowerpots of a small size suitable for growing small plants or seedlings were present, as well as a glazed example of the same size with a number painted on the base which may be a test-piece. Two further flowerpots of a larger size are decorated with black slipped bands around the upper part of the vessel, over which is a white slipped decoration of wavy lines and dots.

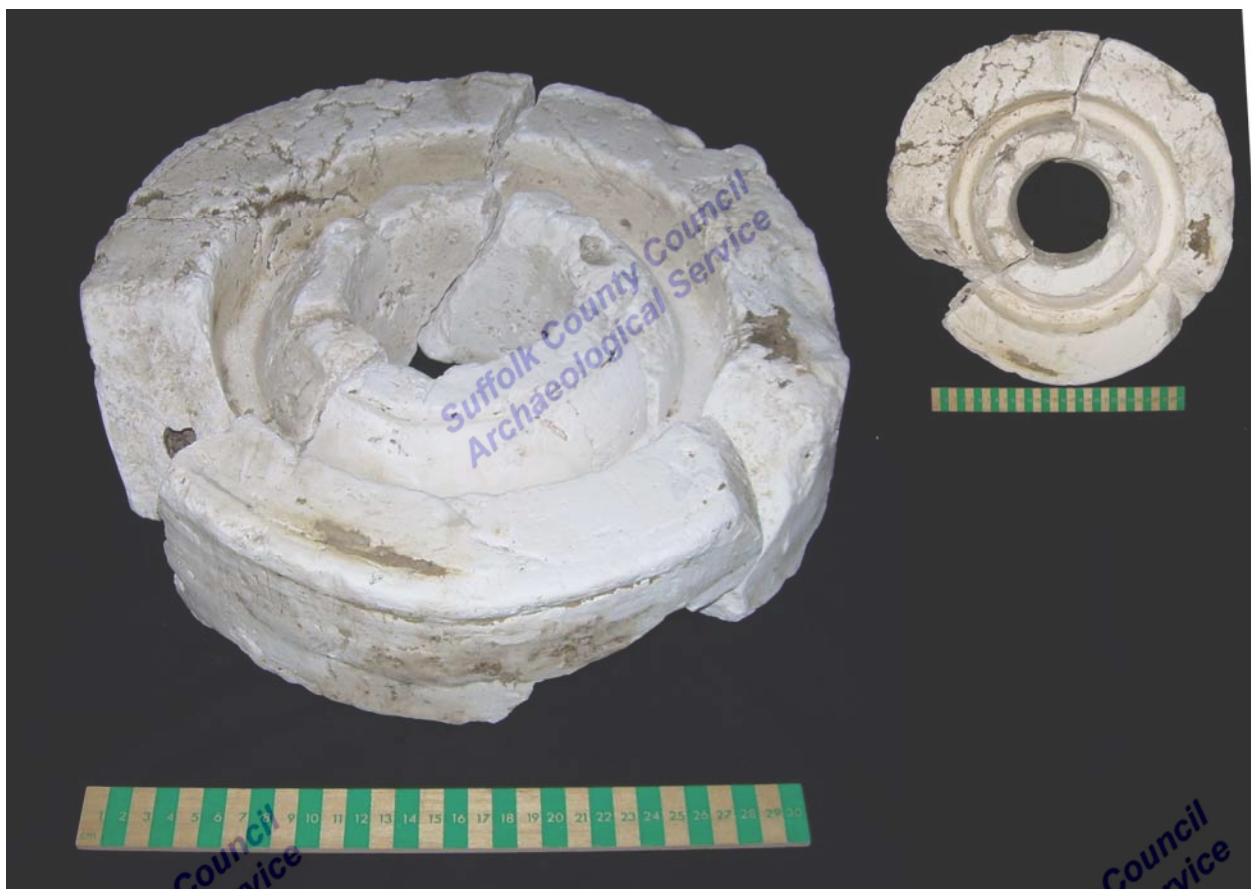
Figure 27. Plaster mould 0021

An almost complete plaster mould was also found (SF0021). It is circular in shape with a deep, circular depression and central void (Fig. 27). It is unclear at the moment for what purpose the mould was made, but it is possible that it may have been used experimentally when developing new techniques in the post-war period, when casting rather than hand-throwing was increasingly used. The mould was found amongst debris above flue 0015.
