Travelodge Hotel, Duke Street, Ipswich

Archaeological Excavation Report

SCCAS Report No. 2011/168

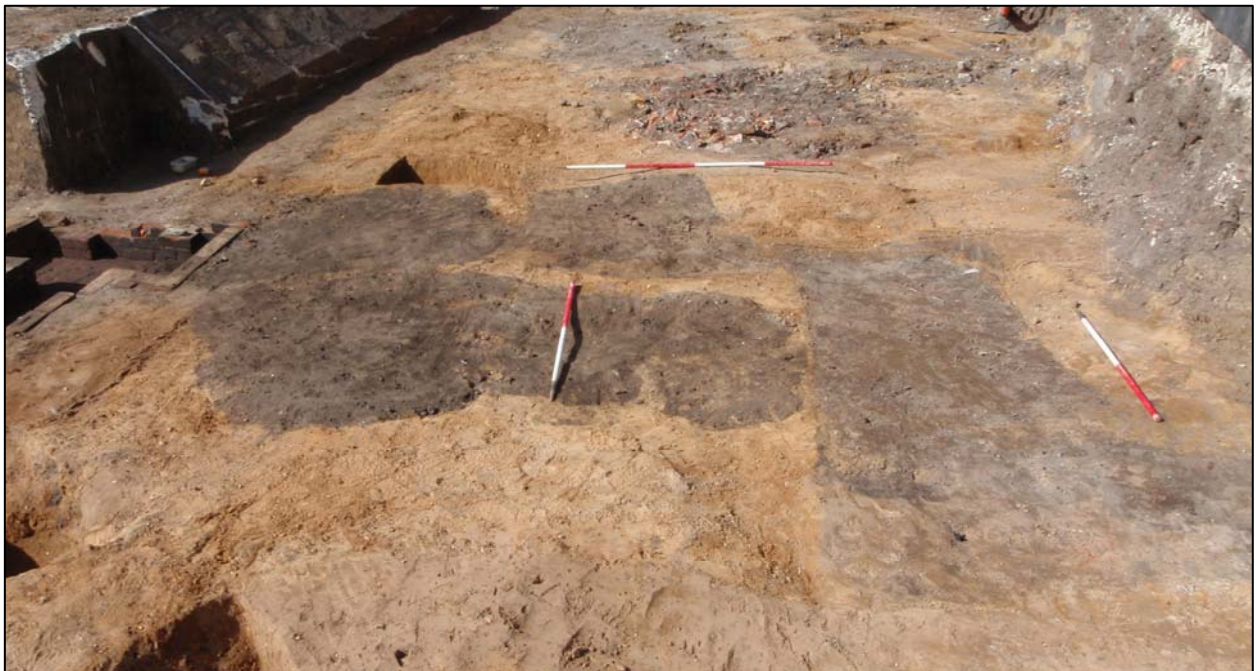
Plate 2 post-medieval pit group (ref. HLP 14)

A group of twelve roughly square or rectangular shaped pits were noted in close proximity in a discrete area in the north of the site (Plate 2). It was concluded that these were relatively late features and consequently only four were sampled. This was undertaken not only to confirm their late date but primarily to access earlier features. The pits excavated (numbers 0023, 0044, 0046 and 0052) were found to be similar in nature with near vertical edges, flat bases and dark, organic rich fills containing few

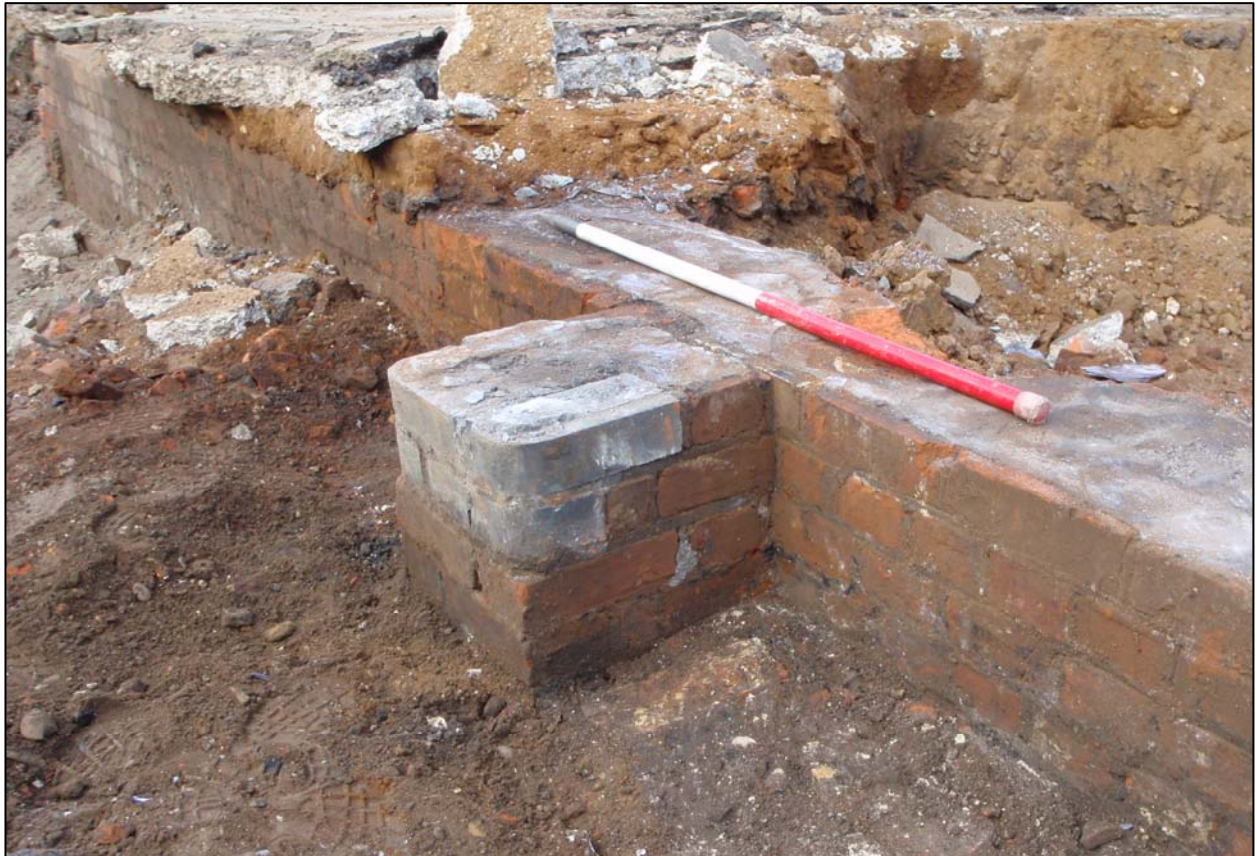
Plate 3 boundary wall (Wall 0003) (ref. HLP 46)

The south-east edge of the section of Siloam Place present within the site was marked by a continuous length of wall (0003), 0.4m in width, built of red-brick resting on a foundation formed of concrete mixed with fragments of red brick. At the bottom of the wall the lower two courses of brickwork stepped out to create a wider base (visible in Plate 4). A single buttress, faced in blue engineering bricks with rounded corners, was noted on the south-east side of the wall (Plate 3). A further section of a similar wall (0117) was located on the south side of the east-west section of the street. These walls represent a later alteration to the area in the later 19th and early 20th centuries when the houses on the south-east and south sides of the street were demolished and the area incorporated into the adjacent factory complex with Walls 0003 and 0117 forming the new boundary. Wall 0003 runs directly along the front of the terrace and has

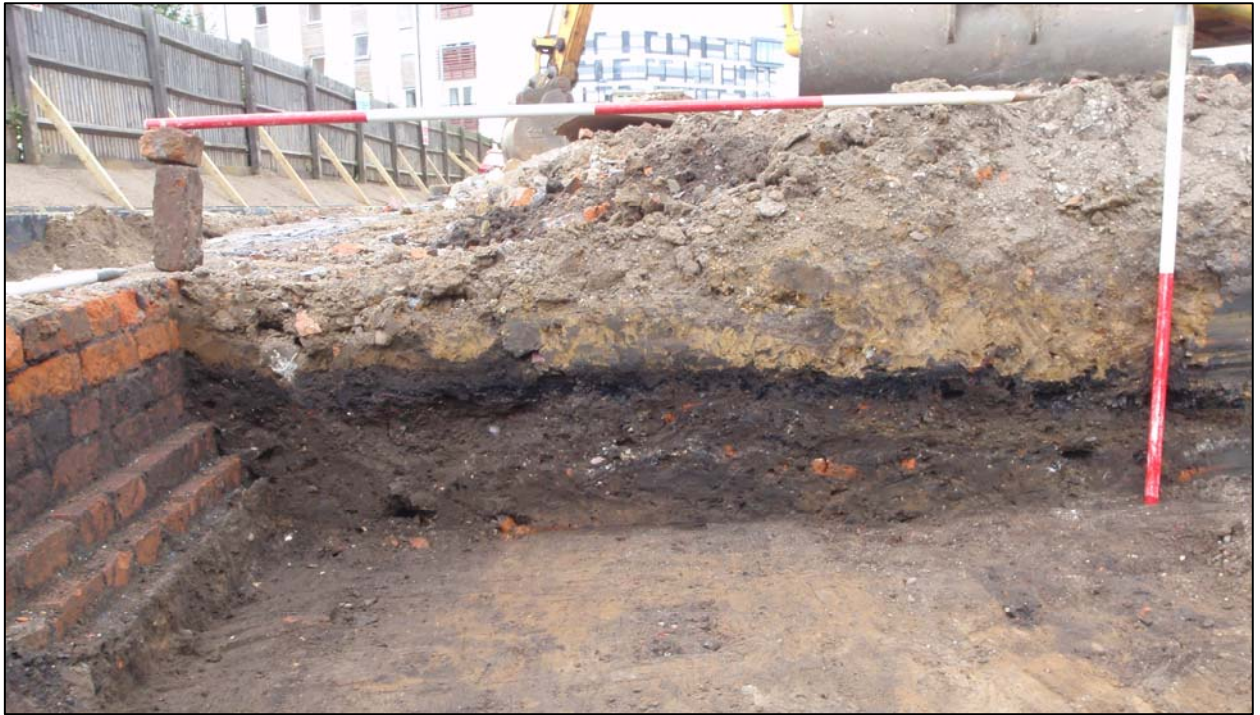
Plate 4 section across Siloam Place showing roadway surface
(foundation of Wall 0003 is visible to the left) (ref. HLP 39)

The north-west side of the south-west to north-east section of the street was marked by walls 0063 and 0083, which would give this section a width of 5.8m. The northern edge of the east to west section of street was not as clearly marked as the houses on the corner were cellared and the ground level walls had not survived. The distance between Wall 0117 and the cellar walls (0097, 0113 and the robbed wall-line 0103) measured about 6m. The street surface appeared to comprise a simple spread of compacted gravel with ash, clinker and fine black silt (Plate 4). This could not be traced across the

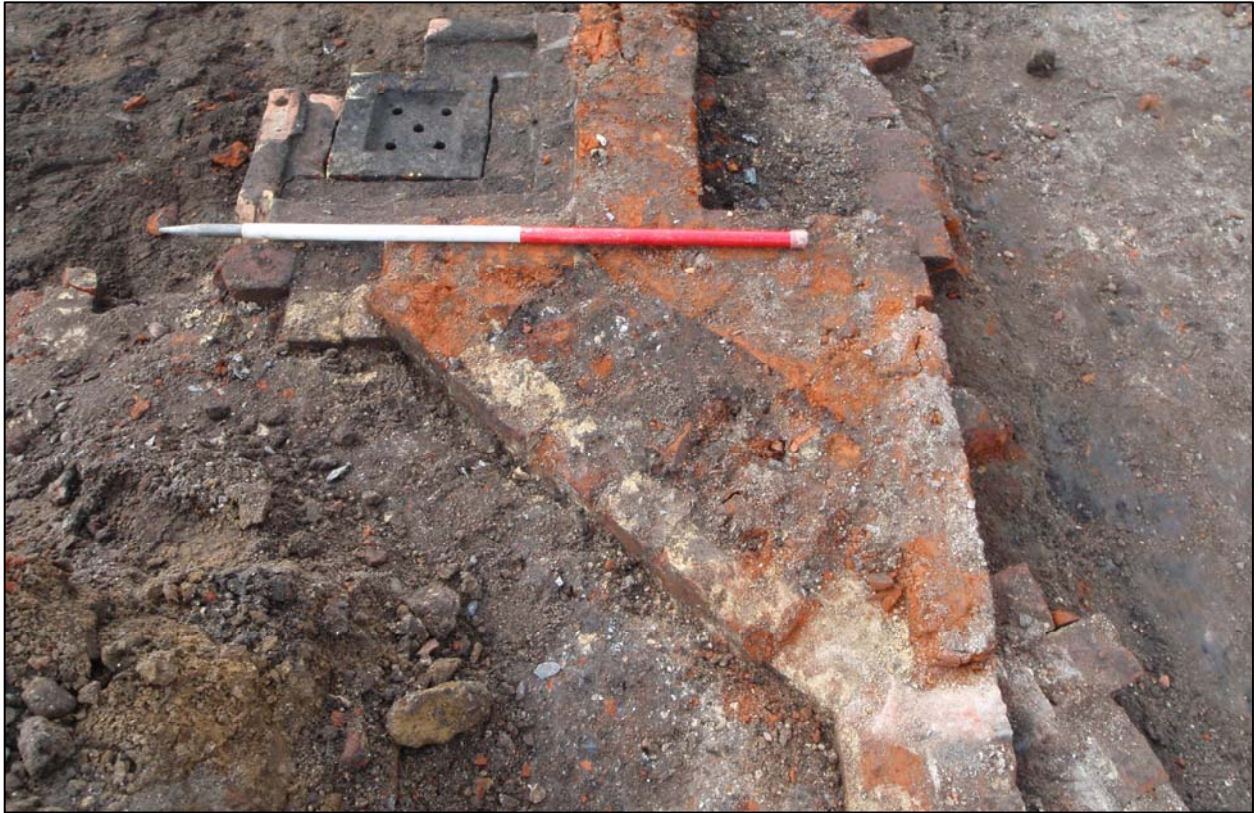
Plate 9 probable corner fireplace at junction of Wall 0066 and 0070 (ref. HLP 36)

A south-western extension to the main body of the school was marked by Wall 0008 and Wall 0070. These were located 3.65m apart, but both had been cut short by a later disturbance so it was not possible to determine the full width of this room. Wall 0008 appeared as a continuation along the street frontage of Wall 0063. Wall 0070 joined Wall 0066, at which junction a length of brickwork ran across the internal corner leaving a clear rectangular void within (Plate 9). Although no evidence of burning or associated deposits were noted, this feature suggests this was probably the site of a corner fireplace.

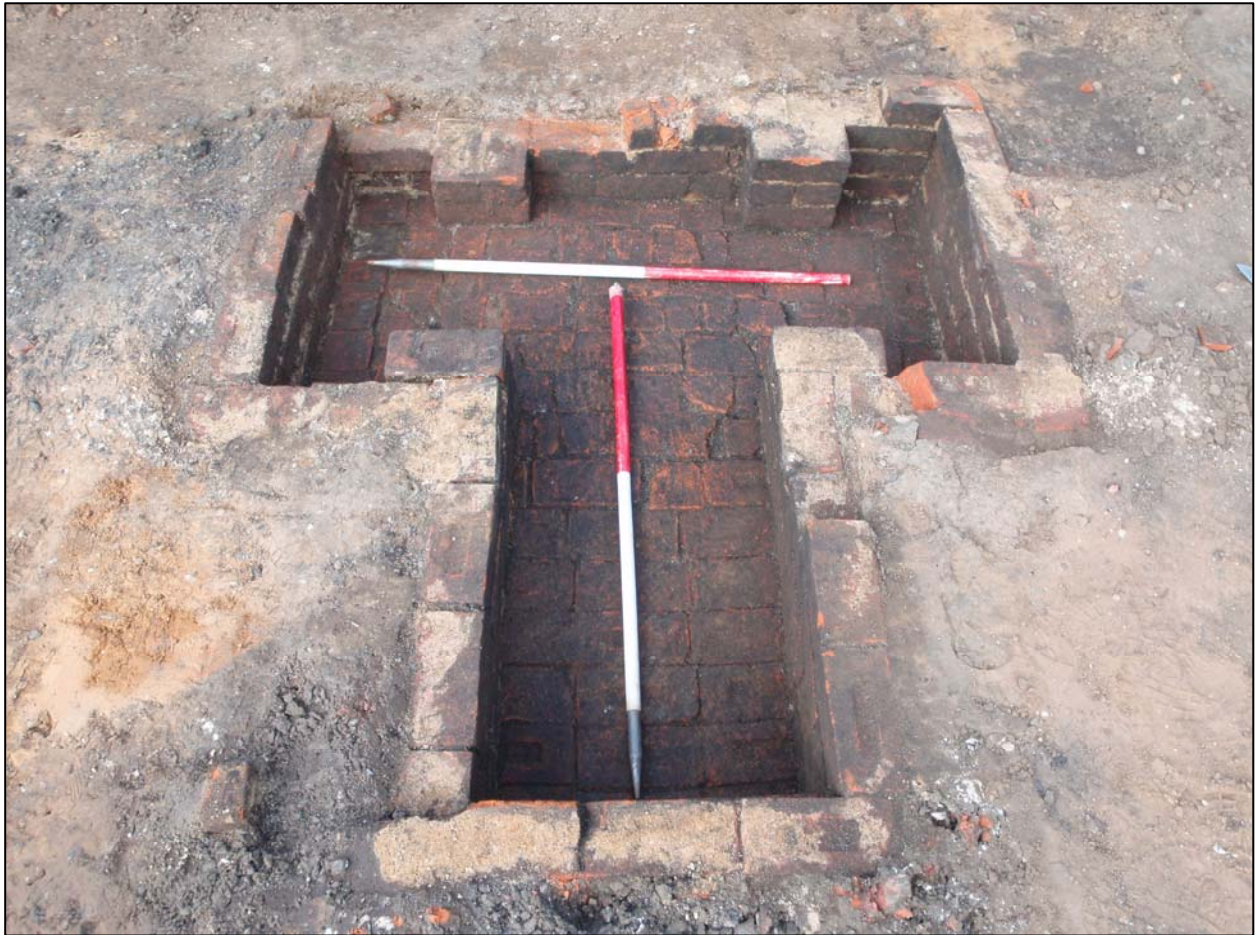
Plate 12 cess pit (0059) (ref. HLP 88)

A brick lined cess pit (0059, Plate 12) was located on the north-west side of the yard. It was found in association with a series of narrow brick walls (0067 and 0069) and a slab of slate (0068), all of which have been interpreted as components of an outside toilet block. Part of the building which housed the toilets survived as Wall 0069. The interpretation of this is slightly ambiguous, but it appears to mark out a single cubicle to the north-east of the cess pit, part of which overlies the cess pit. There was presumably a matching cubicle immediately south-west of pit. The slate slab (0068) was probably part of a urinal and was set horizontally at ground level in the northern corner of the yard, against Wall 0066 (Plate 11). The south-west end of the slab appeared to connect with a ceramic pipe which ran into the cess pit. This area was screened off from the

yard by Wall 0069 and Walls 0067. The cess pit was lined with walls a single brick width which tapered in towards the base, and had a brick floor constructed of frogged red-bricks. It was 'T' shaped with part protruding beyond the south-east side of the toilet block. This had been covered by a large stone slab, found broken into three within the upper fill, which could be lifted using an iron ring mounted on the upper side (Plate 13) to enable access to the cess pit for cleaning. Much of the upper fill of the cess pit consisted of demolition rubble whilst the lower fill comprised a dark, fine, organic rich silt (degraded cess) from which numerous fragments of writing slates and slate pencils were recovered. Other finds from this context included a number of fragments of window glass (not retained).

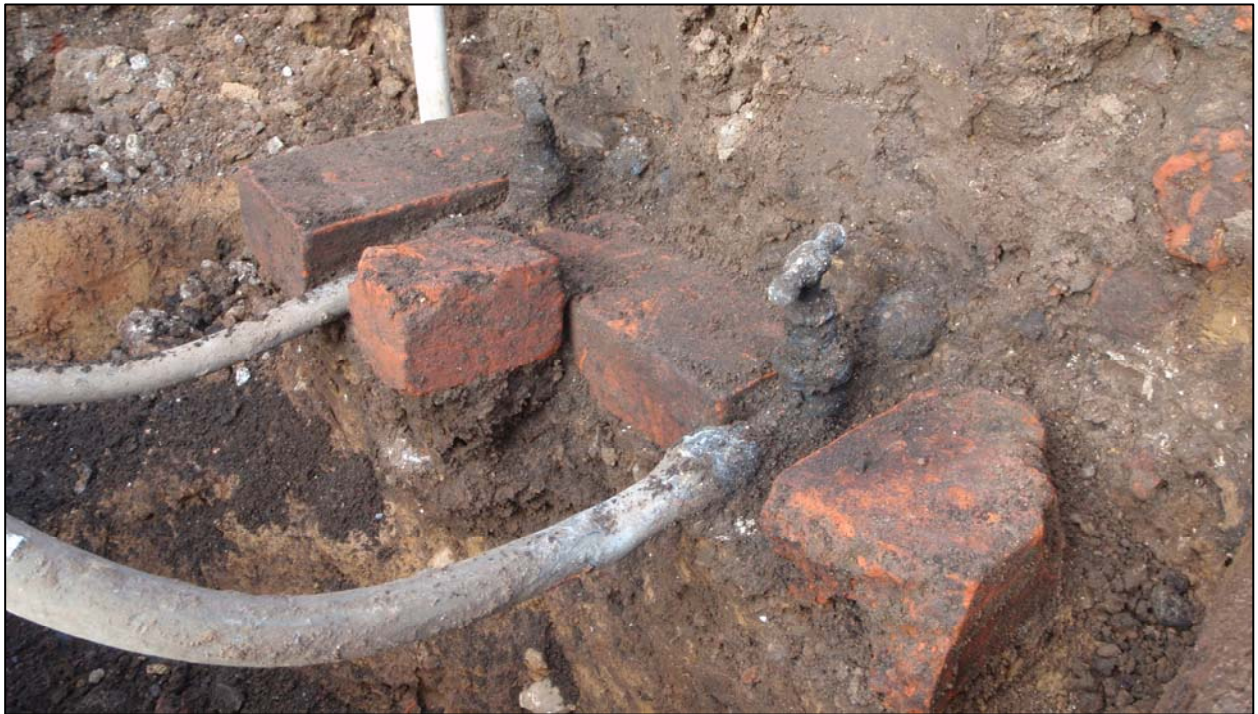
Plate 16 stopcocks (0084) at the front of houses 2 and 3 (ref. HLP 85)

Evidence for a mains water supply to these houses was present in the form of two stopcocks (0084) located immediately adjacent the front wall of houses 2 and 3 (0083/0095). They comprised a pair of in-line taps, each connected to lead pipes (Plate 16), that ran from the cast iron water pipe running the length of Siloam Place and under the house walls. Access to the taps from pavement level was via a pair of salt-glazed ceramic pipes placed upright in the ground with the lower ends resting on a pair of bricks and enclosing each tap (Plate 17). A narrow ?cast iron pipe ran directly into the houses, between the two ceramic pipes but at a higher level than the water pipes; it was interpreted as a probable gas supply.

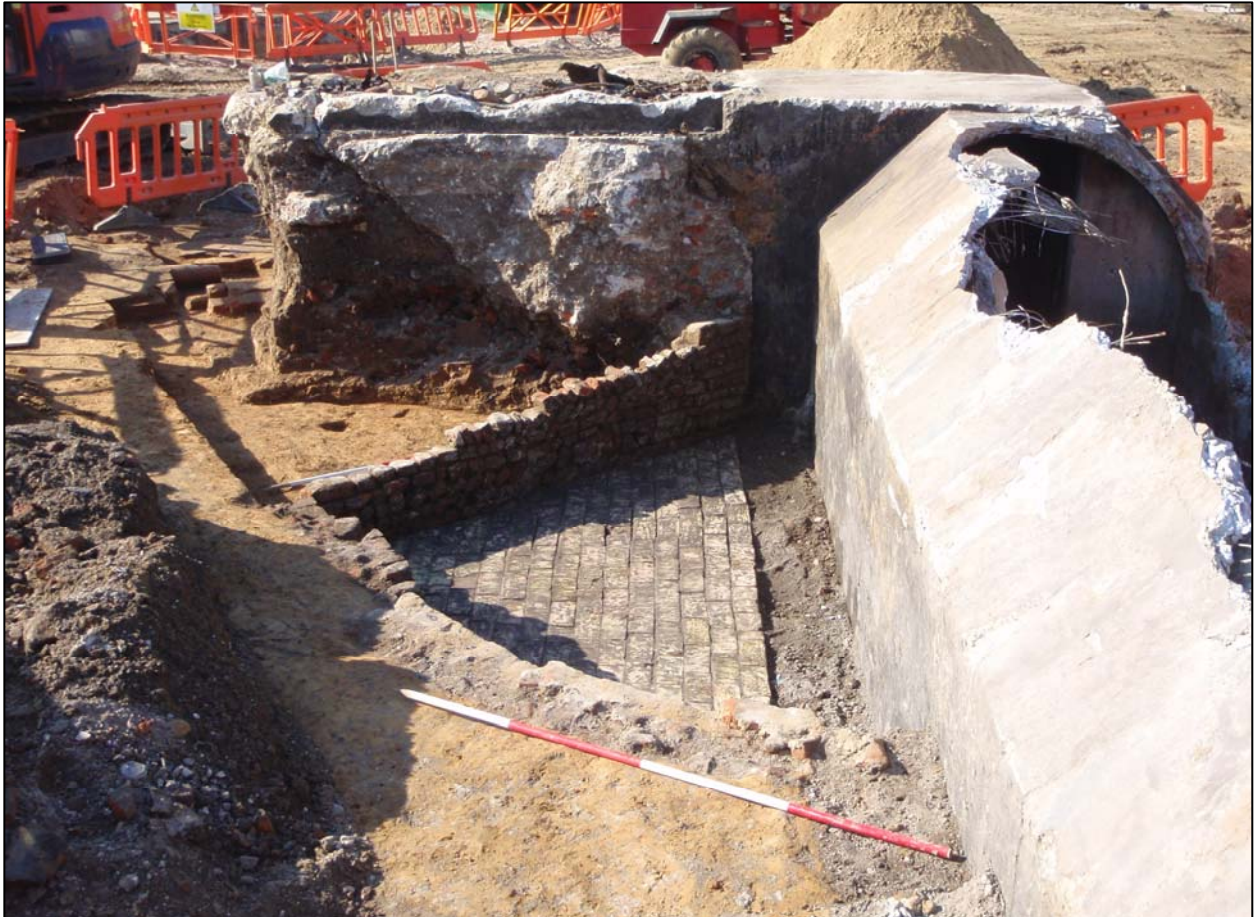
Plate 20 house 3 cellar, showing Walls 0097, 0098 & 0113 and Surface 0100. Shelter 6 is visible to the right (ref. HLQ 21)

Situated beneath house 3, and confusingly, partly beneath house 4, was a large, slightly irregular shaped, cellar marked by walls 0095, 0097, 0098 and 0113 (Plate 20). The floor (0100) was composed of cream coloured floor bricks with their long axis aligned with the north-east wall of the cellar. An air-raid shelter (Sh6) cut a swath across part this cellar although sections survived on each side of the shelter. The cellar floor lay at a height of approximately 3.4m OD. The base of the floor joists (based on the height of the joist support in house 2) was 5.2m OD, giving a headroom of 1.8m. In the surviving section to the north-east of the shelter a cast iron pipe, resting on three separate columns of brickwork, ran along the north-east wall of the cellar (Plate 21).

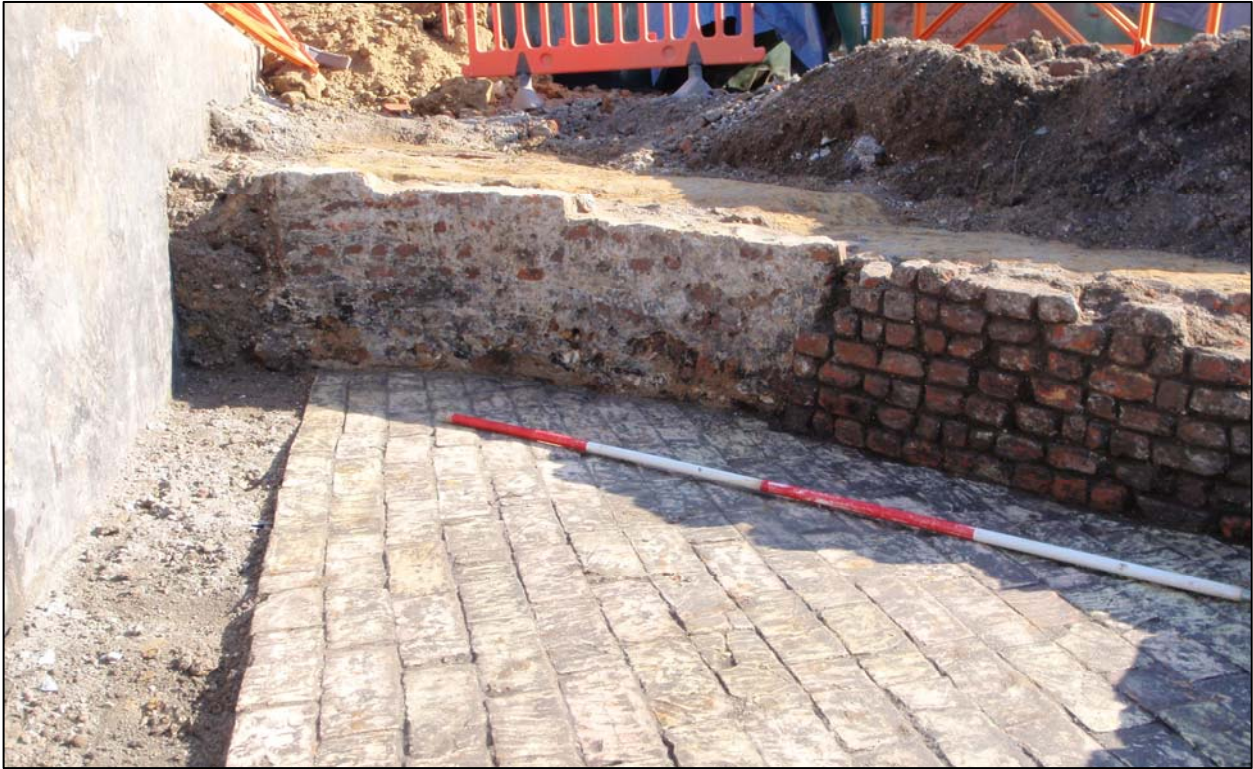
Plate 23 variation between Walls 0097 (left) and 0113 (right).

quality with whole bricks set in a hard mortar and had been partially rendered and whitewashed (Plate 23). The location of this wall, set back from 0113, would suggest it was later and had been inserted to replace a length of Wall 0113.

Shelter 6 and its cut is visible to the right (ref. HLQ 15)

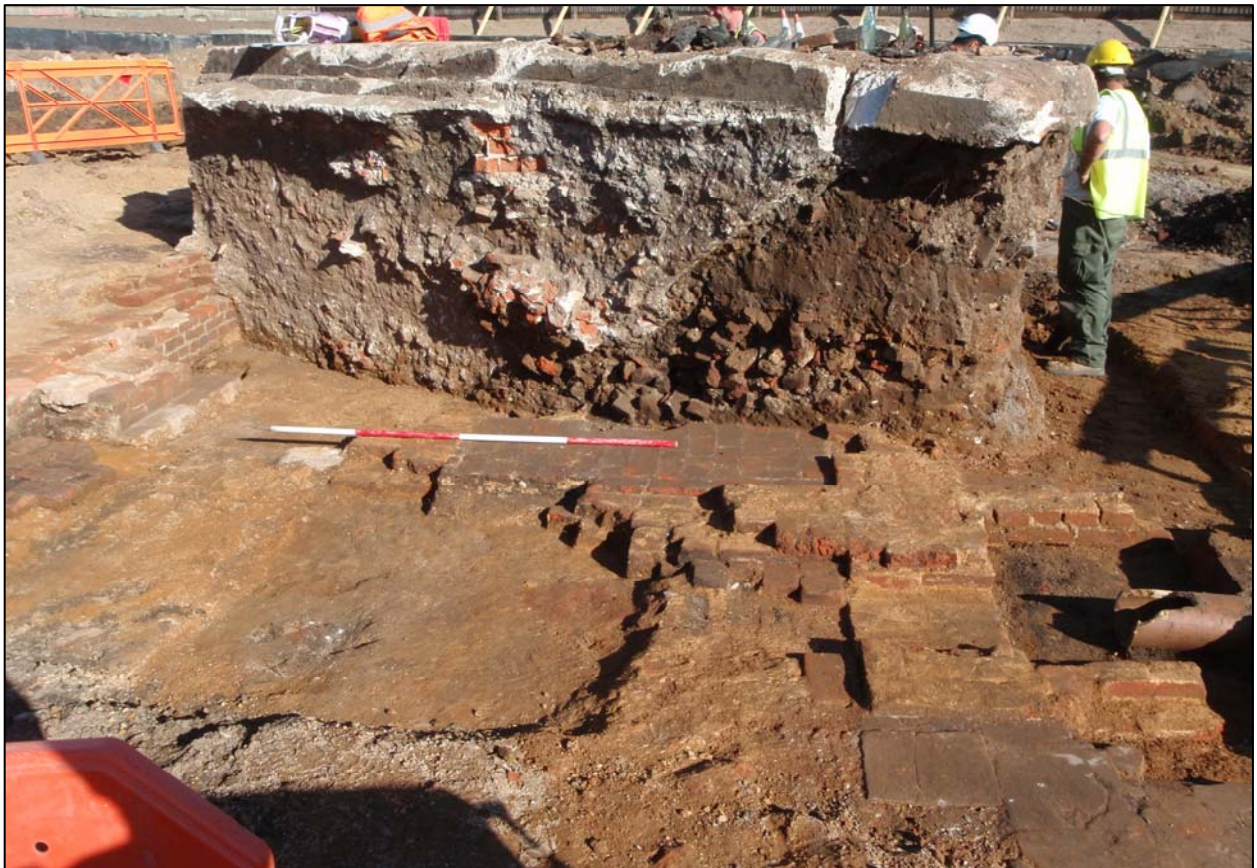
Plate 24 cellar chambers beneath houses 4 and 5 (the ranging rod is lying on surface 0105) The entrance to Shelter 6 stands behind (ref. HLP 96)

Beneath houses 4 and 5 a series of substantial brick walls (0099, 0102 and 0112), each up to 0.5m thick, formed part of a complex of cellars (Plate 24). They appeared to be associated with at least four or possible five separate and relatively small chambers. The south-east chamber was 1.6m wide and no more than 2.3m in length, its full dimensions being obscured by a later cut (0114), with a red-brick floor (0105). To the south of this a smaller chamber, with a width of 0.9m and an unknown length, was also present. This also had a brick floor although only a small segment survived in the north-west corner. The southern wall of this chamber, which may have been the front wall of the houses 4 and 5, had been robbed although a clear, vertically edged, cut remained (0103).

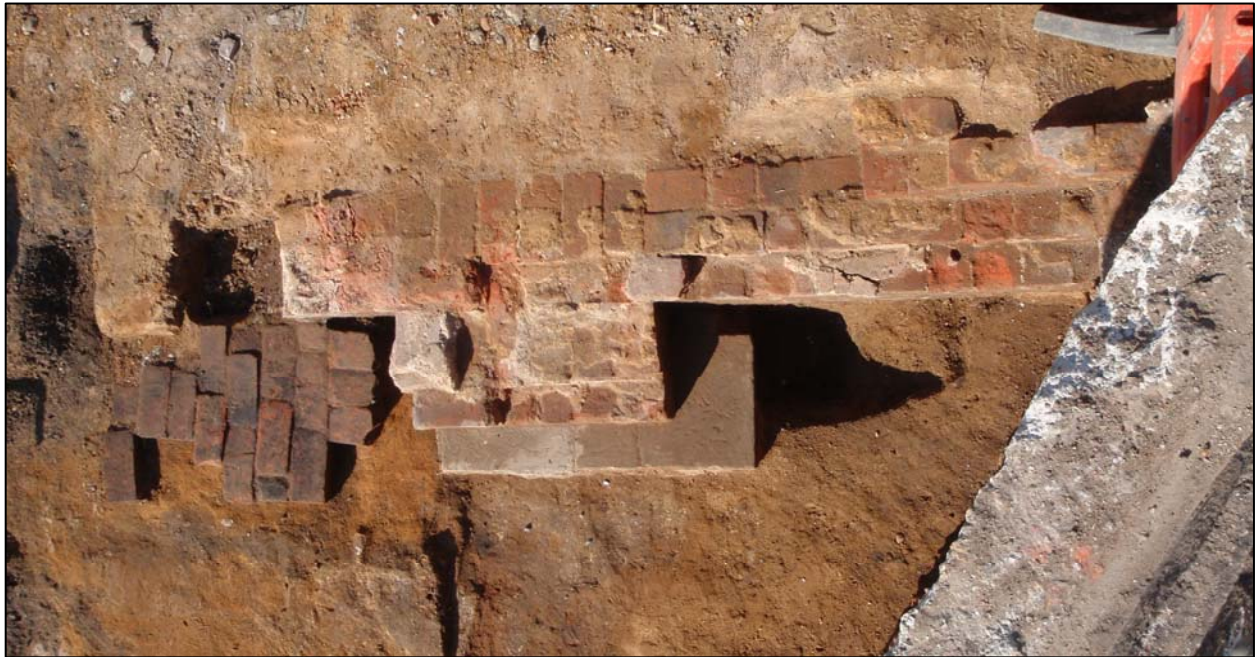
Plate 25 Wall 0099 with part of the section flagstone floor (0106) trapped below a section of brickwork. Brick surface 0109 is visible to the left (ref. HLQ 13)

half had formerly had a flagstone floor but only a small area survived (0106), trapped beneath a block of brickwork interpreted as a possible buttress, although it was not tied into the wall, or a support that had been built over this section of floor (Plate 25). The western portion contained the partial remnants of a brick floor (0109) at a slightly higher level than the flagstones with a clear straight sided, vertically edged, shallow cut between the two (0111). This may be a robbed out wall line or possibly the setting for a stone step.

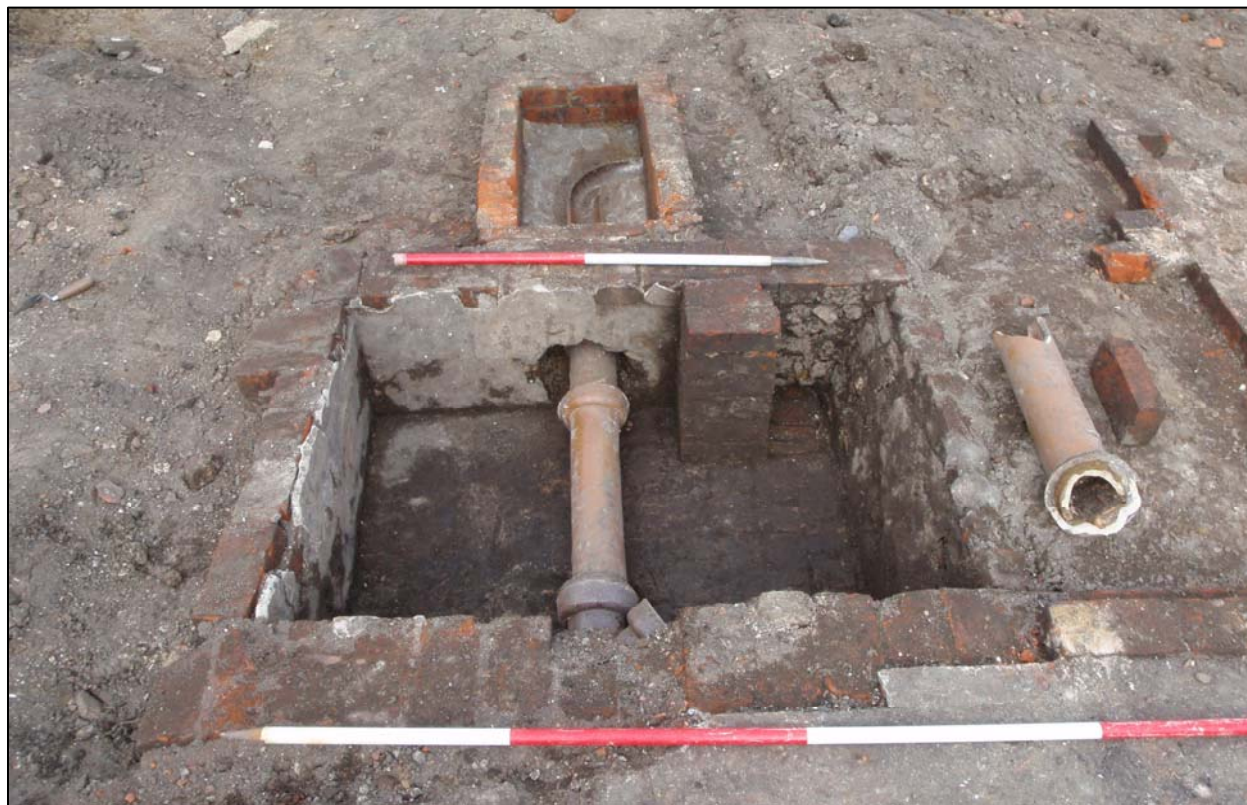
Plate 26 cess pit 0074 showing later foul water drain pipe.

At some stage in the street's life, probably early in the 20th century, foul water drainage was installed to replace the cess pits and the need for their manual cleaning. This modernisation is clearly demonstrated by the cess pit to the rear of house 1 (0074). Adjacent to the cess pit a brick-lined inspection chamber (0073) had been installed. It was constructed of hard pink bricks, mortared with a hard cement, and gave access to a foul water drain pipe formed of salt-glazed lengths with cemented joints. Within the inspection chamber a half-pipe had been installed to allow the pipe to be cleared. The pipe exited the inspection chamber and passed through a hole broken through the side of the cess pit, continued across the base of the pit and out through a hole broken cut into the opposite side (Plate 26). Within the cess pit a second pipe coming in through the top, presumably from the toilet at the rear of house 1, connected to the pipe at a 'Y'

junction. A trench had clearly been cut across the concrete surface (0076, visible in Plate 15) within the yard on a north-west to south-east alignment and small part had been broken out adjacent the cess pit which would suggest that further pipe runs had been installed, probably related to the drainage of water from within the house.

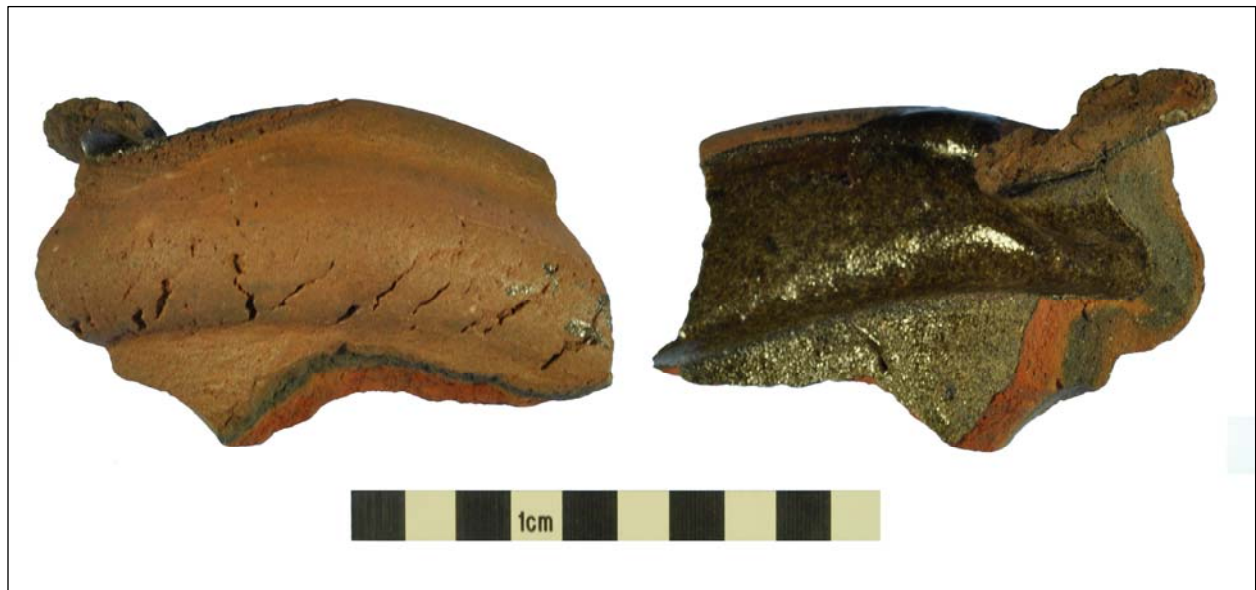
Plate 52 Redware waster from pit 0046 (fill 0047)

groups are stonewares and glazed/unglazed red earthenwares. A redware waster in pit 0046; fill 0047 is of particular significance. The distorted vessel has a grey core and intermittent areas of the surface are vitrified whereas other surface parts are like stretched dough. The glaze is green and the lower half of this has been considerably heat affected, as demonstrated by its 'bubbled' appearance (Plate 52). The remains of another pot are also attached to part of the rim. The fabric is dated from the 16th-18th century.
