**Archaeological Evaluation Report**

**SCCAS Report No. 2011/202**

**Client: Suffolk County Council Corporate Property**

# Landmark House, Whitehouse Road Ipswich, Suffolk IPS 656

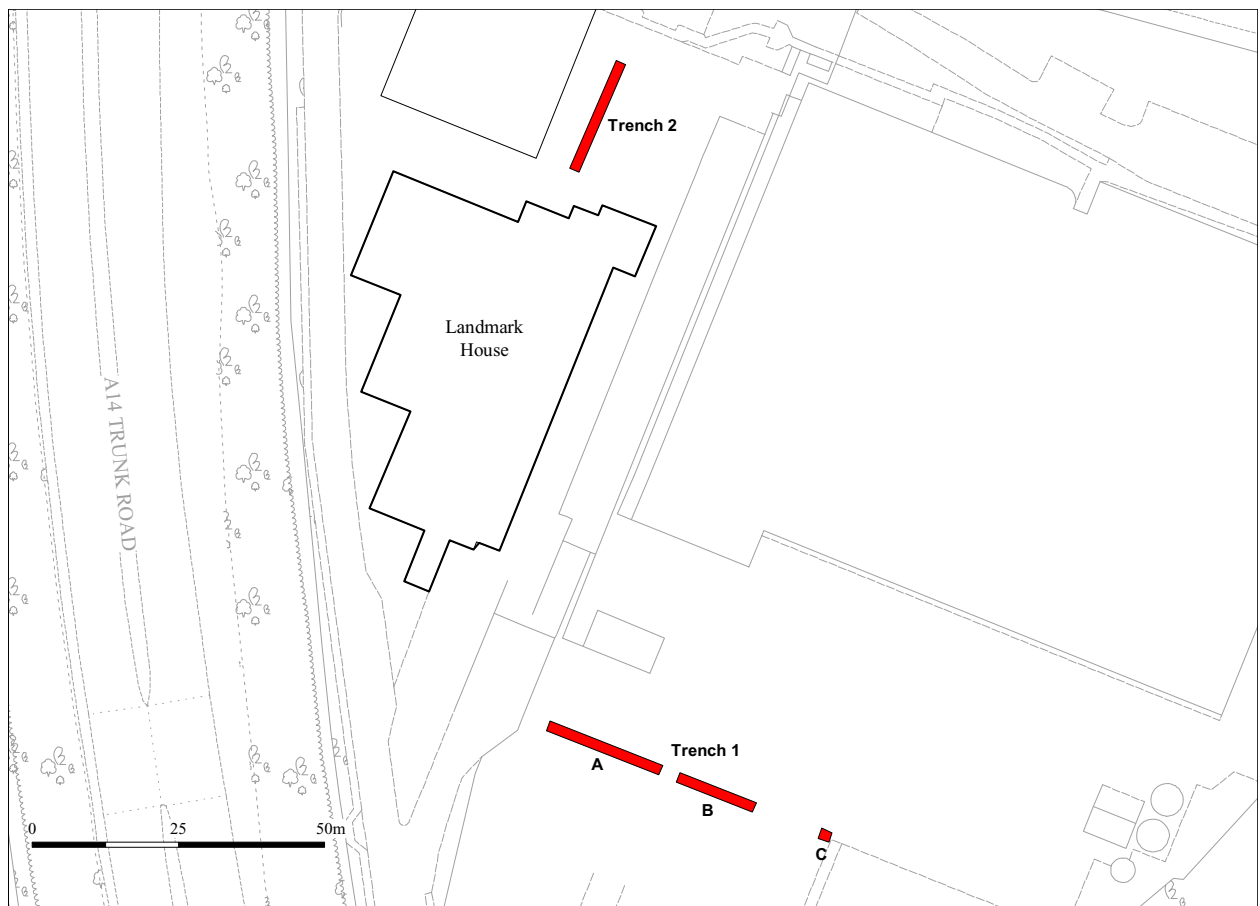
Fig 2. Trench location plan

Two evaluation trenches were excavated (fig. 2); Trench 1 was excavated across the site of the proposed storage building whilst Trench 2 was located across the area of proposed car parking. The natural subsoil, where exposed, consisted of a clean yellow sand with occasional gravel.

**Trench 1:** Was to be a single trench 50m in length but due to a presence of a possible service pipe a 4m wide gap was left (between sections A and B in fig. 2). The area of this trench had previously been under concrete hardstanding which had been removed, crushed and then spread over the site. Excavation of the trench revealed this layer of crushed concrete to be c. 0.3m thick. It lay directly on the surface of the natural subsoil, which had clearly been truncated (Plate 1).

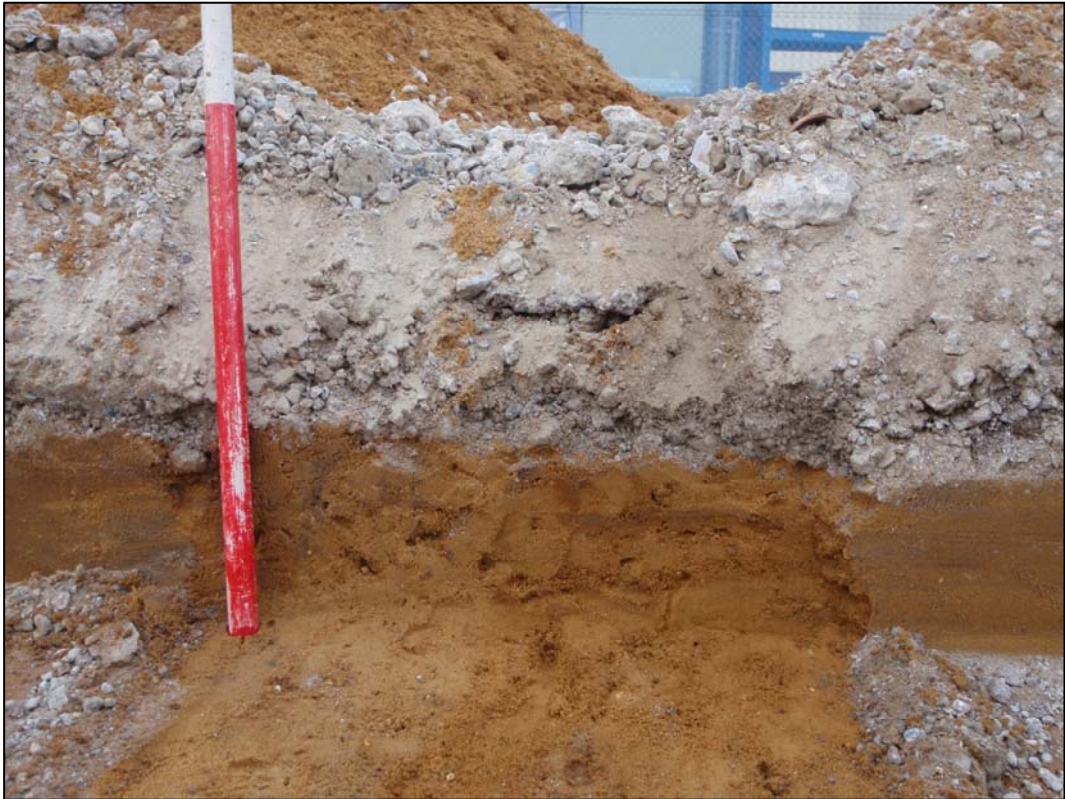
Plate 1. Trench 1, camera facing NE showing the truncated natural subsoil (ref. HLR35)

The results of Trench 1 indicate that the natural subsoil over a large part of the proposed storage building site has been previously truncated by an unknown degree. Towards the south-east end of the trench significant deposits of imported material were present. The area to the south of this trench slopes rapidly to the east and it is likely that this material has been deposited in order to create a large, level terrace.

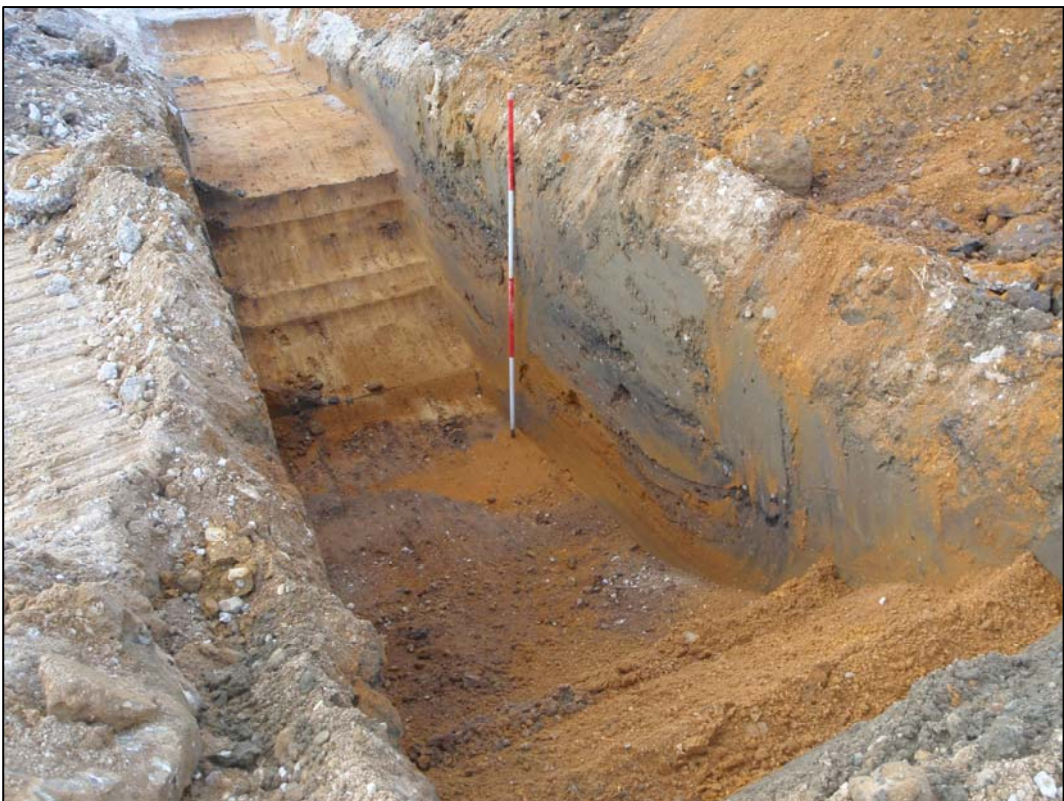
At a point 33m from the north-west end of the trench the natural subsoil dipped abruptly down to a depth of 2.1m (plate 2). A possible buried topsoil was present, suggesting the natural subsoil may not have been truncated in this area, which was immediately overlain by a thick deposit of clean orange sand and layers of darker material containing modern debris. Excavation of the trench was stopped at a point 39m from the north-west end due to the increasing depth. A test pit was excavated at the south-east end of the trench which revealed the natural subsoil had continued on a downward slope and now lay at a depth of 2.7m (Plate 3); the overburden present was similar to that seen to the north-west.

Plate 2. Trench 1, camera facing NW showing the great depth of overburden (ref. HLR38)

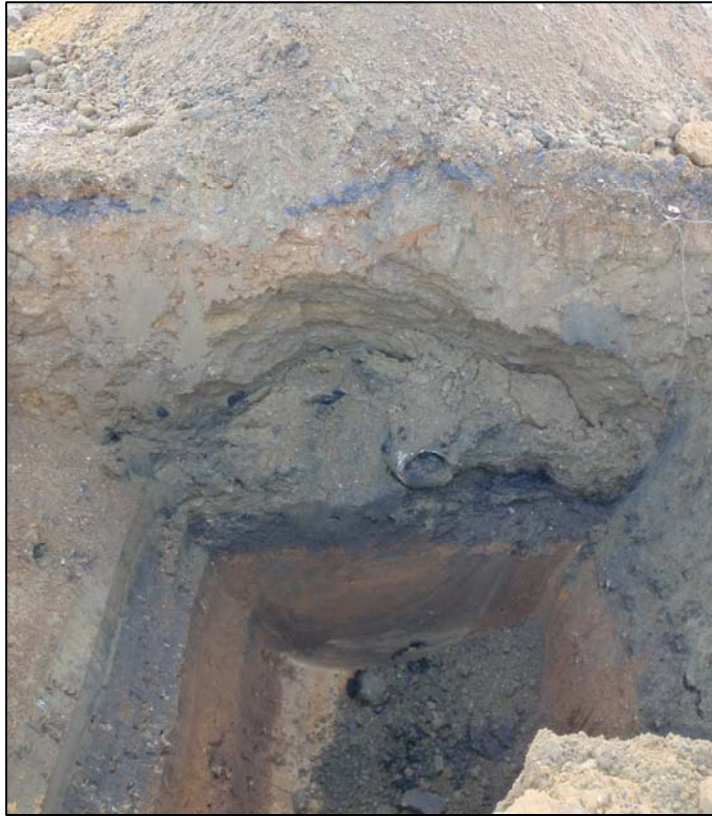
Plate 3. SE end of Trench 1 showing great depth of overburden (ref. HLR34)

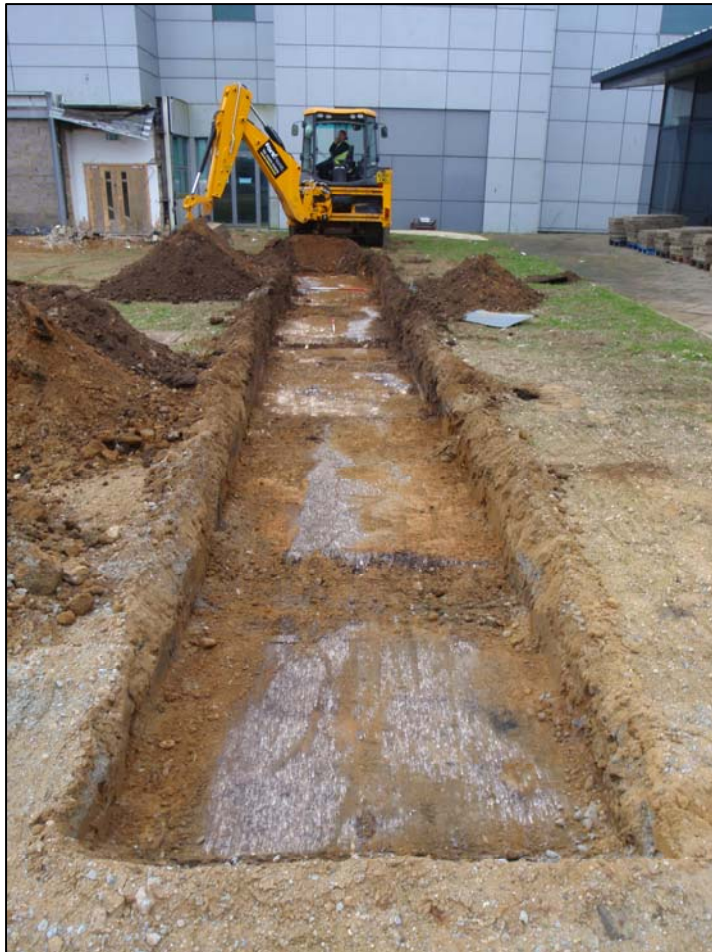
**Trench 2:** Was a single trench 20m in length in a formerly grassed area surrounded by existing structures. The trench was excavated to a maximum of 0.5m deep at which point a near continuous surface comprising tarmac over an unknown thickness of concrete was encountered (Plate 4). It was not possible to break through this surface to investigate the underlying deposits.

Plate 4. Trench 2, camera facing SW (ref. HLR40)

It was hoped that the area of Trench 2 was relatively undisturbed by the recent construction work associated with Landmark House, being an open area of grass, but the presence of the tarmac and concrete surface would indicate that this area has also been truncated.
