# RAF Martlesham Heath structures, Martlesham, MRM 140

## **Archaeological Building Record**

**SCCAS Report No. 2012/002**

Archaeological Monitoring Report

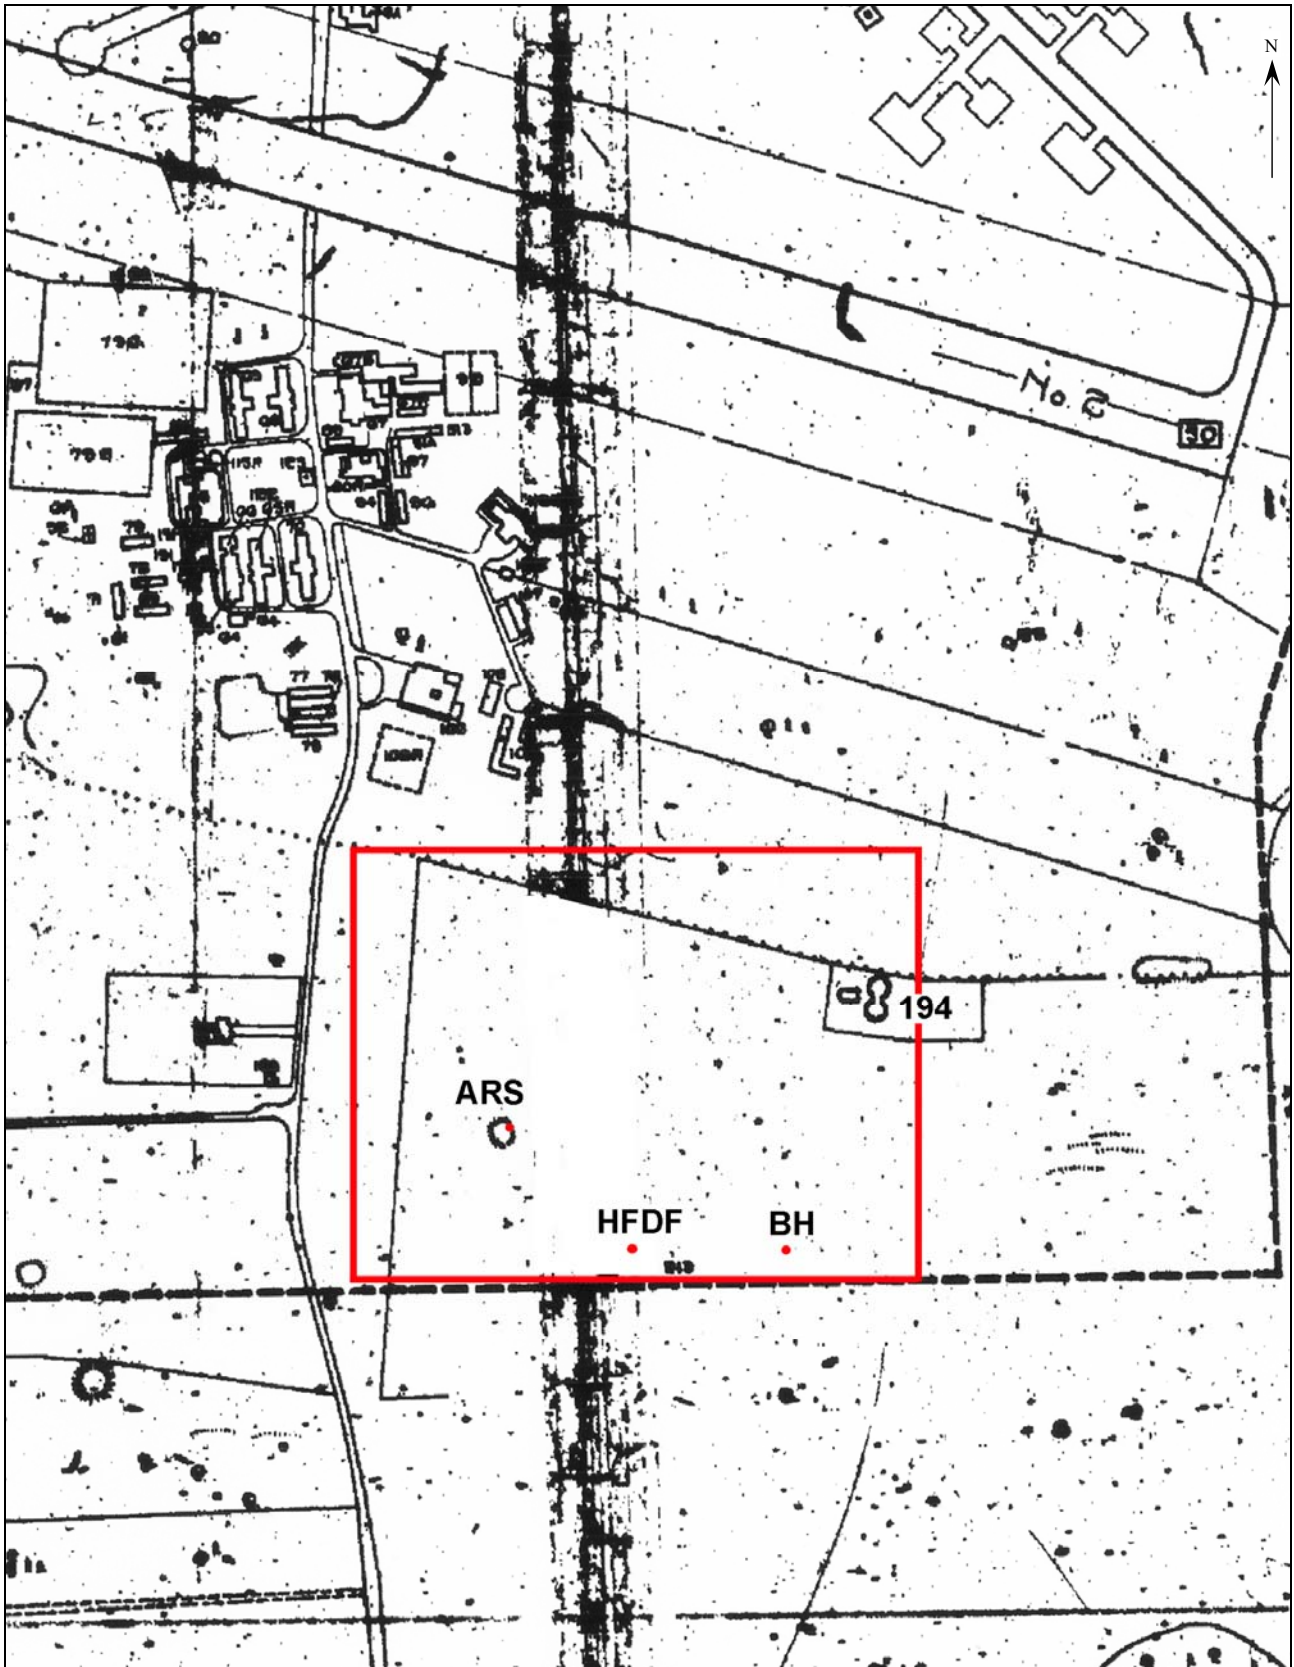
Figure 2. Plan of RAF Martlesham with structures highlighted in red and probable Bulk Oil Installation labelled as '194'.

RAF plans of the site, as provided by the RAF Museum, London, do not clearly indicate the functions of the three structures. The air raid shelter barrow is shown on one of the plans from 1945 (Fig. 2). Although the legibility of the plan is rather unclear, it also seems to indicate a structure to the north-east labelled as '194', which is recorded as a bulk oil installation.

The drawing number is 6257/45(?), and the plan is thought to date to 1945. Reproduced with permission of the Royal Air Force Museum, London.

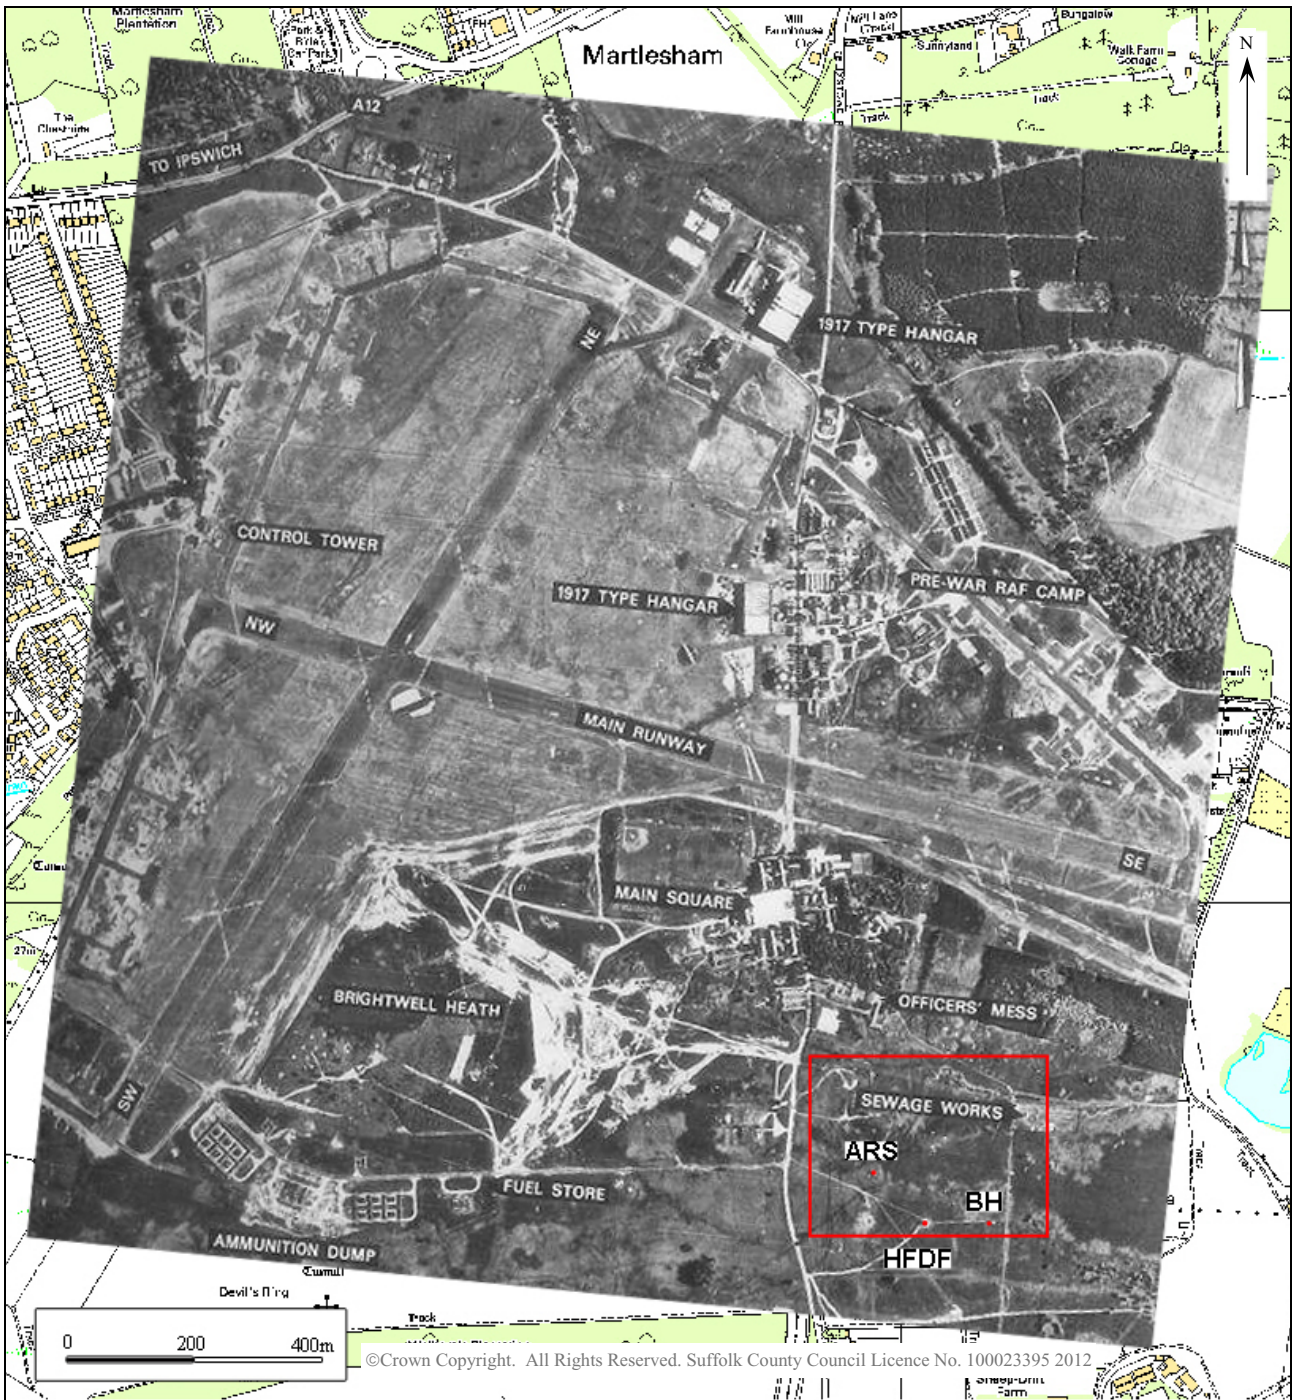
Figure 3. 1946 aerial photograph of the airfield and surrounding landscape, with the three structures highlighted (red)

A search of the Suffolk HER 1945 aerial photography collection showed that the coverage does not extend to this area. However, an Ordnance Survey photograph from 1946 reveals that the structures were located in an area labelled as the 'sewage works' and that the HFDF remains and the brick hut were on part of the site's road network (taken from Freeman, 1978 and reproduced here as Fig. 3).

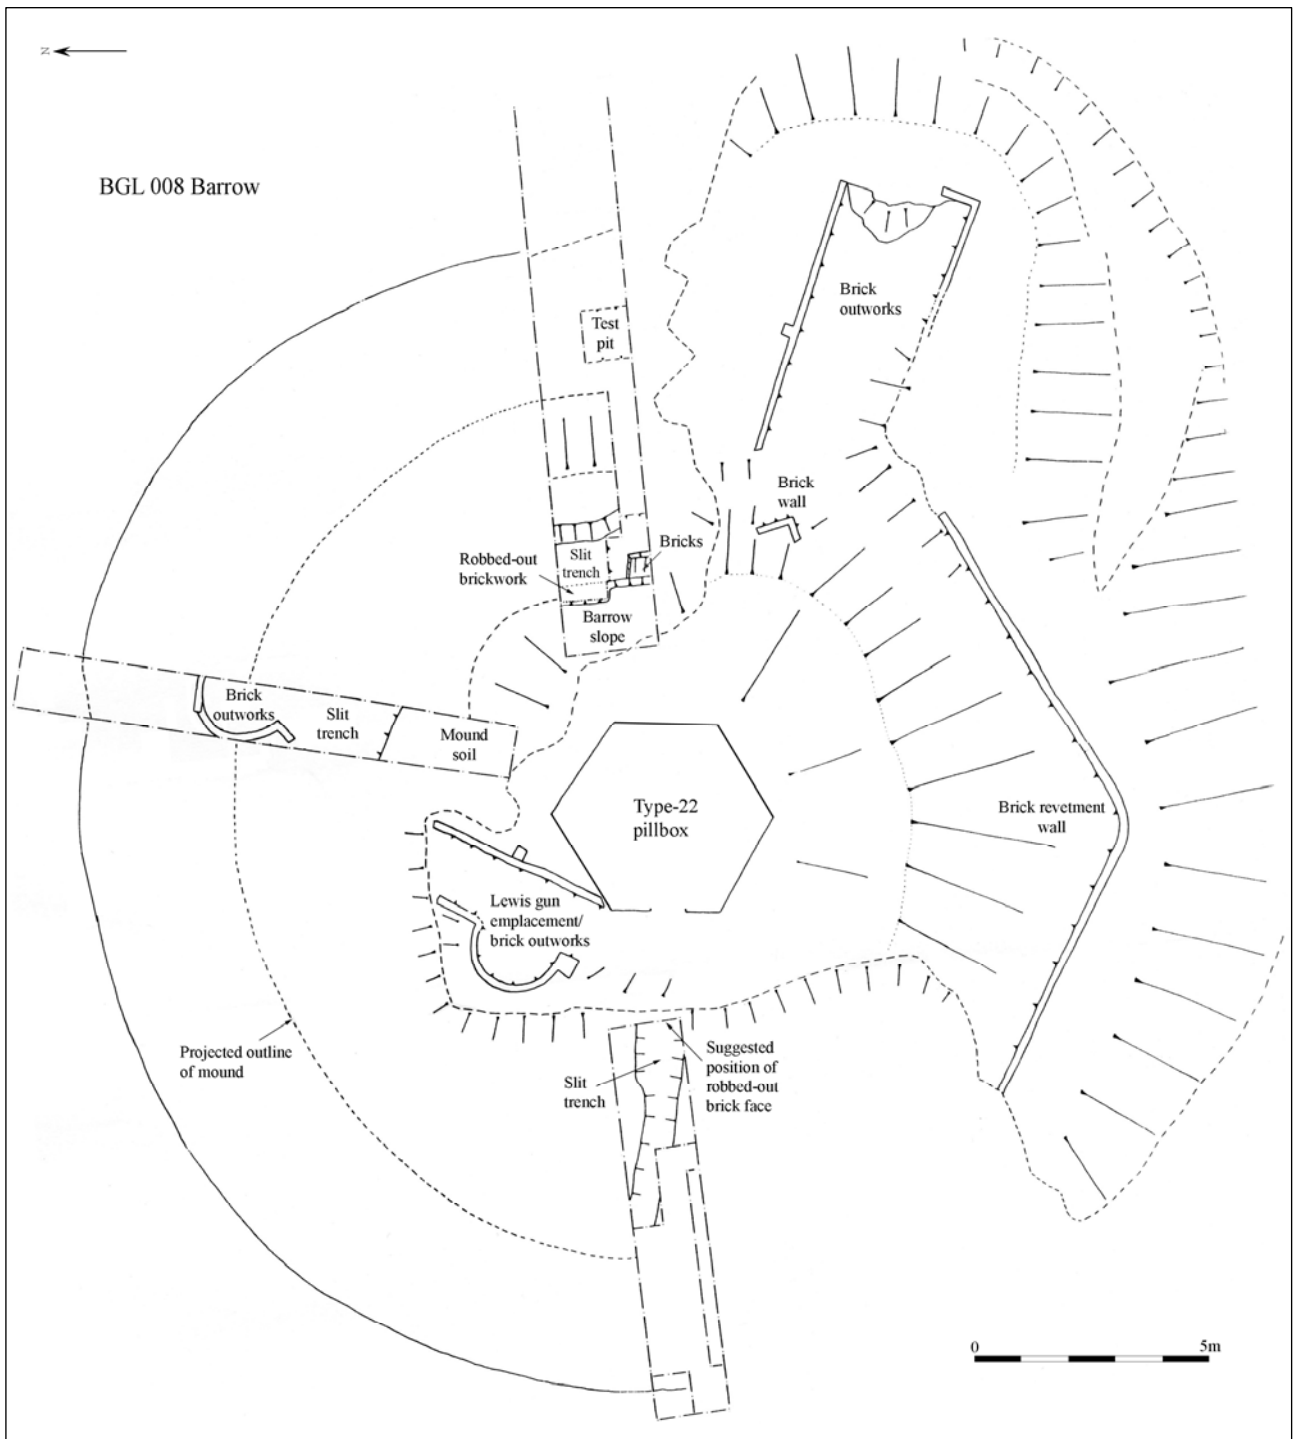
Figure 6. Type-22 pillbox and surrounding slit trenches, outworks and gun emplacements (Plans combined from Tester, 1991, and Muldowney, 2008)

A series of brick walls and earthworks was recorded surrounding the pillbox (Fig. 6). These walls and trenches functioned in conjunction with the pillbox. They include two semi-circular brick emplacements for anti aircraft light machine guns on the north and north-west sides of the pillbox. These may have been positioned to fire on RAF Martlesham itself, in the event that it had been overtaken by invading forces. However, as the gun emplacement on the north of the pillbox was only uncovered after the 1991 excavation, it is possible that further machine guns may have been positioned around and set into the mound, which have yet to be found. Slit trenches were also recorded during the 1991 trenching on the east, north and west sides of the pillbox. Presumably these would have formed a network around the mound that could be used to move around the area during attacks. A brick revetment wall on the southern edge and a rectangular brick structure to the south-east of the pillbox probably also functioned as further cover. Both of these outworks are recorded as being only one brick thick, presumably functioning to be bulletproof, rather than shellproof. They may also have been structural reinforcement for the mound.

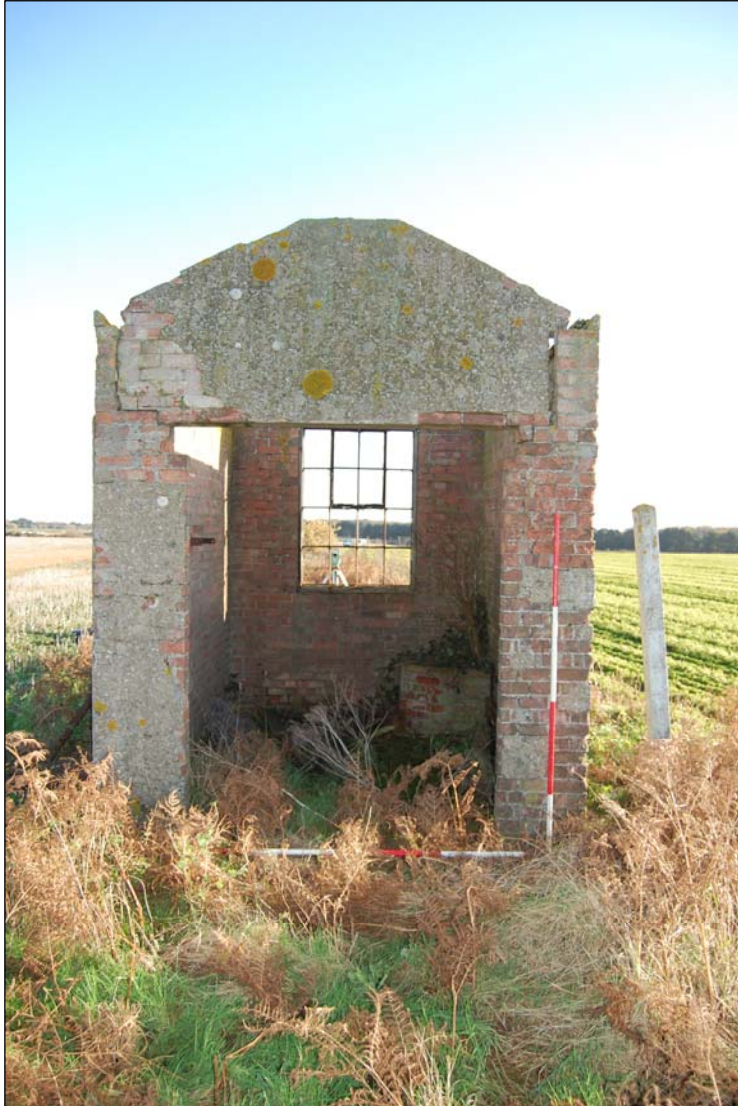
Plate 1. Left - brick hut external, wall 1, facing east, 2x2m scales

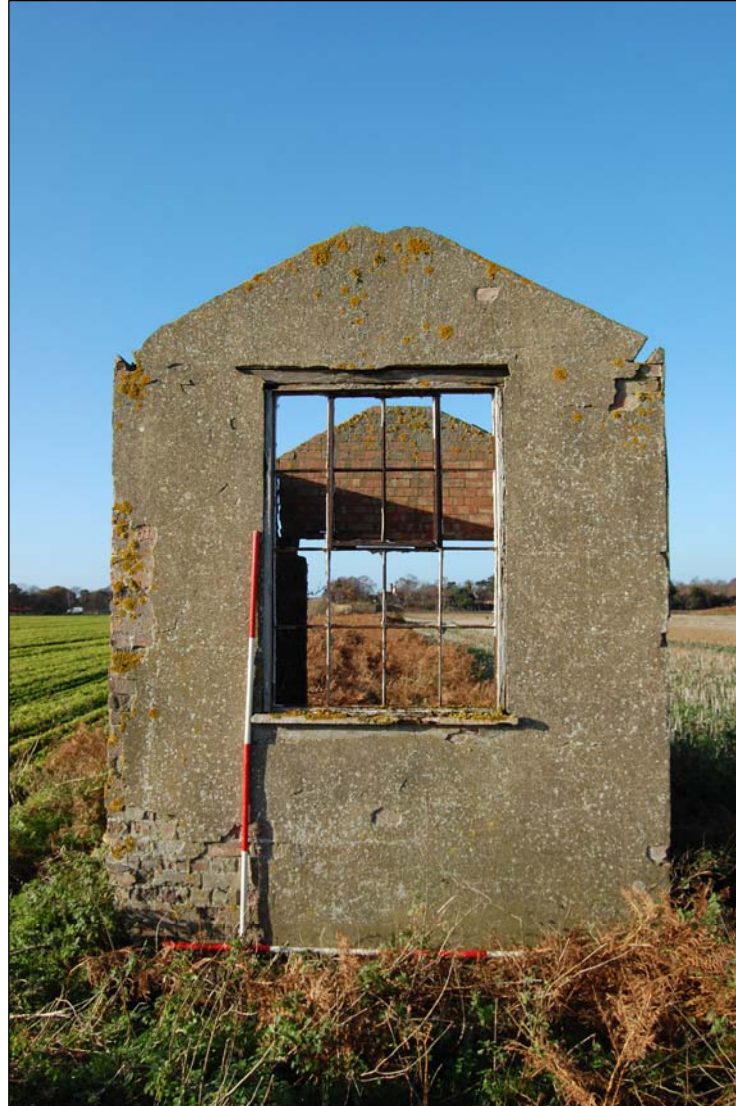
Plate 2. Right – brick hut external, wall 3, facing west, 2x2m scales

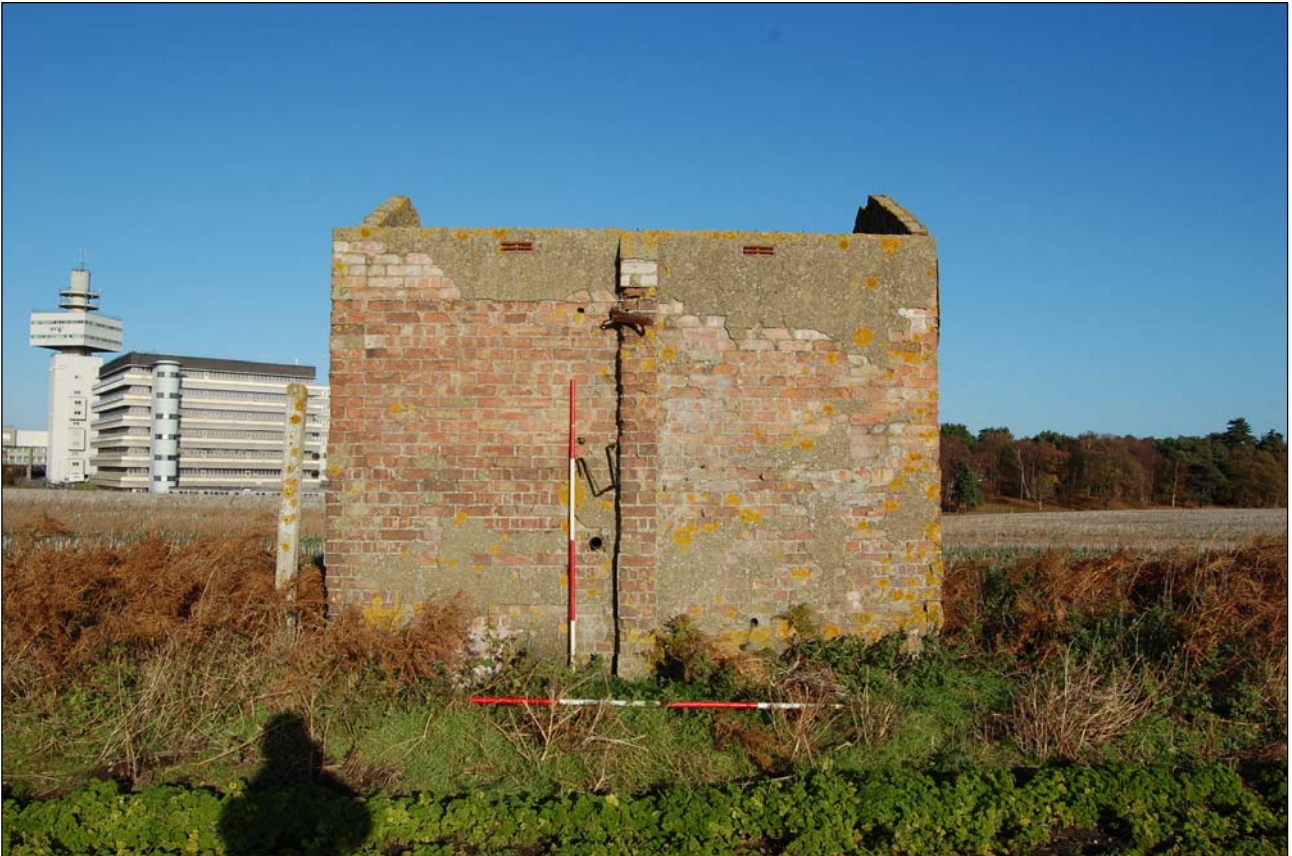
Plate 3. Brick hut, wall 2, facing north, 2x2m scales

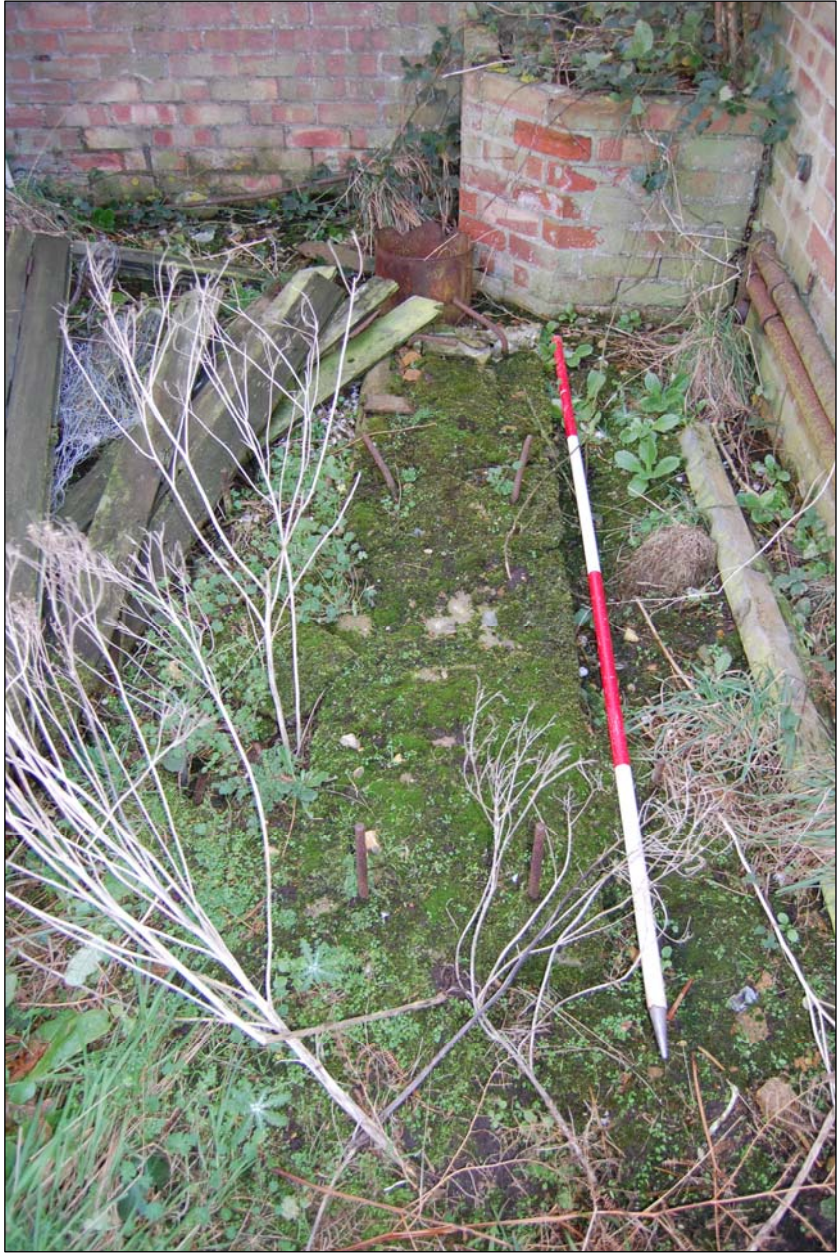
Plate 5. Left - brick hut internal, concrete stand, brick enclosure, wall mounted metal pipes and low brick partition parallel to wall, facing east, 1x2m scale,

Internally, the hut retains some of its original features, albeit in a poor state of repair. There is a low brick wall (eight courses tall) in the south-east corner of the building, which forms a small compartment, and a two cylinder pipe system attached to the southern elevation that runs into the brick enclosure. The purpose of these features is unclear, although the presence of the pipes indicates that they were possibly associated with water or steam.

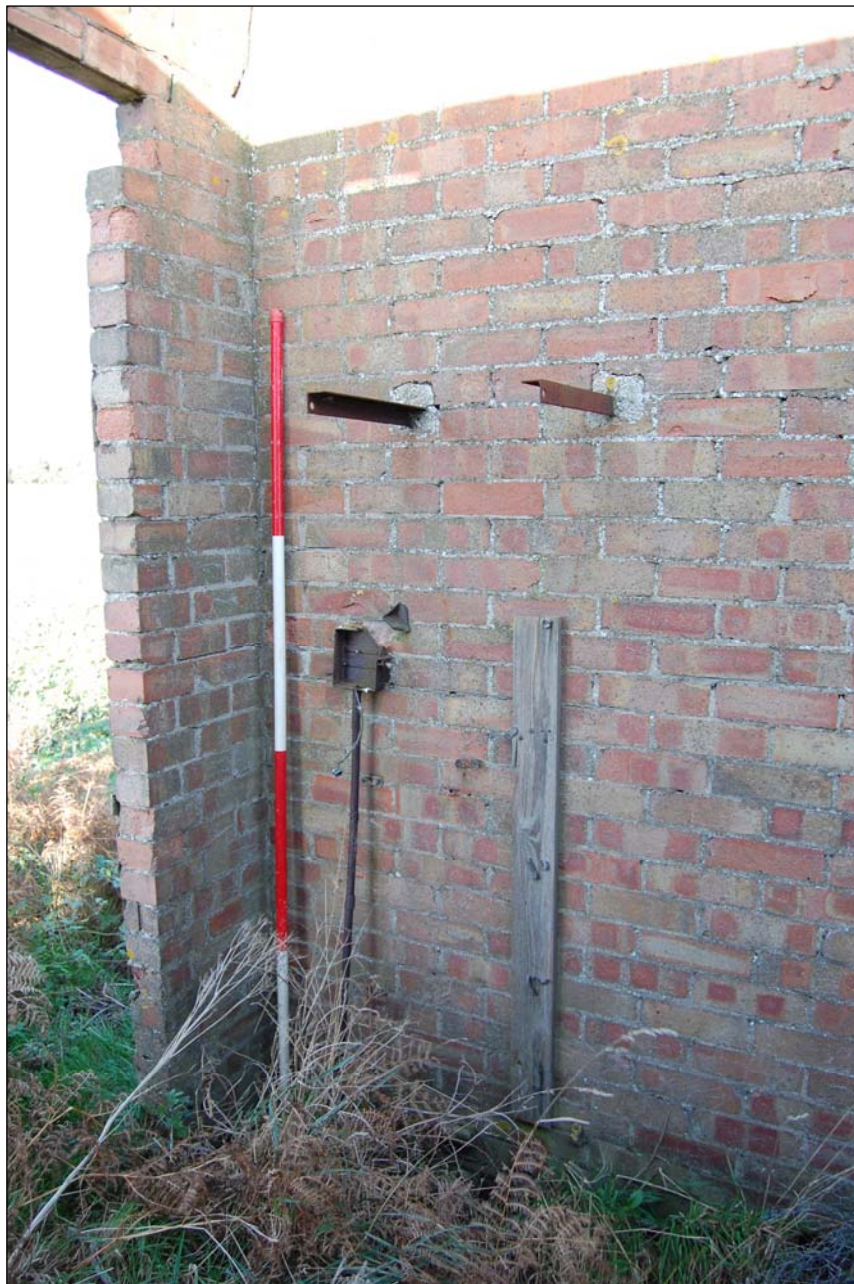
Plate 7. Left - brick hut internal, shelf brackets and wiring, facing north-west, 1x2m scale

Two angle iron brackets, a piece of timber and a wall socket, including wires and a metal conduit are present on the northern elevation, next to the doorway, showing that a piece of equipment was mounted here (Pl. 7). The conduit pipe continues along the base of the wall to the east, curving round at the north-east corner, following the eastern wall south, into the brick enclosure. The presence of another pipe or wire is indicated by two metal brackets which are mounted (aligned vertically) just to the north of the window in the eastern elevation. Various items can be seen on the floor, including what appears

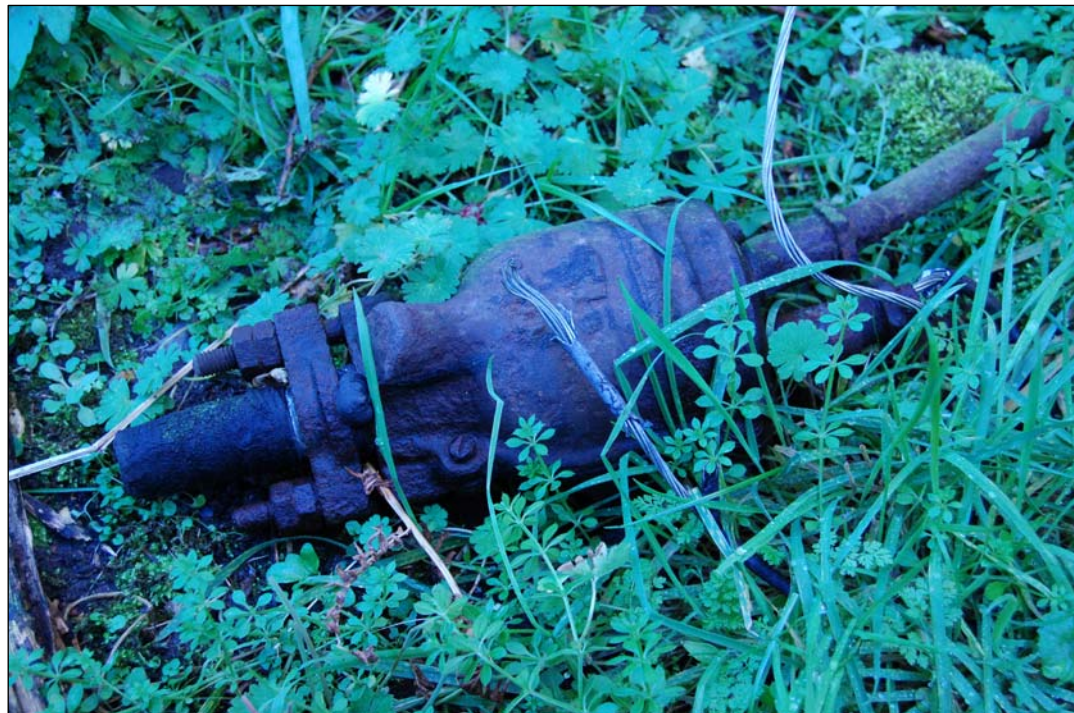
Plate 8. Right - metal 'pump' found on floor of brick hut

to be a metal pump with electrical wires leading from it (Pl. 8), as well as pieces of timber frame, which may be the remains of the doorframe.

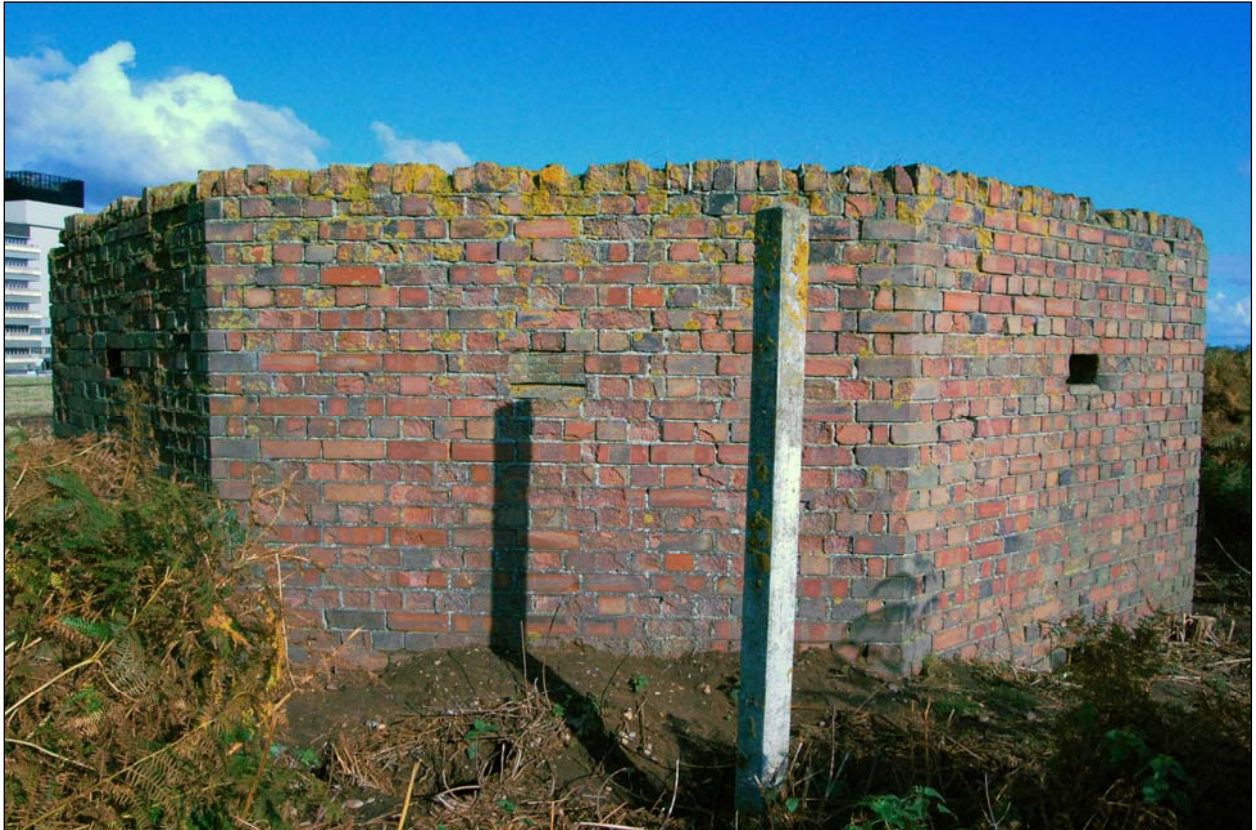
Plate 9. HFDF curtain wall, typical elevation with loophole, facing north-east (photo edited to compensate for low light conditions)

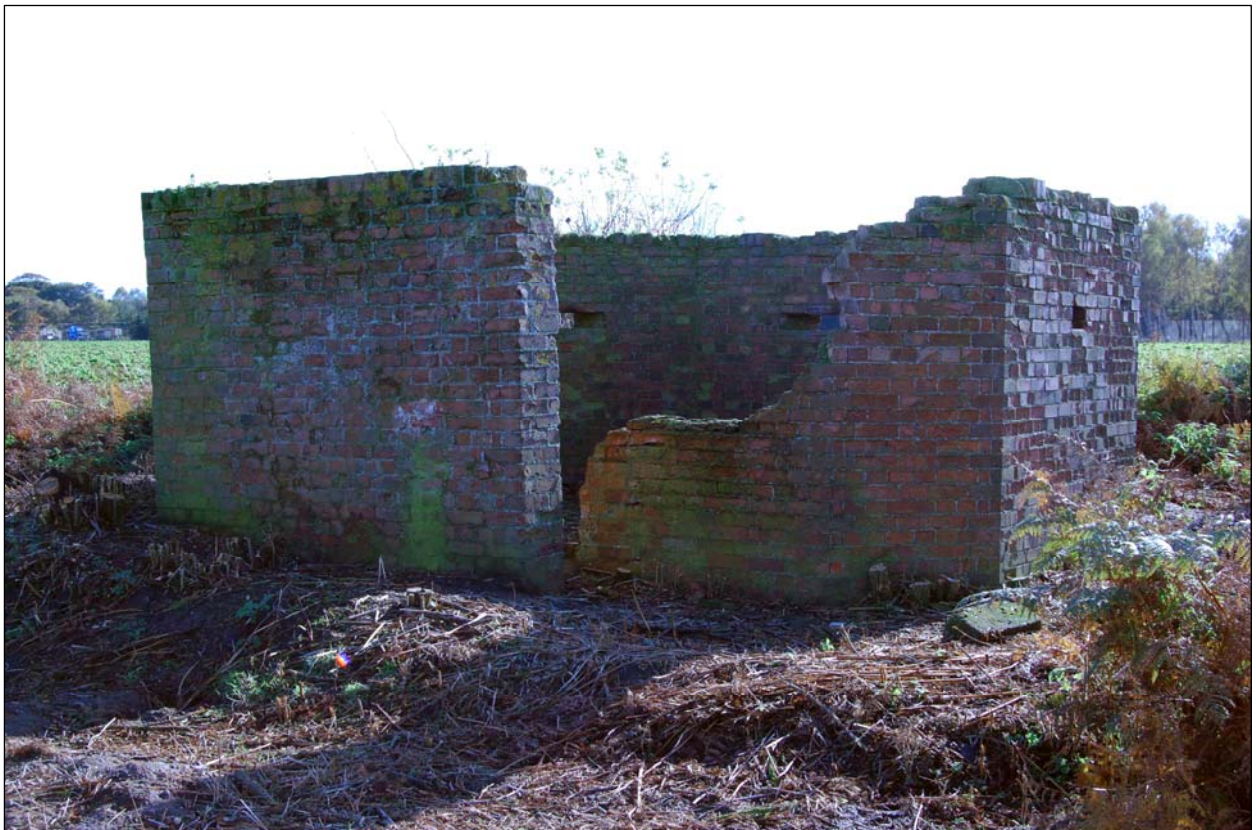
Plate 10. HFDF curtain wall, walls 5, 6a and b/entrance, facing south-east (photo edited to compensate for low light conditions)

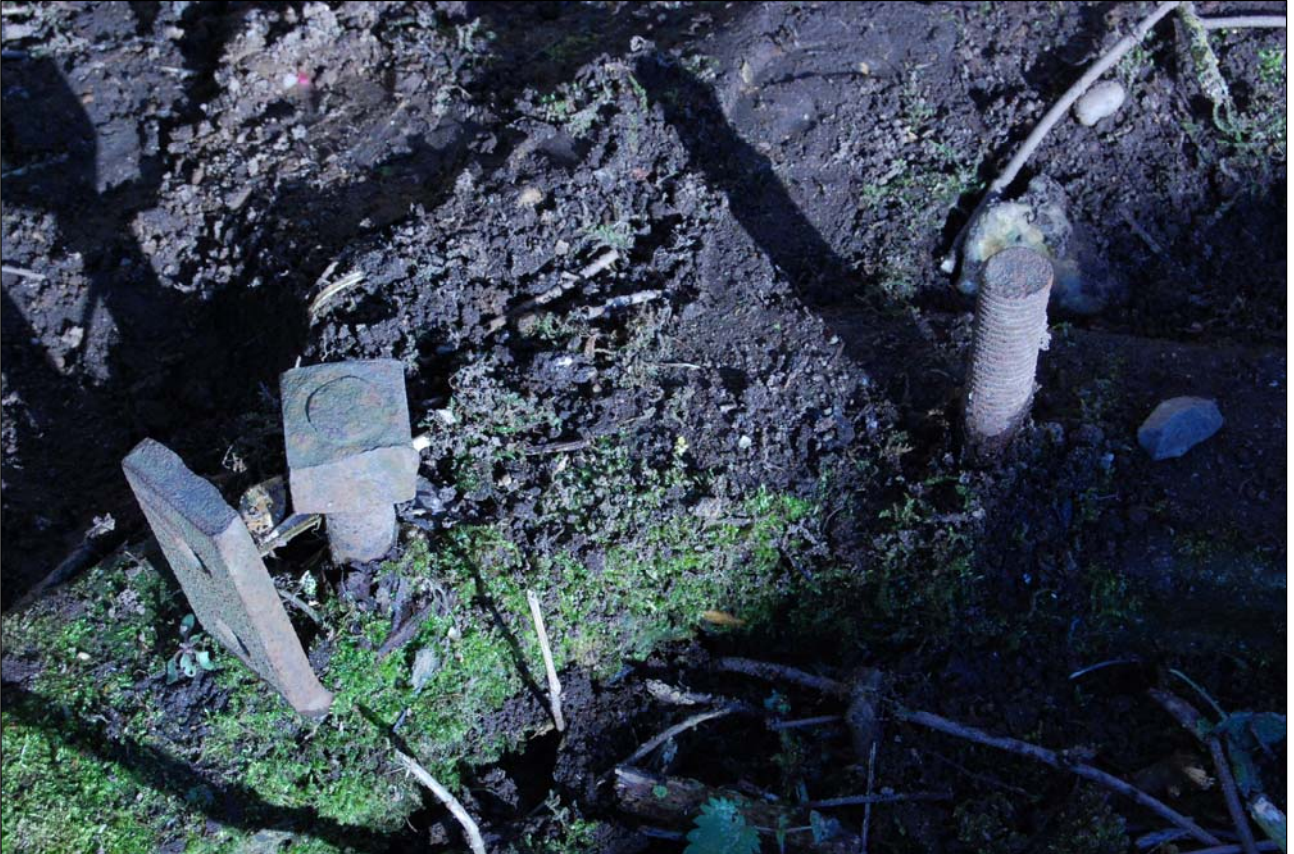
Plate 12. HFDF tower foundations, concrete sill and iron fittings

The foundations of the HFDF tower itself lie within the brick walls and comprise just over five visible sides of octagonal concrete footings with iron fittings. The concrete foundations survived to between 0.10m to 0.15m wide and were approximately 1.6m long, with the iron rods being approximately 0.03m in diameter. These foundations would have served as the base for the otherwise largely wooden octagonal tower. The tower would have been built almost completely from wood in order to minimise any potential interference from metal components. Two concrete slabs lie within the north and east sides of the wall. It is not clear what function they may have performed although the larger slab may have been used as the base for steps to enter the structure.

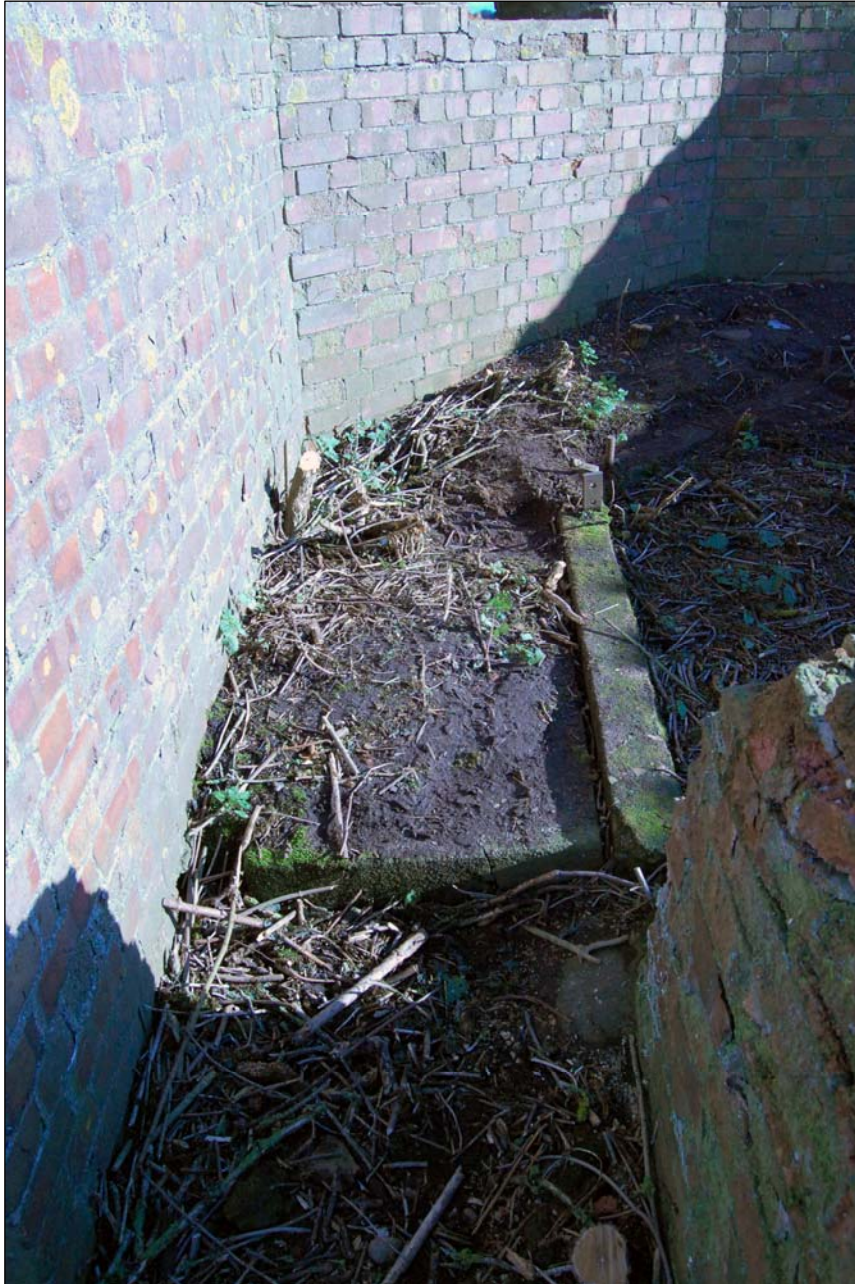
Plate 13. Left – HFDF curtain wall & foundations entrance, with concrete slab and octagonal internal foundation, facing east (photo colours edited to compensate for low light conditions)

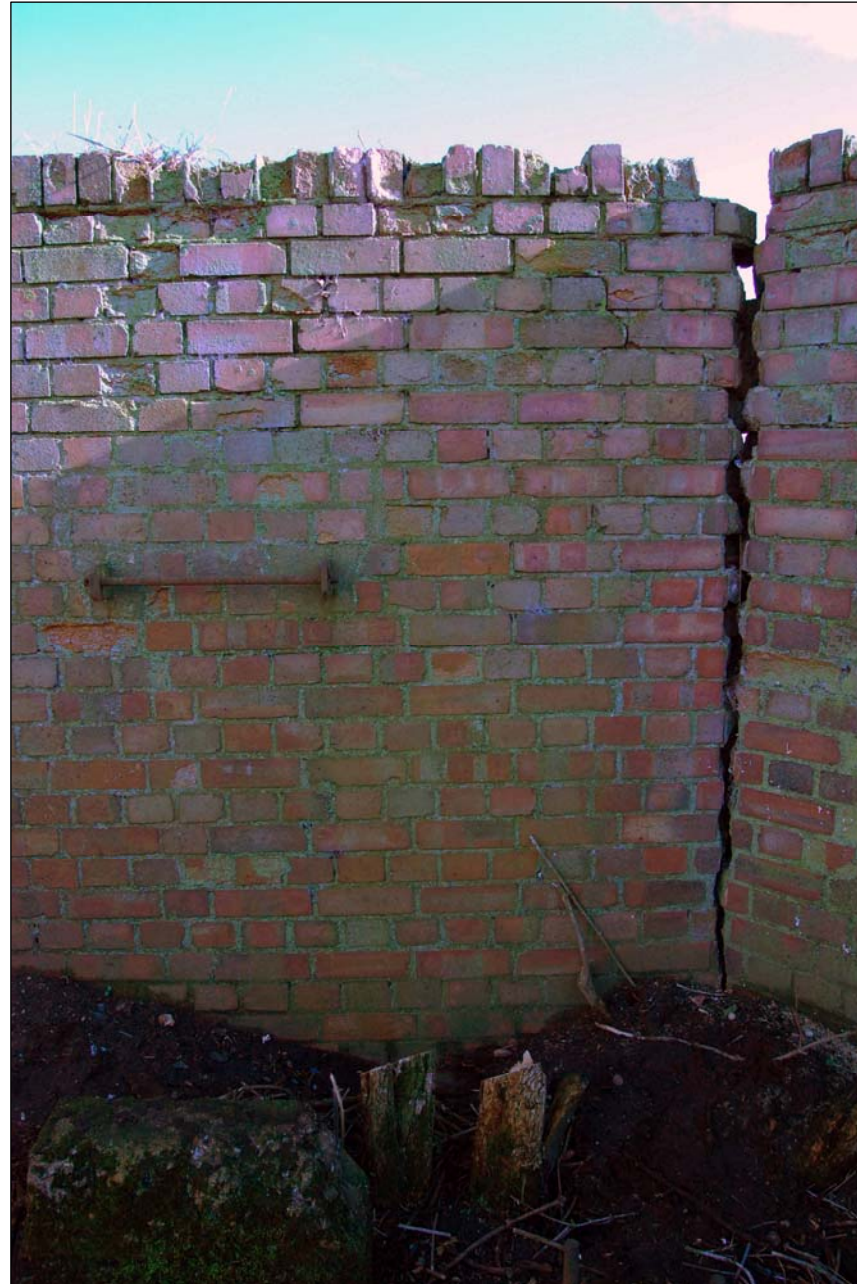
Plate 14. Right – HFDF curtain wall, east wall showing iron bracket and poor condition of structure, facing east (photo colours edited to compensate for low light conditions)

Internally, unlike the Type 22, this structure has no shelves or other supports under the loopholes, indicating that they were not manned as they would be in a pillbox. However, there is an iron bracket on the eastern wall and the west wall also retains an upright wooden 3"x1" bracket or strut to the left of the loophole, although no similar item is present on the right hand side. It is unclear what function these had. The lower half of the west wall (below the loophole) was painted white. The condition of the curtain wall was poor, with part of the internal north wall missing and a large crack at the corner of

the east and south-east facing walls. In addition much of the brickwork itself is crumbling, both internally and externally and the topping bricks are also badly eroded.

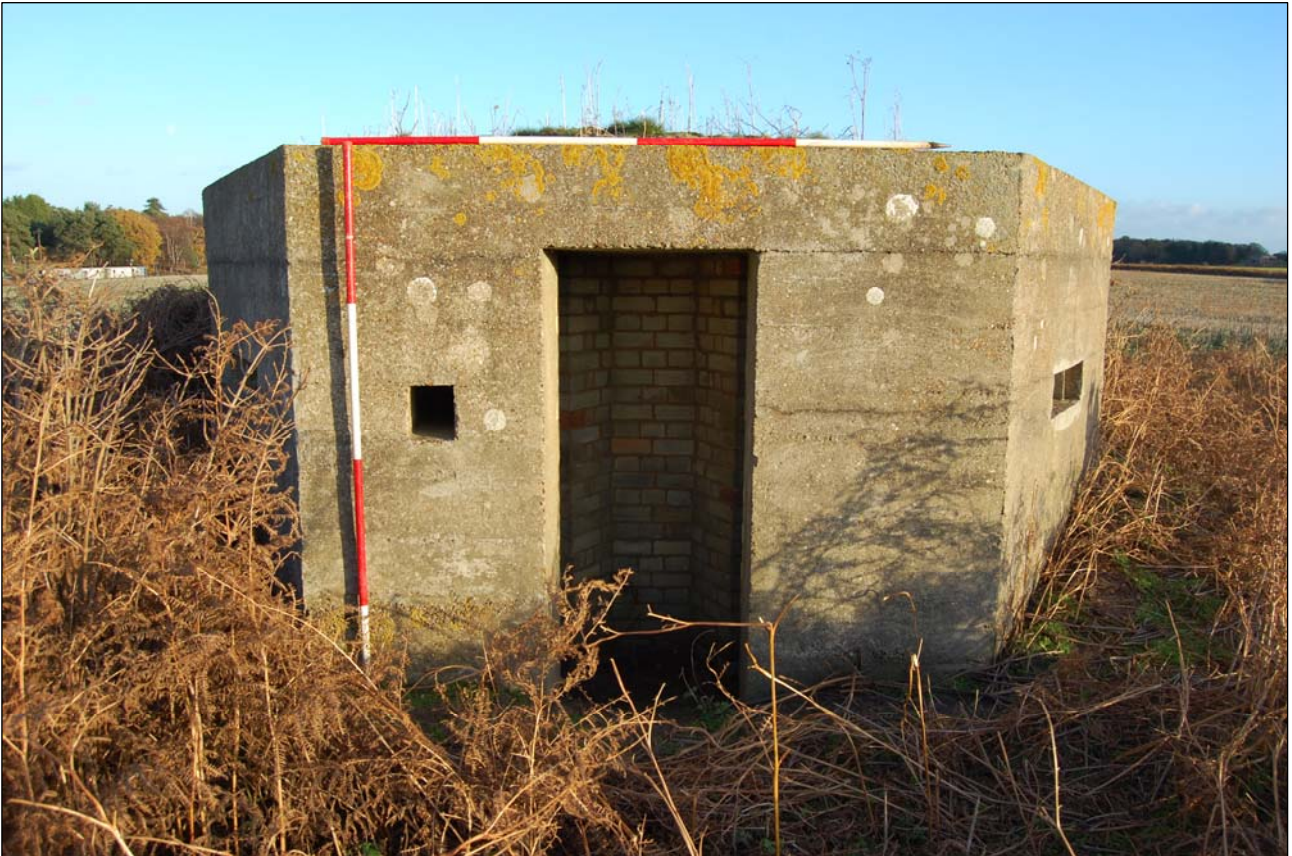
Plate 15. Type 22 pillbox, showing doorway and small loophole, facing east, 2x2m scales

There is a rectangular splayed single loophole on the door elevation to the left-hand side of the entrance (Wall 7, Fig. 7). Five other loopholes are present on the remaining identical elevations and these are of the 'stepped splay' design (Wall 8). On the roof of the pillbox there is a small, somewhat eroded, mound of earth and grass which served as a means of camouflage.

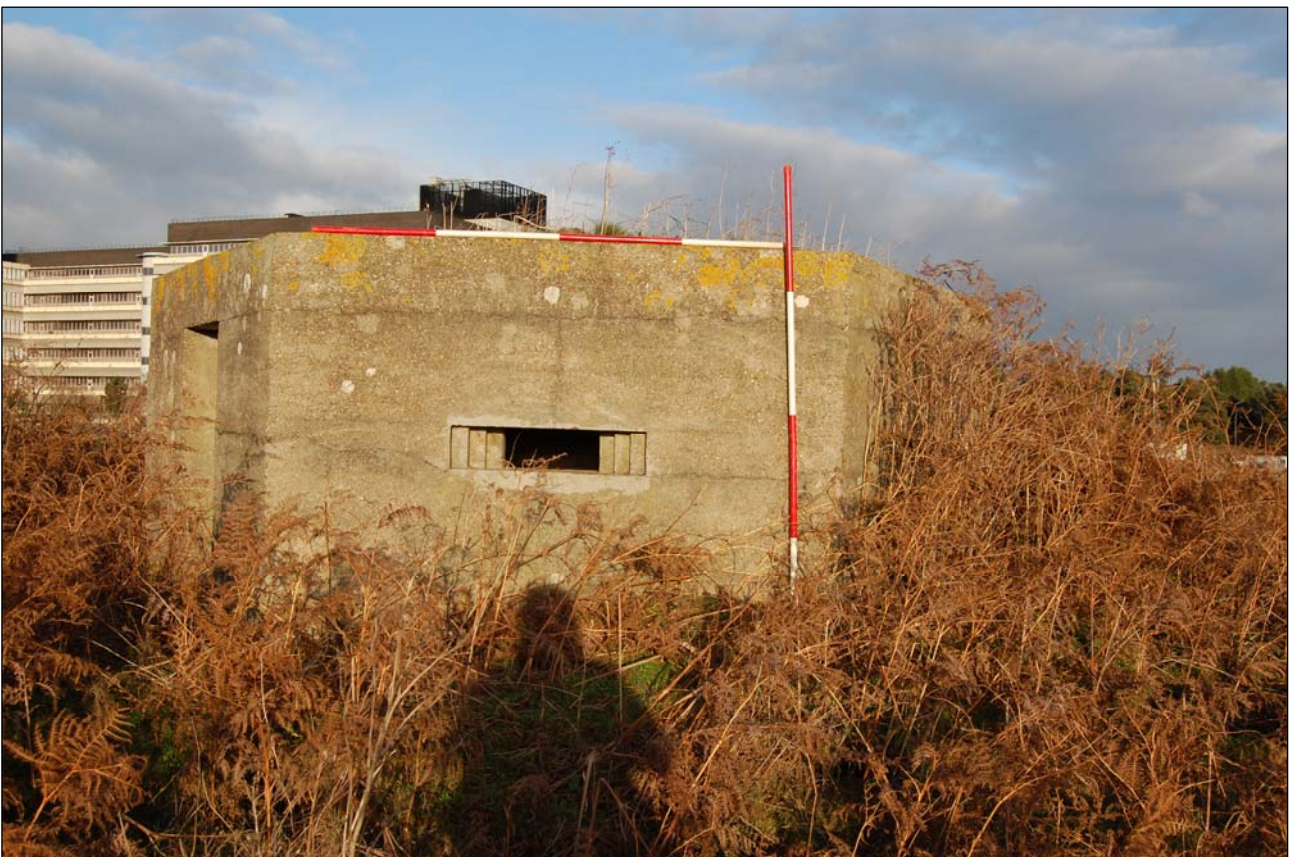
Plate 16. Type 22 pillbox, showing typical elevation, facing north-east, 2x2m scales

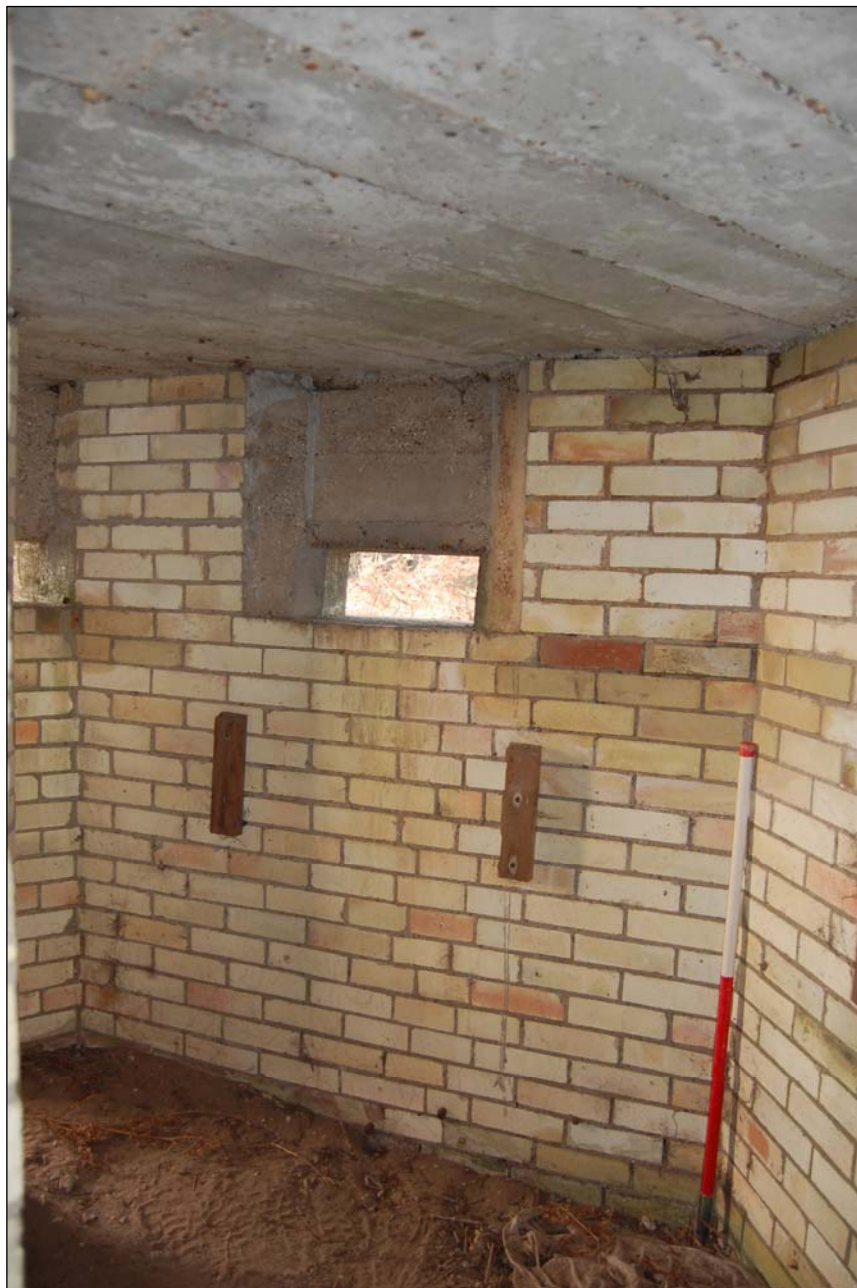
Plate 17. Left – type 22 pillbox showing internal wall I-3, facing north-east, 1x1m scale
