# RAF Martlesham Heath structures, Martlesham, MRM 140

## **Archaeological Building Record**

**SCCAS Report No. 2012/002**

Archaeological Monitoring Report

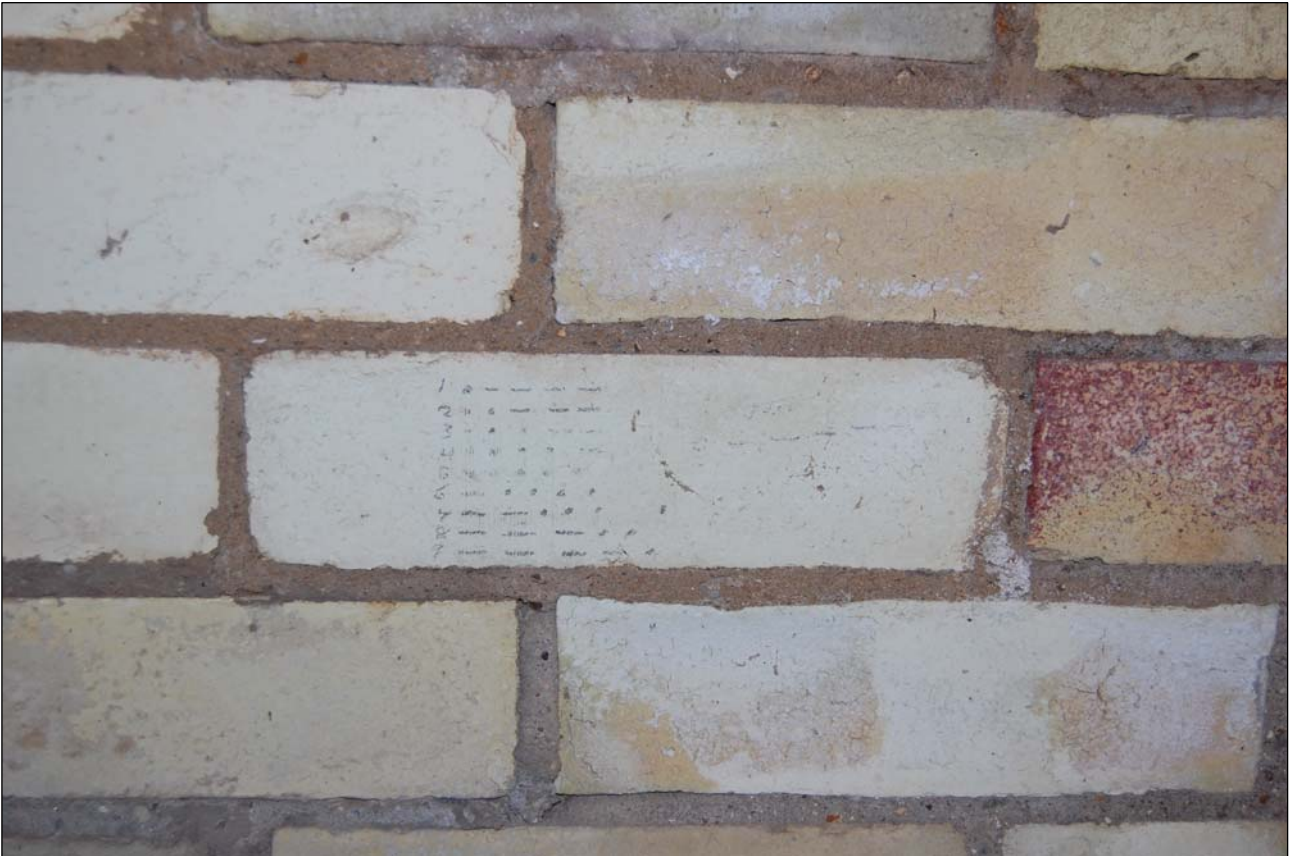
Plate 19. Type 22 pillbox internal, Morse code list on wall I-3

Further points of interest within the pillbox include a series of graffiti from both the Second World War and more recent years (Appendix 1, Pls. 19-29). Several of the images which are likely to be contemporary with the pillbox's use are listed below. A key to the location of the internal wall numbers featuring these pictures and text can be seen in Appendix I to accompany the photographs (Fig. 8). The WWII examples include details of individuals who were presumably based at Martlesham, as well as images of a dreadnought battleship and a rare M-Class submarine, which appear to have been drawn in pencil or ink. The more recent graffiti mainly consists of names and dates (the earliest example of which was from 1989) and these tend to be inscribed into the brick. The other recent graffiti consists of expletives and some of this, along with three
