**Ex-Crane site, Nacton Road
Ipswich, Suffolk
IPS 658**

Archaeological Evaluation Report

SCCAS Report No. 2011/209

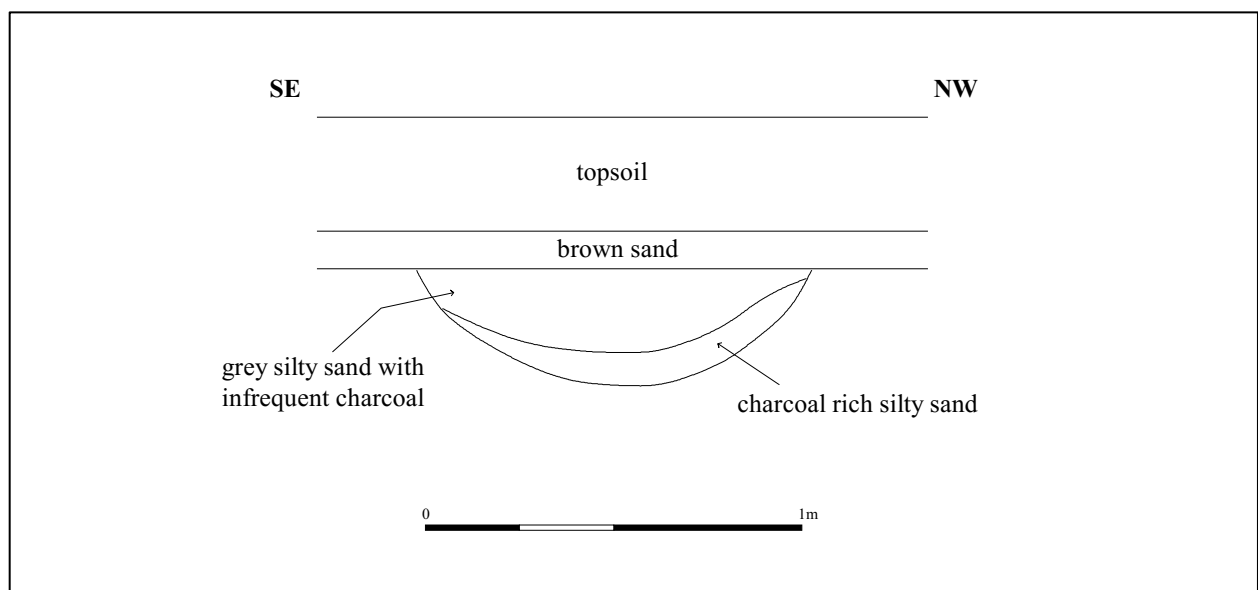
Figure 4 Pit 0002 (T19) section

Only one feature was recorded during the evaluation, an oval shaped cut located in Trench 19 and interpreted as a pit (numbered 0002 - see Fig. 3). It was situated on the edge of the trench. It measured 1m by at least 0.6m and was 0.3m deep with a bowl shaped profile (see Fig. 4 and Plate 1 for the recorded section).

The fill (0003) comprised a basal layer of charcoal rich silty sand with occasional charcoal lumps overlain by a mass of grey silty sand with frequent charcoal. It was cut into the natural subsoil which lay beneath 0.3m of topsoil and a 0.10m thick layer of brown sand. No artefacts were recovered but a bulk soil sample from the fill was retained for further analysis, should this be deemed necessary.

A bulk sample of the fill of pit 0002 was retained to enable the extraction of a sample suitable for radio-carbon dating. A decision regarding the merit of such analysis is pending.

The undated pit (0002) could potentially be an early feature and relate to prehistoric activity on the heath. Similar pits have been located elsewhere within the former heathland that have yielded Bronze Age pottery and are thought to be associated with settlement sites.

The pit, located in Trench 19 toward the Nacton Road frontage, is assumed to be Bronze Age in date, like similar features recorded in the general vicinity.

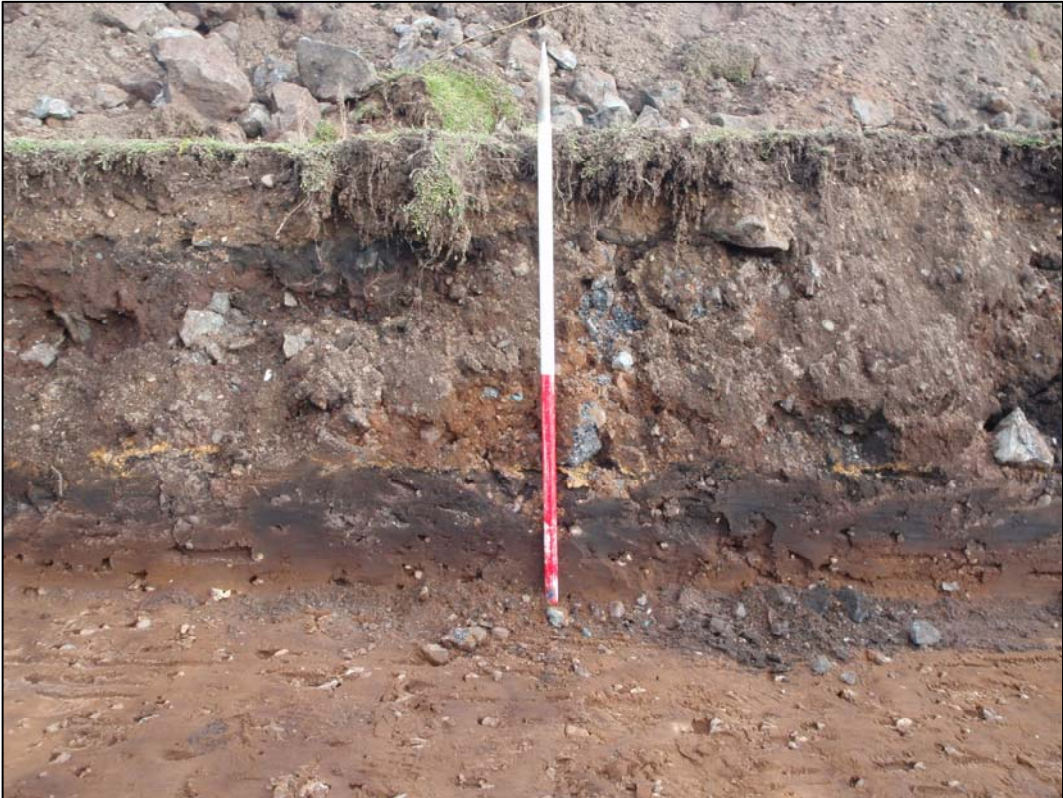
Plate 2. Trench 5, camera facing NE. showing the typical soil profile (ref. HLR54)

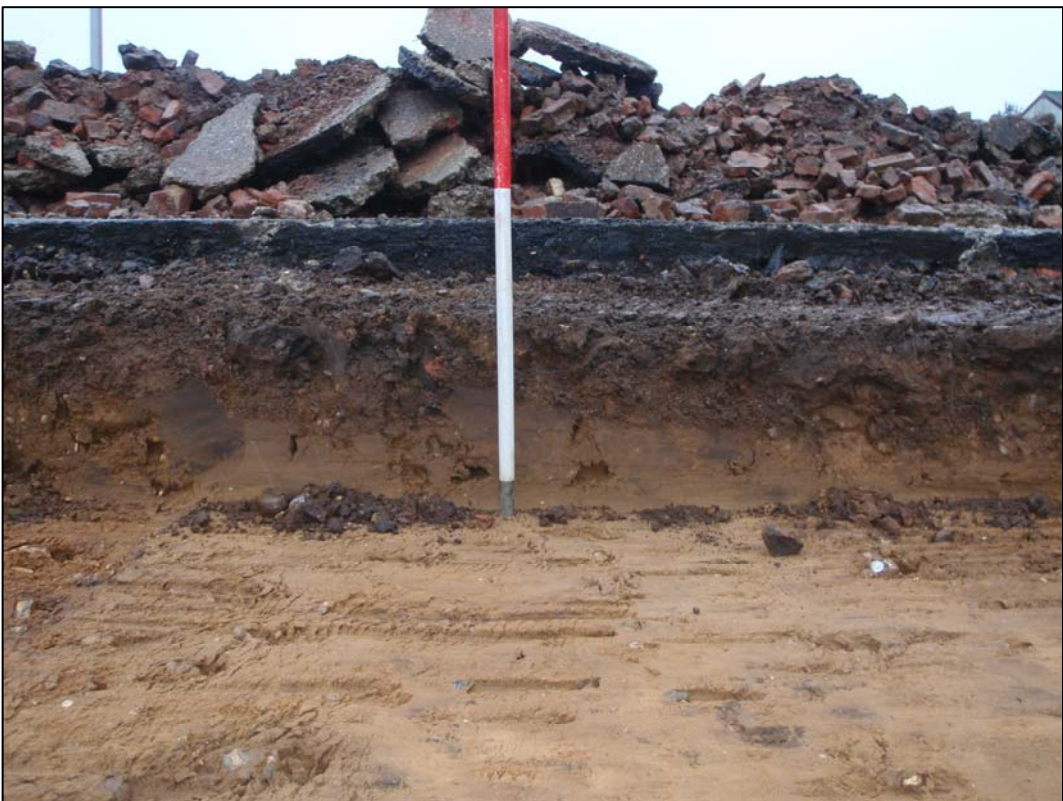
Only in the area of Trench 18 was the surface of the natural subsoil obviously truncated. This trench was cut through a relatively substantial concrete surface, the formation of which was clearly the cause of the truncation. It was noted during the evaluation that the floor surface of the factory buildings immediately to the northeast of Trench 19 lay approximately 0.5m lower than the grassed area around the trench. The natural subsoil within the trench was at a depth of only 0.4m. It is therefore highly likely that the natural subsoil has been truncated in the area of the adjacent standing buildings. This truncation may not be as severe at the northeast end of the site as the local topography

Plate 3. Trench 18, camera facing SE showing the truncation of the natural subsoil (ref. HLR81)
