**16 Mill Street, Mildenhall  
MNL 674**

**Archaeological Evaluation Report**

**SCCAS Report No. 2012/014**

**Client: Baker Construction**

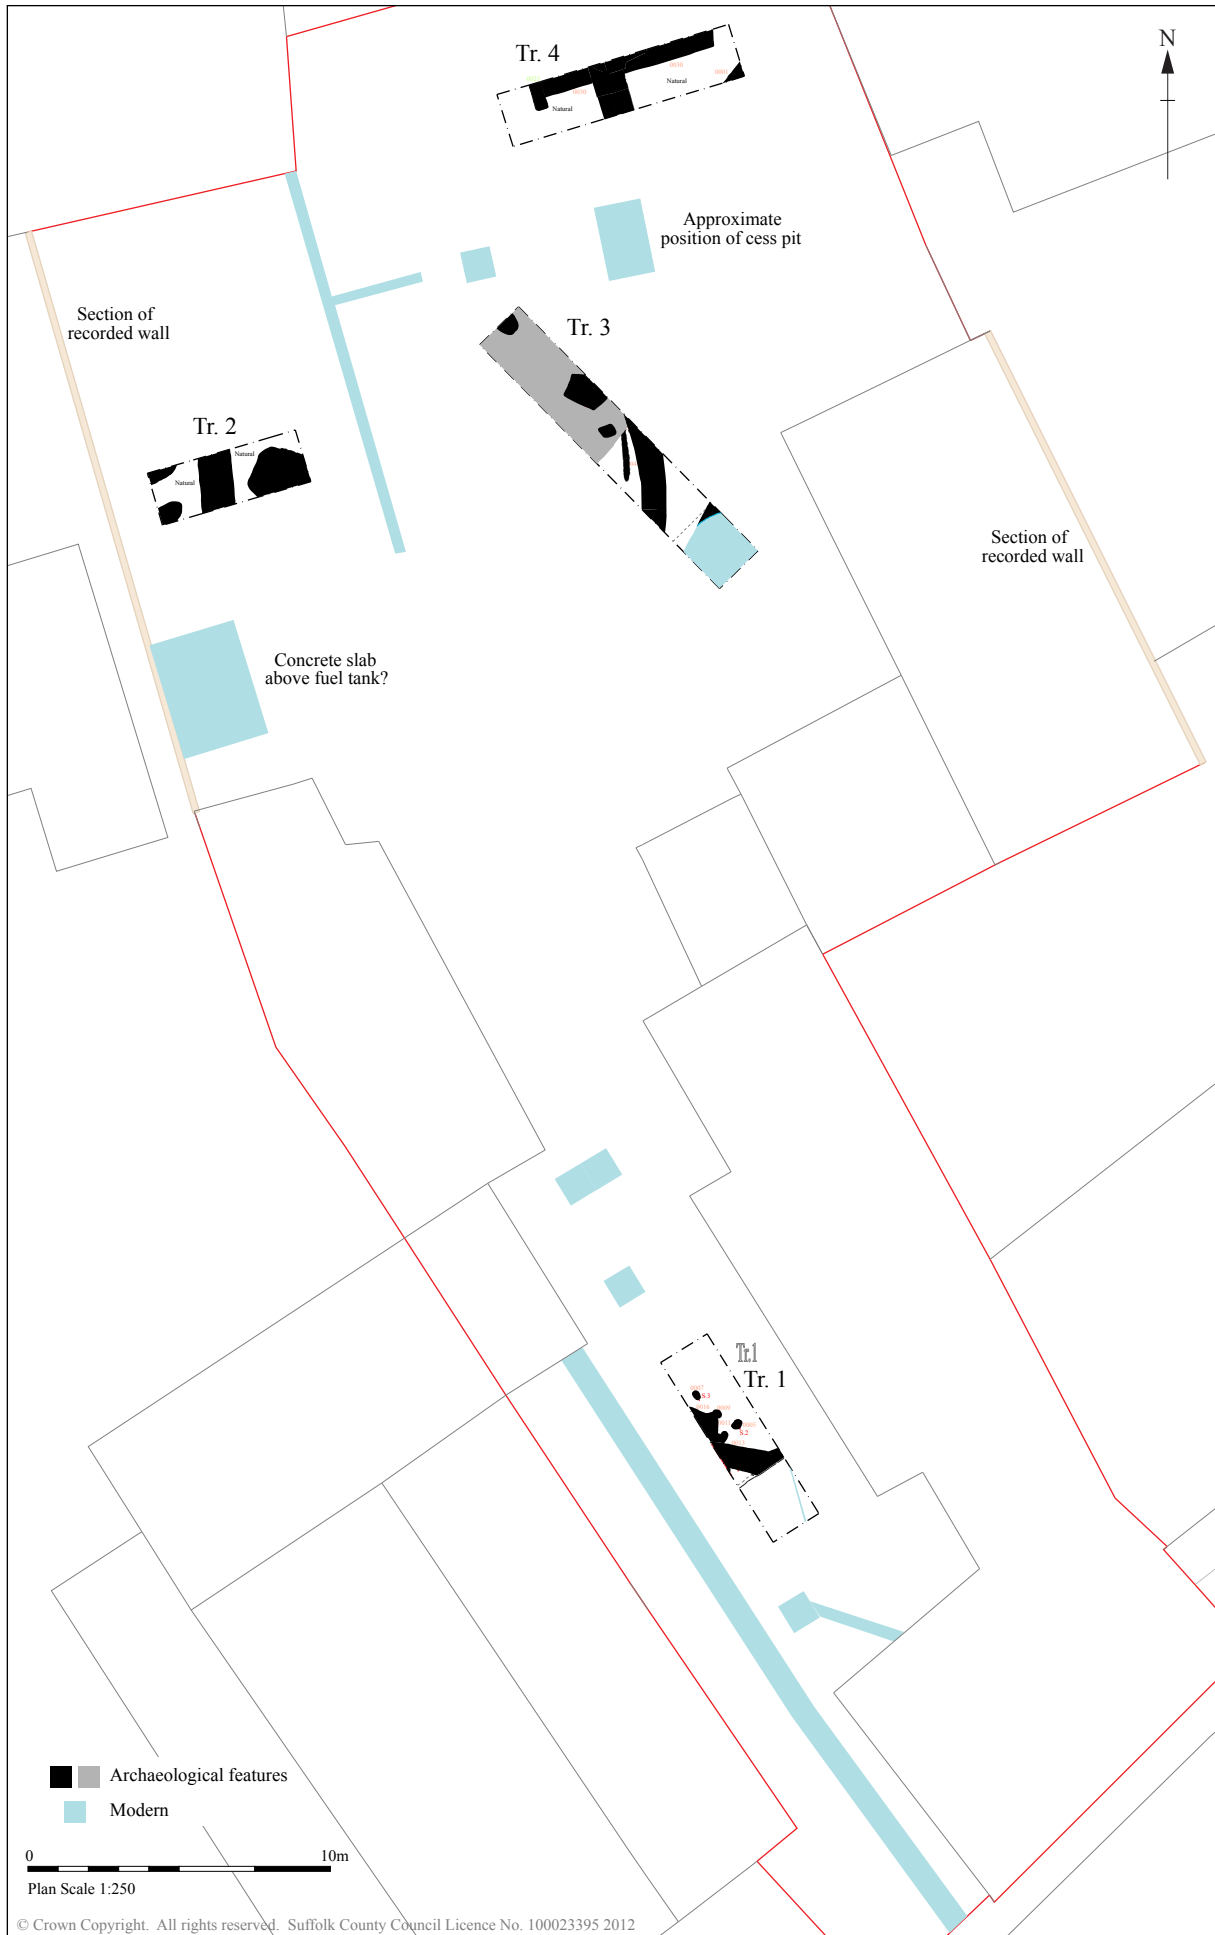
Figure 3. Trench plan, showing feature extents, recorded wall sections and modern disturbance

The total area of the development available for evaluation measured 1214sqm, and within this four trenches were excavated, covering a total area of 57.6sqm, or 4.75% of the development area. Trench 1 was 7.05m long, Trench 2 was 5.15m long, Trench 3 was 11.23m long and Trench 4 was 8.52m long. The trenches were positioned to sample all areas of the development, including all the new accommodation blocks as well as the access road (Figs. 3 and 9). However, there were multiple services running across the area, as well as a cess pit, party walls, several buildings and the site of a possible buried diesel tank which affected where the trenches could be positioned. Some of the services and other obstructions are recorded on Figure 3.

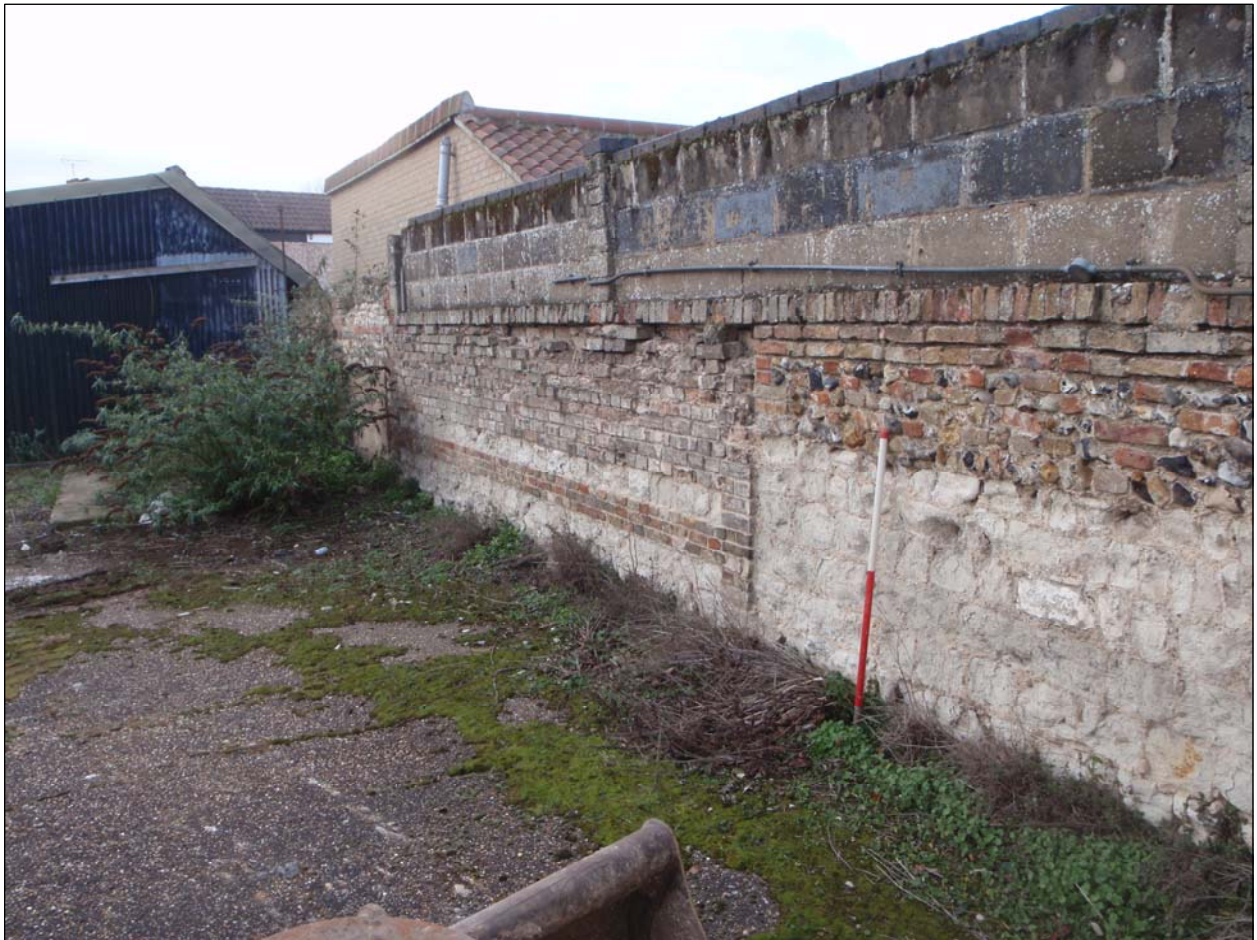
Plate 1. Western wall, southern half, 1x1m scale, facing SW

Surviving along some of the western site boundary at its northern end, and along the eastern site boundary within the barn next to Trench 3, were sections of older walls which were of sufficient historic interest to have a photographic record made (Fig. 3 and Pls. 1-4). The walls survived in a variable condition, with various repairs having been made throughout their existence. The western wall was apparently in the worse state due to its exposure to the elements (Pls. 1-2). It consisted of clunch block construction up to c.1m above ground level, on top of which either grey bricks, or red and yellow brick and flint construction. The eastern wall was almost entirely built out of clunch blocks, although they were laid in different bonds and were in varying states of repair, indicating reuse and repair (Pls. 3-4). This wall survived to c.2m above ground level, at which point the timber frame construction of the building continued. Occasionally there were courses of pale grey brick within the construction.

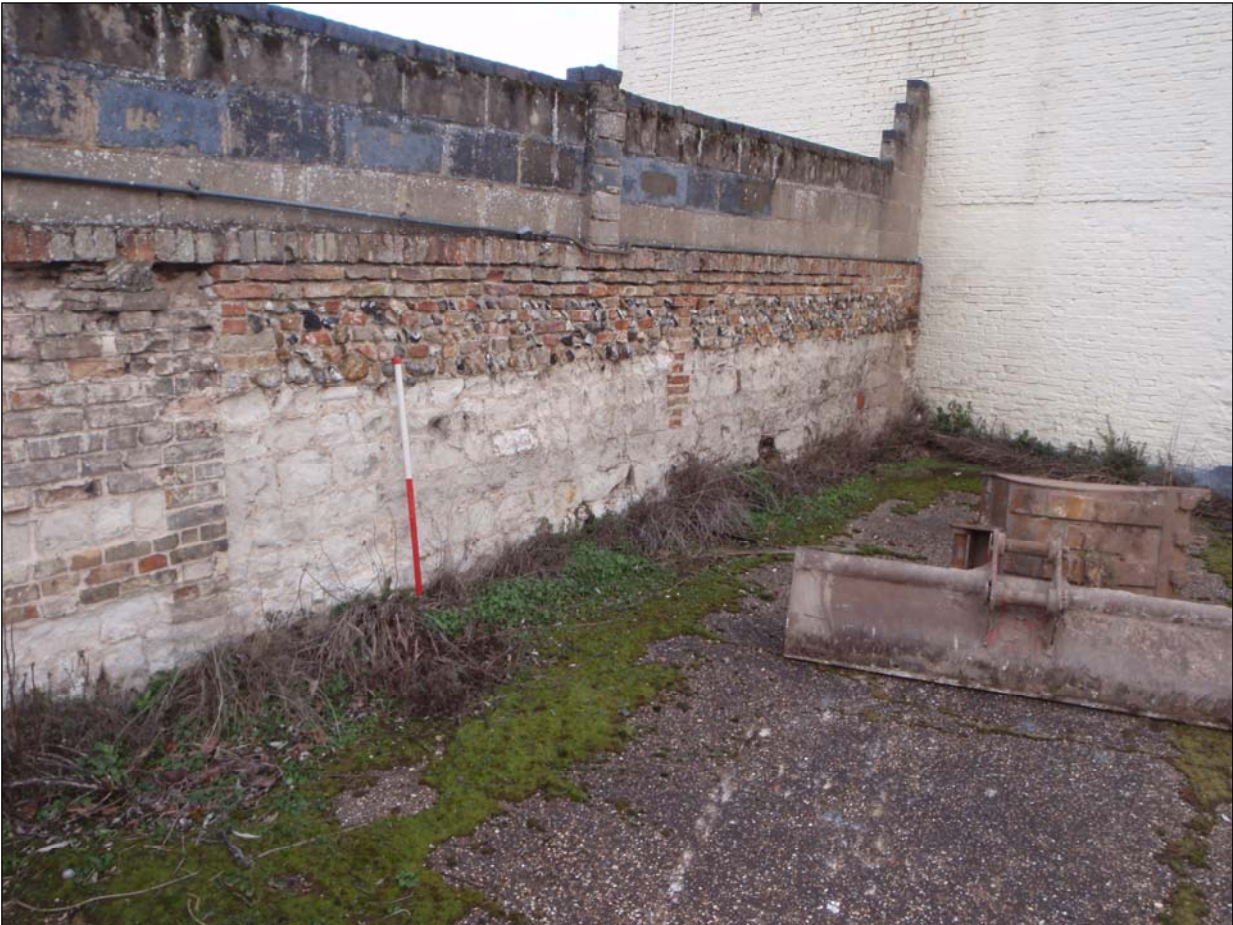
Plate 2. Western wall, northern half, 1x1m scale, facing NW

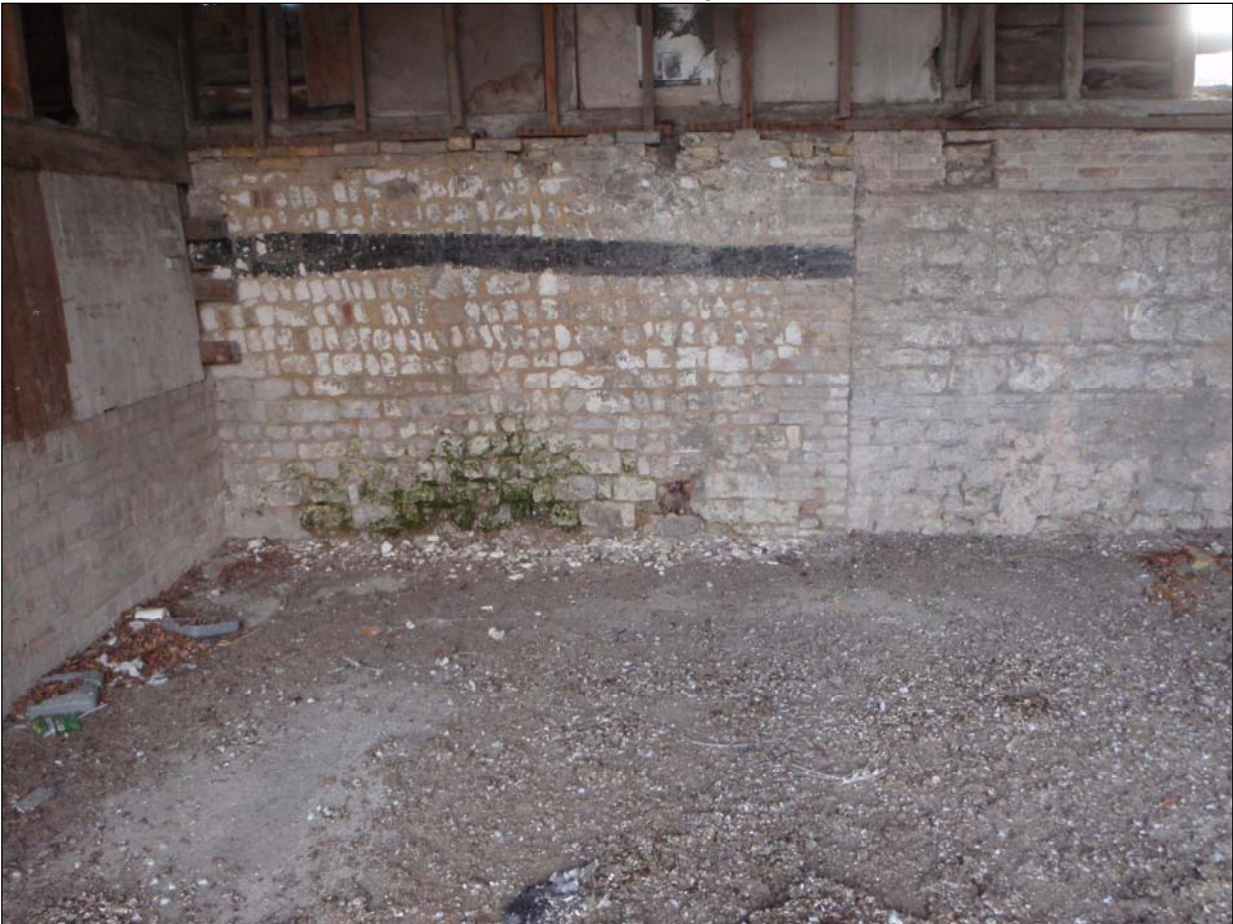
Plate 3. Eastern wall, northern half, facing NE

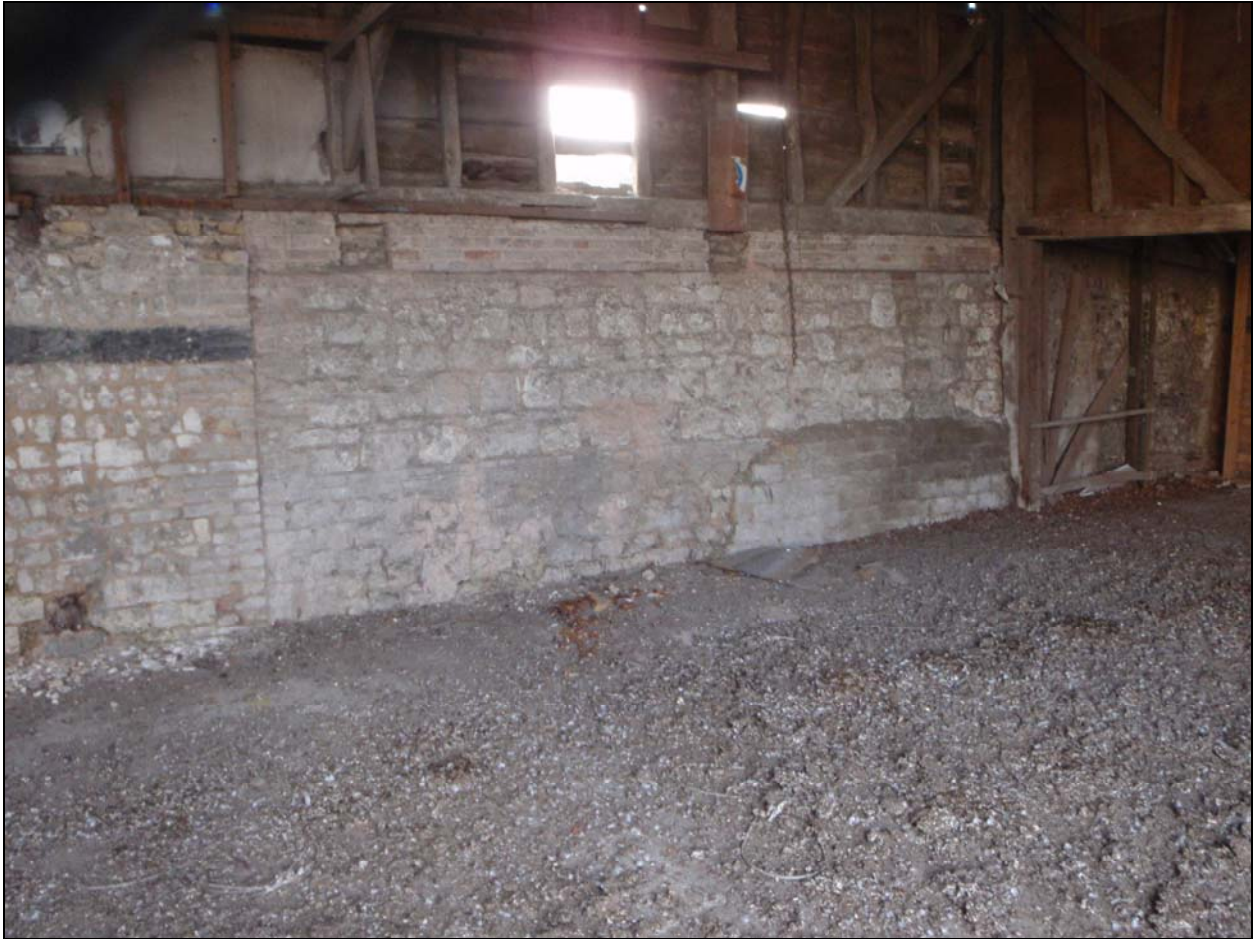
Plate 4. Eastern wall, southern half, facing E

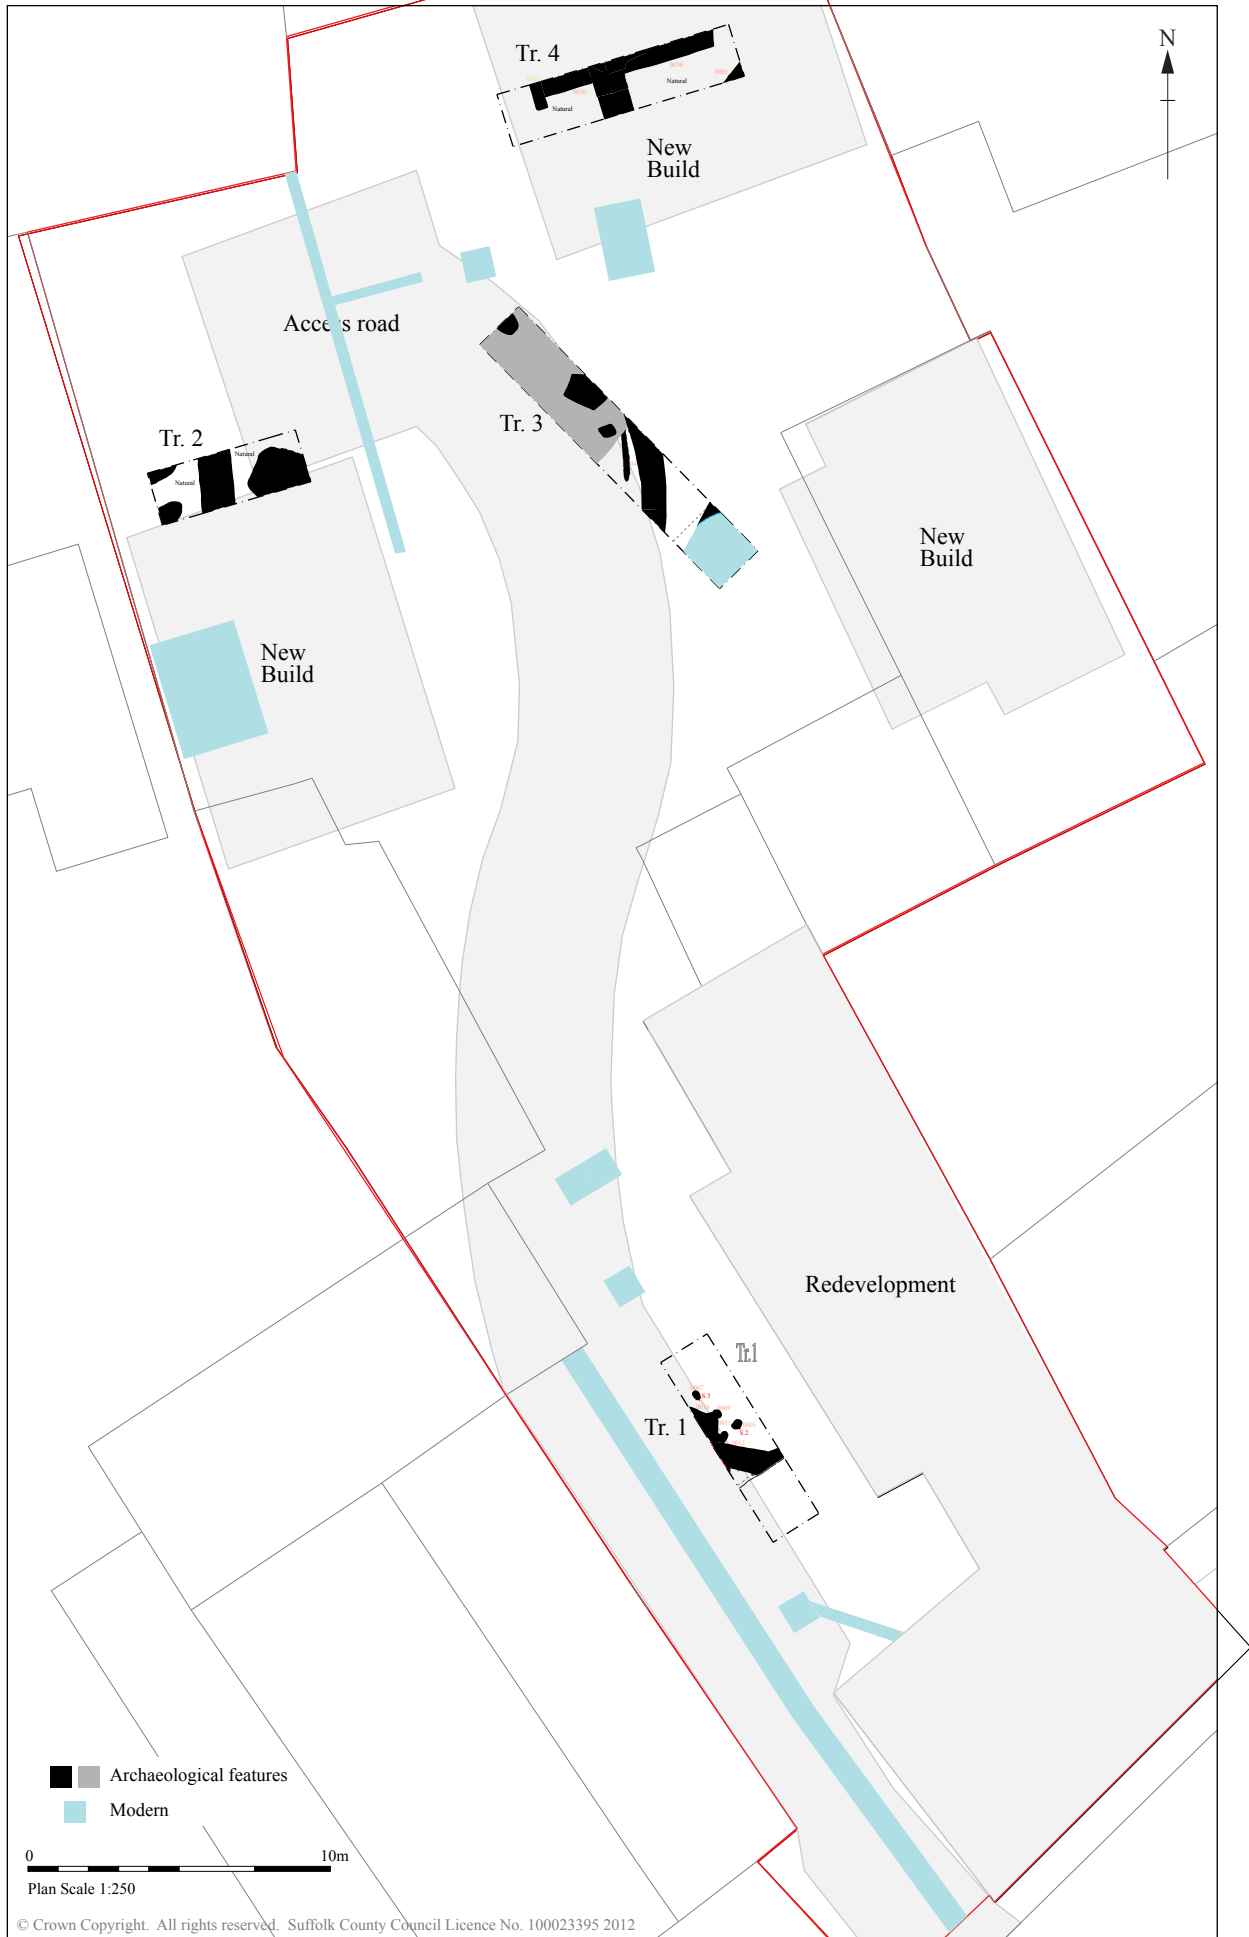
Figure 7. Development plan
