Palace House Stables, Newmarket NKT 032

Archaeological Excavation Report

SCCAS Report No. 2012/012

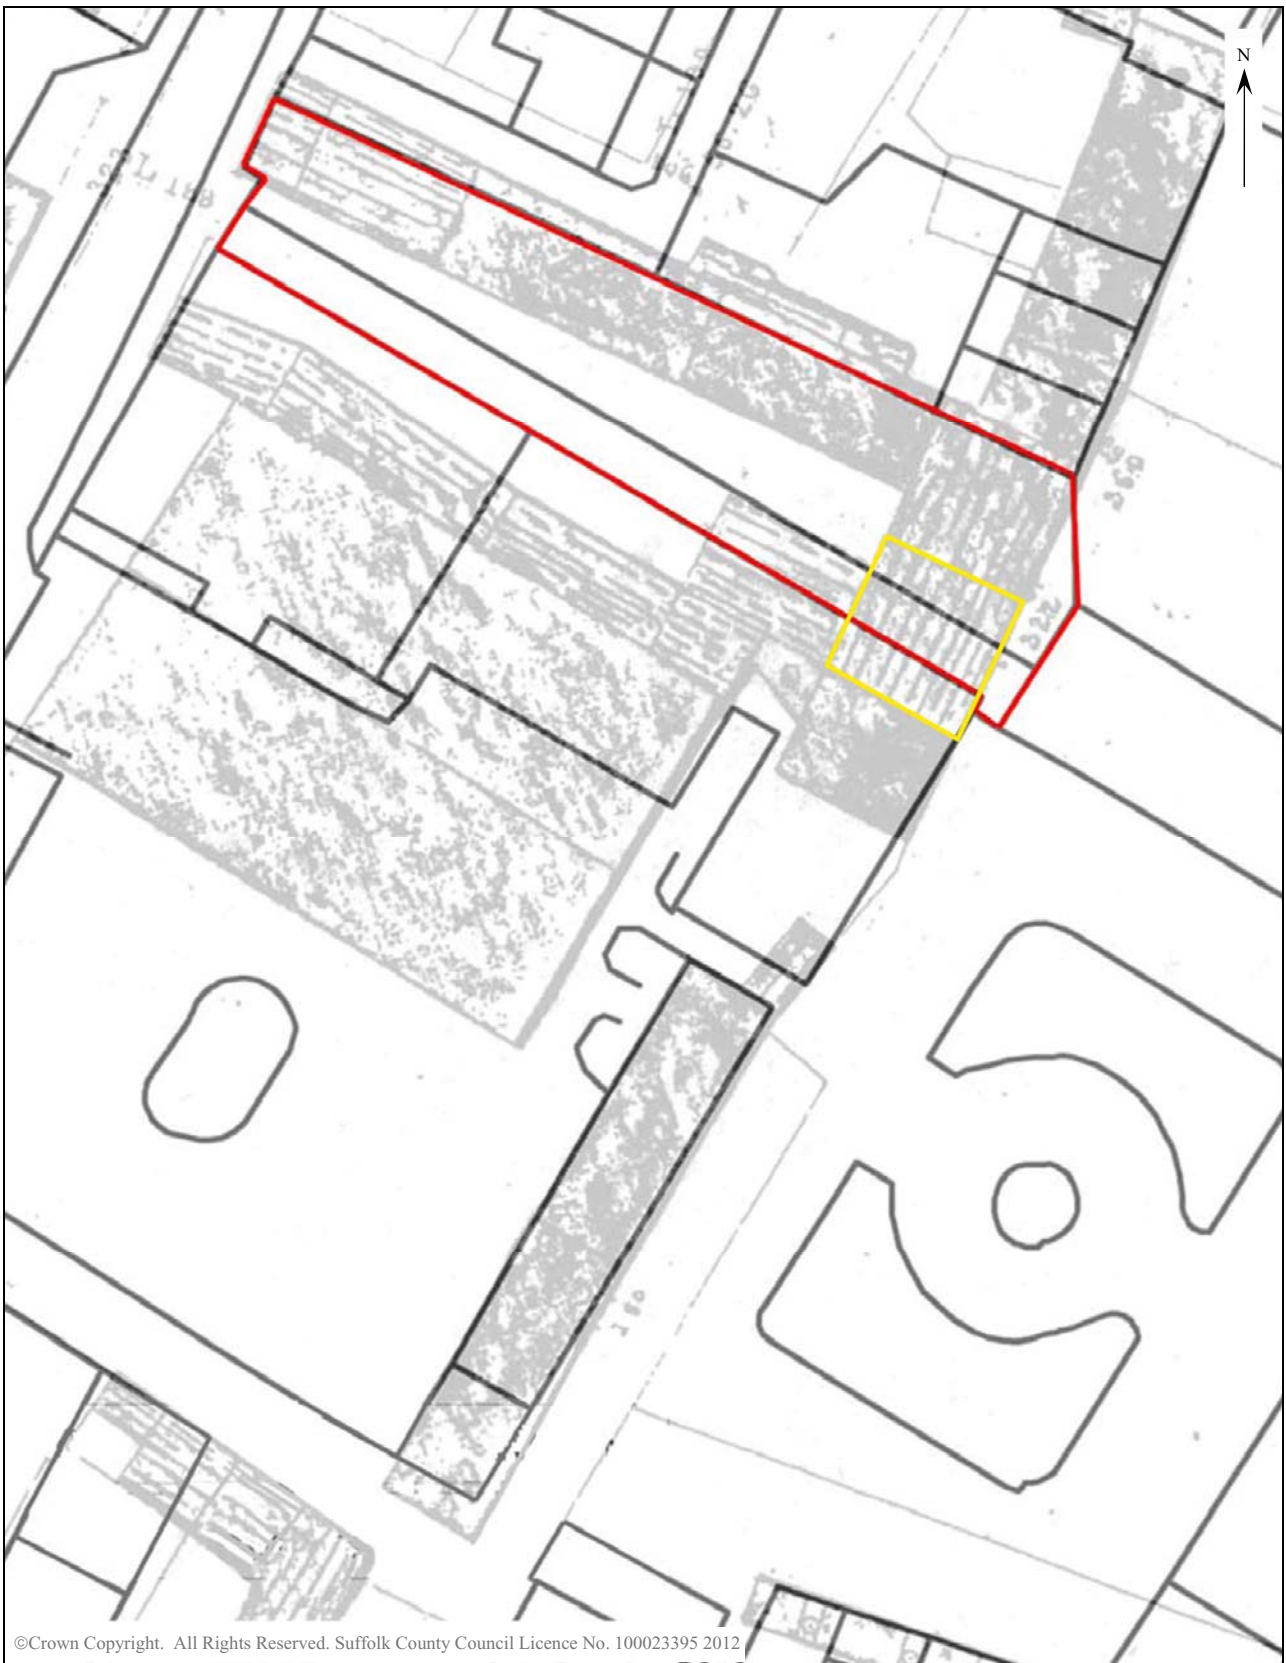
Figure 2. 1787 Chapman map with the museum development outline (red), approximate site outline (blue) and possible outline of structure 0154 (yellow)

range of buildings. These structures were dated to the late 18th or early 19th century and their earliest full depiction is on the Public Health Map of 1850, although part of the south-eastern end may have been visible on Chapman's 1787 map (Figs. 2 and 3). The wall footings were covered by modern topsoil, but overlaid earlier deposits including a post-medieval posthole and possible floor surfaces, which were above a buried topsoil layer (which produced 16th to 18th century pottery and building rubble). The structures identified in the evaluation appear to have incorporated part of an earlier clunch-built structure within the north-east boundary wall which echoes the construction of the stable complex illustrated on the Fort plan. Several further examples of clunch construction still survive within the 19th century stables and trainer's house to the south-west, notably within the spine wall of the trainer's house, which is likely to be the rear wall of stables associated with the Charles II Palace.

The earliest activity on the site is characterised by two posthole clusters, a pit, a linear feature (possibly structural) and brick walls with a chalk floor (Phase 1a). Most of these features do not clearly correspond to any of the activity previously recorded either during the evaluation works or on the 1787 Chapman map. Structure 0154 was part of the range of buildings shown on the Chapman map and as such this makes this the earliest remains on the site of a known date (highlighted on Figs. 2 and 3).

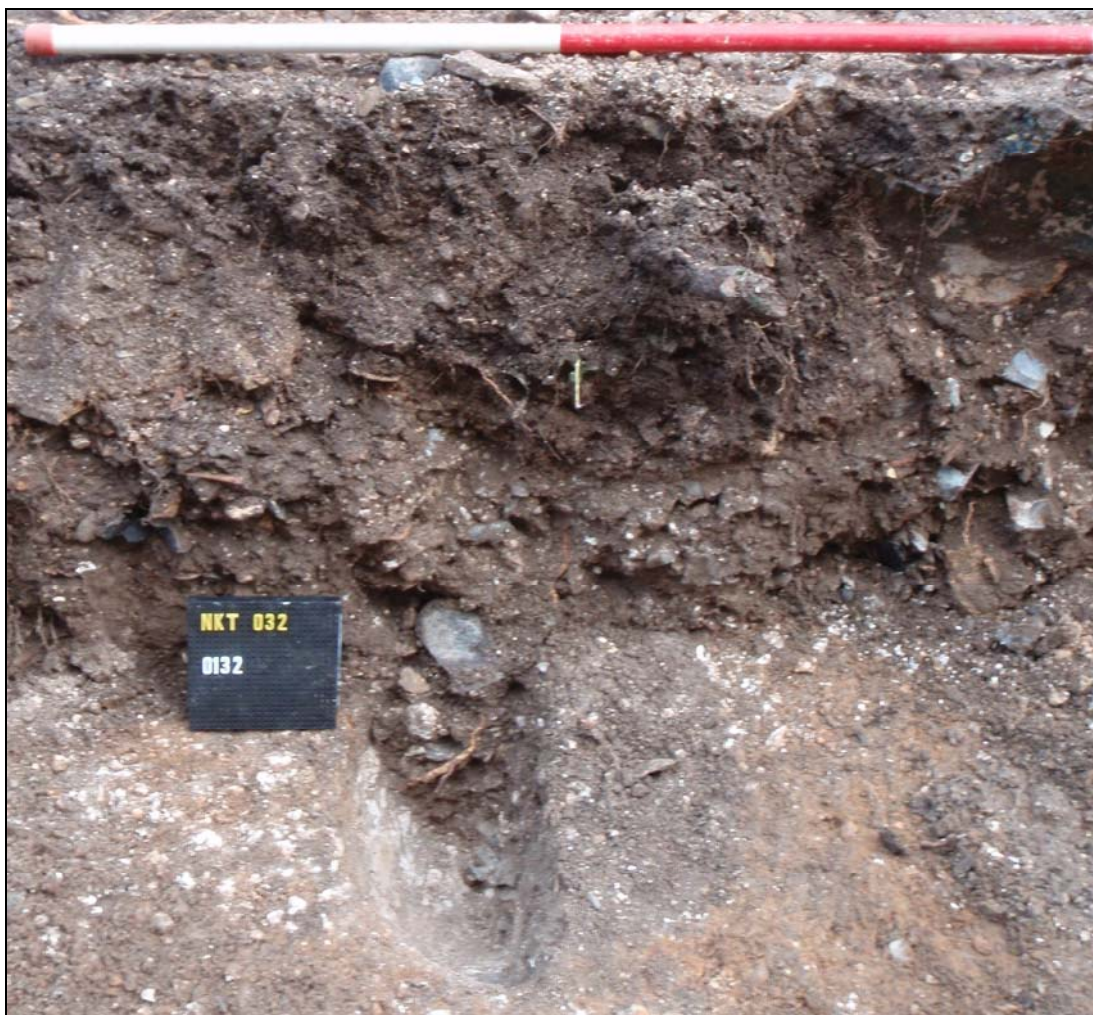
Plate 1. Posthole 0132 from group 0166, overlaid by layers 0129 and 0130, facing north-east, 1m scale

posthole 0124 and 18th-19th century CBM was found in several contexts. All of the postholes were overlaid by a topsoil layer recorded as 0130/0137, which produced 18th to 19th century abraded CBM. Both posthole clusters formed layouts that cannot be readily assigned to obvious structures, although it is notable that postholes 0139, 0151, 0152 and potentially 0018 (recorded during the evaluation) were aligned parallel with the boundary wall. The cuts were also quite distinct between the two groups, with those from group 0167 having flatter bases and steeper slopes than those in group 0166. This would tend to indicate two distinct structures and possibly different dates, although the date ranges of the finds from both clusters are identical.

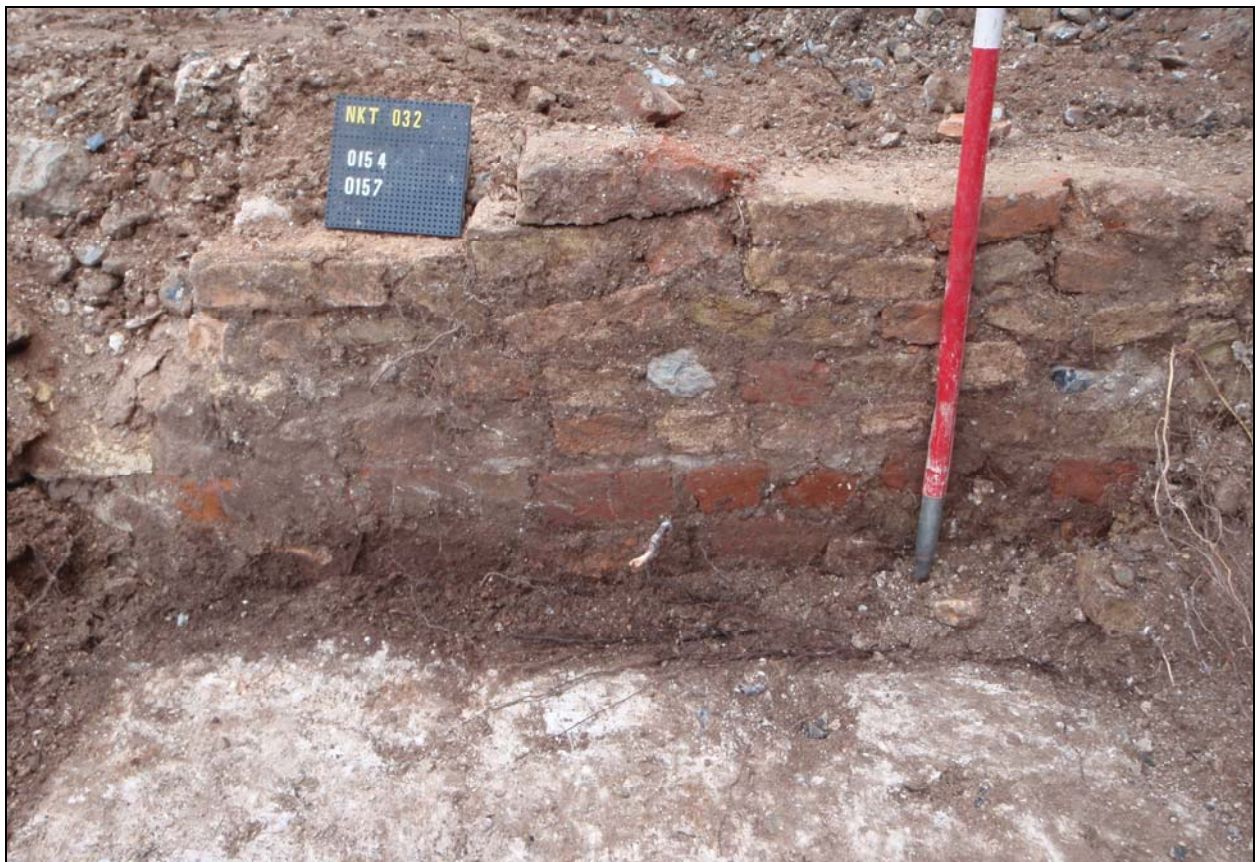
Plate 2. South-east wall of structure 0154, with chalk floor 0157, 0.5m scale, facing south-east

At the south-east end of the site was a brick structure recorded as 0154. It measured 5.95m (NW-SE) x >3m (SW-NE). It was divided into two rooms and was generally constructed of unfrogged red post-medieval brick. However, the far south-east wall was made up of a mixture of reused red and yellow bricks (18th to 19th century), as well as occasional flint nodules. Initially the structure had been covered by a layer of sand, gravel, chalk/clunch, mortar and CBM, thought to relate to its demolition. This material was itself then covered by topsoil 0130/0137, although here it was quite disturbed and thin. The structure appears to feature as part of the layout of buildings on the 1787 Chapman map (Fig. 2) and is also shown on the 1850 Public Health map (Fig. 3). Unlike any of the extant surrounding structures or those depicted on the historical maps, this structure had a notably sunken floor 0157. A sondage was excavated into an area of structure 0154. This revealed more demolition rubble to the base of the surviving walls, at which point the chalk floor was uncovered. This was a thin compacted surface which incorporated occasional flints and CBM flecks.

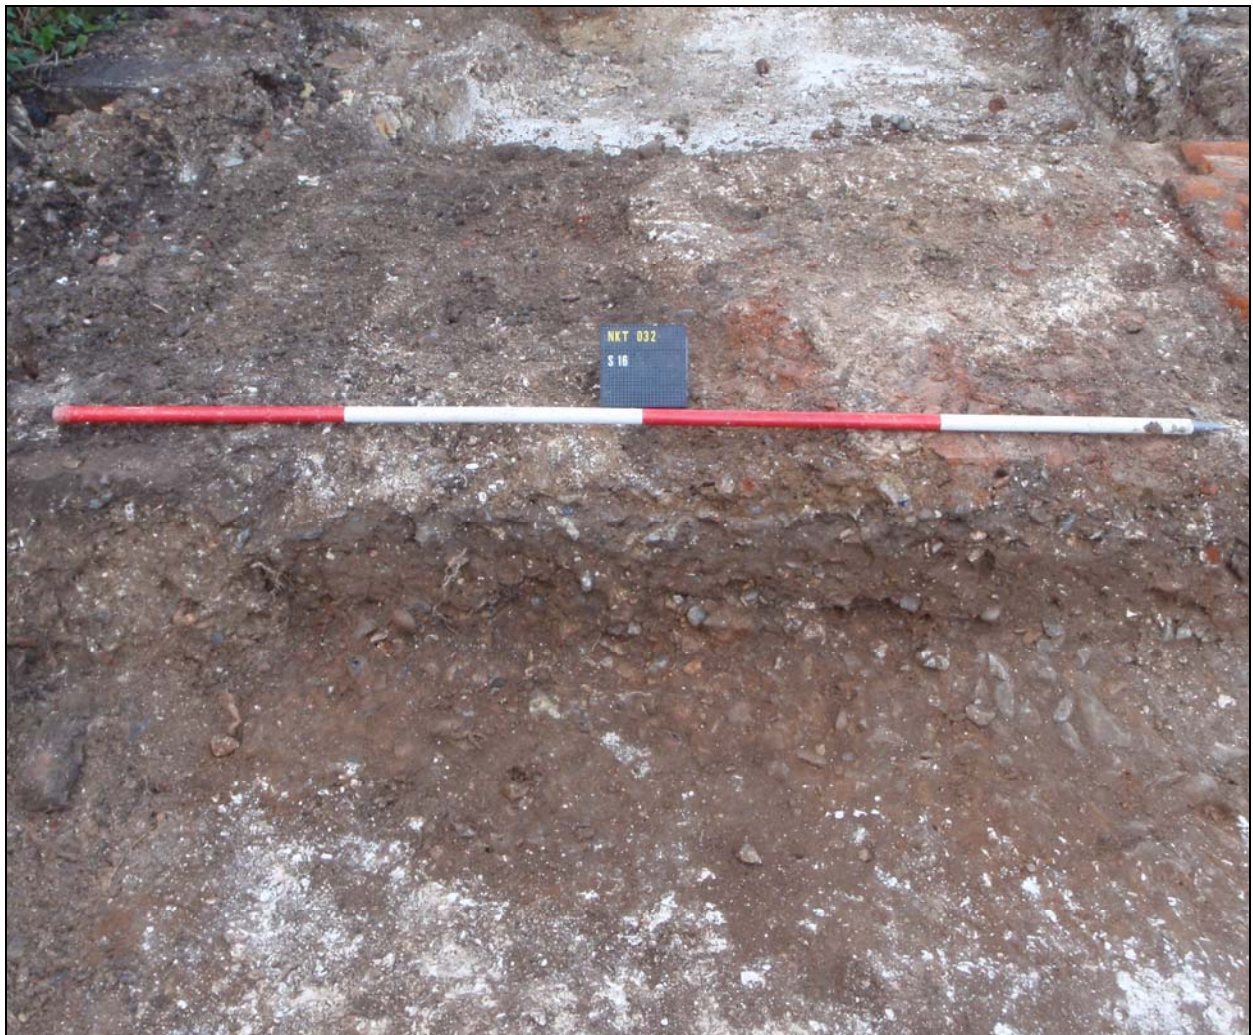
Plate 3. Topsoil 0130/0137, overlaid by surface deposits 0159, 0158 and 0120, which are cut away by drain deposit 0136, facing north-west, 2m scale

This layer of buried topsoil was 0.2-0.35m deep and overlaid the features in Phase 1, with the possible exception of structure 0154. It was mixed mid-dark orangish-brown and greyish-brown clayey-sandy-silt and produced three abraded CBM fragments of post-medieval date (18th to 19th century), where excavated as 0137 in section 16. It is likely that this layer corresponds to layers 0012 and 0013 recorded in the evaluation at the north-west end of the site. The layer continues into section 19 at the south-east end of the site, although here it was more naturally derived and mixed. The thickness of the layer and its position above the other features in Phase 1, indicates that it formed over an extended period of time, presumably when the site was either not being used or was functioning as a garden or dump area for soil from elsewhere.

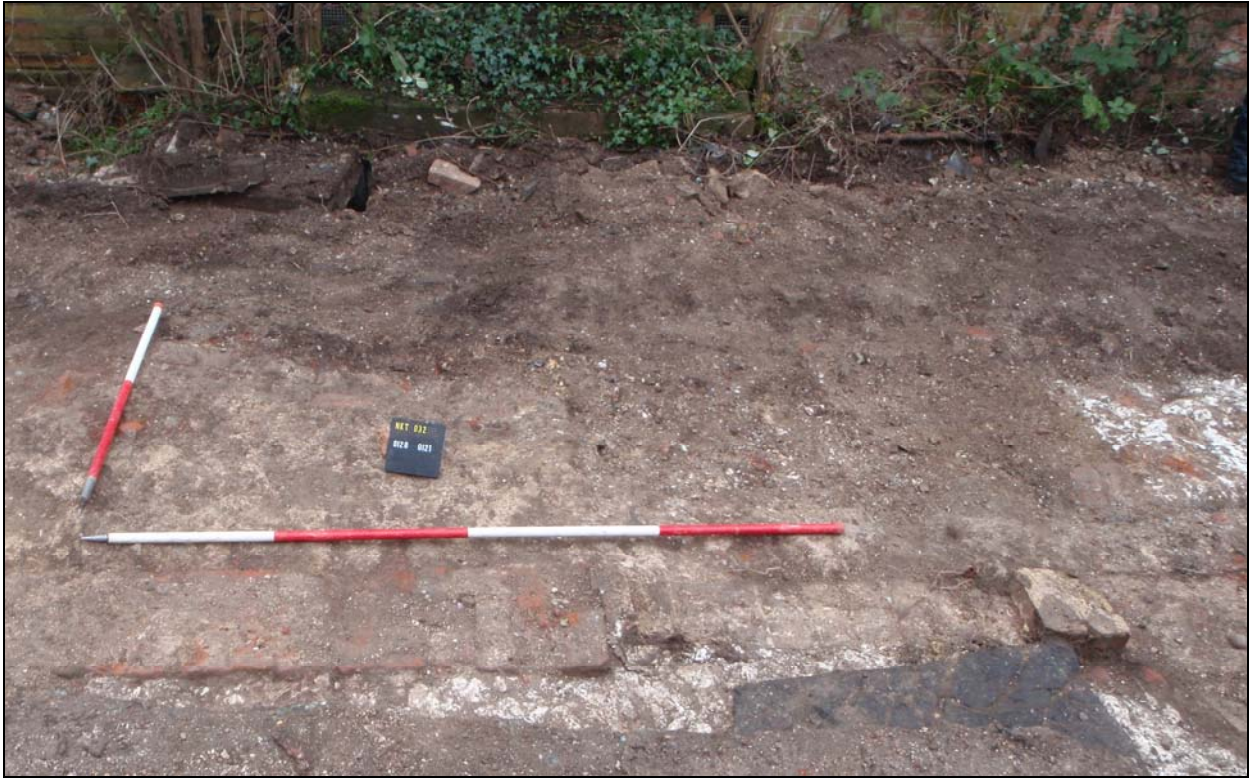
Plate 4. Surface deposits 0120, 0158, 0159 and 0104, with wall 0121 immediately right of 1m scale and tarmac block 0107 in bottom right, facing south-west, 1m and 2m scales

Overlying buried topsoil 0130/0137 were chalk and mortar surfaces 0104 and 0120, which were flanked to the south by walls 0100 and 0121. Together, these various contexts formed building range 0164. Two associated layers were also recorded under surface 0120, which were made up of compacted orange sand, gravel and mortar, and recorded as 0158 and 0159. Another small area of chalk surface, 0101, and a chalk, brick and flint wall foundation, 0100, have also been recorded as part of this phase as they fall outside the structure associated with Phase 3. It is also notable that wall 0100 is roughly aligned with wall 0121. A drain and soak-away immediately south-west of wall 0100 are thought to have been associated with the existing stable block and drain deposit 0136 rather than with 0100, which it is close to.

There were also several surviving chalk surfaces (0108, 0109, 0117 and 0161), a piece of tarmac surface (0107, Pl. 4), and brick surfaces 0110 and 0135 within the walls. Brick samples from 0110 and 0135 were dated as 18th to 19th century, with tentatively assigned ranges of ?1750-1850. These brick surfaces were slightly raised within the surrounding chalk surfaces, probably indicating that they were inserted repairs within the chalk. The rectangular block of tarmac 0107 (>1.05m E-W x >0.35m N-S x 0.08m thick) was found overlying chalk surface 0108, being partly cut away by a concrete foundation. It was not aligned with the structure as a whole and its purpose is unclear. However, it was immediately under demolition deposit 0106 and may have been associated with this activity (Phase 4), rather than the structures in Phase 3.

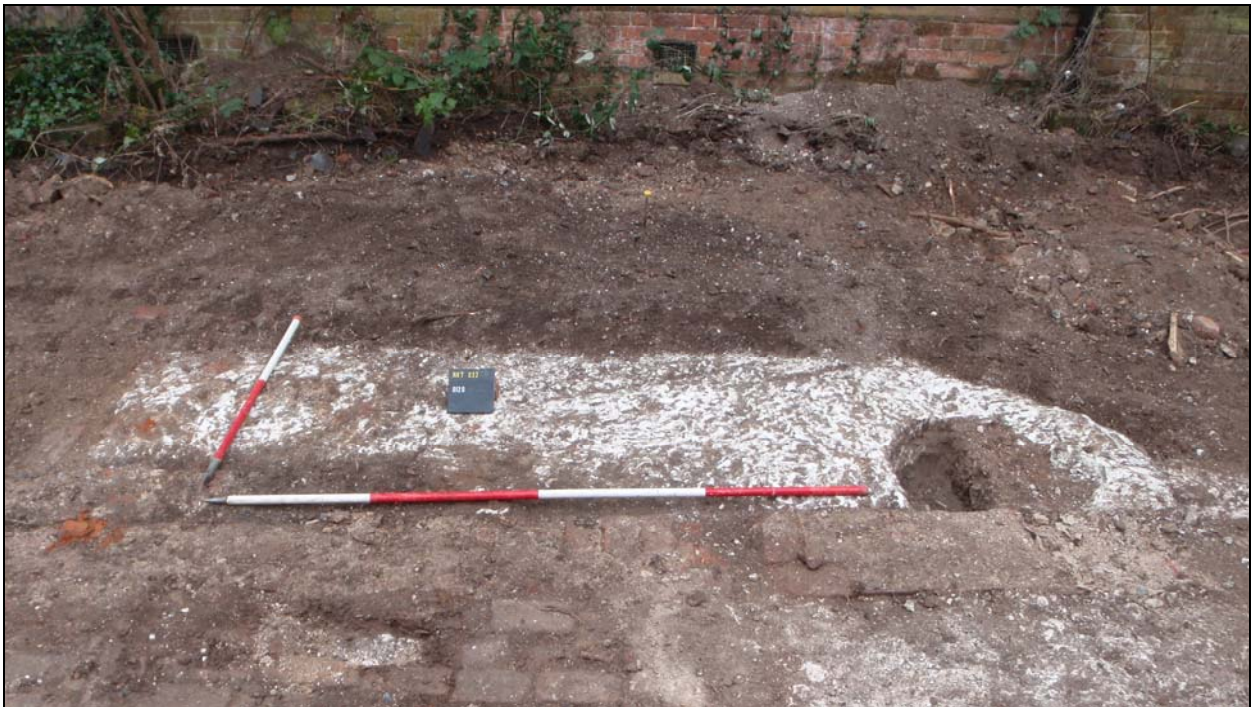
Plate 5. Surface 0104 and posthole 0102, facing south-west, 1m and 2m scales

At some point after the construction of building range 0164, posthole 0102 was inserted through chalk surface 0104. It was circular and steep-sided, but its base could not be defined within buried topsoil 0130/0137. It was cut away on its north-east edge by wall 0105 from Phase 3 and its fill, 0103, produced seven pieces of post-medieval CBM, generally dated to the 18th to 19th century.

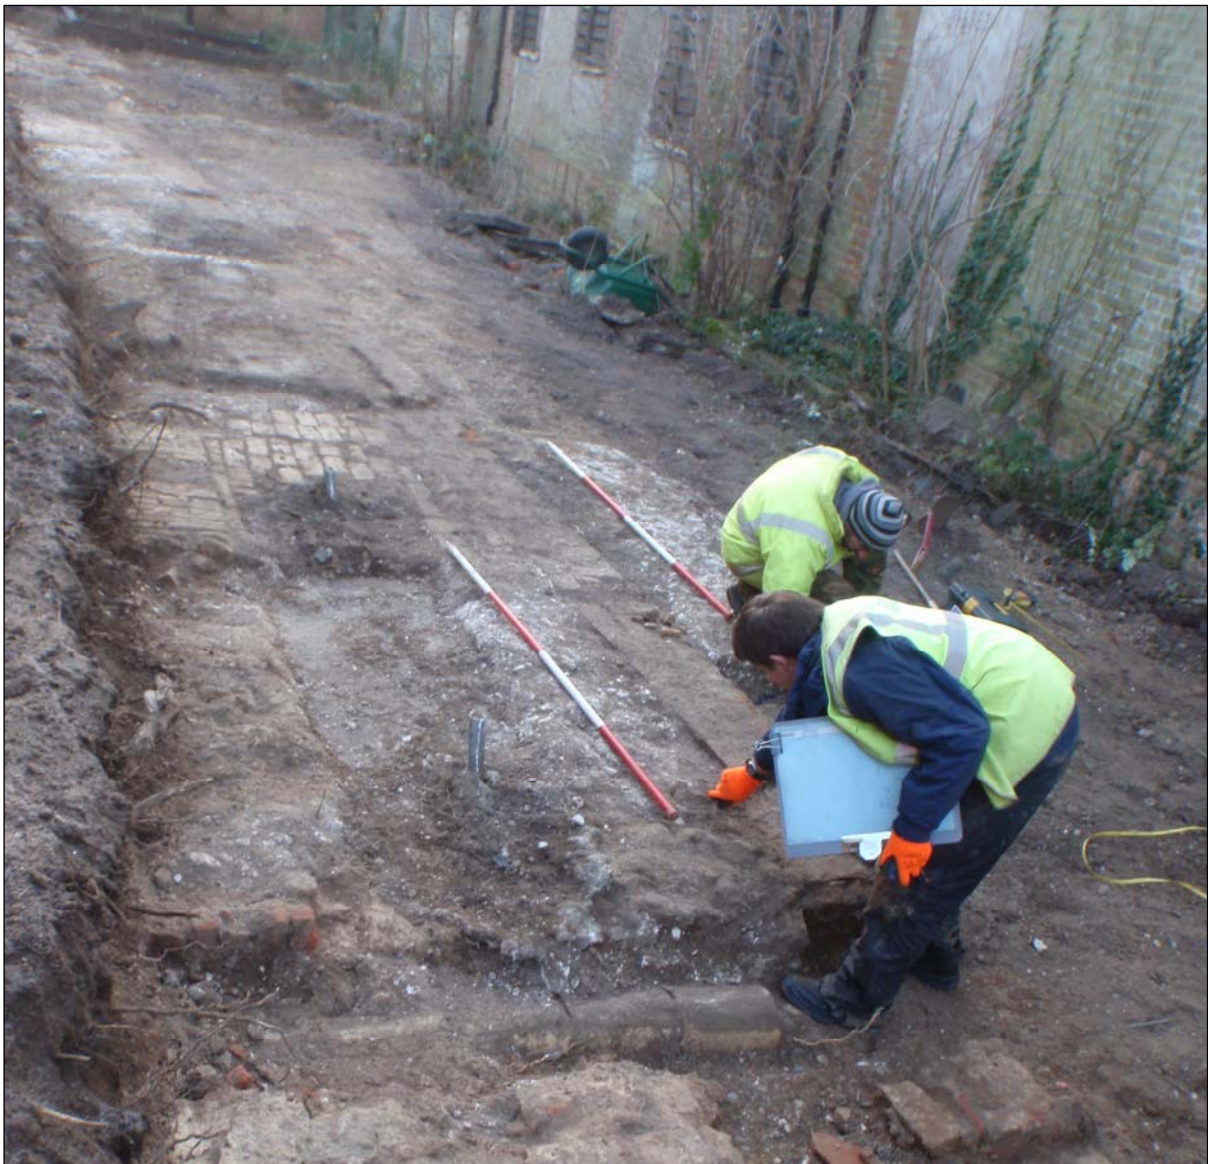
Plate 6. Walls 0105, 0113 and 0112, associated chalk and brick surfaces, and drain trench 0119, facing south-east, 2x2m scales

This was made up of a south-east to north-west aligned range, comprising up to three phases of construction and modification (Pl. 6). The longest surviving span of wall was built from red brick (reused late 17th to 18th century) and measured c.15.5m (SE-NW). It was made up of three lengths, 0003, 0105 and 0113, which were intersected by one doorway (indicated by threshold 0118) and drain 0119. The main walls were laid in alternating header and stretcher courses. Wall 0003 was recorded in the evaluation, but was not uncovered again in the excavation, having presumably been damaged during machining works. Two surviving return walls, running south-west to north-east towards the north-east edge of the site from walls 0003 and 0105, flanked drain 0119. These were constructed of smaller pieces of red brick, clunch and mortar, with the differing construction indicating that the drain was inserted into the structure group 0162. Door threshold 0118 was made up of twelve pale yellow bricks, matching those in surfaces 0110 and 0135 that were dated as 18th to 19th century (?1750-1850).

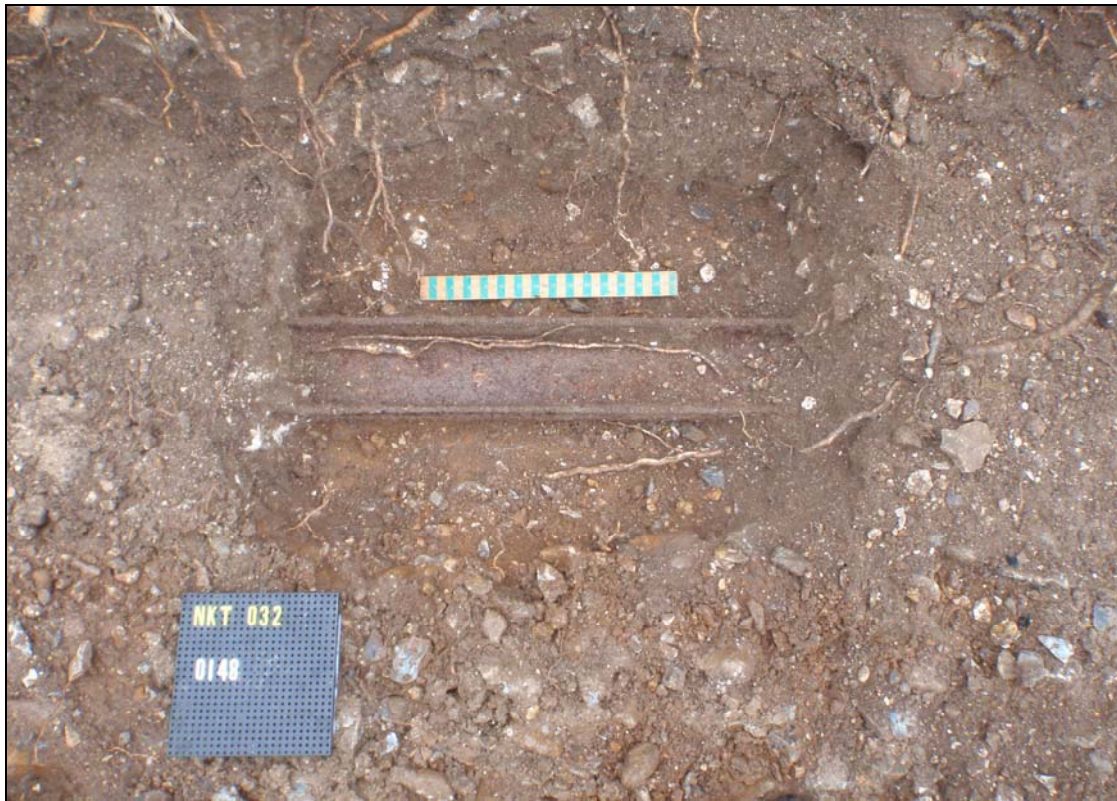
Plate 7. Linear feature 0148 with iron girder in base, facing north-east, 0.3m scale

0147	0148		Linear Fill	Mid/light brownish-grey sandy-silt. Loose compaction. Moderate chalk flecks and small lumps. Occasional flints. Clear horizon clarity. Contains an iron girder(?) following the SW edge of the feature. This was U-shaped, the sides being 80mm high and the base 120mm wide. Fill of 0148.	>3.2	>0.42	0.14				0148		Yes	No			
0148	0148		Linear Cut	Linear, aligned NW-SE. Only partially visible on NE edge of site. 50° straight side with curving break of slope to base. Flat base with iron girder(?) running along base, parallel with the feature. Structural feature serving as a foundation slot for girder? Although iron girder is not fixed within the slot.	>3.2	>0.42	0.14					0147	No	No			
0149	0151		Posthole Fill	Dark brown sandy-silt. Loose compaction. Frequent chalk flecks and small occasional rounded flints. Clear horizon clarity. Post-pipe fill of posthole 0151.		0.36	0.44				0150		Yes	No	0167

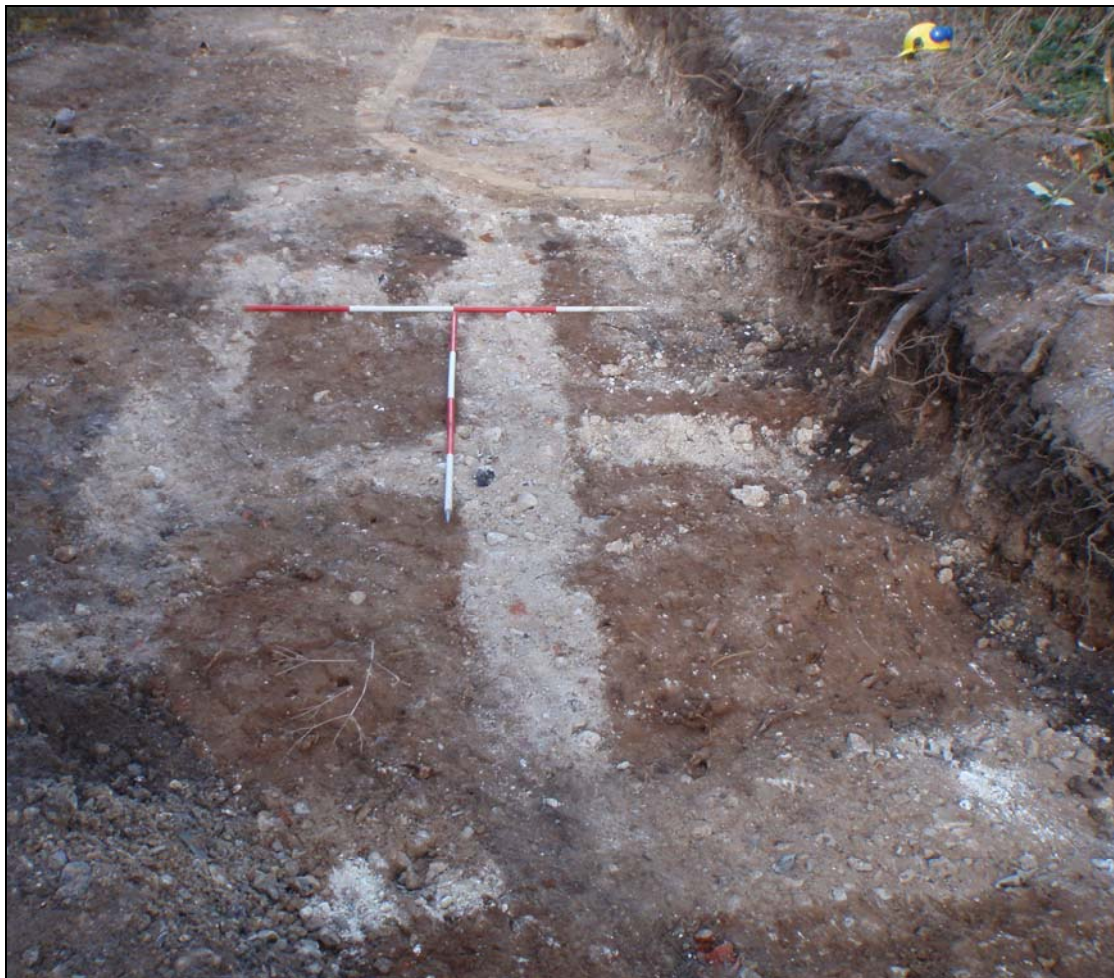
Plate 8. Footings 0115 in foreground, with wall 0114 to rear, facing north-west, 2x2m scale

Footings 0115 appear to be the earliest structure in this phase, although being made from Portland cement they can be no earlier than 1824 when this material was patented (Pl. 8). It is also clear from the 1850 Public Health map and the 1886 OS map that the site retained the buildings from Phase 3 until 1886, making the structure associated with footings 0115 later than this. The remains of the footings form a roughly rectangular plan with several subdivisions and measure 6.2m (SE-NW) x >3.2m (SW-NW). They were cut at the north-west end by structure 0114.
