**Outbuilding at
The Olde Bungalow,
Battisford, Suffolk
BAT 018**

Historic Building Record

Outbuilding at The Olde Bungalow, Straight Road, Battisford, Suffolk

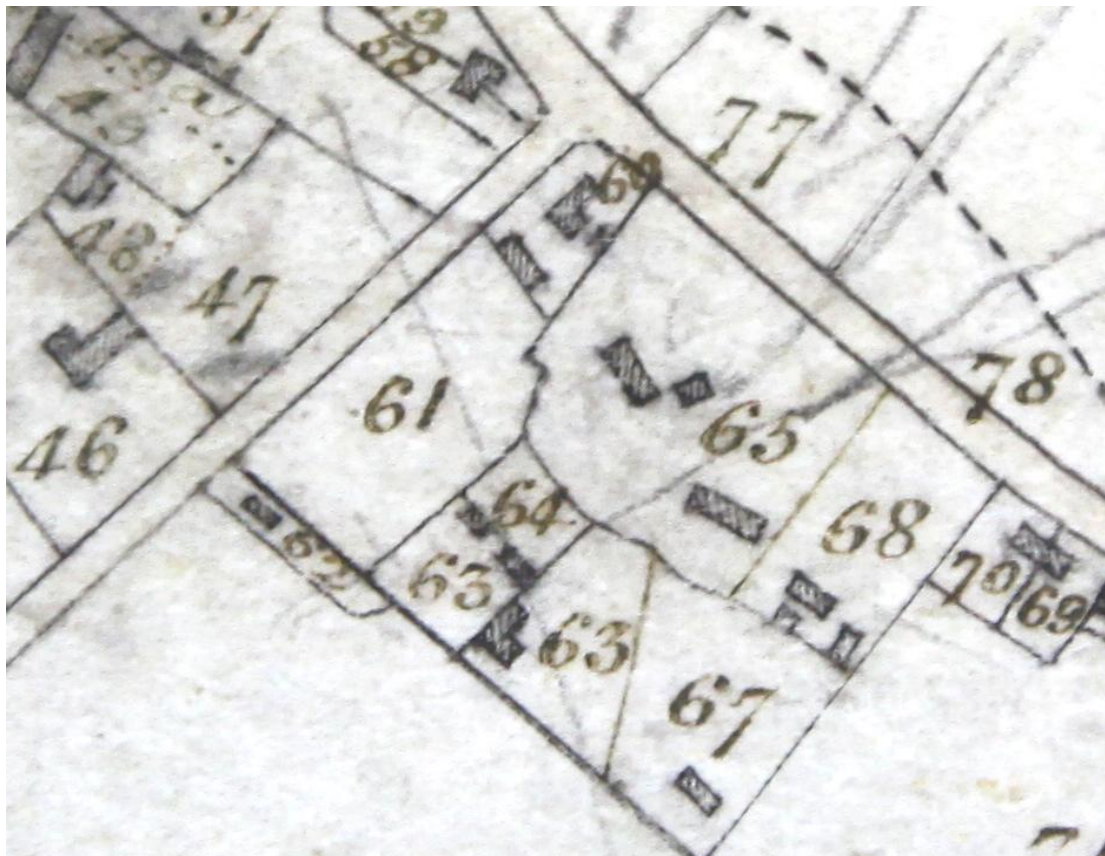
Figure 4. The Battisford tithe map of 1842. The only trace of the large pond of 1842 is the curved boundary to the south-west of The Olde Bungalow (which lies beneath the plot number: 65). The half-acre site was described as a blacksmith's shop, house & land.

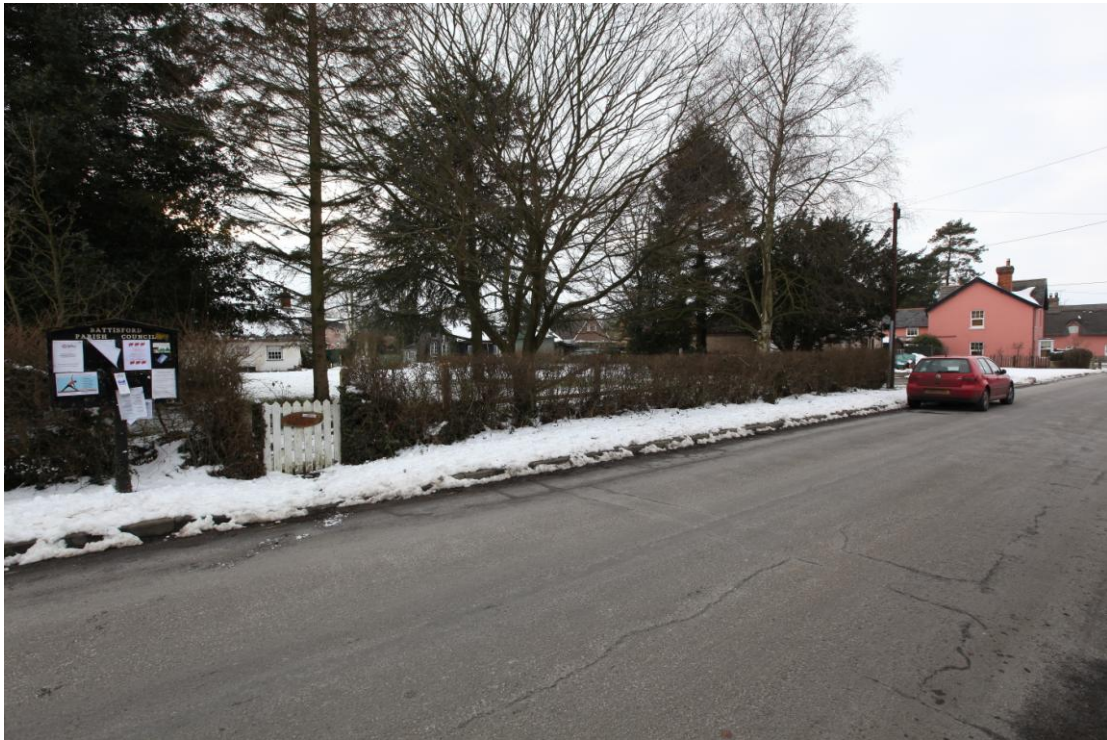
Illus. 1. General view site from Straight Road to the east showing the Olde Bungalow gate to the left with the workshop in the centre rear.

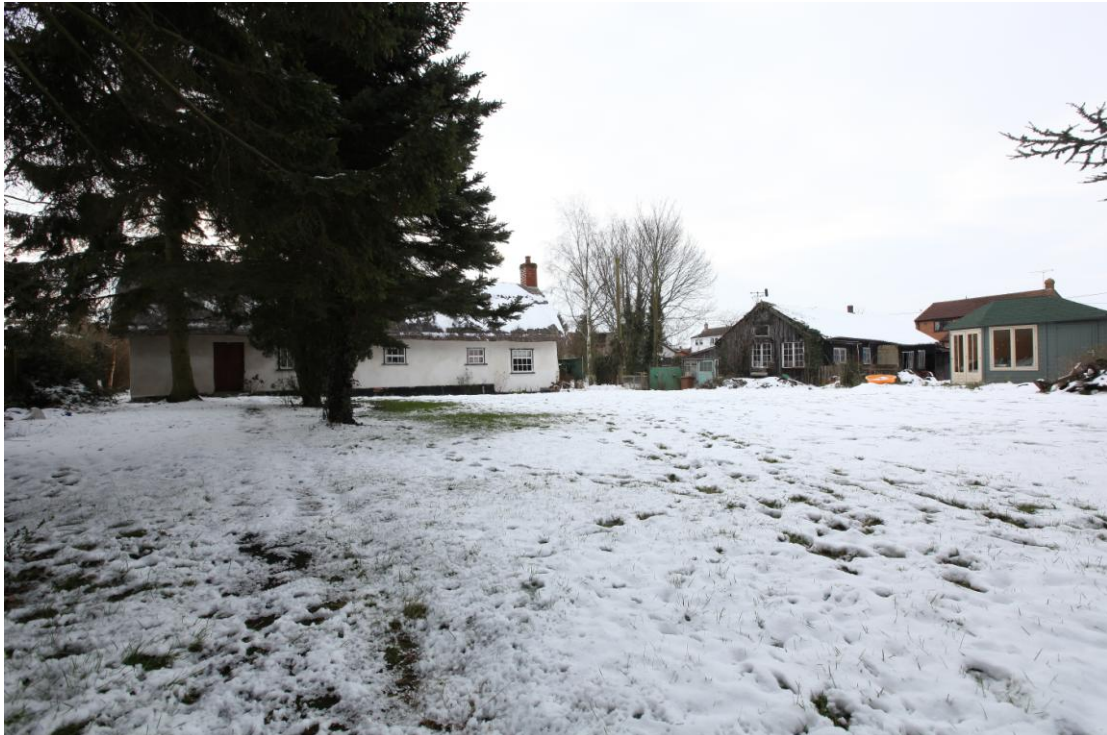
Illus. 2. General view of site from north-east showing Olde Bungalow to left and workshop to right with remnant medieval green in foreground.

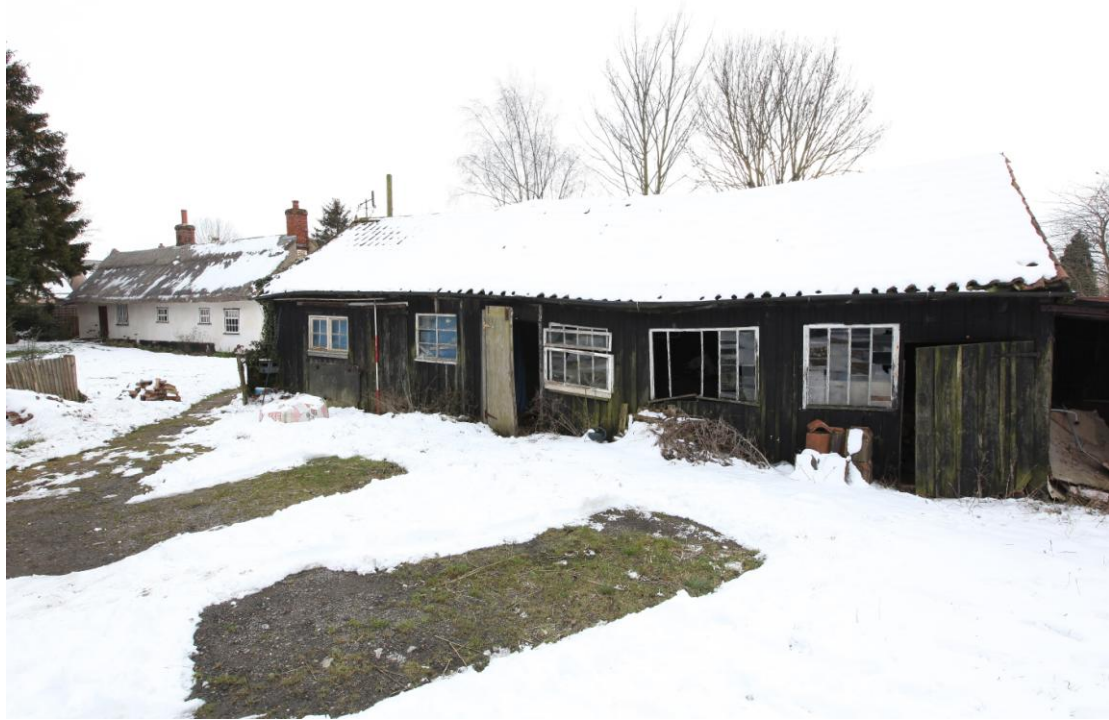
Illus. 3. General view of site from north-west showing workshop to right with Olde Bungalow in rear to left.

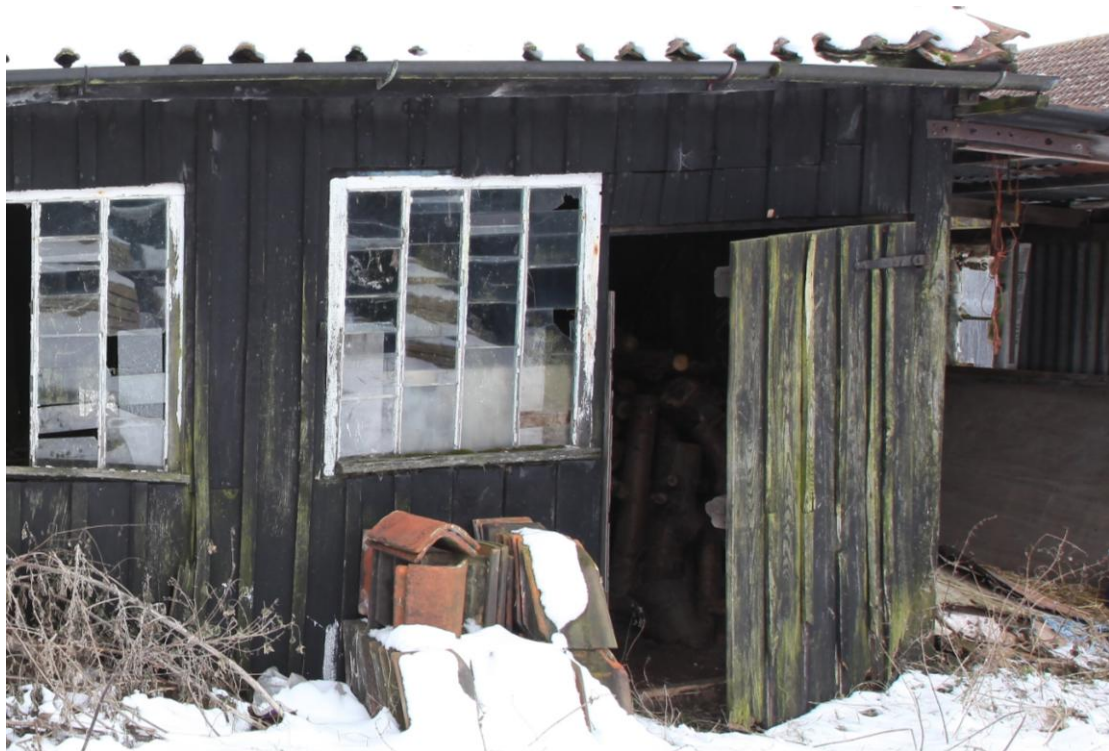
Illus. 4. Western end of northern exterior showing entrance door and windows with overlapping 'waster' panes of forge (B).

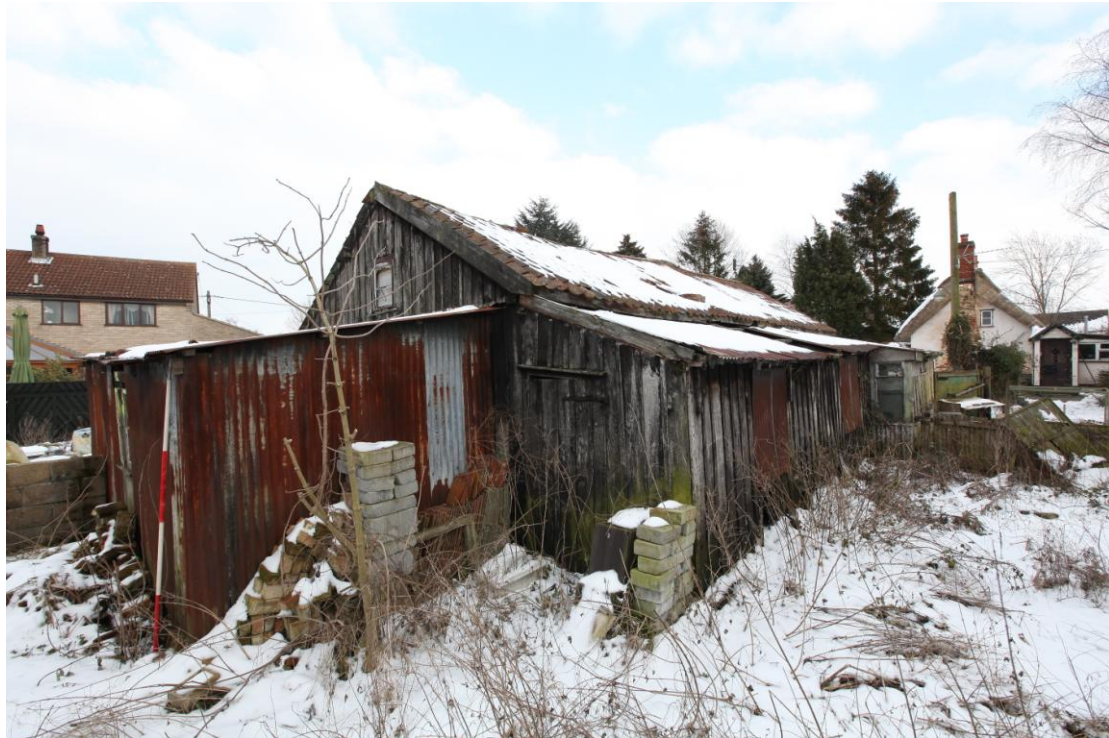
Illus. 5. Exterior from west showing rear lean-to sheds (C & D) with Olde Bungalow in rear to right and gable lean-to (E) to left.

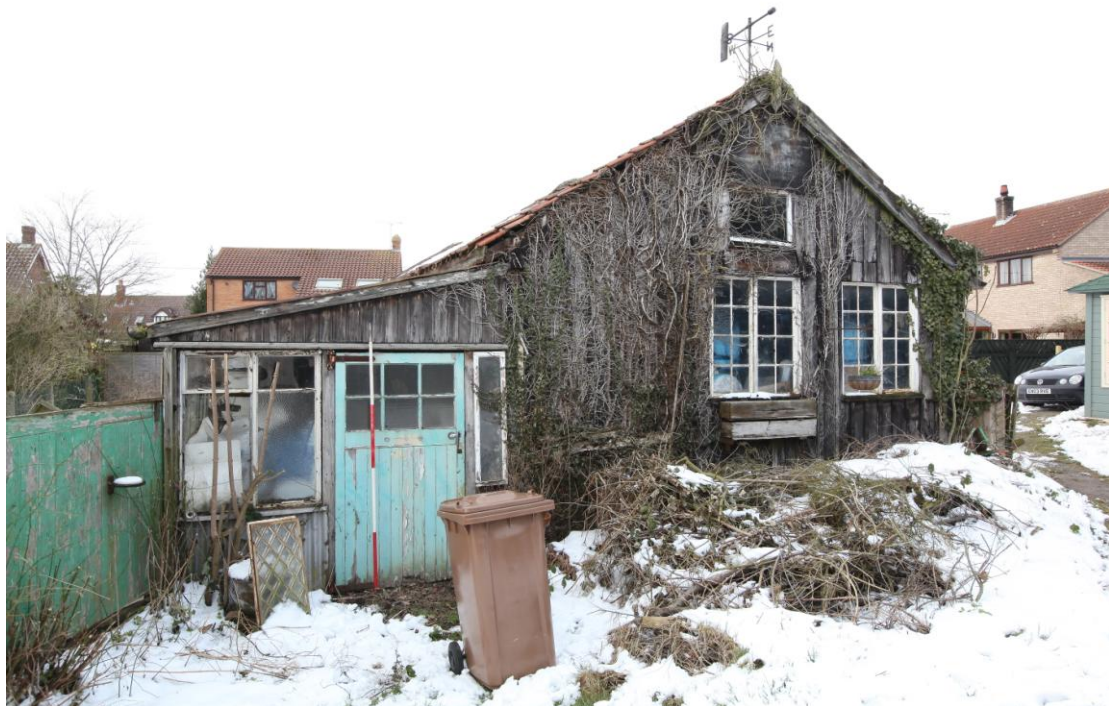
Illus. 6. Eastern external gable showing glazed lean-to shed (C) to left and windows of carpenter's shop (A) to right.

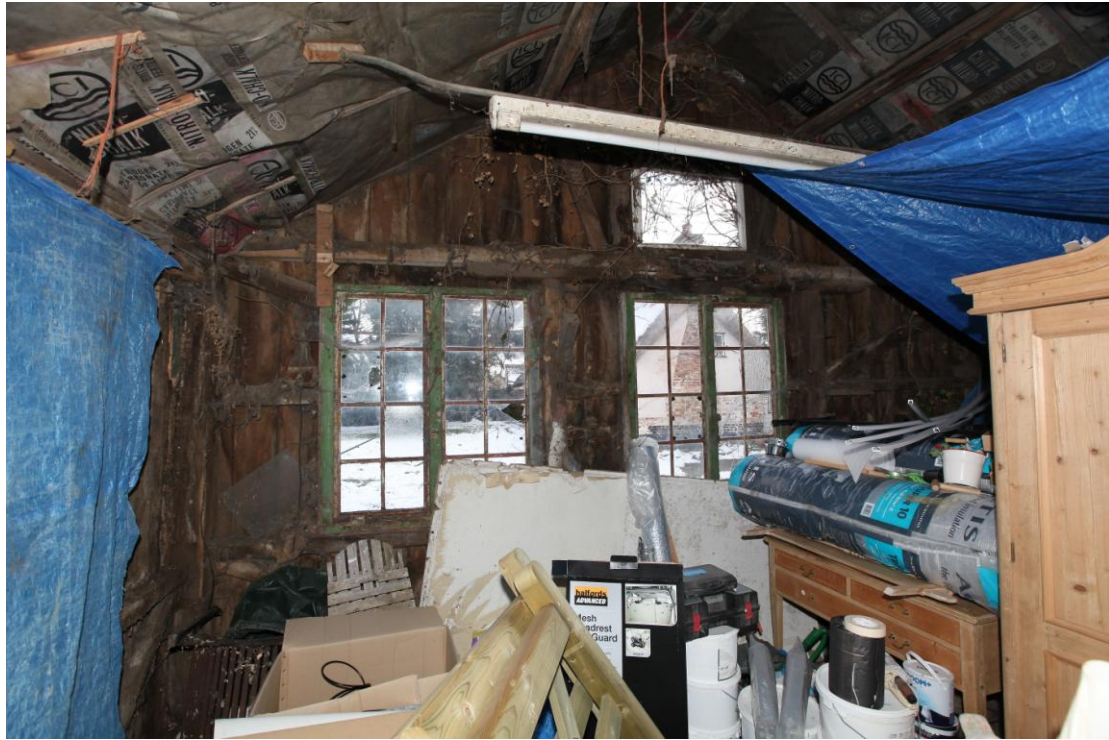
Illus. 7. Internal eastern gable of carpenter's shop (A) showing metal casement windows with red and green paint.

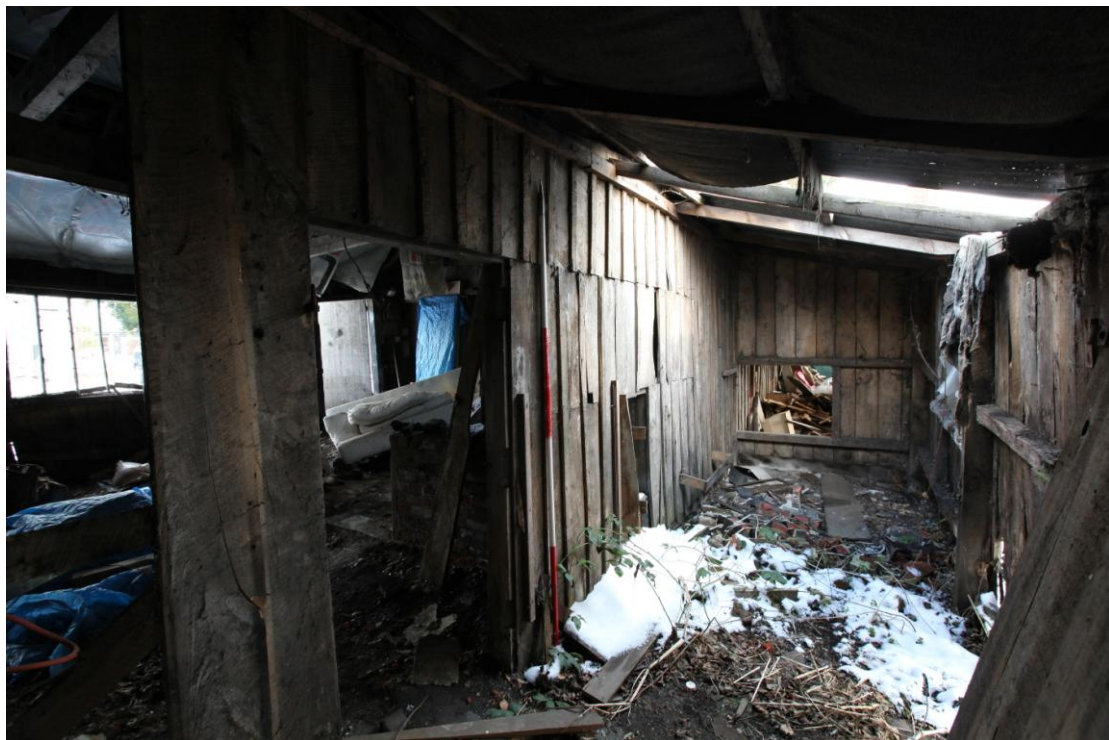
Illus. 8. Interior of southern lean-to shed (D) from west showing position of door to forge (B) to left.

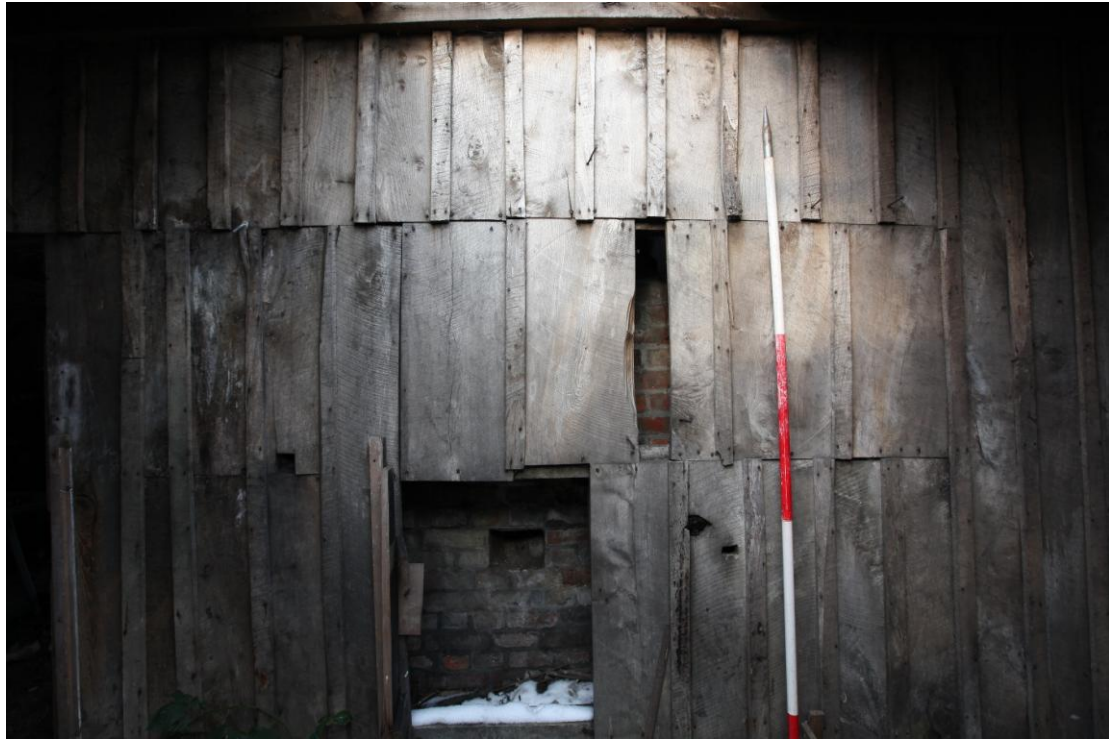
Illus. 9. Detail of boarded partition of forge (B) from southern lean-to (D) showing marks of circular saw and possible blocked hatch behind brickwork of flue.

The walls are of post-and-rail hardwood construction with vertical external boarding, chiefly of elm and bearing the marks of a circular saw, and the joints are sealed by nailed external fillets. The floors are of 20th century concrete and the roof structure is of softwood with clasped-purlins, nailed collars and a ridge board. The metal casement windows of the eastern gable and southern exterior appear to be insertions of the mid-20th century but the three windows of the northern facade are original and retain sections of overlapping irregular panes of glass. Boarded walls of this kind, and windows containing inexpensive waste glass, were typically used for workshops and other utilitarian outbuildings in the late-19th and early-20th centuries, but few examples now survive. The present structure is not shown on the Ordnance Survey of 1904 but must have been built soon afterwards and was probably in existence by 1920. A similar smithy on Cockfield Great Green was built before 1885 (as recorded for Suffolk County Council Archaeological Service in December 2009) and it is even possible that all or part of the structure was moved from the site of the smithy shown a few metres to the north on the Ordnance Surveys of 1885 and 1904.

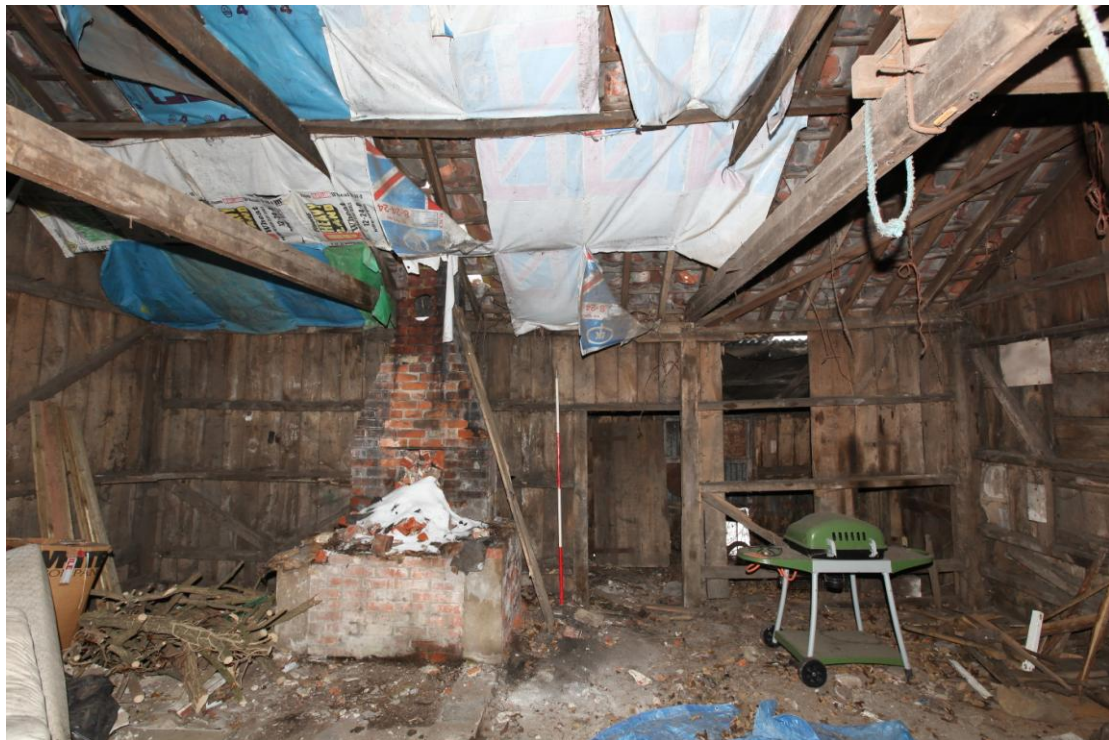
Illus. 10. Southern interior of forge (B) showing brick forge to left and door to rear lean-to (D) to right.

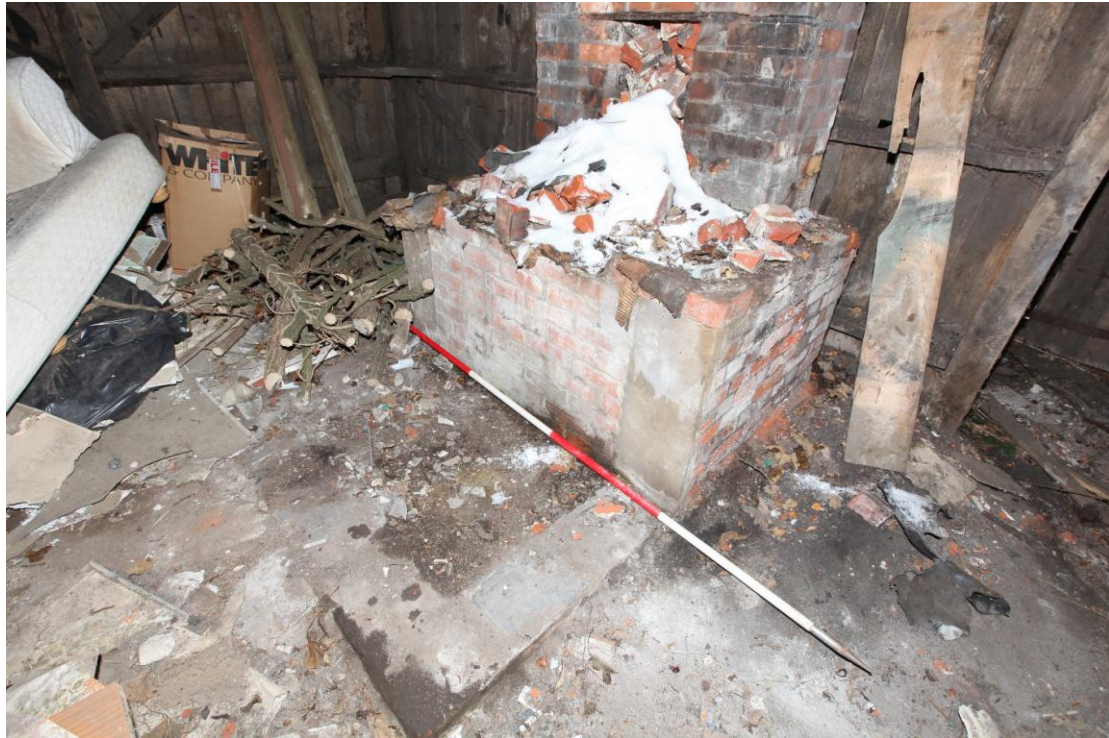
Illus. 11. Interior of forge (B) from north -west showing brickwork of forge against rear wall.

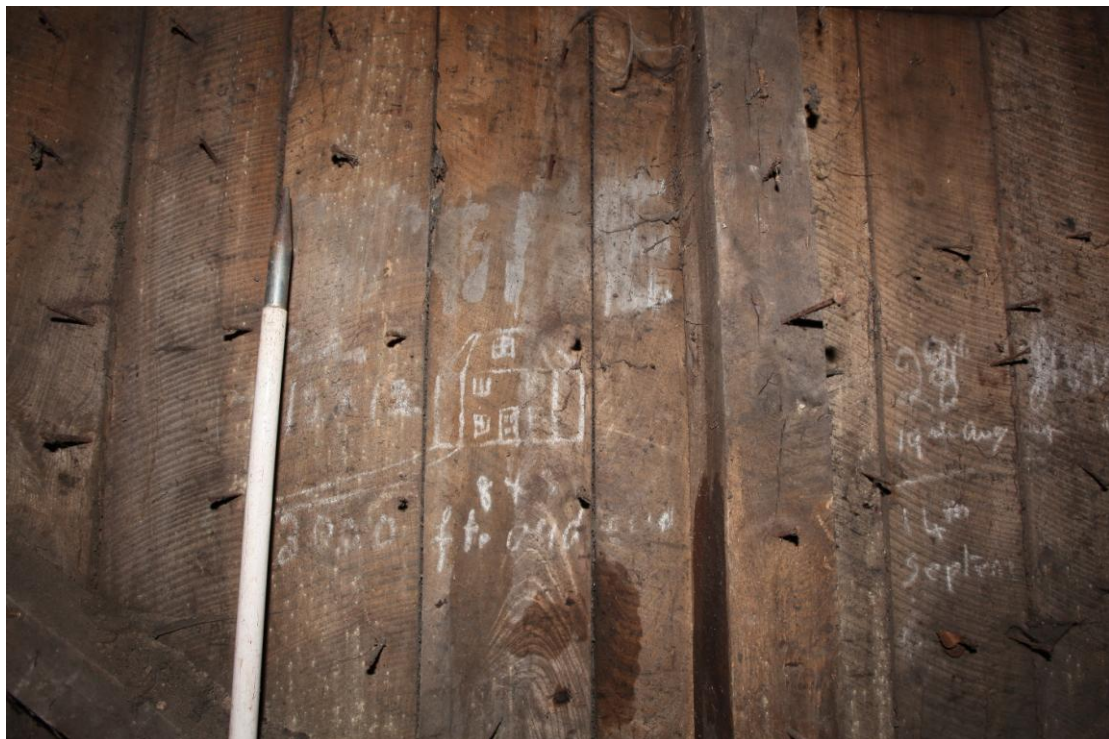
Illus. 12. Detail from west of chalk graffiti to partition between forge (B) and carpenter's shop (A) showing drawing of house and iron nails for hanging tools.
