**Outbuilding at
Hill House,
Needham Market, Suffolk
NDM 032**

Historic Building Record

Outbuilding at Hill House, Hill House Lane, Needham Market, Suffolk

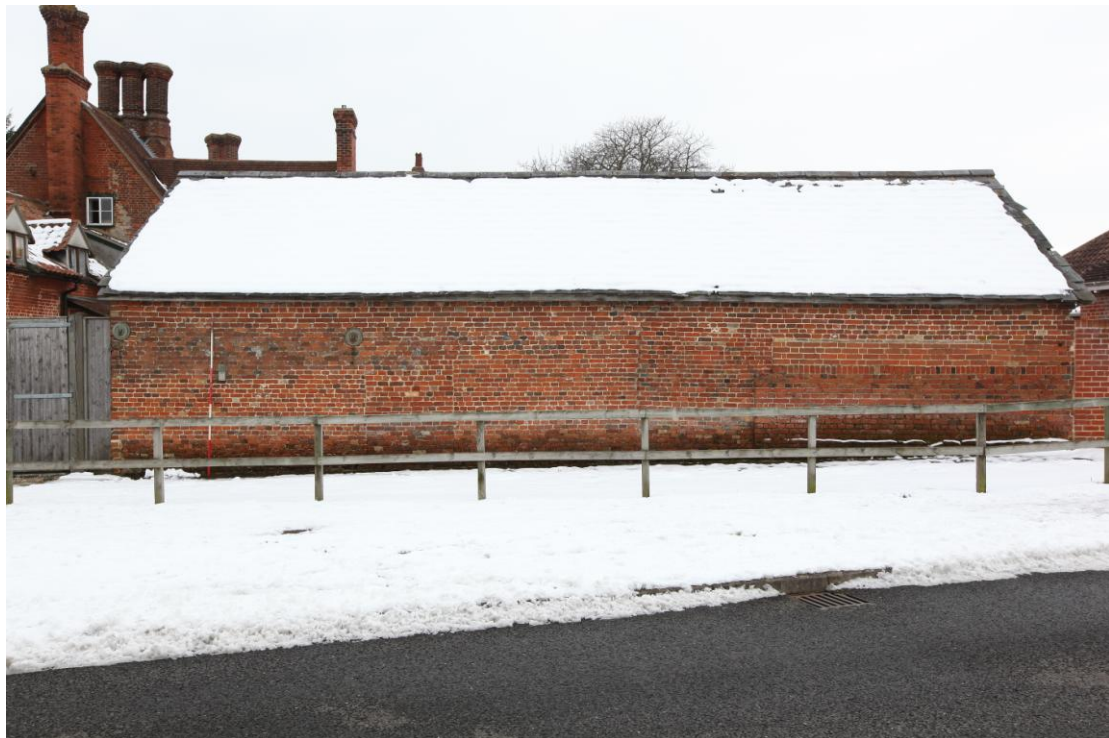
Illus. 2. Rear external elevation showing several phases of brickwork with earliest section to lower right.

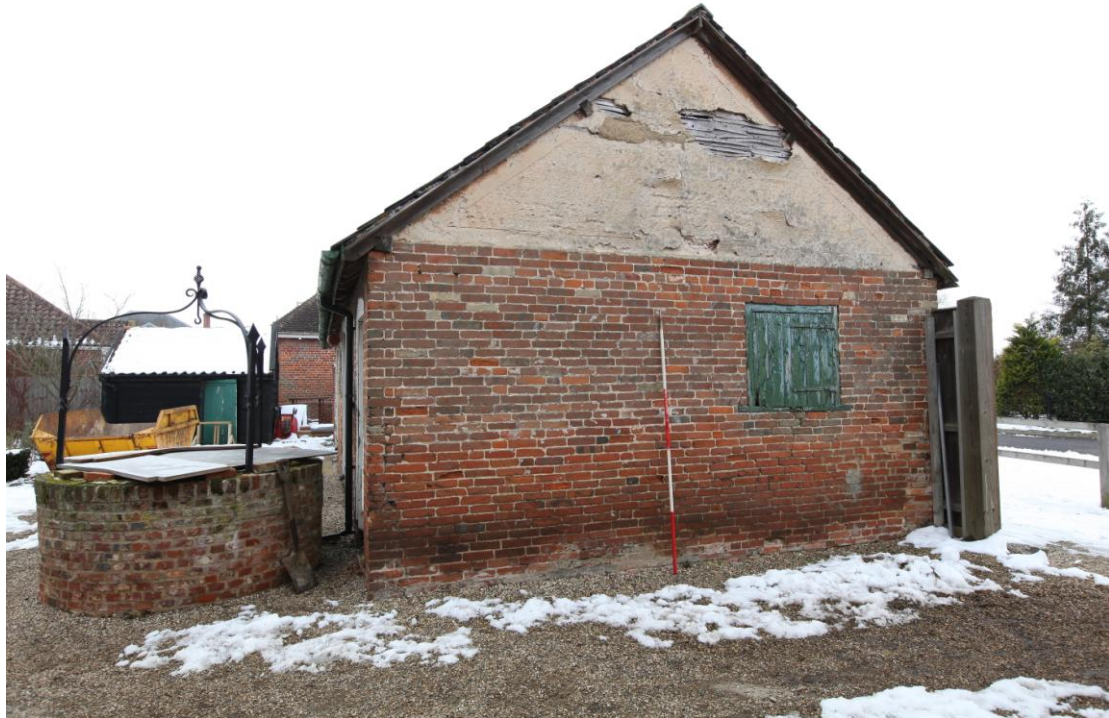
Illus. 3. North-eastern external gable showing secondary hatch and gate to Hill House Lane to right with cable-pattern pargeting to roof gable.

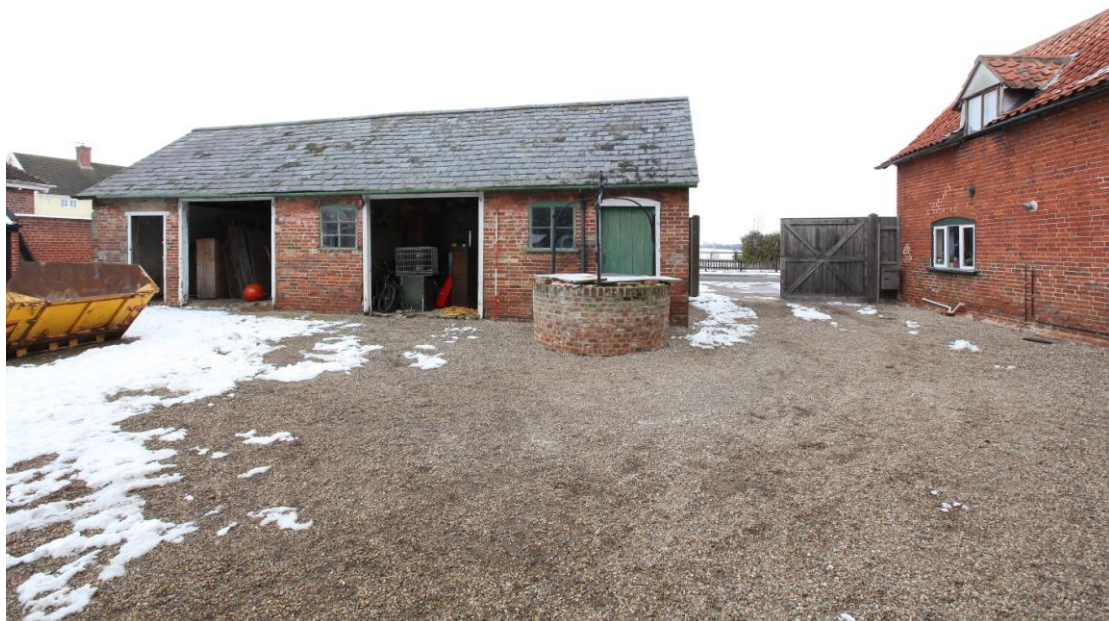
Illus. 4. South-eastern facade of outbuilding showing secondary vehicle doors with gate to Hill House Lane to right.

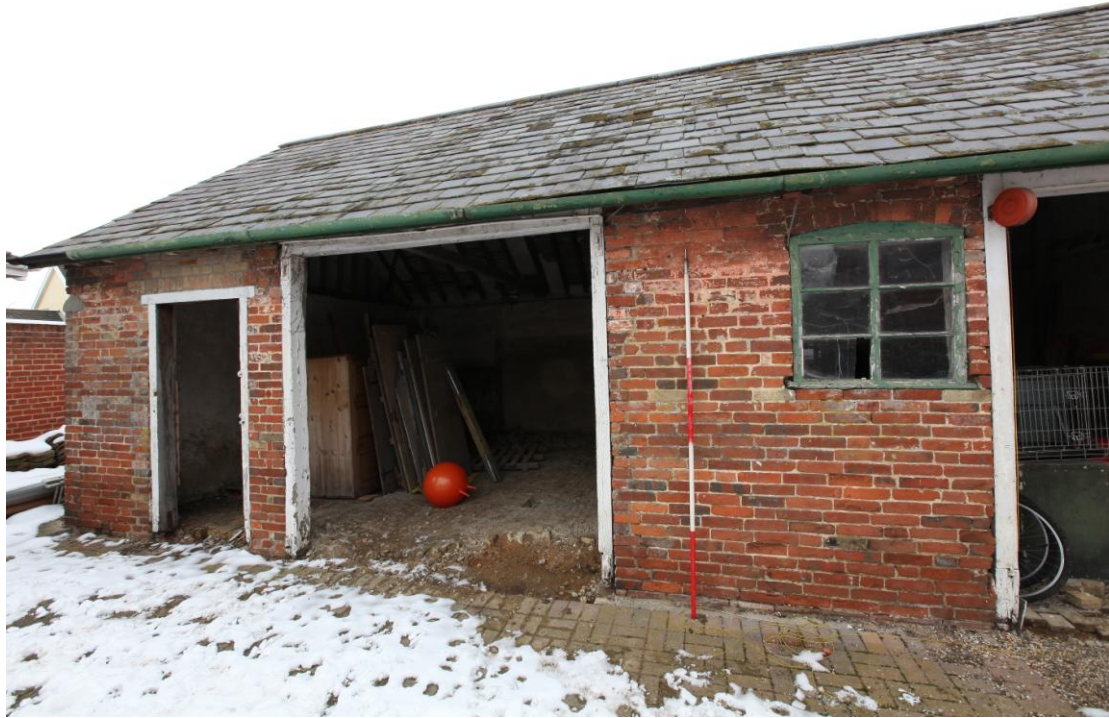
Illus. 5. Southern vehicle door (A) showing edge of original narrow door respected by brickwork to left & cut bricks to right. The smaller left-hand door is surrounded by cement pointing and is entirely secondary. This shed was originally entered by a narrow central door.

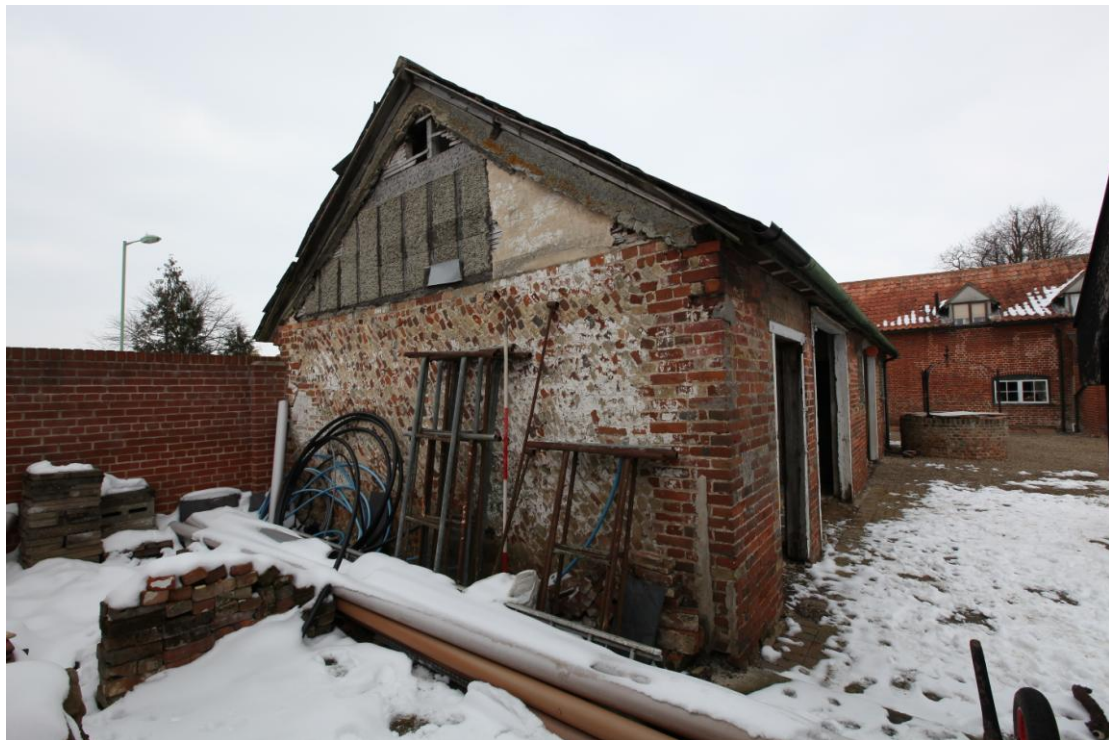
Illus. 6. South-western external gable showing rubble-bond brickwork and fragment of cable-pattern pargeing.

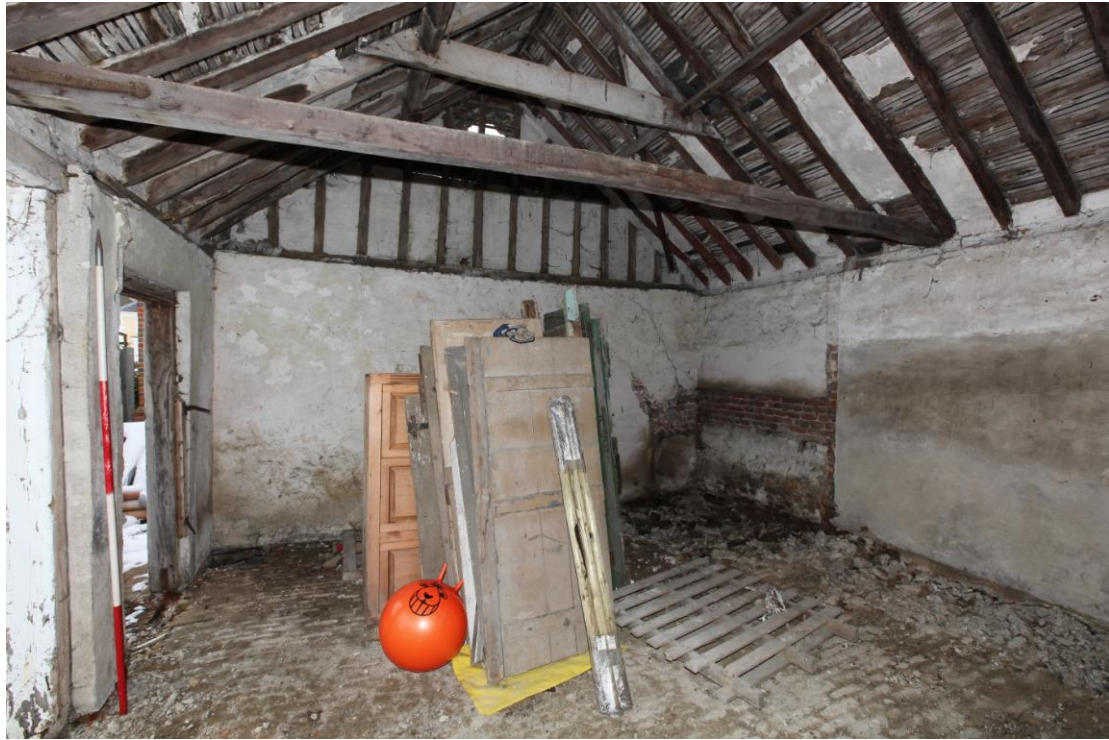
Illus. 7. Internal south-western gable of southern shed (A) showing the dated tie-beam in the foreground and the scar of a secondary partition (since removed) immediately behind.

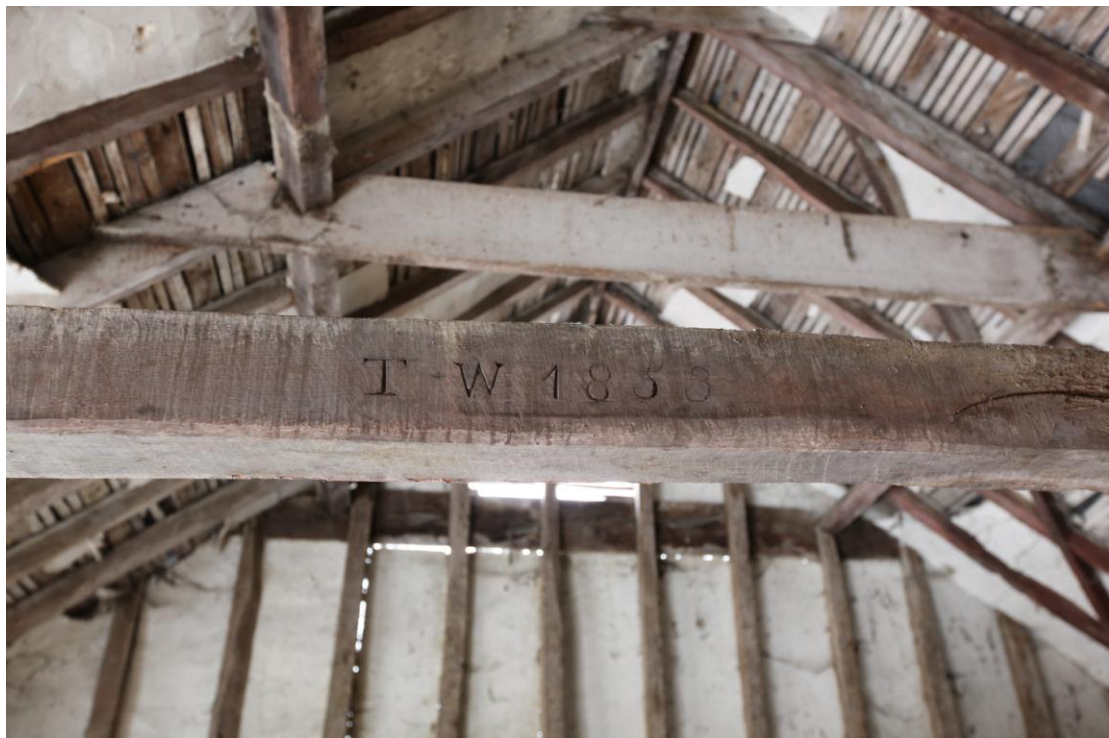
Illus. 8. Detail of the dated tie-beam in the southern shed (A) seen from the north-east 'T+W 1853'. The farmer in 1855 was William Page.

The outbuilding is entirely consistent with the date 1853 neatly carved into the northern side of the tie-beam spanning the southern compartment (A). The associated initials 'T+W' are more likely to commemorate the site's owner or tenant rather than the shed's builder, and the 'W' may derive from William Page who is recorded as the farmer here in White's Directory of 1855.

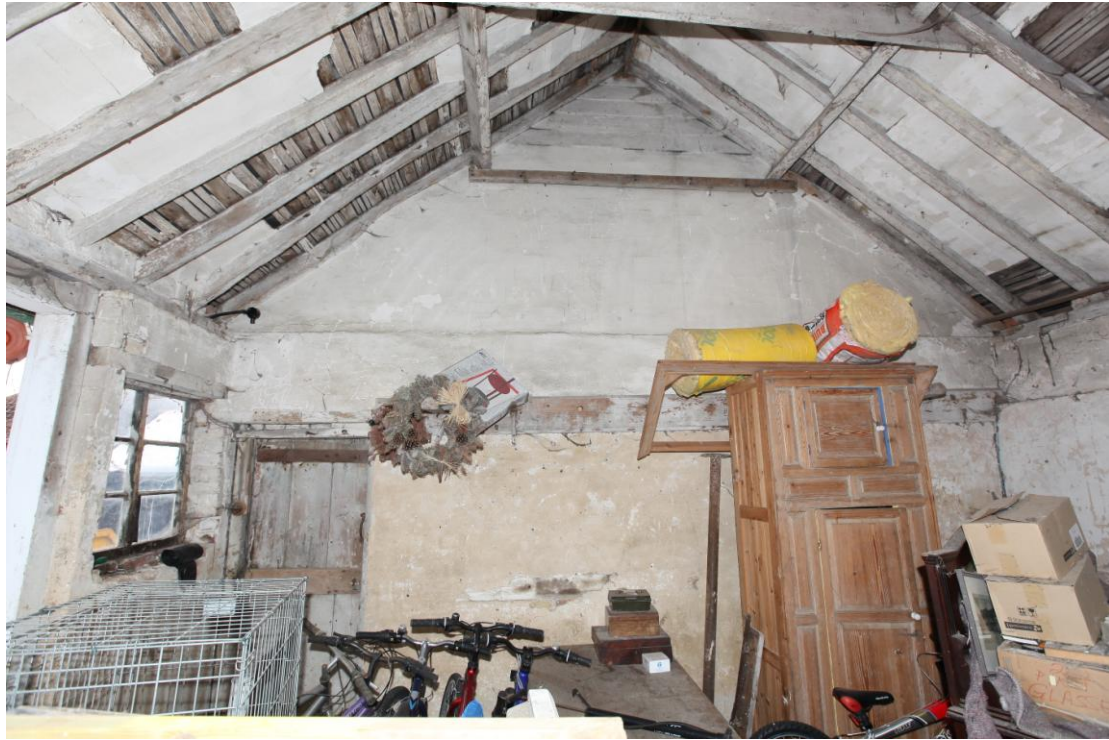
Illus. 9. Interior of central shed (B) from north-east showing internal door to southern shed (A) to left and harness hooks projecting from wooden rail in centre.

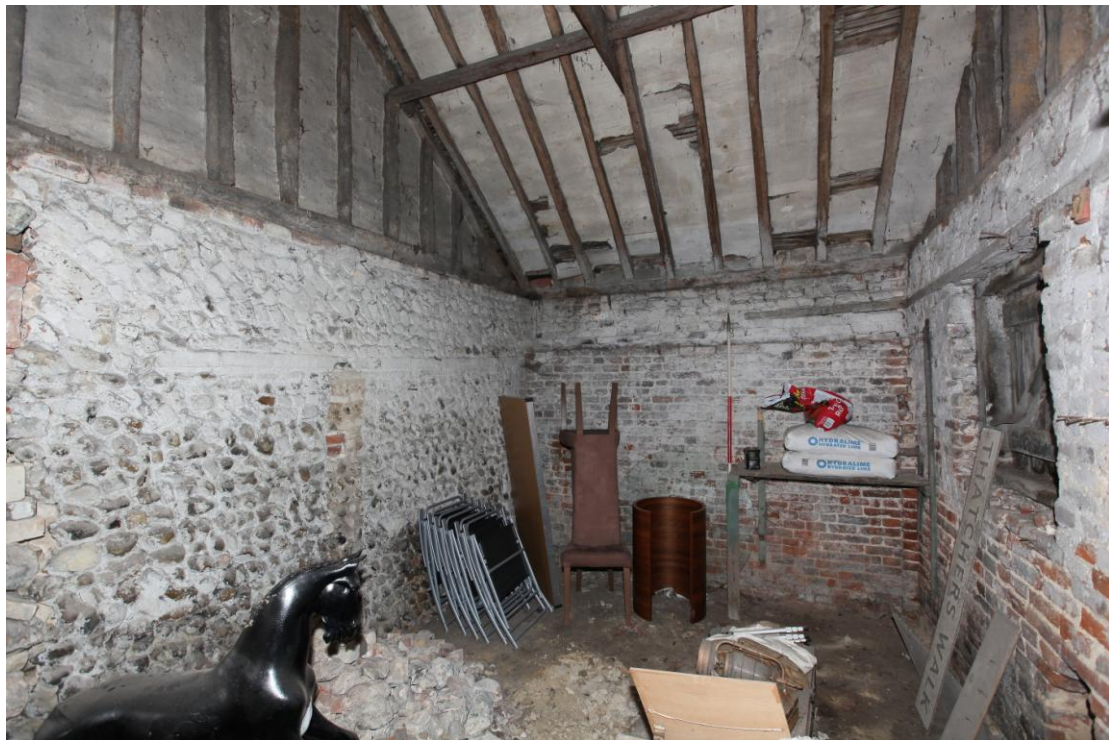
Illus. 10. Interior of northern shed (C) from south-west showing flint-rubble partition to central shed (B) to left. The shelf in the brickwork of the rear wall marks the 19th century 'lift' and is respected by a line of brick in the left-hand partition – suggesting its lower fabric may also pre-date the building of 1853.

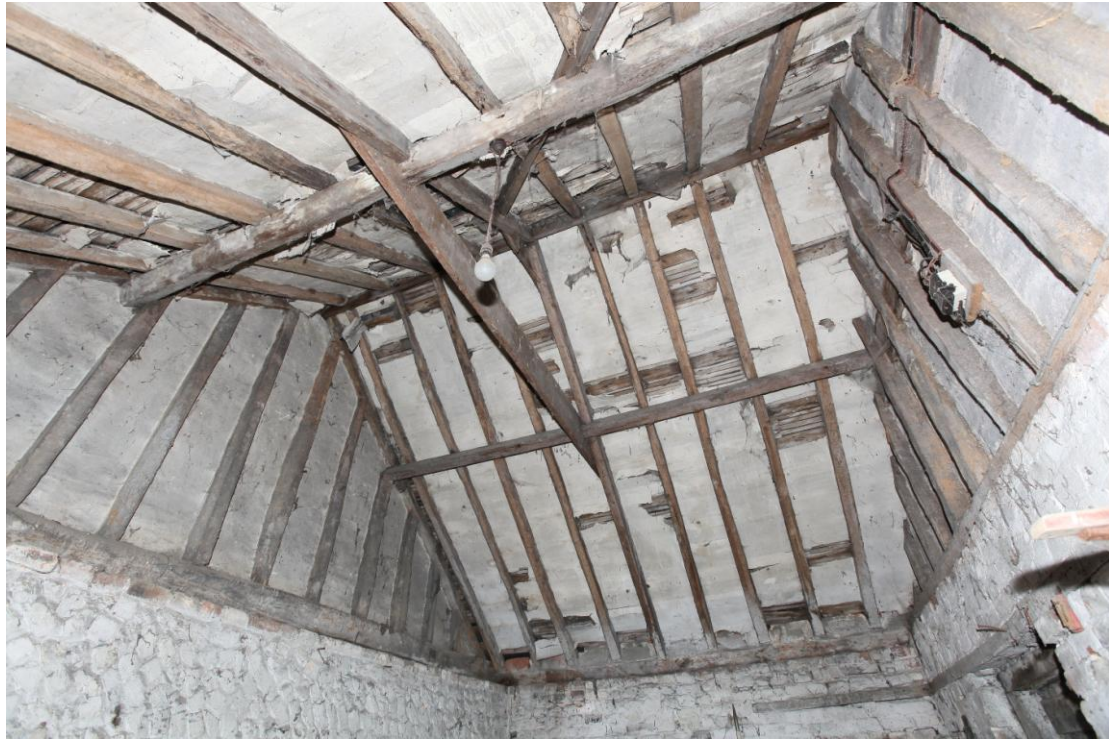
Illus. 11. The clased-purlin roof structure of the northern shed (C) with original lath-and-plaster, seen from the south-east showing the northern gable to the right.

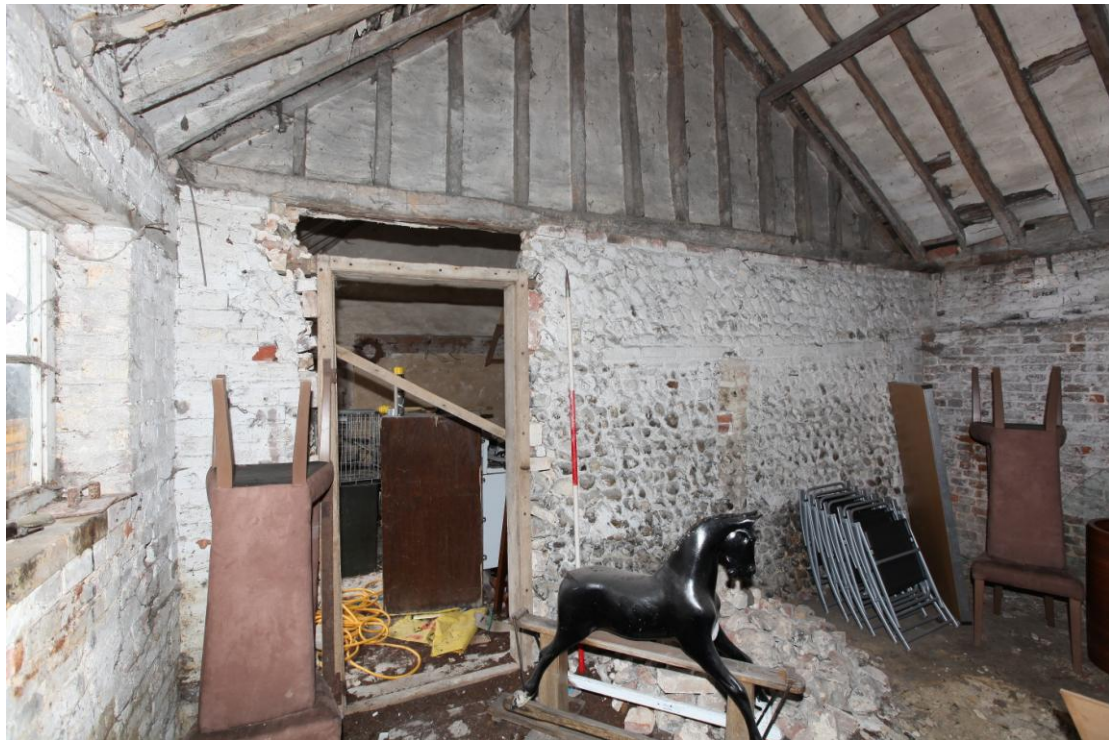
Illus. 12. The interior of the northern shed (C) from the north-east, showing the flint-rubble partition to the central shed (B) with evidence of a 'lift' above the brick course. The present doorway appears to have been inserted recently.
