New irrigation reservoir, Hill Farm,
Tuddenham
TDD 026

Archaeological Evaluation Report

SCCAS Report No. 2012/032

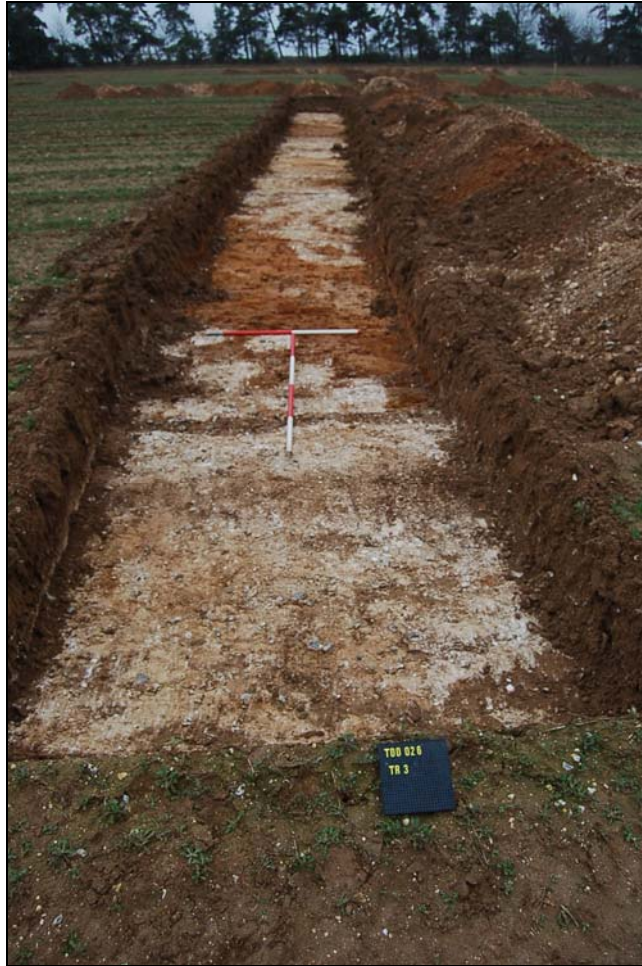
Plate 1. Trench 3, facing south (2m and 1m scales)

This trench was 30m long, 1.8m wide and up to 0.4m deep, orientated approximately north-south adjacent to the western edge of the site (Pl. 1). The stratigraphy encountered consisted of c.0.38m of mid greyish/orangey brown sandy silt topsoil over up to 0.05m of weathered chalk and mid orangey brown silty deposits interpreted as natural geological deposits and water-eroded natural drainage channels. No finds or features of archaeological relevance were observed in this trench.

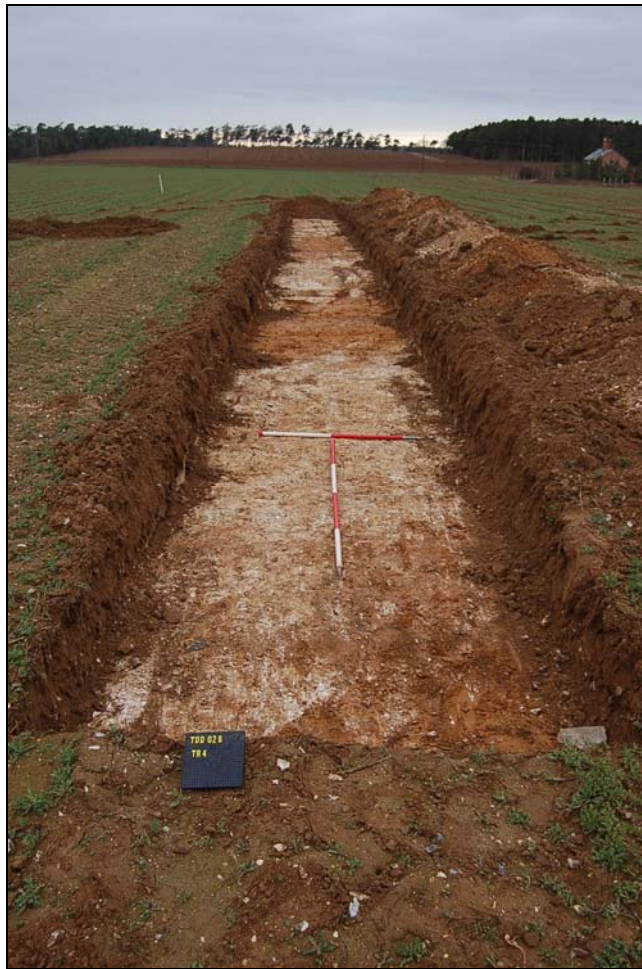
Plate 2. Trench 4, facing west (2m and 1m scales)

This trench was 30m long, 1.8m wide and up to 0.4m deep, orientated approximately east-west adjacent to the western edge of the site (Pl. 2). The stratigraphy encountered consisted of c.0.38m of mid greyish/orangey brown sandy silt topsoil over up to 0.05m of weathered chalk and mid orangey brown silty deposits interpreted as natural geological deposits and water-eroded natural drainage channels. No finds or features of archaeological relevance were observed in this trench.

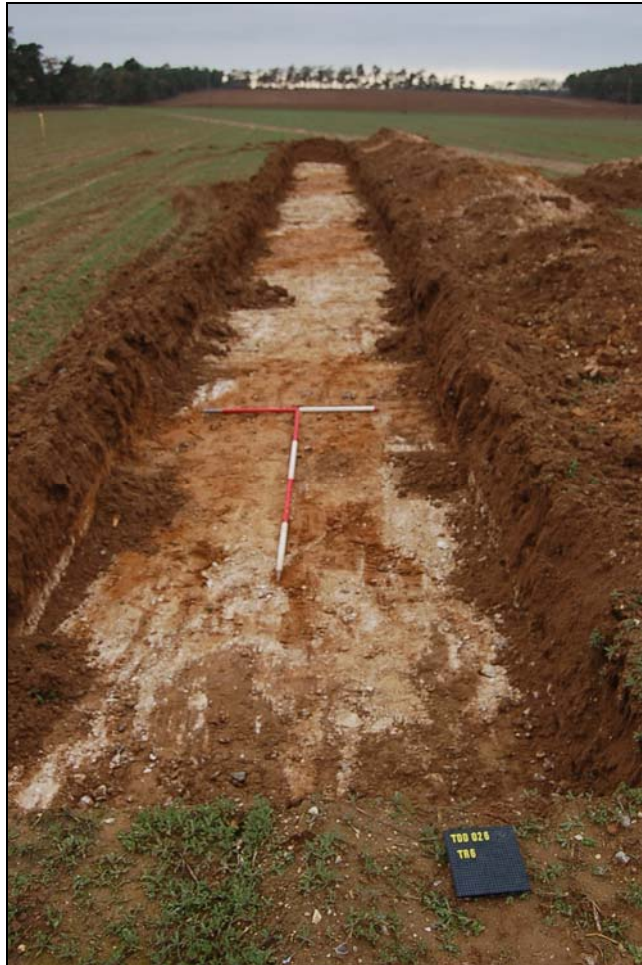
Plate 3. Trench 6, facing west (2m and 1m scales)

This trench was 30m long, 1.8m wide and up to 0.4m deep, orientated approximately east-west in the south-western corner of the site (Pl. 3). The stratigraphy encountered consisted of c.0.4m of mid greyish/orangey brown sandy silt topsoil over weathered chalk and mid orangey brown silty deposits interpreted as natural geological deposits

and water-eroded natural drainage channels. No finds or features of archaeological relevance were observed in this trench.

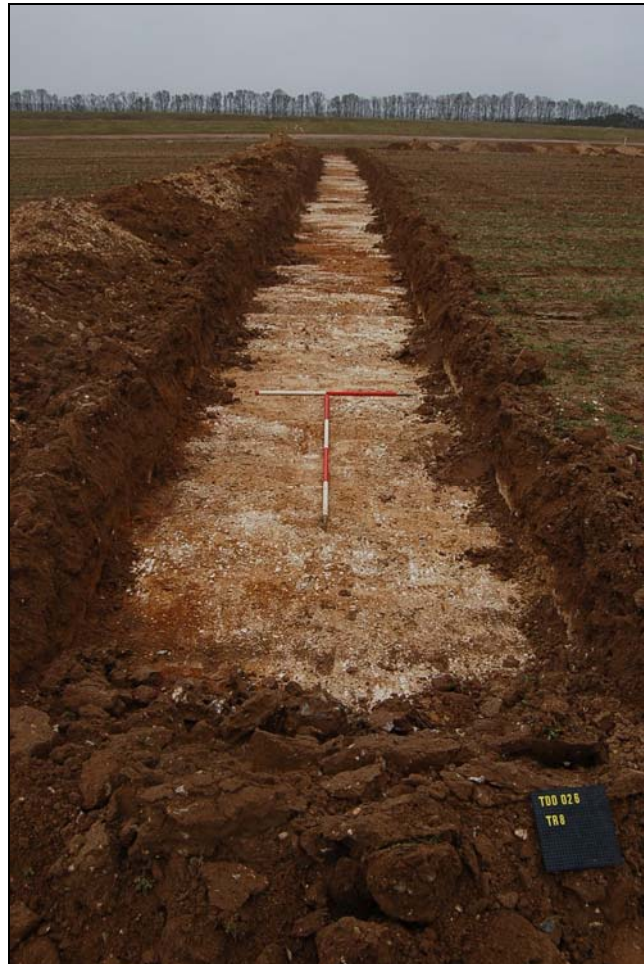
Plate 4. Trench 8, facing south (2m and 1m scales)

This trench was 50m long, 1.8m wide and up to 0.38m deep, orientated approximately north-south towards the centre of the site (Pl. 4). The stratigraphy encountered

consisted of c.0.38m of mid greyish/orangey brown sandy silt topsoil over weathered chalk and mid orangey brown silty deposits interpreted as natural geological deposits and water-eroded natural drainage channels. No finds or features of archaeological relevance were observed in this trench.

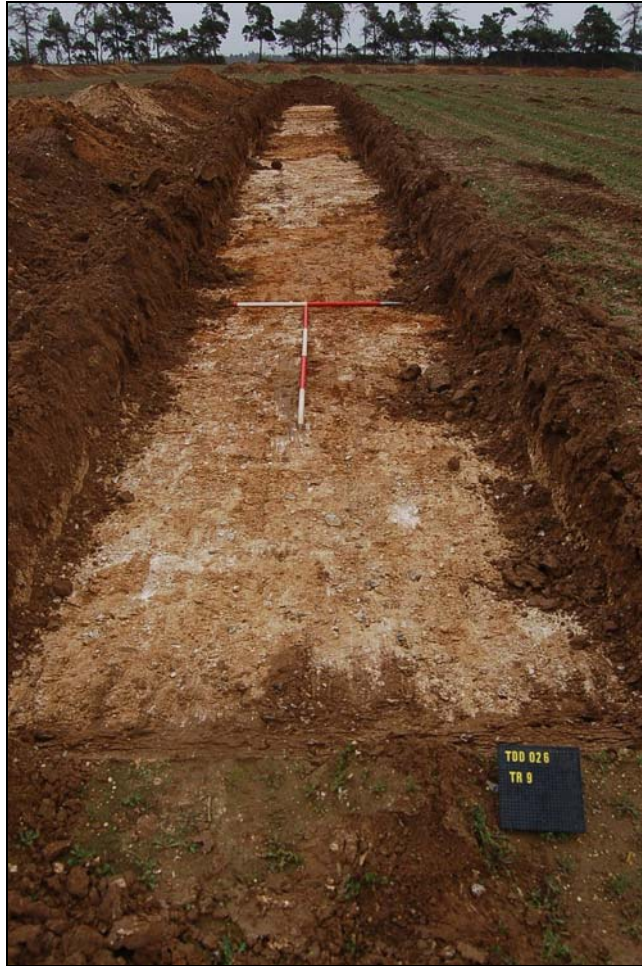
Plate 5. Trench 9, facing east (2m and 1m scales)

This trench was 30m long, 1.8m wide and up to 0.36m deep, orientated approximately east-west in the centre of the site. The stratigraphy encountered consisted of c.0.36m of mid greyish/orangey brown sandy silt topsoil over weathered chalk and mid orangey brown silty deposits interpreted as natural geological deposits and water-eroded natural drainage channels. No finds or features of archaeological relevance were observed in this trench.

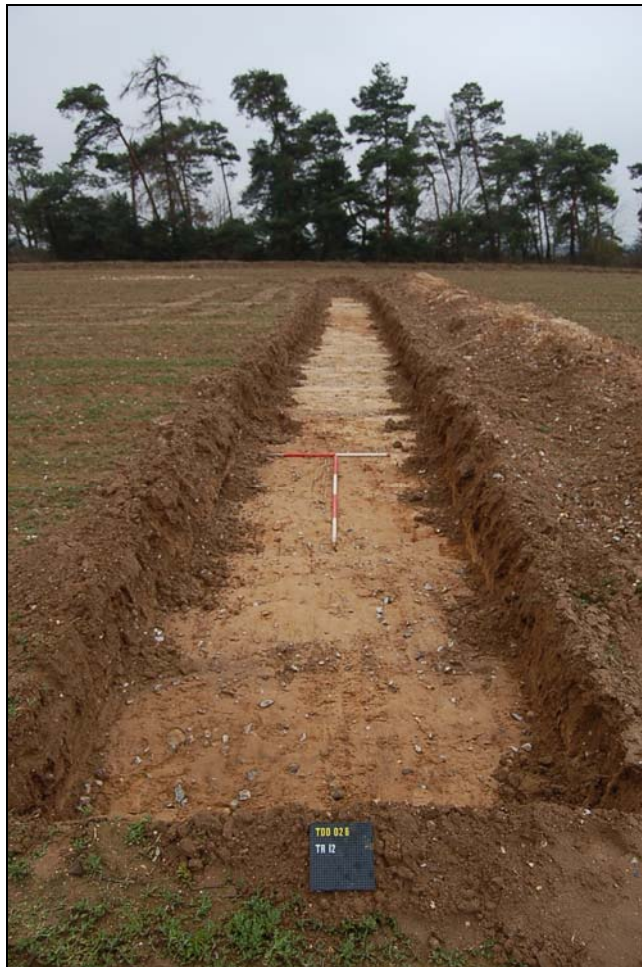
Plate 6. Trench 12, facing south (2m and 1m scales)

This trench was 30m long, 1.8m wide and up to 0.4m deep, orientated approximately north-south crossing the southern boundary of the site (Pl. 6). The stratigraphy encountered consisted of c.0.4m of mid greyish/orangey brown sandy silt topsoil over weathered chalk and mid orangey brown silty deposits interpreted as natural geological deposits and water-eroded natural drainage channels. No finds or features of archaeological relevance were observed in this trench.

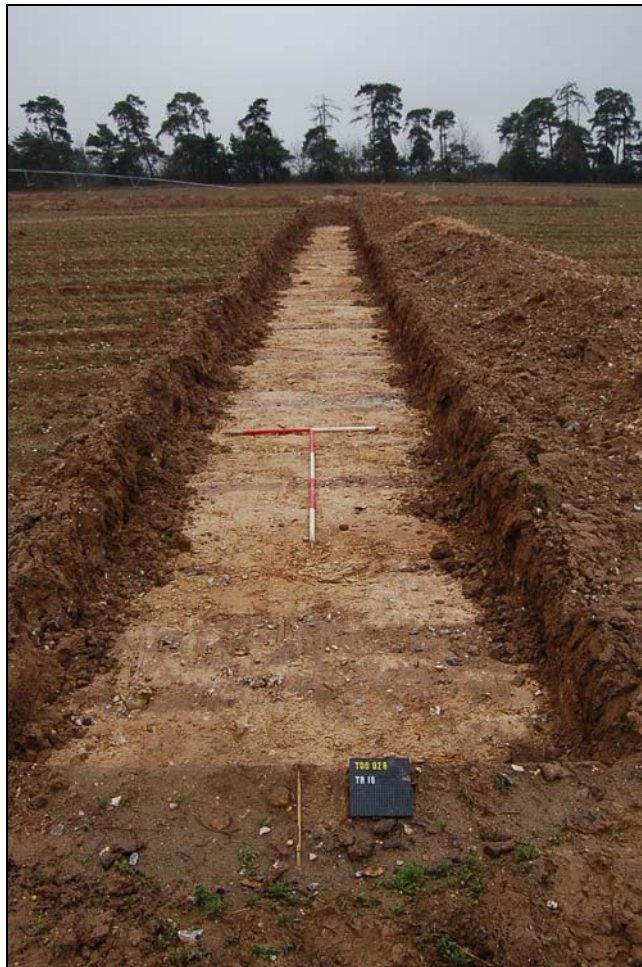
Plate 7. Trench 16, facing east (2m and 1m scales)

This trench was 30m long, 1.8m wide and up to 0.35m deep, orientated approximately north-south towards the north-eastern corner of the site (Pl. 7). The stratigraphy encountered consisted of c.0.35m of mid greyish/orangey brown sandy silt topsoil over weathered chalk and mid orangey brown silty deposits interpreted as natural geological deposits and water-eroded natural drainage channels. No finds or features of archaeological relevance were observed in this trench.

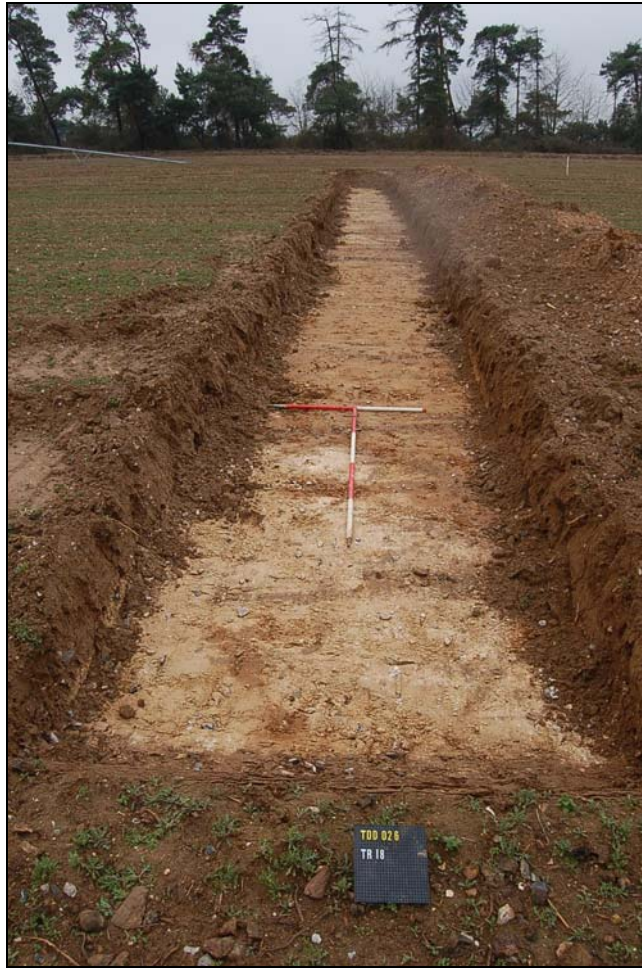
Plate 8. Trench 18, facing east (2m and 1m scales)

This trench was 30m long, 1.8m wide and up to 0.36m deep, orientated approximately north-south by the southern boundary of the site (Pl. 8). The stratigraphy encountered consisted of c.0.36m of mid greyish/orangey brown sandy silt topsoil over weathered chalk and mid orangey brown silty deposits interpreted as natural geological deposits

and water-eroded natural drainage channels. No finds or features of archaeological relevance were observed in this trench.
