Survey of the Keep at Mettingham Castle MTT 003

Archaeological Excavation & Survey Report

SCCAS Report No. 2012/022

Survey of the Keep at Mettingham Castle

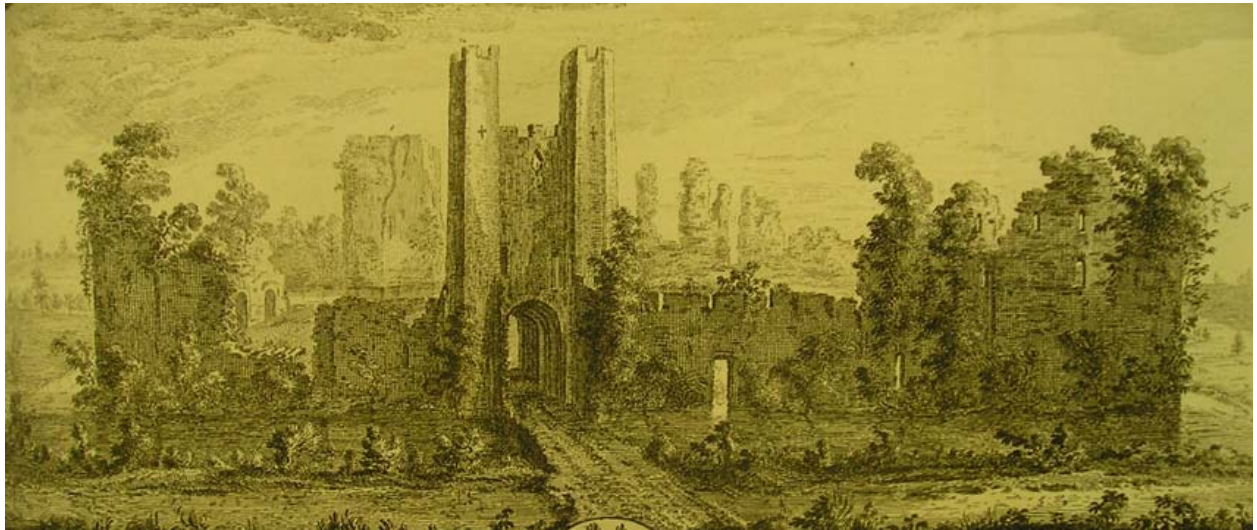
Figure 4. Buck's view of the castle from the north published in 1738 and dedicated to the then owner Tobias Hunt Esq.

(This earliest image of the castle shows the NW tower of the keep in the background to the left of the gatehouses and further ruins, possibly the remains of the SW gatehouse, to the right. The keep is separated from the main north court by a moat and the large crack which splits the tower already appears to be well advanced. Note that the barns which about the interior of the curtain walls in later illustrations are absent).

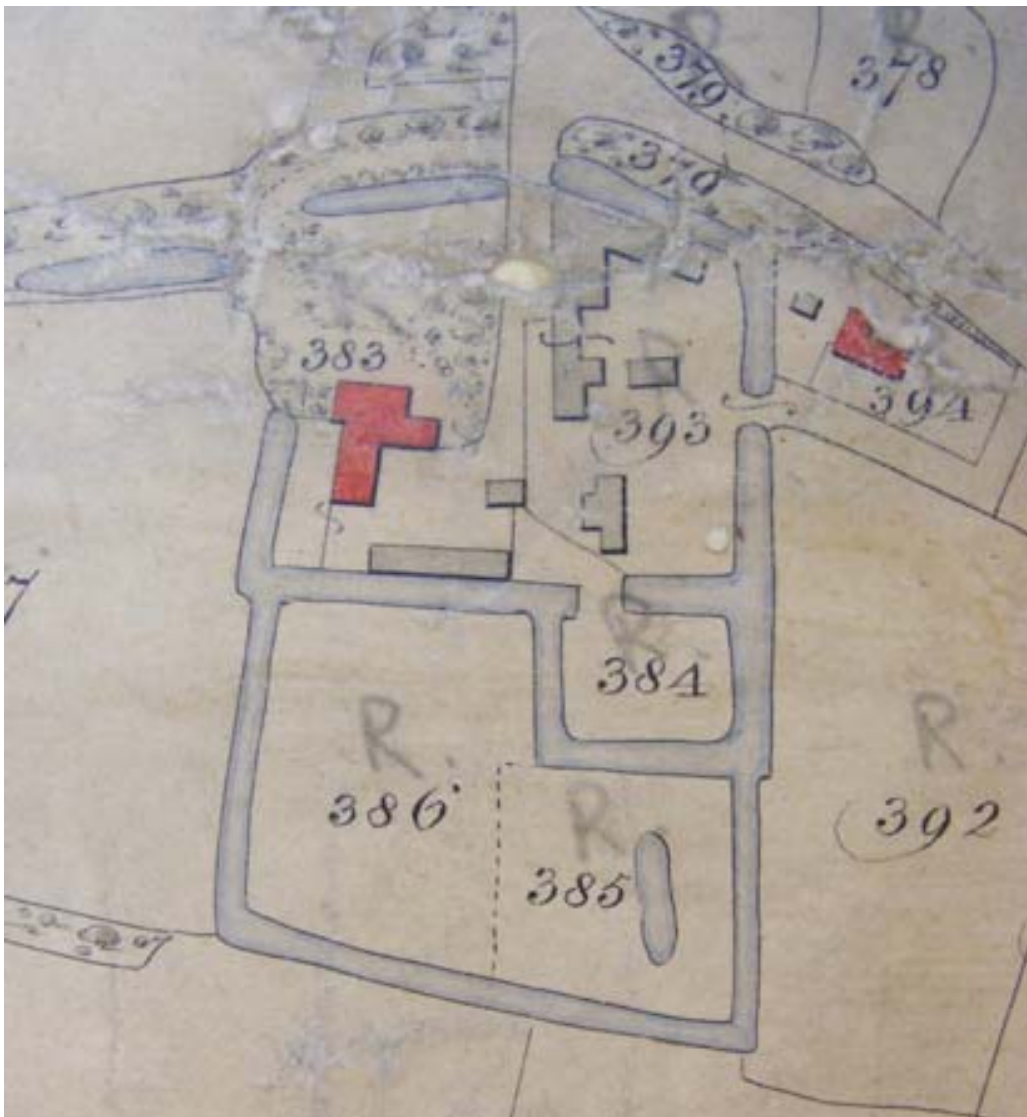
Figure 5. Tithe map of 1846 (Ips. RO ref FDA175/A1/1b)

The residence built by the Rev. Safford is shown in red (383) incorporating the ruins of a highly decorated building purportedly constructed by Dame Margaret de Norwich. The moats surrounding the two baileys are shown as almost a complete circuit with 'causeways' providing access to the base court through the main gate to the north and to the estate farmhouse (394) to the east. The west moat was probably infilled by Safford to create the carriage drive for his new house (See image 14 Appendix 4). The tithe apportionment describes 384 as 'castle yard', 385 as 'garden' and 386 as 'orchard'. A large linear pond is shown in the south garden and a lean-to building is shown attached to the north face of the base court's southern curtain wall.

The NW tower would have completed the circuit of the curtain wall enclosing the keep but any attempts to understand this corner were frustrated. The west wall was truncated before its projected junction with the tower and the presence of a large cedar tree stump at the end of the west wall prevented the geophysics team from gathering data. The interval between the ends of the north and west curtain walls was 8.5m suggesting that the tower had a greater footprint than the standing ones. The tower almost certainly contained a gateway, which controlled entry into the keep, and a causeway across the moat is shown at this point on the early maps (Fig. 5).

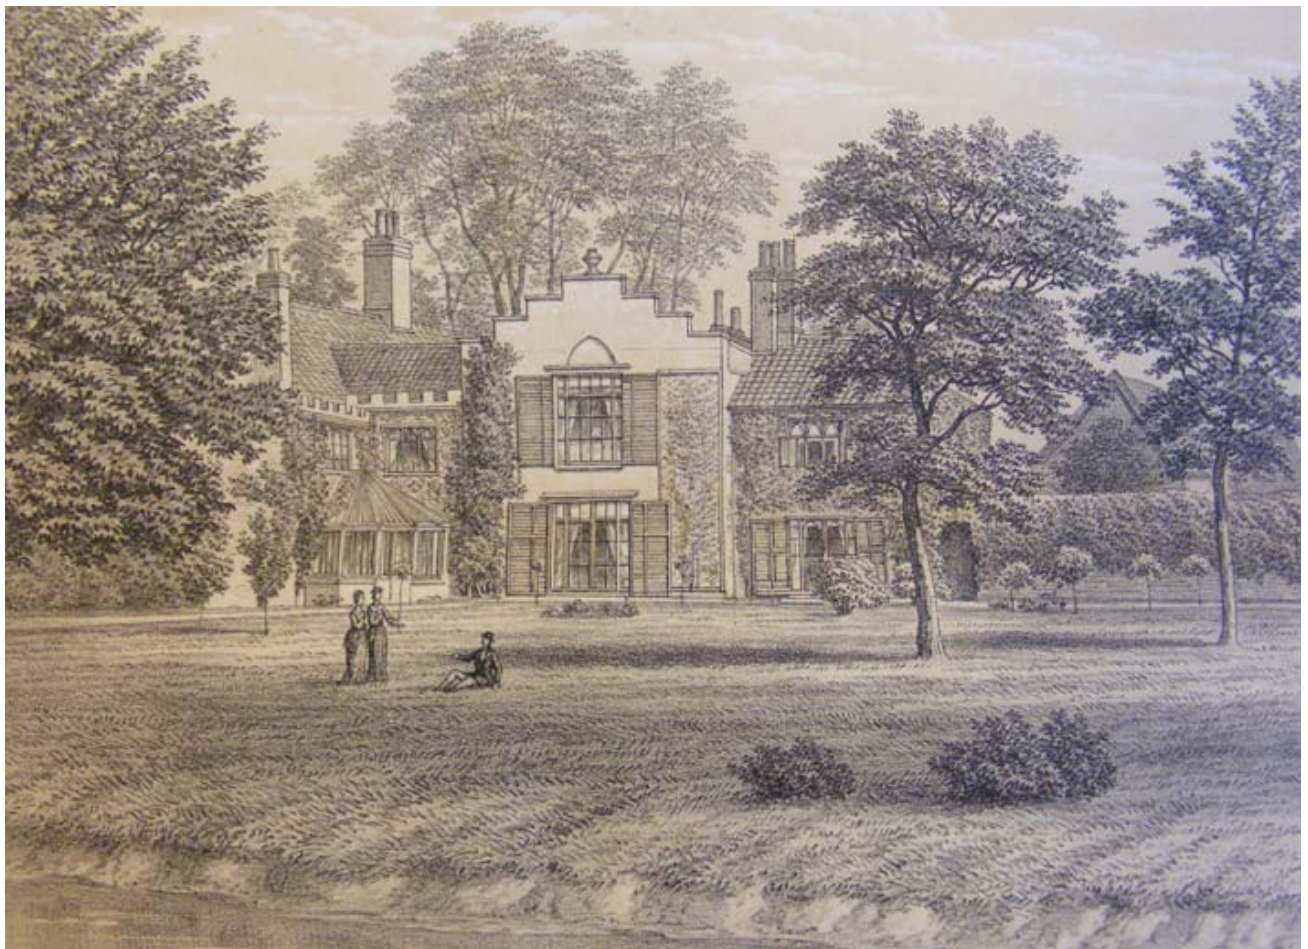
Figure 7. The residence built by Rev. Safford in the first half of the 19th century.

This shows the building viewed from the west across the still open west arm of the moat. It was constructed on the site of a previous dwelling which been created from an existing medieval building, part of which was retained within the angle of the house. The house was built over cellars of an unknown date and a geophysics survey identified a large anomaly on the site of the wing shown facing in this picture and the north (left) of the house. This building was knocked down in 1880 (picture from the sale details of 1876 (Ipswich Record office HD113/2/65)

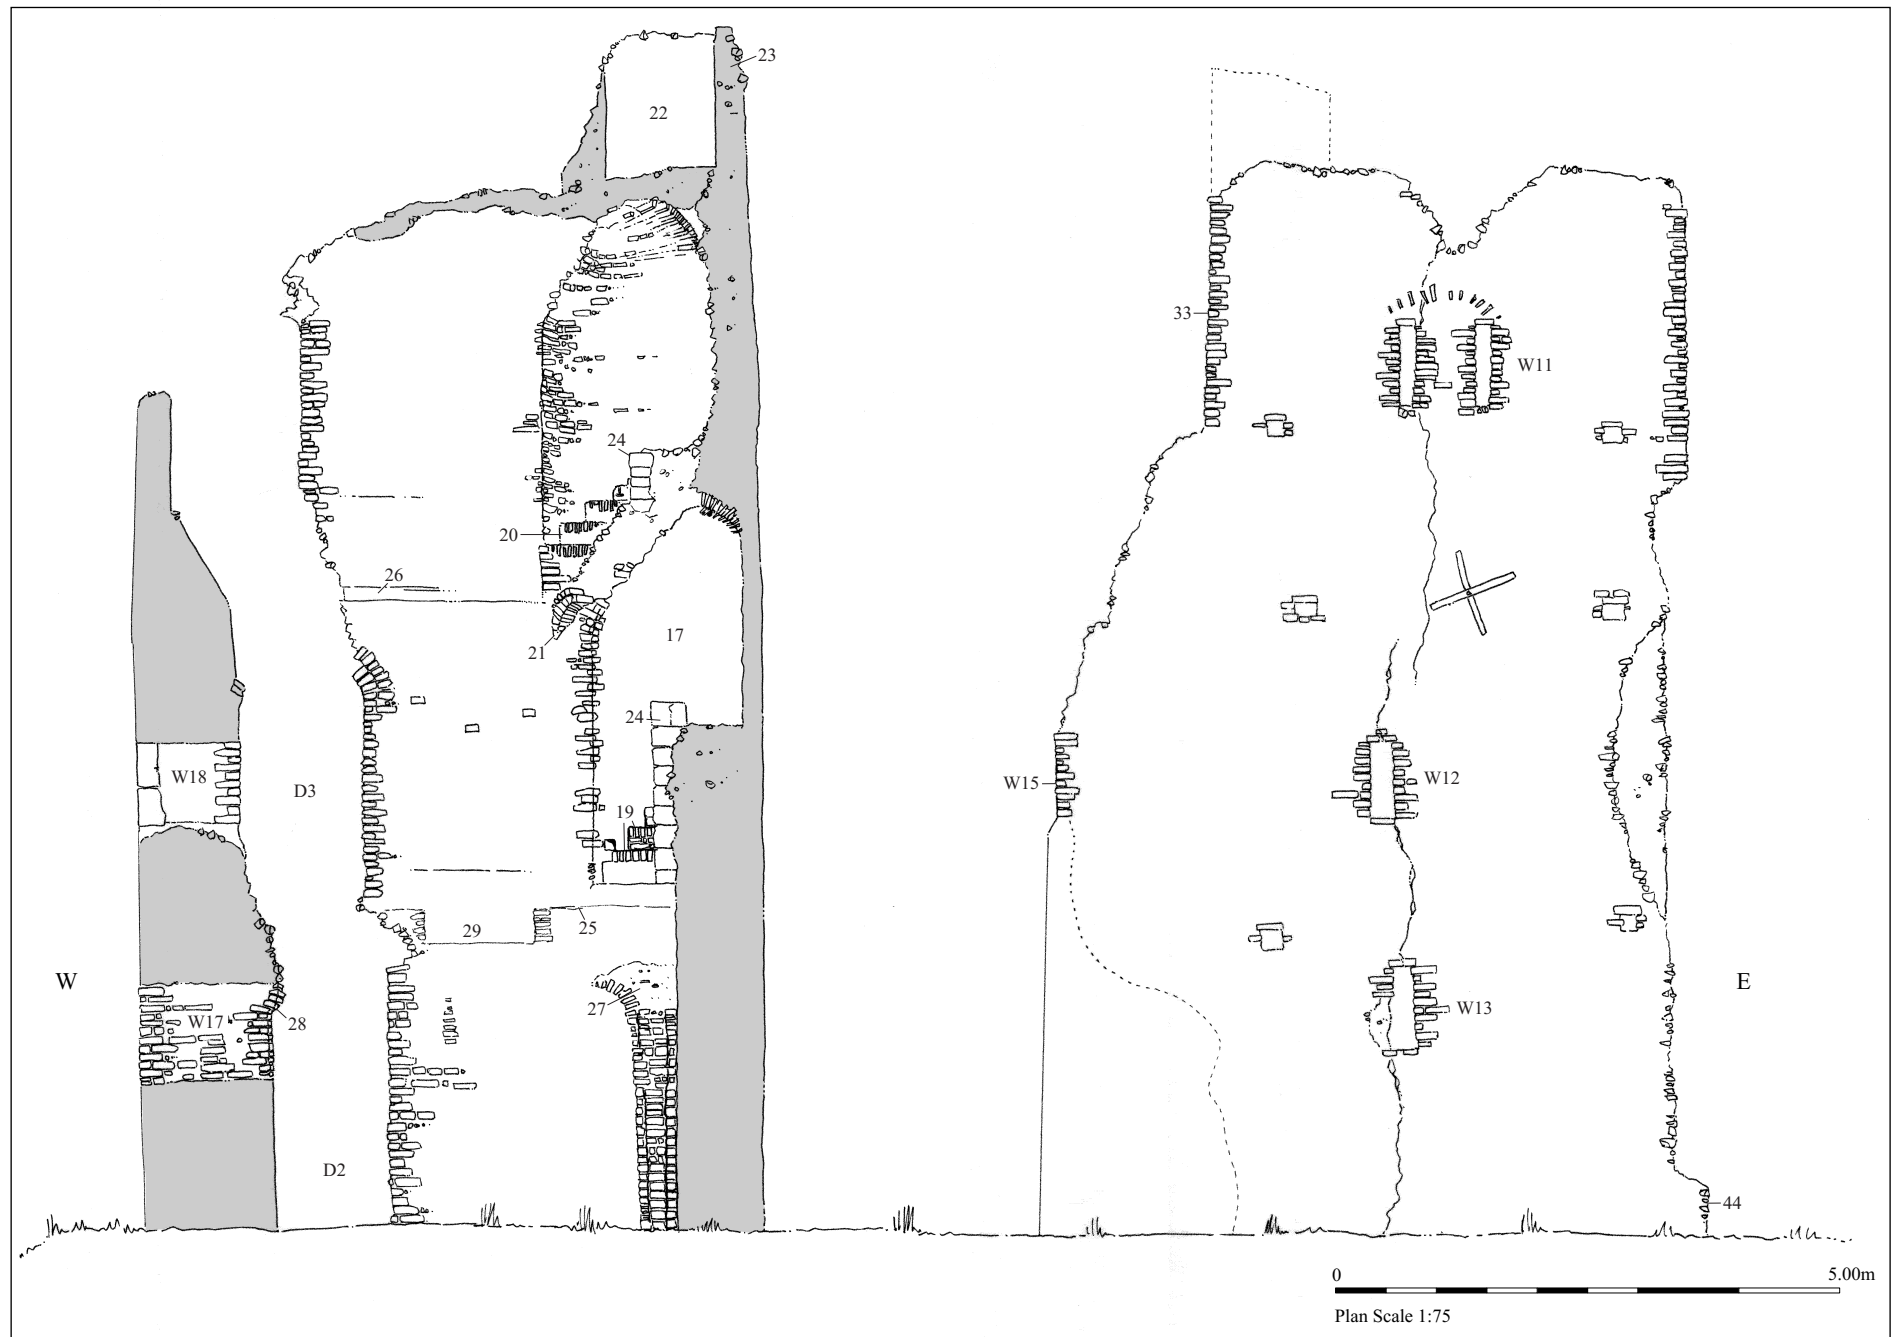
Figure 10. South-west tower (left) and Central tower (right) from the South.

When built, the exterior walls of the SW tower were continuous with the west and south curtain walls and together with the south central tower (T4) formed part of the structure of the timber-framed hall. The tower was built over three floors (including the ground floor),

The south facing window opening was split into two narrow slits (**Fig. 10 W11**) which each measured 0.8m x 0.1m on the exterior elevation. The division between the two openings was maintained for half the depth of the wall before opening out into a single, wide reveal. Over the slits, where the span is narrow, of the wall above the window is supported on timber lintels made up of a pair of stout planks but above the wider reveal a strainer arch is used. Repairs to the setting of the planks suggests that the planks have been replaced but they replicate the original to the build. The thickness of the south wall, the external wall of the keep, is 1.2m and greater than that of the other walls of the tower (1m).

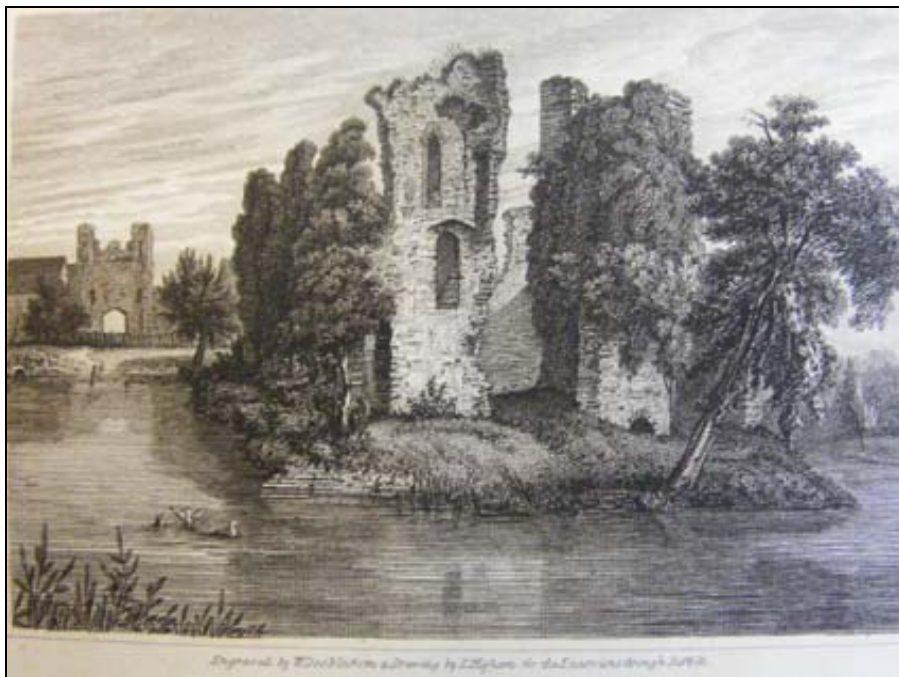
Figure 11. An engraving of the SW tower published in 1819 from a drawing by I. Higham. Note the entrances to the stairwell intact and the corbelled vault above the first floor to support the top half of the stairwell, also what appears to be a revetment to the moat island at the water's edge and drain outlet at the base of the mid tower (Ips. RO ref HD1678/97/2)

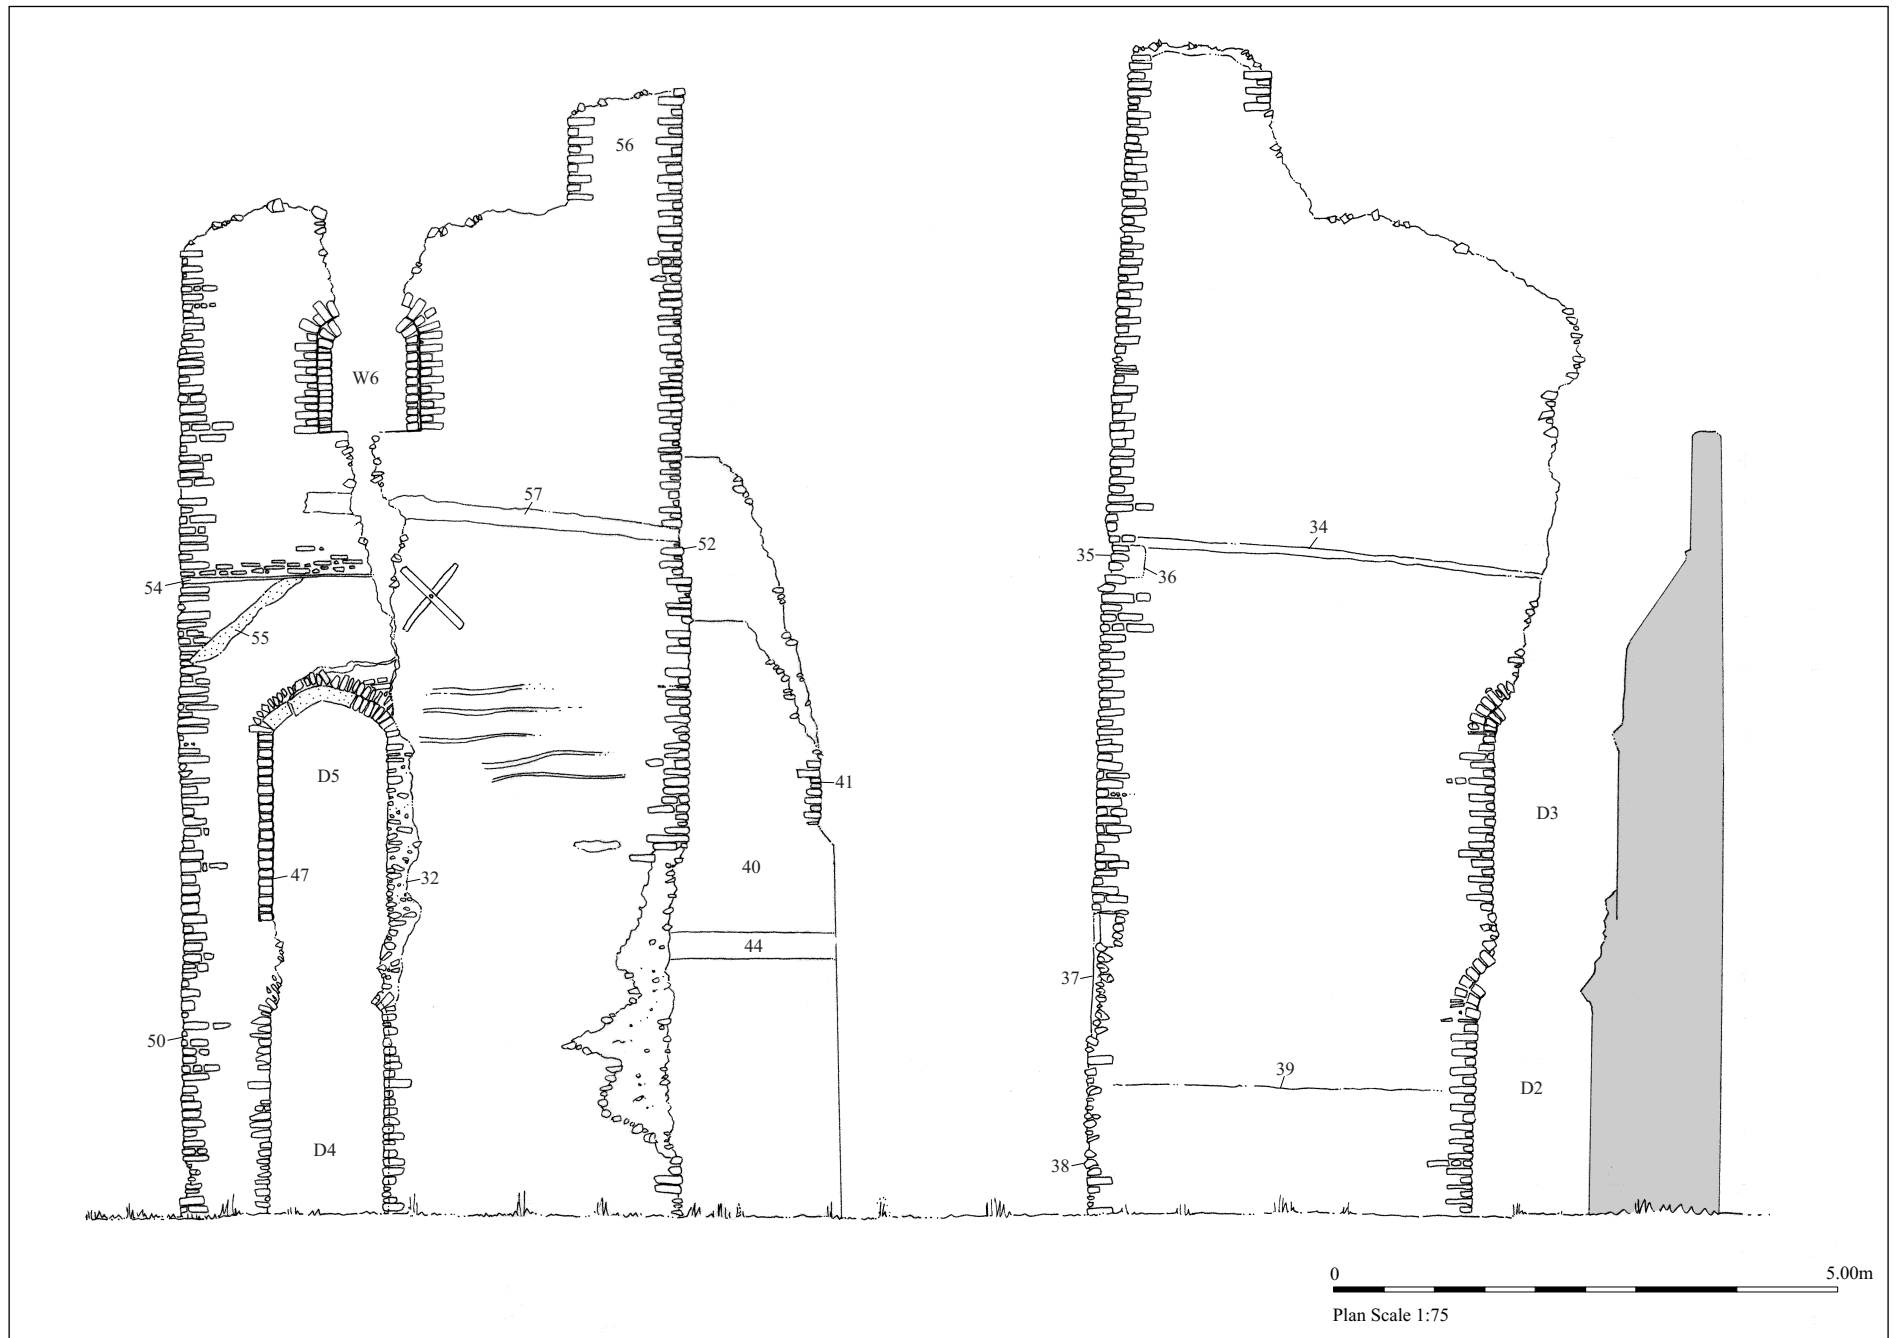
Figure 12. Central tower (left) and southwest corner tower (right) from the north.

Ledges (**25 and 26**) created by the diminishing wall thickness at each floor level provided a setting for the floor joists on the north wall and at the base of the stairs. Below the first floor these were supported by brick corbelling (**27**), which projected in a curving arc and bisected the NE and NW corners. On the east side the corbelling simply underpinned the stairs but on the west side there appeared to be the stub of a narrow rib-vault (**28**). The vaulting was low (springing from a point lower than the door arch) and was set away from the door to avoid restricting the passage through it – although the entrance and the window on the west wall were still compromised. The rib-vault projected toward the diagonally opposite (now missing) SE corner of the tower. The

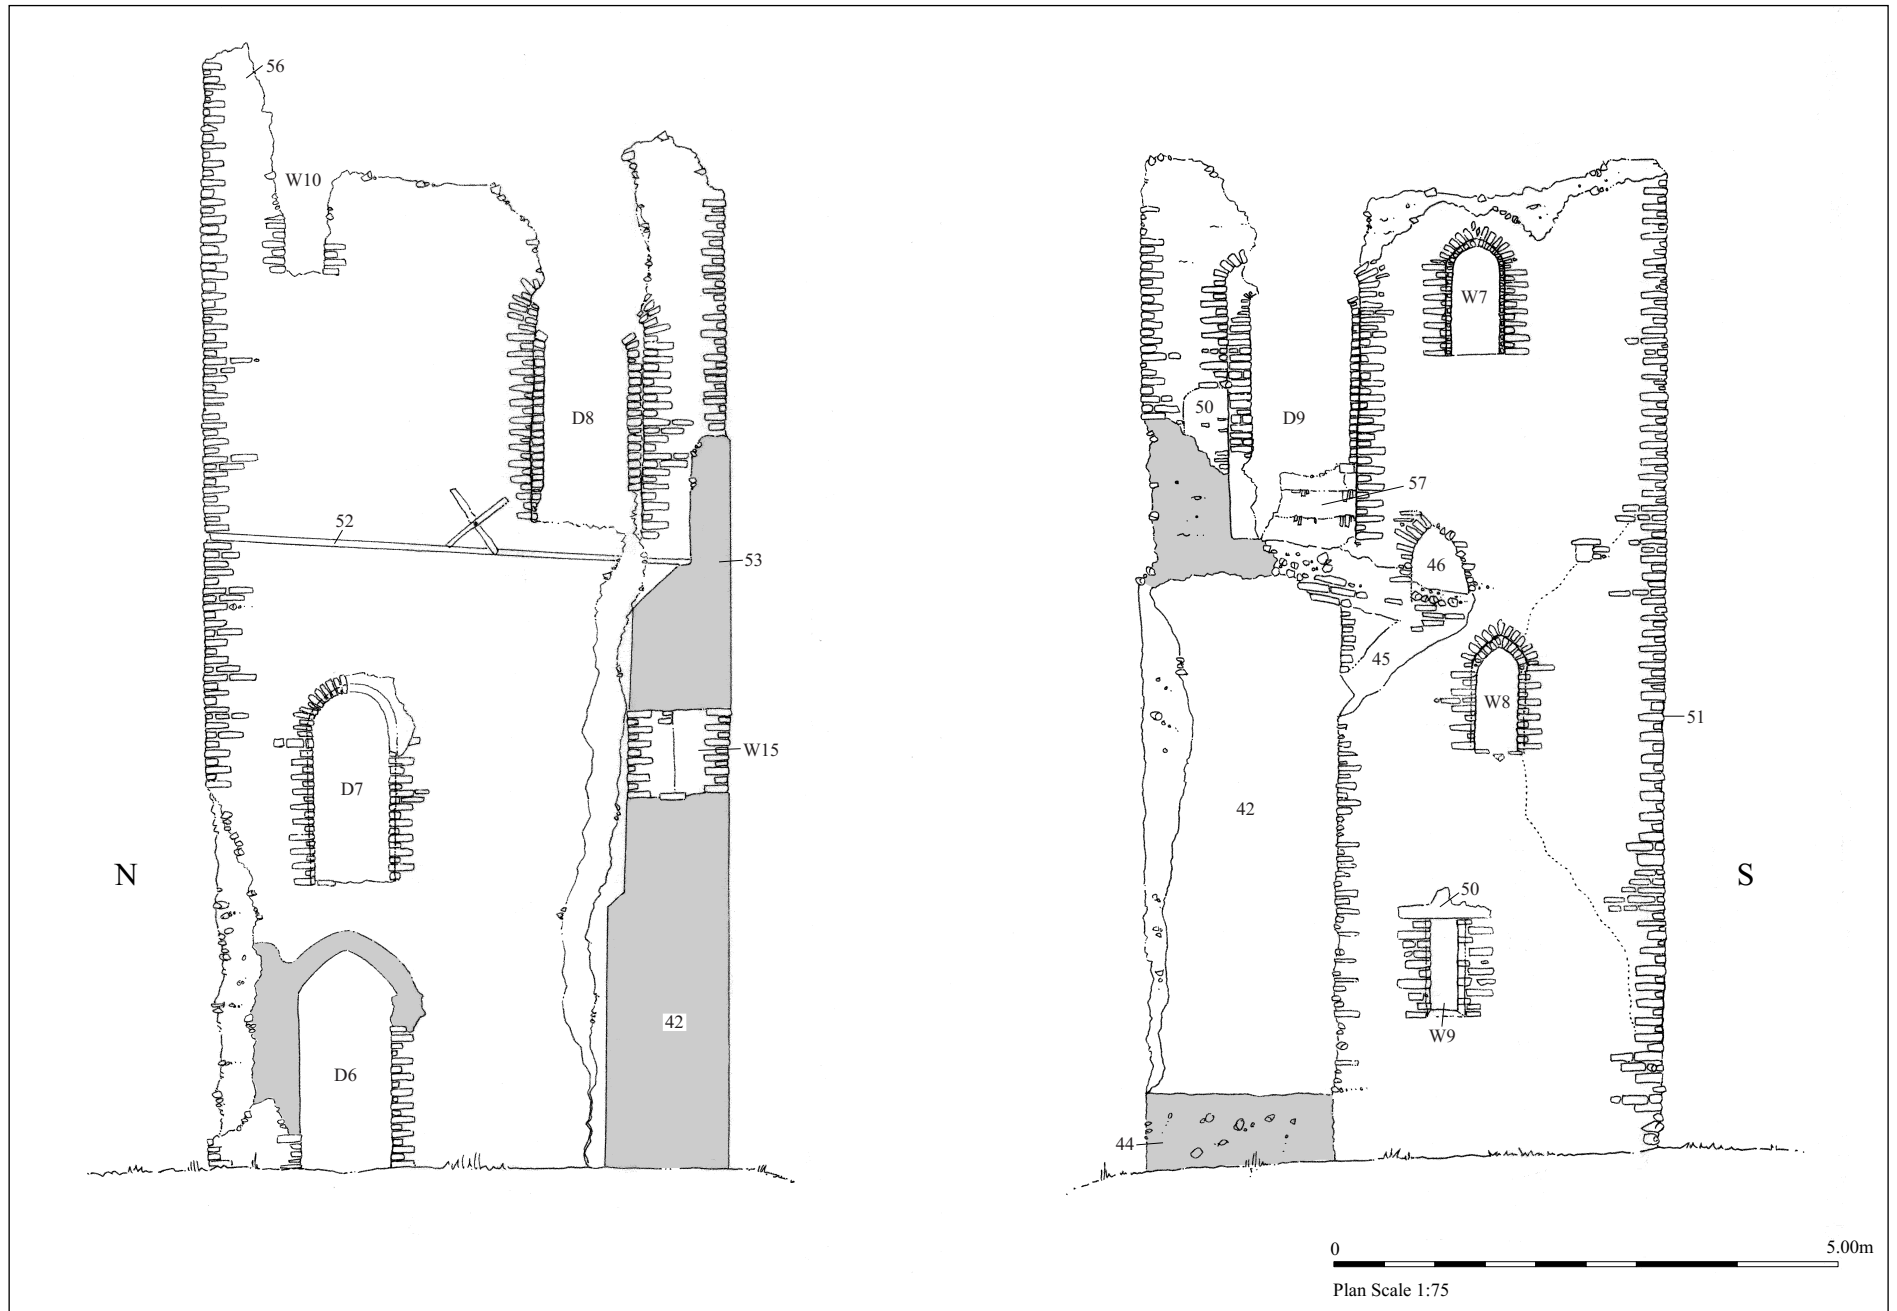
Figure 13. South mid-tower. East (right) and West (left) elevations

The central tower is the best-preserved component of the keep with all four walls standing to close to their full height. The tower stood at the SE corner of the hall and was originally joined to the SW tower by a curtain wall, which formed the south end of the manor house. Only a short stub of the curtain wall remained **(40)**, projecting from the central tower's SE corner. The shear point where the south curtain wall had collapsed has been consolidated in the past and repaired by creating a squared-off terminal. This showed the stepped profile of the curtain wall in cross-section where the first floor and hall roof and wall walks were lodged (Fig.13, **44**). The curtain wall survives to its full height, demonstrable by the extent of the brick quoin on the tower corner. It is 7.30m high and at its base 1.2m thick, dimensions it shares with the curtain wall on the north side of the keep. Metric comparisons with the better preserved north wall indicated that the south wall was also crenellated and was attached to the mid tower at a raised merlin. However the extended section of parapet which shielded the doorways to the tower's upper rooms on the north wall did not occur here. The vertical line of truncation of the south curtain wall occurred through a window (Fig. 12, **41**) on the first floor and the internal face of the east jamb is preserved in the end elevation of the wall. The window was at the same level as the first floor window in the tower and

The north half of this face is pierced by a window on each of the three floors (**W7, W8 and W9**); the windows although vaguely in the middle of this part of the elevation did not align and instead respect internal features within the tower. The upper story windows have arched heads and all are relatively wide openings (0.4m x 0.9m with external splays) which reflect their position looking into the courtyard compared to the slit windows that look out to the south (Fig. 10). The former arch of the ground floor window (**W9**) had been removed and replaced with a wooden lintel (**50**) which in turn was badly rotted.

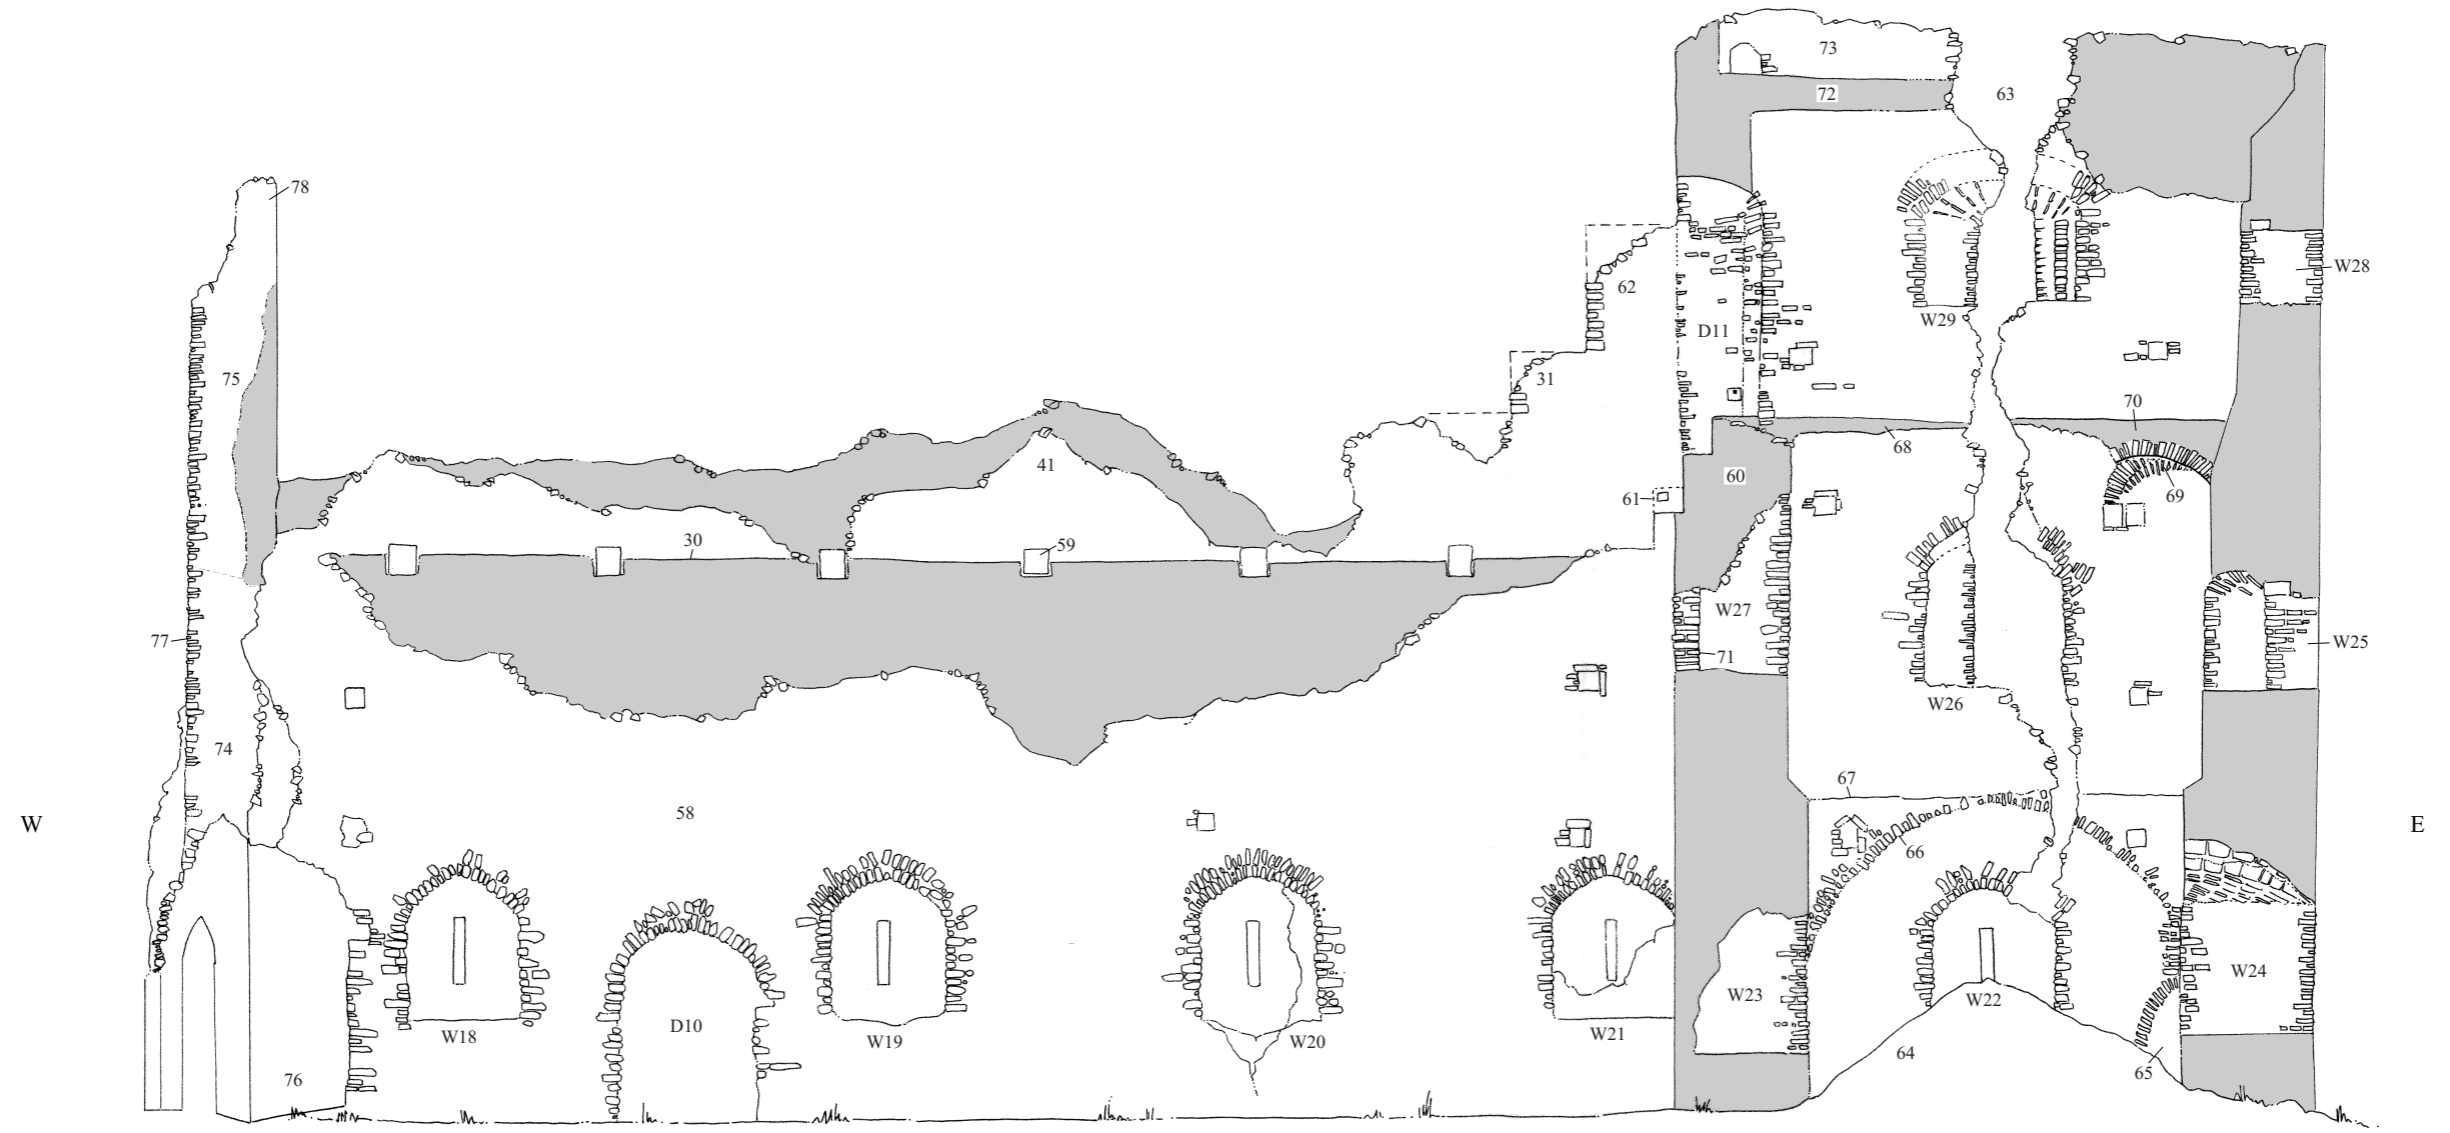
The crenellations at the top of the parapet were edged with brick similar to the quoins and edging of the openings. Although almost entirely missing, enough brickwork survived at the top of the wall to establish that the merlins were square with a height, width and interval of 0.65m and that the height of the parapet was 1.3m between the merlins and 1.95m behind them. Alongside the east tower a short section of the parapet **(62)** was raised by a further 1.2m and provided protection to anyone standing on the steps to the tower's upper floor (Pl. 19 Appendix 2).

Below the wall-walk the curtain wall was pierced by an alignment of five ground floor narrow windows **(W18-22)** including the one in the east tower and a low door **(D10)**, all of which are now blocked. The windows were at the same height (1.3m to the sill) and equally spaced presenting from the outside an even row of slits 3.5m apart. The pattern was interrupted at the west end of the wall where the last two windows were set 4.15m apart to accommodate a small door **(D10)** set between them. Externally the windows

Figure 14. Interior elevation. North curtain wall with Northwest and Northeast corner towers.

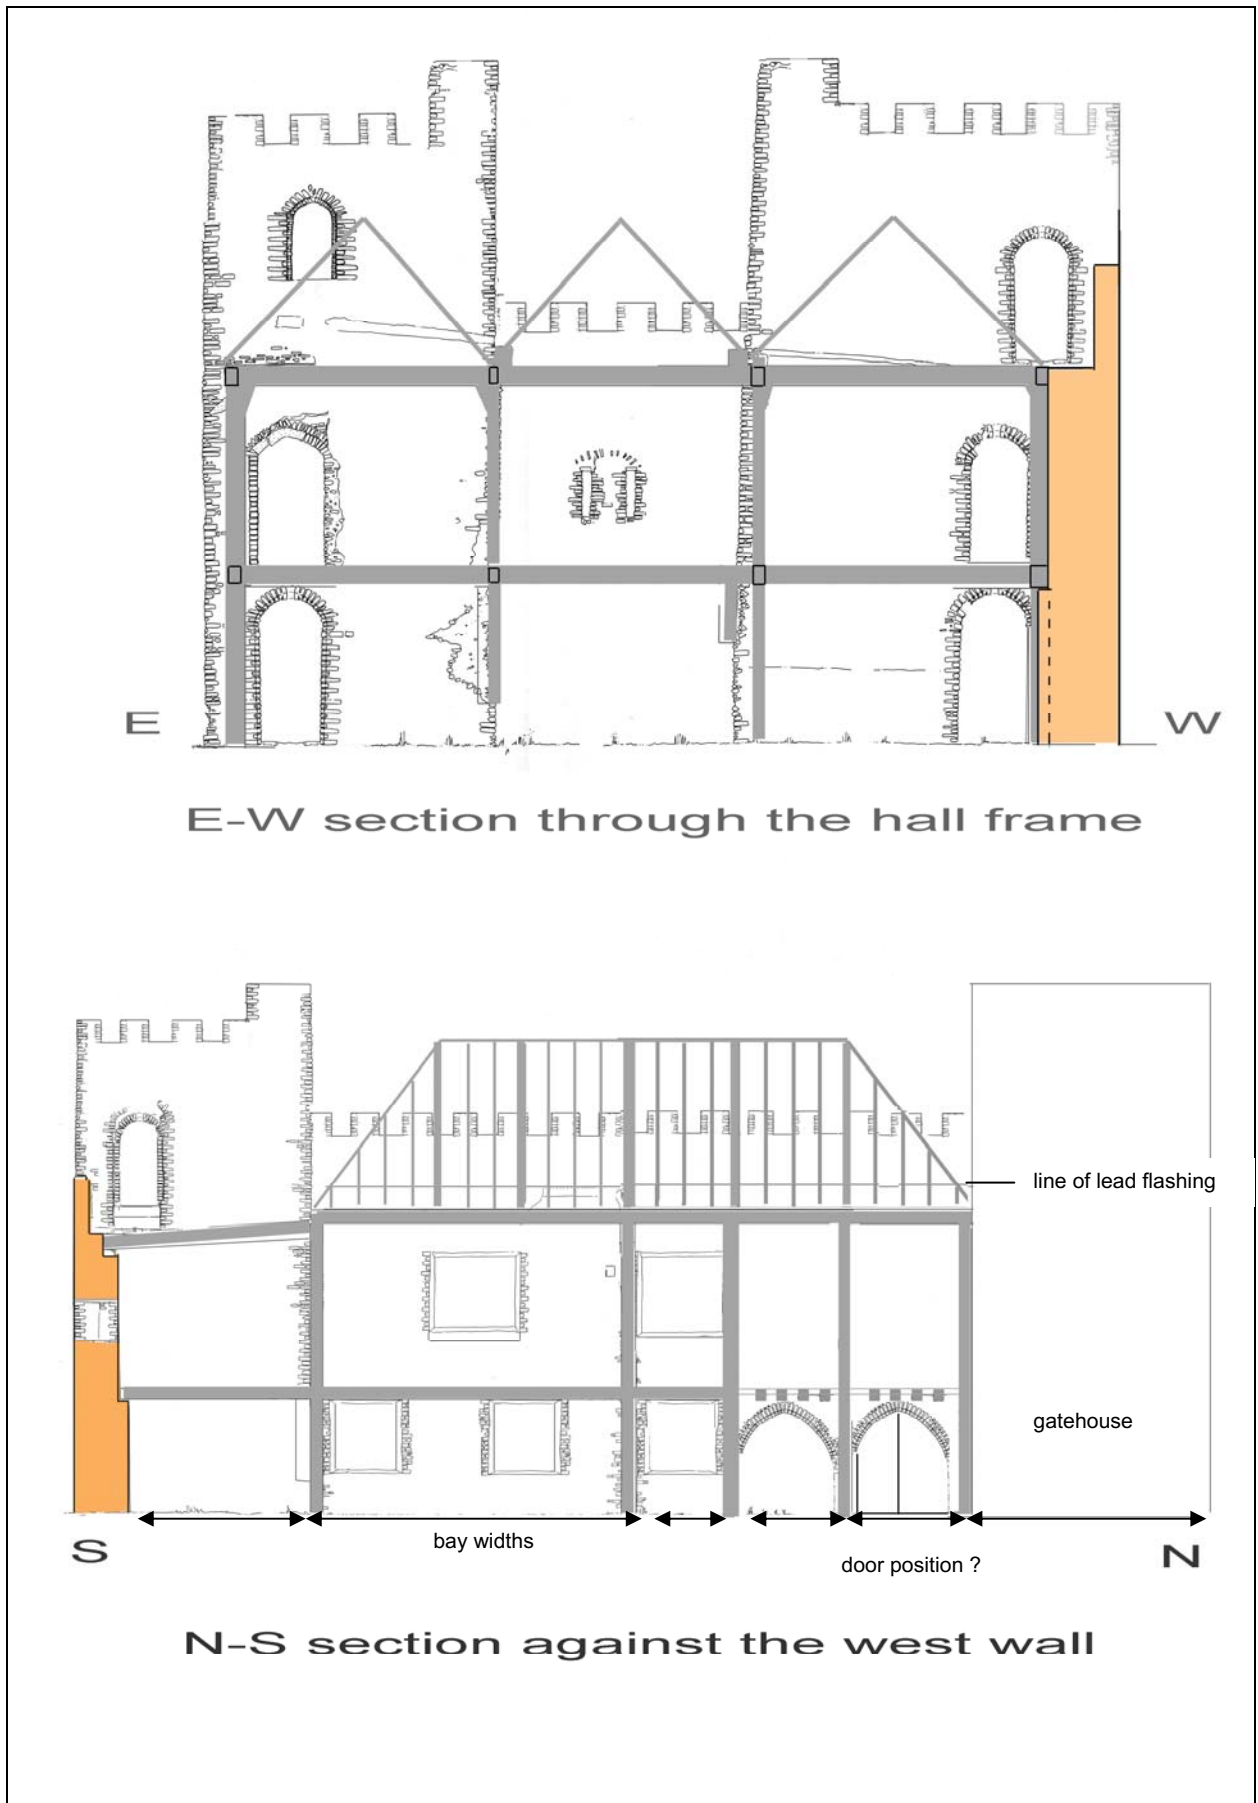
Figure 16. Hypothesised reconstructions of the hall frame. Preferred triple-ridged roof alternative whereby the manor house is formed by with three conjoined ranges of equal length.

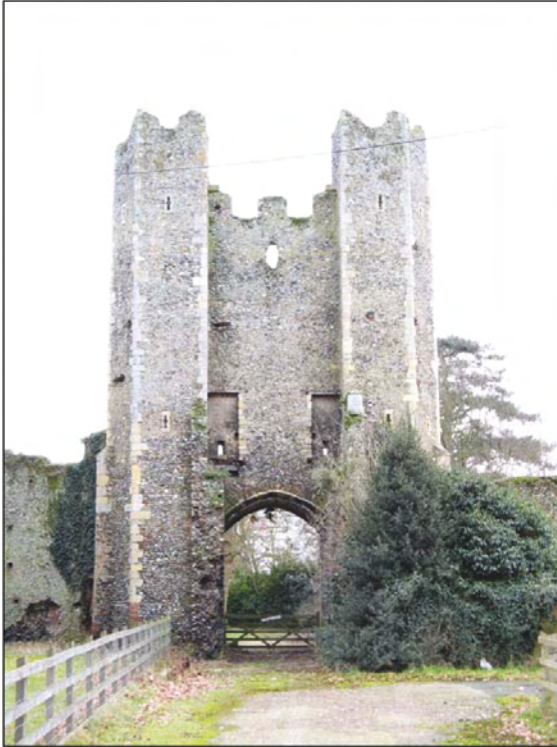
Plate 1. Main gate to the base court from the south

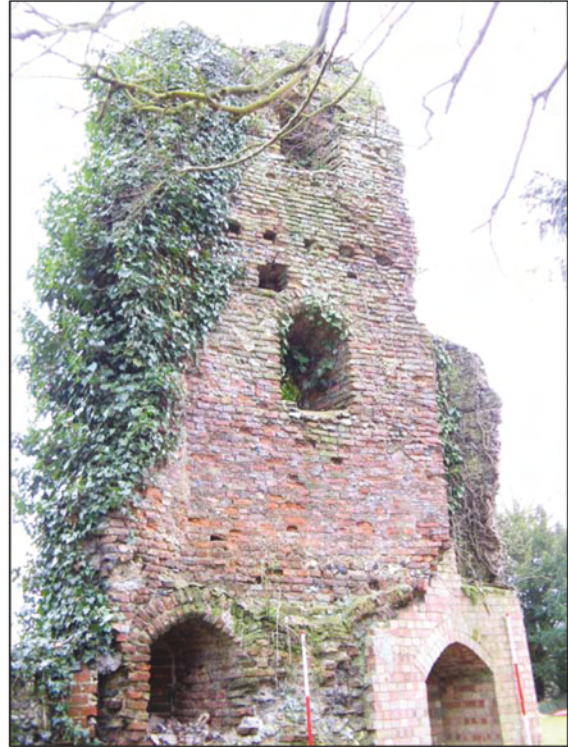
Plate 2. NW tower (Tower 1) gate to the keep east wall from the west

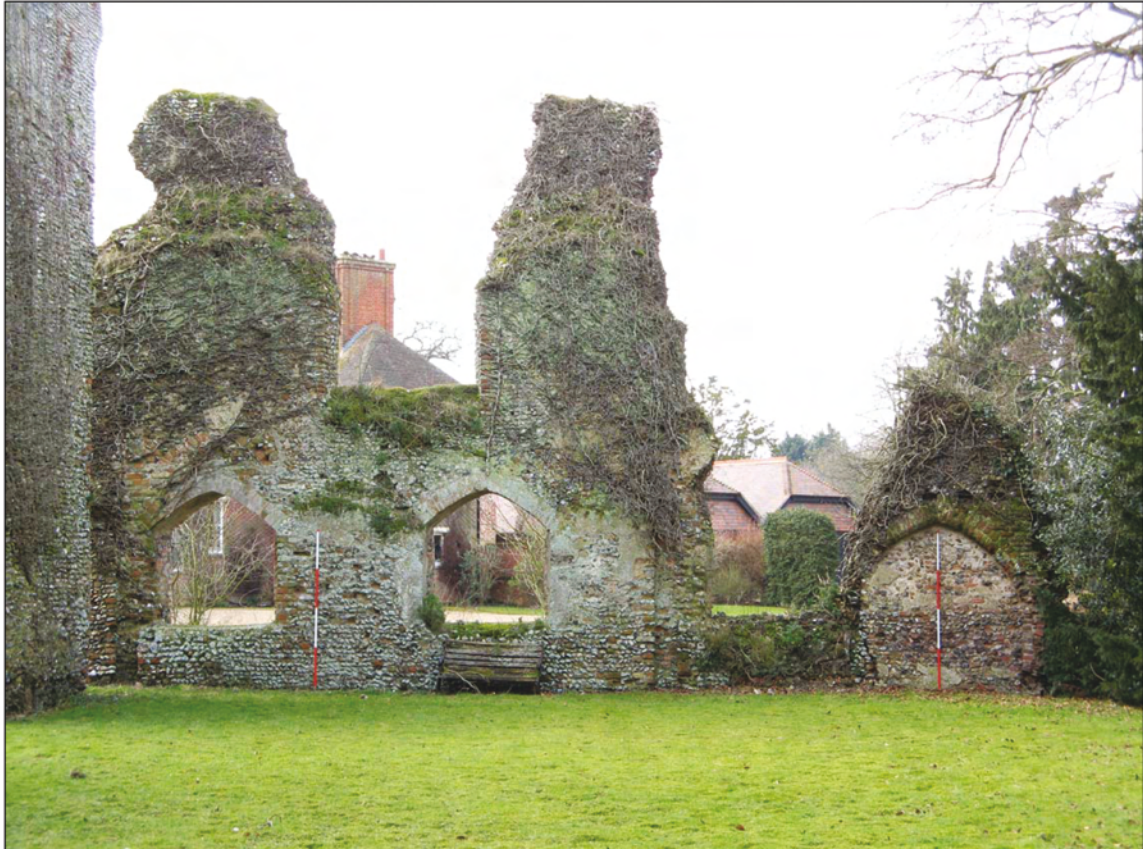
Plate 3. West curtain wall from the east (inside the castle) scales 2m

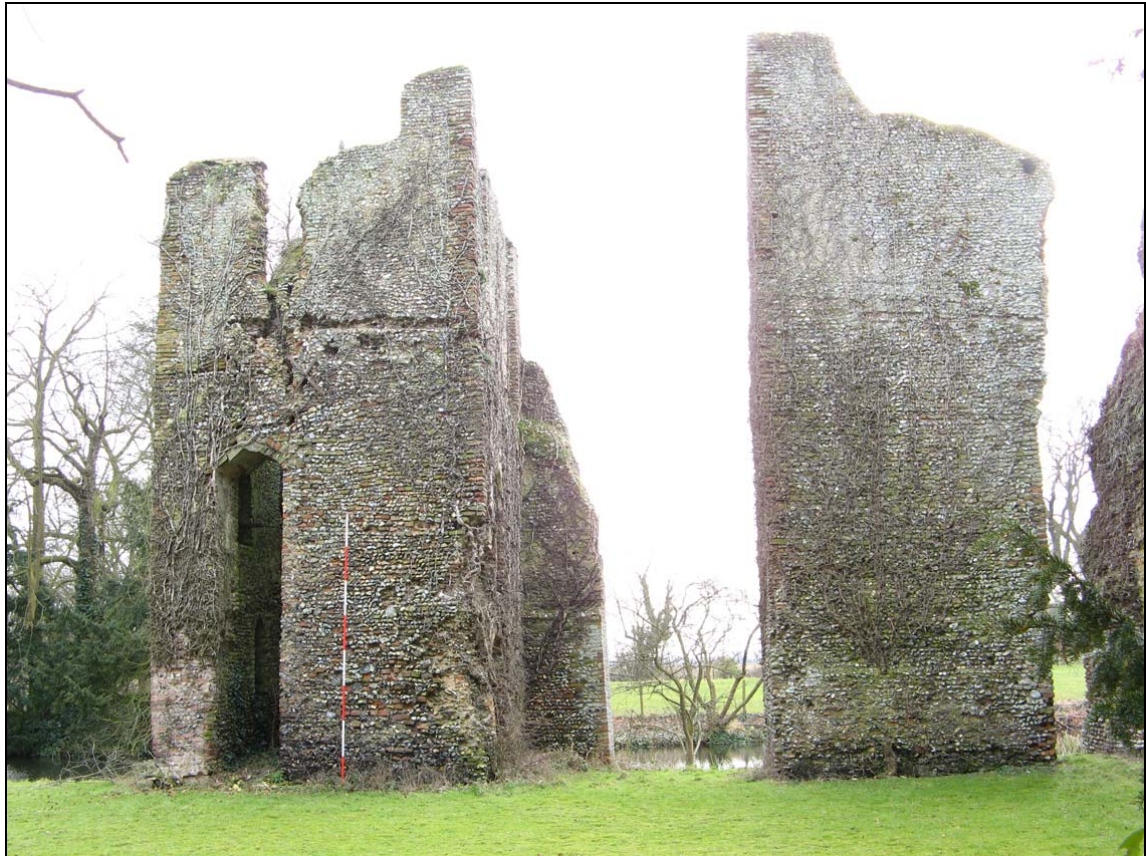
Plate 4. North side of the mid and SW corner towers (Towers 4 and 5) with the remains of the south curtain wall between them. The arched head of the ground floor door has collapsed giving the appearance of one elongated opening. Stair turrets project from the top of the inside corner on both towers. 1 x 4m scale

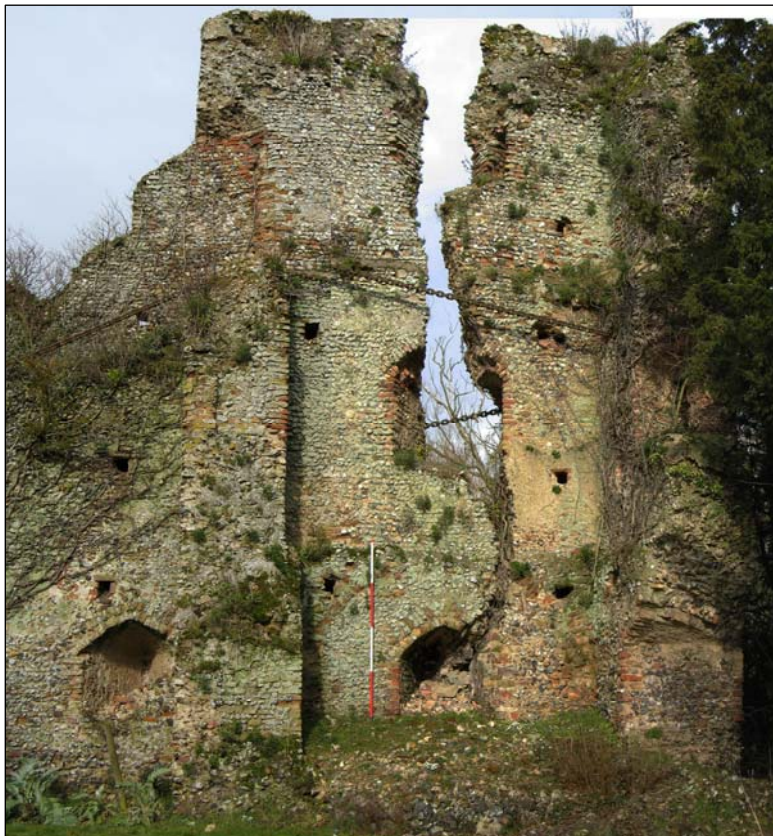
Plate 5. NE corner tower (Tower 2) interior viewed from the south showing east side of the tower detached from the west and anchored by a large chain, with rubble banked up at the base.

The NE corner tower was built into the right-angle of the north and east curtain walls. The north wall of the tower stands close to its full height, buttressed by truncated stubs of the east and west returns. A wide, full height crack **(63)** which passes through the centreline of the north windows means the remains of the east half of the tower was almost completely detached from the west which has been prevented from collapsing into the moat by a great iron chain which looped around the end of the tower with its ends anchored to the exterior and interior faces of the north curtain wall. The chain is purported to be from a naval battleship. From within the keep the viewer is rewarded with an almost complete internal cross-section of the tower and enough of the south wall remains to establish its footprint.
