Survey of the Keep at Mettingham Castle MTT 003

Archaeological Excavation & Survey Report

SCCAS Report No. 2012/022

Survey of the Keep at Mettingham Castle

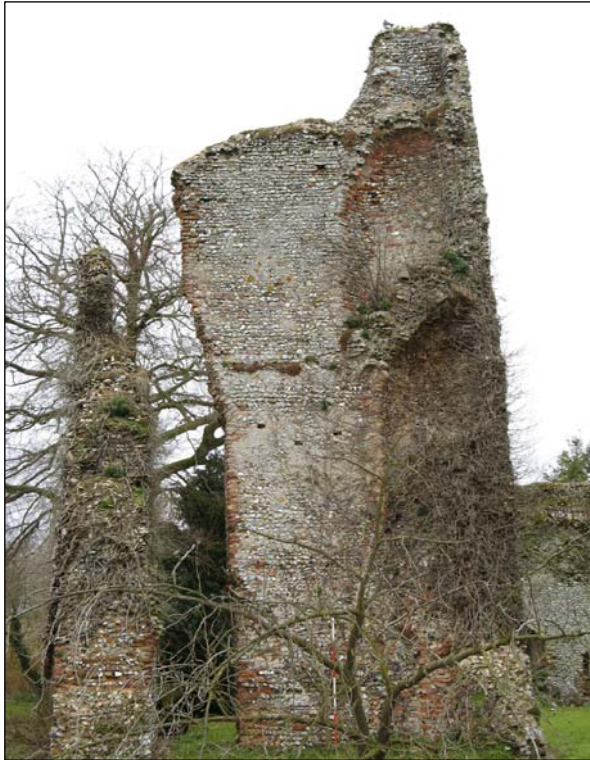
Plate 6. SW corner tower (T5). Interior of the north wall viewed from the south, showing spiral stair well and projecting stair turret above .

Although little of the tower exists, the interior of the north wall provides an informative cross-section and shows that the first and second floors and entry onto the roof were linked by a spiral stair **(19 and 20)** built across the angle of the NE corner. The stairs were not a continuous spiral but two separate flights, with the rooms between effectively acting as landings. Half of the width of the stair was cut into the thickness of the north and east wall and each flight appeared as two domed alcoves **(17 and 18)** each containing treads winding around a central shaft. The missing half of the stair would have wound into the room supported on a brick vault **(21)** spanning the diagonal across the corner, the remains of which could be seen below the bottom flight of steps. The top of the stairs exited out onto the tower roof where the head of the stair well was enclosed within a small turret **(22)**, which projected above the general roofline. Evidence of the east and west returns still remained and the internal (E-W) measurement of the turret was 1m; the winding of the stair indicates that the turret door would have faced west. A curious square-section vertical hollow **(23)** (Pl. 13 Appendix 2) was built into the thickness of the turret east wall which turned through a right-angle and exited horizontally through the external face. The opening was constructed of brick, in the manner and the size of a putlock hole suggesting that this was a setting for a timber structure raised above or out from the turret, but whether it was part of the construction works (a crane/winch mount perhaps) or part of the finished building is unknown.

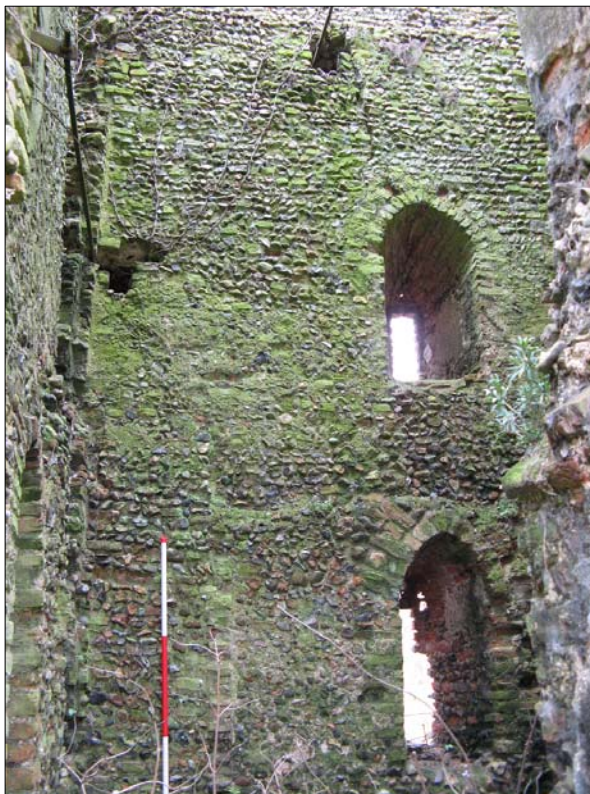
Plate 8. Interior of mid tower (T4) showing stepped ledge at first floor level. The scale is within the remains of enclosed shaft in the SE corner. 1 x 1.5m scale

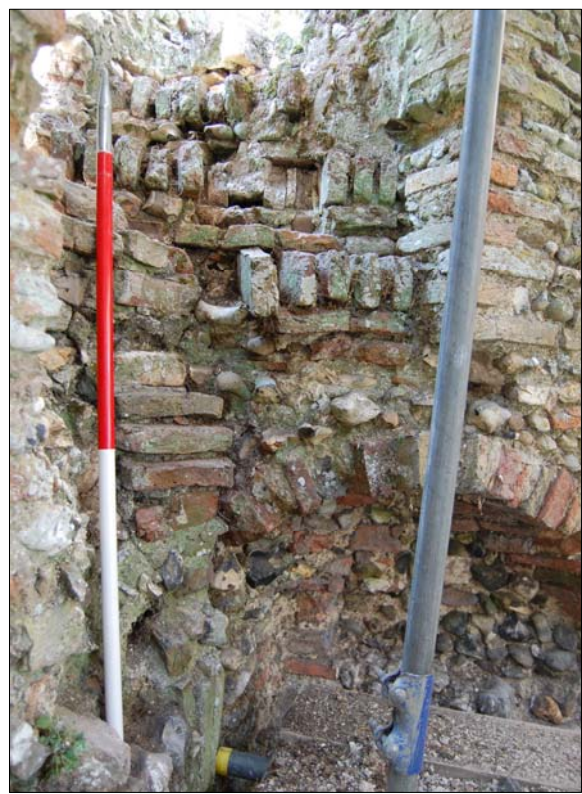
Plate 9. Mid tower (T4) Spiral stair to the roof underpinned by an arched vault across the NW corner of the tower. 1 x 1m scale

pivots on which the eye of the hinges turned were found set into limestone blocks in the jambs. A brick-built internal spiral stair which rose, clockwise, in the north-west corner room gave access onto the roof. As with the stairs in the west tower, the stairwell was part cut into the depth of the wall and part cantilevered out into the room itself supported on a brick-built, arched vault which spanned the diagonal of the corner (Pl. 9 Appendix 2). The remains of nine steps survived; these were steep and narrow with a riser height of 0.26m and tread width of 0.2m at the outer edge of the winder. Above the roof level the top of the stairwell was enclosed within a small turret (**56**), similar to that on the west tower, which would have opened out onto the roof at an east facing door. The bottom of the stair was lit by a slit window (**W10**) which pierced the west wall where, due to the cut of the stairwell, it was at its thinnest and only the width of the bricks that made up the embrasure (0.12m thick). The bottom two steps were dog-legged both to improve the access to the stair and create the window's splayed reveal and sill.

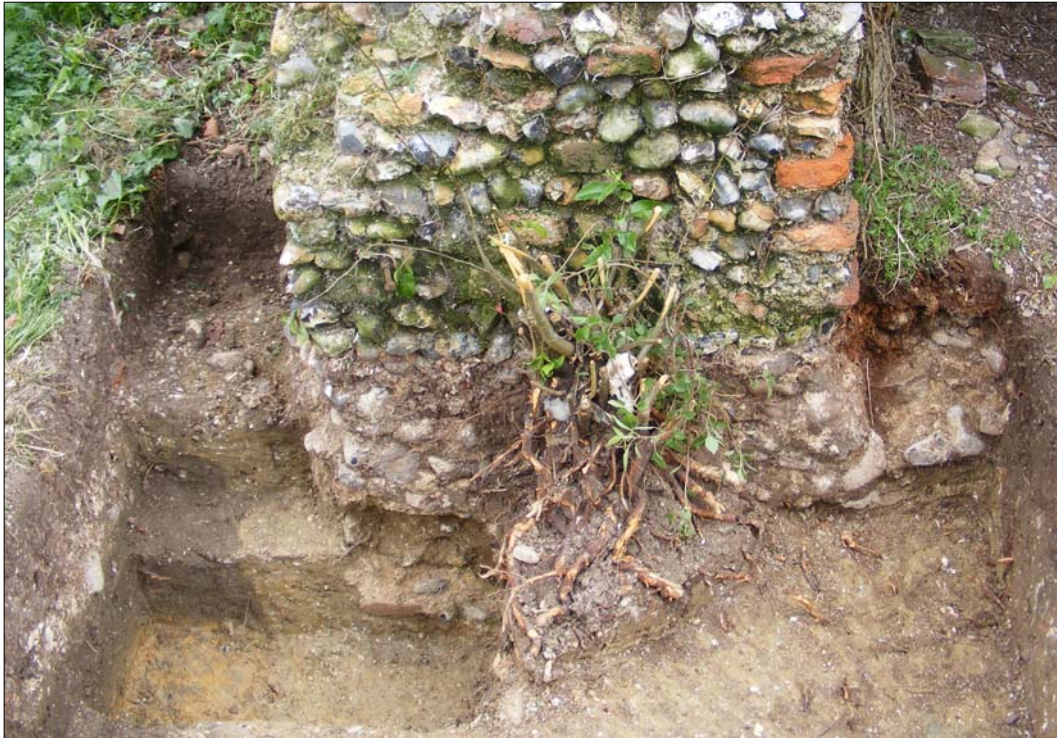
Plate 10. Foundation below NW corner of Mid-tower(T4) showing green clay packed trench cutting buried medieval topsoil. The brick quoin to the right is the edge of the west door opening; the lowest brick indicates ground level. Note bonded flint footing extends across the opening.

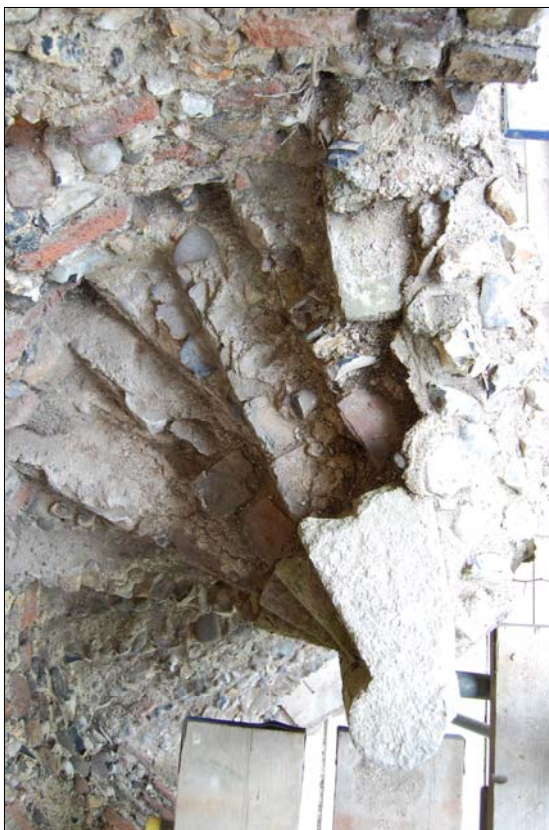
Plate 11. Spiral stairs in the SW corner tower (T5). The stone centre post with the stub of winders are reused from a previous building.

The stairs themselves were based around stone treads robbed or recovered from a previous building, which also provided the moulded stones that created the centre-pillar and the stub of each winder (Pl. 11 Appendix 2). The stones re-created the pitch of the former stairs but had been broken, greatly reducing the width of the treads, either because they came from a wider stairwell or could only be recovered by breaking them. The remainder of each of the winders was a composite of brick which formed the riser

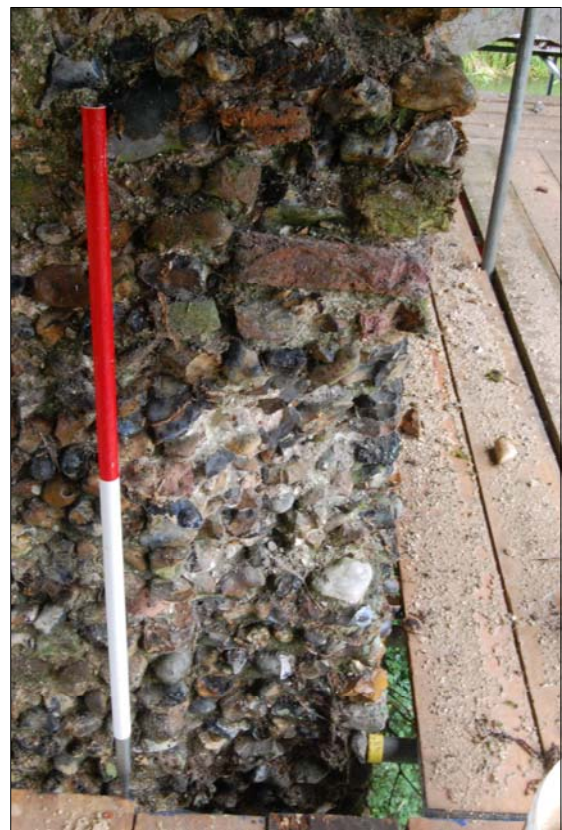
Plate 12. Rebated section in the NE corner of the NW corner tower (T5) possible setting for vertical wall post. 1 x 1m scale

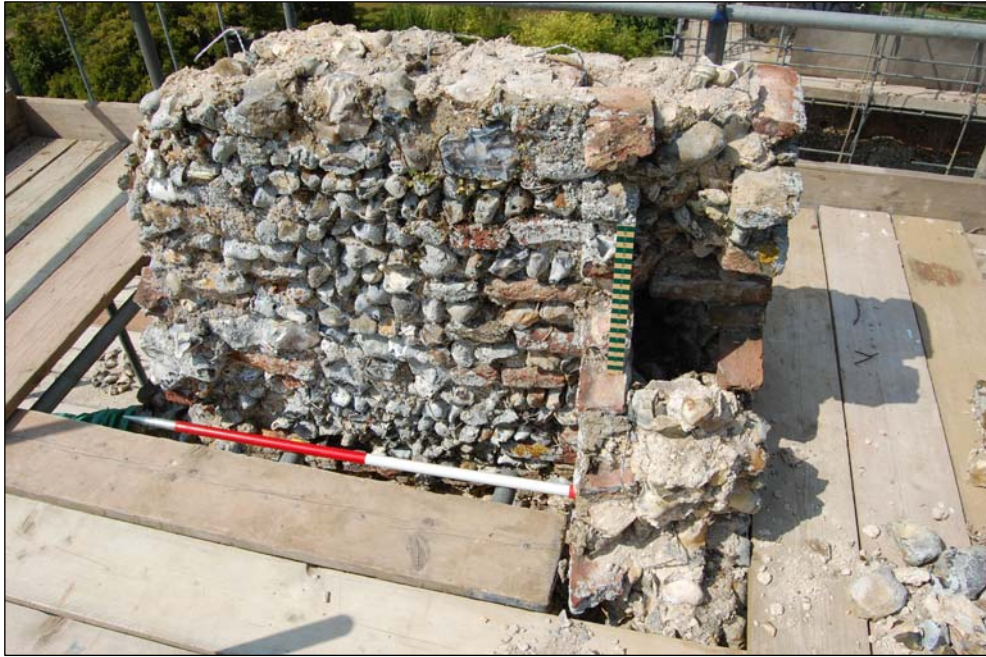
Plate 13. Remains of the stair turret above the roof-line of the SW corner tower (T5) with socketed timber setting built into the thickness of the wall (to the right of the 30mm scale). The shape suggests that it supported a vertical post but there is also a putlog for a horizontal timber to exit through the east (right) face. 1 x 1m scale, 1 x 0.3m scale

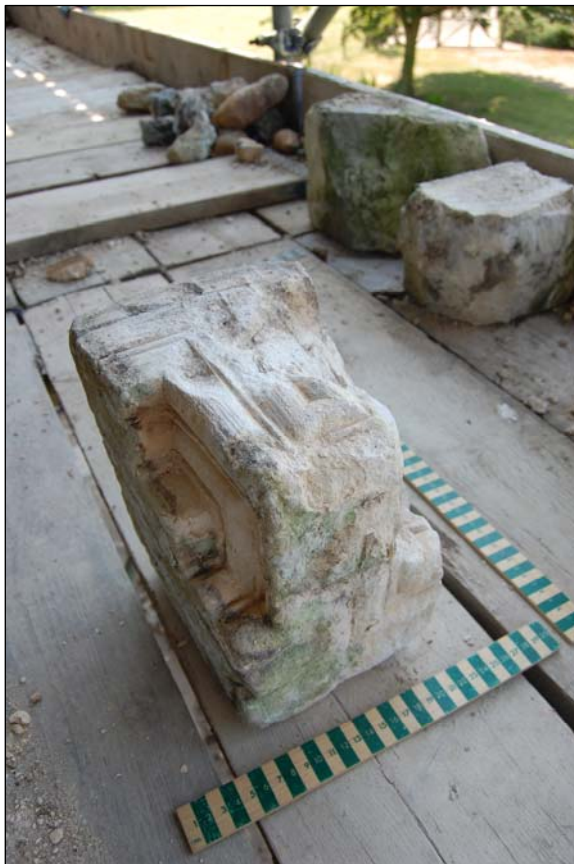
Plate 14. Re-used moulded stone recovered from the west wall windows. The stone was decorated on four faces with a raised Romanesque-style fret ornament. 2 x 0.3m scale

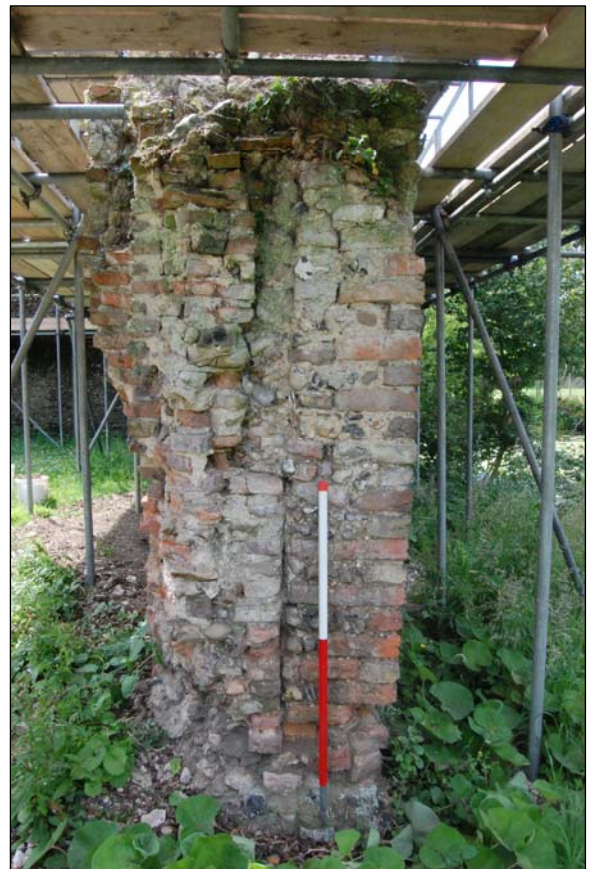
Plate 15. Brick quoin at the north end of the west curtain wall, the jamb of a now missing door (D1), with raised brick stop to the left of the scale. 1 x 1m scale

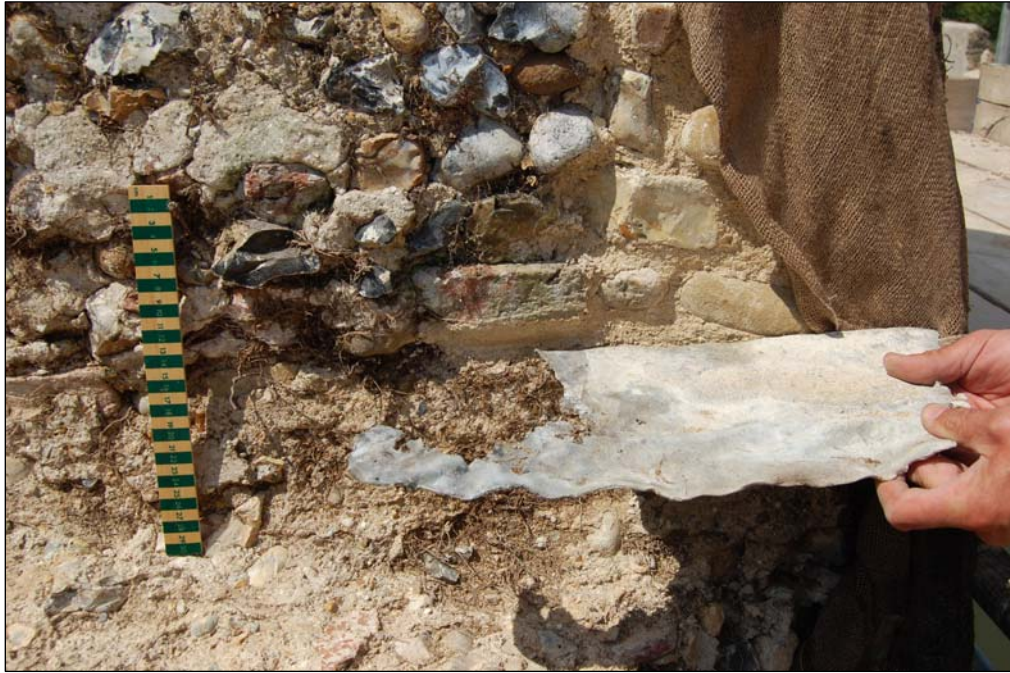
Plate 16. Lead flashing at the base of the parapet of the west curtain wall (15). 1 x 0.3m scale

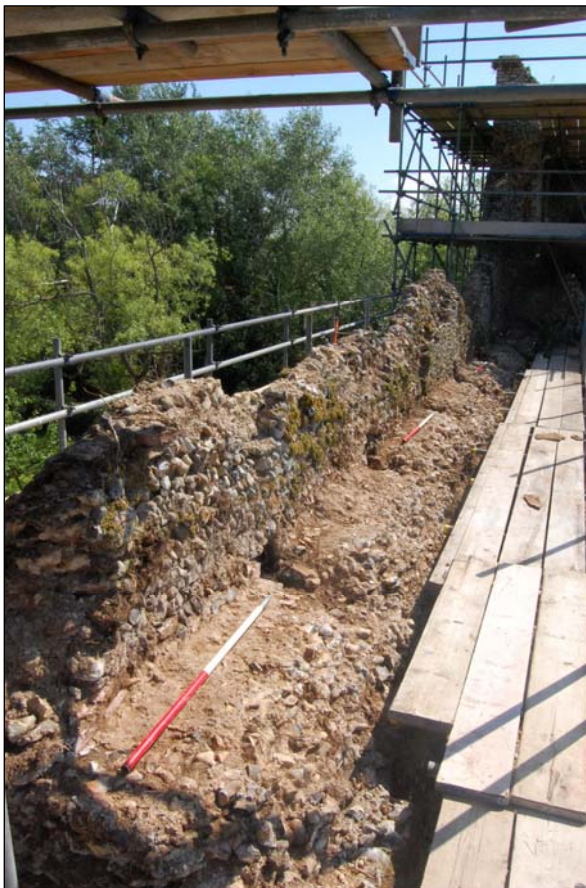
Plate 17. The wall-walk across the top of the north curtain wall. Slots to retain the joist of a boarded deck were regularly spaced along its length and can be seen between the scales. 2 x 1m scale

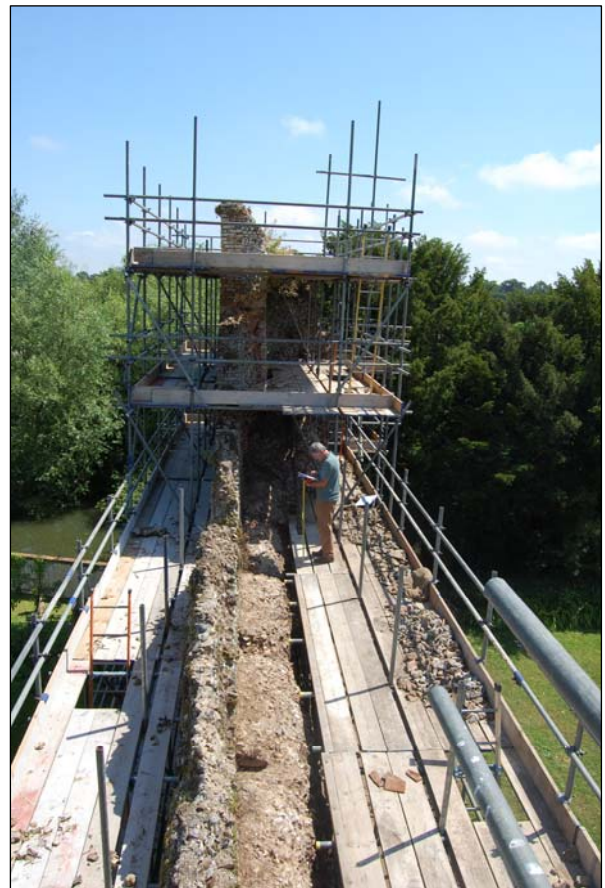
Plate 18. North curtain wall-walk seen from the gate tower (T1). The parapet wall has been truncated and the crenulations lost from its top.

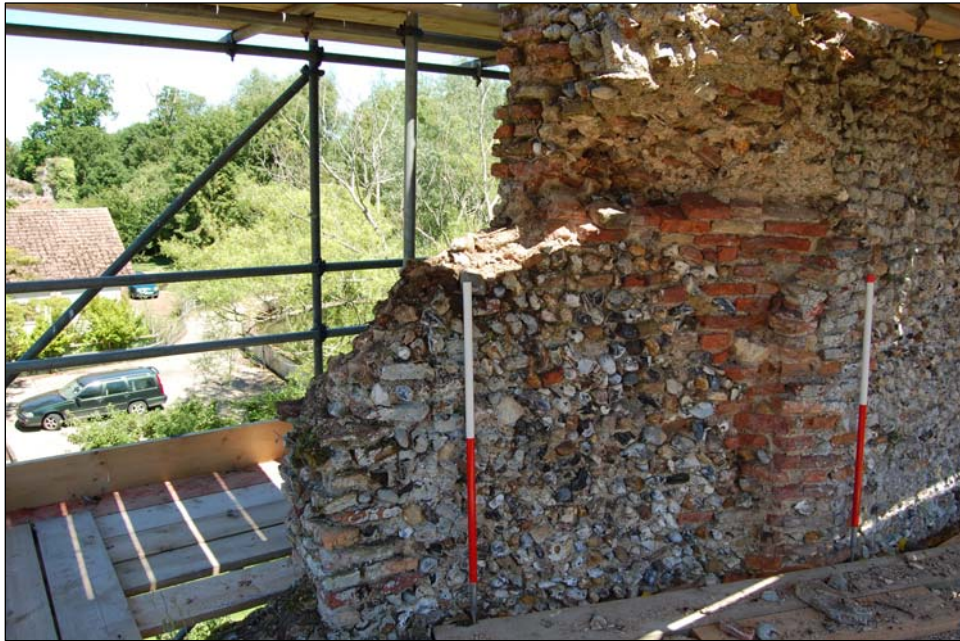
Plate 19. The raised section of parapet (62) at the east end of the north curtain wall shielding the entrance (D11) to the second floor of the NW corner tower. The top of the only surviving merlin of the crenulations that once topped the parapet can just be seen between the scaffold floor boards to the left of the picture. 2 x 1m scale

The crenellations at the top of the parapet were edged with brick similar to the quoins and edging of the openings. Although almost entirely missing, enough brickwork survived at the top of the wall to establish that the merlins were square with a height, width and interval of 0.65m and that the height of the parapet was 1.3m between the merlins and 1.95m behind them. Alongside the east tower a short section of the parapet **(62)** was raised by a further 1.2m and provided protection to anyone standing on the steps to the tower's upper floor (Pl. 19 Appendix 2).

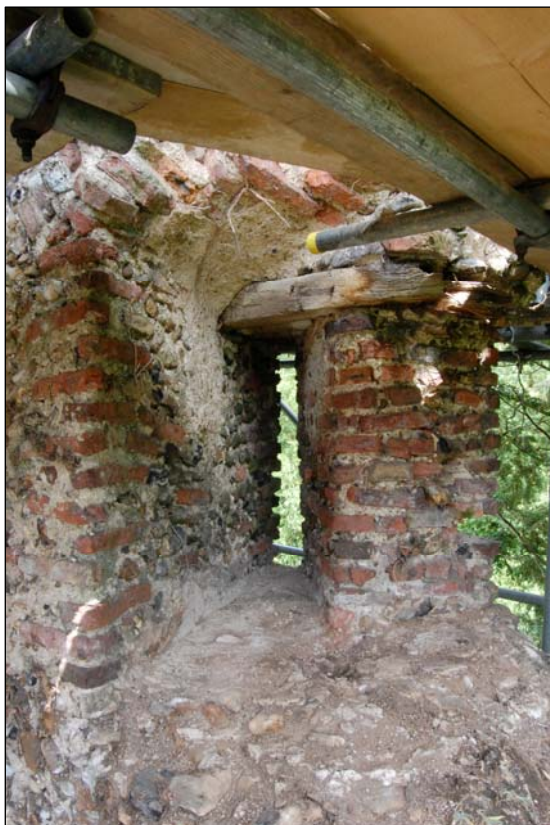
Plate 20. Angled double slit window in the east wall of the NE tower (first floor), the window reveal angled to view the NE approaches to the keep.

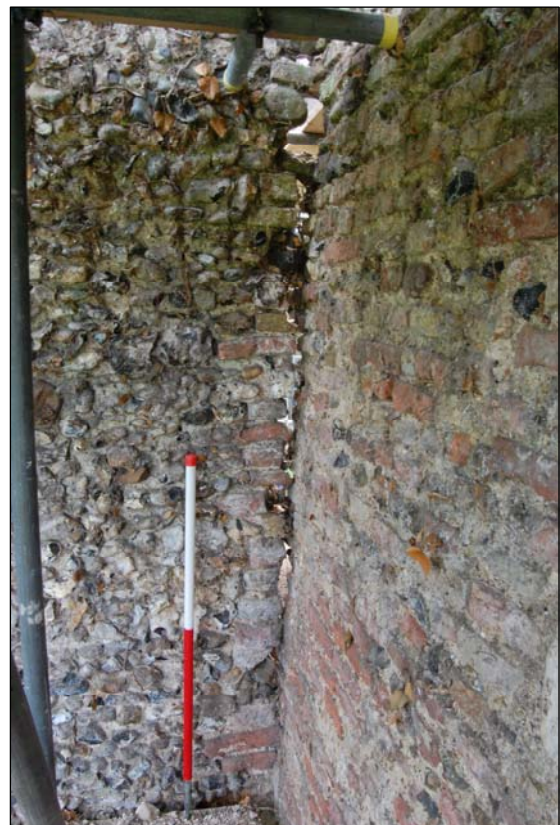
Plate 21. Butted joint between the first phase flint work of the north curtain wall and the later brick-built NW corner gate tower. 1 x 1m scale

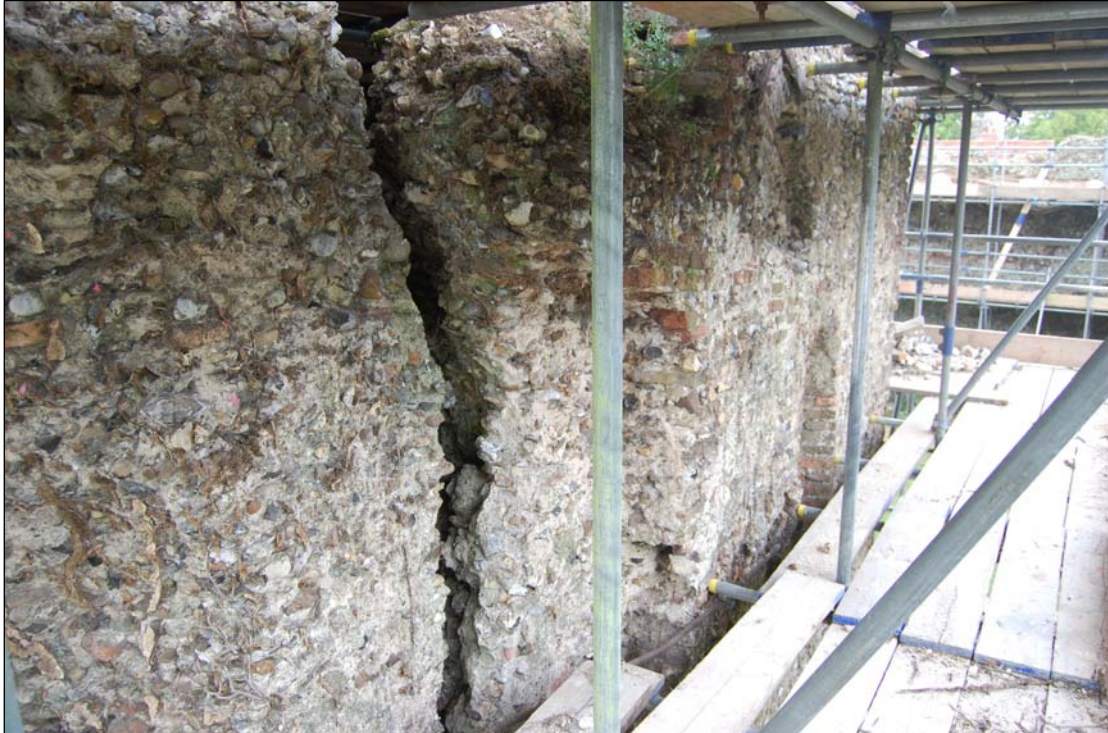
Plate 22. Stepped east face of the mid tower (T4), showing the south half of the wall face recessed back from the plane of the north. The recessed section enables a door to be opened flush to the wall.

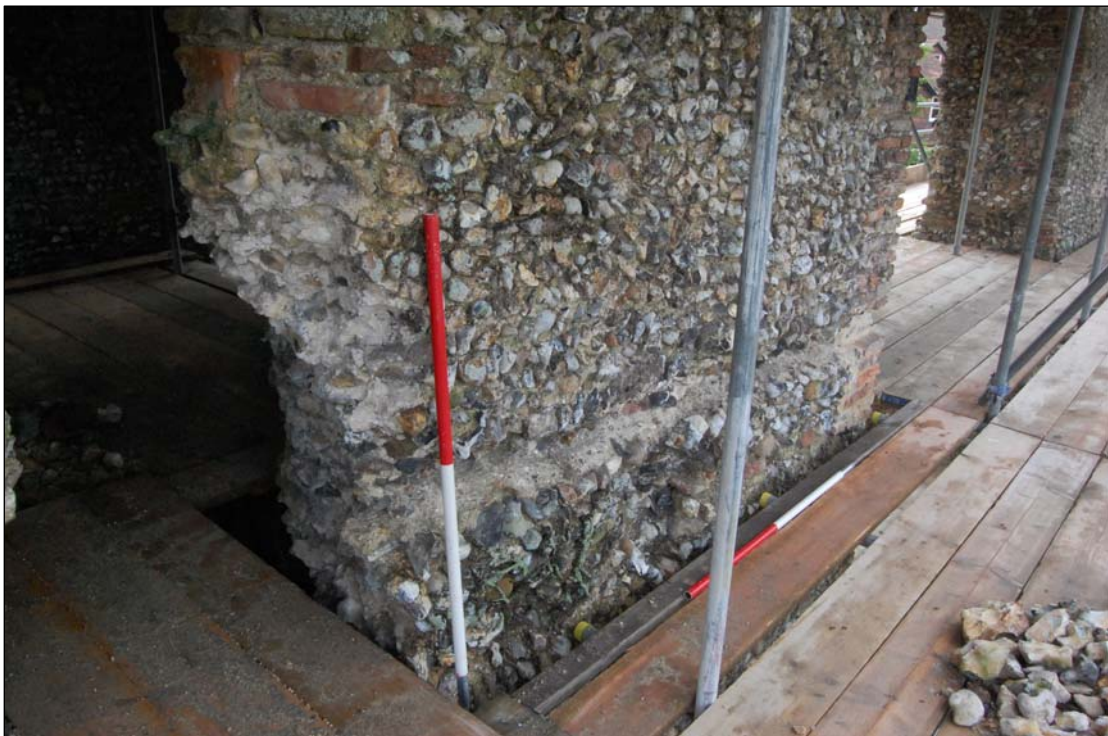
Plate 23. Horizontal scar across the north face of the mid-tower (T4) where the roof of the timber-framed hall was attached to the tower at its eaves. The section of the wall between the first floor door and second floor window, to the left of the scale has been removed prior to repairs. 2 x 1m scale

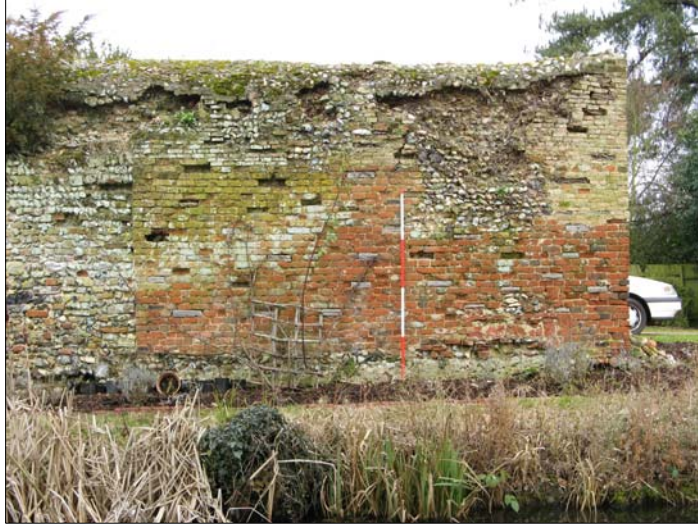
Plate 24. South curtain wall brick infill on the south face and truncated east end. 1 x 2m scale

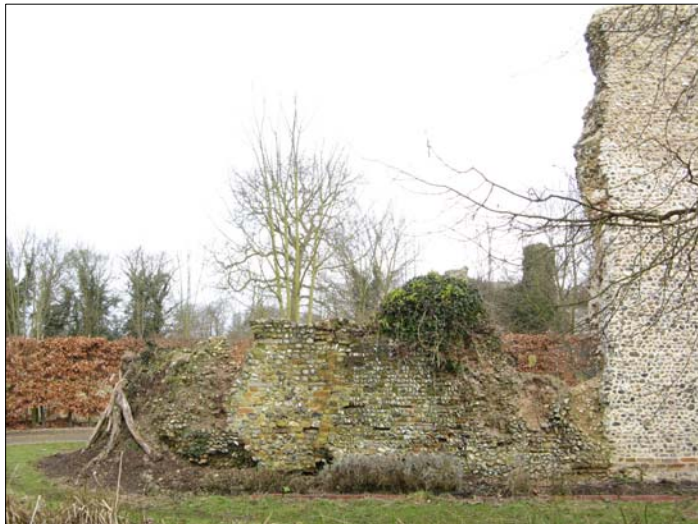
Plate 25. Vestigial remains of the corner tower at the west end of the south curtain wall

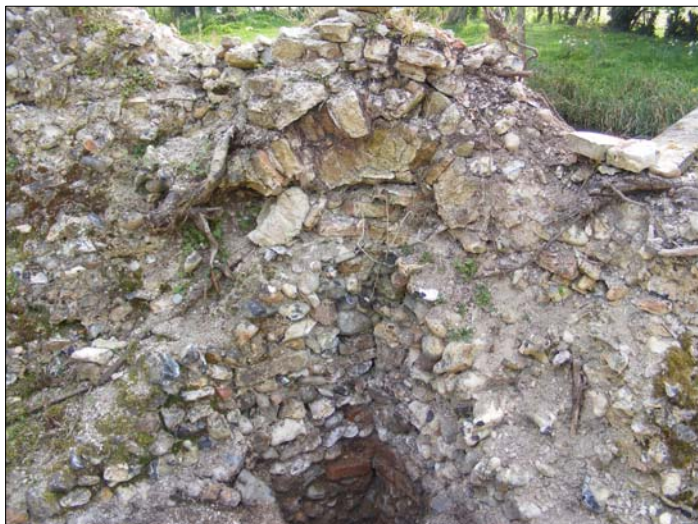
Plate 26. Brick squinch internal corner of the south curtain wall's west tower

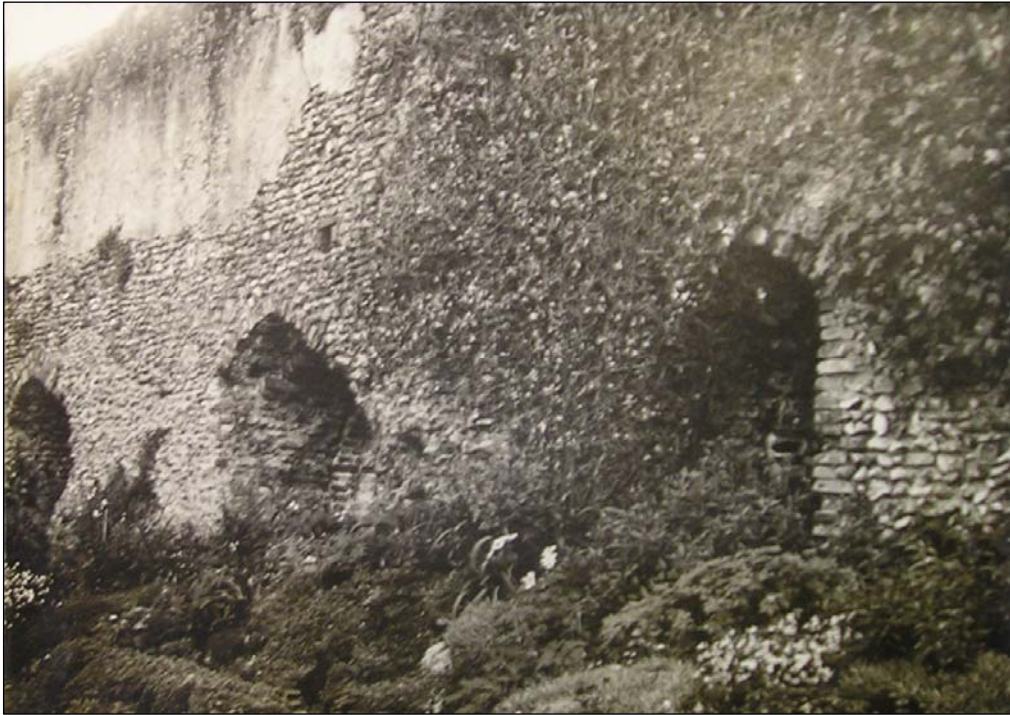
Image 6. Interior of the north curtain wall (1954)

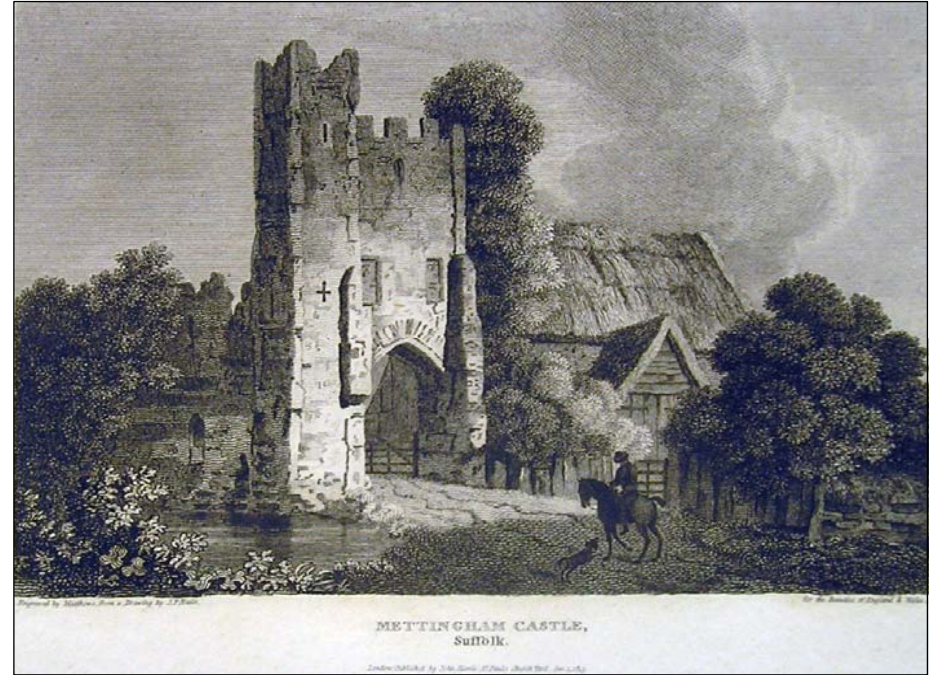
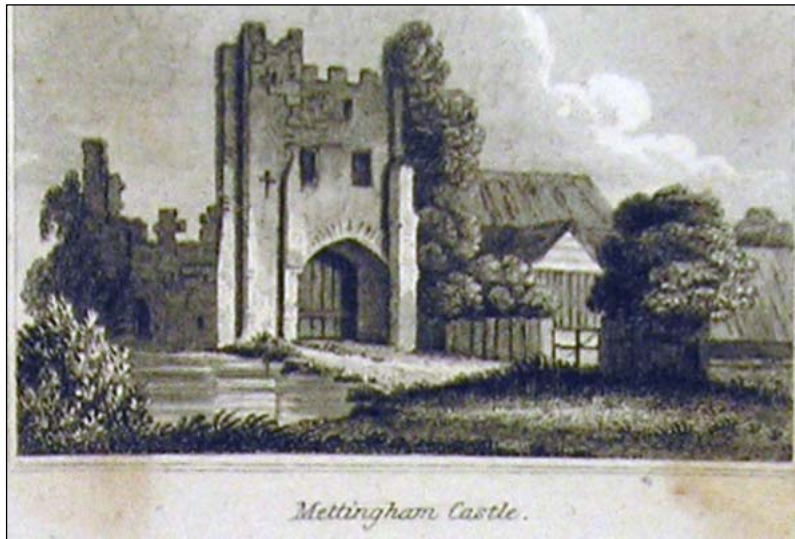
Image 11. Engraved by Mathews from a drawing by J P Neal for *The Beauties of England & Wales* (Lowestoft Record office Record office 13/77/3)

Image 10. Undated engraving (Ipswich record office HD1678/97/3)

Early images of the gatehouse at Mettingham Castle. The architectural details are similar to the exterior of the main gate but Images 10 and 11 seem to show the right turret as missing (which on the main gate is still extant) and a barn in full view to the west. The tithe map drawn in 1846 (Fig.5) show the barns *inside* the curtain walls and located to the east of the tower. However there was a barn with this relationship to the keep gatehouse which did not collapse until about 1840 – c. 30 years after these images were created and would have been seen by the artist. Could this be an image of the lost keep gatehouse?

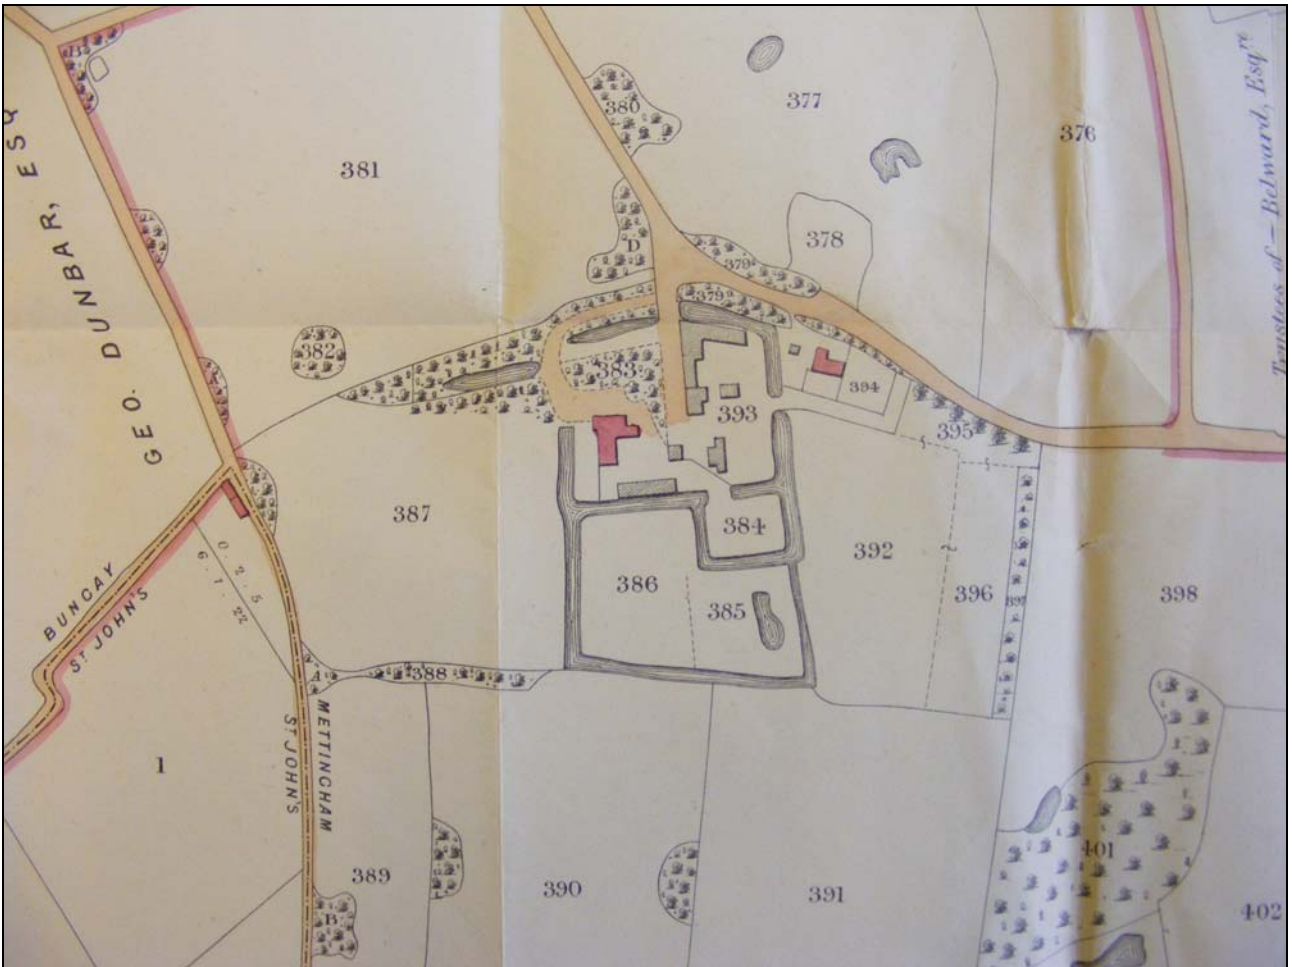
Image 14. Map from the sale particulars of 1876 (Ipswich record office Ref HD113/2/65). Note the line of the carriage drive through the east moat
