Risbygate Street Car Park, Bury St Edmunds BSE 390

Archaeological Evaluation Report

SCCAS Report No. 2012/085

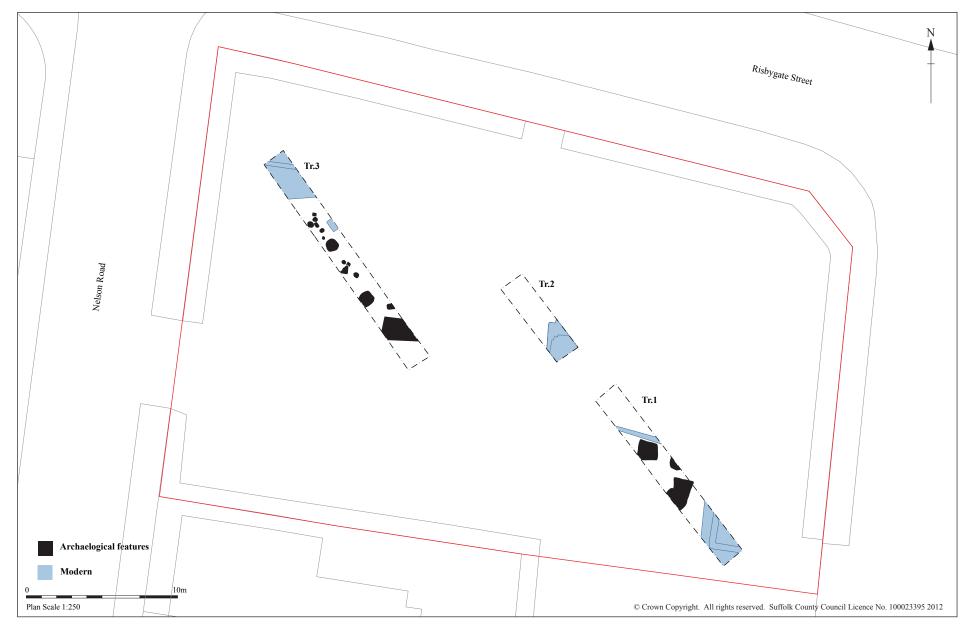
Figure 2. Detailed trench location plan showing archaeological features

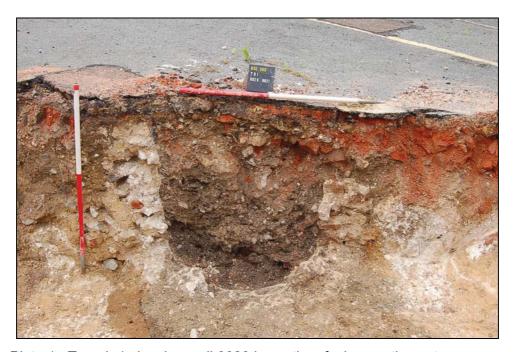
Well 0020 was a mainly chalk, flint and CBM mortared circular structure (though only a small amount of the feature was within the trench), cutting through pit 0021 to the east. The internal fills were mixed where visible in section and the feature survived to approximately 0.1m below the current surface and had a diameter in excess of 1.55m (the maximum exposed within the trench). While there was no well marked on the early Ordnance Survey maps of the site, the height of the well wall suggests that it was at least on a level with the late 19th century ground surface, if not standing proud of it (visible in Pl.1)

Plate 1. Trench 1 showing well 0020 in section, facing south-west (2 x 1m scales)

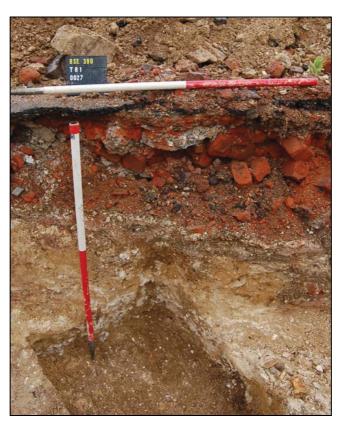
Pit 0027 was square in plan with rounded corners, very steep/near vertical sloped sides and the base was not exposed (again due to combined trench/feature depths). It measured 1.26m by at least 1.06m and was excavated to 0.3m below the trench floor, and was filled with a firm compacted pale brownish-grey sandy clay with common small chalk nodules, rare charcoal flecks and small stones. Voids observed in the fills were thought to possibly indicate the feature was a well, but these are now believed to be more likely to represent rapid backfilling with uncompacted material. Medieval artefacts were recovered within two of the fills of the feature and in general terms it seems similar to pit 0004 and seems likely that it had a similar function.

Plate 2. Trench 1 showing pit 0027, facing north-east (2 x 1m scales)

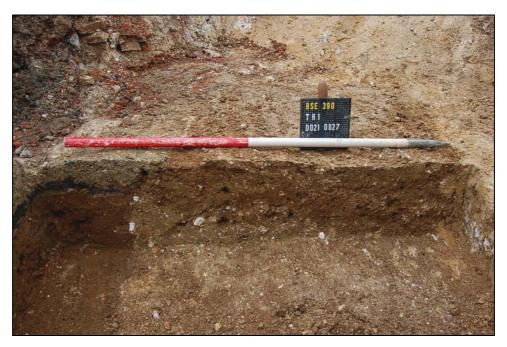
Pit 0021 appeared to be sub-square in plan, though as there was significant truncation of this feature it is possible it was more circular originally, with c.70 degree slightly concave sides apart from the north side which curved to c.45 degrees near to the drawn section. The feature was not fully excavated, but measured 1.35m by 0.85m by at least 0.35m deep and was found to cut pit 0027 to the east. Initially, this pit was thought to possibly be a construction cut for well0020, though after excavation this was thought to be less likely (though further excavation will be required to entirely prove or disprove this).

Plate 3. Trench 1 showing section across 0021 and 0027, facing north-west (1m scale)

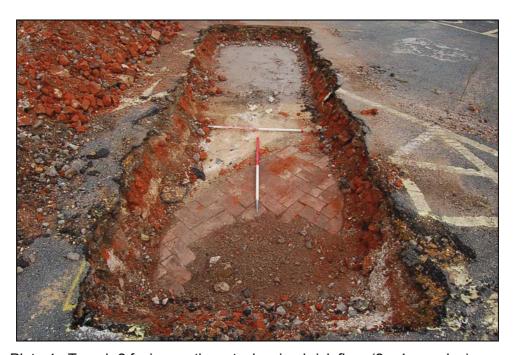
This trench was 6m long, 1.8m wide and c. 0.45m deep, orientated northwest/southeast towards the centre of the site. The stratigraphy encountered consisted of 0.1m of tarmac and hogging over 0.35m of red brick demolition rubble, sealing natural creamy brown chalky till. While no archaeological features survived in the trench, an area of brick paving was noted towards the southern end of the trench, believed to correspond with the area of the old Hare and Hounds Inn which was demolished along with the school in the 1930's. A large disturbance through this surface was noted towards the end of the trench (visible at the bottom of Pl.4) but not investigated further at this time. These bricks appear to have been set directly into the natural clays and no traces of surviving walling or foundations were located. This does raise the possibility that there may be surviving structural remains of the inn, whether just floor layers or possibly wall stubs and/or a cellar (if one was present).

Plate 4. Trench 2 facing northwest, showing brick floor (2 x 1m scales)

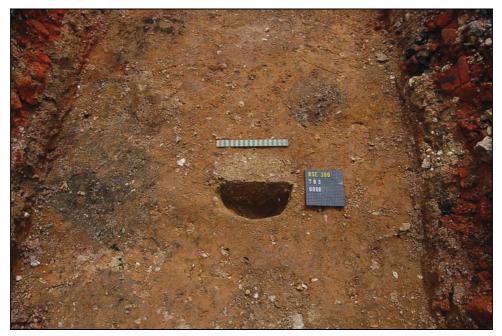
Posthole 0008 was a circular posthole in the centre of the trench, towards the north-western end. It had steep-sloped sides to a shallow concave base and was 0.3m in diameter and 0.2m deep, filled with a mid greenish grey chalk-flecked clay. Bone and shell fragments were recovered from this feature, though they were not dateable.

Plate 5. Trench 3 posthole 0008, facing south-east (0.3m scale)

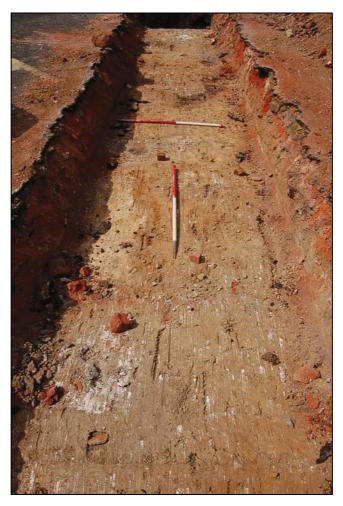
Plate 6. Trench 3 showing centre of trench facing north-west (2 x 1m scales)

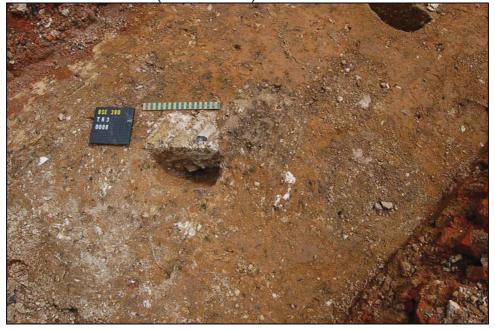
Posthole 0006 was a square posthole with near-vertical sides to a shallow concave/flattish base (0.27m x 0.3m and 0.22m deep), orientated approximately square on to Risbygate Street and filled with a pale creamy brown hard chalky clay with moderate medium-sized flint nodules. CBM and shell fragments were found as well as a short segment of clay pipe stem in the fill but these finds were not closely dateable other than being of 17th century or later date.

Posthole 0011 was a small circular posthole adjacent to 0006, 0.3m in diameter and with a similar fill to 0008. It was not excavated at this stage.

Posthole 0012 was a suspected posthole in the vicinity of 0011 and 0006 with a sub-rectangular shape in plan and a loosely compacted fill (possibly of modern/post-medieval origin).

Posthole 0013 was a circular posthole close to 0006, 0011 and 0012, approximately 0.4m in diameter which contained a similar fill to that in posthole 0014. Small fragments of slag were retrieved from the surface of this feature, but were not dateable.

Plate 7. Trench 3 posthole 0006 and postholes 0011, 0012 and 0013, facing south-east (0.3m scale) $\frac{1}{2}$

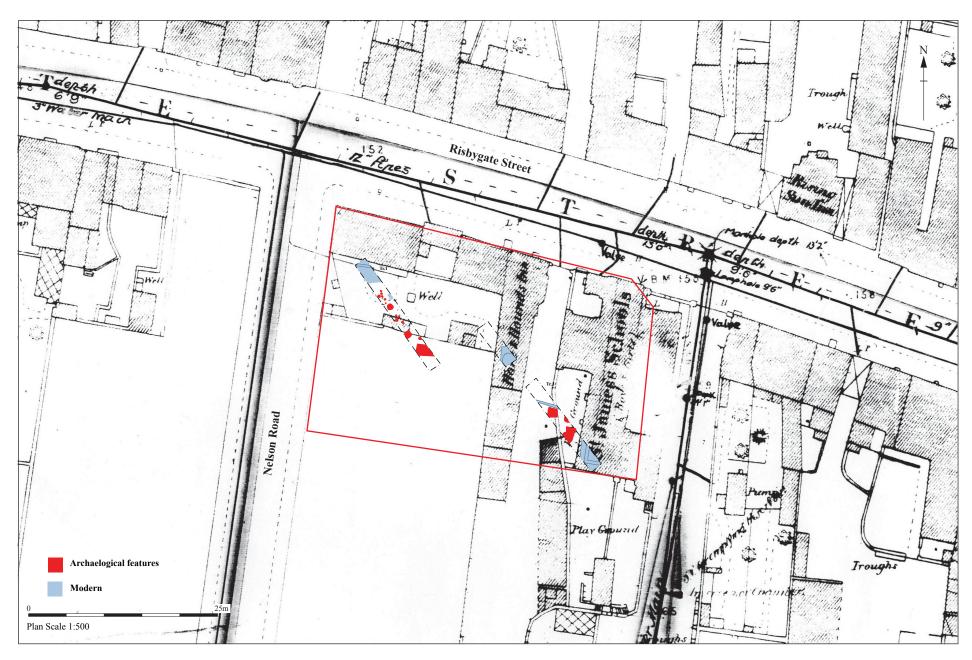
Figure 5. Trench locations and features over the 1880 First Edition Ordnance Survey □Map
