Land adjacent The Marvens, Chapel Lane
Copdock, Suffolk
COP 016

Archaeological Evaluation Report

SCCAS Report No. 2012/102

Client: DCH Construction Ltd.

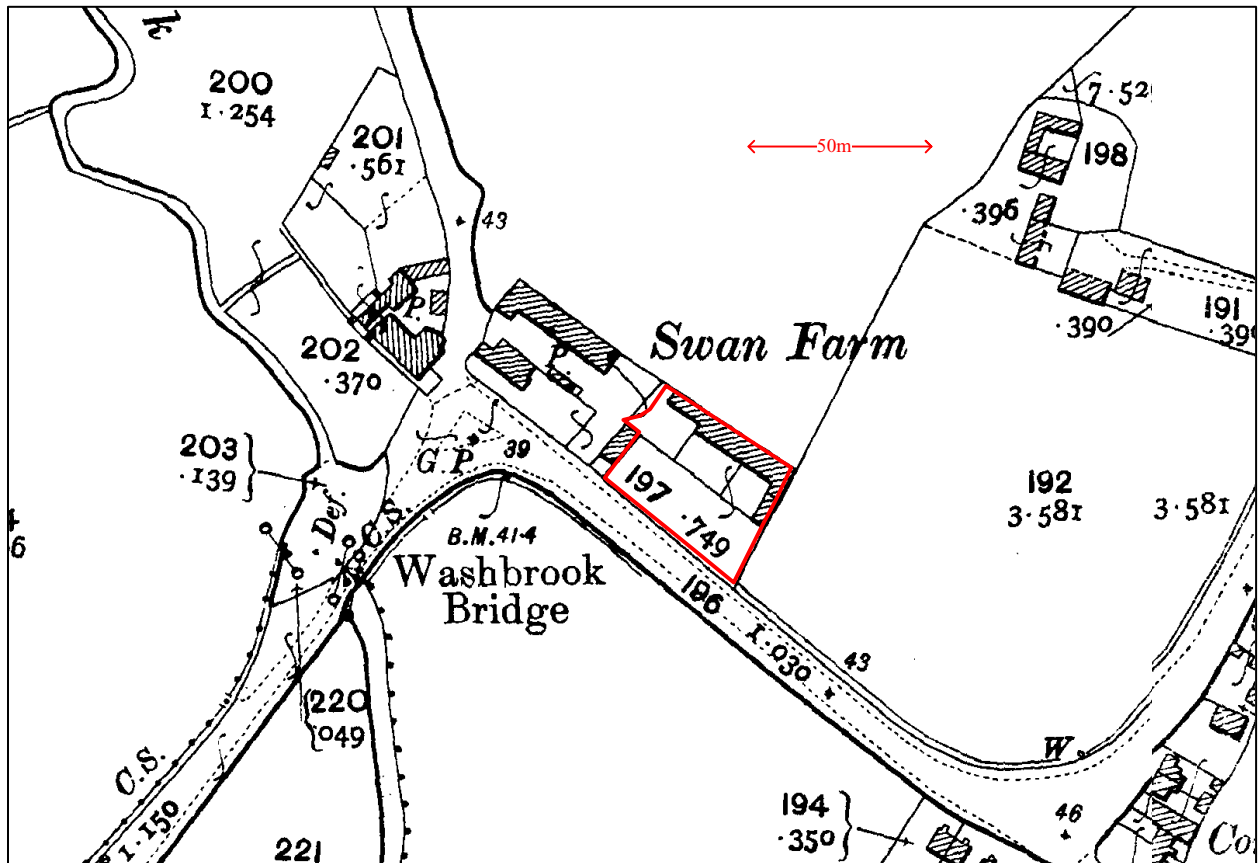
Figure 2. 2nd Edition Ordnance Survey map of 1904 (rescaled extract)
evaluation area outlined in red

The 2nd Edition Ordnance Survey map of the area (1:2500 scale sheet, published 1904: fig. 2) shows a group of buildings and enclosures that together comprised Swan Farm. The evaluation area comprises a set of enclosed areas to the south-east and an elongated, L-shaped building sited on the north-east boundary.

The wall forming the north-east boundary of the evaluation area is undoubtedly the north-east wall of the L-shaped building as show on the 2nd edition Ordnance Survey map (fig. 2). It now acts as a retaining wall between the evaluation area and the higher land to the north-west. This may not have always been the case as the rain water down

The junction noted on the dividing wall corresponds with the north-western of the two south-west to north-east boundaries marked on the 2nd Edition Ordnance Survey map (fig. 2).

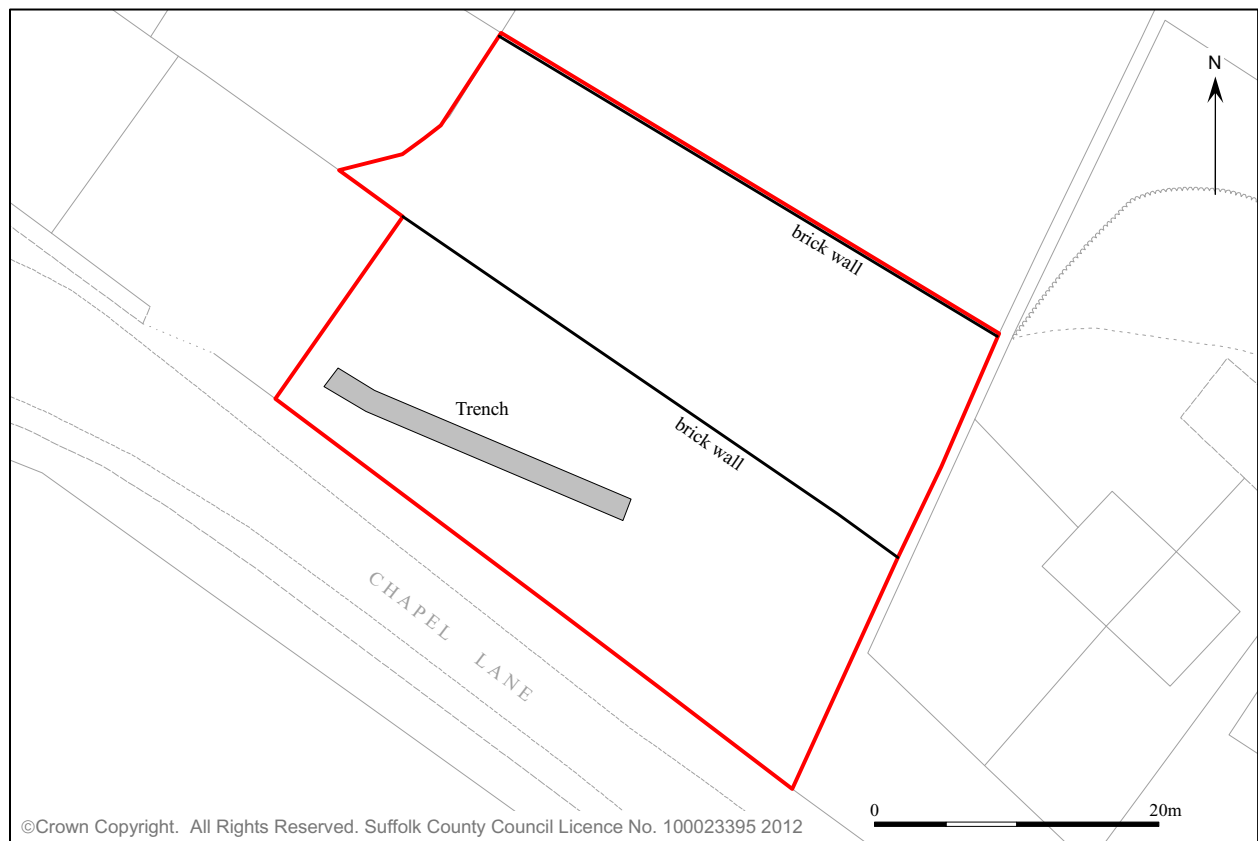
Figure 3. Trench location plan

A single evaluation trench was excavated (fig. 3 and plate 1) across the south-western half of the evaluation area. The natural subsoil, as exposed in the trench, consisted of a pale brown silty clay with occasionally areas of clay with chalk flecks and occurred at a depth of 1.0m (plate 2). It was overlain by a layer of pale brown sandy silt within which were very occasional fragments of red brick and tile, becoming more frequent towards the base of this layer. The interface between the overburden and the natural subsoil was slightly blurred and there was no positive indication that the natural ground levels had been significantly truncated. No archaeological features were identified and no artefacts were recovered from the excavated spoil.

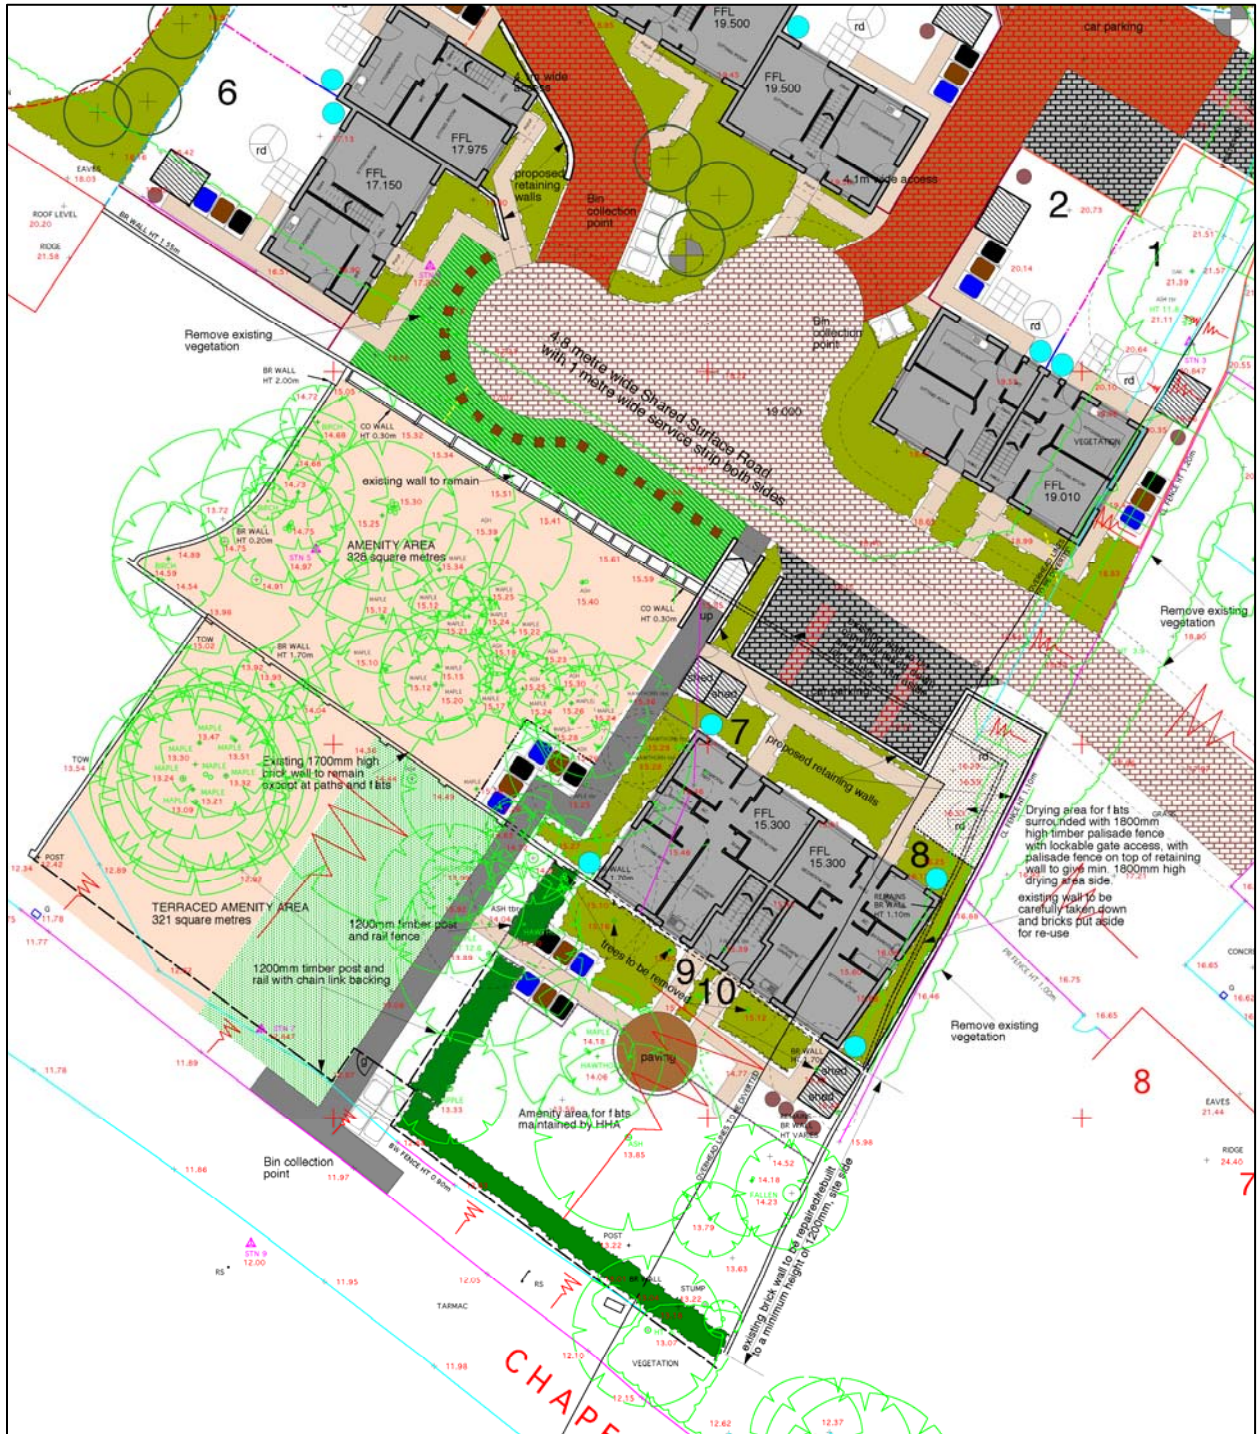
Figure 4. plan of the proposed development (extract of drawing no. 09, rev. C; no scale)

The brick walls noted during the evaluation are of some local history interest, being associated with the former Swan Farm, and are possibly worthy of recording. This said, an adequate record may already exist in the form of one of the site plans, submitted as part of the application (drawing no. 09, Rev. C: see fig. 4) and the limited photographs taken during the evaluation. The plan indicates that a large proportion of both walls will be retained within the development.

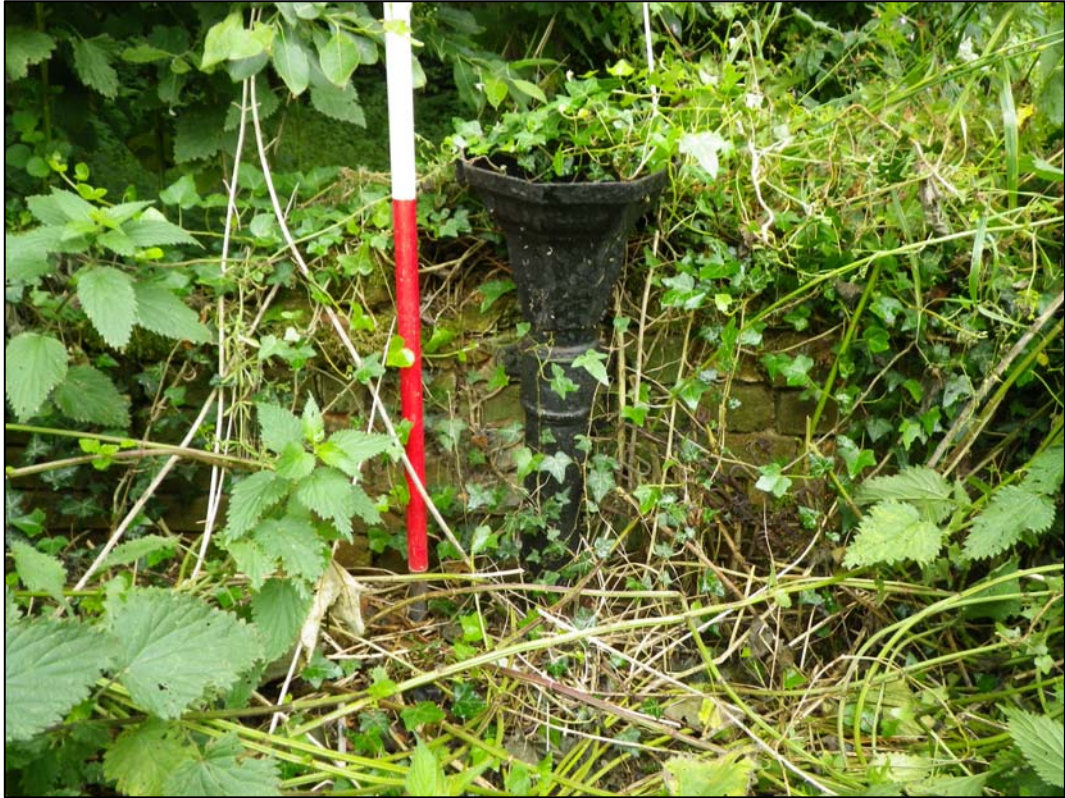
Plate 3 rainwater down pipe (ref. HLW 67)

The brick walls in this area were briefly examined and photographed. It was noted that the wall forming the north-western boundary was originally part of an agricultural building, as indicated by the presence of a rainwater down pipe on the north-western face (plate 3). What was interpreted as a feeding trough for cattle ran along the entire length of the south-west side of the wall (plate 4). It was constructed of brick and cement and was separated into sections by further brickwork (plate 5).

pipe would have probably run to a now hidden drain suggesting there may have been a significant build up of material on the outer face.

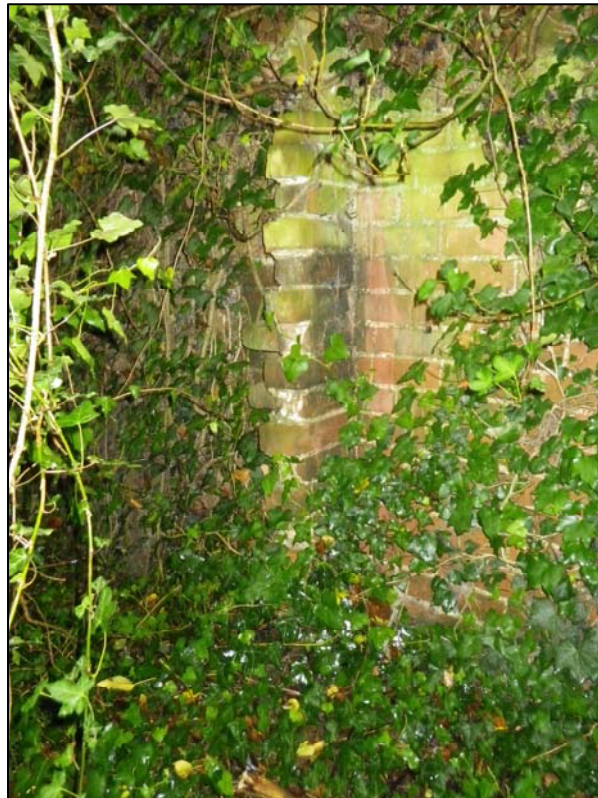
Plate 6 junction of walls noted on the dividing wall (ref. HLW 68)

The wall dividing the evaluation area was only briefly inspected. The only feature noted being the site of bonded junction with a now demolished wall (plate 6) although much of this wall was partially hidden by vegetation.
