Old Thatches, Preston St Mary, Suffolk

Archaeological Record

Old Thatches, Rookwood Lane, Preston St Mary, Suffolk

An Archaeological Record

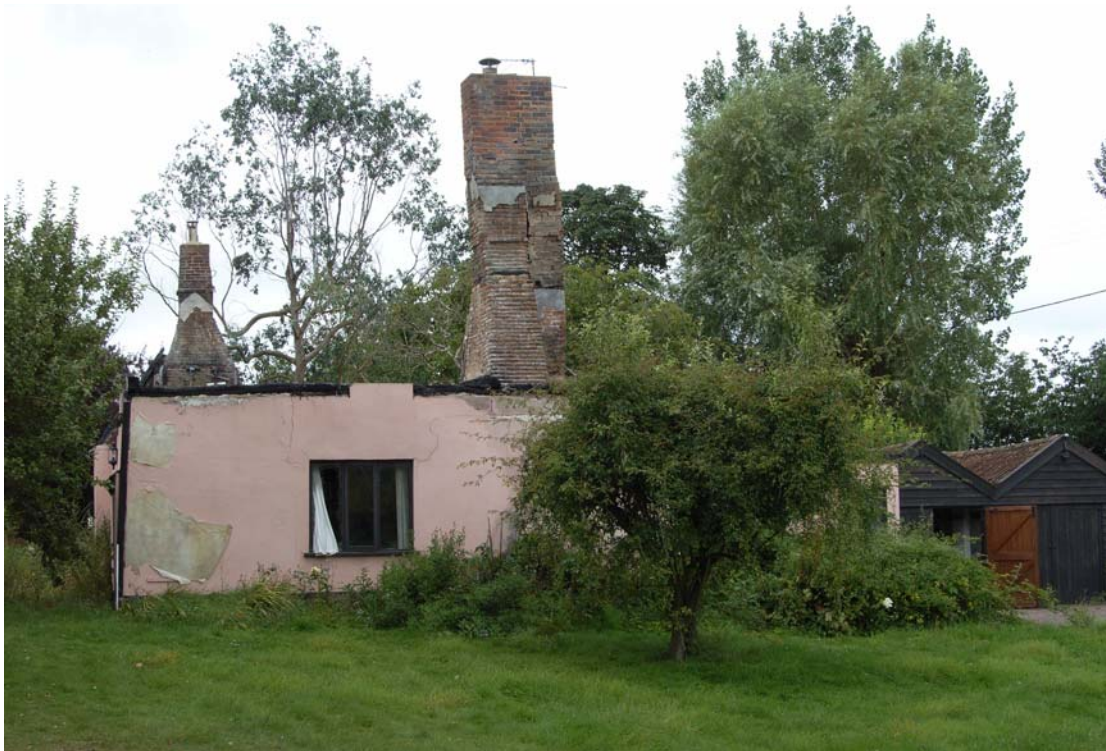
A2.1 External elevation H-N from east prior to demolition

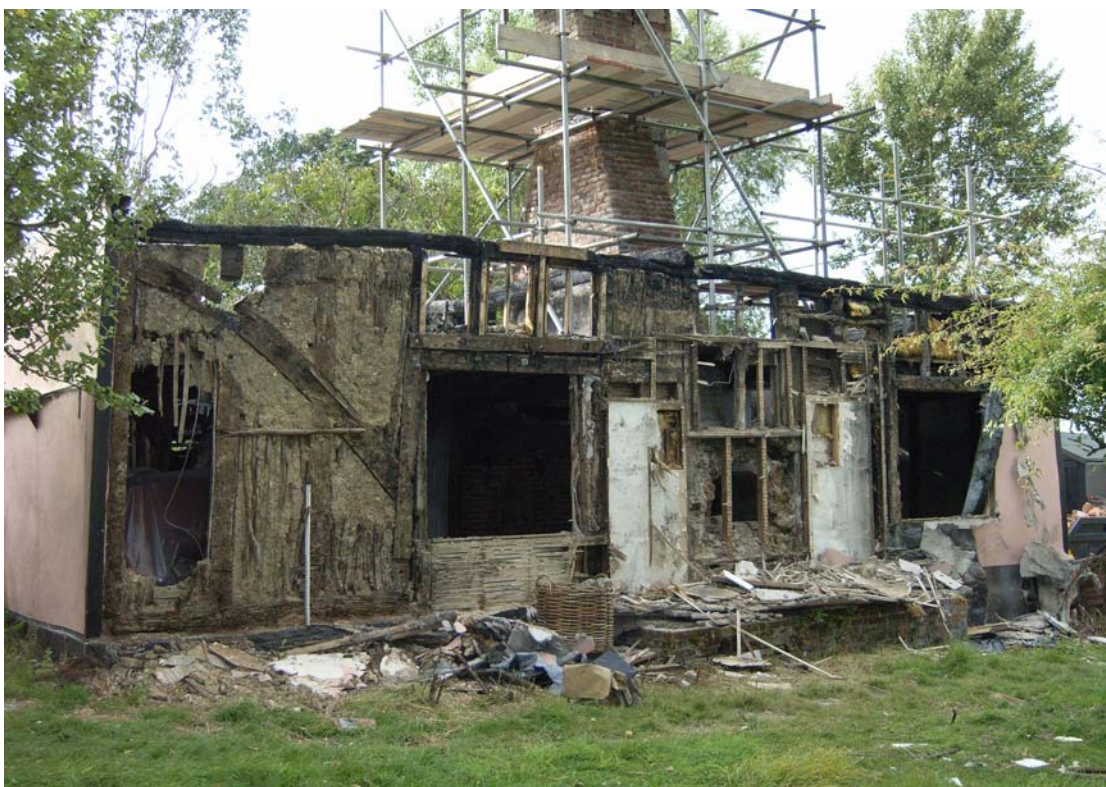
A2.2 External elevation H-N from south-east after commencement of demolition, showing original brace to left and infill of wattle-and-daub attached to externally trenched laths. A secondary bread oven against the eastern side of the chimney formerly projected beyond the plane of the wall.

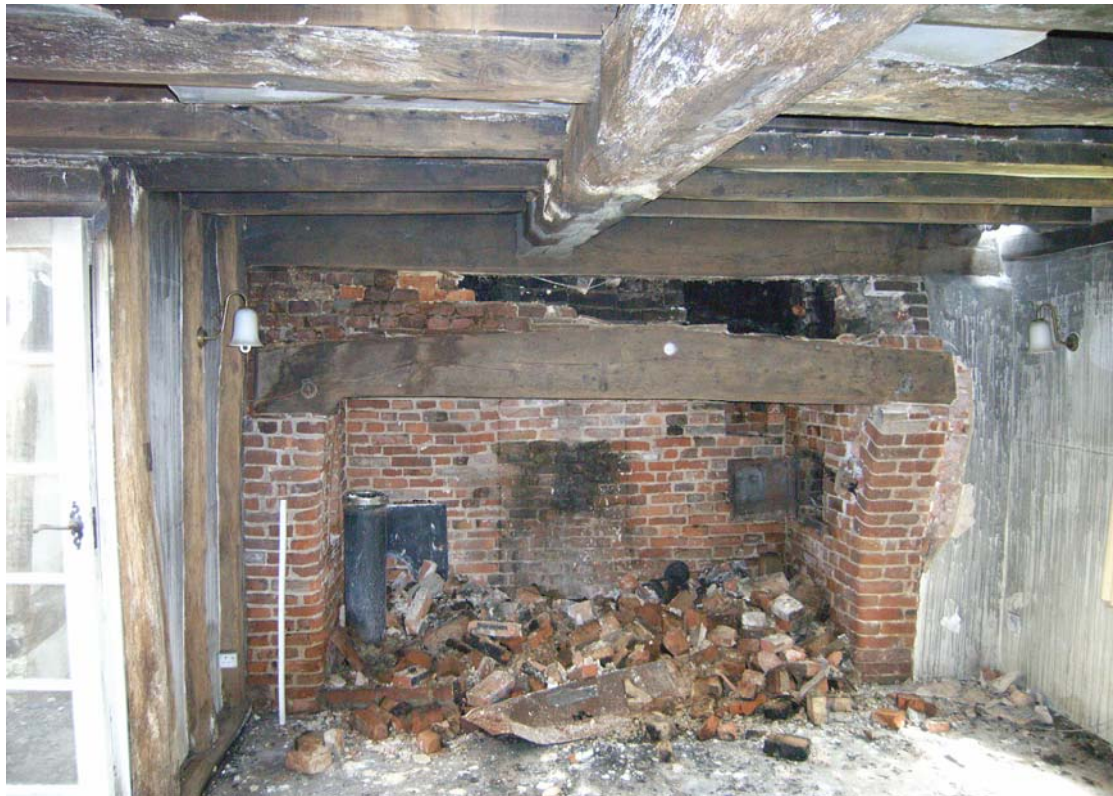
A2.3 Internal view of truss J-I from south, showing partly collapsed fireplace and largely original 17th century ceiling in room G-J-H-I.

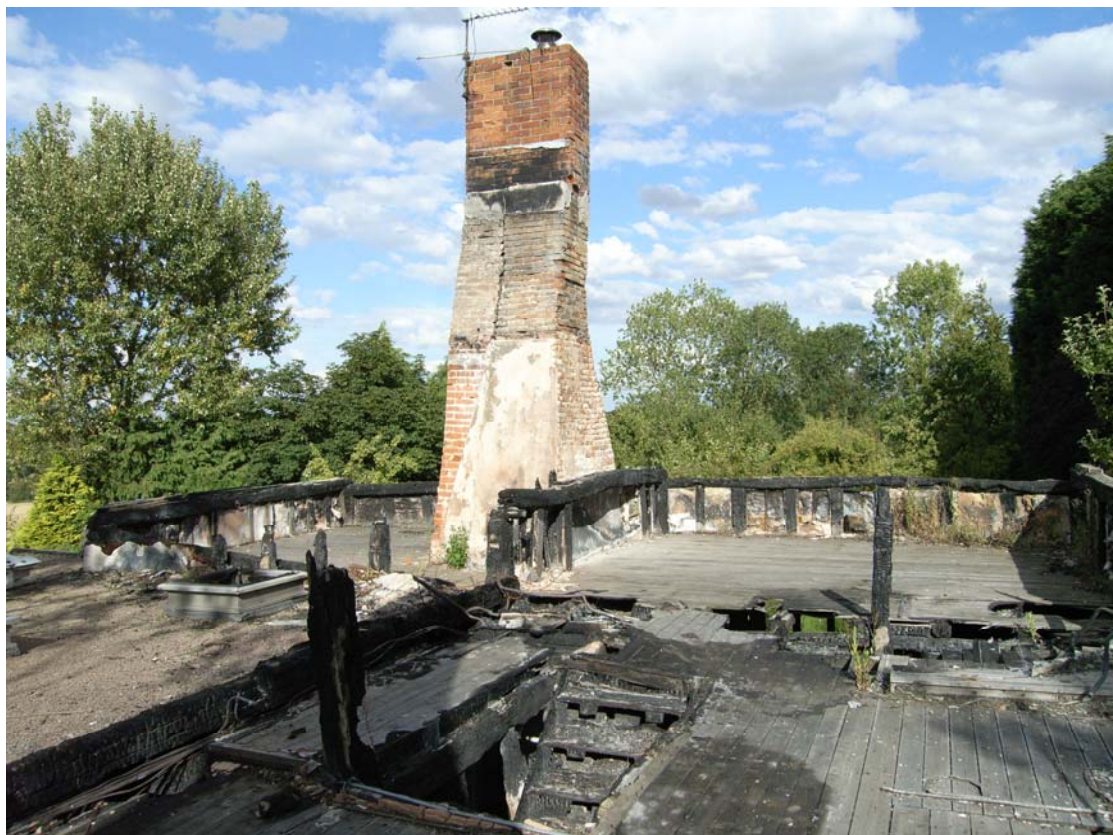
A2.4 Upper storey of structure G-H-M-N from west showing 17th century chimney to right with secondary chimney to left.

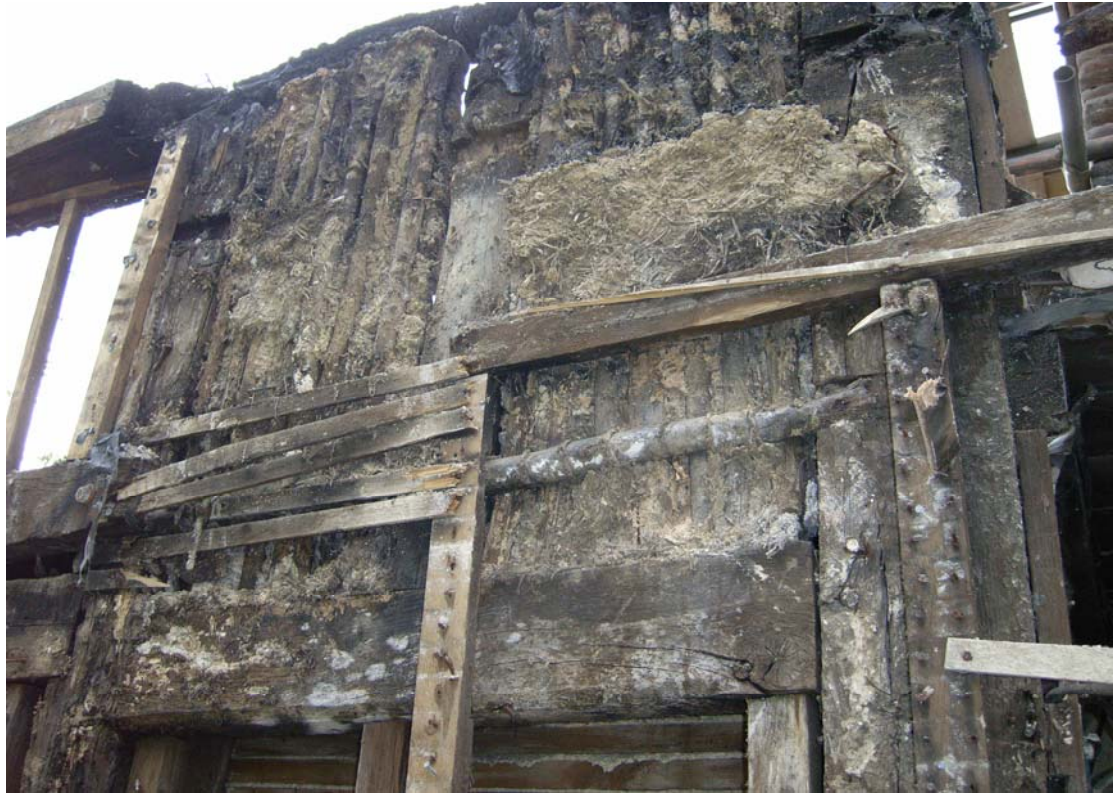
A2.5 Detail of external elevation H-I from east showing neatly chamfered original entrance lintel (bottom) with mason's mitres and original infill above (post I to right).

An original external door opened into the north-eastern corner of the larger, southern room, as indicated by its remaining lintel and southern jamb. This lintel contains an empty mortise for a missing northern jamb which would have abutted post I, and bears a neat chamfer to its lower external edge that continued down both jambs with mason's mitres at its two corners. There is no evidence of an arched head, and the door was originally 75 cm wide by 165 cm high between the ground sill and lintel (2 feet 6 inches by 5 feet 5 inches). A door of similar proportions lay immediately opposite in the western wall, of which only the pegged mortise of its lintel in post J now remains, while a third door lay at the southern end of the same wall and coincided with the ceiling trap in the western wing. The tenoned and pegged lintel and both jambs of this third doorway survive intact (figure 6). The presence of the original door against post J, which was the only one of the three to remain in use (leading to a passage between the western wing and the extension of the 1980s) is also indicated by the irregular spacing of the wall studs.

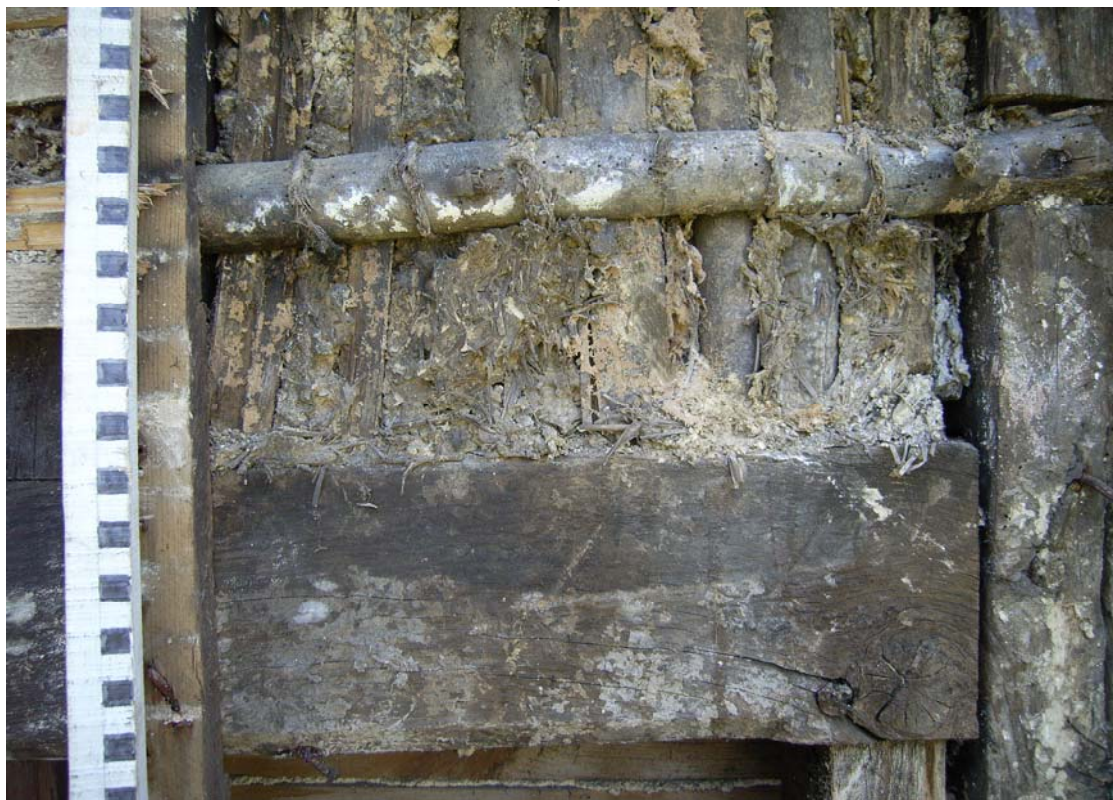
A2.6 Detail of external elevation H-I from east showing entrance door lintel (right-hand jamb lacking) and infill construction: Withy ties secure horizontal half-poles that are trenced and nailed against the exterior to vertical poles and half-poles between the studs.

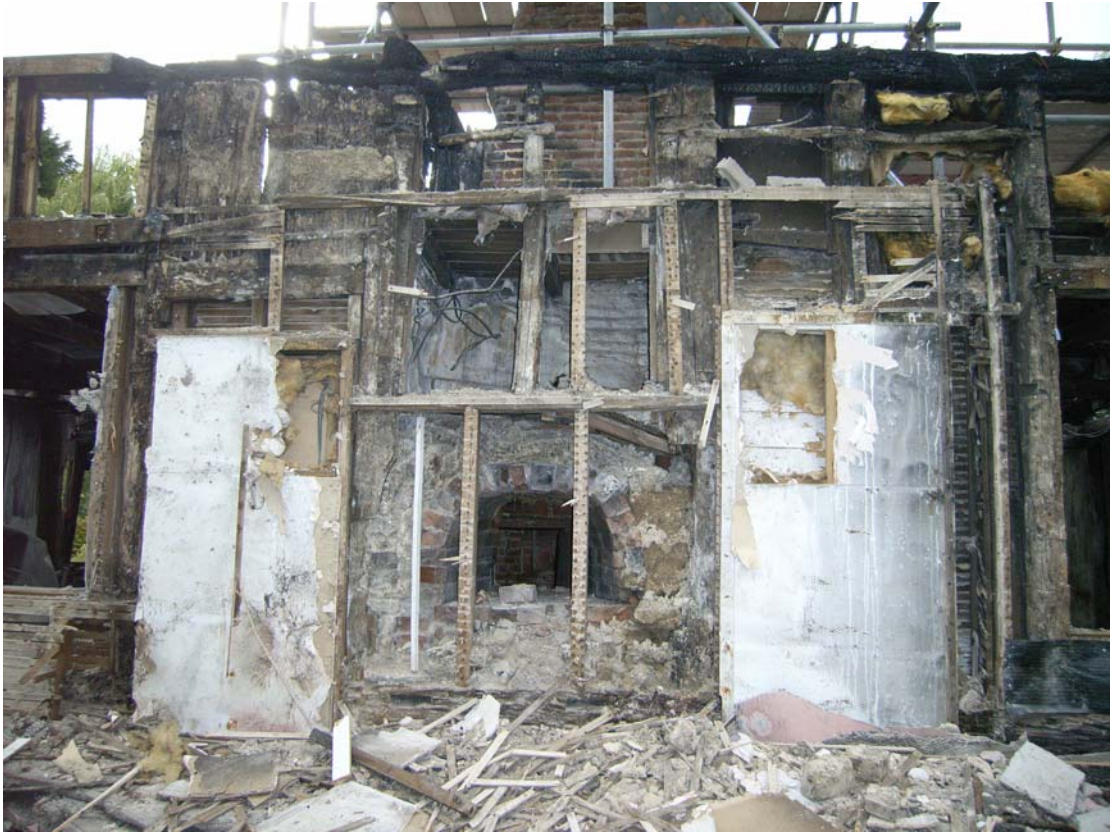
A2.7 Detail of external elevation H-I from east showing truncated brick oven between posts I and J in centre

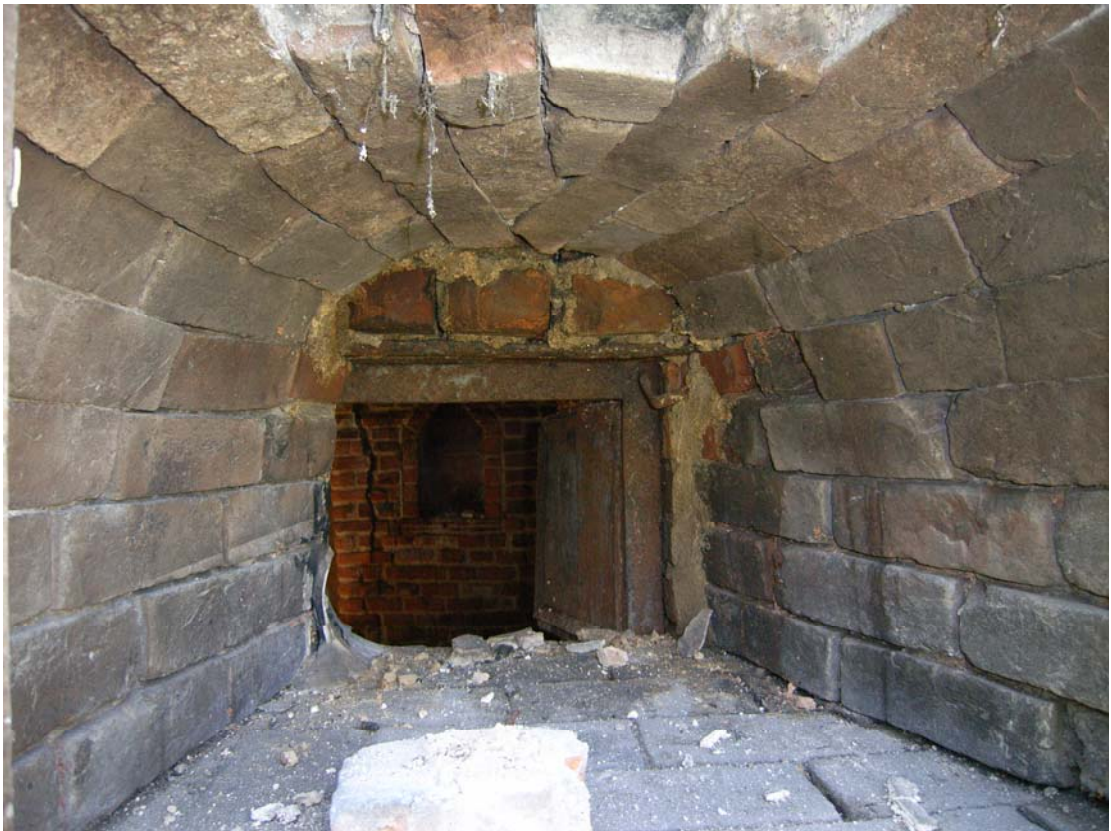
A2.8 Interior of brick oven between posts I and J

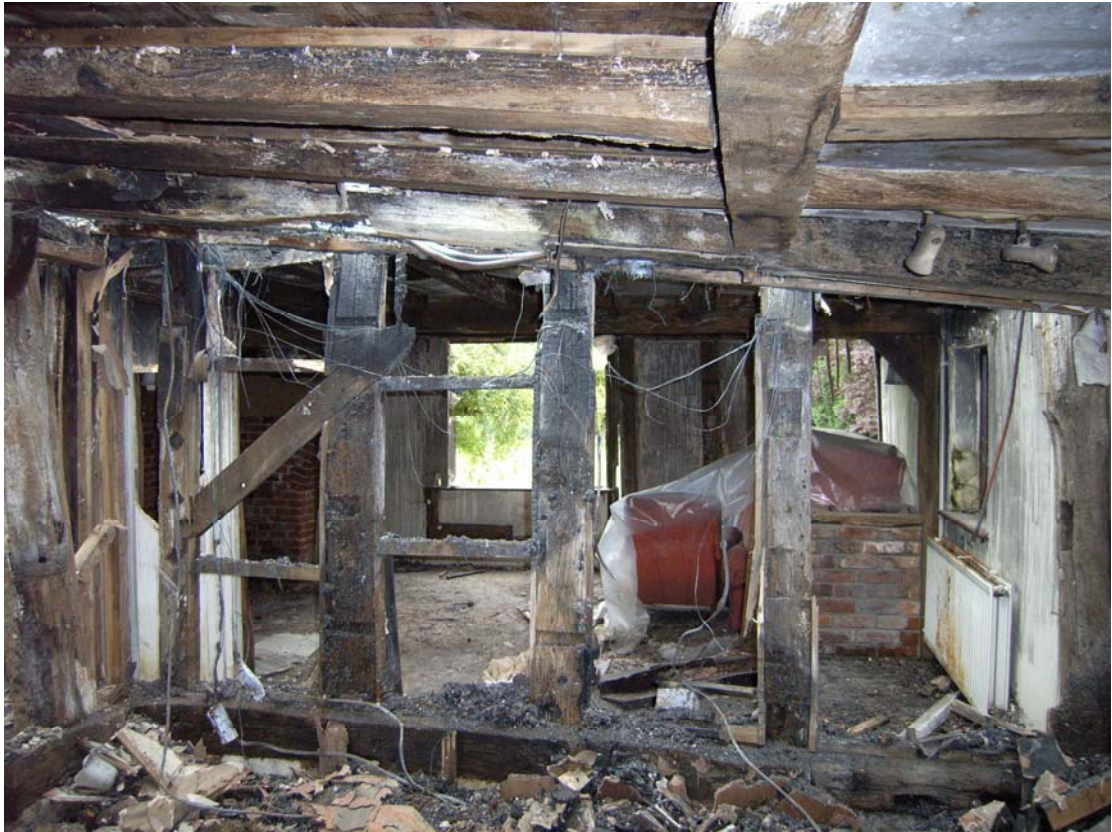
A2.9 Elevation J-G from west showing infill trenches and a window sill or lintel re-used as a stud to left (with original brace attached). Former door and stair trap to right.

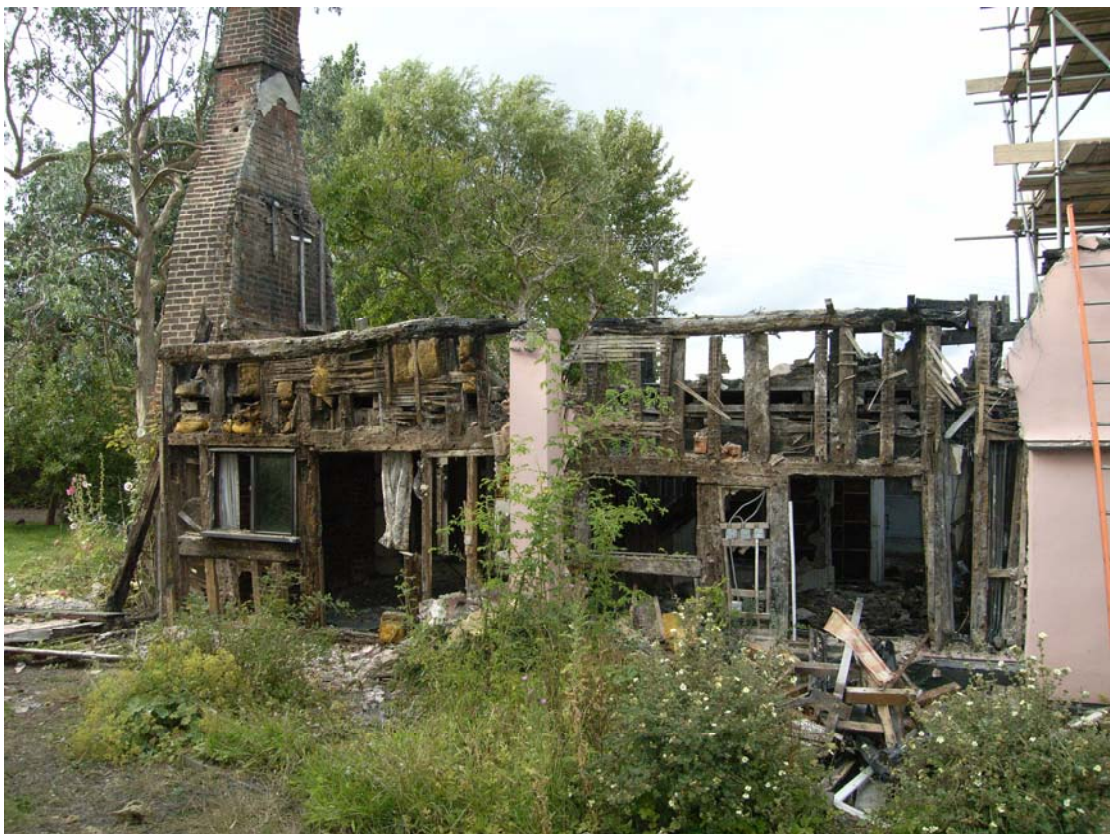
A2.10 External elevation A-E from south

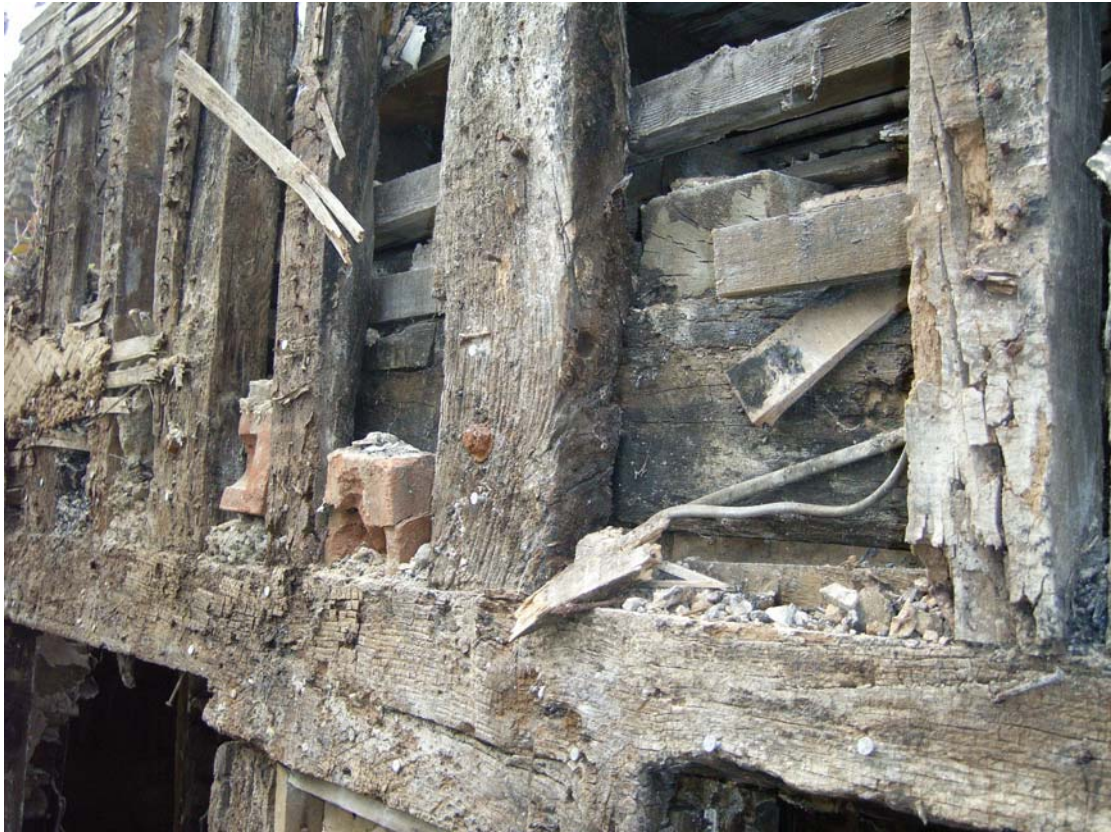
A2.11 Detail of external elevation A-E from south-east showing externally weathered studs with notches for infill staves (in contrast to infill of structure G-M-H-N).

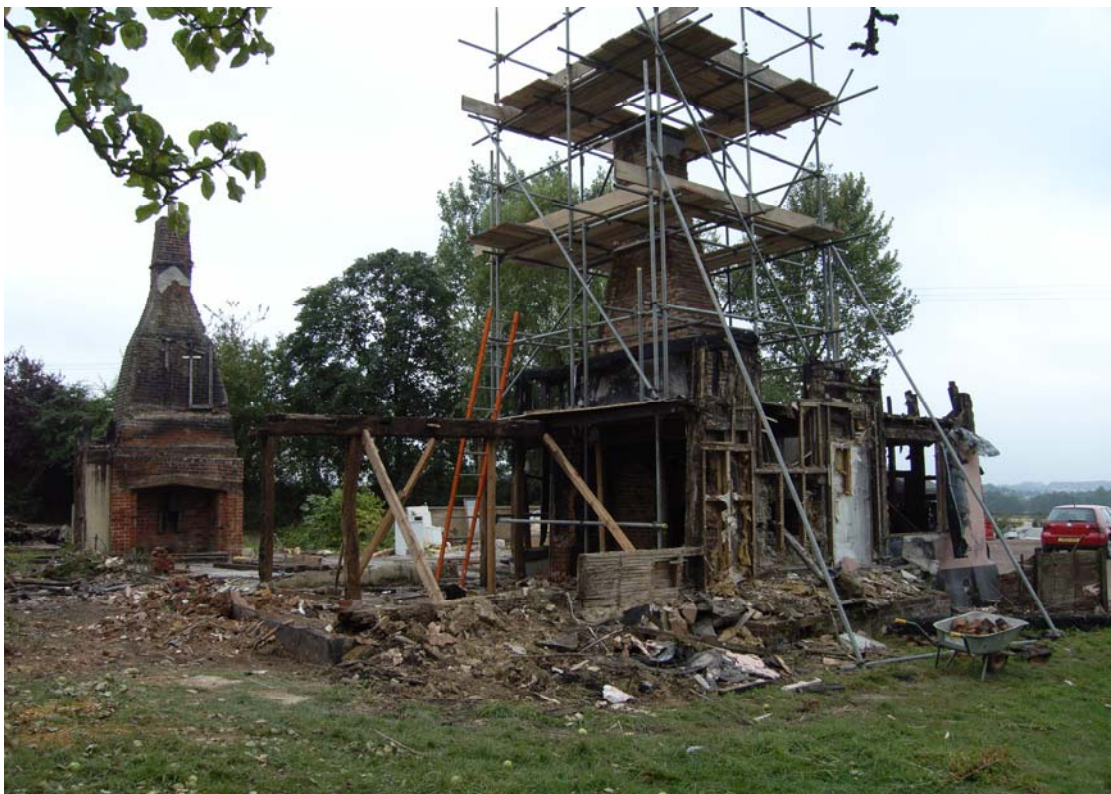
A2.12 General view of site from south-east showing demolition nearing completion (chimneys to remain *in situ*).
