**ARP Control Centre/Lowestoft Sub Control  
Normanston Drive, Lowestoft  
LWT 179**

**Archaeological Building Record**

**SCCAS Report No. 2012/045**

**Client: Wellington Construction Ltd.**

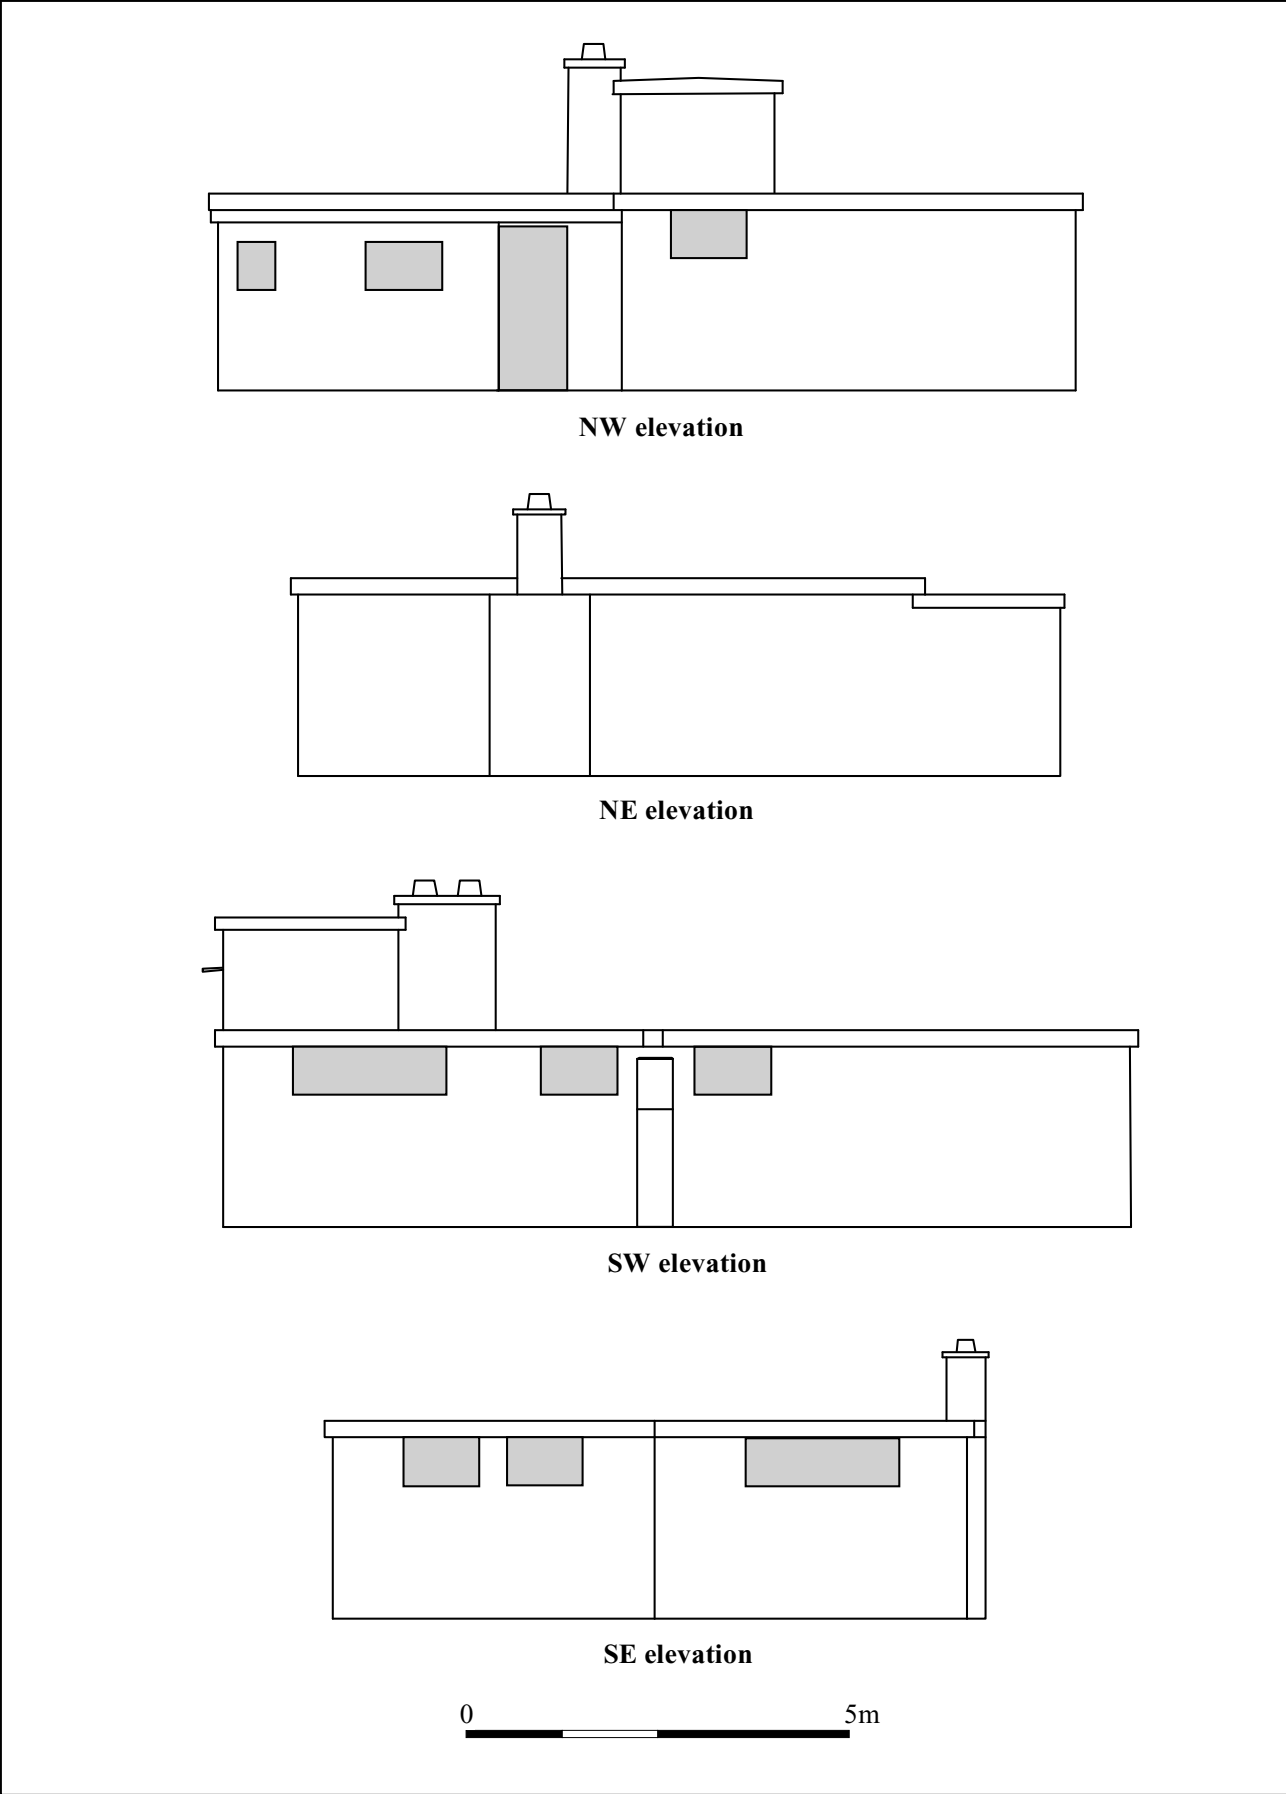
Figure 2. External elevations

The basic appearance of the structure comprised a plain flat roofed, single storey building in the shape of an irregular rectangle with irregularly spaced and sized windows on three of the sides. It had two separate chimneys and a small low structure on the roof (plates 1 to 4). It was situated in a large, triangular grassed area in front of a crescent of relatively modern housing and was aligned approximately south-east to north-west. For elevations of the structure see Figure 2.

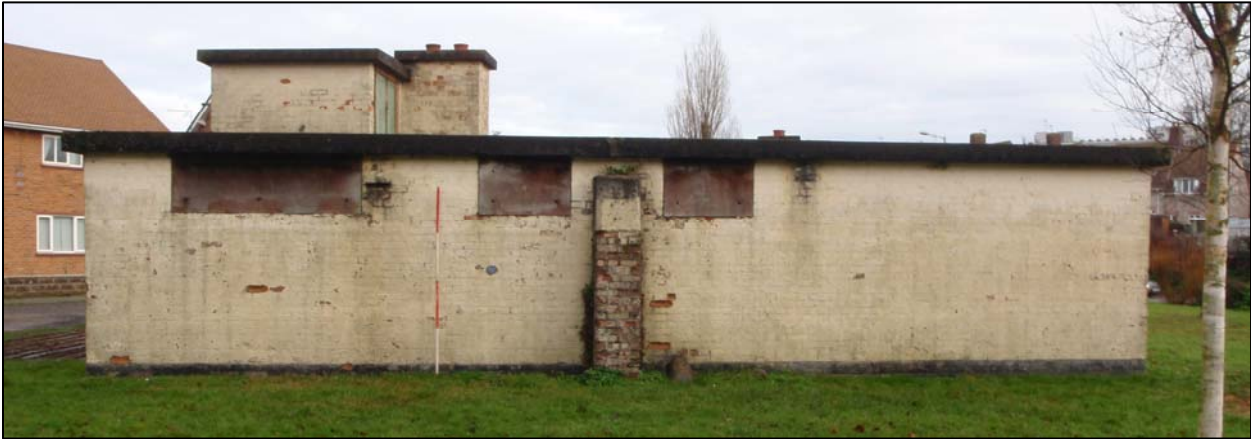
Plate 2. South-west elevation (ref. HLX 02)

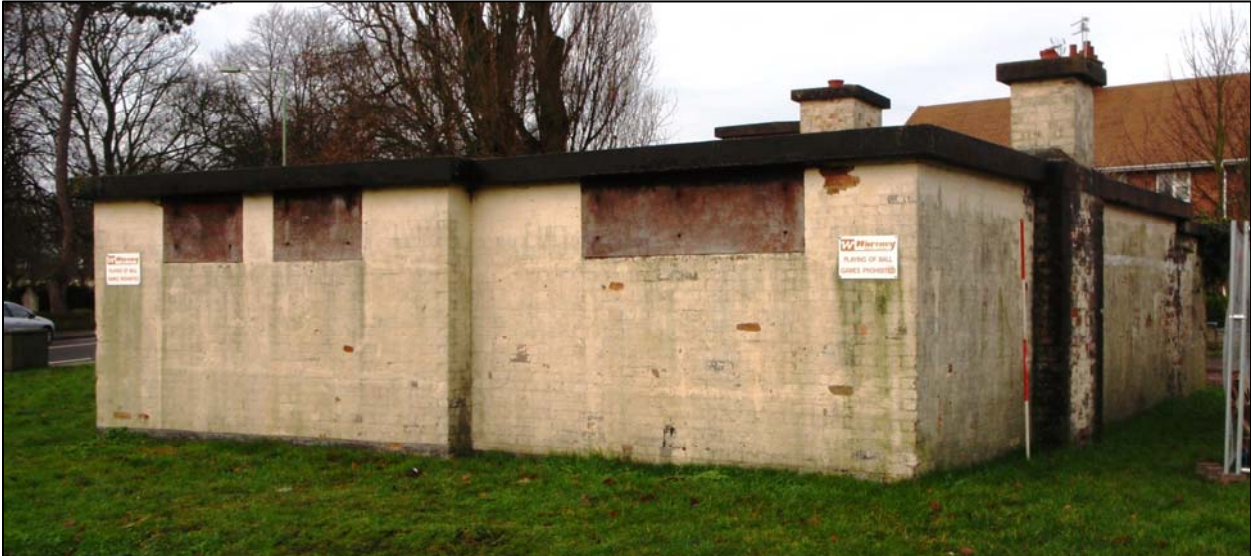
Plate 3. South-east elevation (ref. HLX 07)

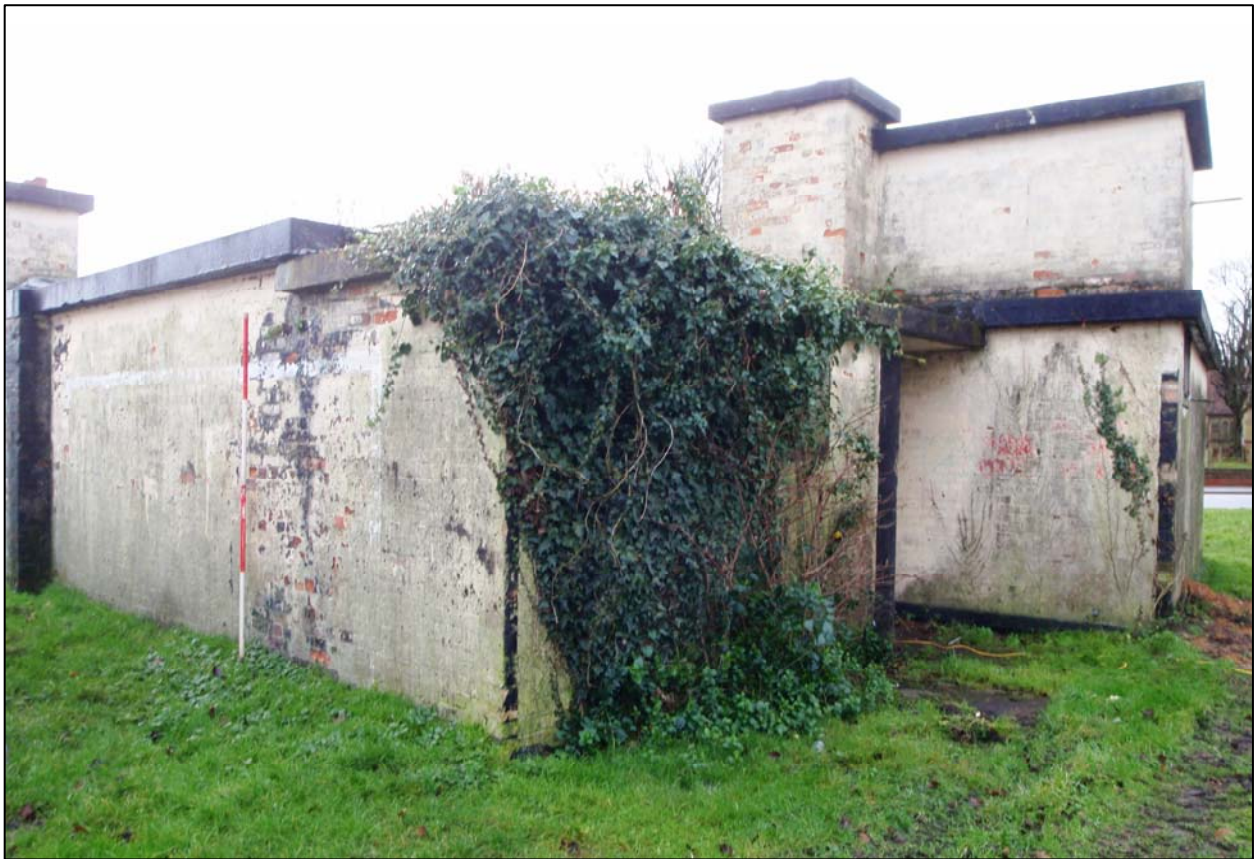
Plate 4. North-east elevation (ref. HLX 08)

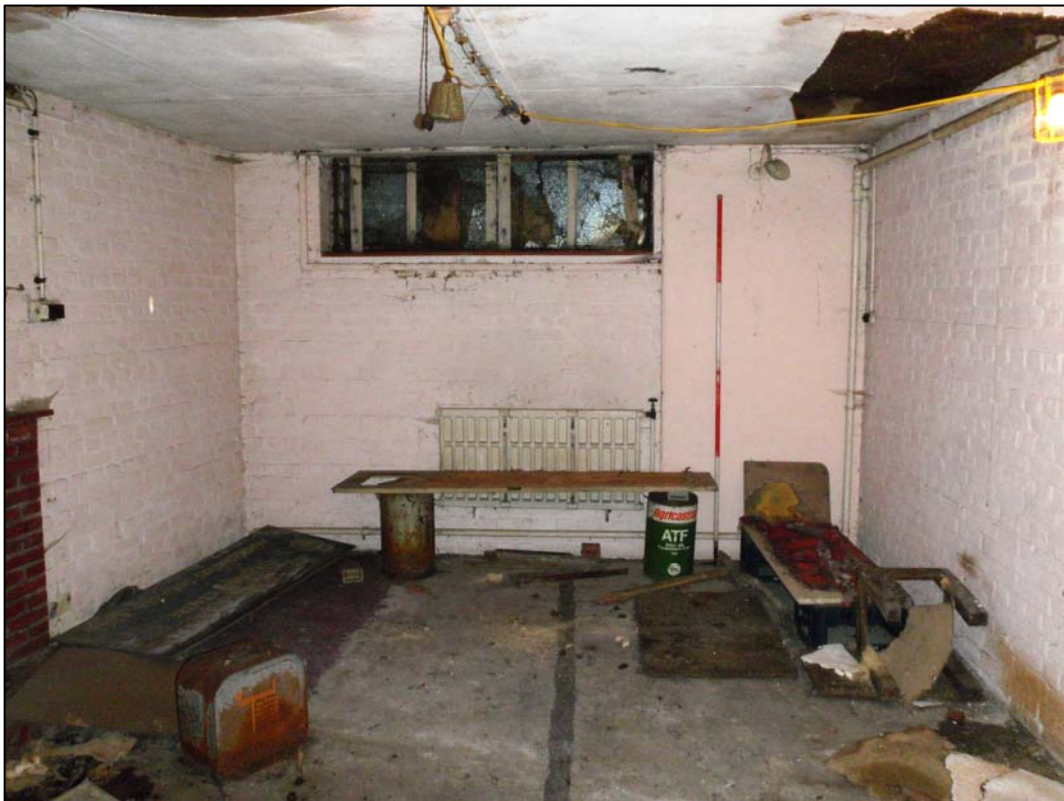
Plate 5. Room G3, camera facing south-east (ref. HLX 15)

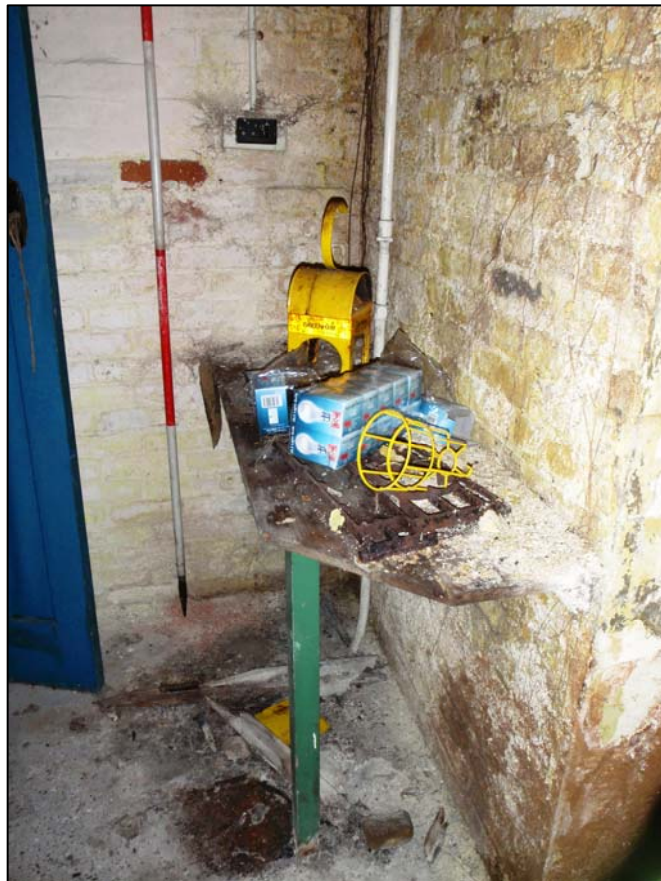
Plate 9. Room G4, camera facing south-west (ref. HLX 21)

Power sockets were noted in the majority of rooms. These were of the older large three round pin type (BS 546) introduced in 1934 (see plates 9 and 40 for examples). The present three pin plugs (BS 1363) were introduced in 1947 although the older type continued in use for some time.

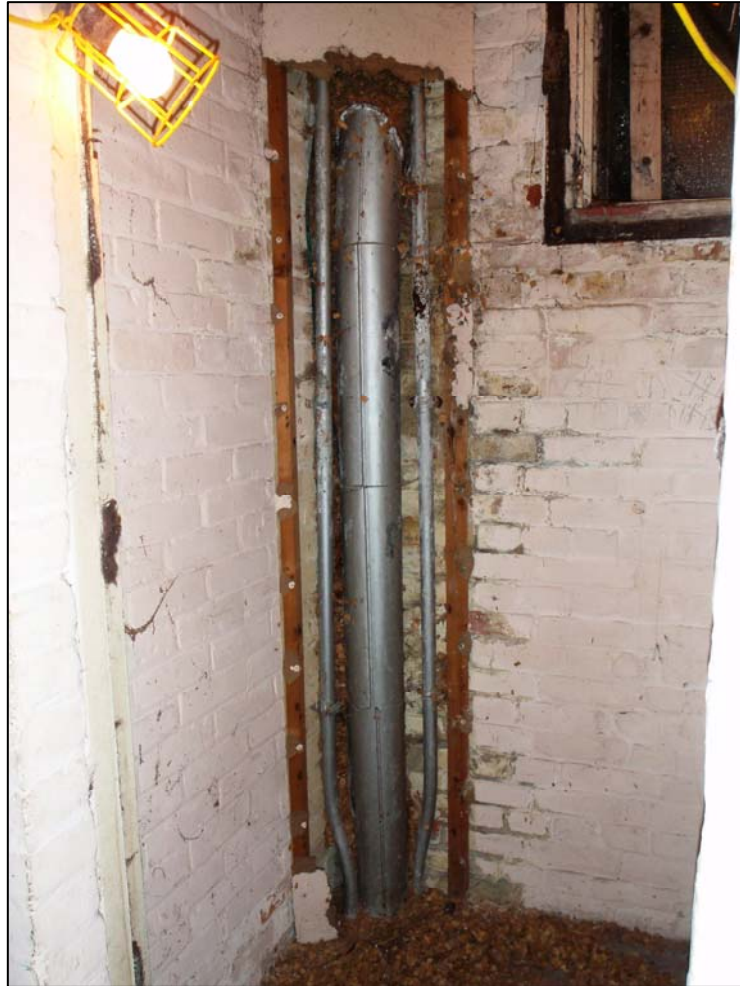
Plate 26. the exposed air supply pipe, camera facing south-west (ref. HLX 60)

G12: A small square space leading to a set of stairs down to the basement level. A series of three vertical pipes were present in the southern corner (plate 26). These had been boxed in behind sheets of hardboard but this had been partially removed. The space had clearly been filled with an insulating material. The large diameter central pipe was a ventilation duct that connected to a pump in a room directly below. The doorway from corridor G6 into G12 was also a gas tight doorway. The door would have opened into G12 although this was missing. Fittings within this area consisted a circular one-way air valve set into the wall above the door which allowed air to escape into G6 (plate 27) and a pair of metal brackets located at the top of the stairs (plate 28). A similar bracket was located at the base of the stairs suggesting these may have held a hand rail, probably formed from a length rope.

The air entered through an inlet pipe from the floor above (see room G12 and plate 26). It then passed through an in-line filter that appeared to be a later addition to the system. Its installation had required the gouging out of a trough in the rear wall to allow for clearance (visible in plate 49). This may be related to an upgrading of the filtration equipment when the building was converted to use as the Lowestoft Sub-Control in the 1950s. From here the supply then passed through two valves (yellow and red - see below) and into the bottom of a large cylindrical drum which was undoubtedly a further filter (plate 55). It exited from the top of this cylinder and passed into a centrifugal pump. Upon exiting the pump the air passed through an elongated cylinder, possibly a water jacket to either heat or cool the air, and up to a T junction before distribution to rooms B2, B3 and B4 (plate 56) in the basement via the pipework and vents as shown in Figure 4. The vents could be opened and closed by screwing up a circular fitting (plate 57). An element of colour coding appeared to be in use as all pipework up to and including the pump was painted black whilst from the pump onwards all pipework was painted blue. To avoid uncomfortable increases in pressure a two, one-way valves were fitted. One in the wall of B6 to allow air to escape into the area of the stairs (suggesting a door was once fitted at the bottom of the stairs), and one in room G12 at the top of the stairs (plate 27). Closable vents, identical to those fitted to the air supply pipes, were fitted in the doors to B3 (plate 35) and B4 (plate 42) to allow air to escape. Presumably, the door to B2 would have been similarly fitted.

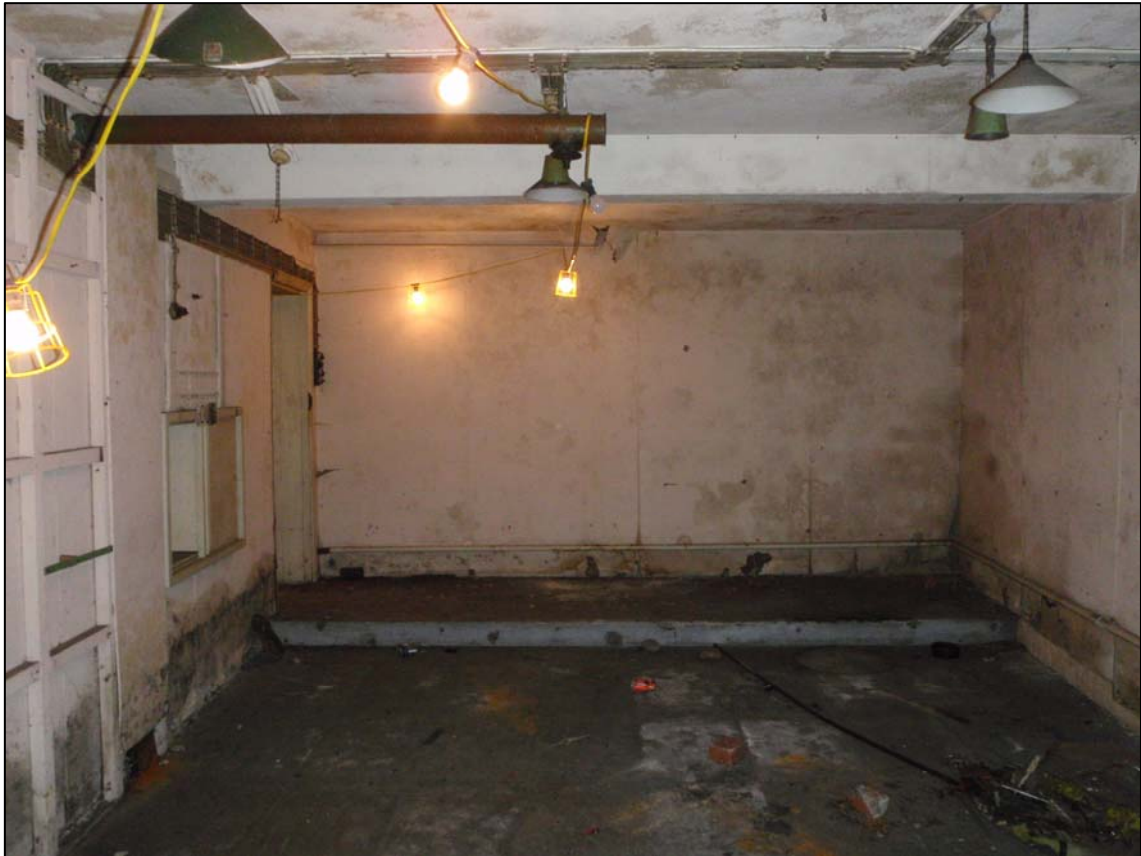
Plate 29. Room B1, bottom of the stairs, camera facing west (ref. HLX 76)

B1: The stairs down from the Ground Floor led to a short corridor from which all the basement rooms were accessed (plate 29).

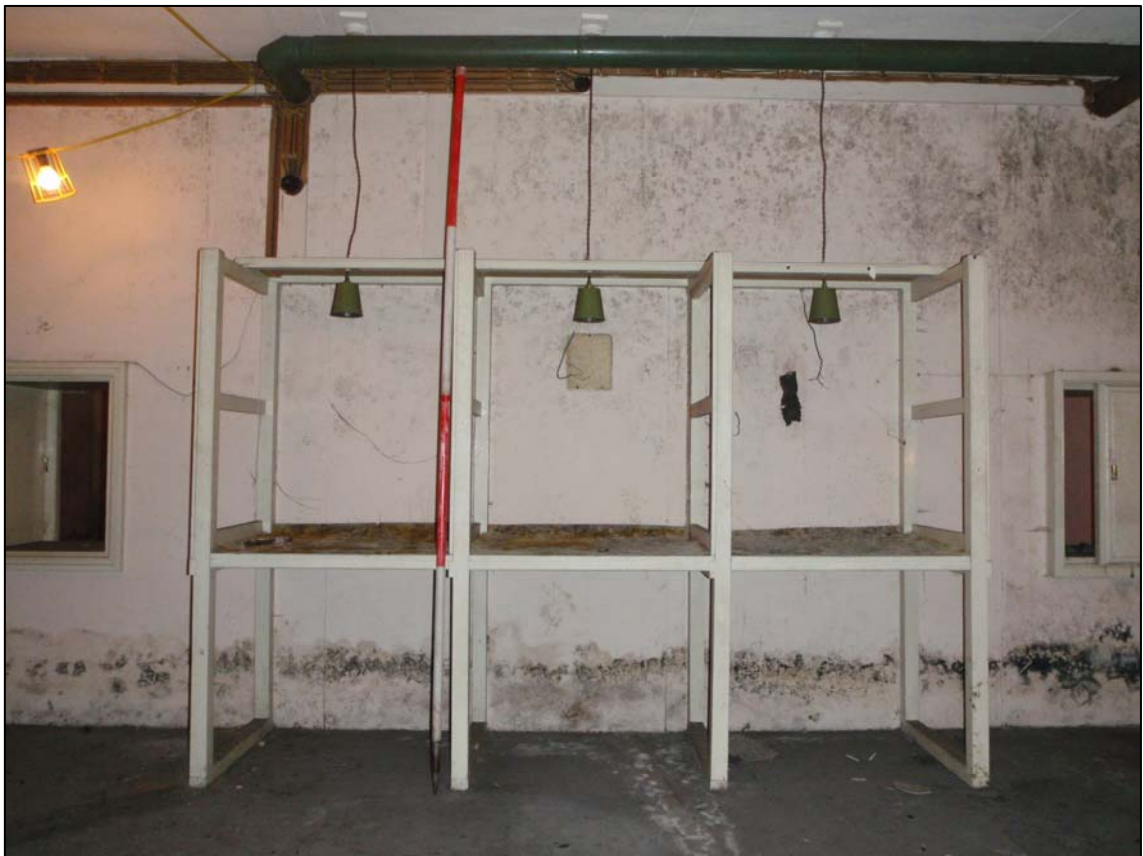
Plate 36. Room B3, camera facing north-west (ref. HLX 89)

Situated around three sides of the room was a series of small booths formed from timber and hardboard. Four were situated against the north-west wall (plate 36), three against the north-east wall (plate 37) and a further four against the south-east wall (plate 38). Each booth was illuminated by its own light and each appeared to have telephone connection. Fitted to the wall in the southern booth was an 'on-off' electrical

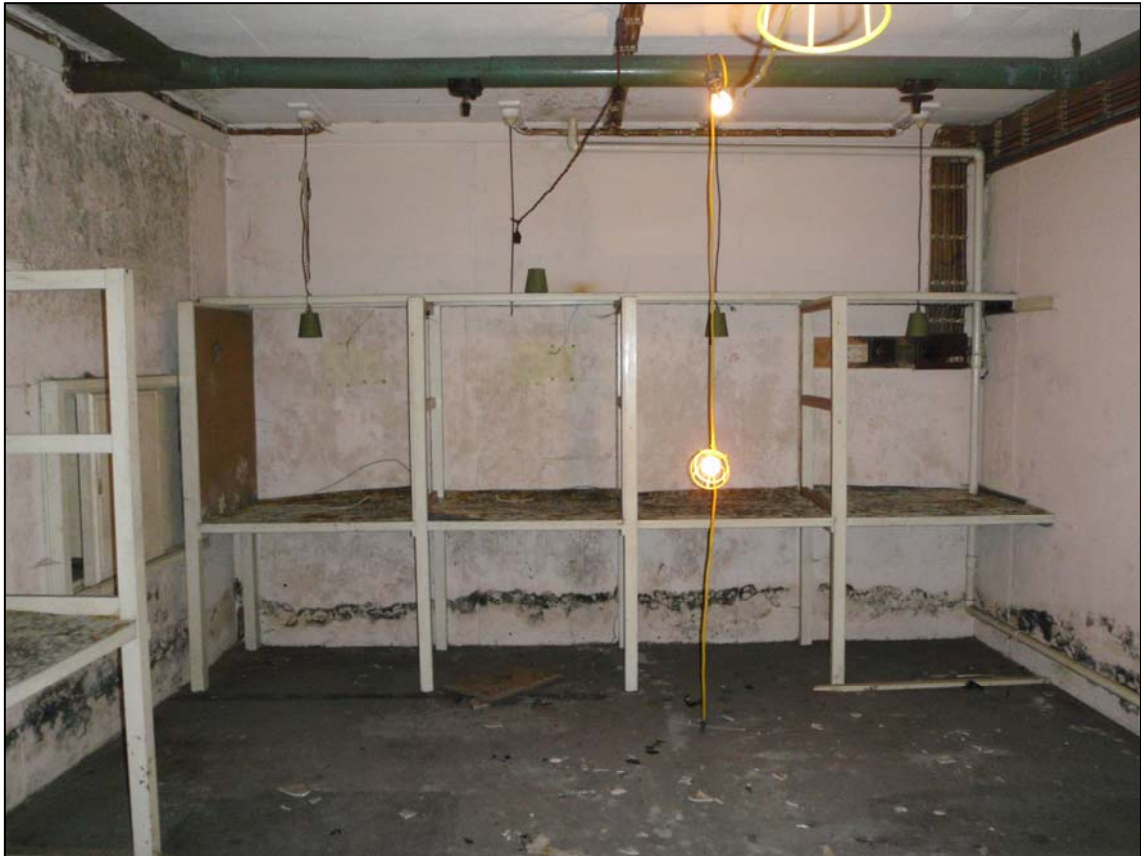
Plate 37. Room B3, camera facing north-east (ref. HLX 95)

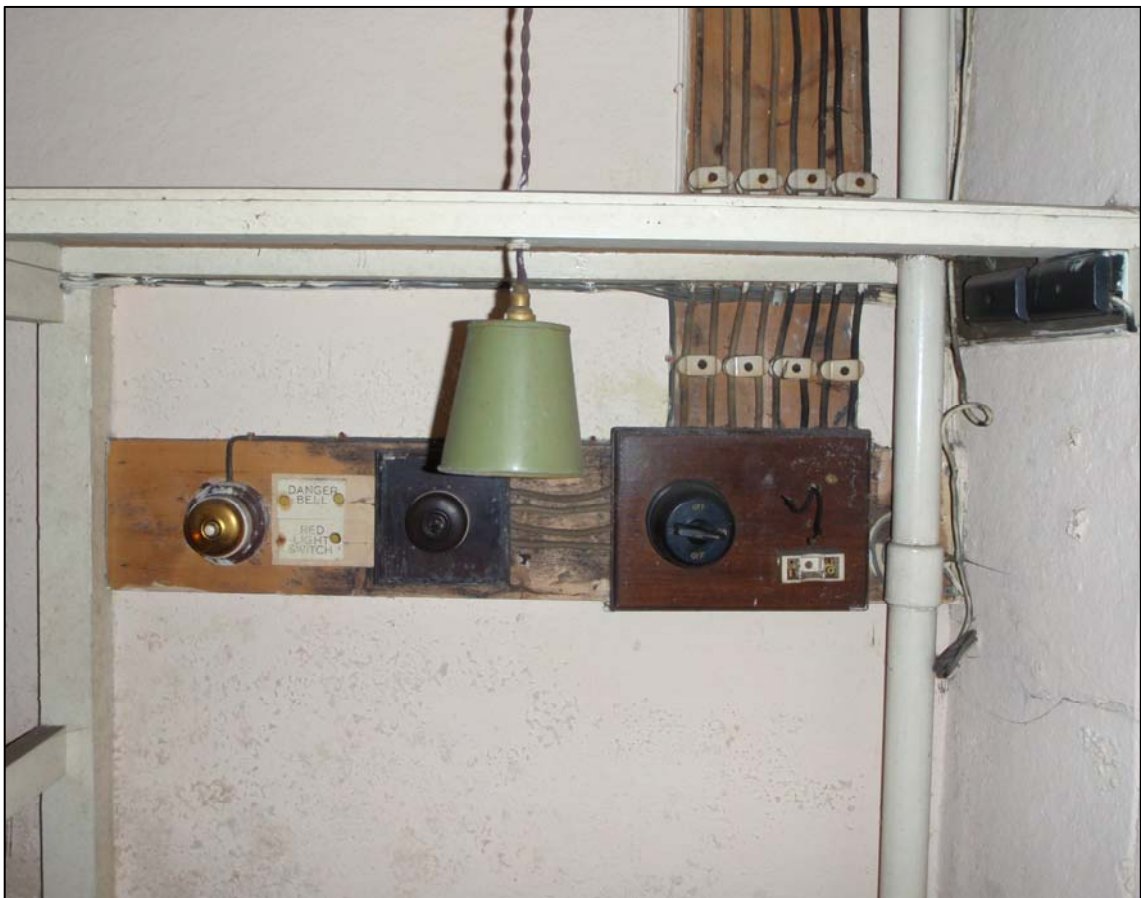
Plate 39. Room B3, switches in southern corner, camera facing south-east (ref. HLX 91)

switch, a light switch and a push button. Between the light switch and the push button were pinned two labels; 'DANGER BELL' and 'RED LIGHT SWITCH' (plate 39). Centrally fitted on the south-west wall was an electrical box associated with the telephone wiring (plate 40).

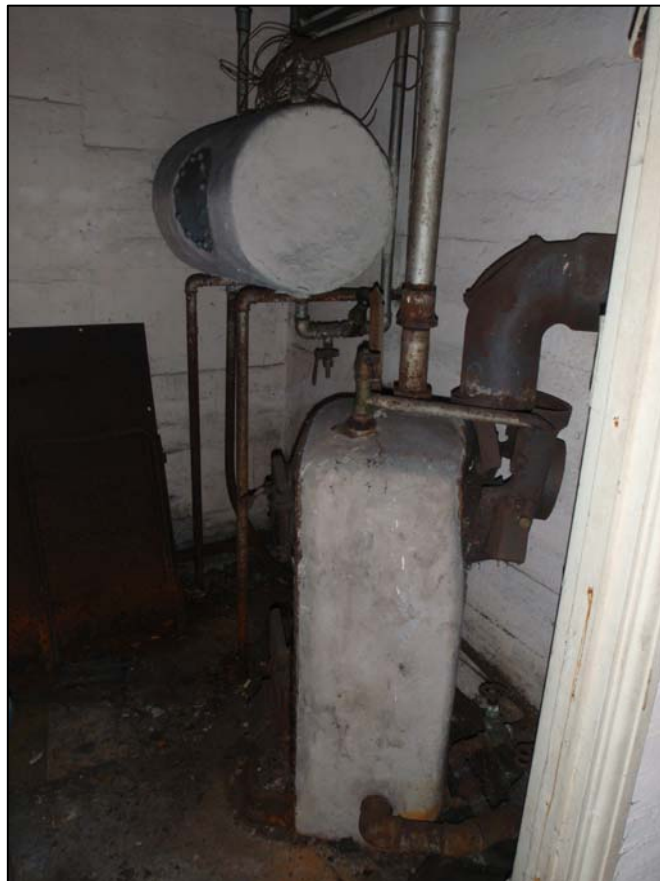
Plate 43. Room B5, solid fuel heater and tank, camera facing north-west (ref. HLX 69)

B5: A small rectangular room which contained what appeared to be a solid fuel fired water heater with associated pipework and a water tank (plates 43 and 44). A large flue pipe emerged from the back of the heater and ran up through the wall into the corridor B1. It ran a short distance juts below ceiling height (plate 45) before passing up to the floor above to presumably exit through the chimney visible on the roof. This equipment was to provide heating for the complex and both levels via the radiators that were present in each of the rooms. It may also have provided a supply of hot water.

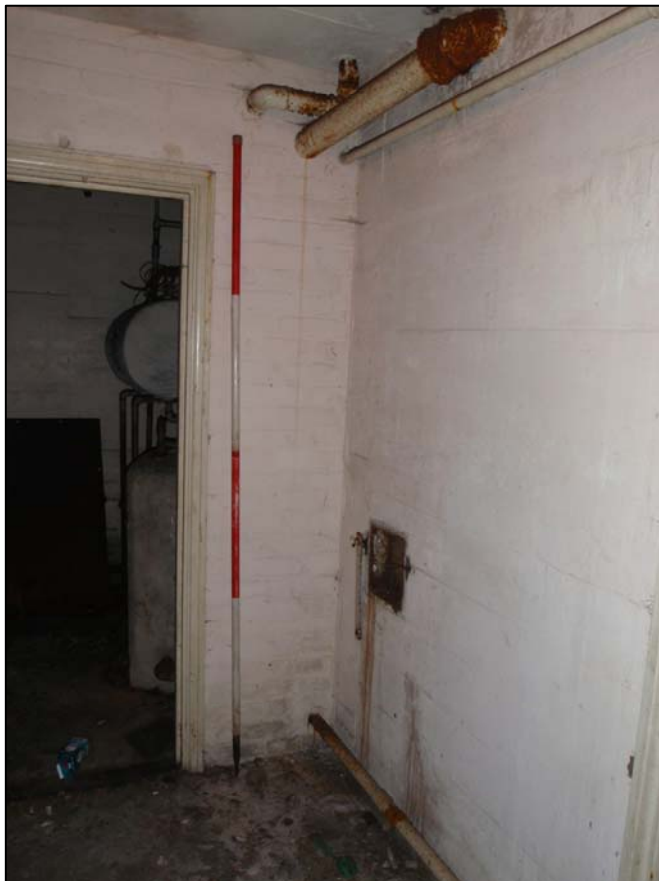
Plate 44. Room B5, solid fuel heater, camera facing east (ref. HLX 70)

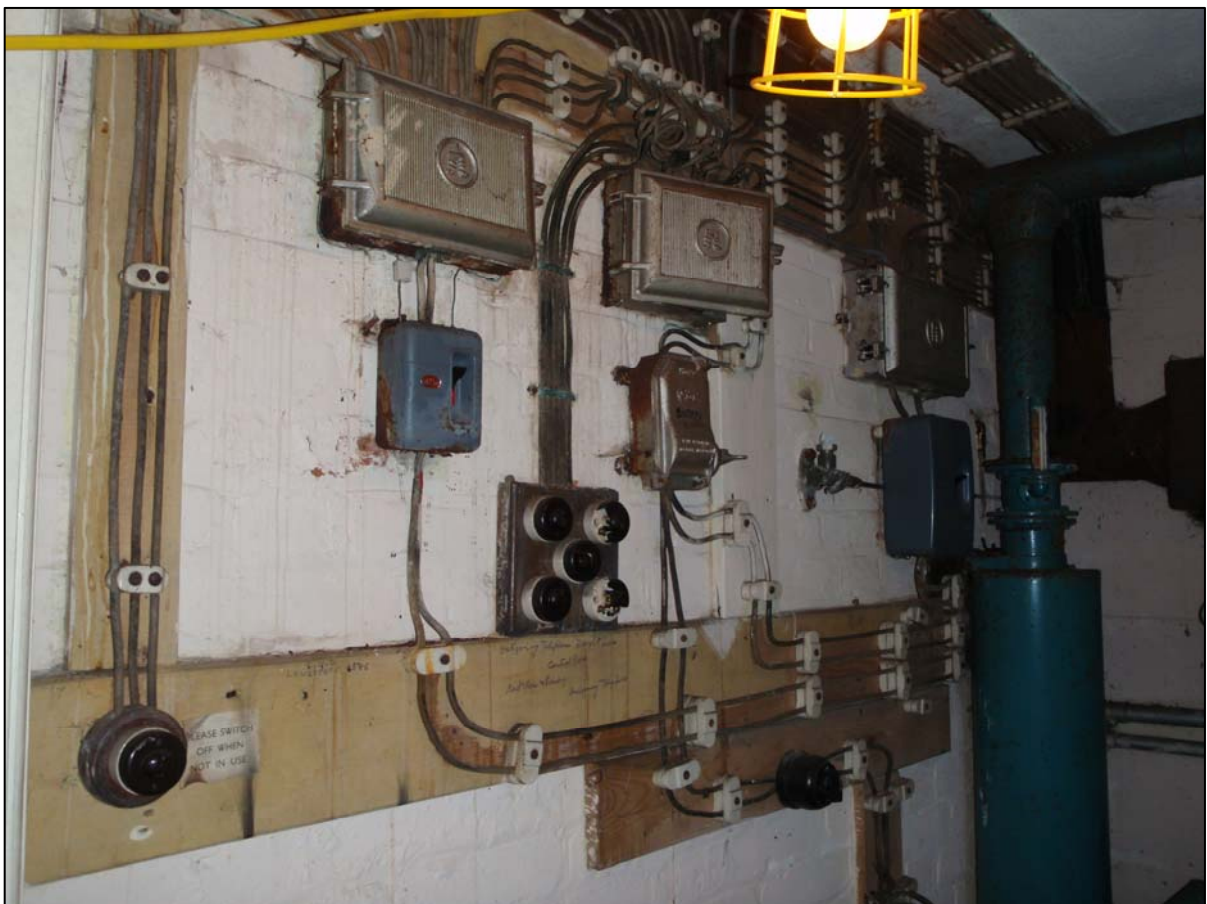
Plate 47. Room B6, fuse boards and switching, camera facing south (ref. HLY 29)

Mounted on the south-east wall was an array of electrical wiring, fuse boxes and switches associated with the electrical supply to the bunker (plate 47). One of the switch boxes was labeled 'Battery LIGHTS' (plate 48), indicating a battery powered back-up system and a large cylindrical battery was noted hanging from the wiring (plate 49). It is likely that this battery was originally mounted on the wall or sat on a shelf as a pair of rusted brackets is visible just behind the battery. At least two other batteries were noted lying on the floor. Amongst the fuse boxes and switches some information was hand written. A set of five switches were identified in biro as: 'outgoing telephones', '?District lines', 'control room', 'rest-room and laundry' and 'incoming telephones' (plate 50). To the left of this what is probably a telephone number is written in pencil as 'C.D.D. LOWESTOFT 4585'. Information was also written in pencil on the cover of one the fuse boxes detailing which circuit each fuse protected (plate 51).

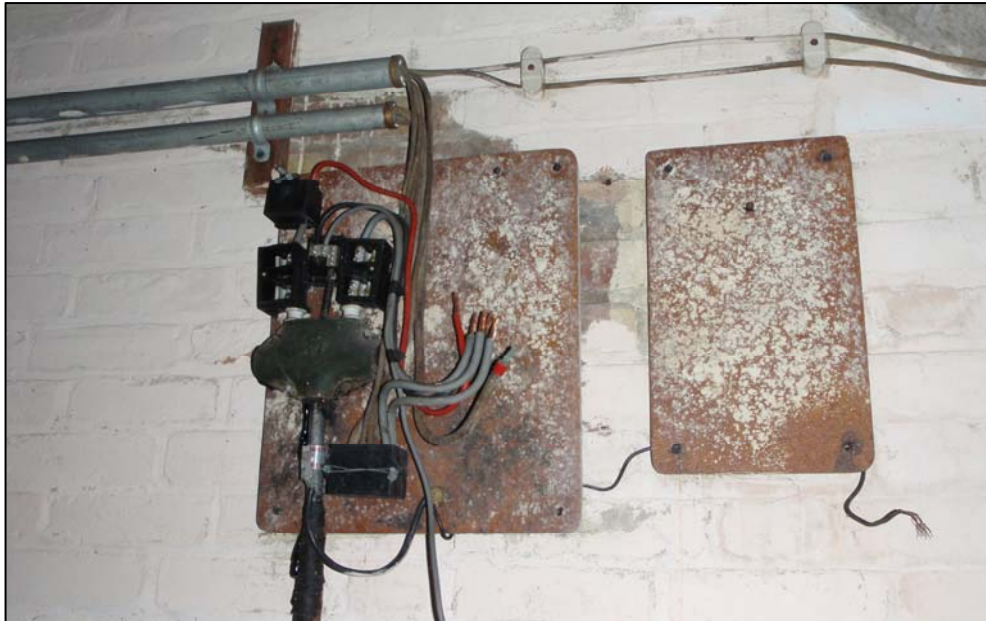
Plate 52. Room B6, power supply and site of ?meter, camera facing north-west (ref. HLY 25)

The electrical supply for the bunker entered this room through the floor in the area directly under the stairs. Fuse and connections were present but the a component, presumably the meter, had been removed (plate 52).

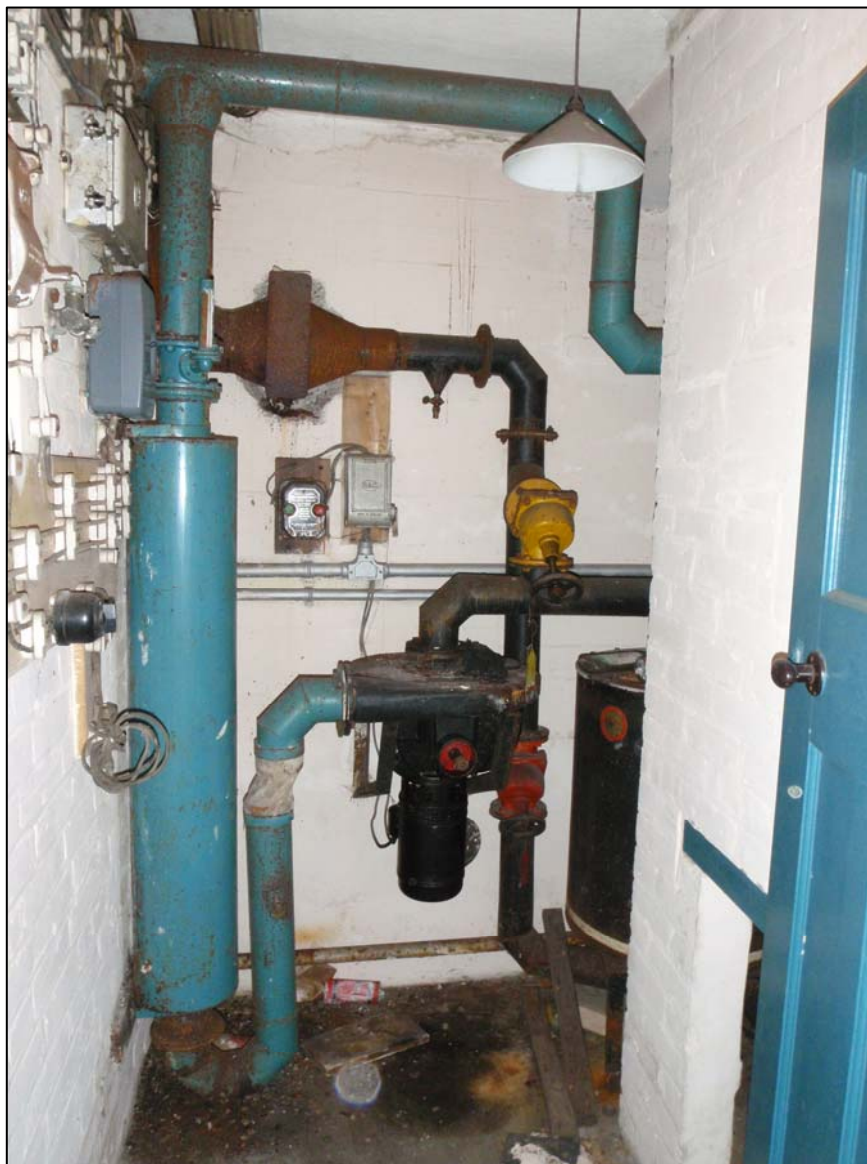
Plate 53. Room B6, air supply equipment, camera facing south-west (ref. HLY 14)

Equipment associated with the supply of air to the basement was mounted at the rear of room B6, either by brackets on the walls or resting on the floor (plate 53). This equipment was supplied by Andamite Limited of London and Rugeley and both the pump and the filter were branded with their name (plate 54). The pump was fitted with an identification plate upon which the date 14/9/41 is marked suggesting this equipment dates from the bunker's use as an ARP Control Centre.

be turned by hand by fitting a crank to a short shaft, highlighted with a red background, on the front of the pump (visible in plate 53).

The main cylindrical filter in the air supply system could be bypassed through the use of a pair of valves, one yellow and one red (visible in plates 53 and 55). A small enameled tag tied to the yellow valve states:

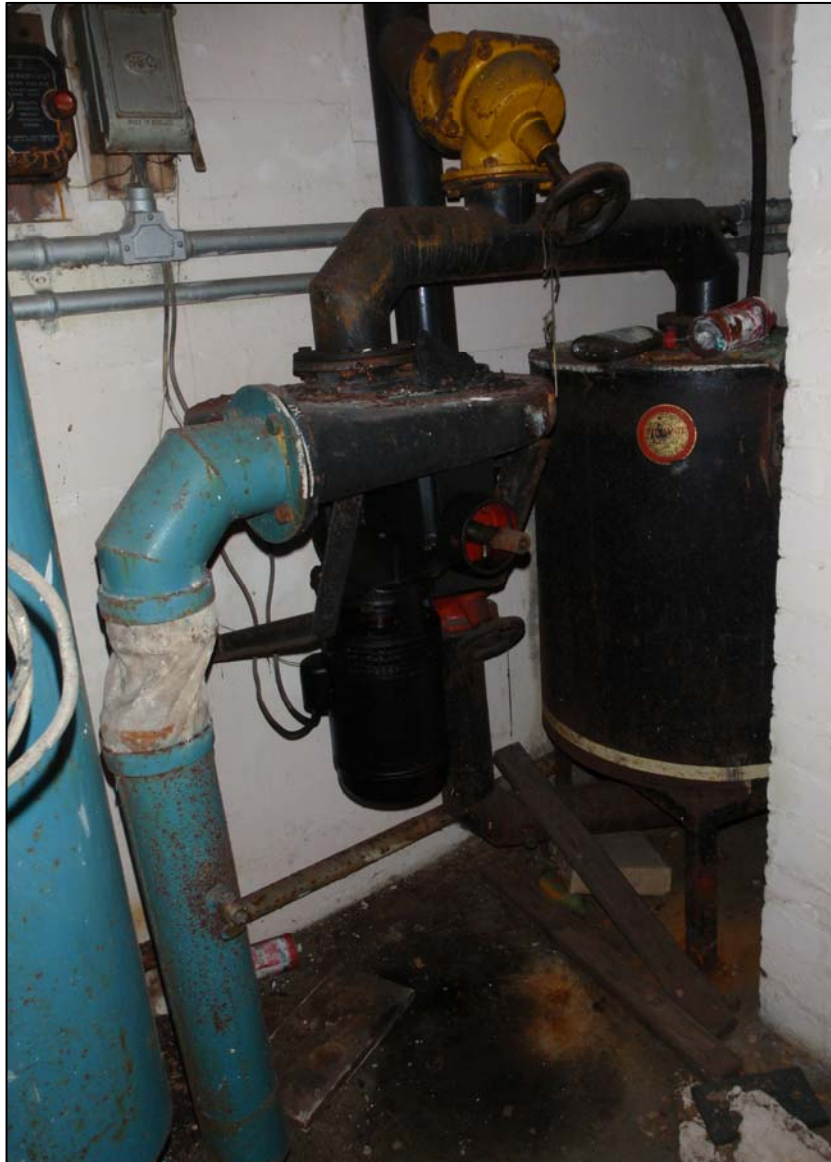
Plate 55. Room B6, air supply equipment - pump and gas filter (ref. HLY 39)

BY-PASS CONTROL VALVE  
IMPORTANT  
IN CASE OF GAS SHUT THIS  
VALVE AND OPEN GAS FILTER  
VALVE COLOURED RED

This would indicate that the large black cylinder was a gas filter and that during normal operation it was by-passed and was only brought into use during a suspected gas attack.

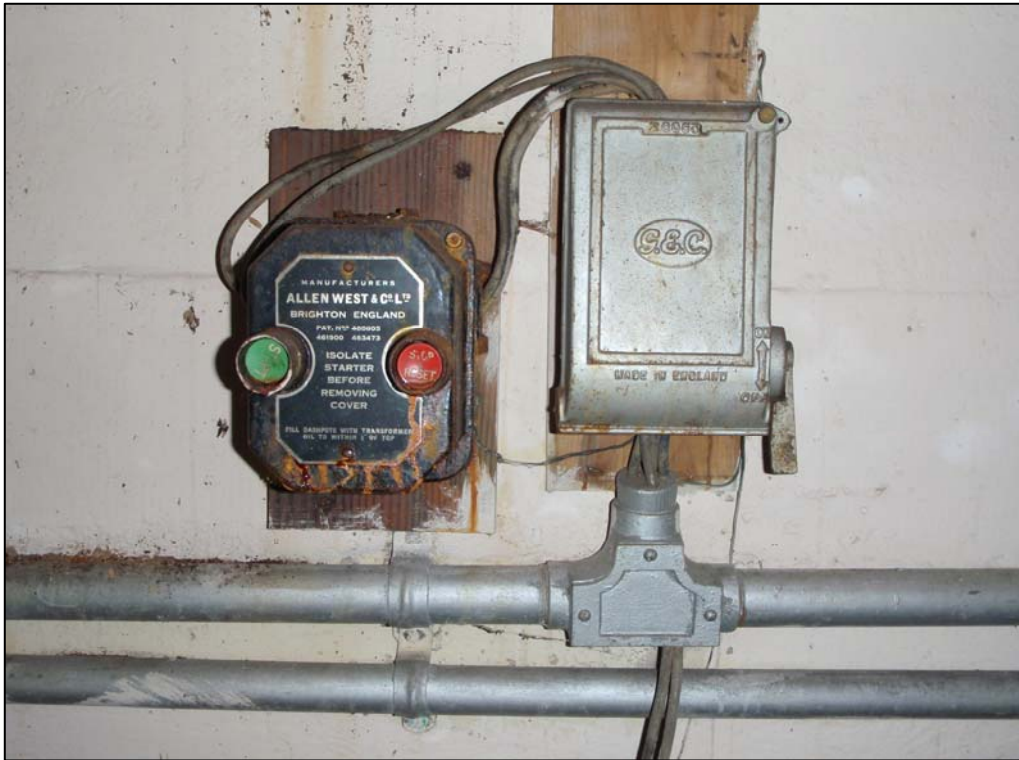
Plate 58. Room B6, air supply pump switches (ref. HLY 19)

The pump was powered by an electric motor controlled by a pair of switches fitted on the south-west wall (plate 58). In the event of an electrical failure the pump could also

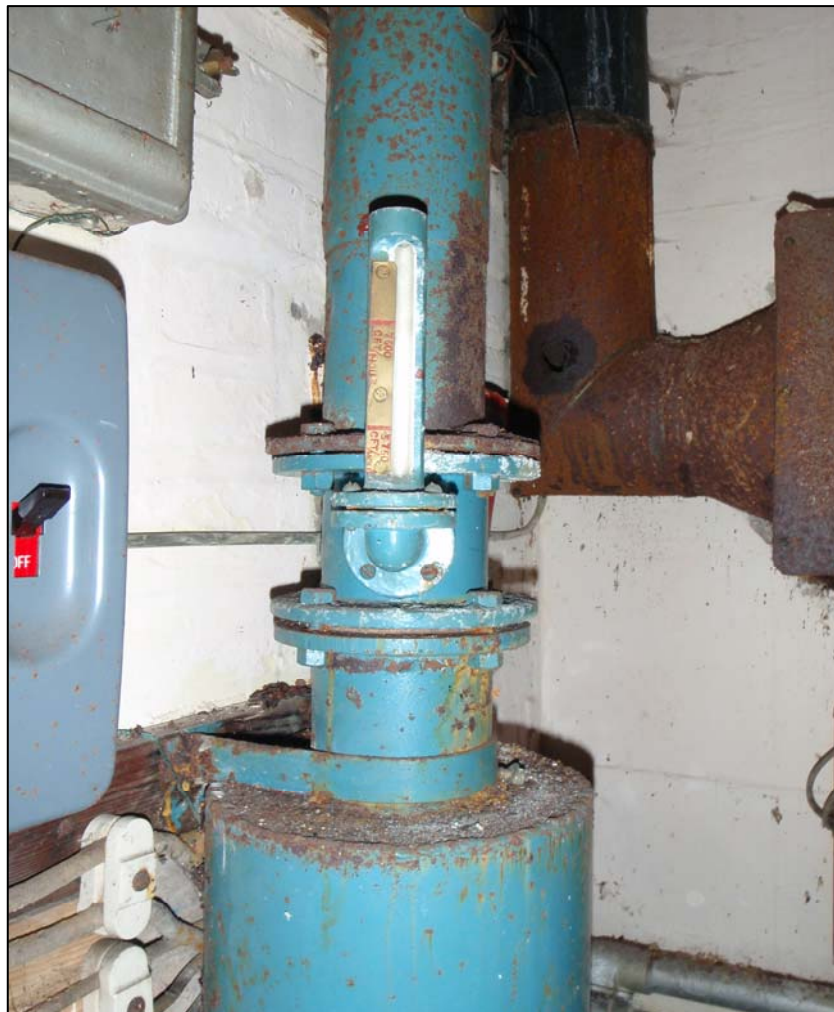
Plate 59. Room B6, air supply flow gauge (ref. HLY 20)

A flow meter was mounted at the top of the possible water jacket (plate 59). Only two measurements were marked, 3750 CFT/HOUR or 7500 CFT/HOUR (cubic feet per hour). A pressure gauge was noted on the floor of the room (plate 60) that had probably been fitted onto the blue pipe running down from the pump (it must have been situated after the pump as it states on the face that it records positive pressure); this was also branded 'Andamite'.

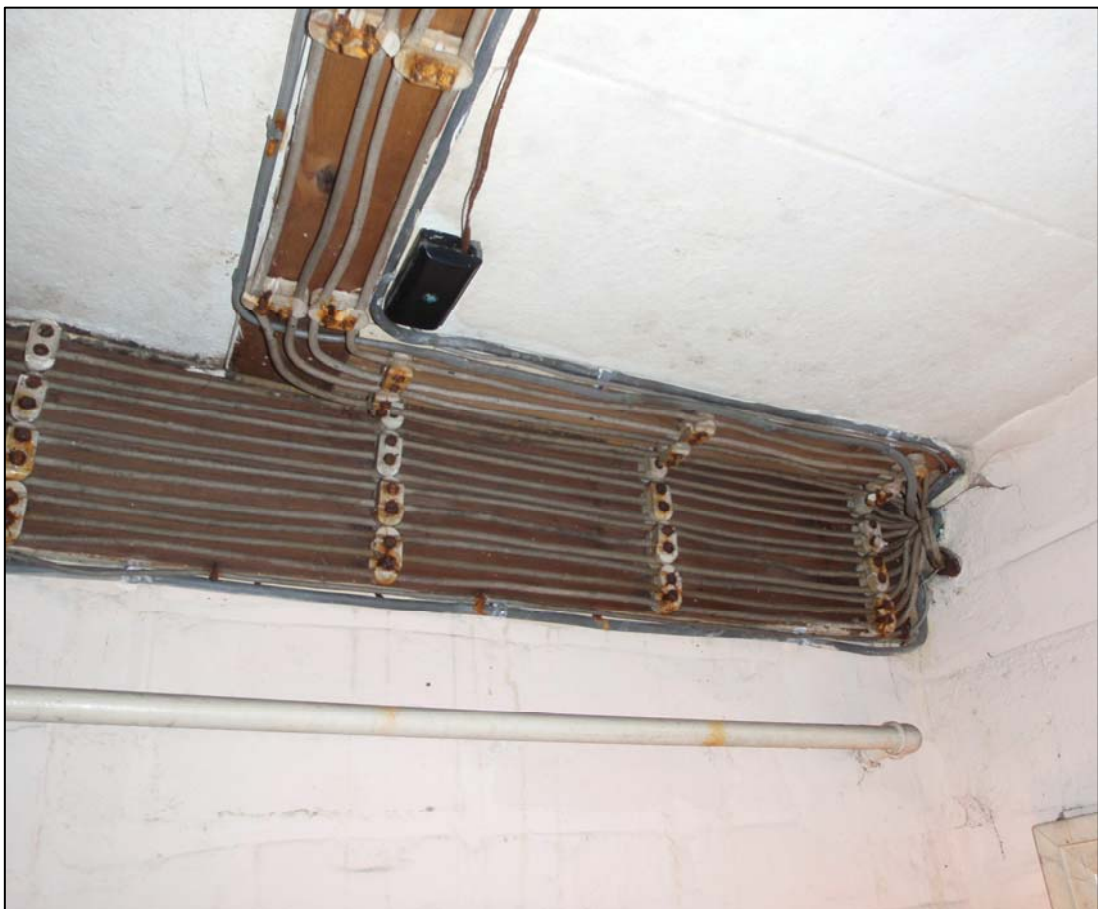
Plate 61. Room B1, electrical wiring (ref. HLY 56)

One of the predominant features noted throughout the bunker was the electrical wiring that was evident in nearly all rooms and corridors. In all cases, each wire was separately insulated and secured, either in pairs or in groups of three, by relatively closely spaced porcelain brackets fixed to a wooden planks that were screwed to the walls or ceilings (plates 27, 61, 62 and 63). This was presumably to allow ease of maintenance and fault finding with all wiring in effect available for inspection.

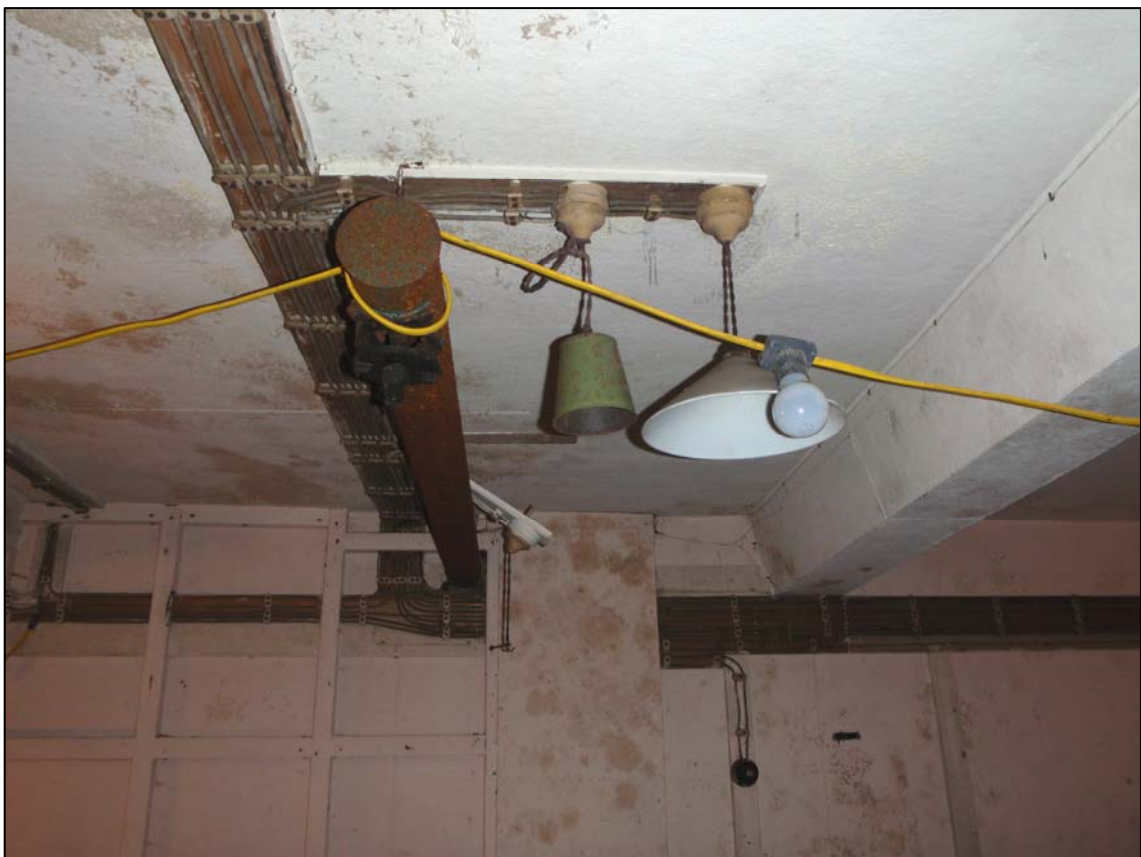
Plate 63. Room B2, multiple light fittings, air supply pipe and vent (ref. HLX 81)

Each room was fitted with two sets of electric lamp fittings, one with a standard lamp fitting and, where surviving, a white glass shade, whilst the other was a smaller lamp fitting in a small green metal shade (see plates 56, 62, 63 and 66 for examples of both fittings). One of these two fittings, presumably the smaller lamp fitting with metal shades, is powered by the battery back-up system whilst the standard lamps were powered by mains electricity.
