**ARP Control Centre/Lowestoft Sub Control  
Normanston Drive, Lowestoft  
LWT 179**

**Archaeological Building Record**

**SCCAS Report No. 2012/045**

**Client: Wellington Construction Ltd.**

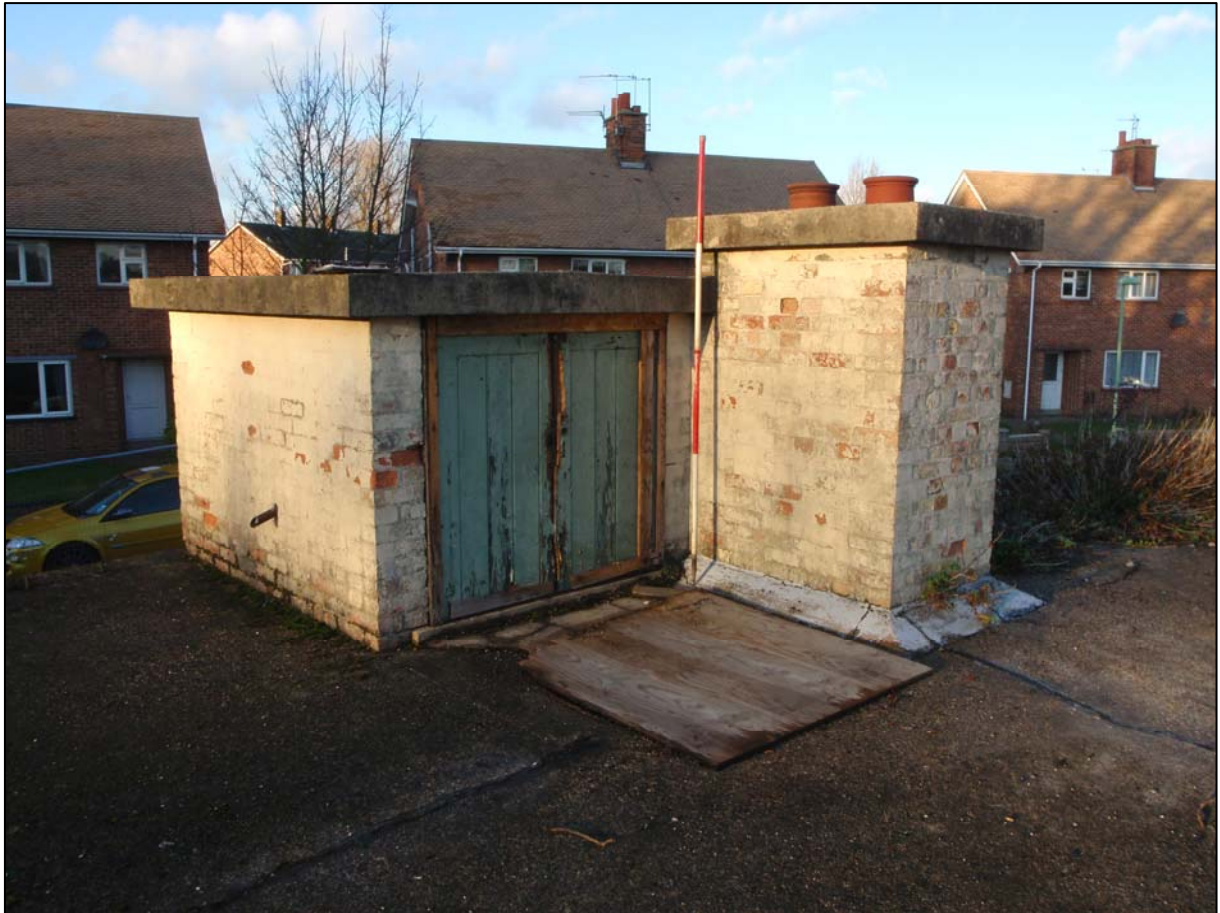
Plate 64. Roof mounted structure and chimney, camera facing north (ref. HLY 59)

Located on the roof of the structure, situated directly above the toilet on the ground floor (G11) was a roughly rectangular structure with a single slab roof (plate 64). The roof of this structure was cast with slightly raised central ridge to aid the dispersal of rainwater would. Two wooden access doors were present on the south-east side but these could not be opened. Two overflow pipes were present, one on the south-west wall and one on the north-west wall which would suggest that this structure contained two water tanks, possibly for hot and cold water.

Attached to this roof structure was a chimney stack containing two flues. One of these was undoubtedly for the solid fuel heater in the basement (B5). No other fires or heaters were noted in this area and it seems highly likely that the second flue is in fact an air intake for the heater. A second chimney stack was located against the north-east wall of the structure (plate 65) which would have served the fireplace in room G3.

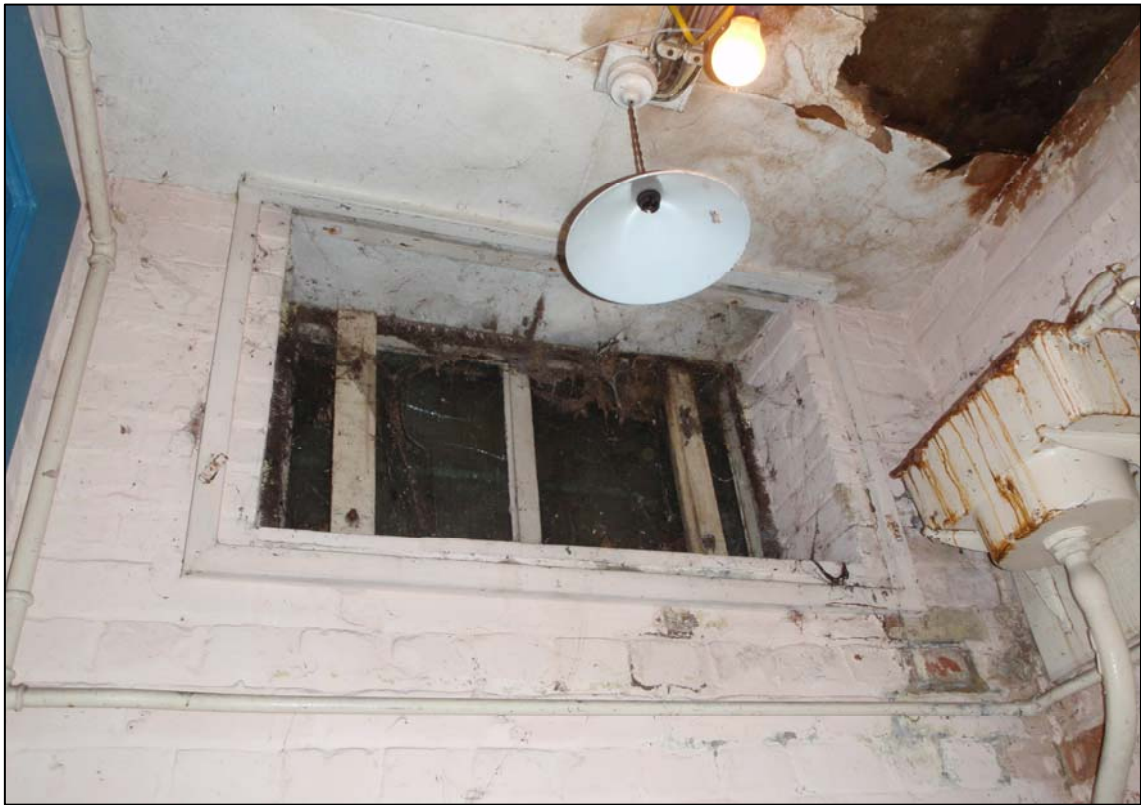
Plate 66. Room G10, window surround for internal shutter (ref. HLX 59)

It was noted that all windows on the ground floor had or at some time had been fitted, with wooden surrounds that would have enabled a shutter to be secured against the wall using a series of latches (visible in plate 66). The surround of the window in room G12, at the top of the stairs accessing the basement, had felt strip to help form a gas tight seal (plate 67).
