**Coastguard Lookout Station  
Sizewell Gap, Leiston  
LCS 166**

**Archaeological Building Record**

**SCCAS Report No. 2012/137**

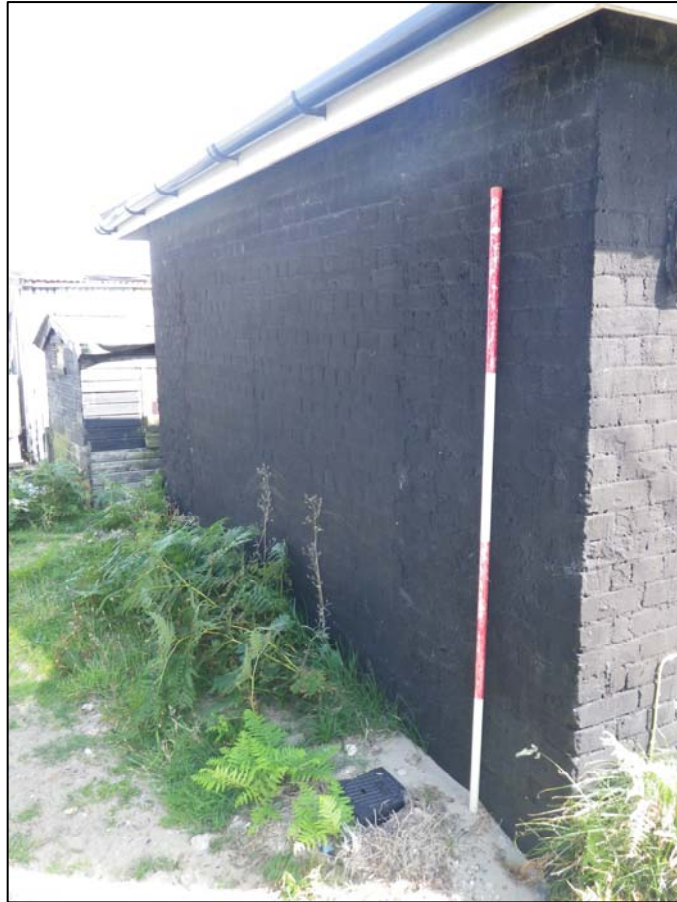
The structure is built of brick and has a slate roof with dark grey ceramic ridge tiles with black plastic guttering and downpipes. Curved wrought hip irons are present on the western corners of the main structure and on all four corners of the second storey. The brickwork exterior of the building is covered in a thick bituminous paint to give protection against sea spray. There are no windows on the ground floor, the only openings being a doorway in the southern façade and a large opening closed by matching double doors at the eastern end. There is evidence that a large opening of a similar size was present at the western end which has been infilled with brick (plate 5).

Plate 5. infilled doorway in the western façade (ref. HQC 58)

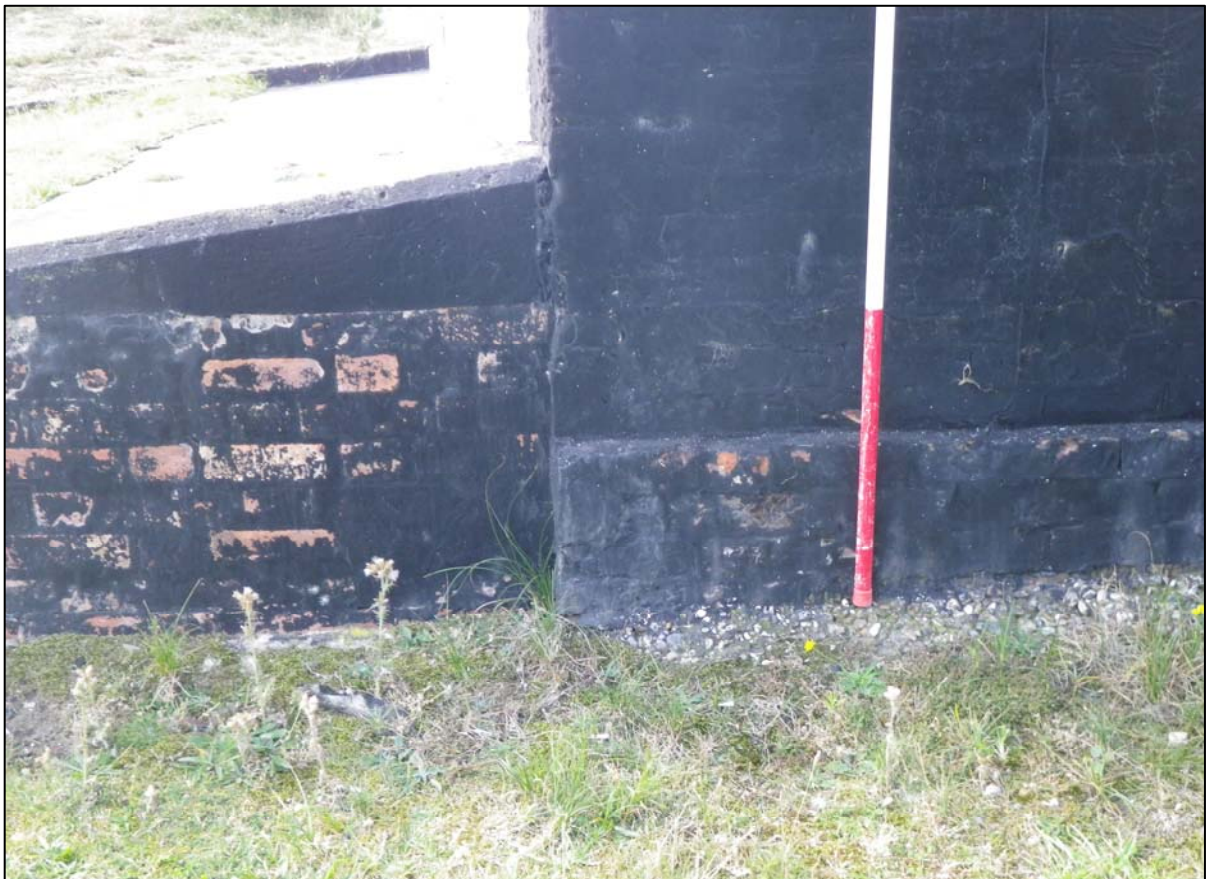
The land surface falls away slightly to the north revealing a stepping out of the brickwork at the base of the wall (plate 6). A deposit of concrete is also visible at the base of the wall although this appeared to be later. It could be the result of underpinning or has just been placed against the wall to protect the building against erosion of the shingle.

Plate 6. stepped brickwork at the base of the northern wall (ref. HQC 63)

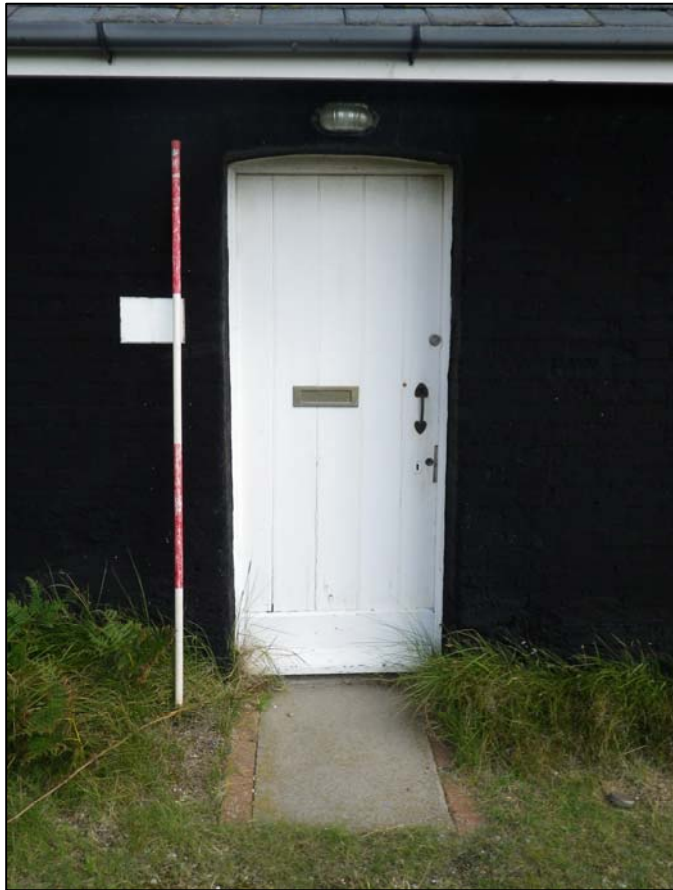
The doorway in the southern façade is closed by a door built of vertical timber planks set in a wooden door frame close to the inner face of the wall and painted white (plate 7). It is hung on wrought iron hinges and opens inwards. It is fitted with a modern 'Yale' type lock, a wrought iron latch with exterior handle, and an internally mounted rim lock (plate 8). An unpainted area on around the rim lock indicates that a larger lock mechanism was once fitted. There are two keyholes for this lock on the outer face of the door, one of which is redundant (plate 9).

Plate 7. doorway in the southern façade (ref. HQC 56)

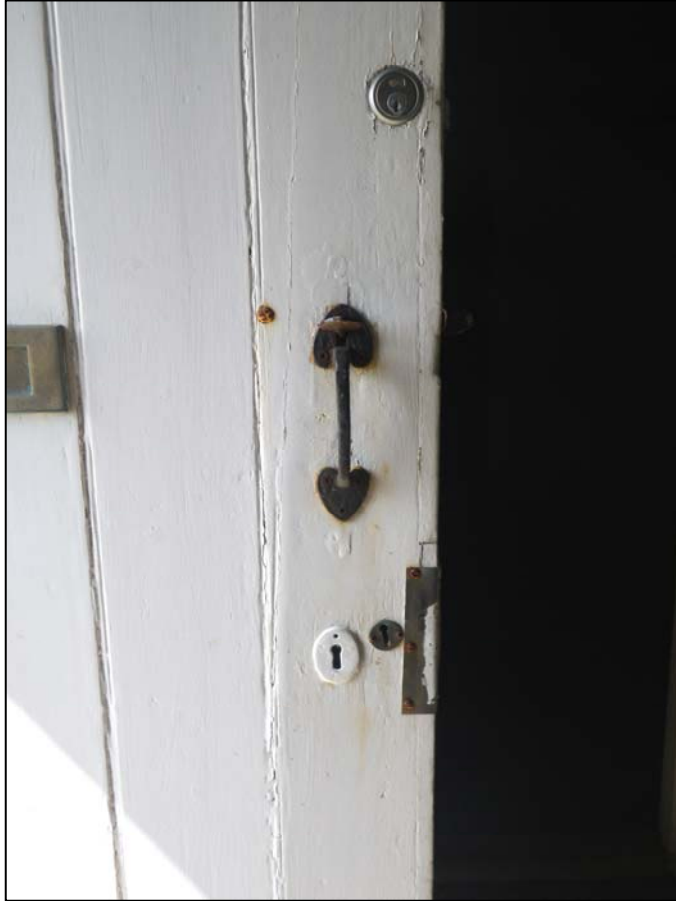
Plate 9. doorway in the southern façade, exterior, locks and latches (ref. HQD 76)

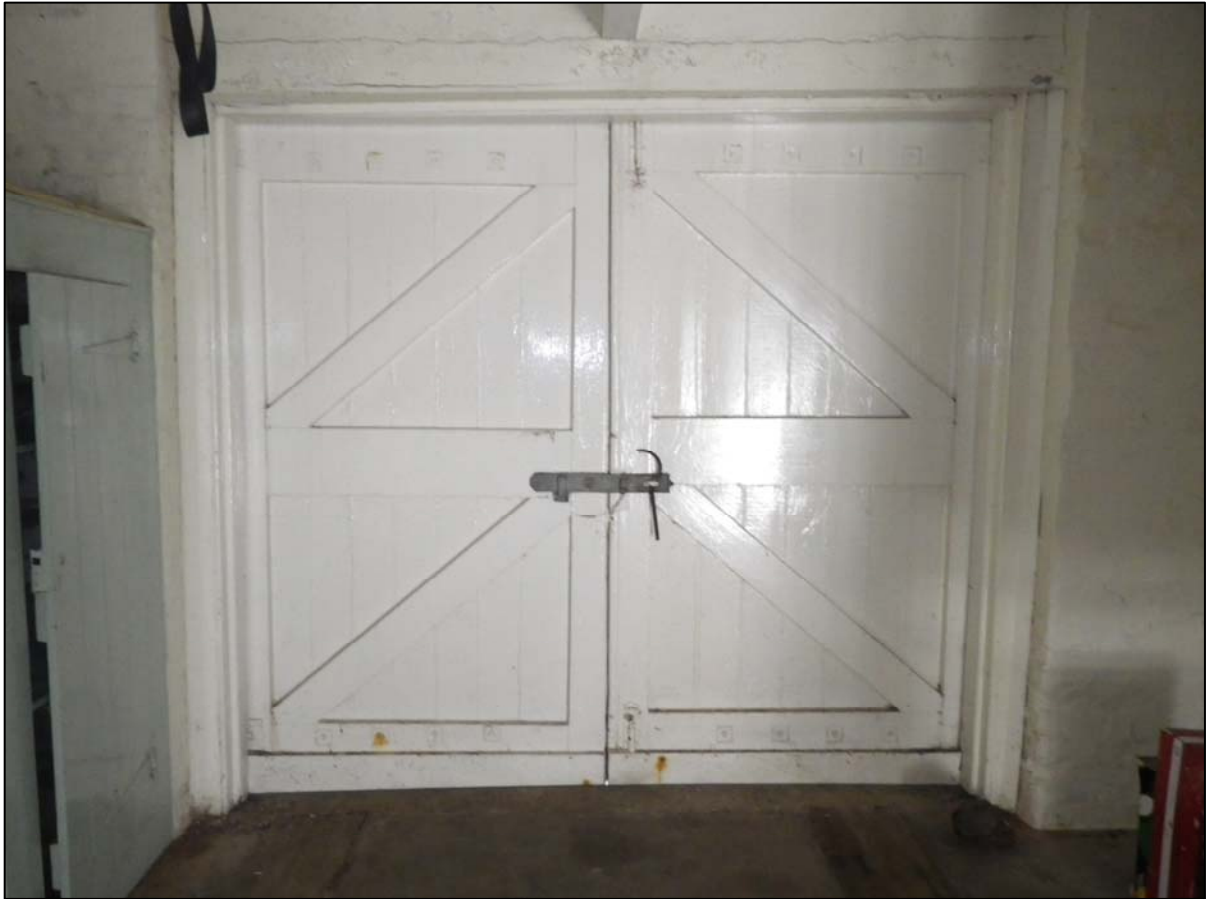
heavy duty swiveling hasp and staple fitted on the inner face of the doors (plate 11). The land surface falls away slightly to the east and north of the building and a gentle ramp revetted by brick walls is present just outside the double doorway. The top section of the ramp is surfaced in concrete whilst the remainder is unsurfaced (visible in plate 4).

Plate 11. double doors in eastern façade, interior view (ref. HQC 91)

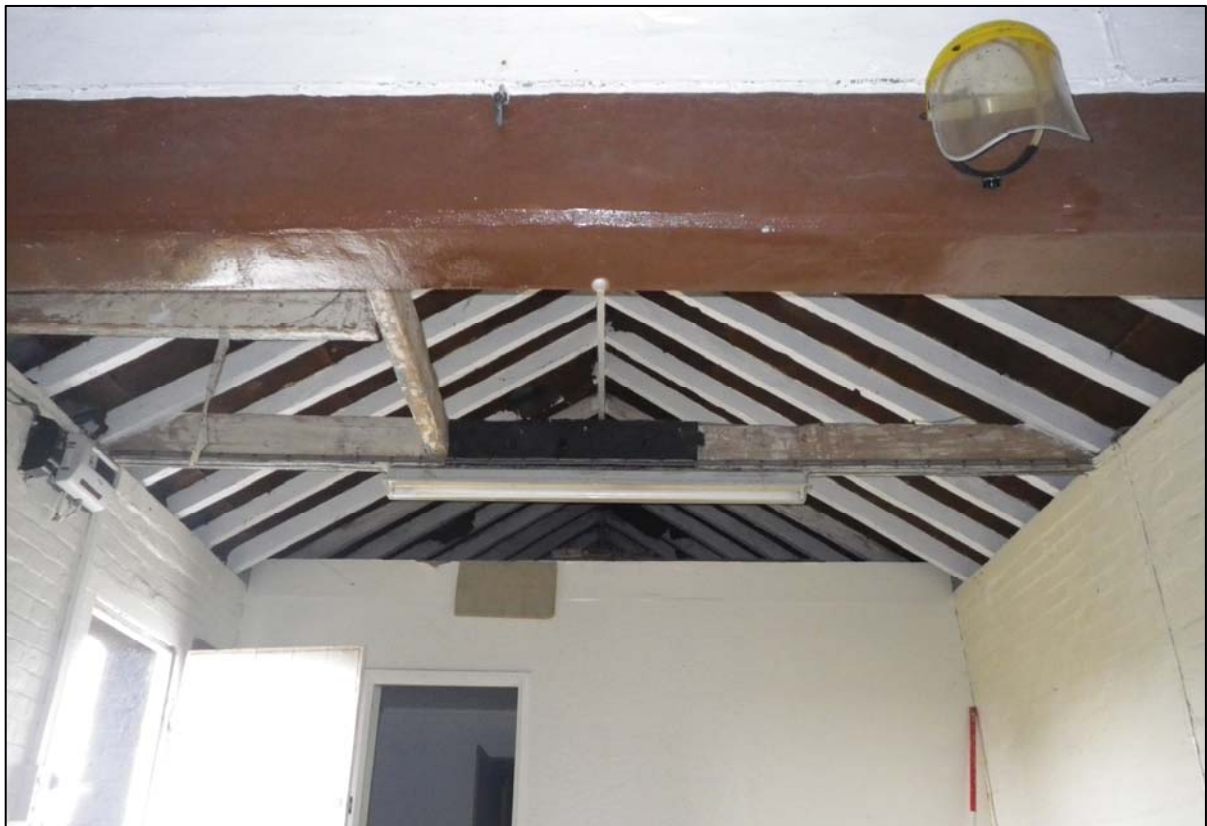
A series of three further beams are also present within the roof space (marked in fig. 7) These do not appear to be structural but have been inserted later for an unknown purpose although a number of hooks are present in one of these (plate 14).

Plate 14. Structural beam and roof structure, some additional, non-structural, beams are also visible (ref. HQD 04)

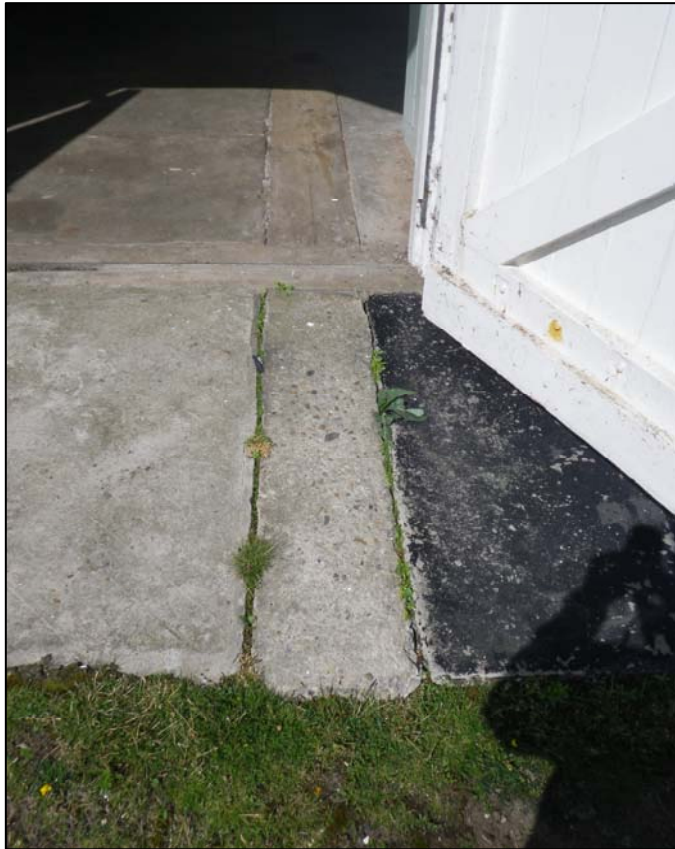
Set into the concrete floor of G1 are lengths of timber forming two tracks running from the double doors in the east end into the building. They measure c. 0.29m in width and are set c. 1.4m apart (plates 17 and 18). They run at a slight angle to the main axis of the building getting closer to the northern wall as they progress to the west, presumably to leave a greater clearance adjacent the southern door. They cannot be seen in Rooms G2 and G3 as the floor surface is obscured by a covering although they originally continued across the concrete surface at the top of the ramp outside the double doorway but have been removed and the resultant spaces filled (plate 19).

Plate 19. site of timber track in the concrete surface of exterior ramp (ref. HQC 73)

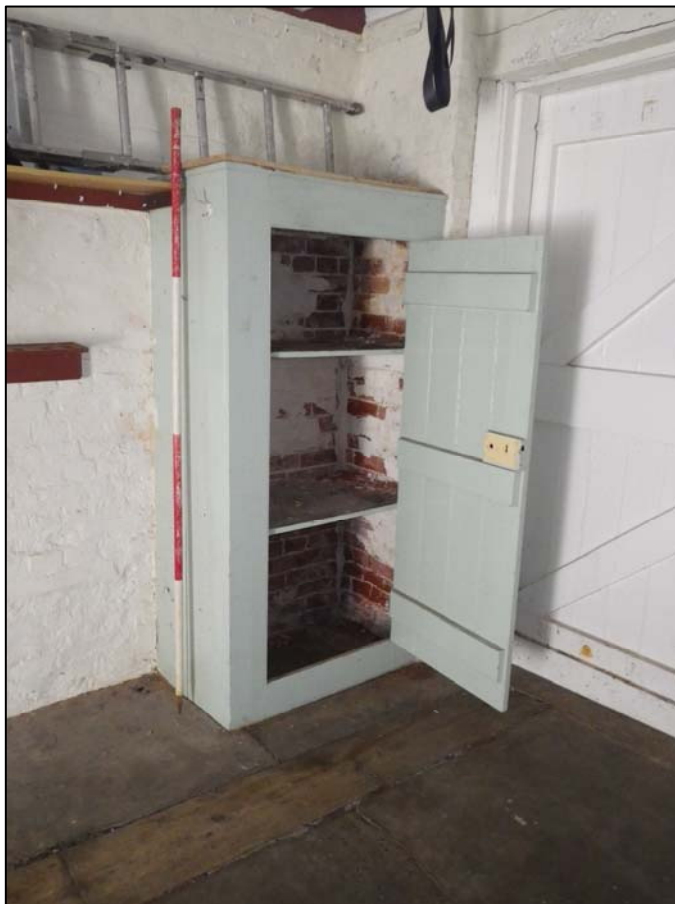
In the north-east corner is a wooden fitted cupboard containing two shelves (plate 20). Fixed to the wall to the west of the cupboard and at a height of c. 1.3m is a narrow wooden shelf, the front edge of which is curved, through which a series of six, roughly square holes have been cut (plate 21). This has been described as a musket gun holder in the architect's plans but these tend to have slots rather than holes suggesting this rack had a different purpose, although its appearance does indicate that it is probably an early fitting.

Plate 20. cupboard, north-east corner, ground floor (ref. HQC 95)

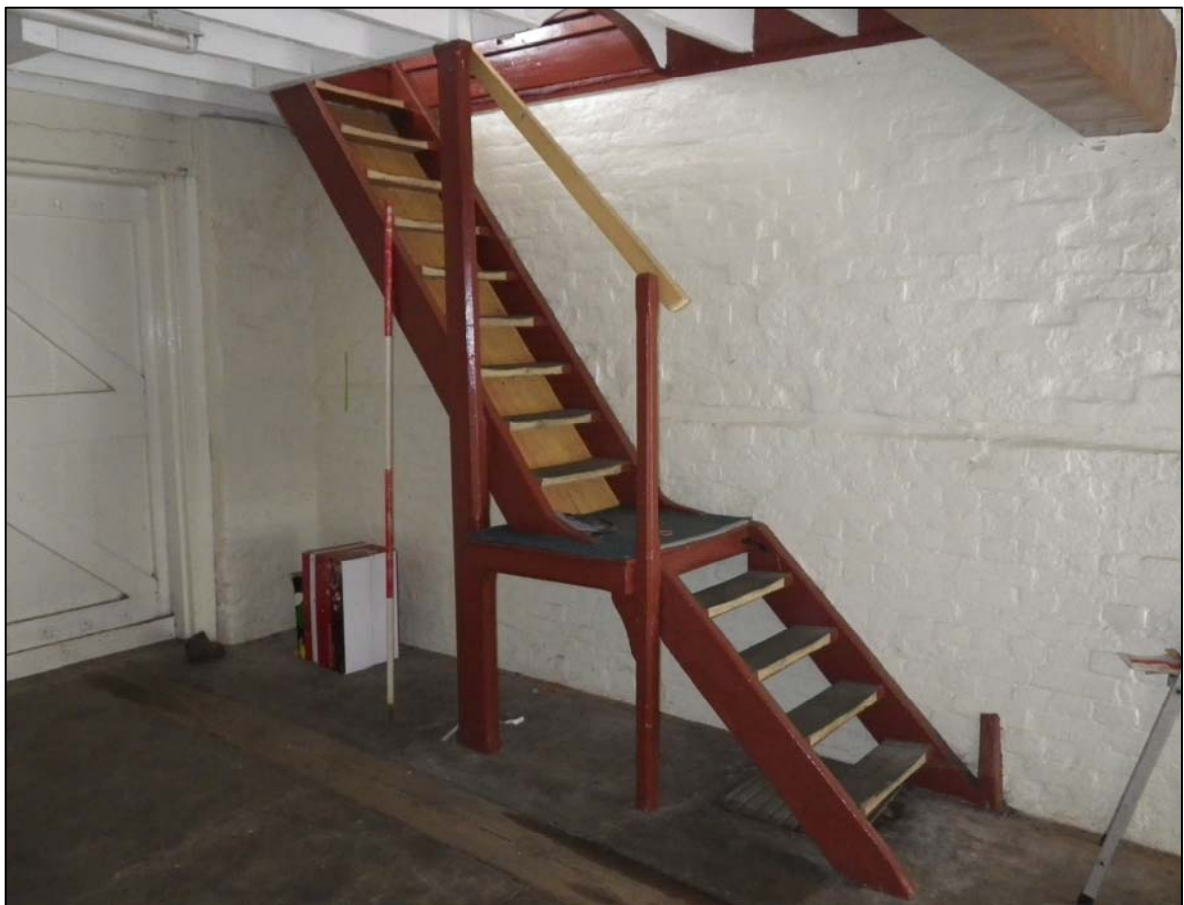
Situated against the southern wall, close to the south-east corner, are a set of stairs up to the second storey (plates 17 and 22). They are constructed of timber and comprise a short section of four steps up to a small platform followed by a further run of ten steps up to the first floor. The lower section is removable being fixed by two metal hooks at the top and braced against a piece of timber fixed to the south wall (plate 23).

Plate 22. stairs to first floor, camera facing south-east (ref. HQC 90)

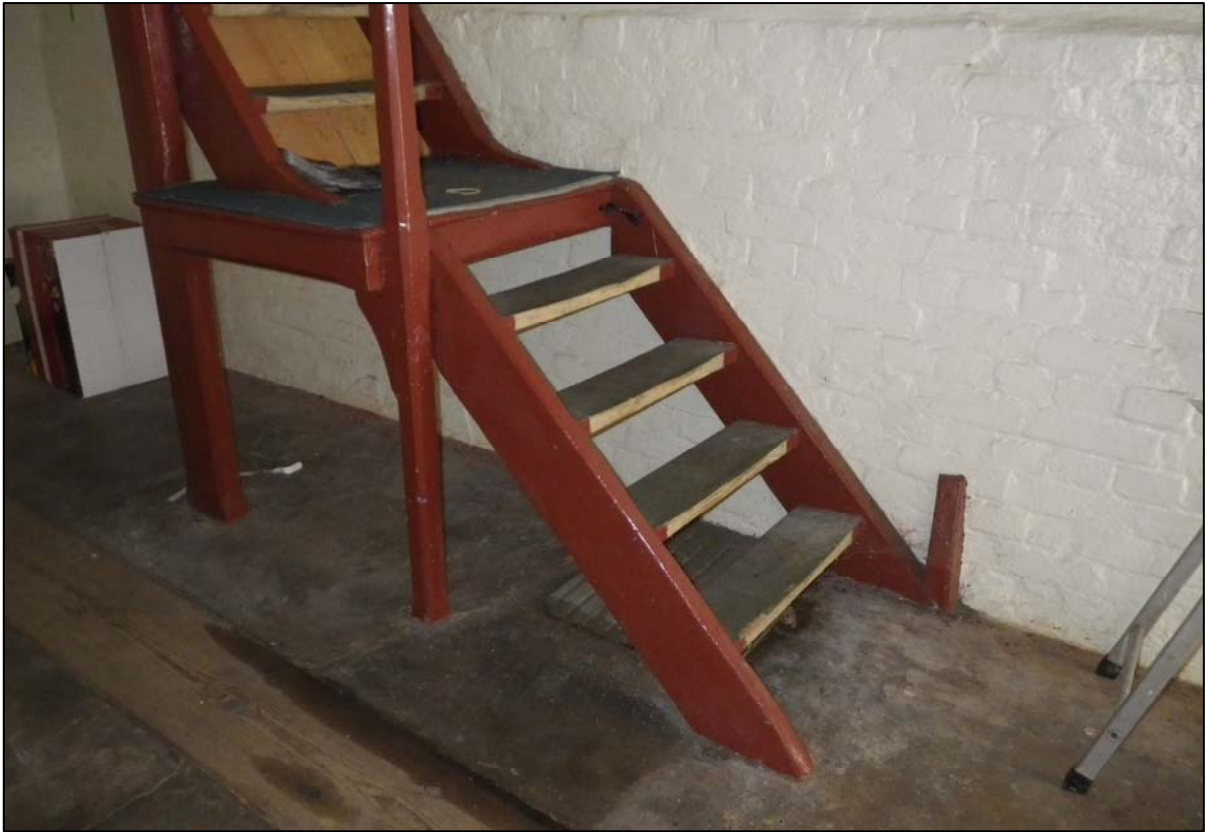
Plate 23. stairs to first floor, removable section (ref. HQC 89)

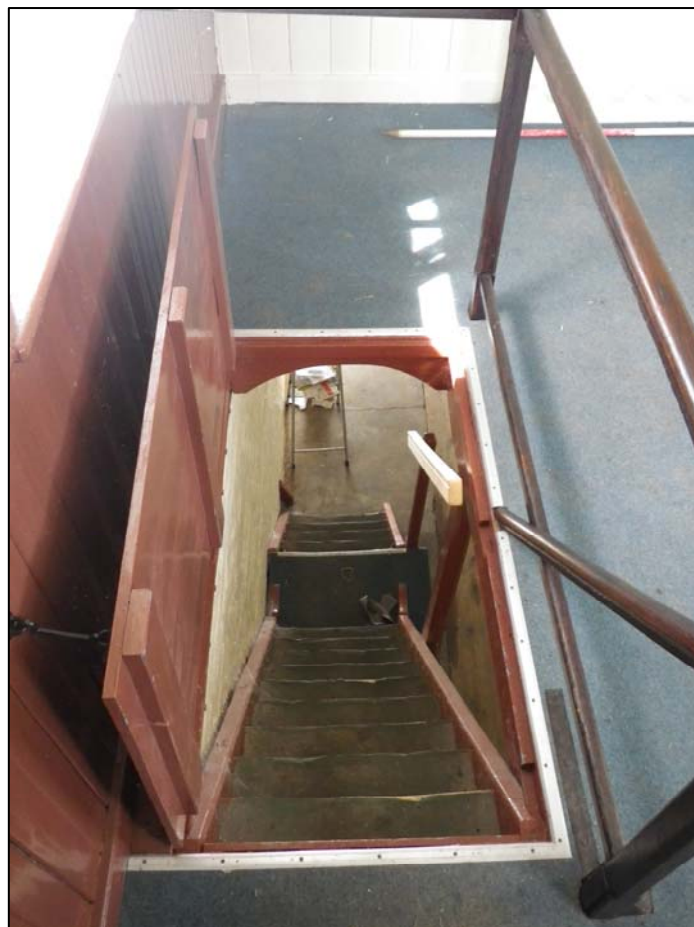
The room is accessed via the stairs from the ground floor through a rectangular stairwell/hatchway which can be closed with a wooden trapdoor (plate 24). To give additional headroom the upper floor beam adjacent the stairwell has a curving cut out. The hatchway is surrounded on three sides by a banister formed of a single horizontal length of timber supported on uprights, the tops of which are carved into 14-sided polygon knobs (plate 25).

Plate 24. view down stairwell (ref. HQD 64)

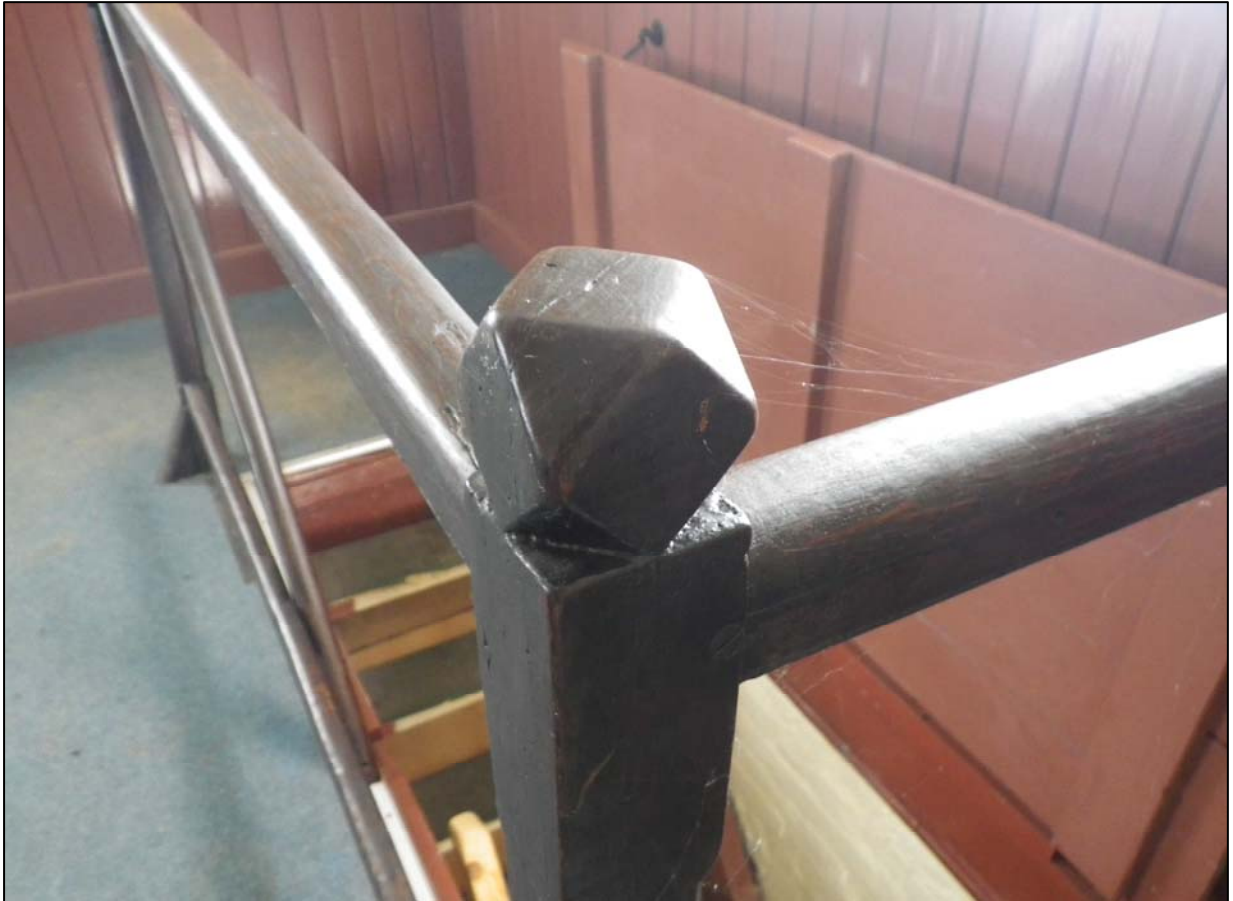
Plate 25. decorative knob on banister (ref. HQD 63)

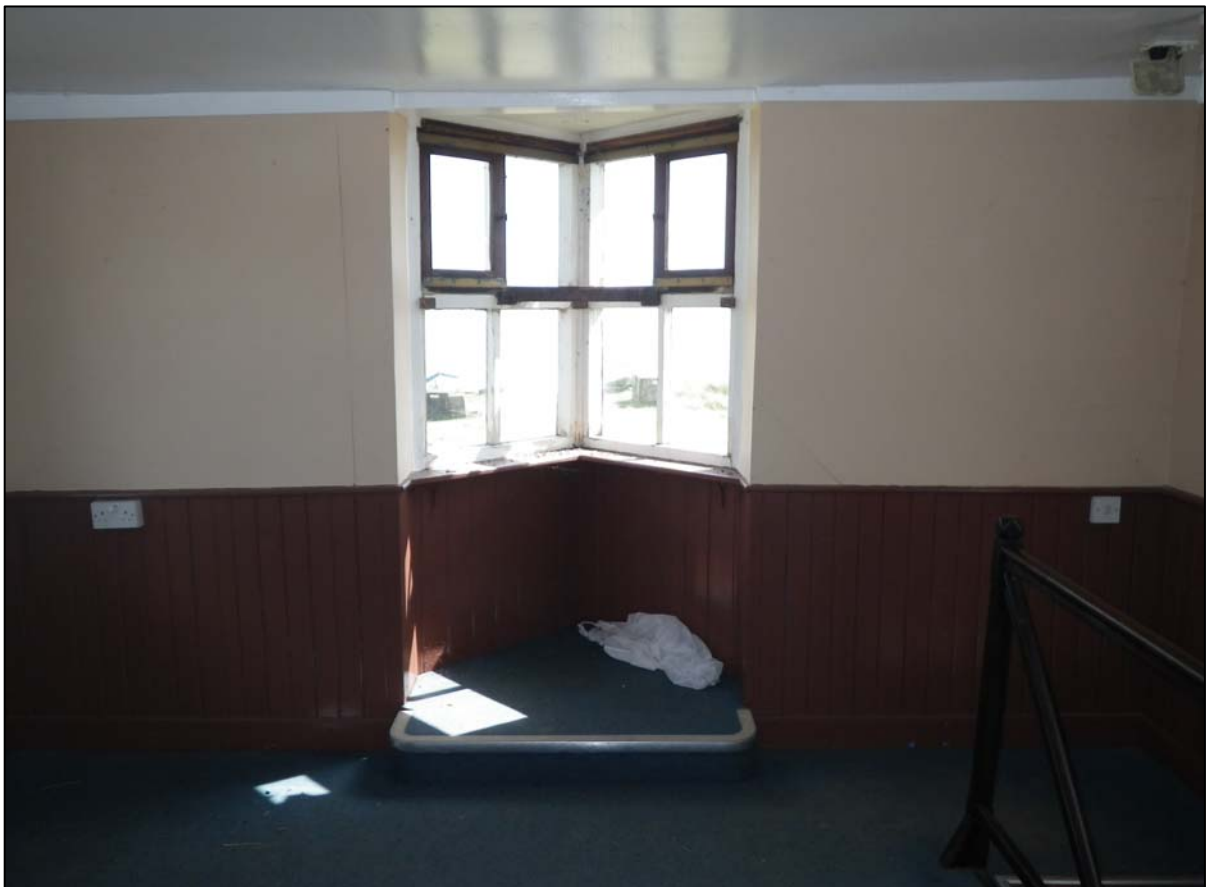
The north, east and west walls are clad in brown painted vertical timber tongue and groove planks up to waist level (c. 0.9m) and plastered and painted beige above (plate 26); the west wall is clad from floor to ceiling in timber and painted white (plate 27). The floor is carpeted and the ceiling is formed of plasterboard with a small rectangular hatch to access the roof space in the centre (plate 28).

A small triangular bay window is present in the centre of the east wall, accessed via a step (plate 26). It is formed in timber with small rectangular windows in the upper half. The windows are divided into four separate panes mounted in wooden frames. The inner pane of each top row can be opened by sliding it forward. The window being held by strips of brass screwed to the bottom of the sliding frame and the top of the fixed frame (plate 29). A short length of timber runs across the angle between the windows which may have been a support for a telescope or a pair of binoculars (plate 30). There are additional windows in the north and south walls. These are rectangular steel, 'Crittall' type frames with three panes, an opening top light, an opening casement and one fixed (plate 31).

Plate 26. first floor bay window, camera facing east (ref. HQD 20)

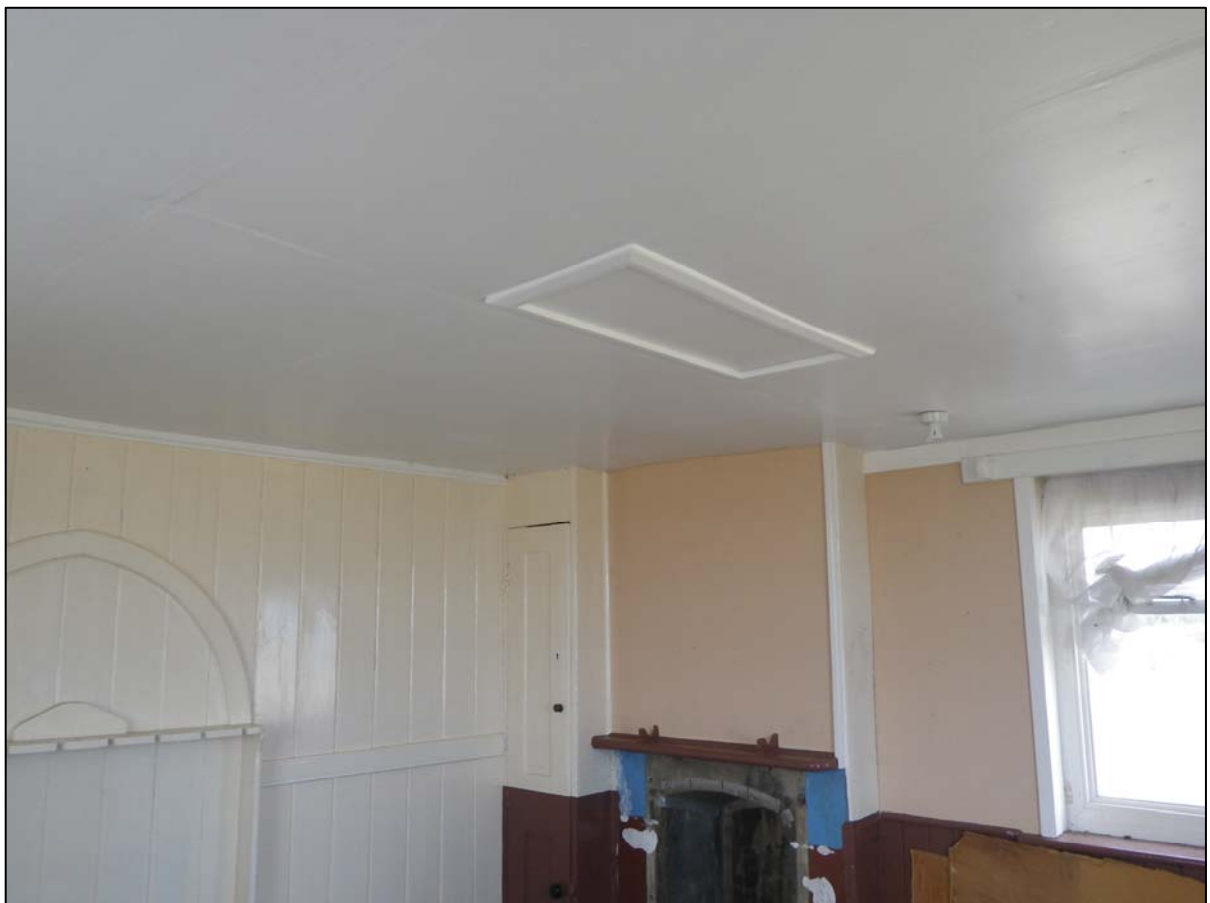
Plate 28. ceiling, first floor, camera facing north-west (ref. HQD 55)

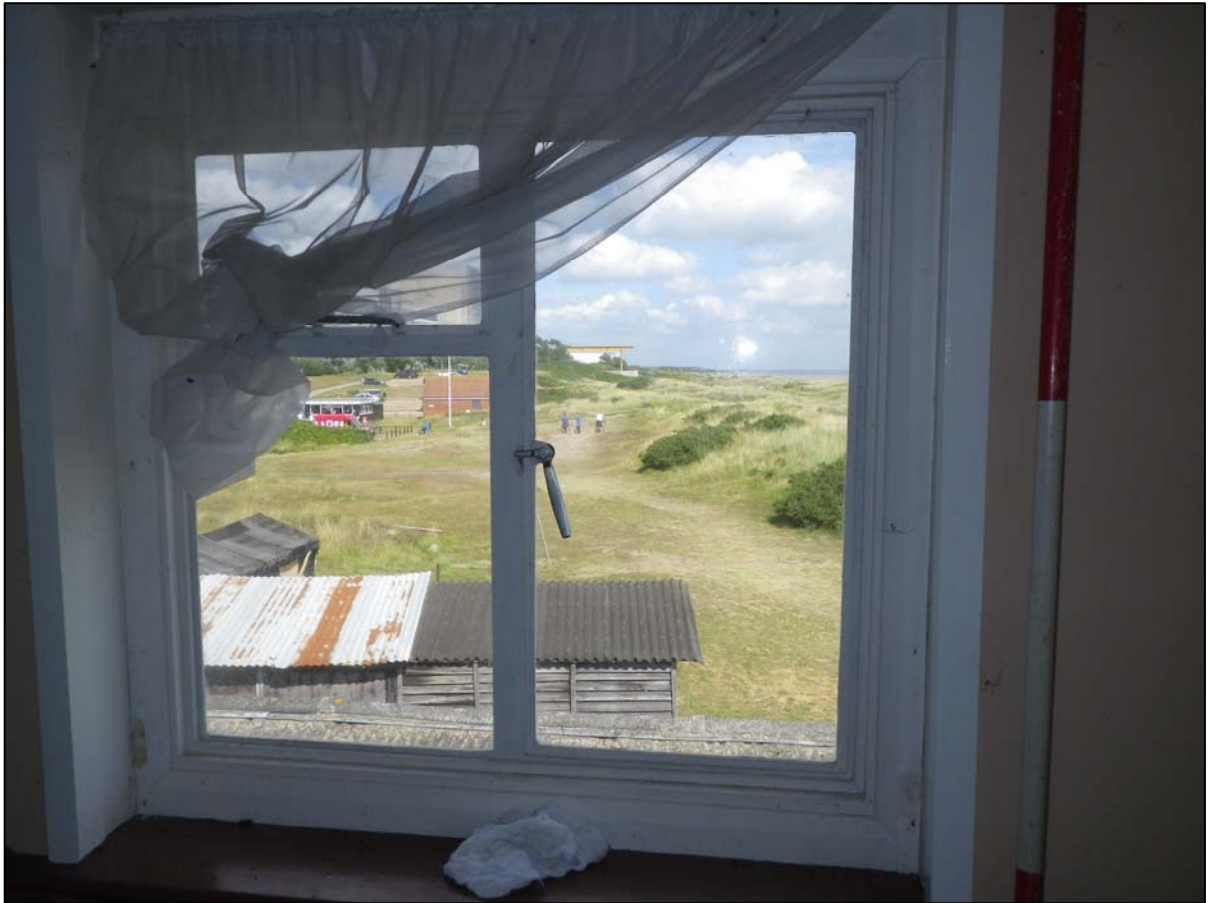
Plate 31. first floor, north facing window (ref. HQD 53)

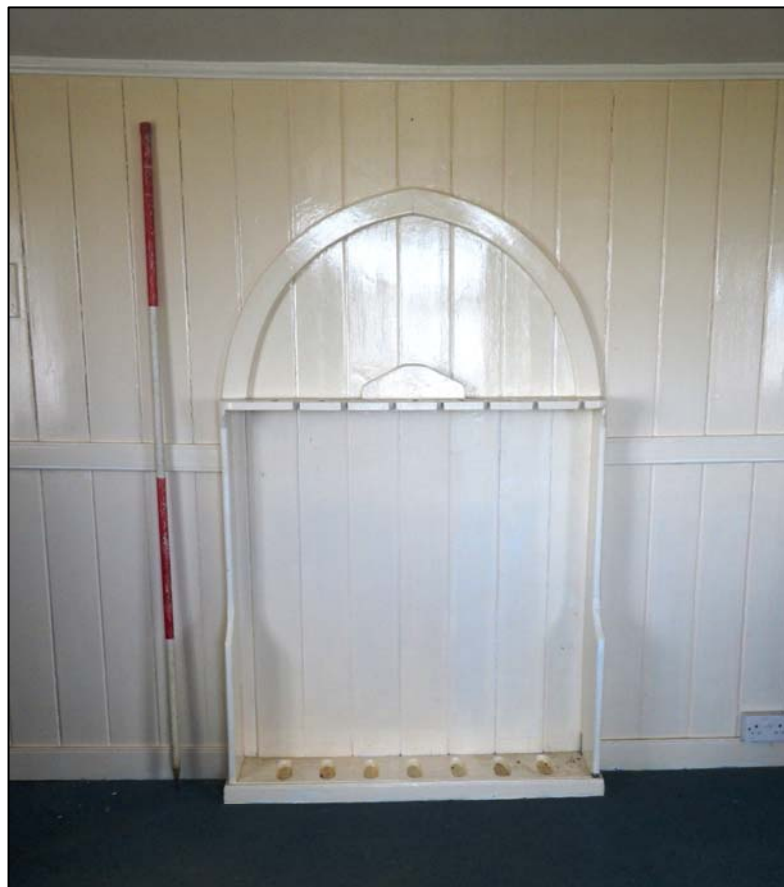
Mounted in the centre of the west wall is a rack for holding muskets (plate 32). It consists of a wooden base with recesses into which the musket butt would be placed, and a higher shelf with slots cut into the leading edge into which the barrel of the musket would be lent; there are recesses for seven muskets. The rack has shaped timber sides and a simple pair of curved timbers across the top. The top shelf into which the muskets would be lent has additional holes cut through which may be for bladed

Plate 32. rack, first floor (ref. HQD 25)

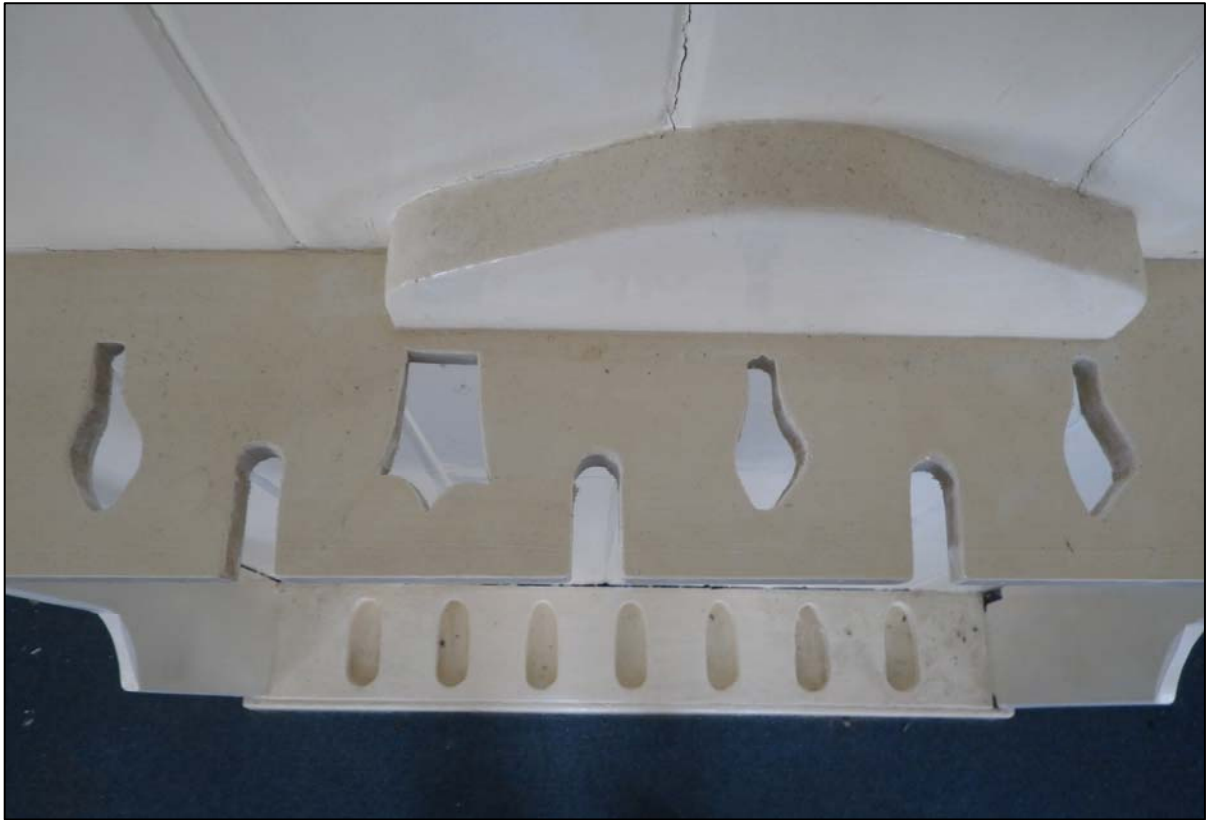
weapons, such as a cutlass, or other equipment (plate 33). The holes and slots in the top shelf show no signs of wear and it is likely that this component of the rack is a modern replacement.

Plate 33. rack, first floor, view facing down onto the top (ref. HQD 57)

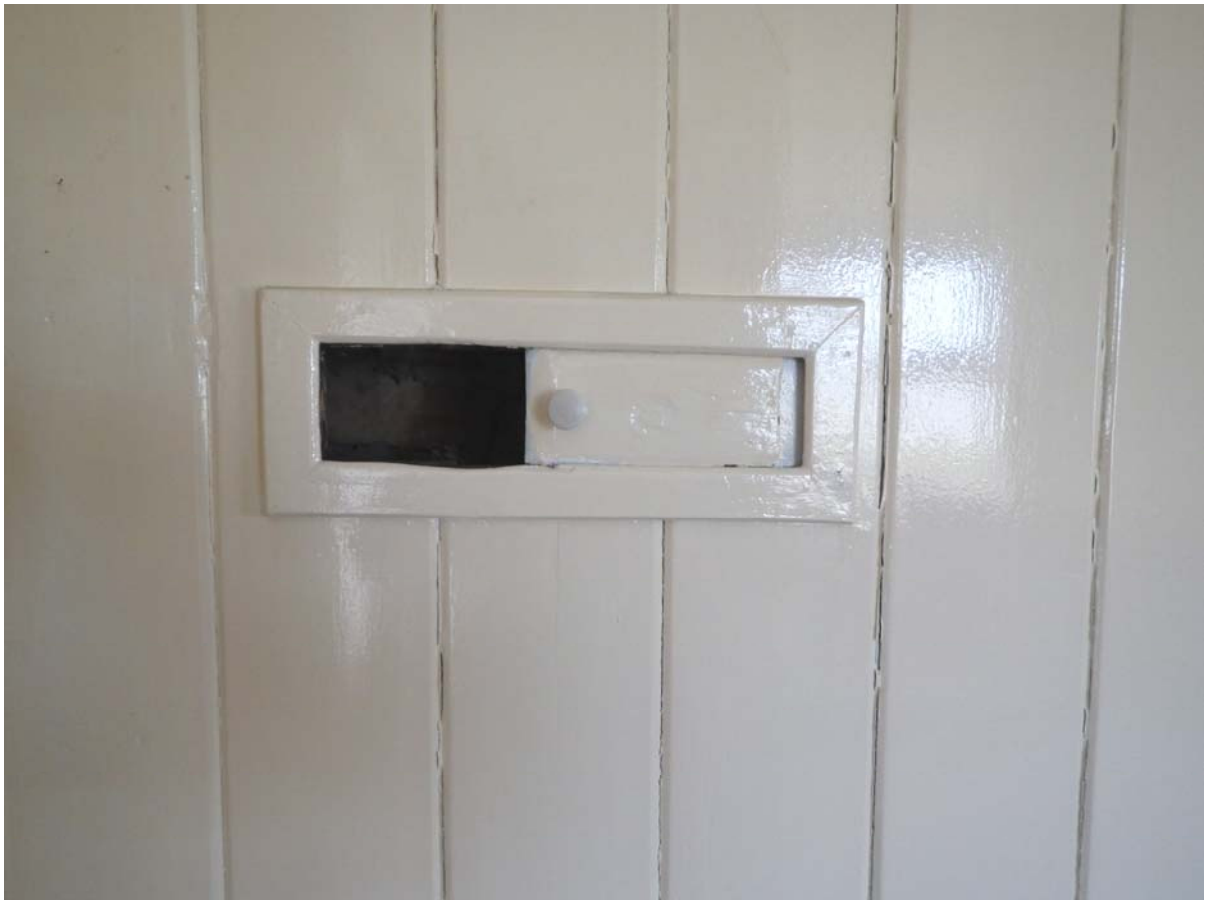
To the south of the musket rack is a small sliding timber panel set in a frame (plate 34). It opens into the space behind the paneling and may act as a vent although in the listing text this is described as a peephole. The brickwork visible immediately behind the panel appears to be recent suggesting there may have been alterations to the external structure in this area.

Plate 34. sliding timber panel, possible vent or peep-hole (ref. HQD 30)

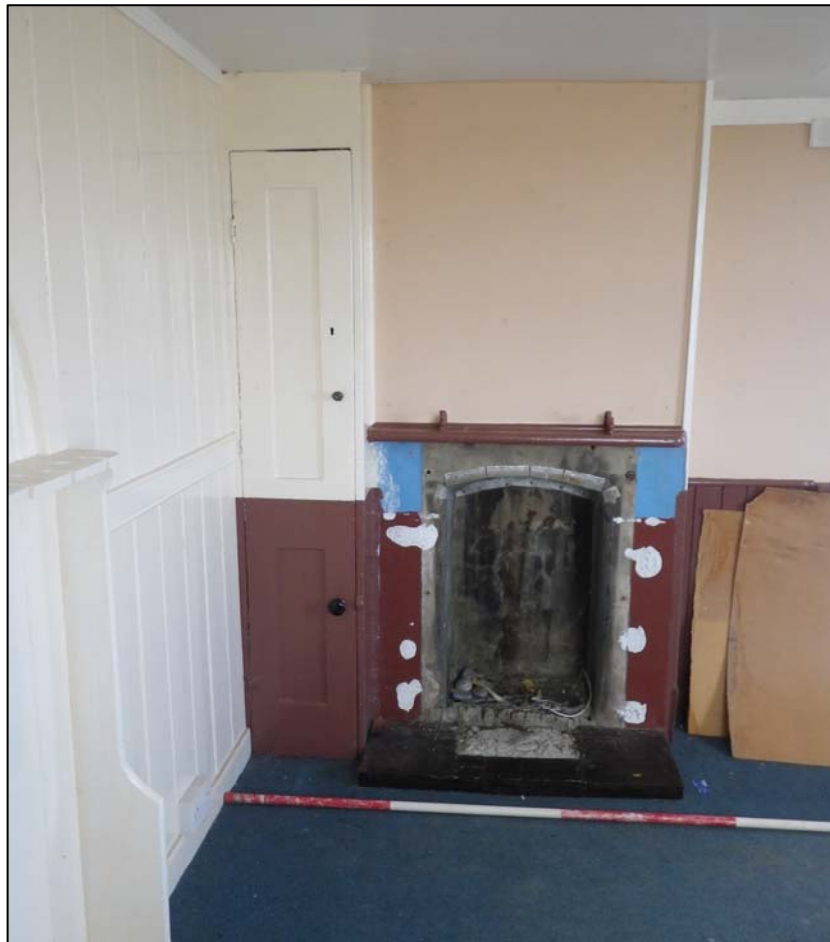
A fireplace and hearth is situated against the northern wall, to the west of the window although the surround and grate have been removed (plate 35). A wooden mantle shelf is extant above upon which are two supports of differing sizes which are probably to support a telescope (plate 36). A wooden built-in cupboard is located in the north-west corner, immediately adjacent to the fireplace. The cupboard has two doors, one above the other, which reflect the paneling on the north, west and south walls and contains five shelves (plate 35 and 37). The upper cupboard door is fitted with a lock.

Plate 35. fireplace, first floor (ref. HQD 41)
