**‘Former Cottages & Packing Sheds’,
Eves Orchard,
Bures St Mary, Suffolk
BSM 062**

Heritage Asset Assessment

‘Former Cottages & Packing Sheds’, Eves Orchard, Bures St Mary, Suffolk

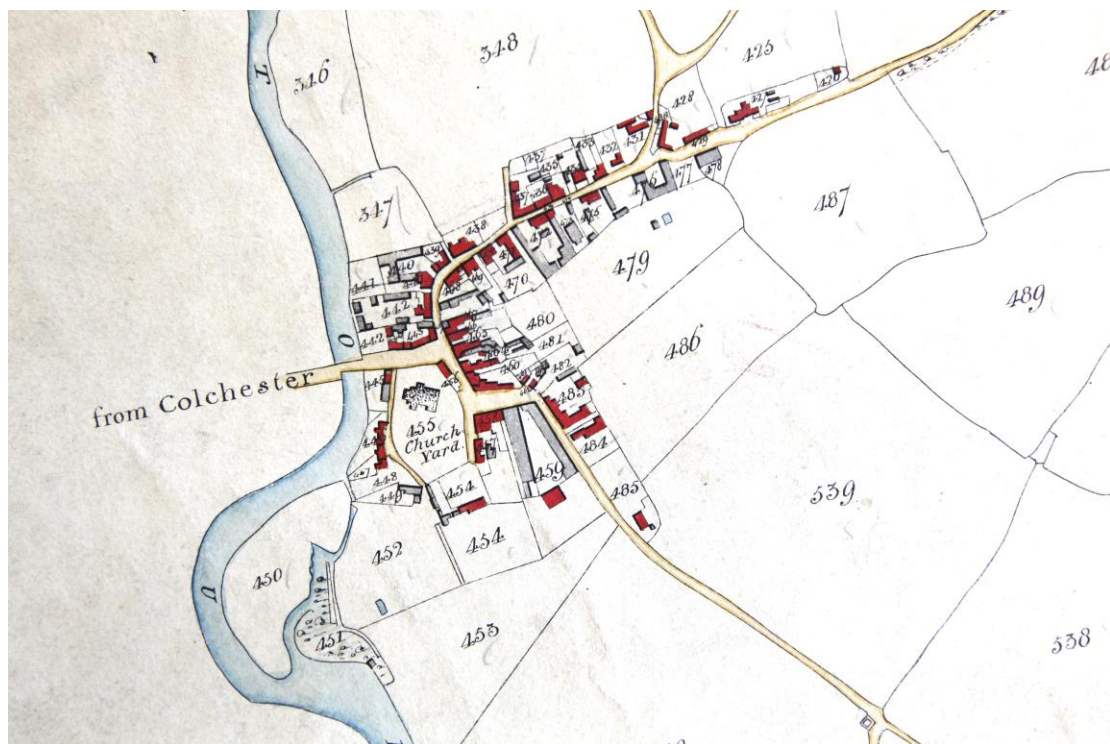
Figure 2. The Bures St Mary tithe map of 1837, showing the area of the ‘orchard and garden’ (486) to the west of the Nayland Road

No part of the present ‘cottages and packing sheds’ appears to have existed at the time of the Bures St Mary tithe survey in 1837, although the tithe map shows strikingly similar structures nearby and may be slightly inaccurate. Abraham Hardy then owned both the orchard of 4 acres 19 perches (plot 486 in figure 2) and the large L-shaped house dividing it from the

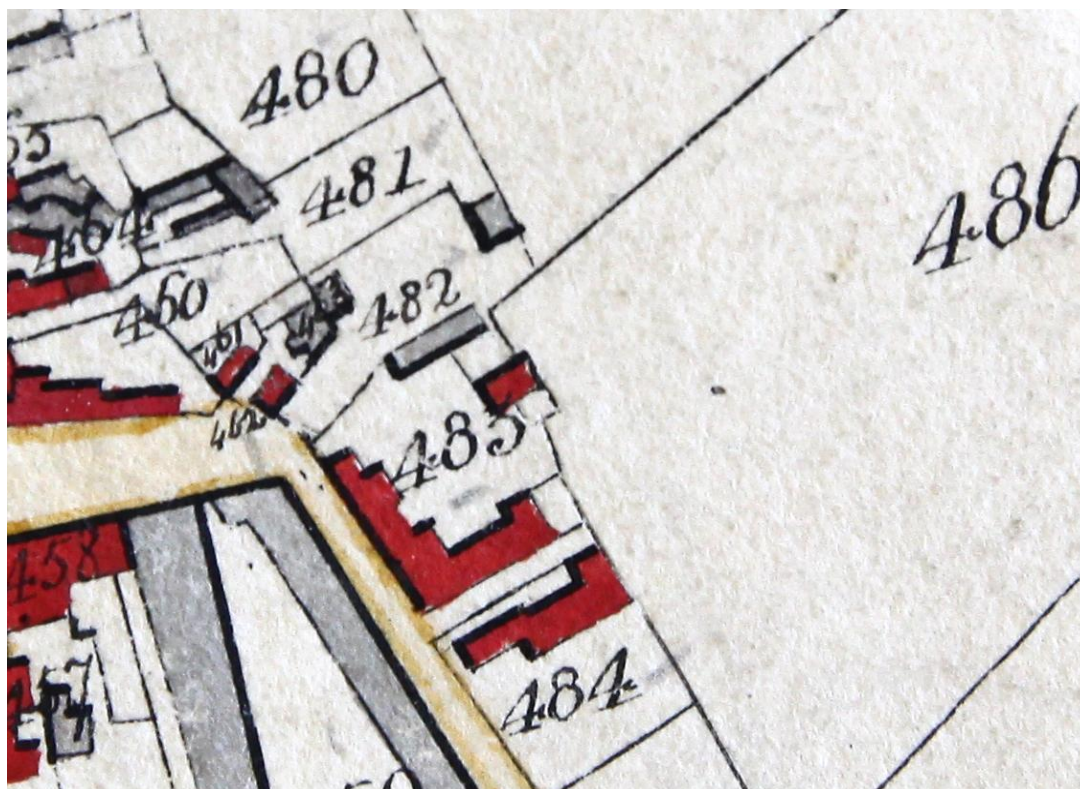
Figure 2a. Detail of the 1837 tithe map, showing the orchard (486) and the adjoining L-shaped range of 13 or 14 cottages (485) in the same ownership. The orchard’s western boundary is nearer the cottages than at present, and the detached building shown in red to the rear appears to lie several metres south of the position now occupied by the ‘former cottages and packing sheds’ – which are conspicuous by their absence from the corner of ‘Great Orchard’ field (479) to the north-east.

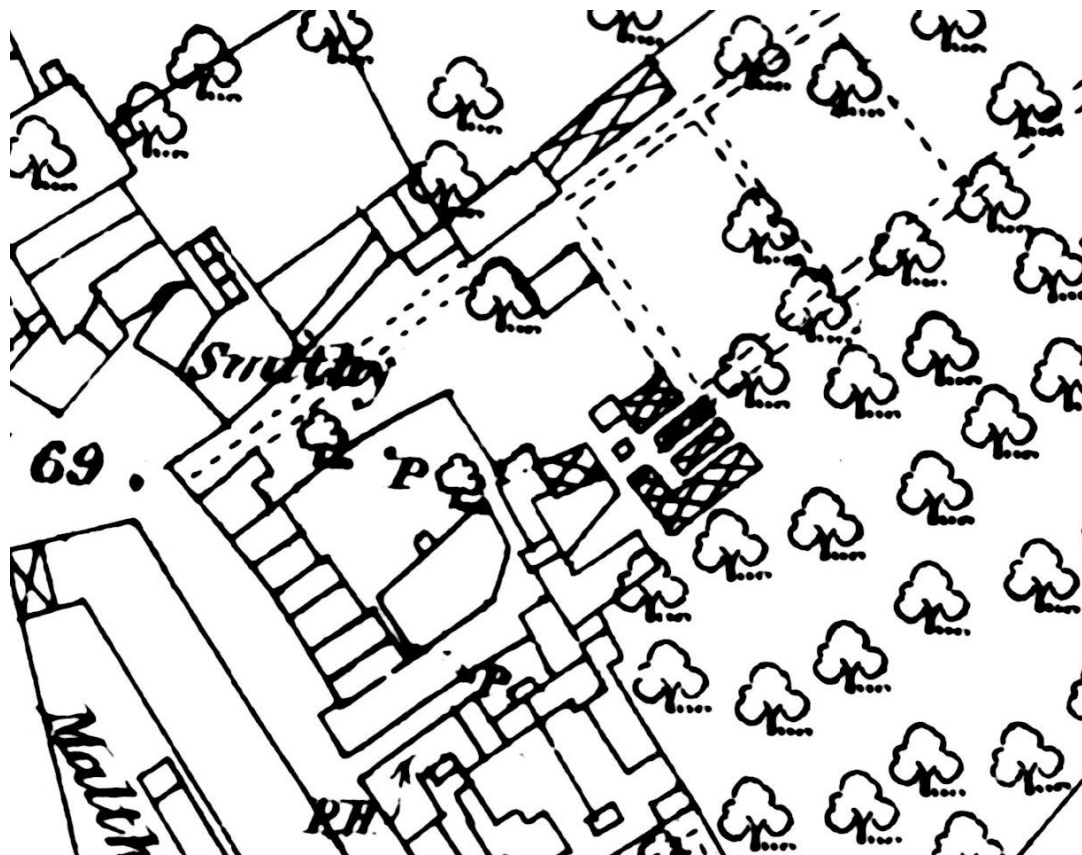
Figure 3a.

Detail of First Edition 25 inch Ordnance Survey of 1885.

The rear wing of the cottages had been demolished since 1837 along with the detached structure on the boundary of the orchard. The early-19th century shed (2) appears to be shown at the corner of the orchard and 'Great Orchard' field to the north, with a narrow shed projecting from its south-western gable and a small, slightly narrower shed separating it from a long glasshouse to the north-east. A new detached shed lay immediately opposite, with a group of glasshouses (indicated by cross-hatching) further to the south. The 'smithy' lay in what is now the car park of the Three Horseshoes.

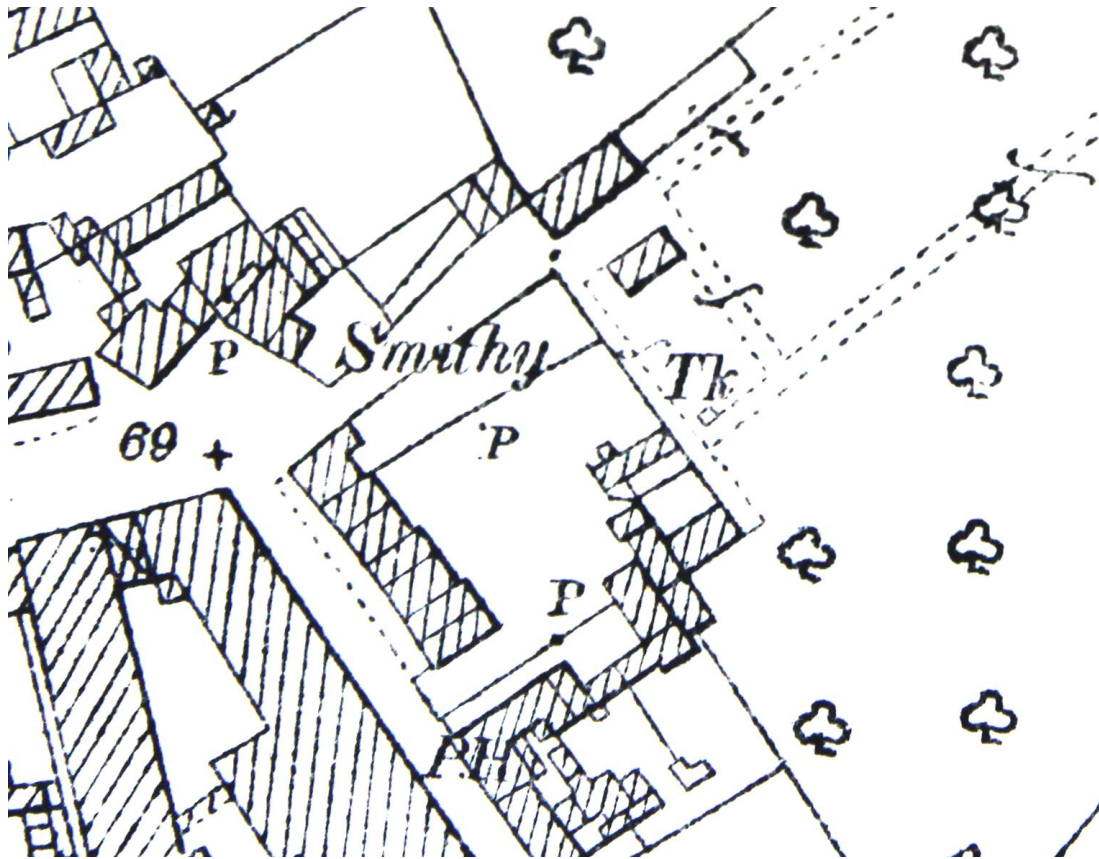
Figure 4. The Second Edition 25 inch Ordnance Survey of 1902. The narrow shed projecting from the south-western gable had disappeared, and the range to the north-east (4) is no longer indicated as a glasshouse. The gardens of the cottages have been extended further to the east, enclosing a group of the new sheds depicted in 1885, and the other glasshouses have also been demolished.

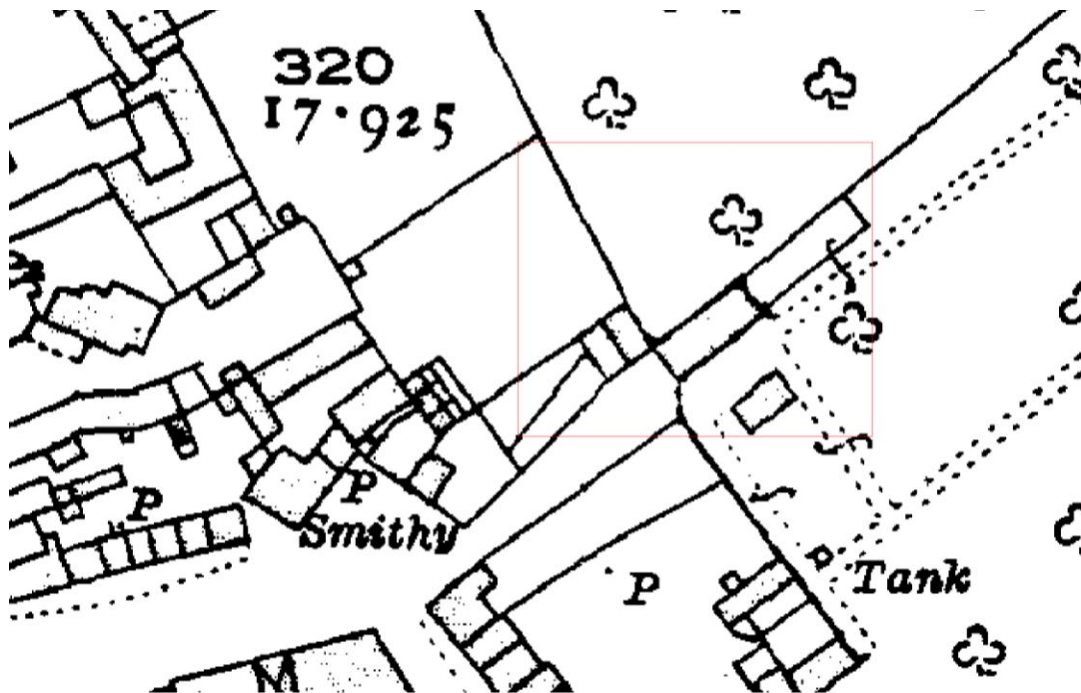
Figure 5. The Third Edition 25 inch Ordnance Survey of 1923, showing no significant change since 1902.

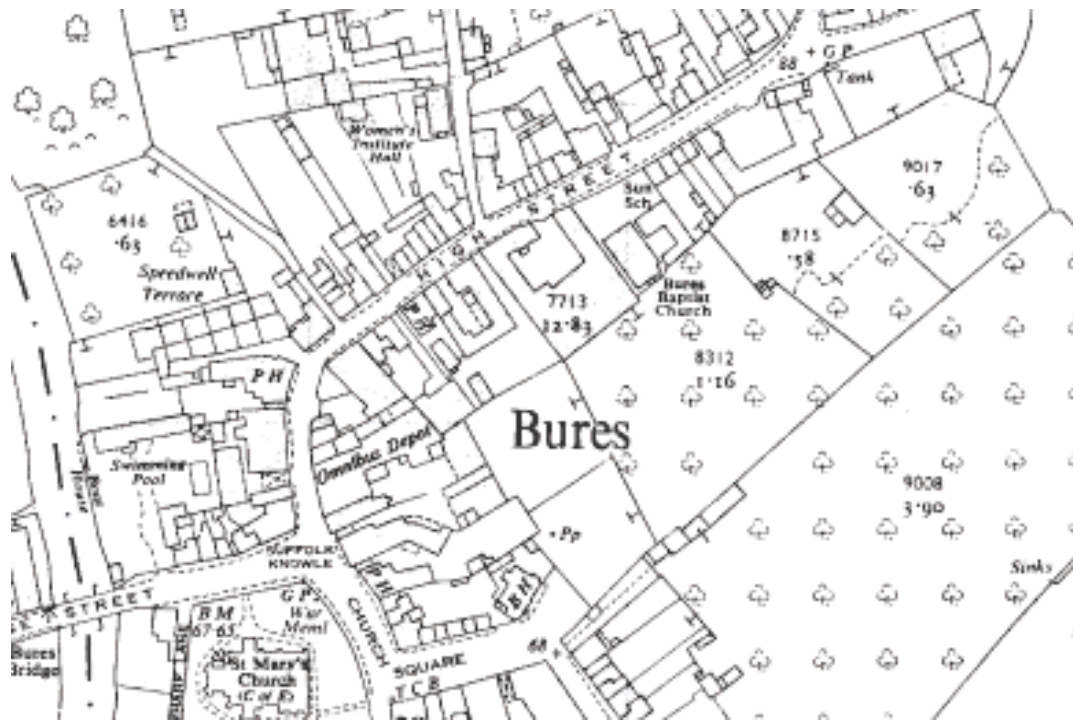
Figure 6. 25 inch Ordnance Survey of 1956. The buildings are now shown in their present form with four distinct elements. Apart from the construction of the access road to the telephone exchange behind the cottage gardens – and the addition of two large housing estates – little has altered since this period.

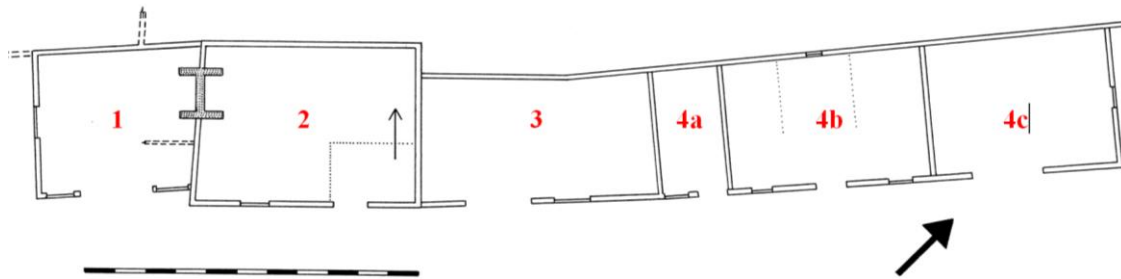
Figure 7

Ground plan of the complex identifying each area with a number for ease of reference in the text and photographic record. Enlarged version on p. 11 below.

1. An early-20th century single-storied vehicle shed of Fletton brick with a corrugated iron roof. Not shown on the 1923 Ordnance Survey but built soon afterwards. The interior preserves an early-19th century fireplace, two phases of external pargeting to the adjoining shed (2) and the outline of a narrower shed on the same site to which the fireplace formerly belonged. This narrower shed was shown on the Ordnance of 1885 but had been demolished by that of 1902. The boundary wall of 'Great Orchard' field was formerly attached to the rear (north-western) wall, and the boundary with the Three Horseshoes PH projected from its western corner.

2. A two-storied early-19th century shed with a red-brick lower storey and a timber-framed & rendered upper storey. Formerly with a peg-tiled roof, recently replaced by galvanised corrugated iron. Not shown on the 1837 tithe map but probably of *circa* 1840. With an original sunken brick floor, 0.5 m below ground level, and a fireplace against its south-western gable (reduced in width and provided with a coal grate in the late-19th century). The studwork consisting largely of re-used timber, including late-15th or early-16th century ogee-moulded ceiling joists probably salvaged from the rear wing of the adjacent grade II-listed building which was demolished at the same time and in the same ownership. Entered from the orchard to the south-east by a door opening onto a ground-level brick platform (indicated by dotted lines) from which a boarded stair (arrowed) rises to the unheated upper storey. With vertical and horizontally sliding sash windows to the orchard but not to the gables or rear elevation. Both gables retain good sections of original lime plaster bearing textured pargeting, each bearing the outline of a smaller adjoining shed. The layout of this building is highly unusual, and it was probably designed as a rare apple store with a fireplace to prevent frost damage. It has been mistakenly interpreted as a cottage.

3. A two-storied late-19th century shed of red brick with mid-20th century double doors to the front (south-eastern) elevation and a corrugated asbestos roof. Used most recently as a retail shop where fruit and vegetables from the orchard and other sources were sold directly to the public, with a storage loft reached by an external loading door and internal ladder. Probably designed as a fruit

warehouse and packing shed. The rear (north-western) wall contains earlier 19th century brickwork belonging to a shorter, lower brick shed (extending less far to the east), and the pargeted external gable of the adjoining early-19th century shed (2) preserves the outline of a still lower shed on the same site. The roof, front elevation and much of the front wall was rebuilt in Fletton brick and asbestos-clad studwork in the mid-20th century.

4. A single-storied late-19th century red-brick shed with a mono-pitch roof of corrugated iron (sloping downwards from north-west to south-east). The rear (north-western) wall incorporates an earlier boundary wall containing over-fired wasters from a brick kiln with a soldier course coping (later raised). The interior is divided by ostensibly original Fletton-brick partitions into three compartments, each with entrance doors and glazed windows to the south-east. The narrow south-western compartment was probably designed as a harness room, the central compartment as a stable with two windows flanking a central entrance door and the remains of three boarded stalls (shown by dotted lines), and the north-eastern compartment as a vehicle shed with double doors and original wooden harness hooks.

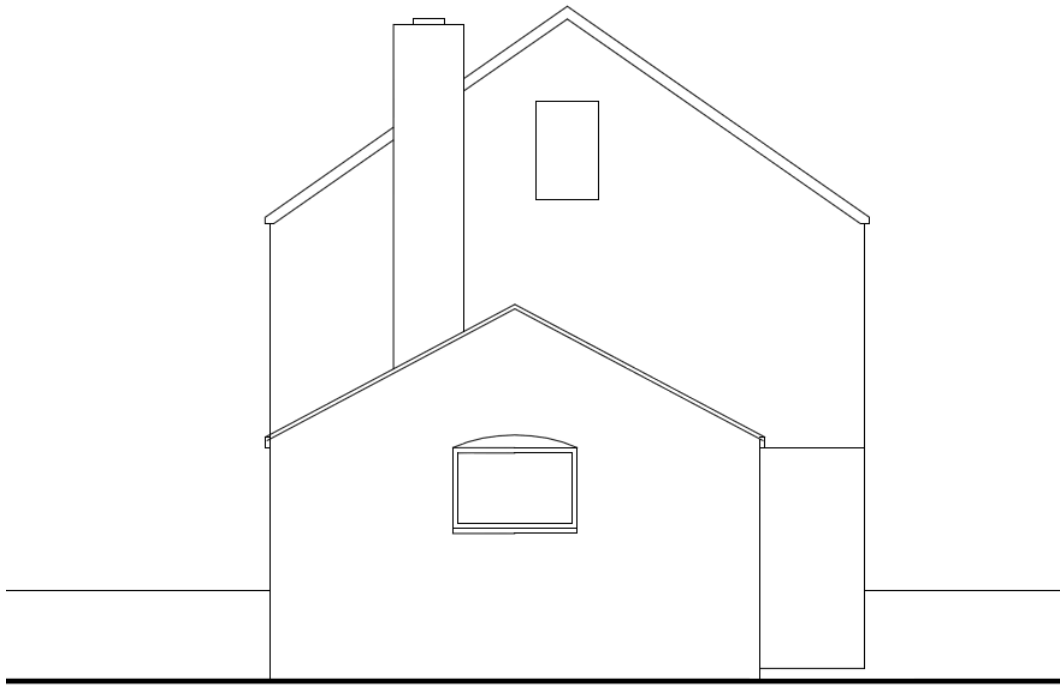
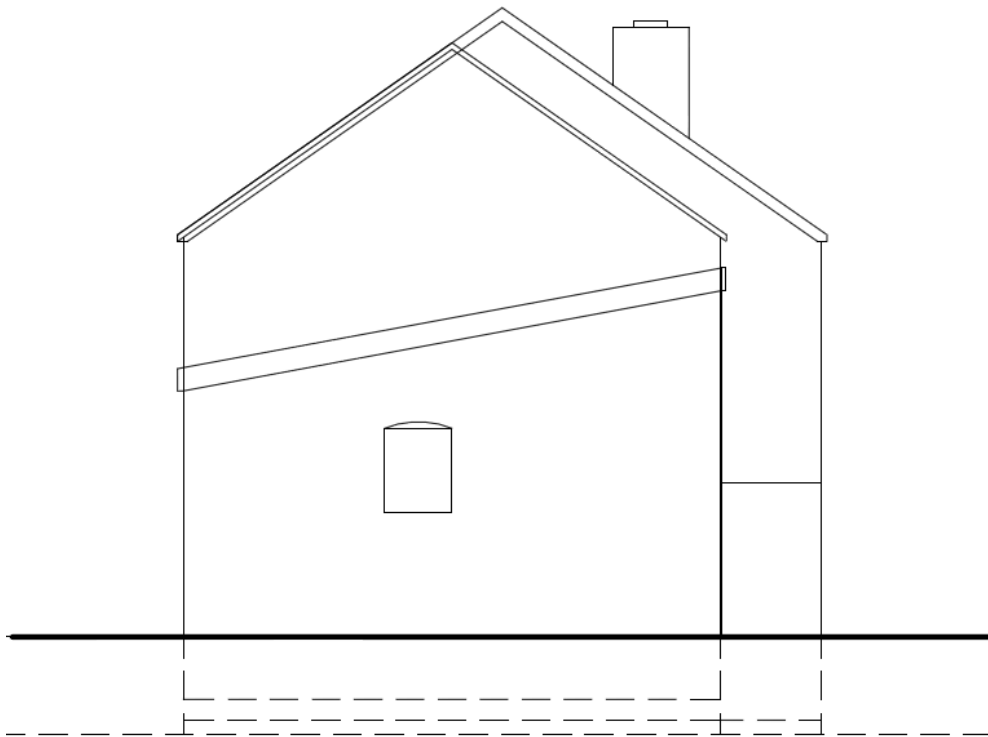
Figure 9
External elevations (courtesy of P.J. Conway)

SOUTH WEST ELEVATION.

NORTH EAST ELEVATION.

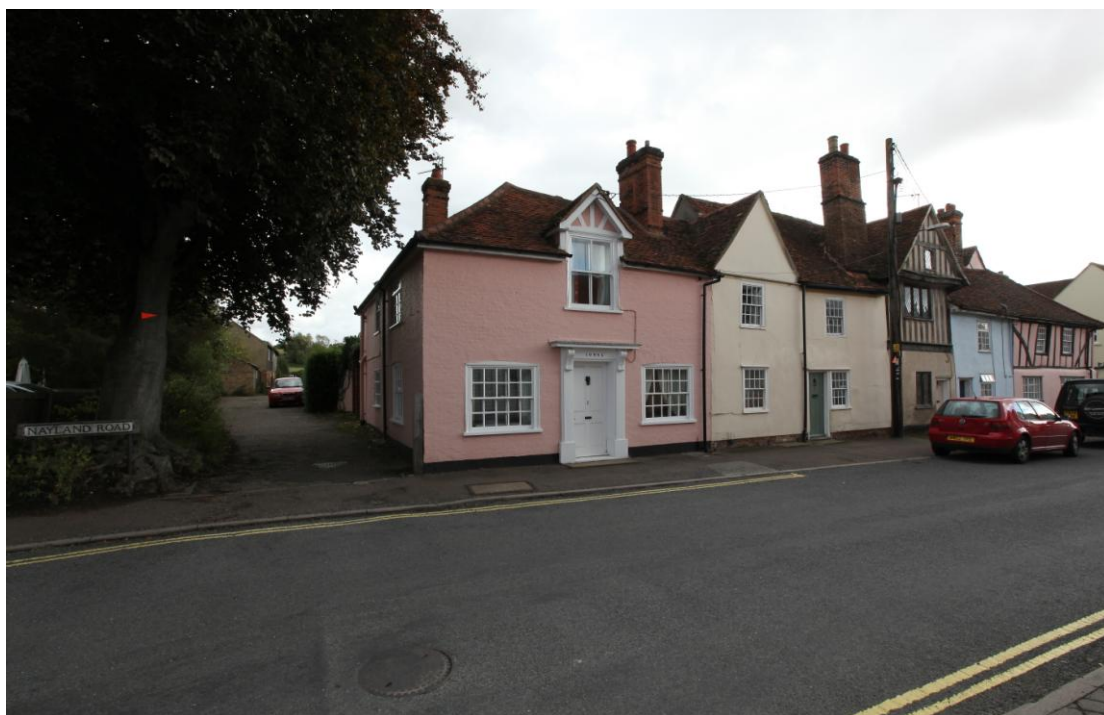
Illus. 1. The entrance to the site from Nayland Road showing the sheds in the rear to the left and the range of cottages to which they formerly belonged on the right. All are listed at grade II and appear to have formed the front range of a large Tudor inn. The tallest gable is a gatehouse that opened onto a courtyard of buildings from which the re-used timber in the early-19th century shed (2) probably derived.

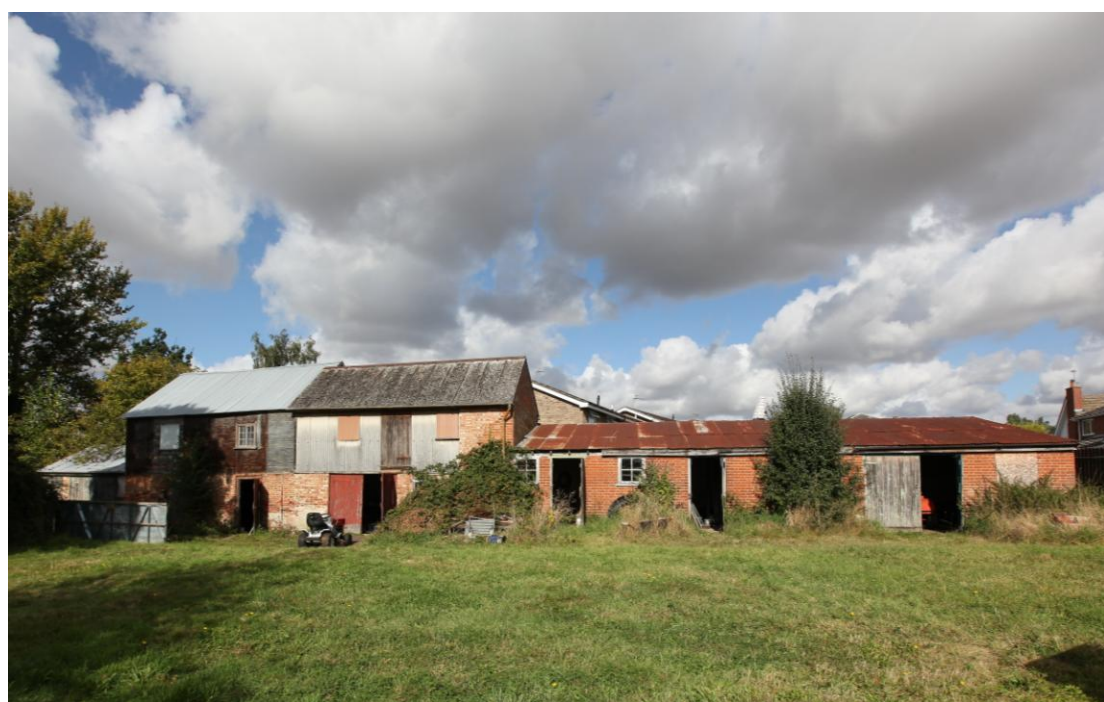
Illus. 2. The buildings from the former orchard to the south-east showing from left to right the single-storied 20th century vehicle shed (1), the early-19th century shed (2), the late-19th century shed (3) and the long, single-storied brick shed with a mono-pitch roof and separate entrances to its three compartments (4a-c).

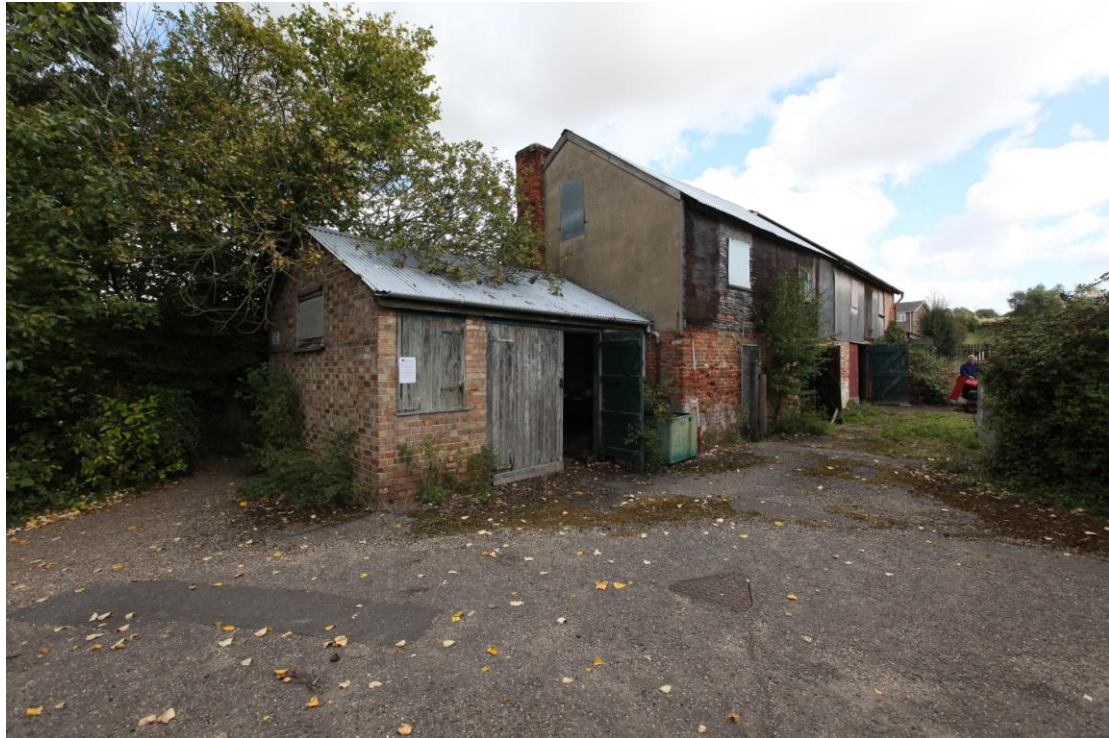
Illus. 3. The sheds from the south showing the footpath to the left of the single-story early-20th century Fletton-brick vehicle shed (1) with the adjoining early-19th century shed (2) on the right.

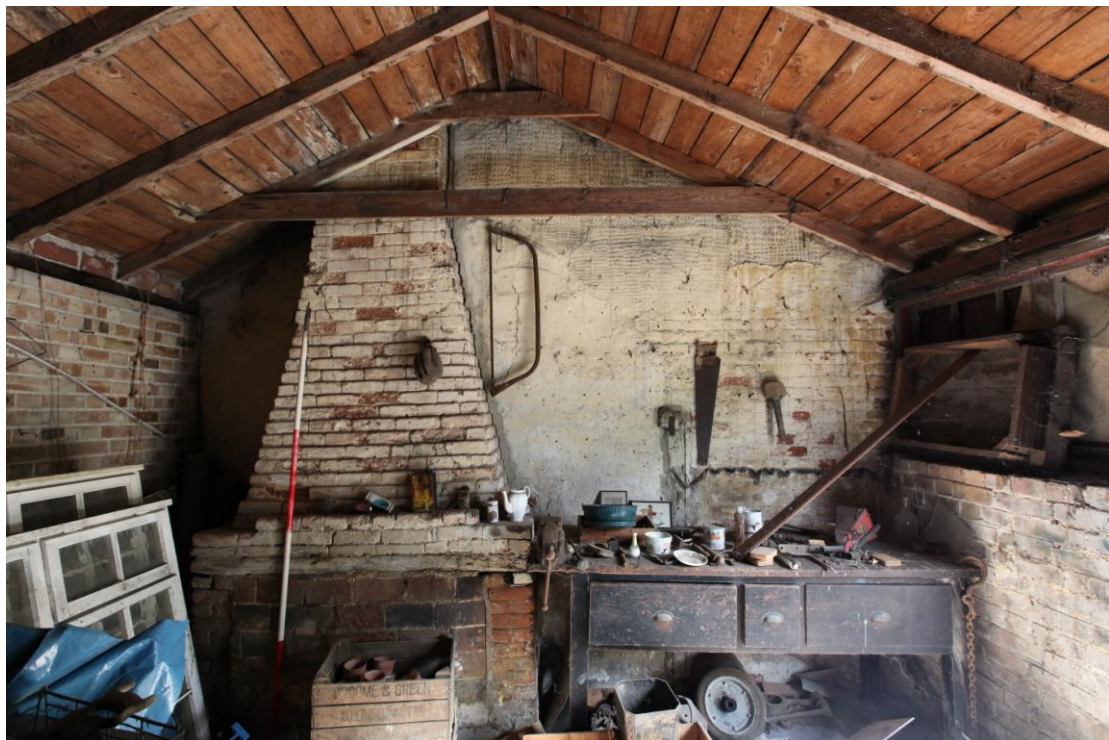
Illus. 4. The interior of the 20th century vehicle shed (1) from the south-west showing the early-19th century chimney and blocked fireplace with the truncated roof plate of an earlier, smaller shed to the right. The profile of this earlier shed is clearly visible in the plaster on the gable of the early-19th century shed (2) which preserves original external pargeing above the whitewashed brickwork of its lower storey.

The location, scale and doors of the building demonstrate that it was designed as a garage for a cart or motor vehicle, but it contains a well preserved early-19th century fireplace with a timber lintel in the gable chimney of the earlier shed (2) to the north-east (illus. A2.4 below). This is blocked with courses of red bricks laid on edge, but appears not to have been reduced in width prior to its obstruction (unlike the identical fireplace in the opposite side of the same chimney). The upper storey of the 19th century gable also contains what appears to be its original whitewashed external plaster with a bold prick-pattern – also preserved by the vehicle shed. A later patch repair was pargeted with a different pattern resembling the weave of a textile (illus. A1.21), but the plaster immediately to the front of the chimney is plain and reveals the roof outline of an earlier, narrower single-storied shed on the same site. A fragment of roof-plate also survives from this shed, which was shown on the Ordnance Survey of 1885 but had been demolished by 1902 leaving the fireplace either exposed to the

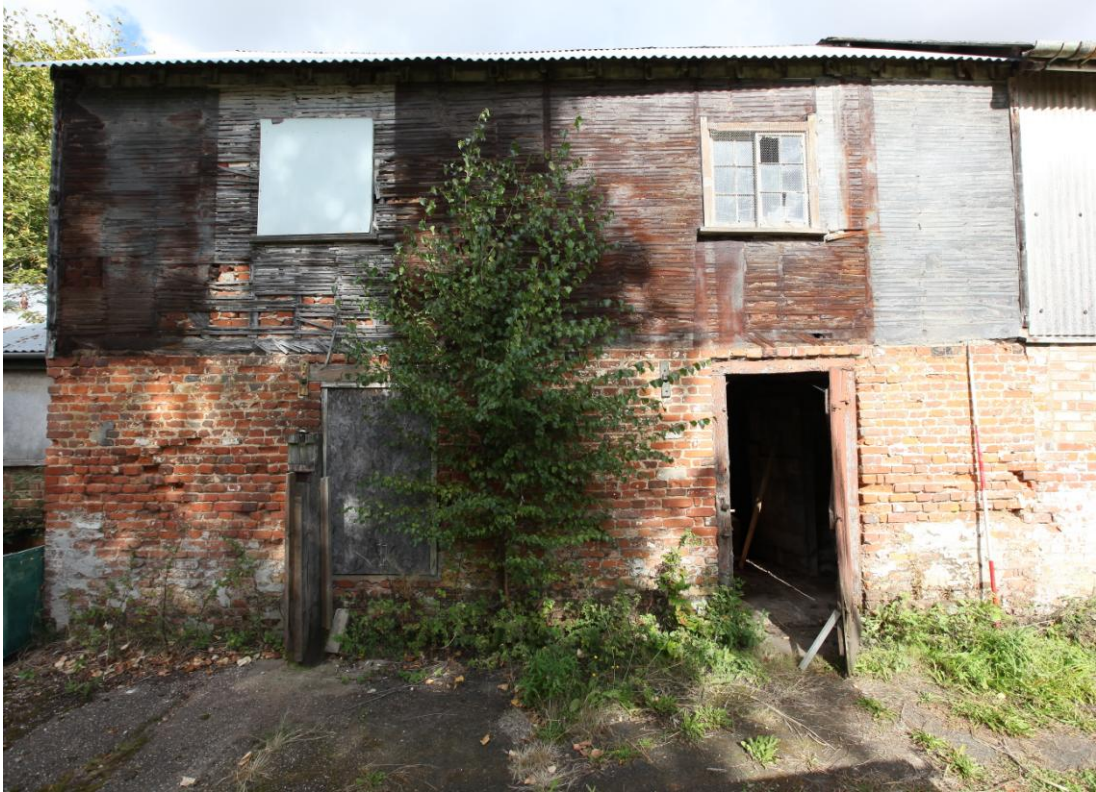
Illus. 5. The south-eastern facade of the early-19th century shed (2) showing its original door and horizontal sash window to the right with boarded sash windows to the left. The plaster of the timber-framed upper storey has been removed and the exposed battens are now covered only by expanded metal lath. The original peg tiles were replaced by corrugated metal after Mr Eaves' death in the 1990s.

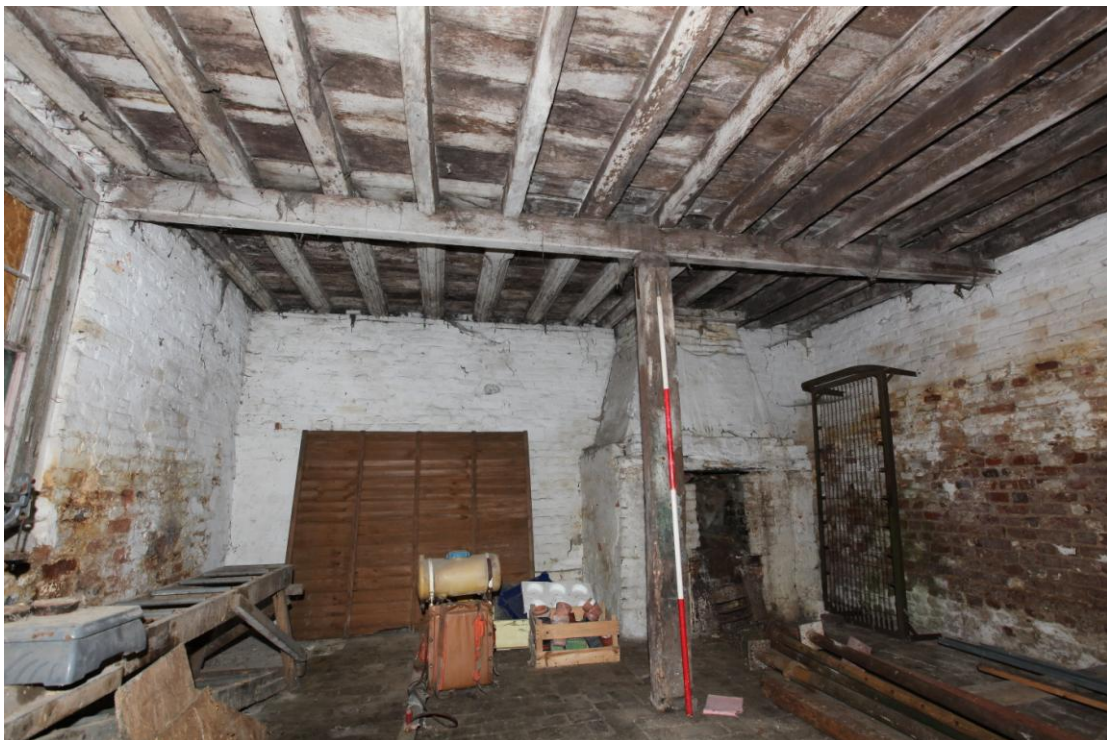
Illus. 6. The interior of the early-19th century shed (2) from the north-east showing its intact sunken brick floor, original fireplace and re-used late-medieval ceiling joists.

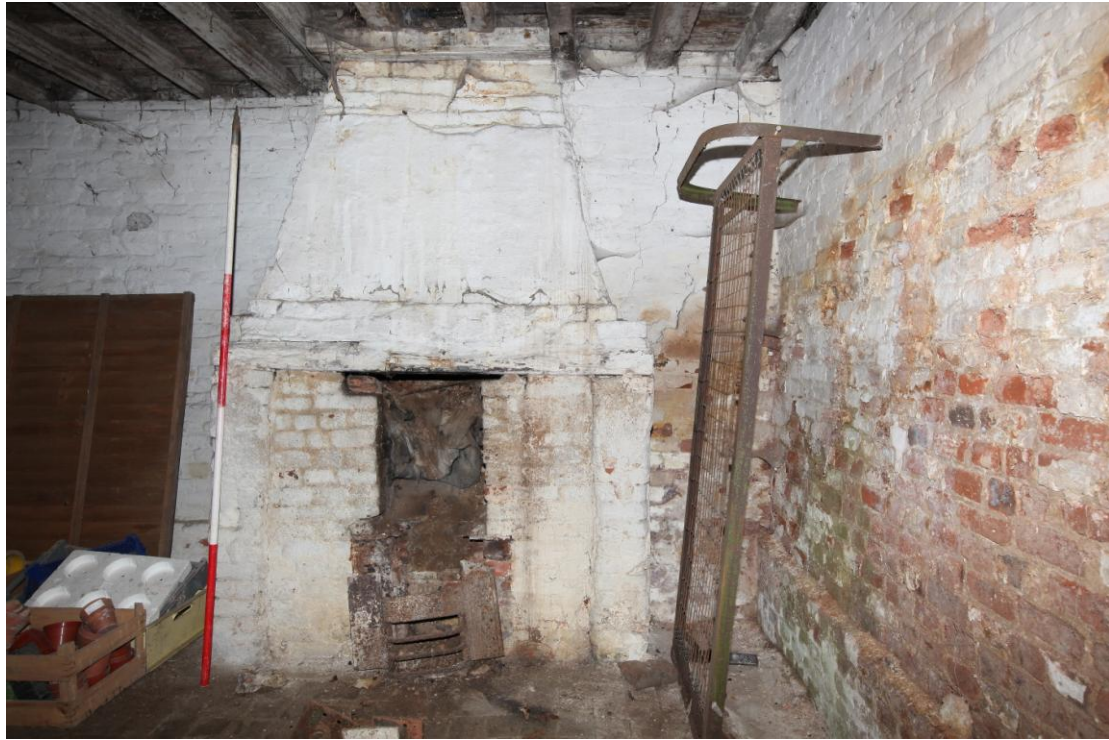
Illus. 7. The original fireplace in the south-western internal gable of the early-19th century shed (2). This was reduced in width to install a cast-iron coal grate with floral decoration in the late-19th century but is otherwise identical to the fireplace on the other side of the chimney (illus. 4) – although its lintel is 0.5 m higher due to the sunken floor.

evidence of domestic decoration and the space is clearly commercial rather than domestic despite the fireplace against its western gable. This fireplace was reduced in width during the late-19th century when a cast iron coal grate with foliate decoration was inserted but was initially 1.2 m wide (4 ft) with a timber lintel and stepped chimney breast in a traditional style that quickly disappeared during the mid-19th century. The insertion of the coal grate may reflect a late-19th century refurbishment that included the present boarded stair which opens onto a spacious loft lit by two horizontally sliding sash windows (often known as Yorkshire sashes but very common locally – including in the rear elevations 1-7 Nayland Road). Both gables contain blocked high windows or hatches above their tie-beams some 2.25 m (7.25 ft) above the floor.

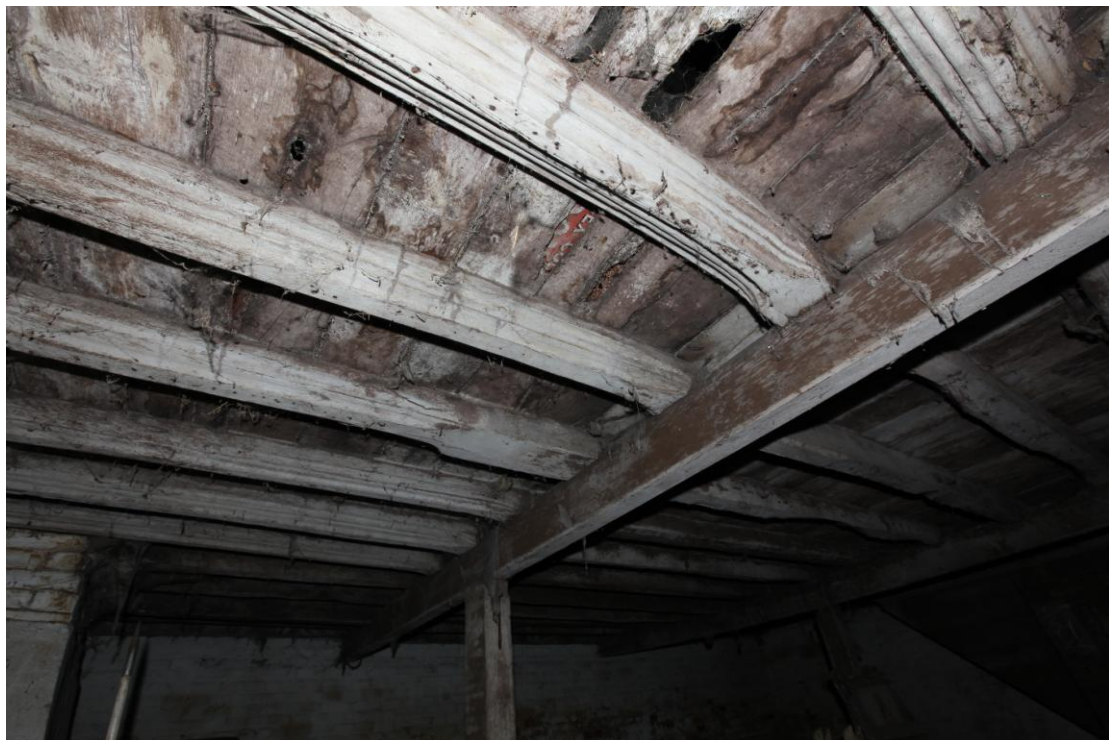
Illus. 8. The re-used late-15th or early-16th century ogee-moulded joists in the three-bay ceiling of the early-19th century shed (2), viewed from its southern corner. Several joists show evidence of a jetty, and were probably salvaged from the buildings in the rear courtyard of the nearby grade II-listed range (illus. 1) which were in the same ownership and demolished at or around the time of the shed's construction.

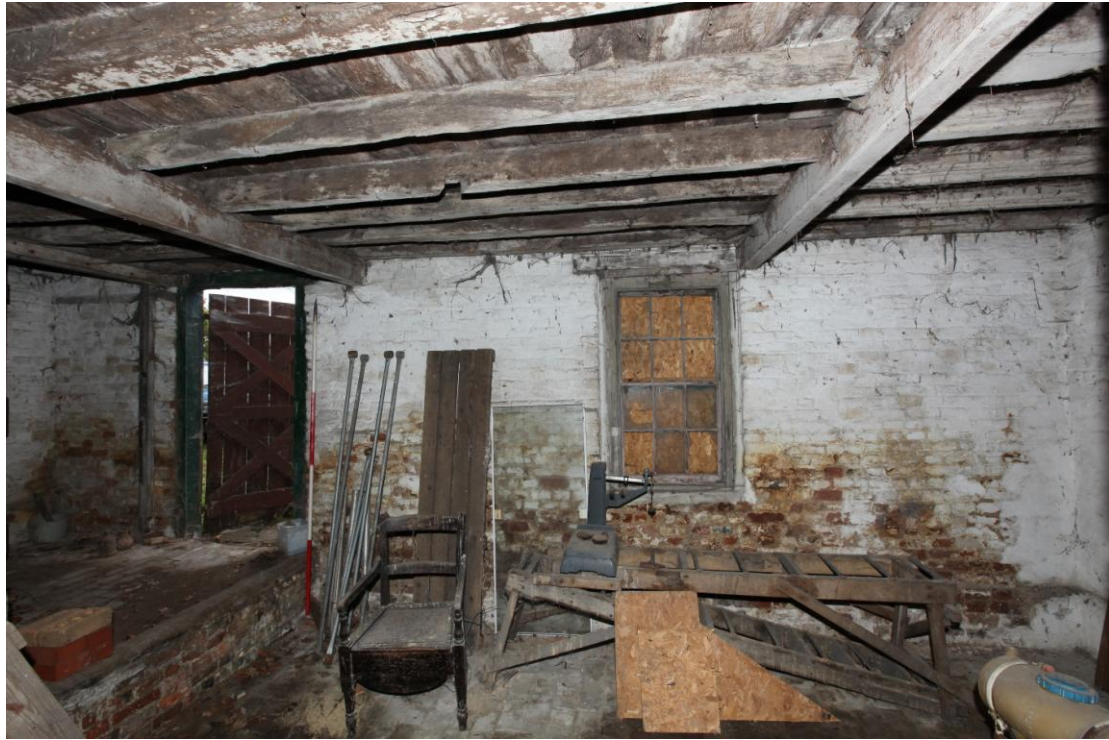
Illus. 9. The internal south-western facade of the early-19th century shed (2) showing the entrance and stair platform at ground level to the left with the sunken floor and original 6 over 6 sash window to the right.

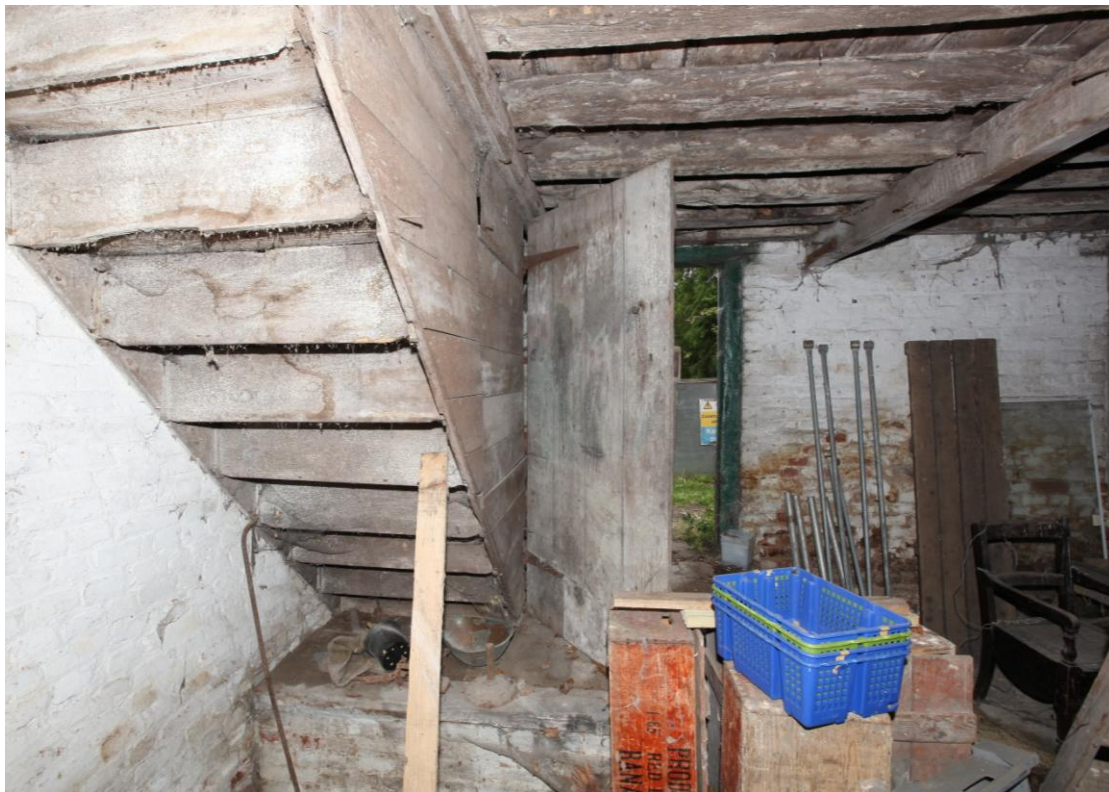
Illus. 10. The underside of the boarded stair in the eastern corner of the early-19th century shed (2). This rests on a brick platform at ground level with the rest of the floor 0.5 m lower.

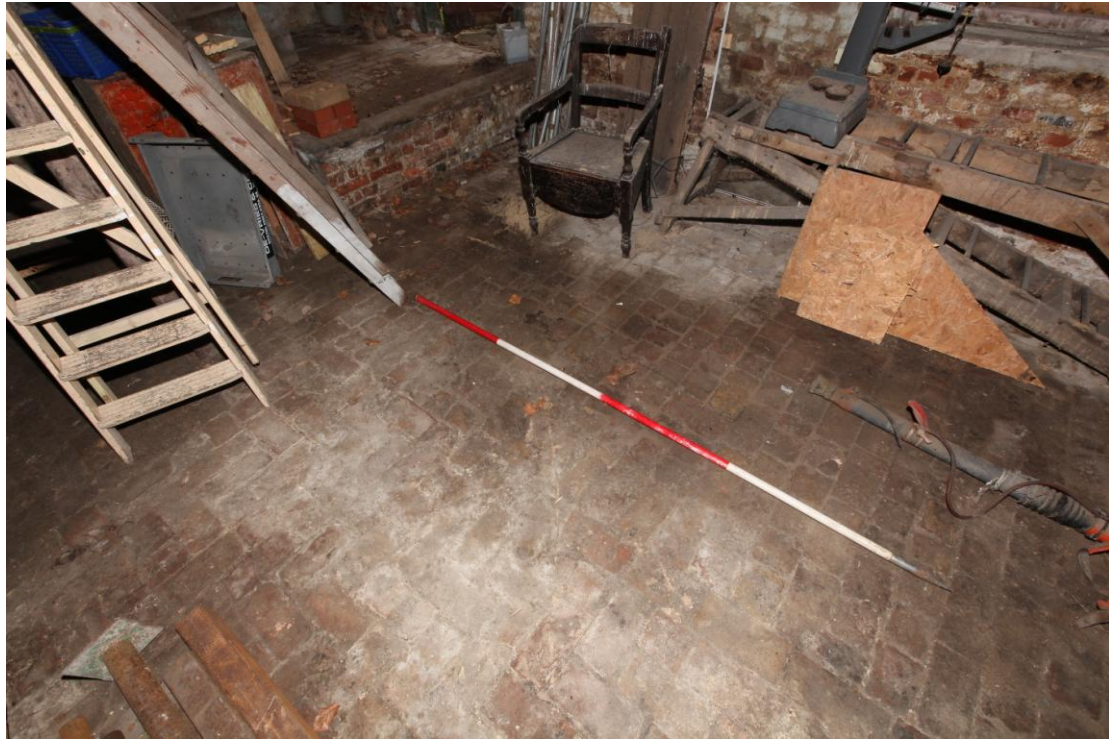
Illus. 11. A detail from the west of the well preserved original sunken brick floor of the early-19th century shed (2) with the entrance platform to the left.

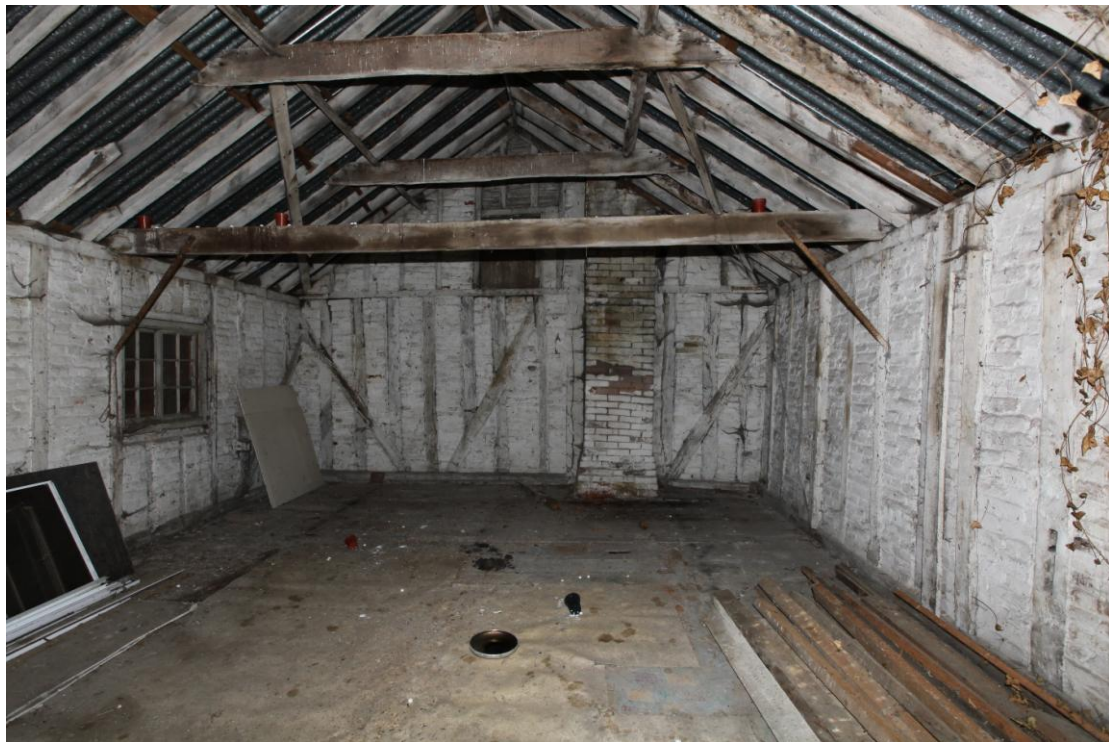
Illus. 12. The interior from the north-east of the loft in the early-19th century shed (2) showing one of the two probably original horizontal sliding-sash window in the south-eastern facade to the left with the chimney and hatch in the south-western gable. There are no windows or doors in the entire rear north-western elevation (right). The wall studs and rafters include a high proportion of re-used medieval timber.

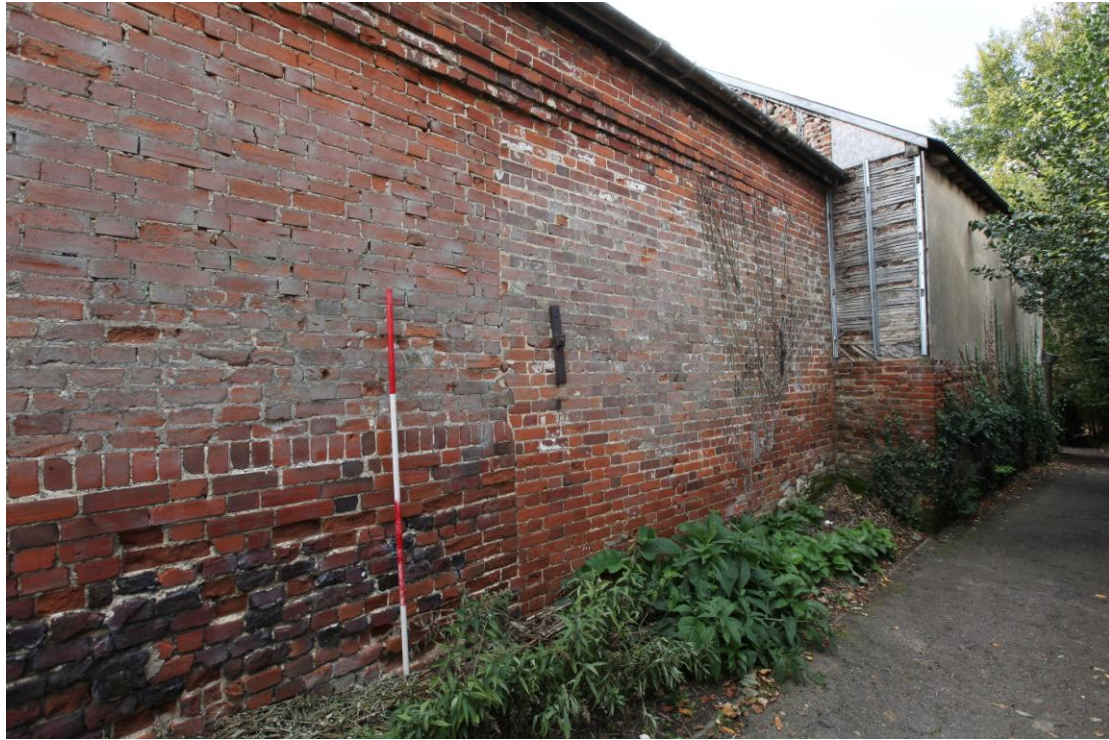
Illus. 13. The ‘blind’ north-western exterior of the late-19th century shed (3), viewed from the tarmac of the adjoining footpath and showing three phases of brickwork with the former low boundary wall at bottom left. The wider early-19th century shed (2) is visible in the rear to the right.

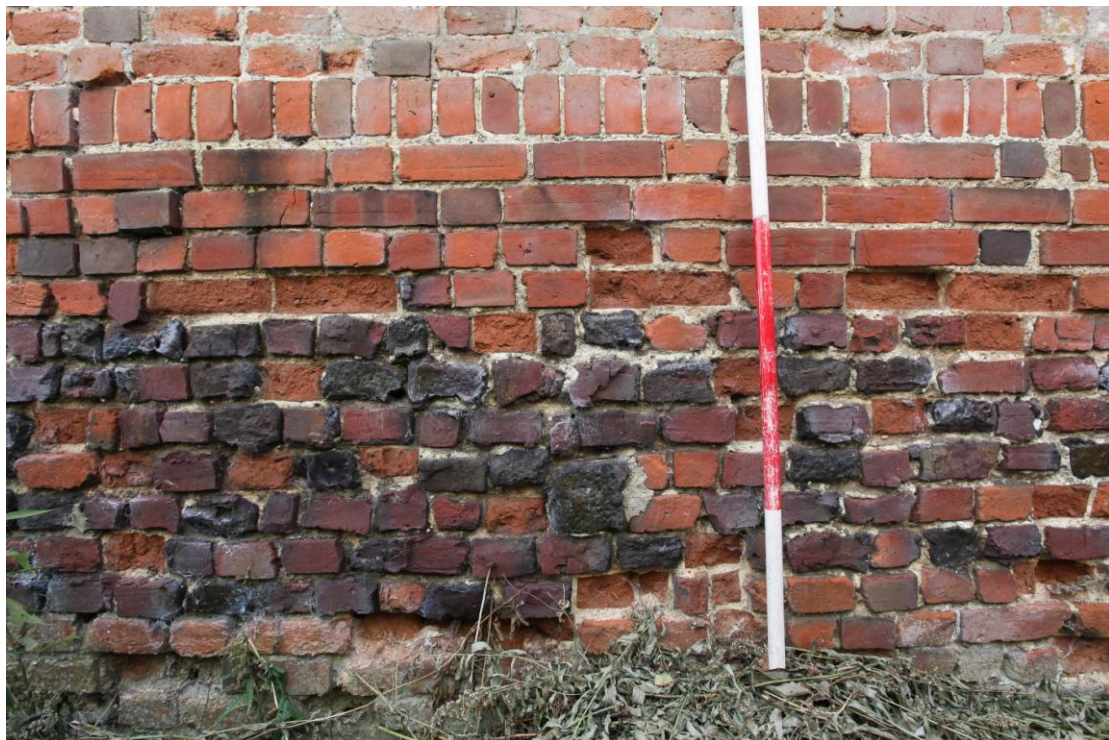
Illus. 14. A detail of the re-used over-fired brick-kiln wasters in the low 19th century boundary wall (capped by a soldier course – i.e. a row of headers set on edge) incorporated into the north-western rear elevation of the mono-pitch shed (4) and part of the late-19th century shed (3). These wasters probably stem from the Garrad brickworks beside the railway at the foot of Lamarsh Hill in Bures Hamlet.

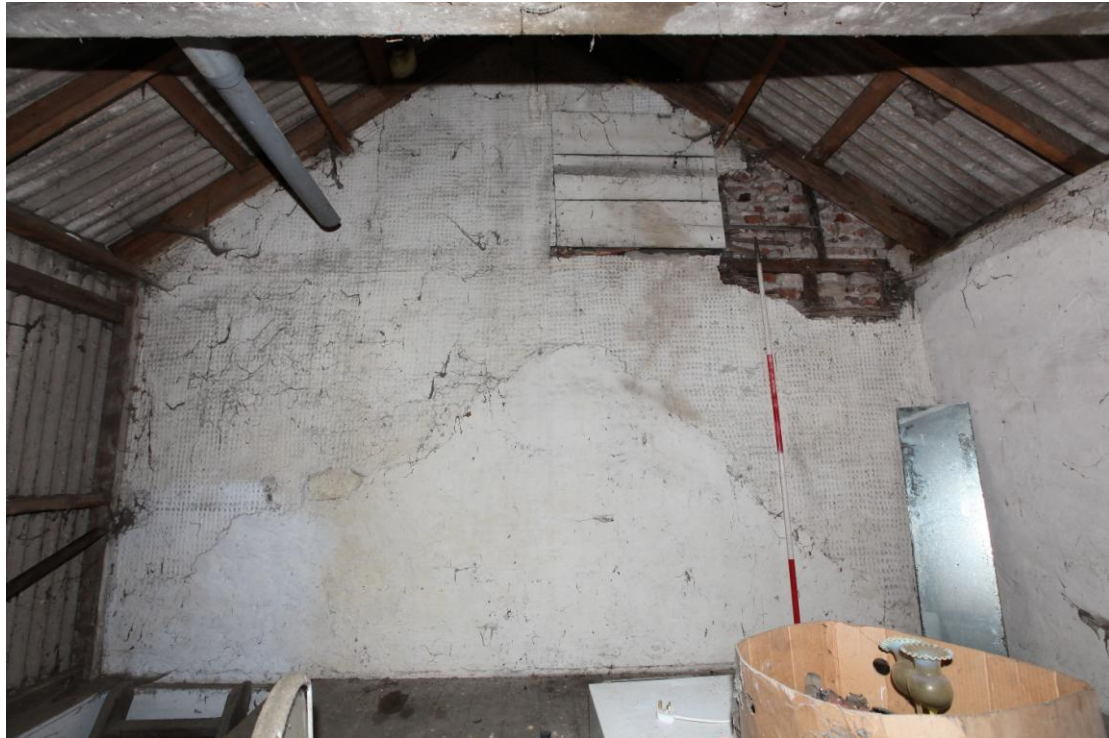
Illus. 15. The interior of the late-19th century shed (3) from the north-east, showing the original whitewashed external pargeting of the early-19th century shed (2) with the roof outline of an earlier, lower building on the same site. The roof and most of the south-eastern facade (left) of the late-19th century shed was rebuilt in softwood and corrugated asbestos in the mid-20th century
