**‘Former Cottages & Packing Sheds’,
Eves Orchard,
Bures St Mary, Suffolk
BSM 062**

Heritage Asset Assessment

‘Former Cottages & Packing Sheds’, Eves Orchard, Bures St Mary, Suffolk

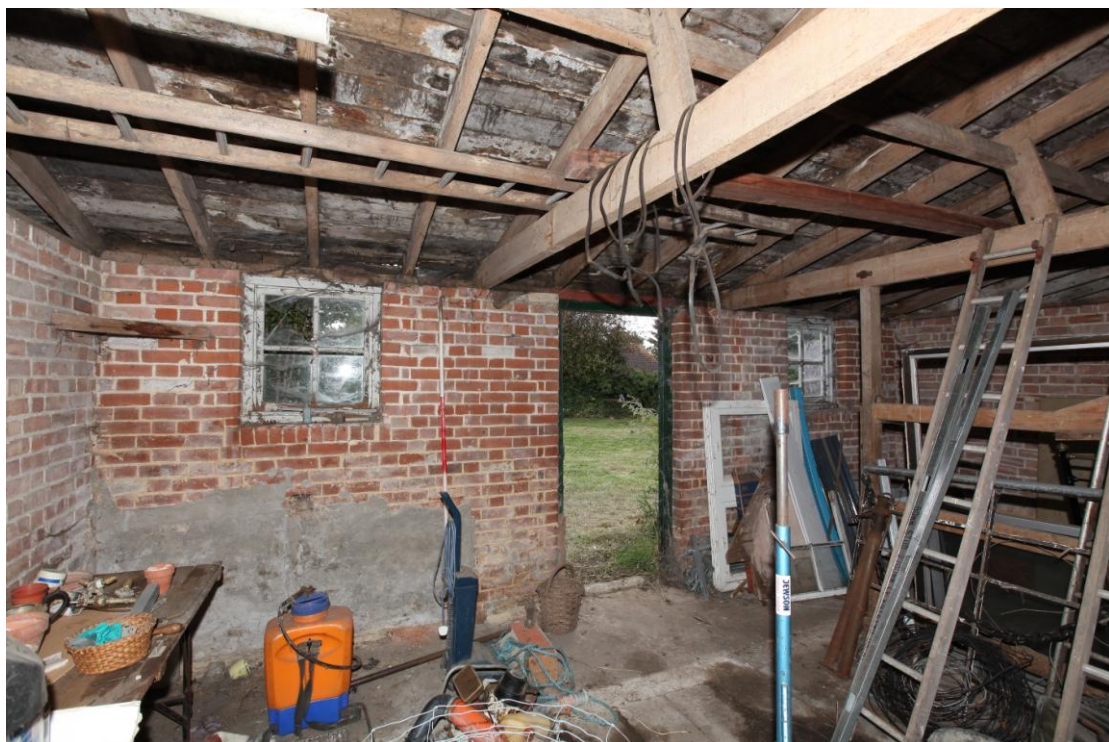
Illus. 16. The south-eastern facade of the central compartment (4b) of the mono-pitch shed showing its boarded roof and central door flanked by original windows. The remains of two original boarded stall divisions are visible to the right and this compartment was designed as a stable.
