Dunwich Greyfriars, Dunwich DUN 110

Archaeological Monitoring Report

SCCAS Report No. 2012/123

Dunwich Greyfriars, Dunwich

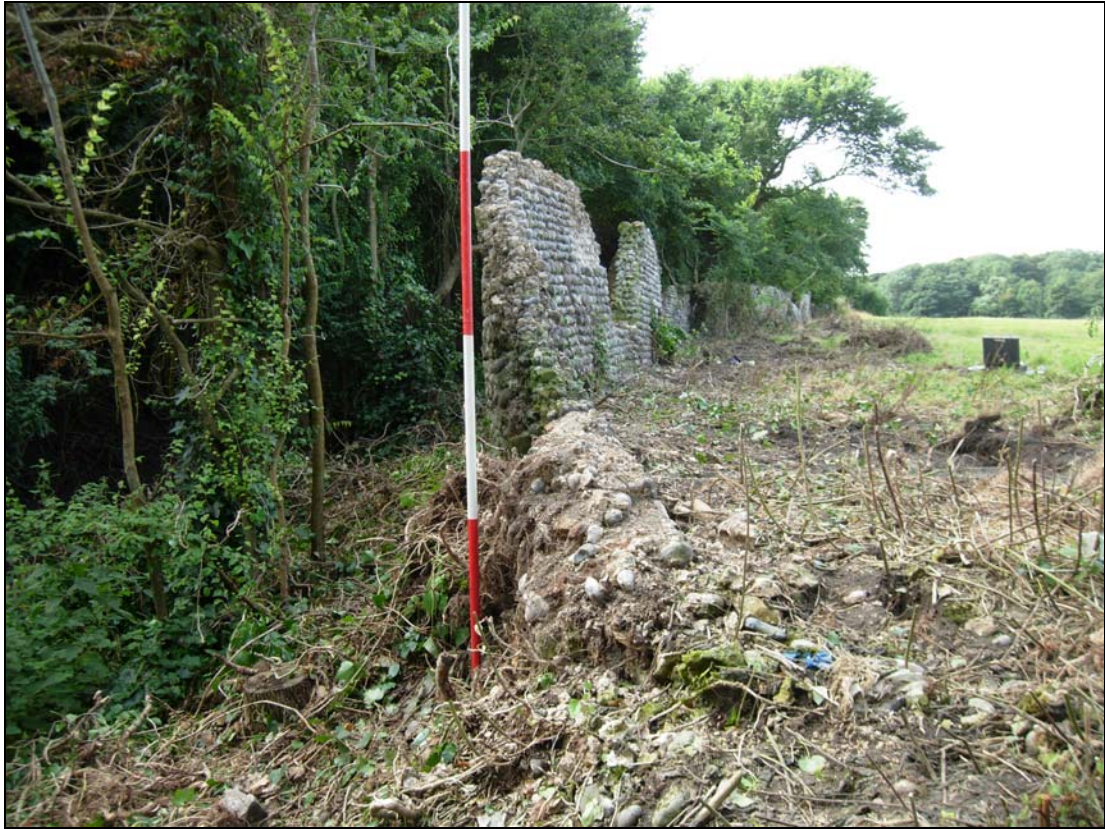
Plate 1. E. precinct wall: surviving stub from N.

The removal of the vegetation in the north-east corner of the precinct revealed that c.3m of the north wall and c.6m of the east wall were effectively missing, surviving only as low stubs of fabric extending locally to a maximum height of 0.3m above the existing ground level (Plate 1). In addition, detached blocks lay on the external slope outside the precinct, presumably where they had fallen (Plate 2).

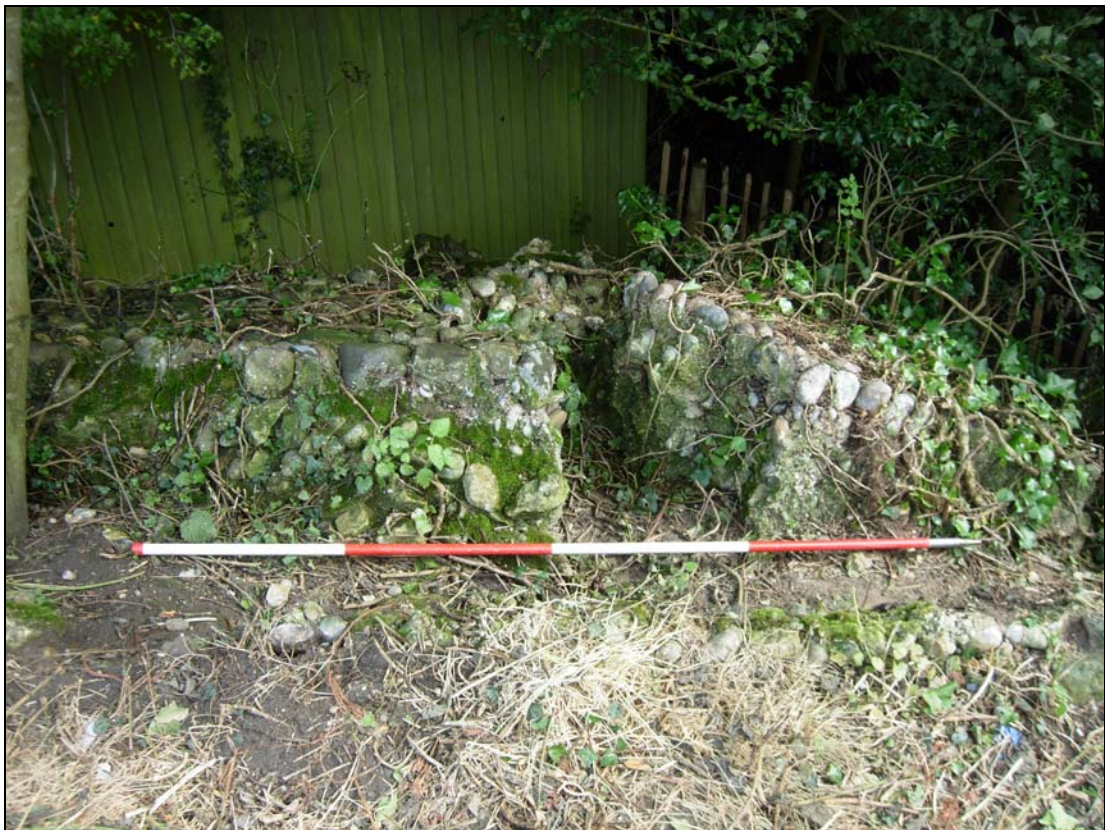
Plate 2. N. precinct wall: detached blocks on external slope

The fallen blocks derived from the north wall exhibited prominent coursing with predominantly rounded flint beach cobbles of c.10cm diameter along with some reused tooled limestone blocks and more exotic pieces set in a hard cream coloured lime mortar with frequent gravel inclusions. This wall fabric was identical in character to, and considered to be contemporary with, that making up the whole north precinct wall, all of the west precinct wall, with the exception of the two medieval gateways, and the westernmost c.3.5m of the south precinct wall.

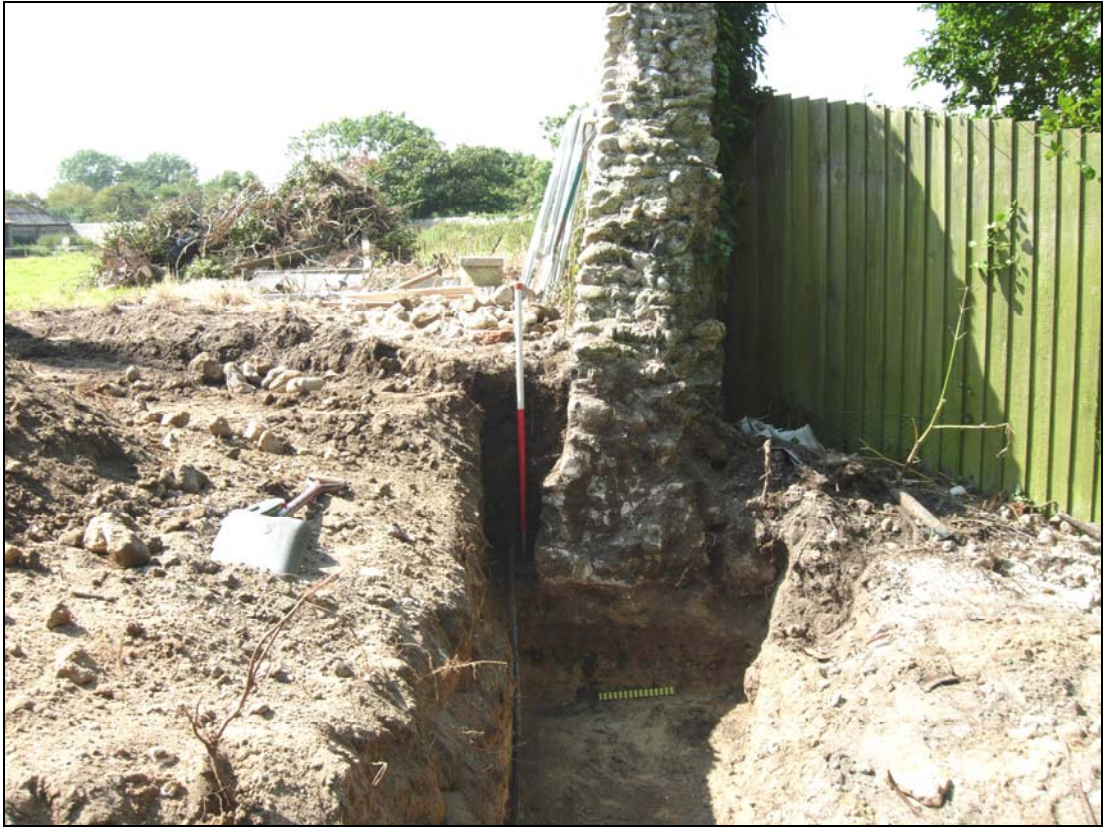
Plate 3. N. precinct wall: S1

A section was excavated around the exposed end of the extant north wall (0002) revealing the toed internal base of the wall stepping out by c.0.1m at a point c.0.4m from its base (Figs. 3 and 4 S1 and Plates 3 and 4). The wall was 0.8m wide at its base, before stepping in, and then tapering upwards to c.0.45m at a height of c.2m. The external face was vertical with all of the reduction in thickness accommodated in the internal face. It is likely that this is the result of some outwards rotation of the wall rather than a deliberate feature.

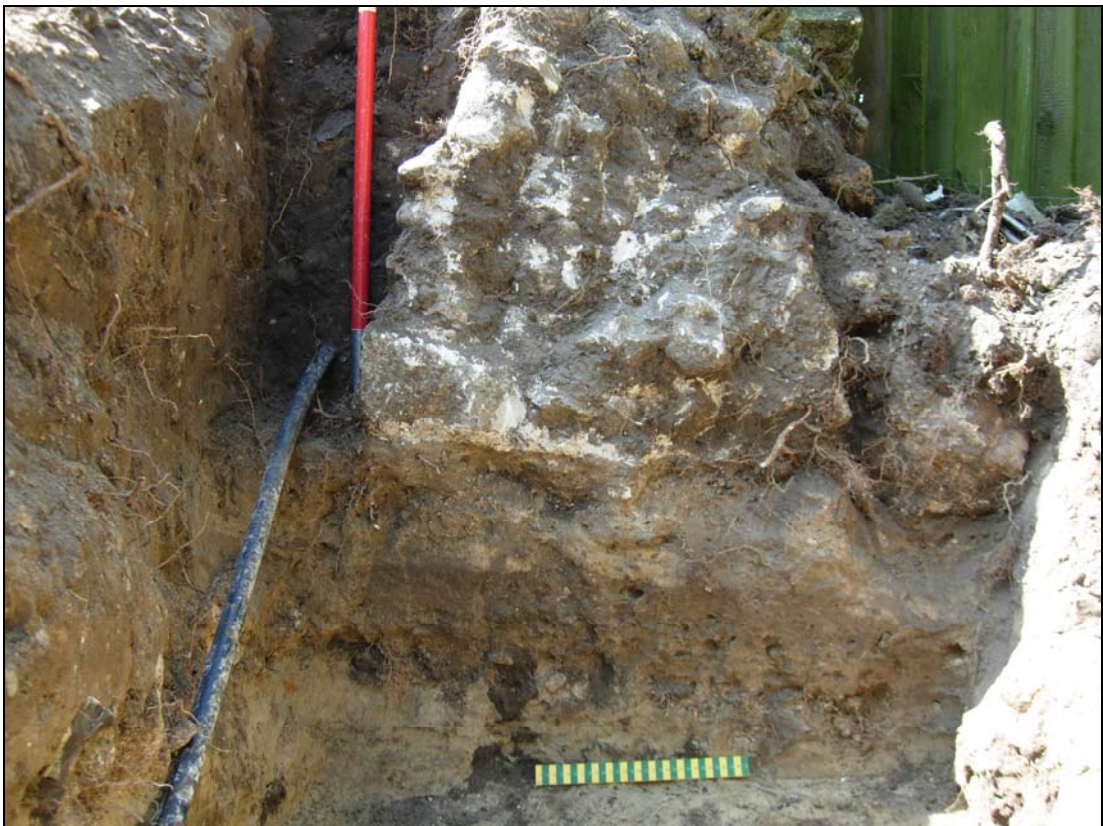
Plate 4. N. precinct wall: detail of wall footing in S1

Beneath the flattish base of the bonded wall there was a c.0.35 thickness of material (0003) interpreted as a footing similar in character with elements of the double footing seen in previous underpinning trenches (Boulter and Everett 2009 figs. 4, 5, 8 – 10 and plates 13, 14, 17 - 28). At this juncture, the footing comprised a thin layer of disaggregated lime mortar immediately below the wall, over c.0.1m of compacted yellow sand, over a further c.0.16m of compacted dark brown clayey sand, over another thin layer of disaggregated lime mortar (Fig. 4 S1 and Plate 4). Neither the internal or external edge of the footing was visible within the confines of the excavated trench. The existing ground level against the internal face of the wall was 0.4m higher than that externally with an internal depth of 0.8m of brown sandy loam topsoil (0001) over well sorted relatively fine grained yellow coloured sand (0004). During excavation, the yellow sand was considered to represent a natural subsoil deposit, but the subsequent excavation of the internal elements of the new footing suggested that it was actually fill within the former town ditch (0014).

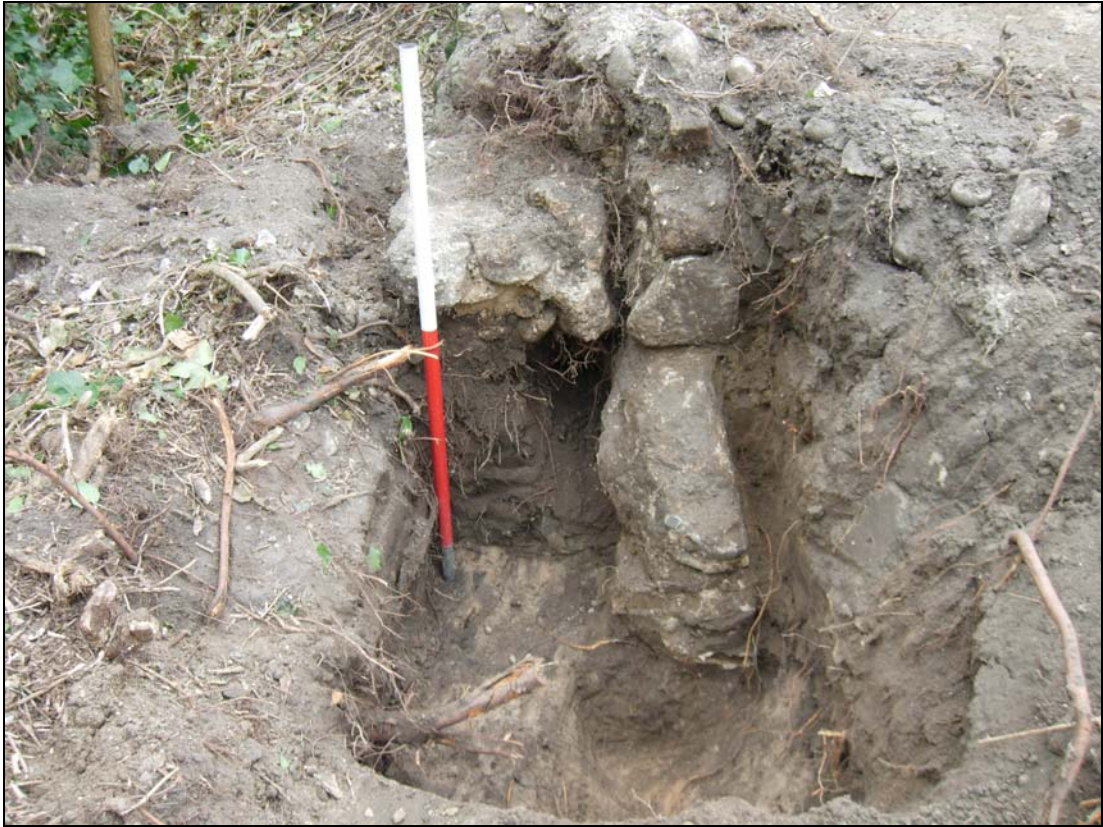
Plate 5. E. precinct wall: S2

At this juncture the base of the wall was 0.55m wide and constructed using large pieces of re-used limestone, septaria and more exotic pieces for approximately two courses, before changing to smaller pieces of predominantly flint beach cobbles in regular courses, all bound by a hard white mortar. The detached block was set within a deposit of orange/brown sandy clay (0008) that appeared to fill a narrow c.0.4m wide cut (0007) on a similar alignment to the wall, but only continuing for c.1m south of the recorded section. This feature did not have characteristics that would suggest it represented the footing of an earlier wall.

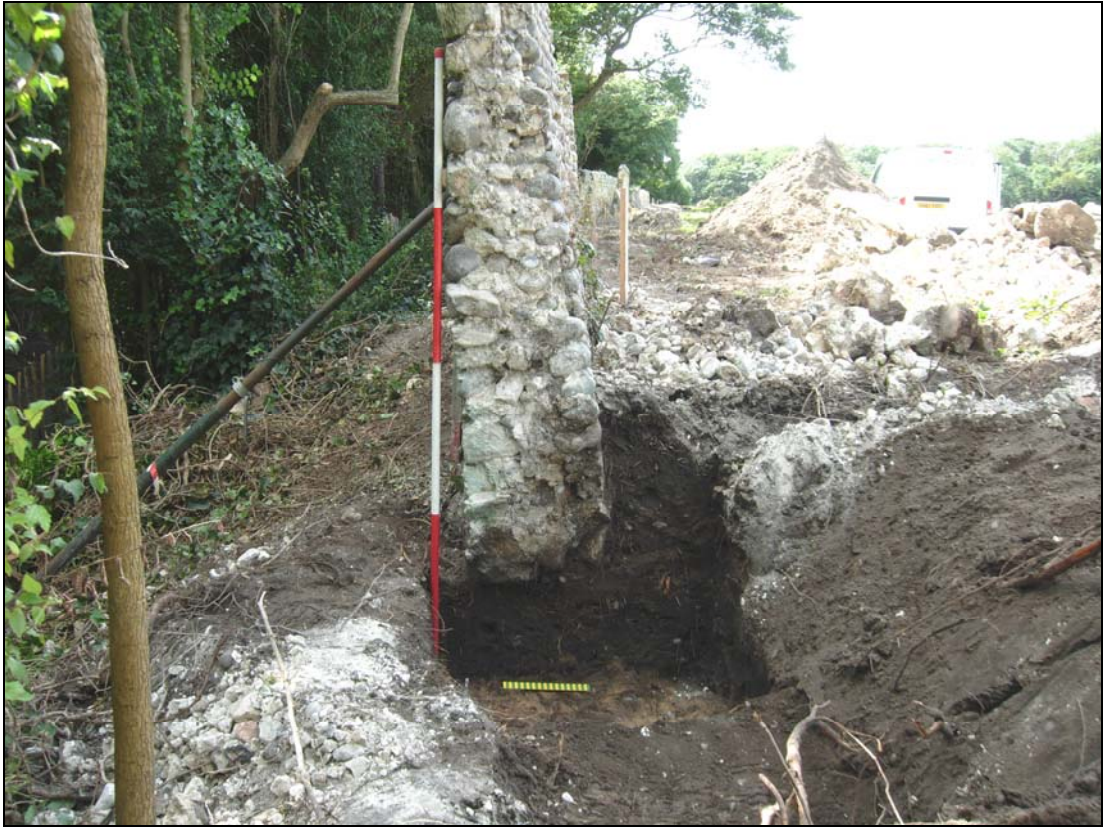
Plate 7. E. precinct wall: S3

The third section (Figs. 3, 4 S3 and Plates 7 and 8) corresponded with the southern limit of the deliberately removed material that would be butted by the new footing. At this juncture wall (0005) extended for 1.2m above ground, internally, with a further c.0.7m below ground. The extant ground level external to the wall was some 0.45m below that of the interior. The wall had been entirely constructed within topsoil with no apparent footing. Naturally occurring well sorted orange/yellow sand subsoil was encountered at 0.3m below the base of the wall. There was no evidence for an earlier footing. The wall itself was 0.45m wide at its base tapering to c.0.3m at its highest point. Similarly to S2, the basal two courses comprised larger blocks which gave way to smaller, more consistently coursed flints above, all set in hard white lime mortar.

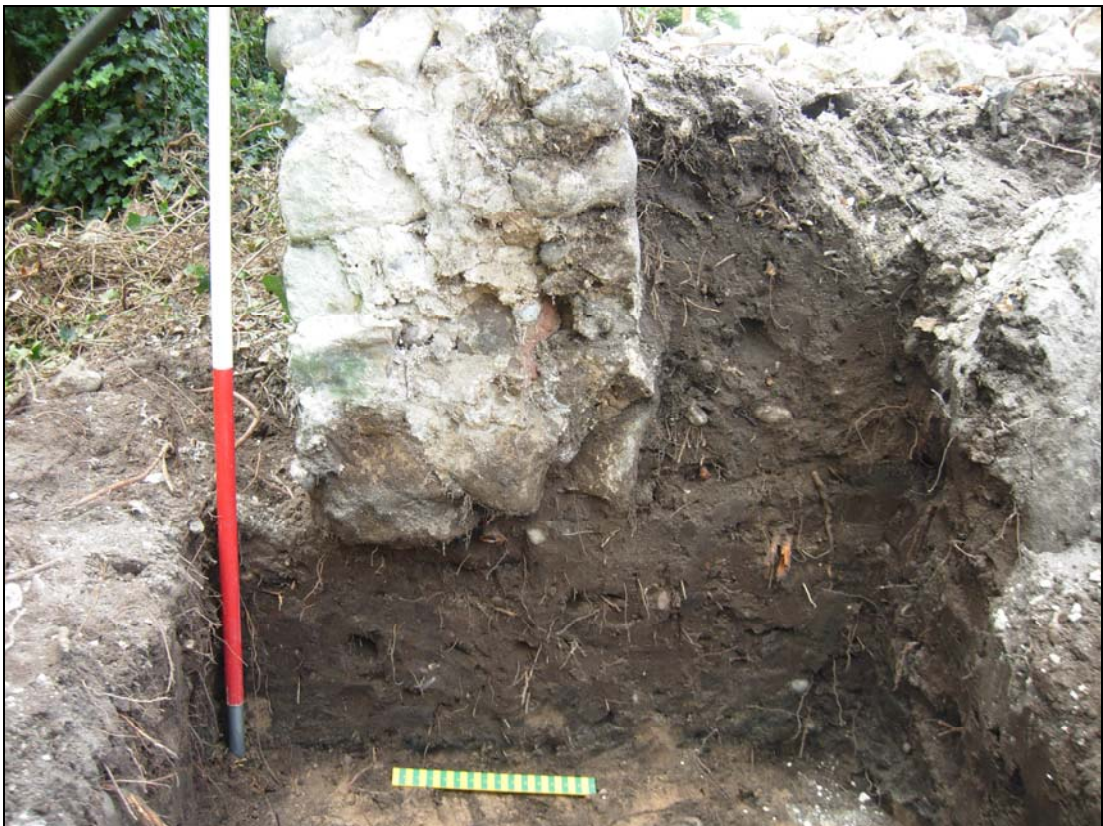
Plate 8. E. precinct wall: detail of wall base in S3

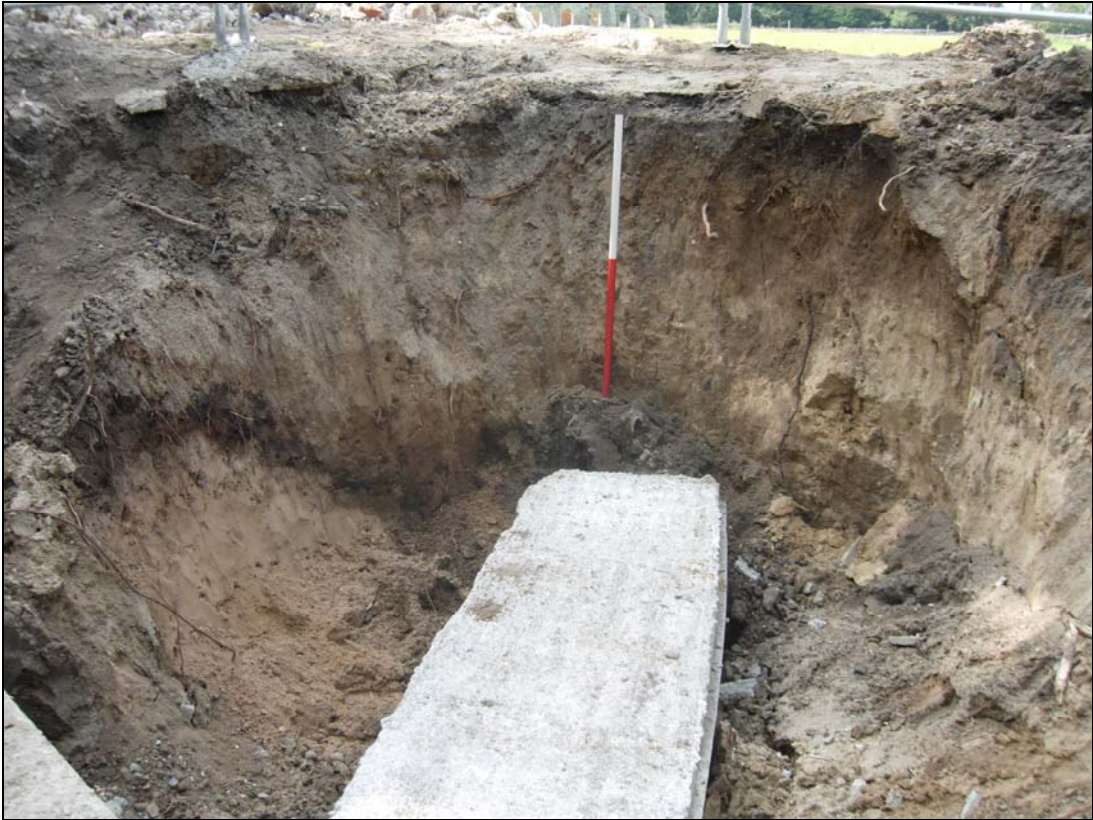
Plate 9. NE corner of precinct: town ditch in S.most footing

After concreting of the main component of the footing for the new wall, two additional elements were excavated under archaeological supervision (Fig. 3 and Plates 9 and 10). These were designed to give the whole structure enhanced stability and prevent rotational movement that would tip the wall down the external slope.

Three distinct fills were recorded in the ditch: a thin basal layer (0017) that followed the edge of the cut, seen only in the southernmost footing component, comprising c.0.2m of brown silty sand, presumably a stabilisation layer that would have formed while the ditch was open. At its highest point in the southernmost footing edge this layer included heat altered material in a discrete basal area, possibly representing *in-situ* burning (Plate 9). Overlying this was a thick layer, up to 1.5m, of relatively homogenous yellowish clayey sand (0016), itself underlying a dark brown silty, clayey sand (0015) that formed a central fill component of the ditch. There was almost certainly further stratification within these major elements, but with access to the trench being denied for health and safety reasons, no cleaning of the sections was undertaken.

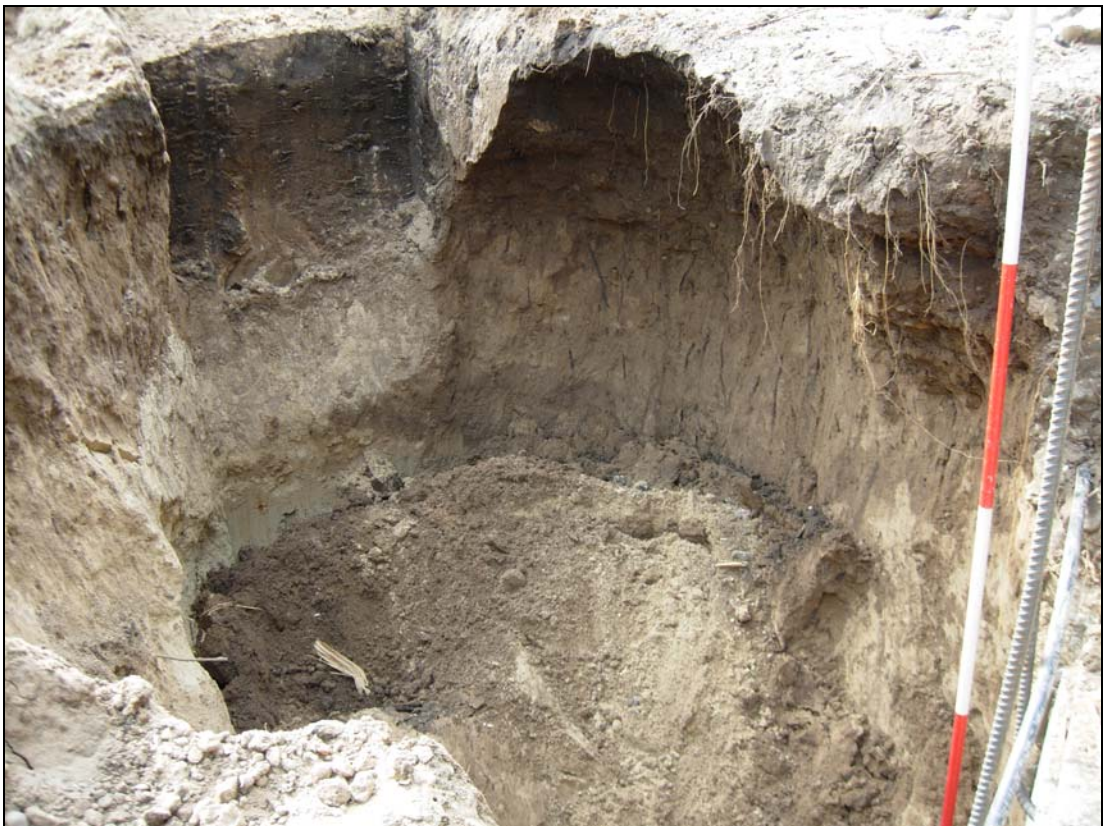
Plate 10. NE corner of precinct: collapsed ditch fill in N.most footing

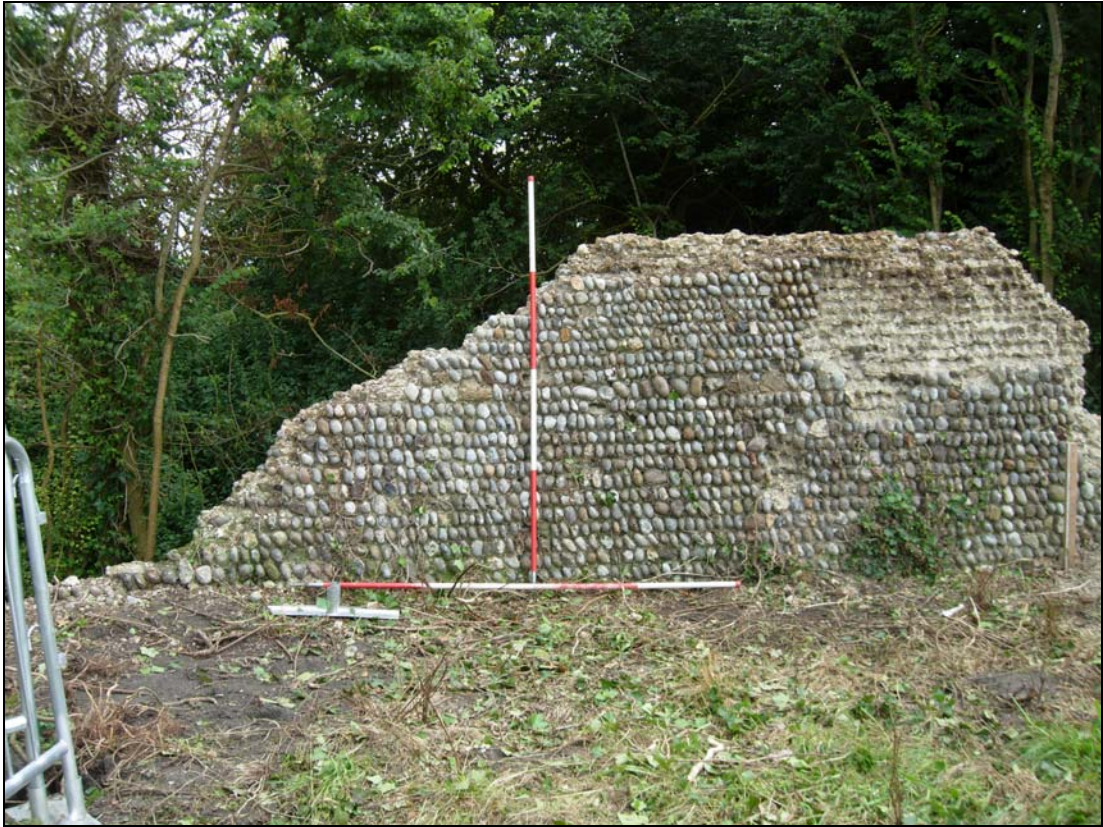
Plate 11. E. precinct wall: Stint 0 – 5m

Internally, the wall facing for the northernmost c.10m (Plates 11 and 12) varied between well coursed, tightly packed beach cobbles predominantly of c.10cm size, but with some variation, of which approximately 80% were flints with the rest exotics. The long axes of the flints were almost always vertical or slightly angled off vertical, all bonded with a hard white lime mortar. The wall dog-legged slightly at approximately 2m from its northern end: a point which, after demolition, became the junction between the new and old builds.

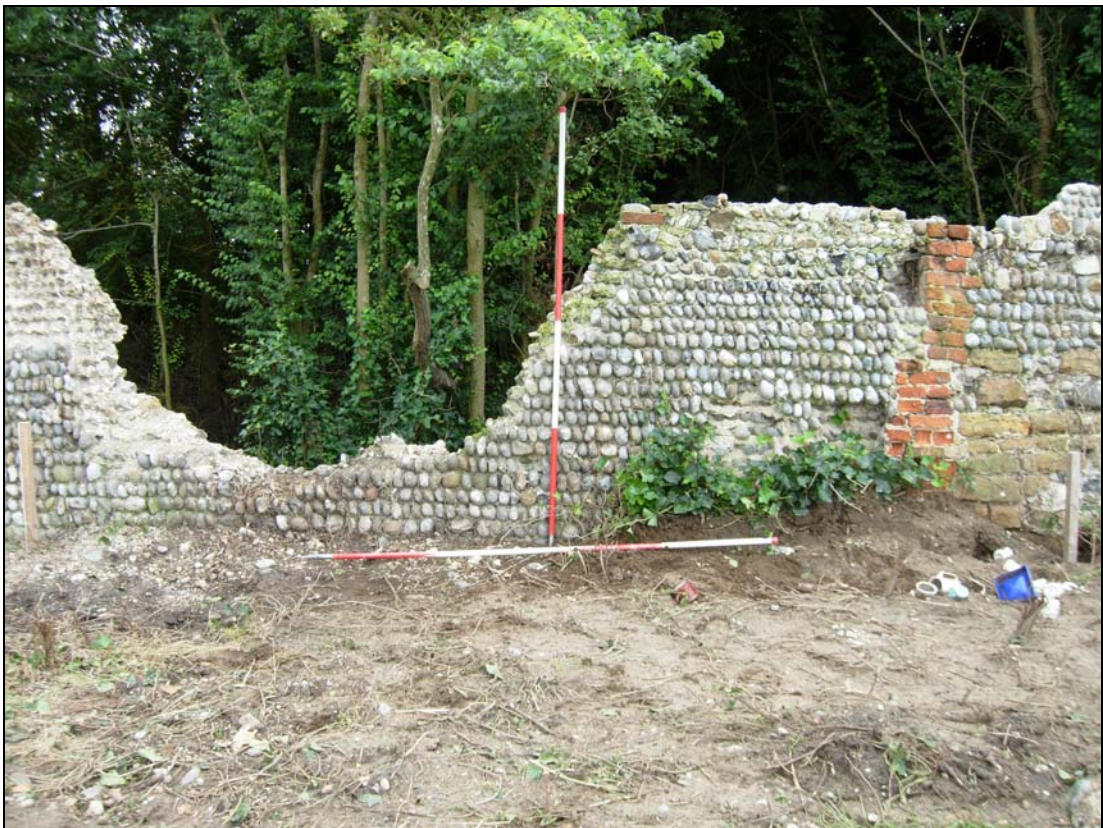
Plate 12. E. precinct wall: Stint 5 – 10m

A vertical element constructed in red brick marked the end of this distinctive internal and external facing (Plate 12). Similar features, although not always constructed in brick, are consistently present in all areas of the precinct wall, particularly in phases thought to be of post-medieval date. Whether constructed in brick, re-used limestone, crag or combinations of the three, they appear to run right through the wall and have been interpreted as representing the lateral extent of a section of wall being worked on at one time. In addition, they also provided strengthening by forming a structural element tying through from the external to internal faces. It is suggested that these constructional features were raised first, followed by the intervening coursed runs. A parallel in modern bricklaying would be the raising of the corners of a building prior to the laying of the main wall runs.

Immediately to the south of the first brick vertical element, the internal wall facing included a c.3m stretch dominated at its base by reused pieces of crag limestone which, in adjacent rabbit holes, could be seen to continue below ground to a depth of c.0.3m (Plates 12 and 13). While clearly appearing different in character to the neighbouring wall facing, the hard white mortar matrix seemed continuous between the two elements.

From this point to approximately 20m, the wall was a relatively regular in height, 1.5 - 1.7m, and included two vertical elements constructed from re-used tooled limestone blocks (Plates 12 to 14). The internal face comprised well coursed flint cobbles, most c.10cm in diameter interspersed with re-used tooled limestone blocks, bricks and some exotics, all set in hard white lime mortar. The larger pieces had the effect of disrupting the pattern by extending over more than one course.

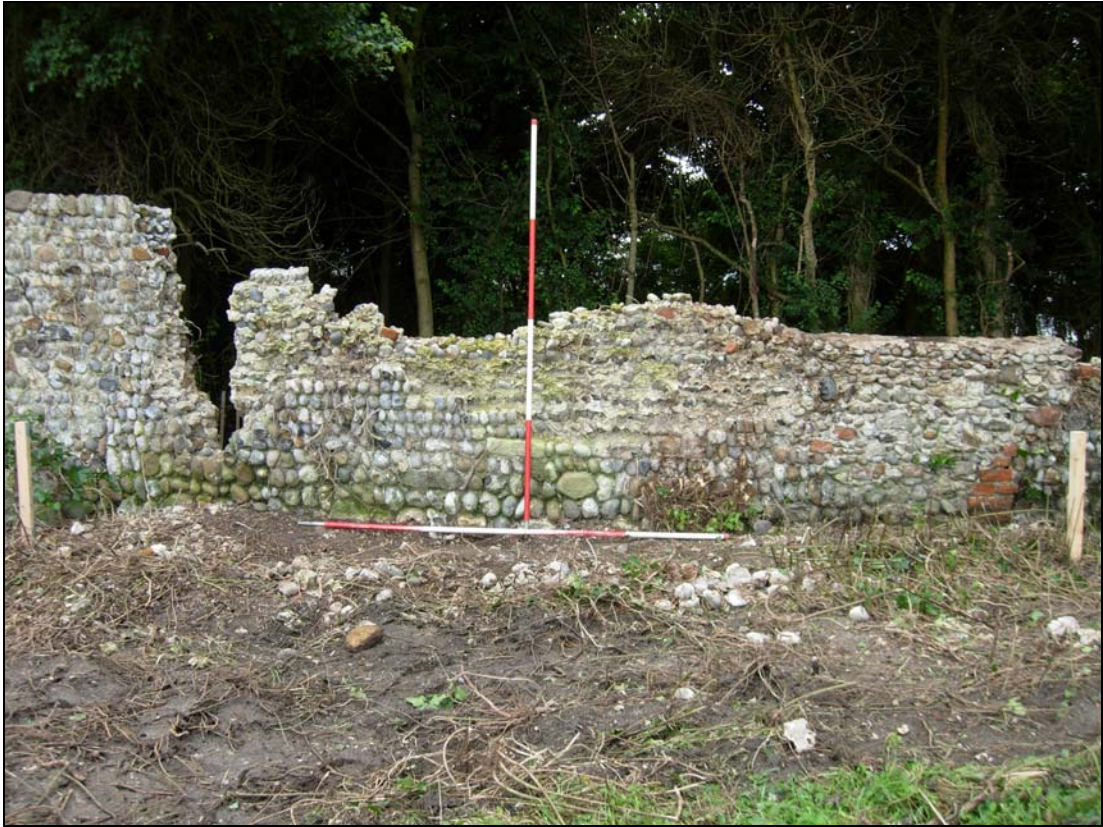
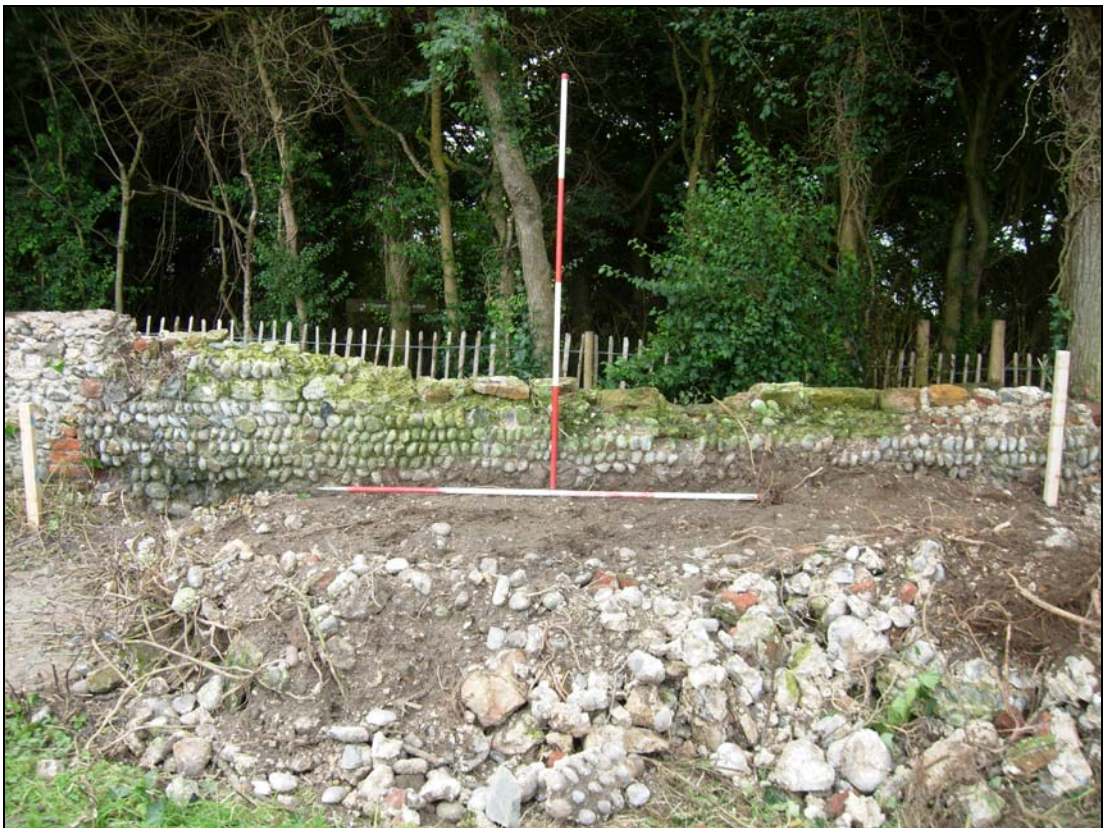
From 20m to 32m the wall was a maximum of 1.3m in height reducing to only 0.5m to the south (Plates 15 - 17). One vertical brick component was present at c.25m. Much of the internal face was missing but, where present, comprised predominantly of well coursed rounded beach cobbles. To the north of the brick element there was a greater range in clast size and occasional inclusions of exotics.

From 32m to 80m the east precinct wall was considered to represent a genuine survival of medieval fabric, although various phases of patching and repair were evident (Plates 17 - 26). Survival above ground varied from a few centimetres to 2.3 metres at 60m, with a further 0.3 metres of more recent capping. The repairs and capping were clearly recognisable as the use of predominantly rounded flint cobbles contrasted with the limestone crag blocks forming the internal face of the original wall. In addition, the lime mortar used in the patching and repairs tended to be hard and white, while that in the earlier wall was softer, buff in colour and included small chalk lumps. In some areas a thin secondary wall capping had been set with projecting shards of glass.

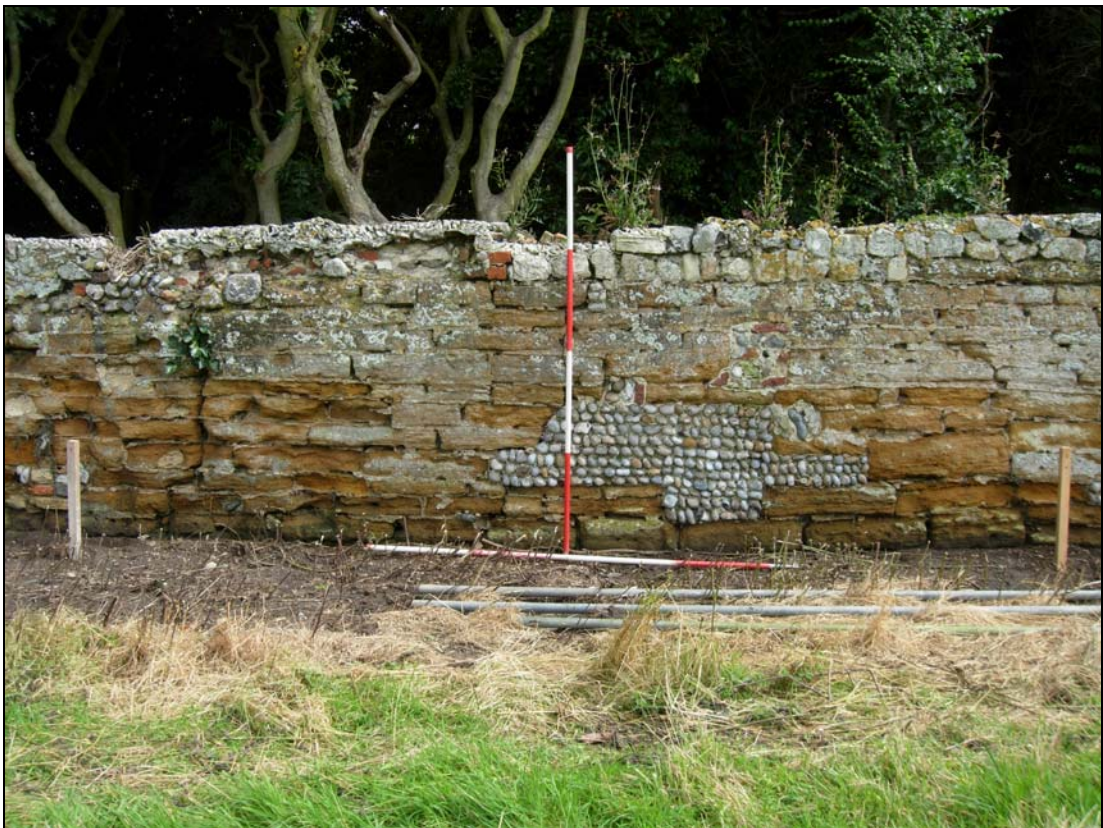
Plate 18. E. precinct wall: Stint 35 – 40m

There was two internal buttresses: one a large concrete structure (Plate 20), the other constructed predominantly from reused limestone blocks and bricks (Plate 22).

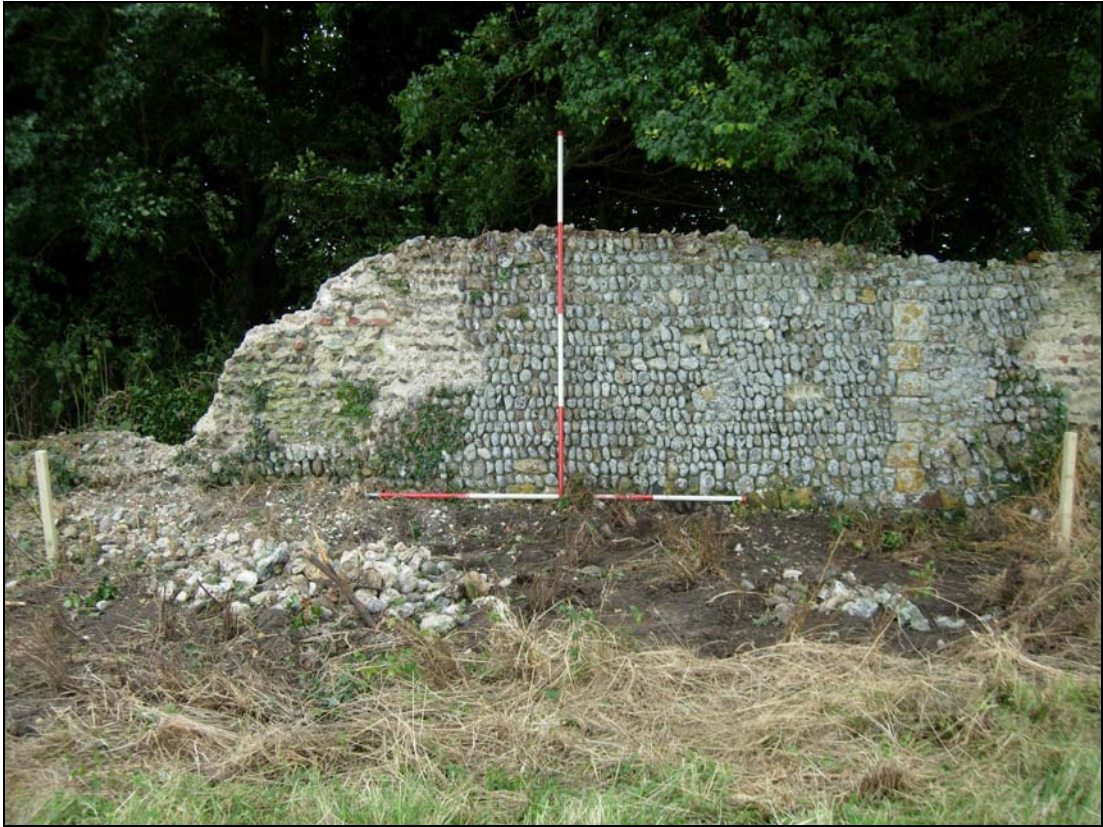
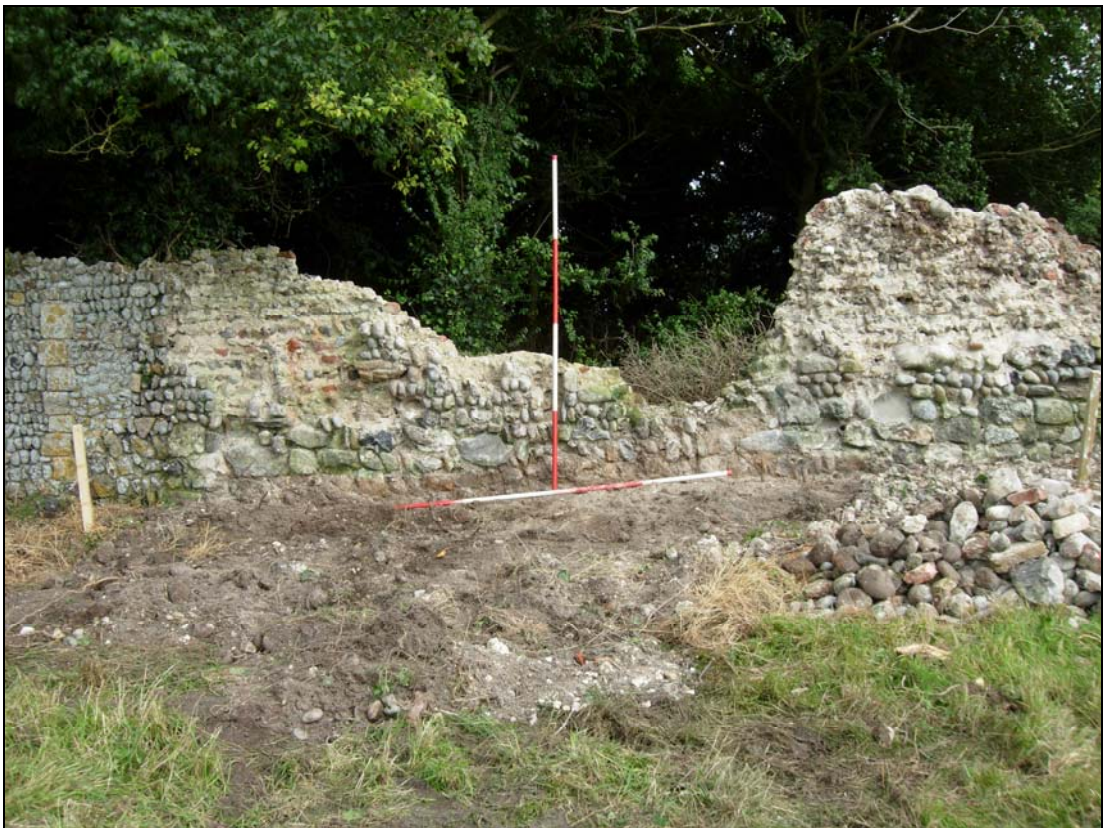
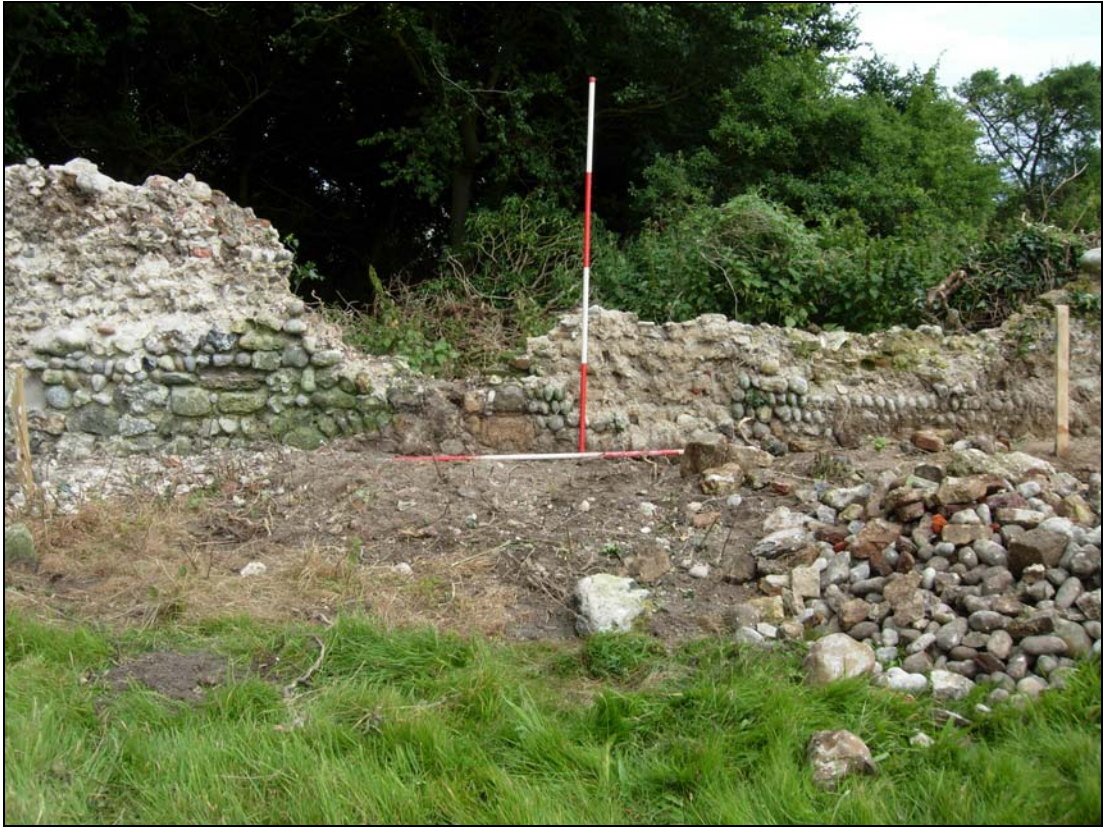
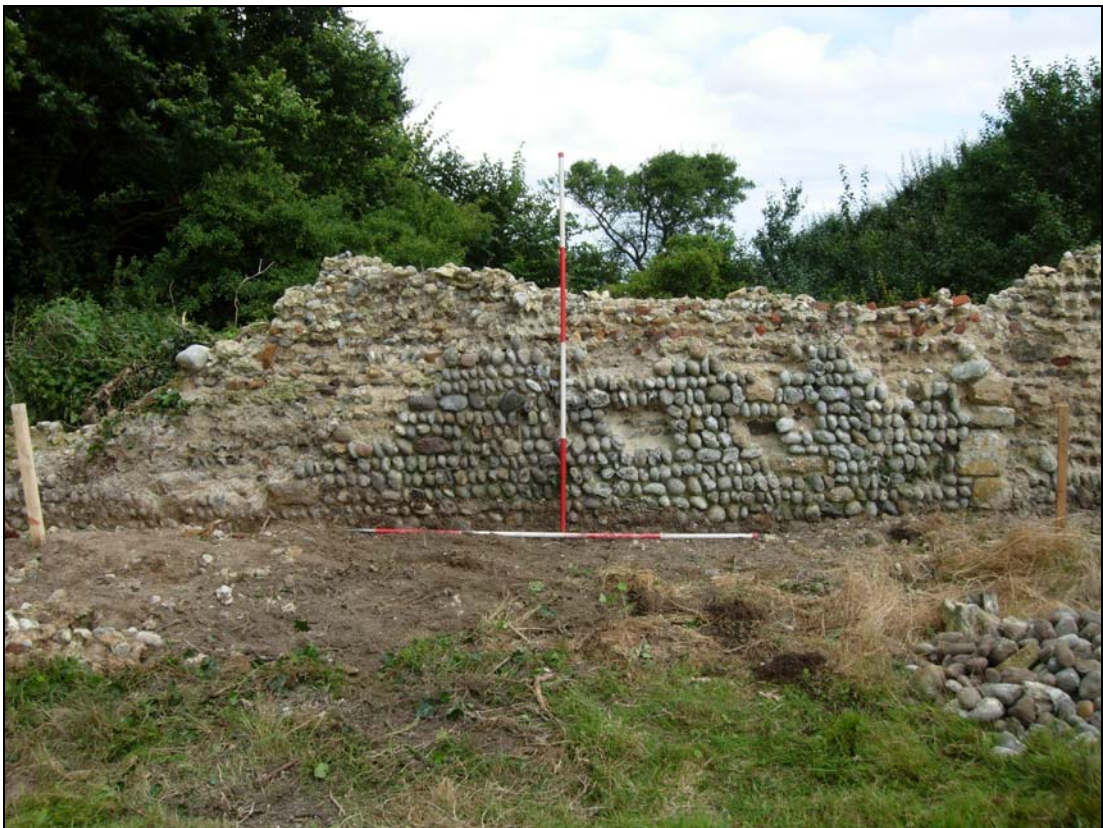
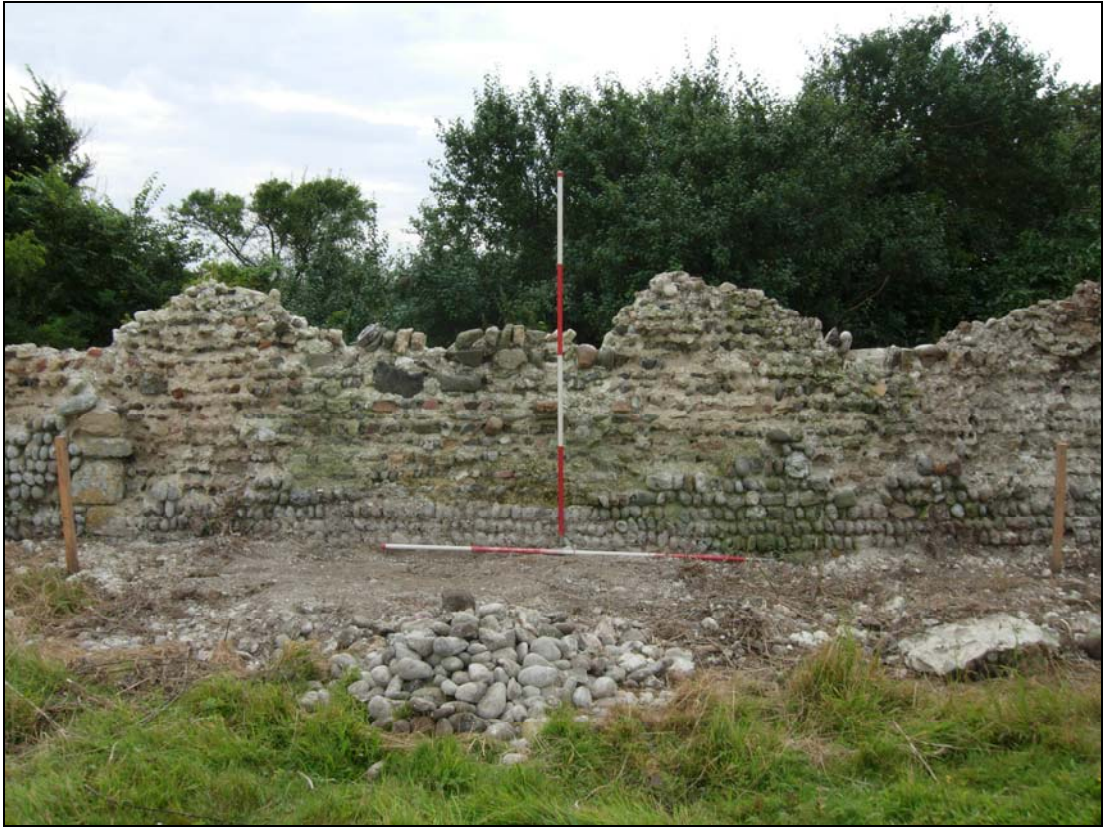
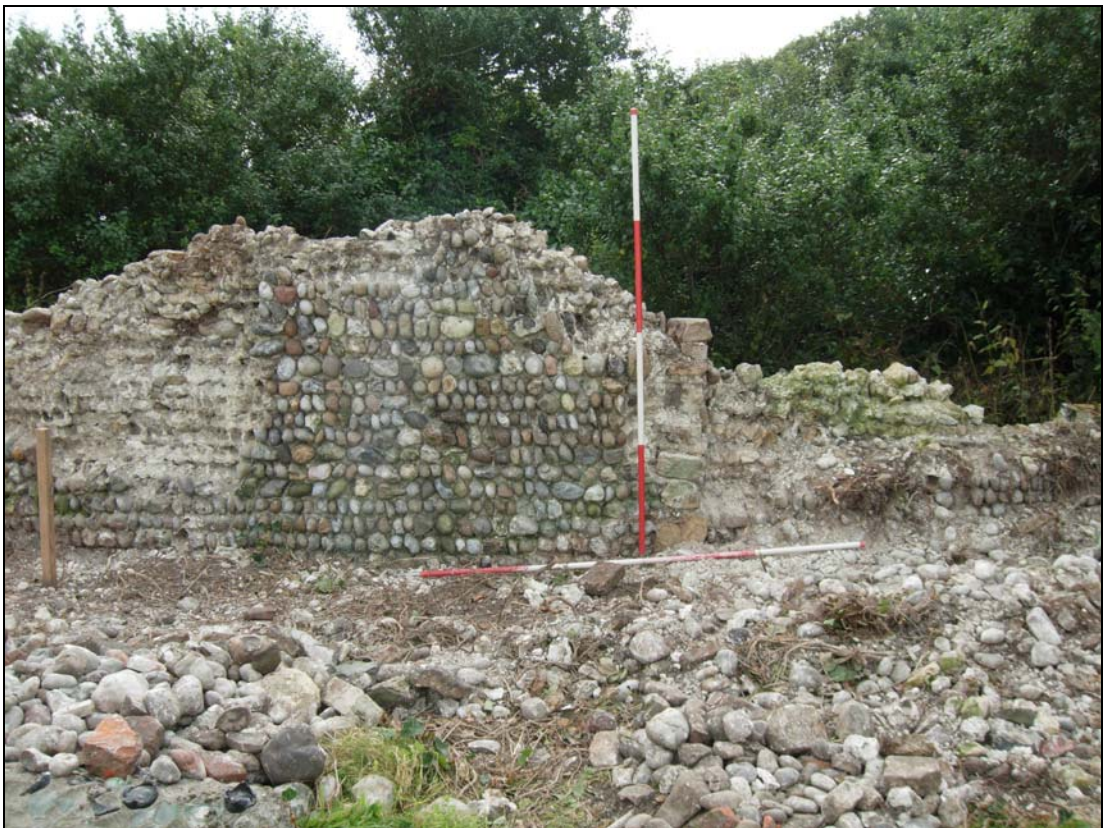
The remaining c.30m, 80m to approximately 110m, of the wall appeared to be of one phase (Plates 27 - 32) which was similar in character and construction to that recorded towards the north end (Plates 12 -14).

Although surviving to a maximum height of c.1.5m, some areas were considerably less than this. In addition, relatively large areas of internal and external facing were missing.

Vertical elements constructed from tooled limestone blocks were evident at intervals. In one instance, at c.100m where some of the internal blocks were missing, it was possible to see that the flanking courses on either side were independent of each other (Plates 30, 31 and 46)

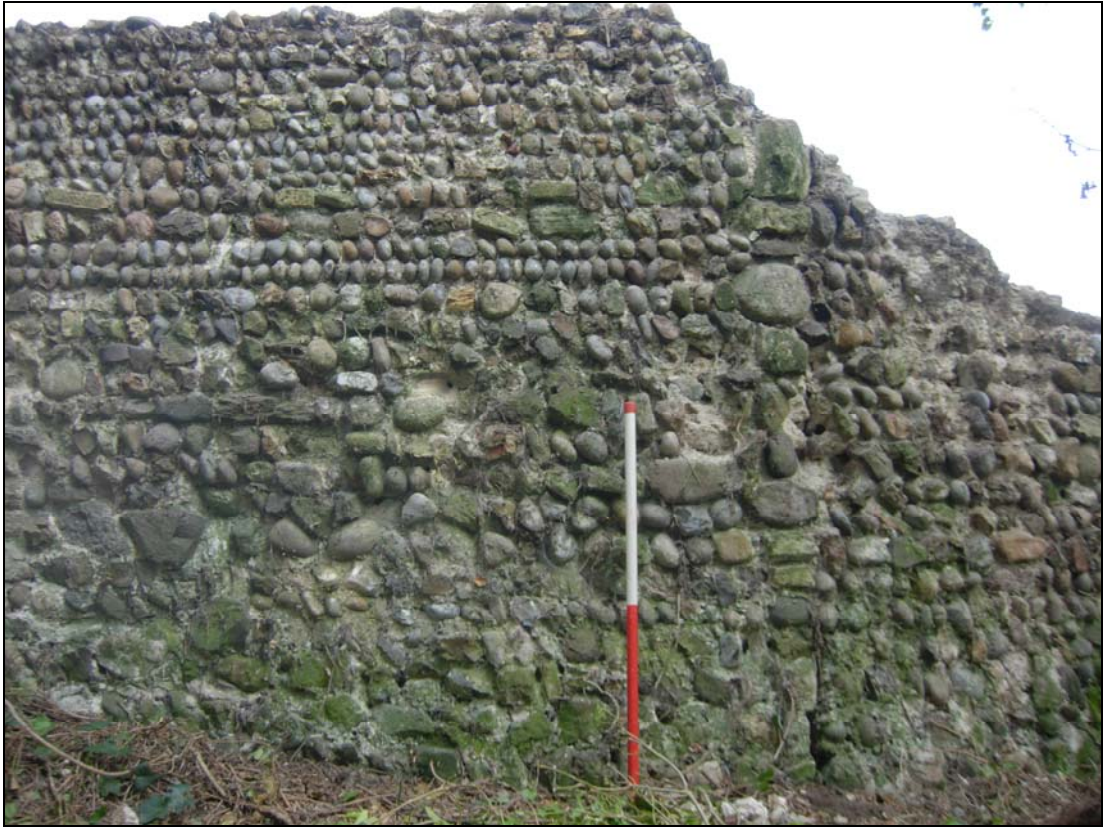
Plate 33. E. precinct wall: representative external wall facing 0 - 10m

Externally, the northernmost c.10m of the wall facing was less uniform than the interior, particularly towards its base. The facing, which still exhibited prominent coursing, although less so towards the base, comprised c.70% flint cobbles with smaller, more rounded pieces dominating at the top. Larger pieces, up to 0.25m, and more exotics occurred more frequently towards the base (Plate 33).

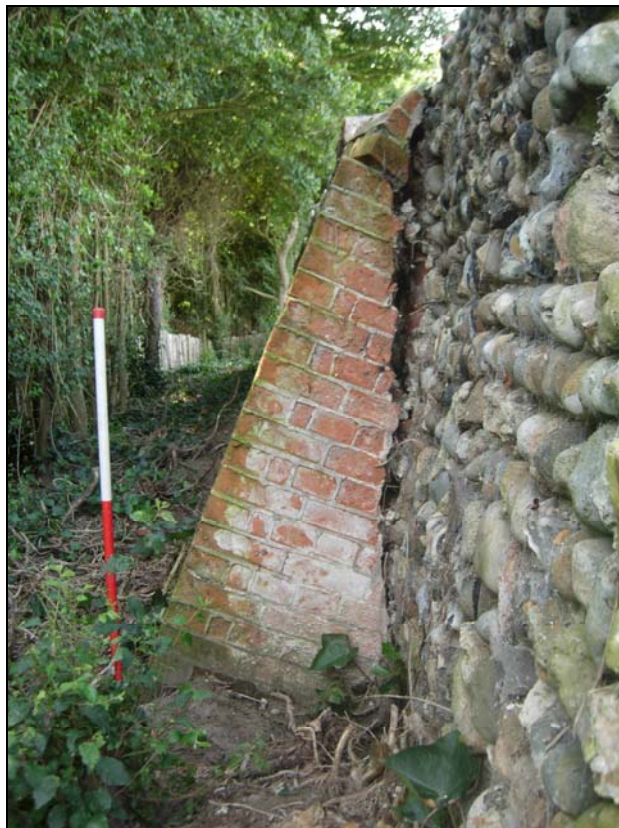
Plate 34. E. precinct wall: brick buttress from the N.

At c.10m, corresponding to the first brick vertical element, an external brick built buttress had been constructed up against the wall, from hard red, frogless bricks measuring $2\frac{3}{4} \times 4\frac{1}{2} \times 9$ inches, in order to arrest its outward lean (Plate 34).

Buttress Footing 1: replaces the northernmost of the two existing external brick buttresses (Plate 34) which was found to have been bedded on no more than a c.0.2m thick concrete pad. This was the only footing excavated both sides of and also underneath the wall and coincided with one of the included vertical structural elements. The smaller, internal, component measured 0.4m out from the wall by 0.8m along its face with the larger, external, component measuring 1.1m out from the wall by 0.9m along its face.
