Dunwich Greyfriars, Dunwich DUN 110

Archaeological Monitoring Report

SCCAS Report No. 2012/123

Dunwich Greyfriars, Dunwich

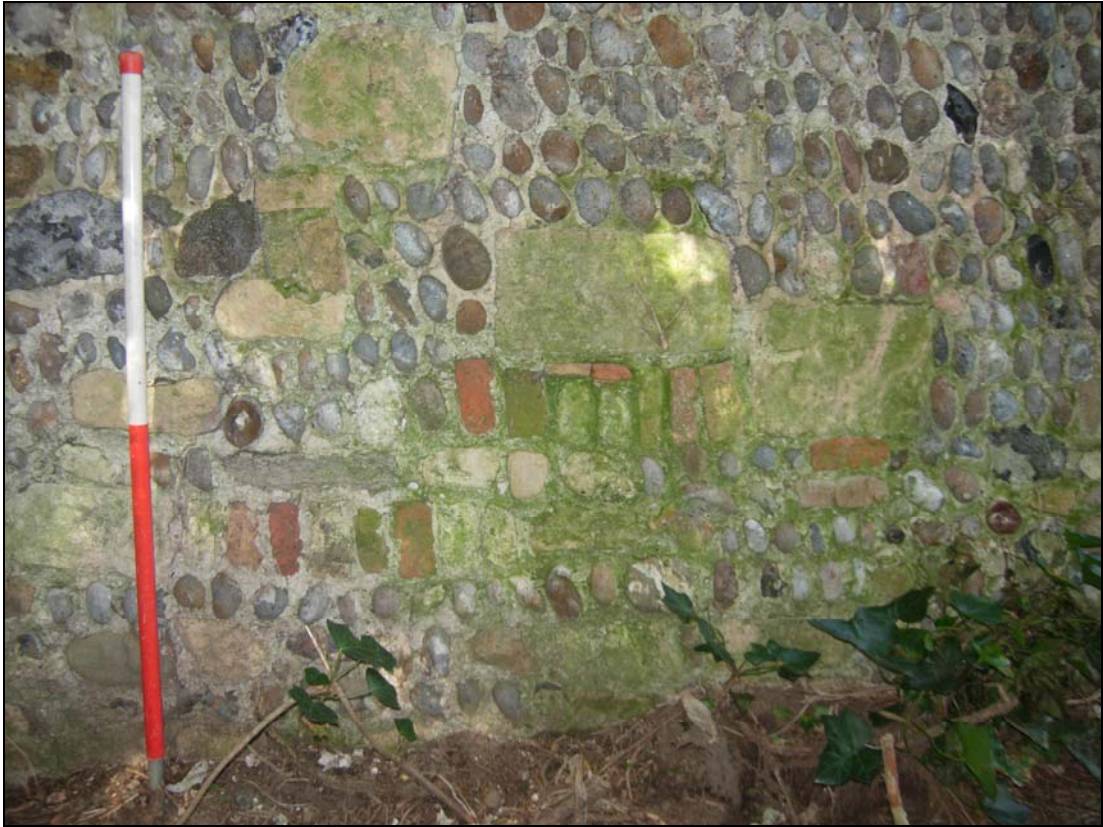
Plate 35. E. precinct wall: representative external wall facing 10 - 20m

Externally, from 10m to 20m, the wall facing was essentially similar to the internal work (Plate 35): the same vertical elements were present, although not as well defined towards the base. An interesting piece of graffiti was noted, carved into one of the re-used limestone blocks in the external wall face (Plate 36).

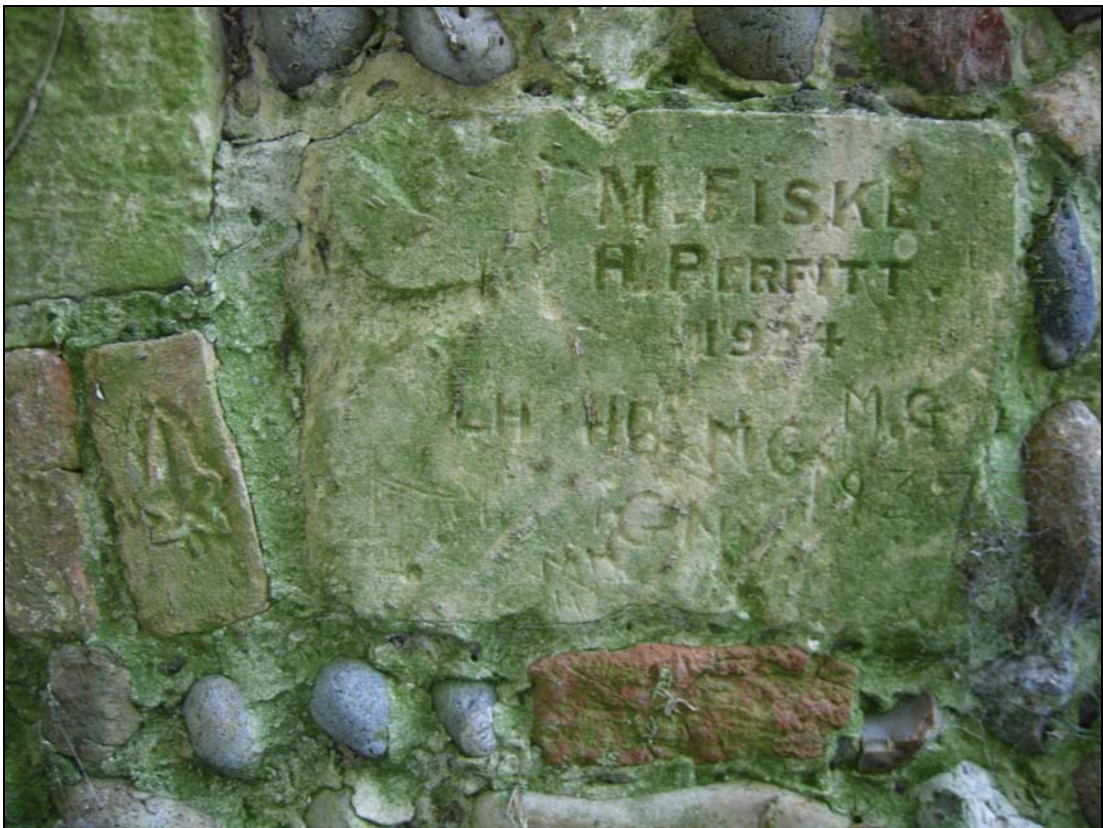
Plate 36. E. precinct wall: external face, graffiti.

In addition to some clearly more recent poorly executed initials on the same stone, including M. G. 1937, and a leaf cut into an adjacent brick, the names M. Fiske and H. Perfitt were accompanied by the date 1924. These names and date appeared to have been inscribed professionally with stonemason's tools rather than just scratched in.

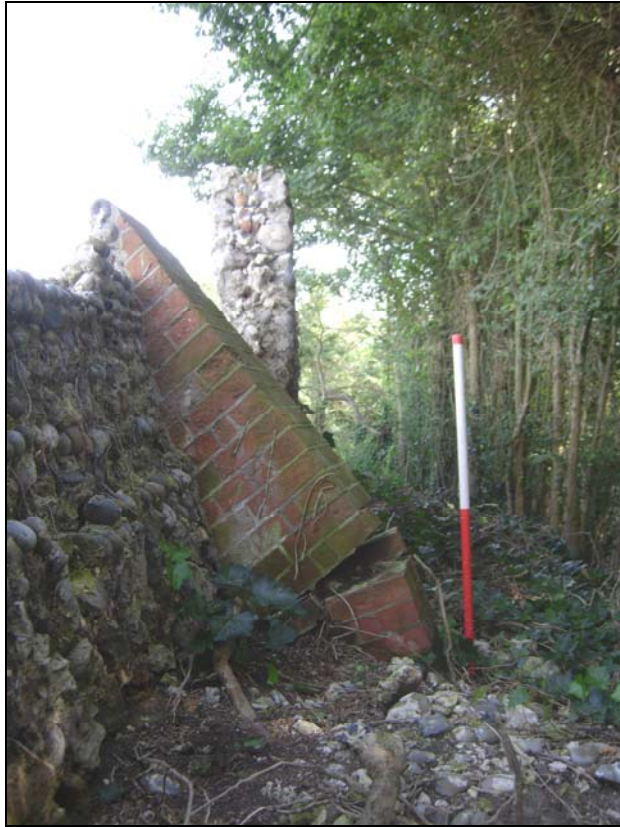
Plate 37. E. precinct wall: brick buttress from the S.

The junction between the changes in character of the wall fabric at approximately 20m was accompanied by a deviation in the line of the wall itself and marked by another abutting brick buttress externally (Plate 37). While this buttress would originally been constructed to stop outward rotation of the wall, the whole structure had since leaned in then opposite direction with the buttress breaking.

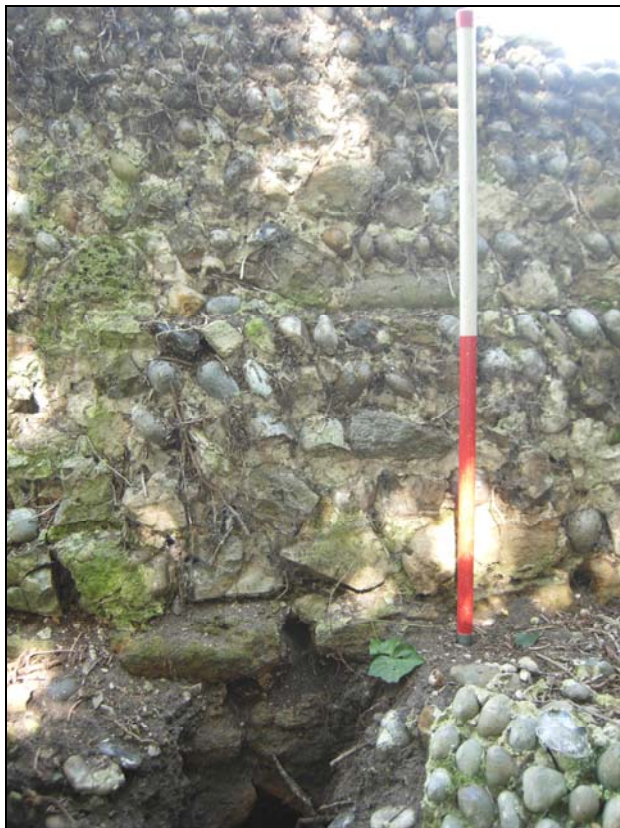
Plate 38. E. precinct wall: external face with limestone crag base

Externally, the difference in character of the wall between 20m – 25m to that of 25m – 32m was more marked. Immediately to the south of the broken buttress and continuing for c.5m to a point coinciding with the vertical brick element internally, the wall face steps back at a height of c.0.5m above the existing ground level (Plate 37). The facing itself comprises a mixture of coursed rounded beach cobbles with less formally lain material, predominantly angular pieces of septaria. Evidence from an adjacent rabbit hole suggests that below ground, the wall base consists entirely of crag limestone.

Given that crag limestone and septaria are the main components of an adjacent stretch of wall, it seems reasonable to assume that these materials either represent the consolidated vestiges of the continuation of this earlier wall, or at least the reuse of dismantled material from it.

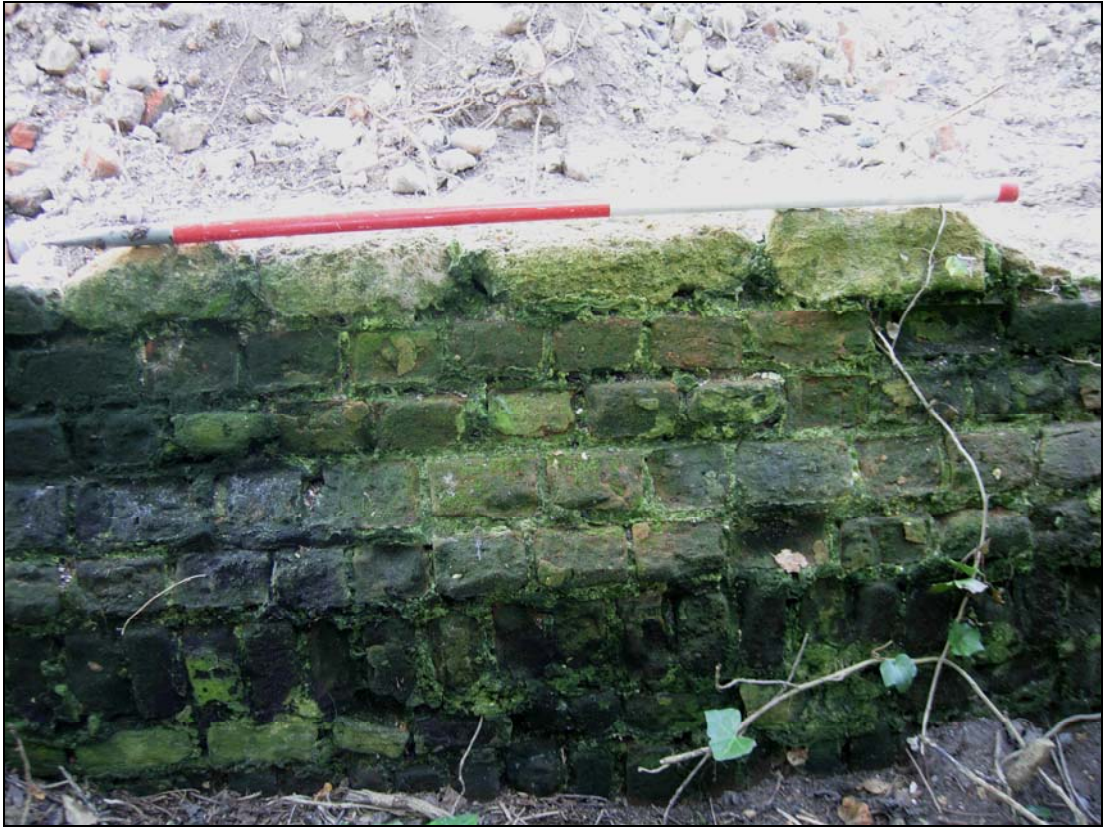
Plate 39. E. precinct wall: external brick face c.25 – 32m

From 25m to 32m the external wall face had been constructed predominantly in brick with some flint cobbles and crag limestone blocks, the latter also forming a capping course (Plate 39). The 2 ½ x 4 ½ x 8 ½ soft red, frogless bricks are worn and broken, possibly also reused from elsewhere. Some of the brick courses had been lain on their long edges with the header forming the face.

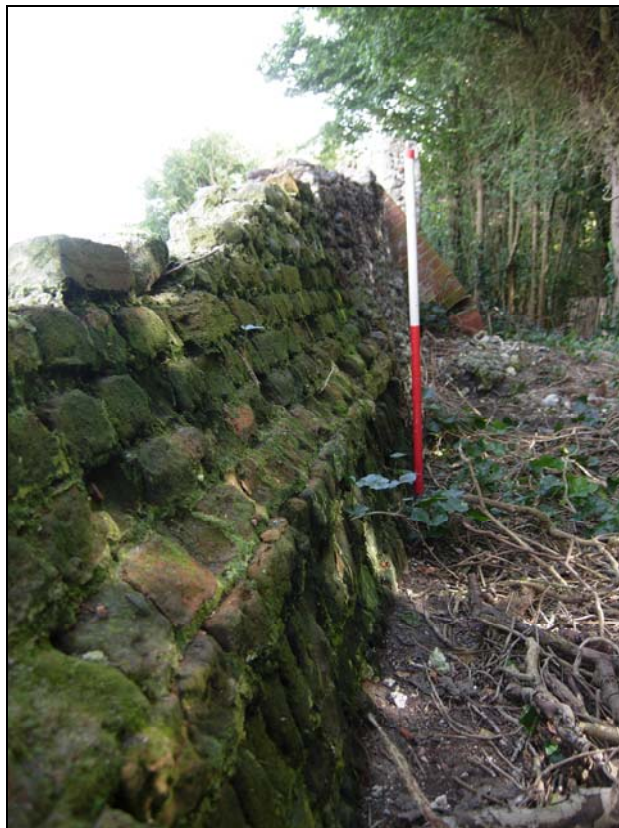
Plate 40. E. precinct wall: external brick face c.25 – 32m, taken from S.

Similarly to the adjoining fabric immediately to the north, the brick facing angled back at c.0.5m above existing ground level (Plate 40). The angled chamfer appears to have been gained by cutting the corners of the bricks in two of the lower courses (Plates 39 and 40).

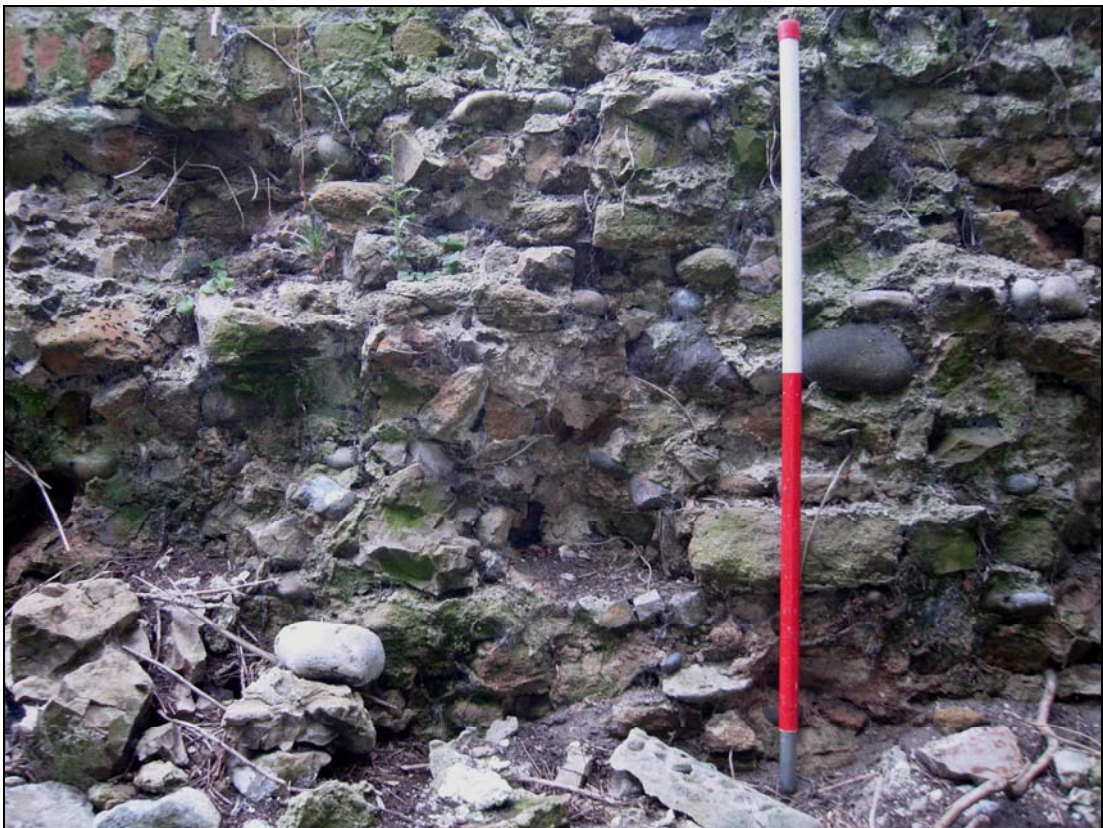
Plate 44. E. precinct wall: external, example of original medieval corework

The exposed corework exhibited coursing with a similar mix of clast material as that used in the facing, although pieces of brick were more common. The lime mortar matrix was hard and cream/white in colour.

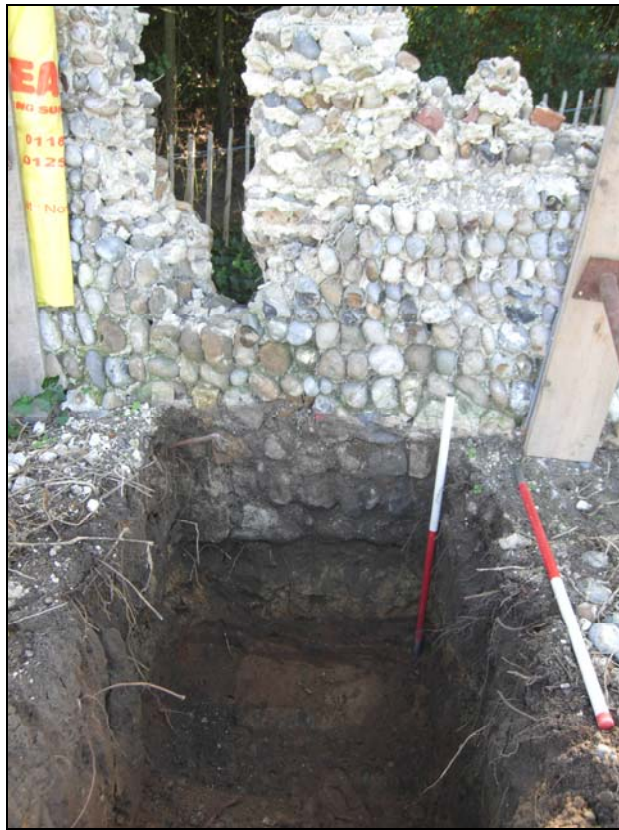
Plate 51. E. precinct wall: buttress footing 2

Buttress Footing 2: located approximately 21m from the northern end of the wall, the second footing was internal to and directly opposite the second external brick buttress and immediately to the south of the slight dog-leg.

Footing 2 measured 0.9m along the base of the wall and 1.2m out into the precinct. At this juncture 0.5m of bonded wall occurred below the extant ground level, comprising four courses of mixed material, with the individual pieces larger than those used in the above ground wall face (Fig. 5 S4 and Plate 51).

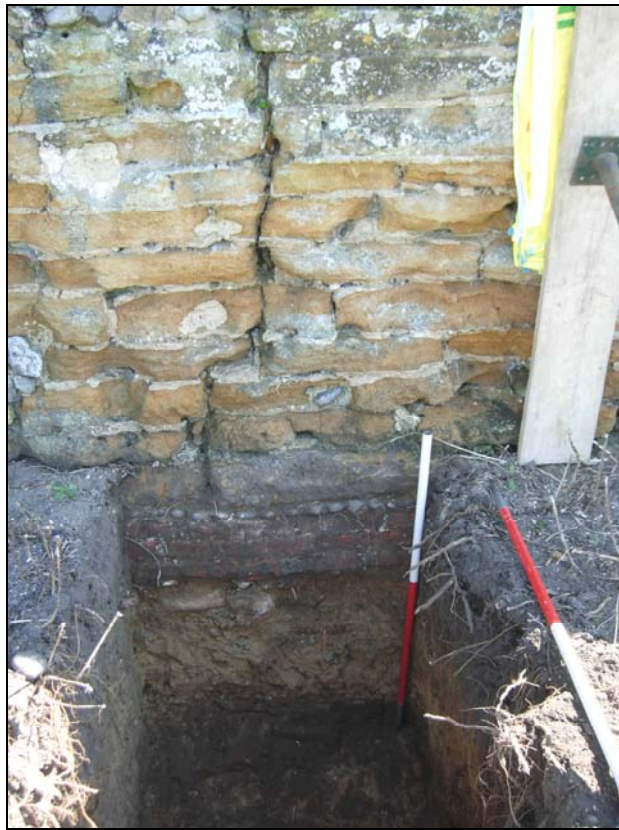
Plate 53. E. precinct wall: buttress footing 4

Buttress Footing 4: located at a point c.37m from the northern end of the wall, Footing 4 was the first of those excavated against the crag limestone phase of the structure (0011).

Interestingly, however, the below ground component of the wall was found to be represented by three courses of hard red brick (0012) with a single capping course of flint pebbles, all set in a hard white lime mortar matrix, the latter different to that bonding the crag limestone blocks above (Fig. 6 S6 and Plate 53). This clearly represented an episode of underpinning which had been recognised previously in a small test excavation (Boulter 1999, 22).

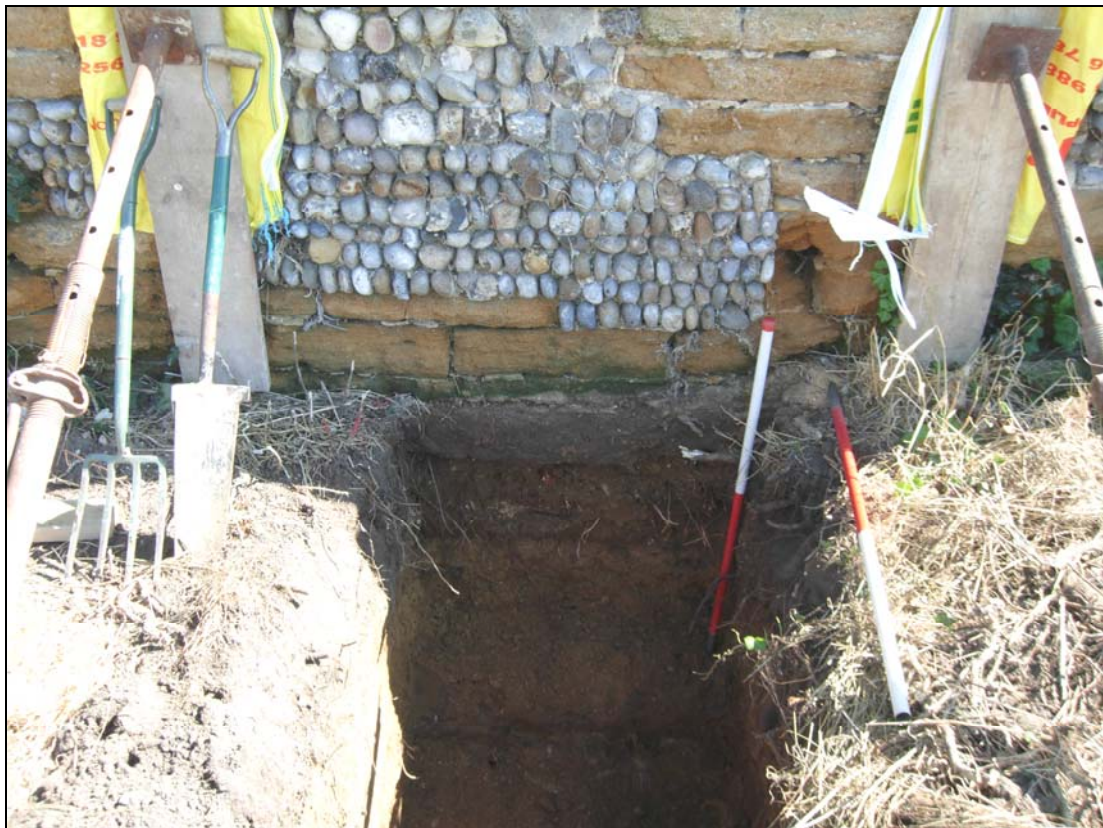
Plate 54. E. precinct wall: buttress footing 5

The crag wall (0011) continued down for only 0.2m below the existing ground surface with the crag blocks towards the base tending to be generally at the larger end of the range of those used in the overall wall (Fig. 6 S7 and Plate 54). The wall base was underlain by 0.8m of a stratified deposit which laterally almost certainly equates to the sandy layer (0009) recorded in Footings 2 - 4. The uppermost component of the stratified deposit comprised buff coloured clay with some mortar and chalk flecks. While having an edge effectively parallel with the wall, it did not have the character of a formal footing. The lower components of the stratified deposit became increasingly sandier with depth. At its base was the now familiar c.0.12 – 0.15m thick brown silty sand layer (0010) overlying the naturally occurring clay subsoil.

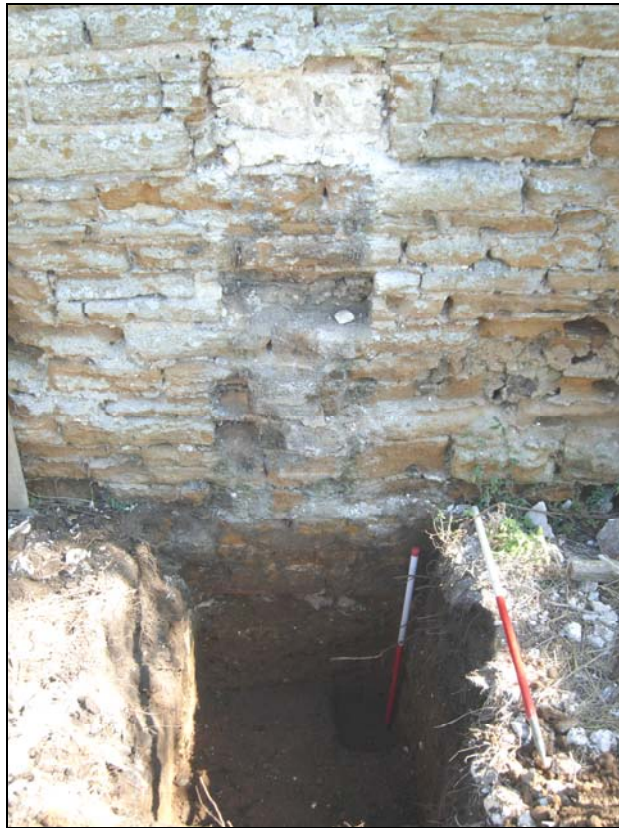
Plate 55. E. precinct wall: buttress footing 6

At this juncture the crag walling (0011) continued down for c.0.45m below the existing ground surface (Fig. 7 S8 and Plate 55). The topsoil was c.0.36m, again overlying a thickish, 0.6m deposit of brown sandy silty clay (0009) with occasional chalk fleck and stones. Here the layer included mortar lumps close to the base of the wall. While the stratification was not as marked as in Footing 5, the deposit was definitely sandier towards its base.

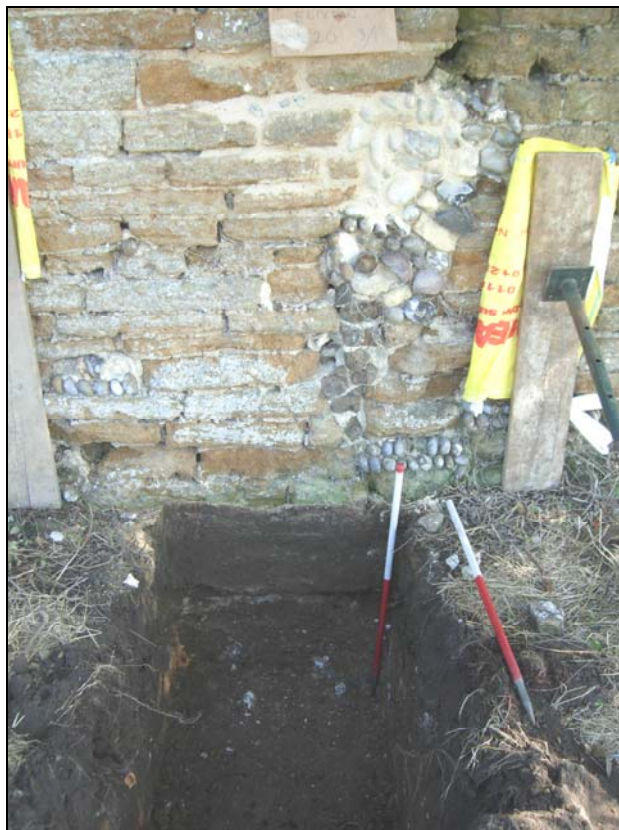
Plate 56. E. precinct wall: buttress footing 7

Here, the crag wall base was encountered at 0.4m below the present ground surface (Fig. 7 S9 and Plate 56). The stratigraphic sequence comprised 0.4m of topsoil over a stiff brown clay layer (0009), with frequent chalk inclusions and occasional flints. This layer continued down beyond the base of the trench at a depth of 0.98m.

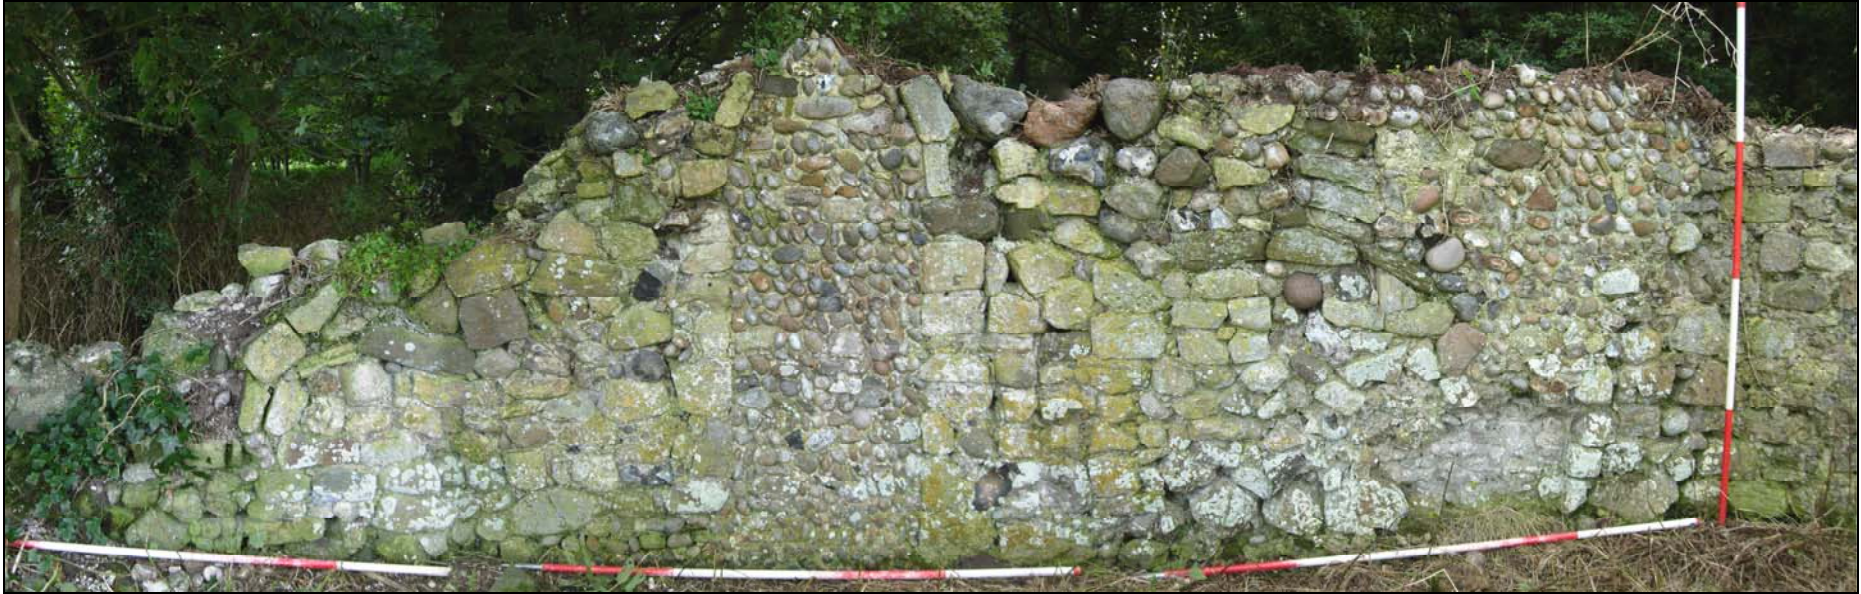
Plate 57. Precinct wall, SE corner: blocked doorway (internal)

The doorway itself had been roughly constructed from re-used tooled limestone dressings, presumably originally from the monastic buildings, set in a hard white lime mortar. Stylistically the door exhibited a simple two centred arch, the apex for which was missing both internally and externally.

Examination of the flanking wall fabric suggested that it was contemporary with the doorway. Internally, the wall face comprised predominantly (c.90%) randomly lain re-used limestone with occasional flint pebbles/cobbles and exotic pieces (Plate 57).

The south wall of the precinct included a blocked doorway towards its south-east corner (Plates 57 and 58). As consolidation works at this juncture would involve some dismantling of the structure, a photographic record, both internal and external, was made prior to this work being undertaken.

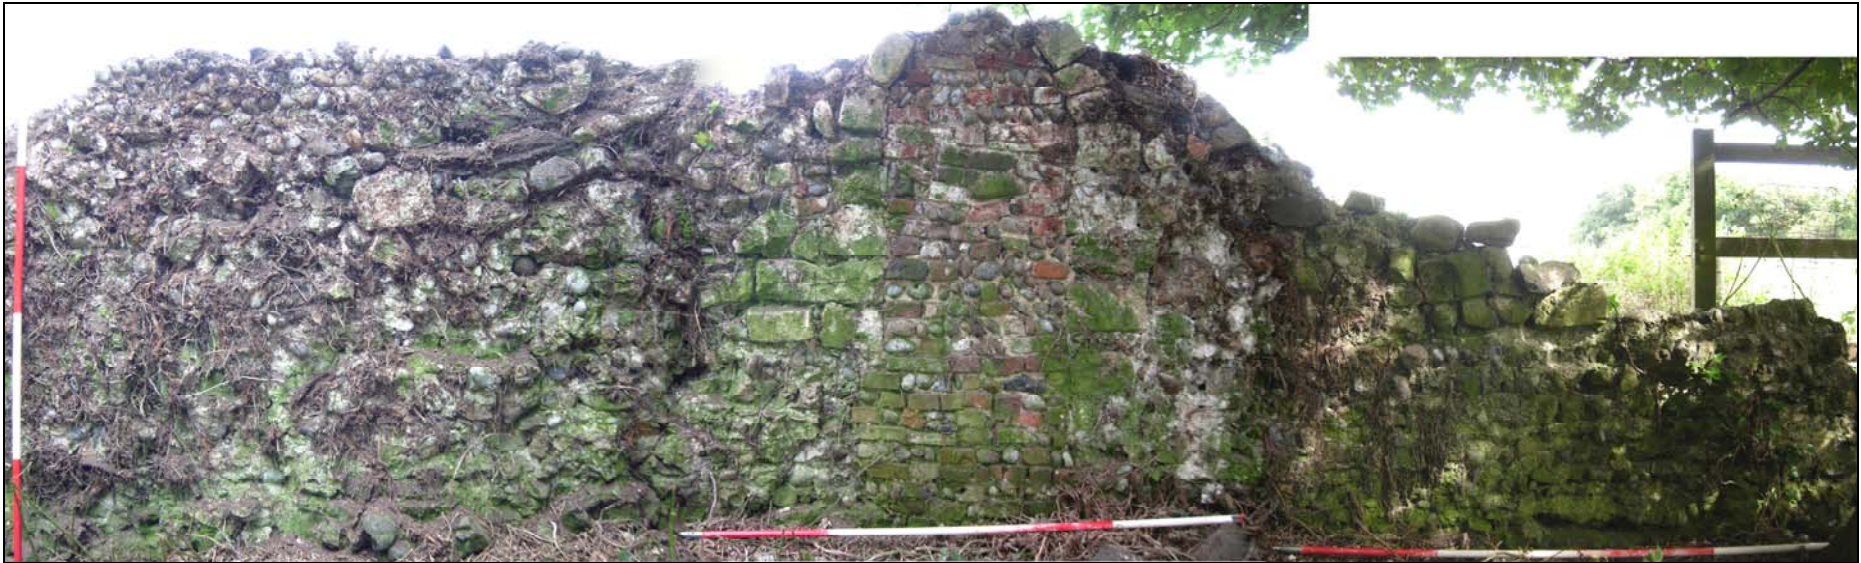
Plate 58. Precinct wall, SE corner: blocked doorway (external)

Externally, the wall facing was even rougher with frequent inclusions of septaria, particularly towards the base, along with re-used limestone, flint pebbles/cobbles and more exotic pieces (Plate 58).

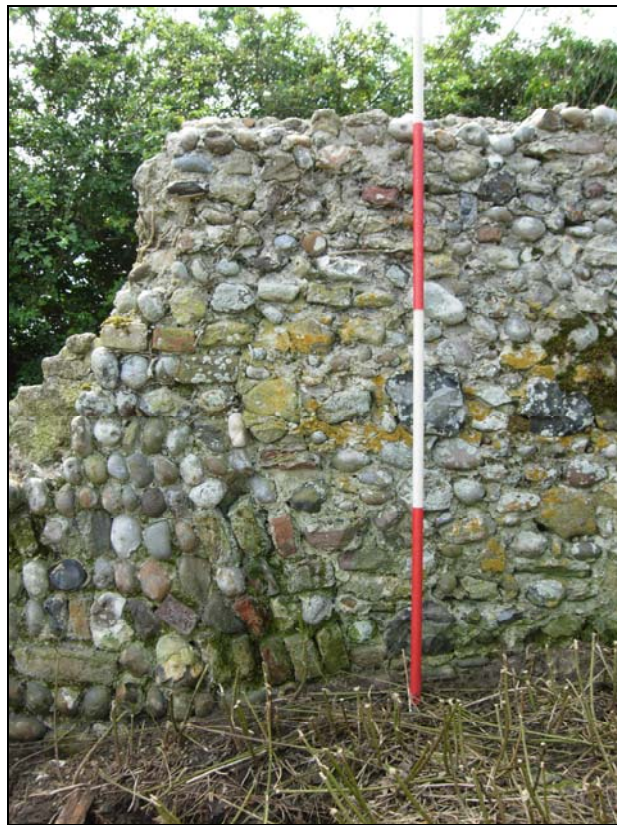
Plate 60. S. precinct wall: W. end, fabric joint, internal

Internally, the junction was marked by an irregular joint with closely spaced bricks at its base, although the facing predominantly consisted of coursed rounded cobbles, with some exotic material, set in a hardish light cream coloured lime mortar (Plate 60). At this juncture, the facing was considered to be a later repair to the original fabric. Where exposed, the coursed corework included frequent fragments of 2 ¼ inch thick hard red bricks. Also associated with this fabric was a vertical arrangement of red bricks which may represent the lateral extent of one of the repairs (Plate 61).

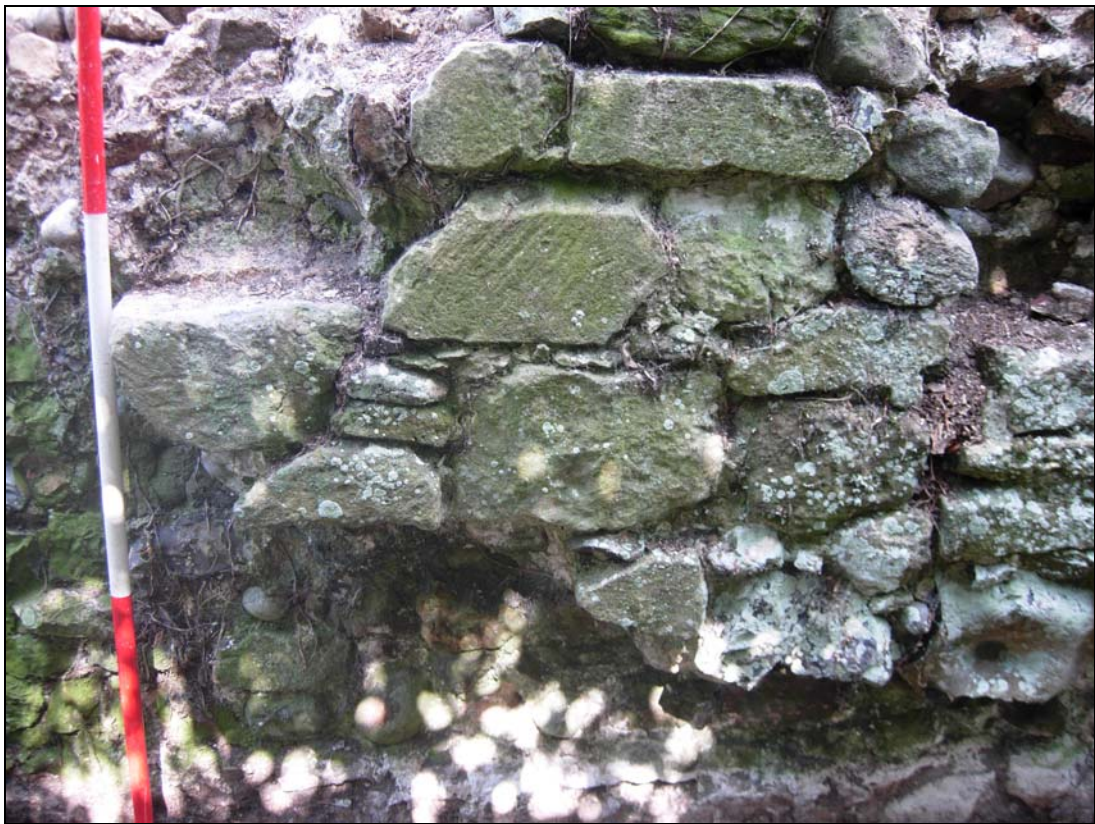
Plate 64. S. precinct wall: W. end, intact face, external

Externally, the situation was further complicated by the disintegration of the wall. The inward lean of the wall had not completely been followed by its associated facing which, for an area immediately east of the corner fabric, had become completely detached, but was still visible in a shallow excavated trench along the base of the wall (Plate 62). The loss of face accounts for the step back associated with the junction between the two wall phases (Plate 63). While the detached facing was considered to equate to the galetted facing described in Section 5.7 (Plates 78 and 79), the westernmost surviving area was somewhat different in character. At this juncture it consisted predominantly of closely spaced reused tooled limestone masonry blocks with only a hint of horizontal coursing (Plate 64).

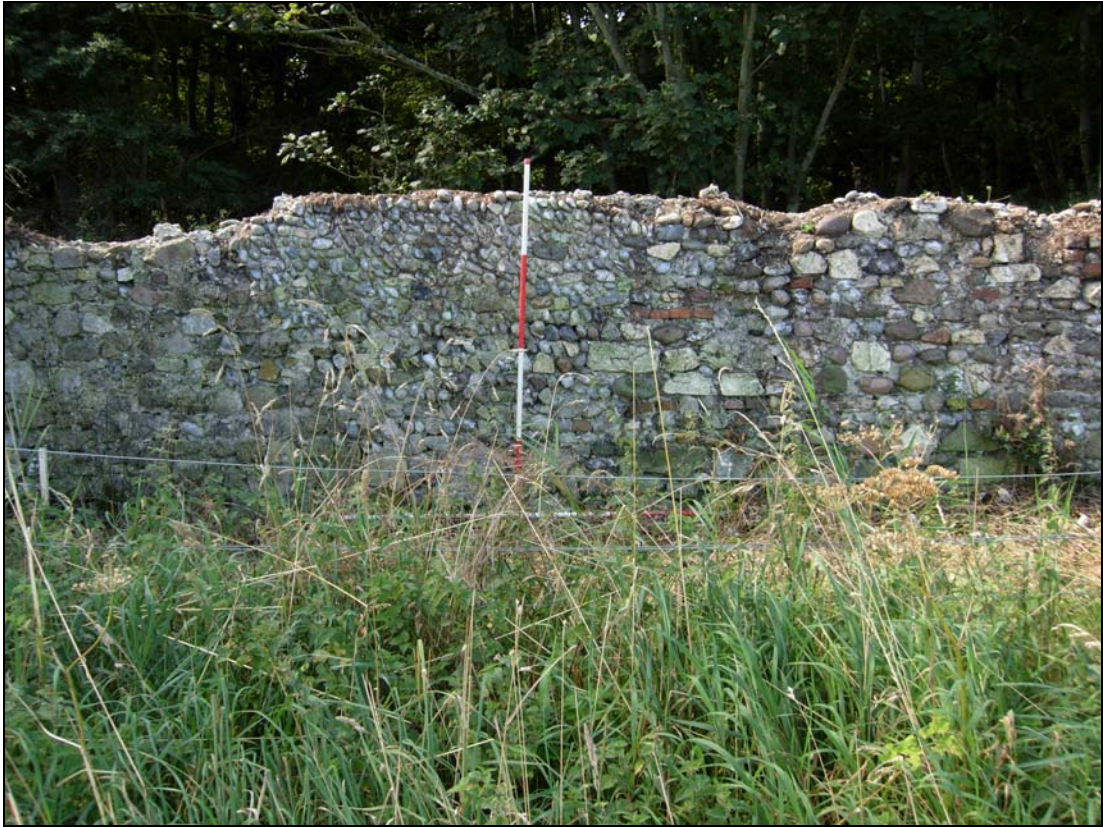
Plate 65. S. precinct wall: internal, E. end fabric with repair

The first phase includes the wall up to the dog-leg and from that point for a distance of approximately 23m. Internally at this juncture, the facing fabric does exhibit coursing, but the use of closely spaced, variable sized, clasts had tended to break up the formality of the courses (Plate 65).

The materials used comprised an eclectic mix of re-used tooled limestone blocks, septaria, bricks, flint cobbles and exotics, all set in a hard white light coloured mortar. Areas of internal repair were obvious as these tended to have been constructed with a facing comprising predominantly of more regularly sized and coursed rounded flint cobbles (Plate 65).

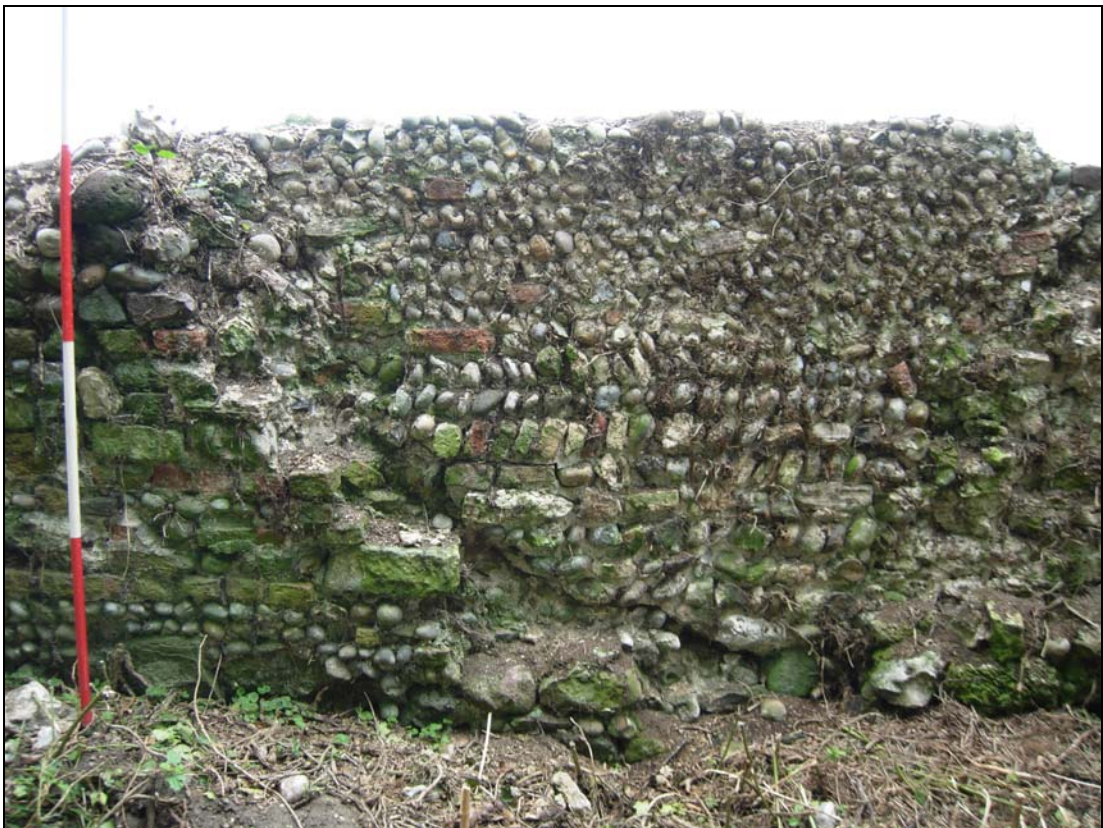
Plate 66. S. precinct wall: external, E. end repaired face

Externally, the facing was also relatively rough, poorly coursed and made up of a mix of materials. Repaired areas were again easily distinguishable, not just because of the contrast in character, but also due to the repaired face not being constructed flush with that of the earlier fabric (Plate 66).

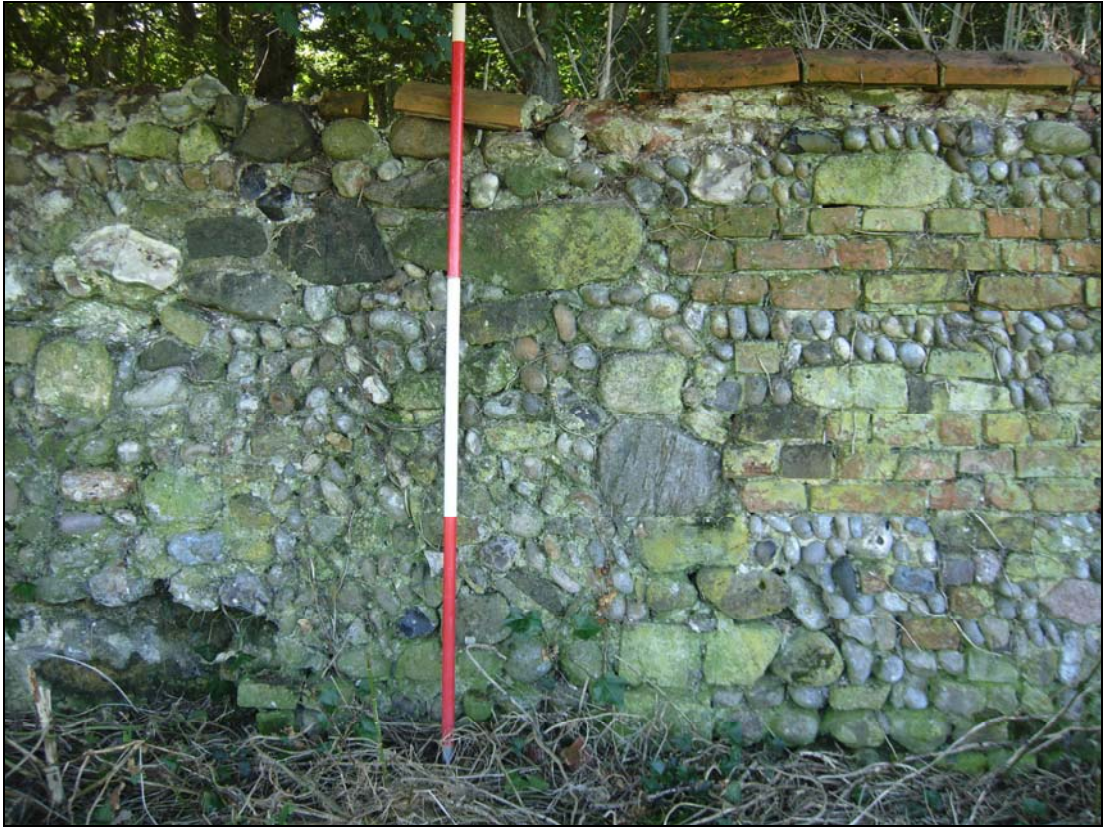
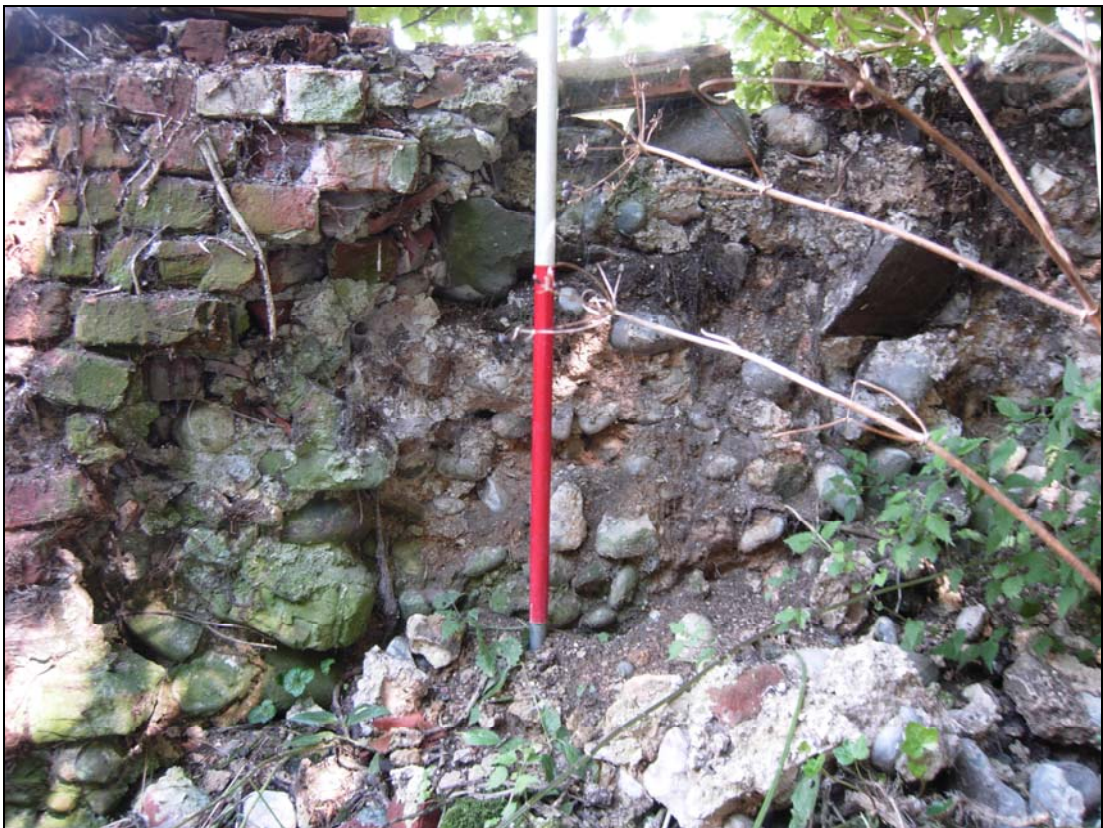
Plate 67. S. precinct wall: internal, junction between fabrics

Its junction with the fabric to the east was clear (Plates. 67 and 68), although the incorporated mortar matrix from both wall types was similar and it was difficult to discern a discrete interface. As a result, it remained unclear as to which fabric was the earlier, or even if, regardless of the obvious stylistic differences, that they were contemporary.

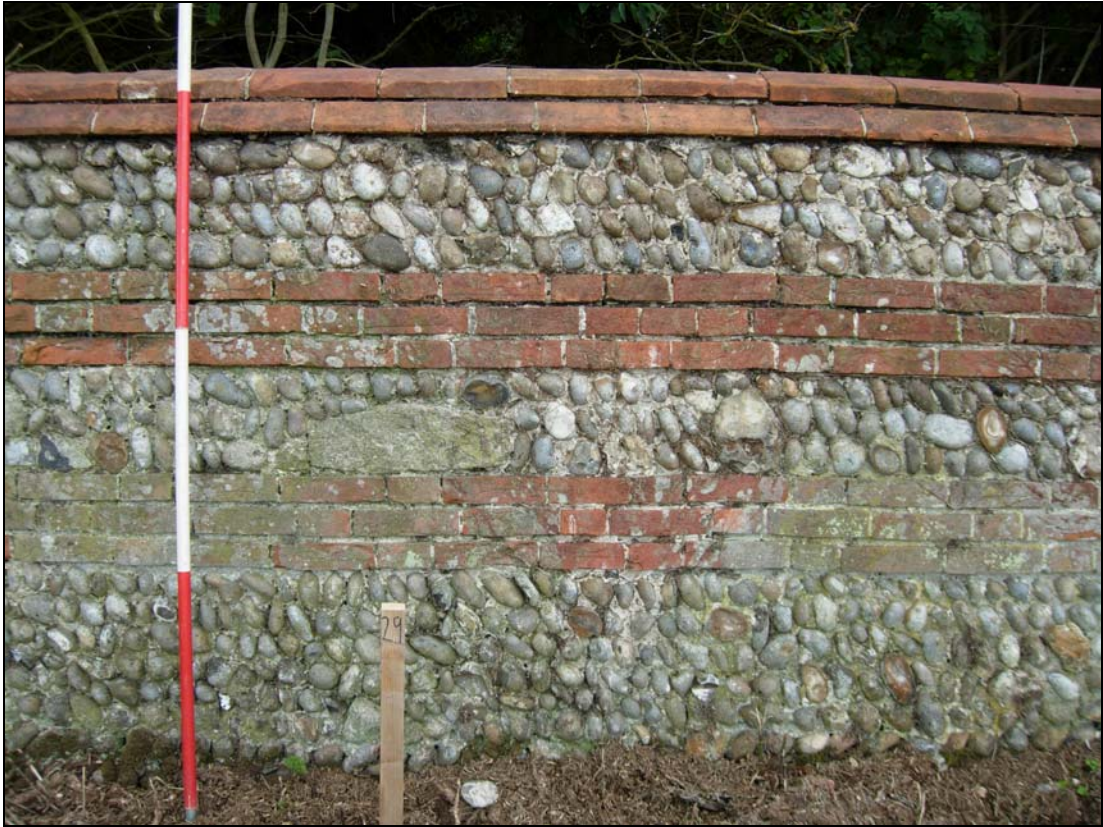
Plate 69. S. precinct wall: internal, example of intact face

Internally, the presented face was characterised by alternating bands of coursed material, predominantly flints (three bands), and red brick (two or three bands) with a coping of moulded ceramic tiles (Plate 69). While the flints used were commonly rounded and pebble to cobble-sized, there were occasional exceptions, along with larger pieces and exotics which crossed the boundaries of more than one of the regular courses. Where only two brick bands were present, the basal flint element generally comprised of six to seven courses visible above ground, with the second, middle band, three courses and the top band four courses (Plate 69). However, for a c.40m stretch towards the eastern end, coinciding with length of wall exhibiting three brick bands, the lowermost flint component also comprised three courses.

Each brick band consisted of three courses that were generally laid with two stretchers for every header, with the bricks themselves comprising hard frogless reds measuring $2\frac{1}{4} \times 4\frac{1}{2} \times 8\frac{3}{4}$ inches. The capping consisted of two courses of moulded red-coloured ceramic tiles forming a central ridge to shed water in both directions off the top of the wall.

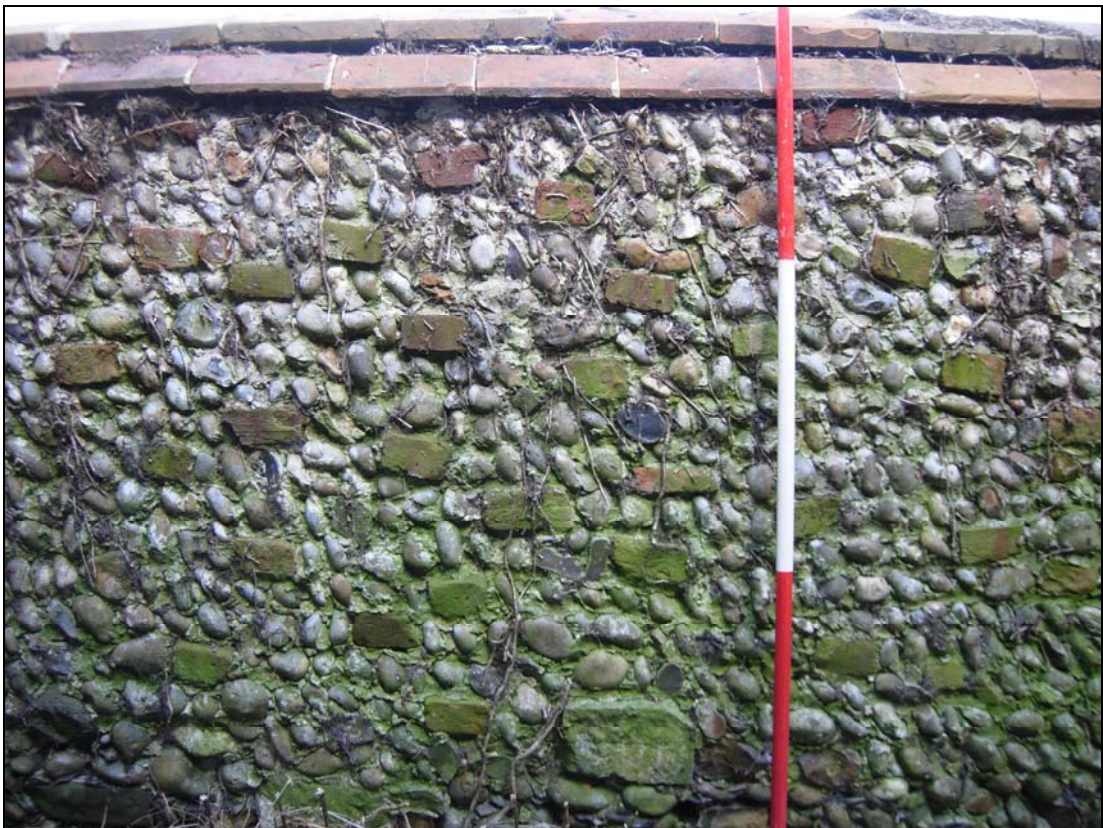
Plate 70. S. precinct wall: external, example of intact face

Externally, the face exhibited some lateral variation, but essentially comprised predominantly of relatively well coursed rounded flint pebbles/cobbles of c.10cm diameter with randomly spaced bricks, reused limestone blocks and exotics (Plates 70). Occasionally, the exotic material included exceptionally large pieces (Plate 71). Vertical brick elements in brick were present at c.6m intervals (Plate 72): these were not visible internally. White bricks were also concentrated locally.

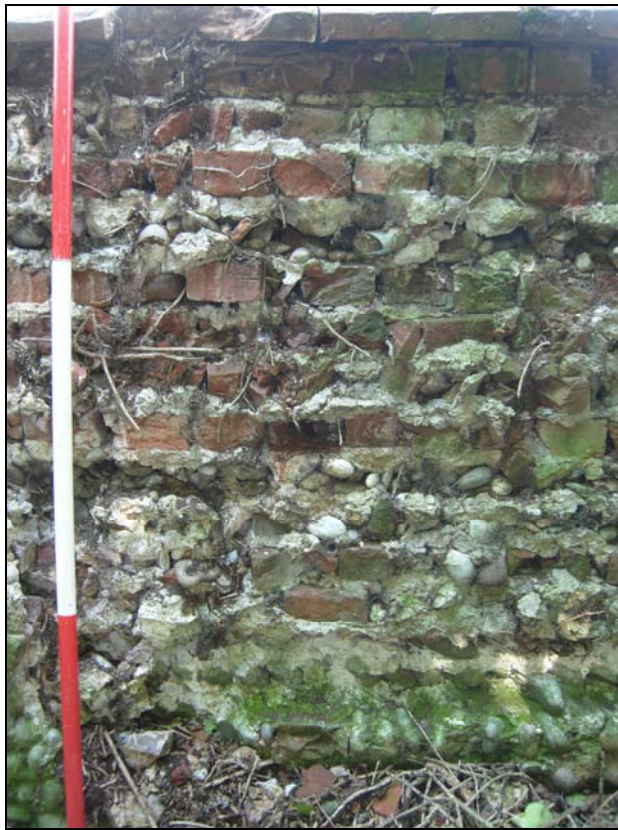
Plate 73. S. precinct wall: external, large exotic clast

Where facing was missing it was possible to see the structure of the corework which exhibited clear coursing and, at that juncture, was constructed predominantly in brick with some flint pebbles, all set in a hard white lime mortar matrix (Plate 73).

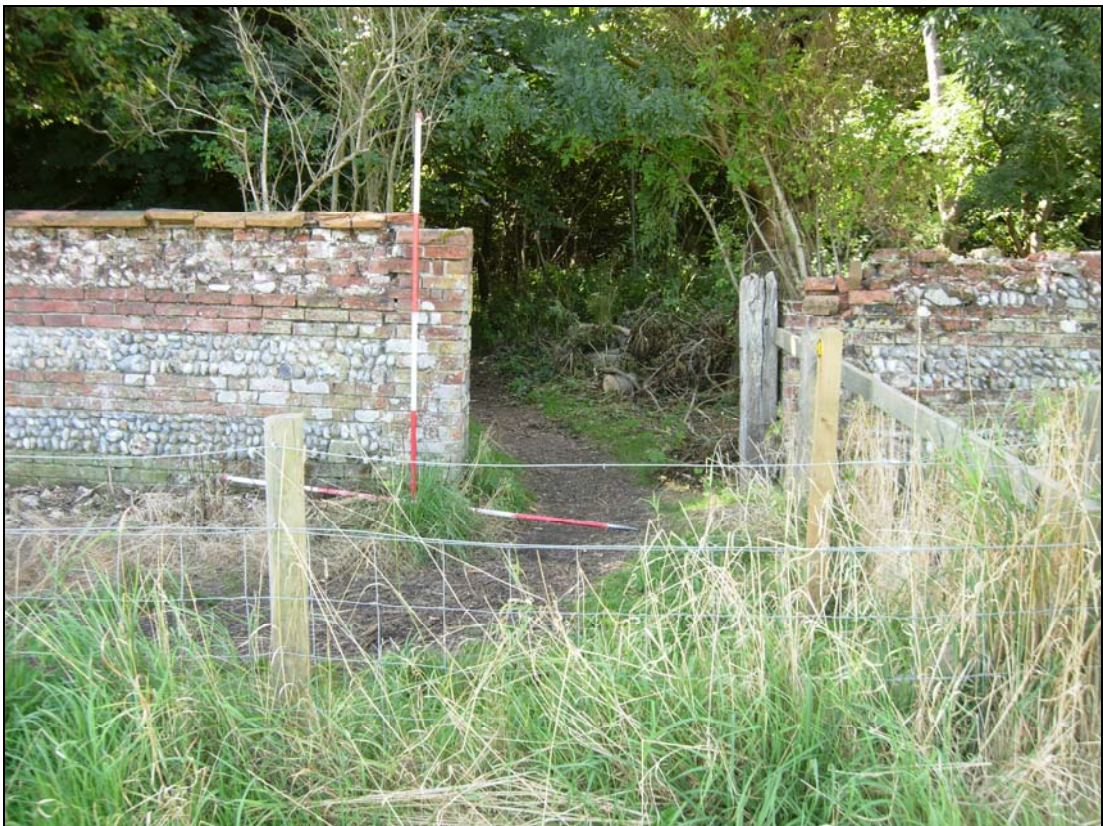
Plate 74. S. precinct wall: internal, extant opening

Within this phase of walling there were two architectural features: an extant opening at c.67m (Plate 74) and a narrower blocked opening at c.35m (Plate 75), both measured from the dog-leg. The latter was marked by a vertical brick element on its eastern side that was not tied in with the adjacent wall and, therefore, part of the later blocking fabric. However, the remainder of the blocking fabric was not as formally constructed, although some attempt had been made to insert bricks on the line of the middle brick band. If this represented a genuine opening/gateway it was relatively narrow and did not have the contemporary brick jambs of the wider opening to the west.

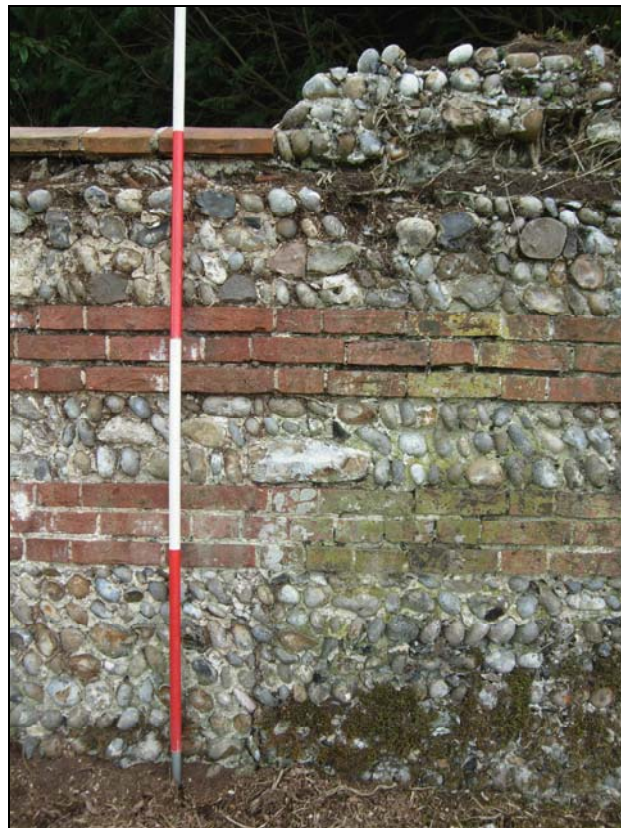
Plate 76. S. precinct wall: internal, wall fabric junction

Close examination of the juncture between the two phases of wall indicated that in the internal face, coinciding with the additional height in the wall, there was also a vertical break in fabric between the ground level and the bottom of the two brick bands (Plate 76). The fabric to the west was similarly coursed with predominantly rounded flint pebbles, but was also characterised by galetting with angular flint flakes.
