Dunwich Greyfriars, Dunwich DUN 110

Archaeological Monitoring Report

SCCAS Report No. 2012/123

Dunwich Greyfriars, Dunwich

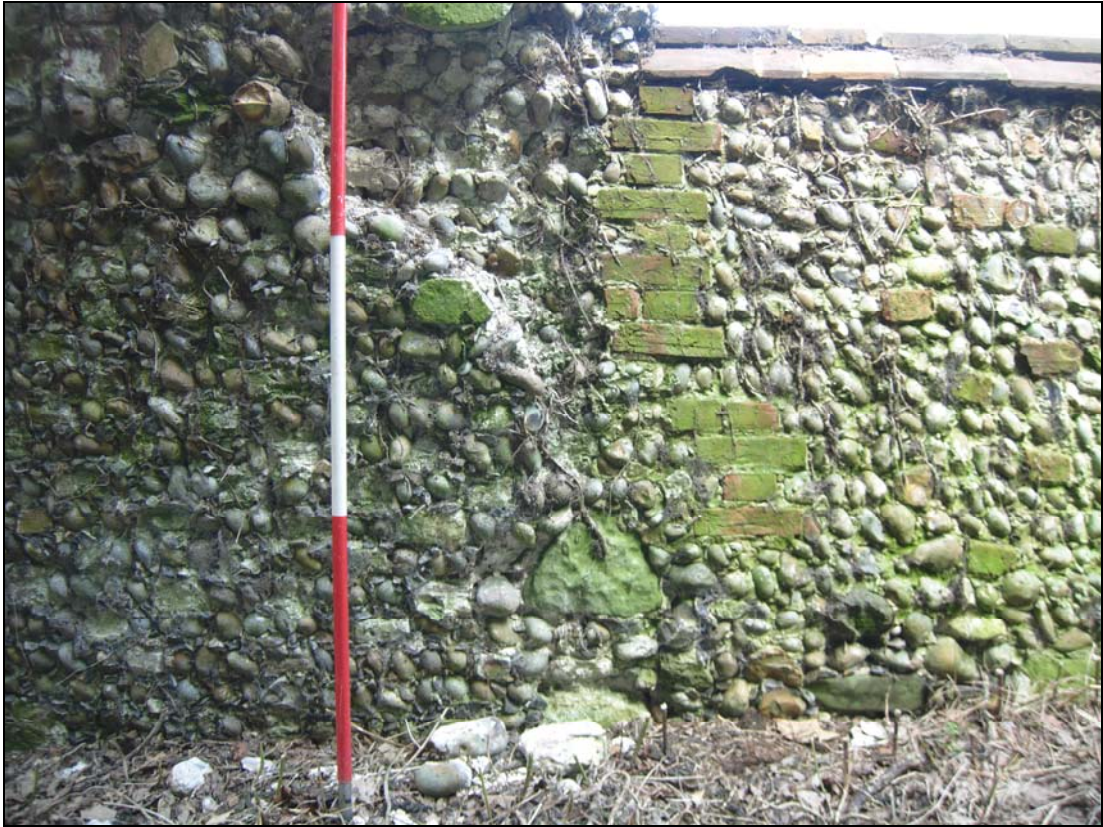
Plate 77. S. precinct wall: external, wall fabric junction

Externally, the point where the wall became higher was marked by a total vertical change in fabric (Plate 77). This suggested that internally, the brick banding and two uppermost bands of coursed facing, from the point where the wall becomes higher to their end c.25m to the west, have effectively been applied to an existing wall, possibly as a repair required due to deterioration of its face. Beyond the c.25m composite wall, the internal facing became consistent with that of the higher external component and can be considered to be part of the same phase.

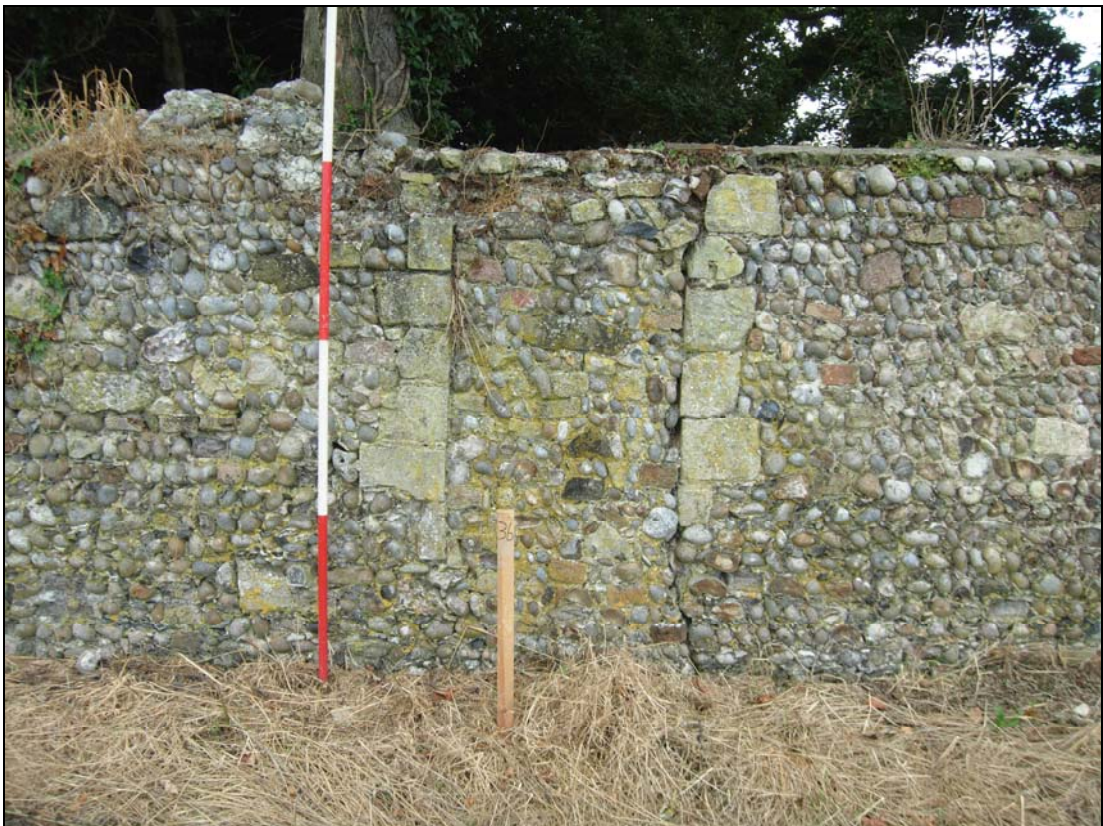
Plate 80. S. precinct wall: internal, blocked opening

One blocked opening was recognised in this fabric (Plates 80 and 81). Initially this was considered to be doorway, but on closer examination, it was clear that the jambs, constructed from reused tooled limestone blocks, did not continue down to ground level and that the lowermost c.0.4m of fabric was continuous with the flanking walls. It is suggested that this opening was actually a stile rather than a gateway or doorway and would once, prior to its redundancy and blocking, have included a wooden superstructure. The blocking fabric facing, both internally and externally, comprised a roughly coursed mix of flint pebbles/cobbles, bricks, limestone blocks and exotics. Interesting, immediately to the east of the east jamb in the external face of the wall, reused medieval gargoyle or waterspout had been set into the wall at a height of c.1.3m above the existing ground surface (Plates 81 and 82).
