**Alderwood PRU Centre, Ipswich
IPS 699**

Archaeological Monitoring Report

SCCAS Report No. 2012/155

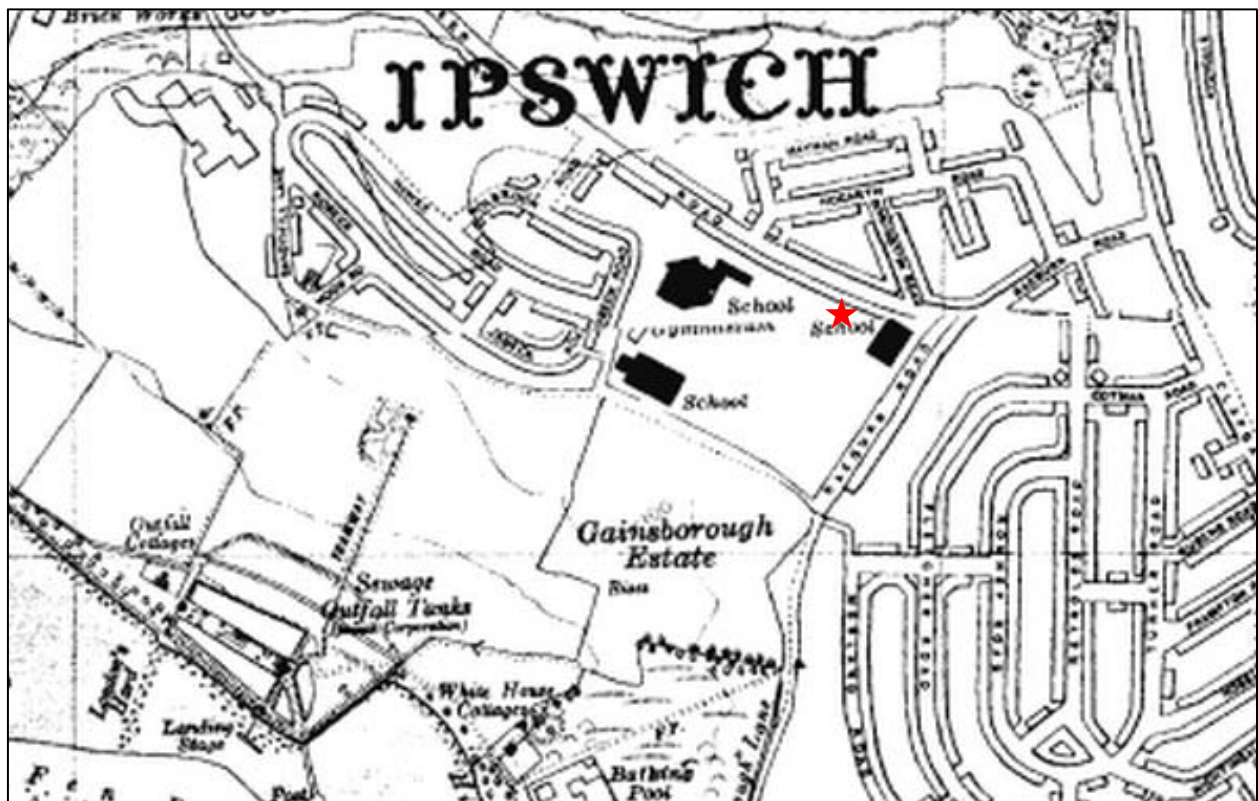
Figure 3. Ordnance Survey 1:10560 scale sheet of 1938 (rescaled extract)

The red star indicates the approximate location of the site

The Alderwood PRU Centre, the adjacent Piper's Vale Primary School and the area of housing off Sandy Hill Lane are all relatively recent developments which have been built on the site of three earlier schools and a large playing field, as depicted on the Ordnance Survey, 1:10560 scale map of 1938 (figure 3).

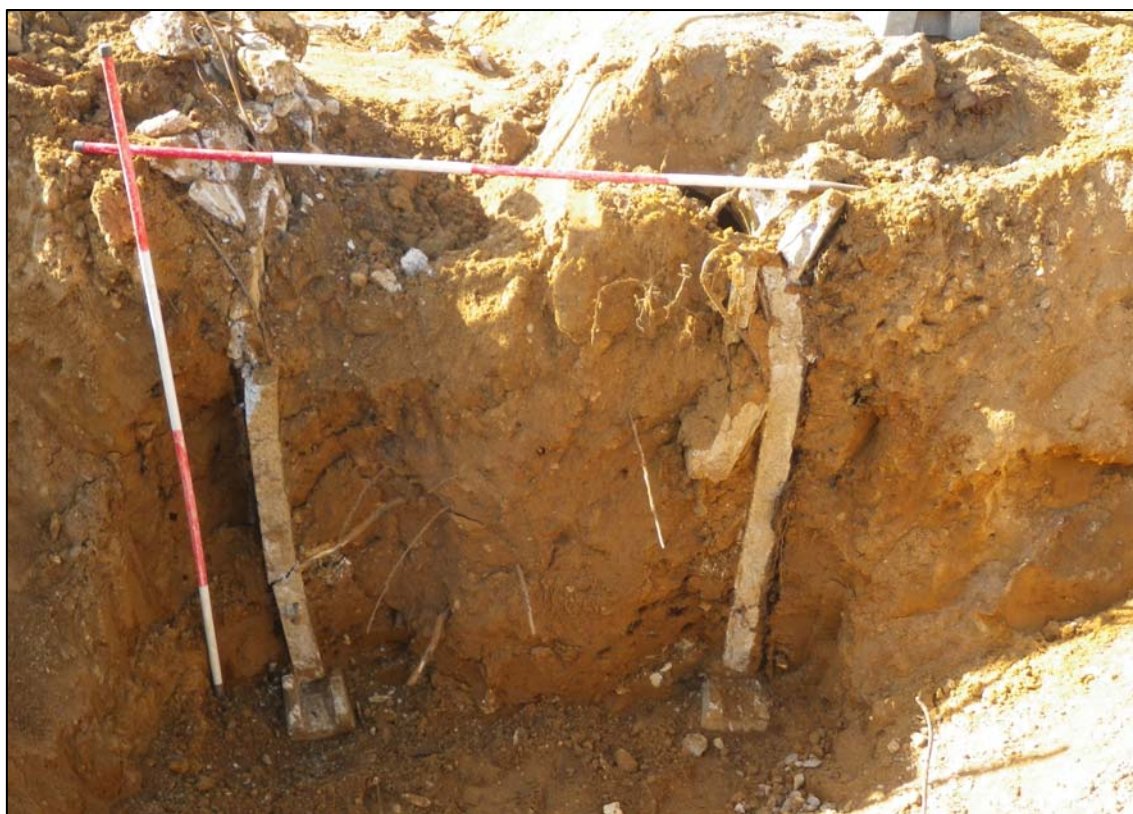
Plate 1. Section across the shelter, camera facing south-west (ref. HQK 79)

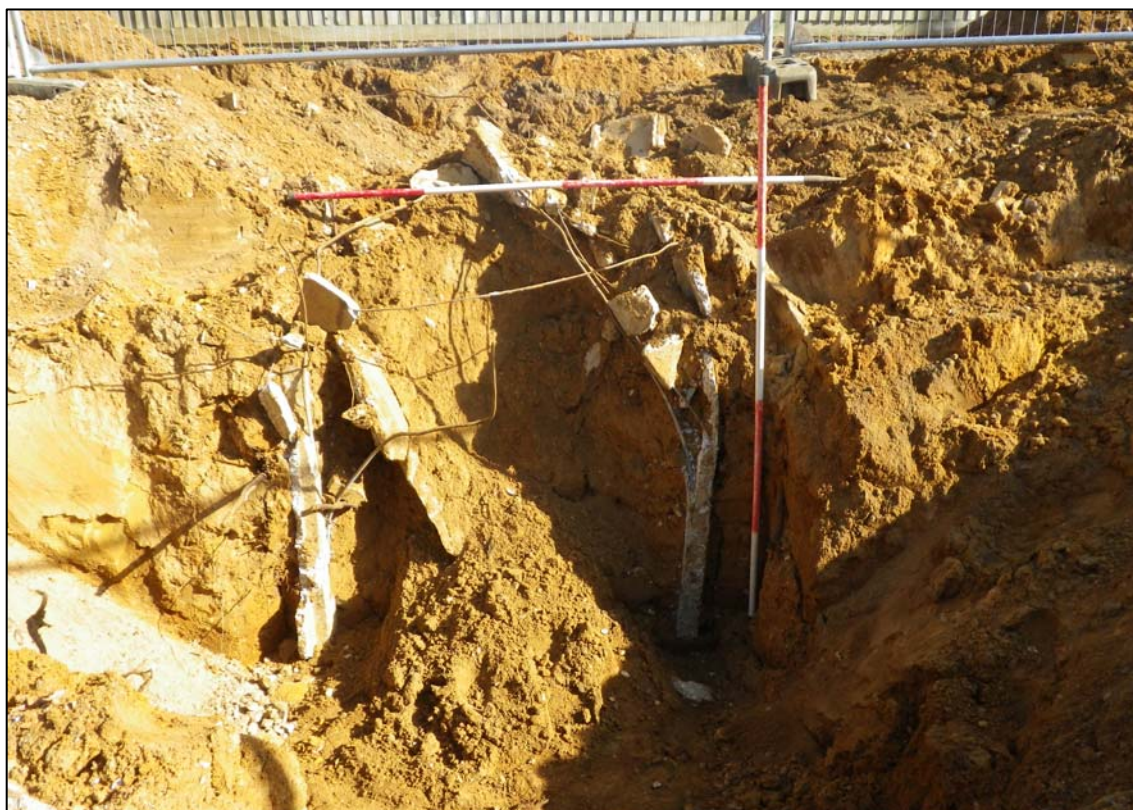
Plate 2. Section across the shelter, camera facing north-east (ref. HQK 85)

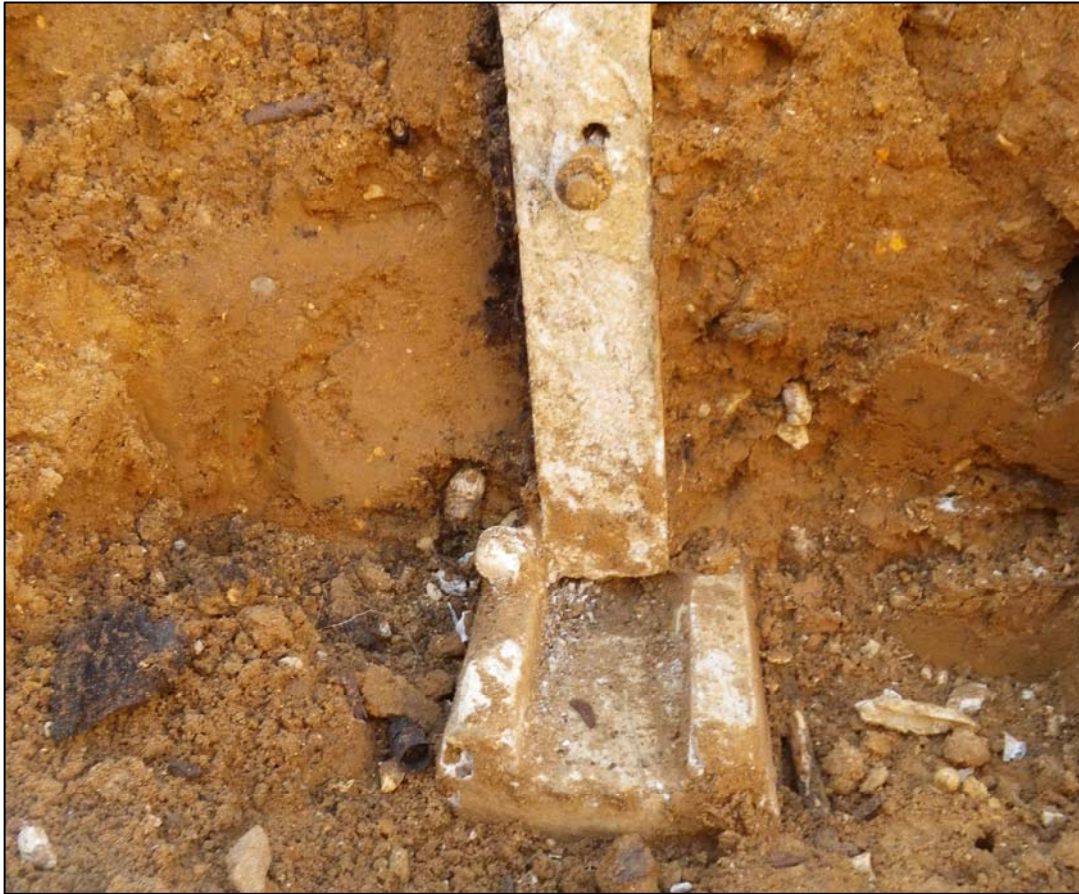
The shelter was formed from pre-cast concrete panels with steel reinforcing that were bolted together side by side (plate 3). Each panel was approximately 31cm wide and would have extended the full height of the shelter. They would have curved over at the top and met to form an arched roof. The bottom edge of the concrete panels sat in a shallow concrete trough (plate 3) at a depth of c. 1.8m below the present ground level. No formalised floor surface was evident within the shelters. The remains of timber sheeting was evident on the exterior face of the shelter walls (plate 4).

Plate 3. Shallow trough at base of panel. One of the tie bolts is also visible.
South-east wall, camera facing south-west (ref. HQK 88)

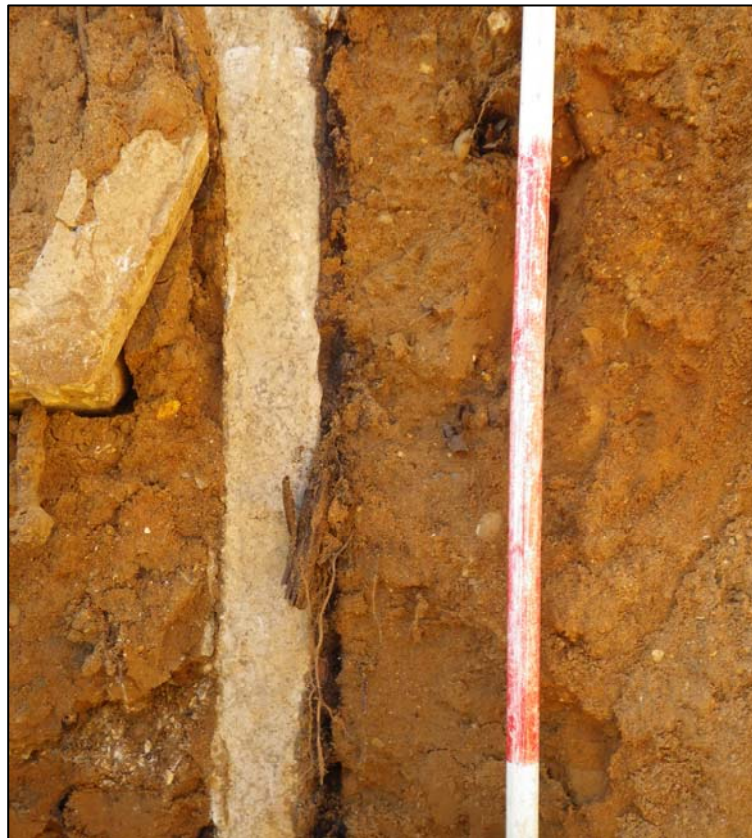
The concrete structures noted are undoubtedly air-raid shelters dating from the Second World War which would have been installed to provide shelter for the teachers and pupils who attended the three schools that formerly stood on this site. They were constructed from mass produced, pre-cast concrete segments within deep cuts by bolting the panels together to create single chambered linear shelters. The tops of each shelter would probably have protruded above the ground level and been covered in spoil. The timber sheeting noted was probably torevet the trench sides during construction.

Plate 4. Remains of timber sheeting on the outer face of the shelter walls
North-west wall, camera facing south-west (ref. HQK 82)
