# ARCHAEOLOGICAL MONITORING REPORT

SCCAS REPORT No. 2012/160	Parish: Woodbridge
<b>3 Lime Kiln Quay</b> <b>WOODBIDGE</b>	Planning Application No.: C/09/0206
	<b>HER Event No.: WBG 088</b> (OASIS ref. suffolkc1 -136276)
Address: 3 Lime Kiln Quay Woodbridge	Grid Reference: TM 2778 4915
	Number of Site visits: 2
	Date of visits: 09/05/11 & 05/10/12

Nature of the work: excavations for a large digester/cess tank

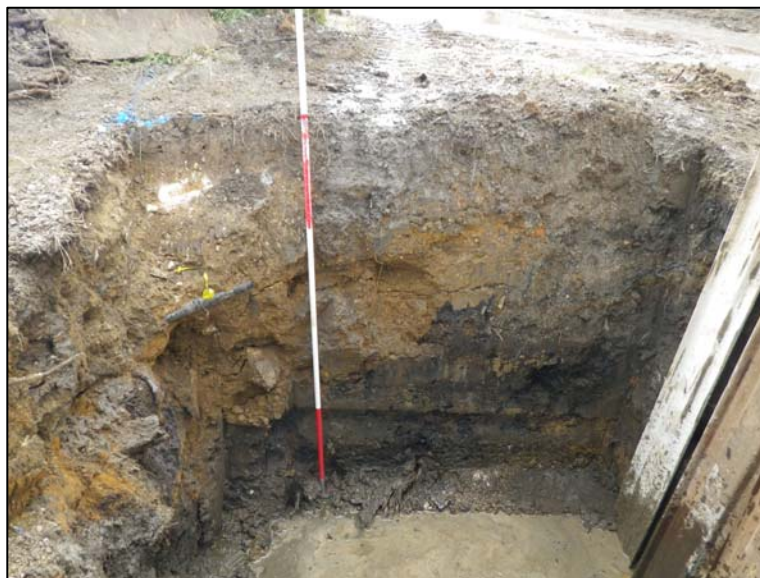
On the surface of the natural subsoil, against the southern edge of the excavation, part a large horizontal baulk of timber was noted along with at least two smaller upright timbers. It was not possible to fully examine these due to the depth of the excavation and the unstable nature of the ground.

The site of the excavation was just to the north-west of a revetted inlet or dock off the River Deben which served Lime Kiln Quay. The stratigraphy noted in the excavation suggested that this inlet originally continued further to the north-west. The timbers may have been simply discarded during backfilling or were possibly associated with revetment of the edges of the inlet.

Plate 1. view of the southern edge of the excavation. The timbers are adjacent the bottom of the ranging rod (the mass of orange sand and gravel is the backfill of a modern cable trench)
