**Braholme, Fornham Road,  
Great Barton, Suffolk**

**BRG 055**

**Archaeological Evaluation Report**

**SCCAS Report No. 2012/169**

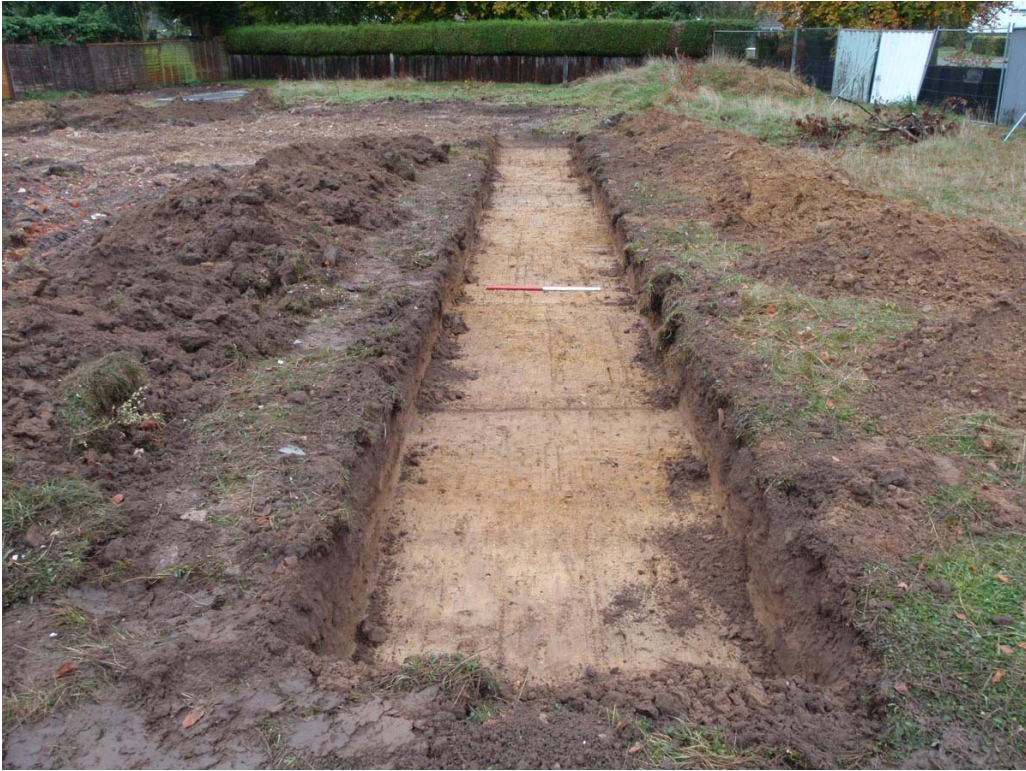
Trench 1 revealed a straightforward sequence of horizontal deposits, as described below and shown on Plates 1 and 2. No archaeological or modern features were found.

The natural stratum was a heterogeneous deposit of soft, mottled orangey brown/yellowish brown/greyish brown slightly cohesive silty sand, with moderate fine to medium pebbles and occasional cobbles. It had an indistinct interface with an overlying subsoil layer.

The subsoil was a layer of soft, mottled light yellowish brown and light greyish brown sand with occasional pebbles. There was much root disturbance throughout the deposit, which was generally about 0.15m thick and had an indistinct interface with an overlying garden soil. No cultural material was seen in the subsoil.

The garden soil was soft, mid brownish grey sandy loam with occasional pebbles and some obviously modern material such as brick fragments, plastic and metal objects. It was about 0.20m thick and supported a layer of turf.

Plate 1. General view of Trench 1, looking north (1m scale)

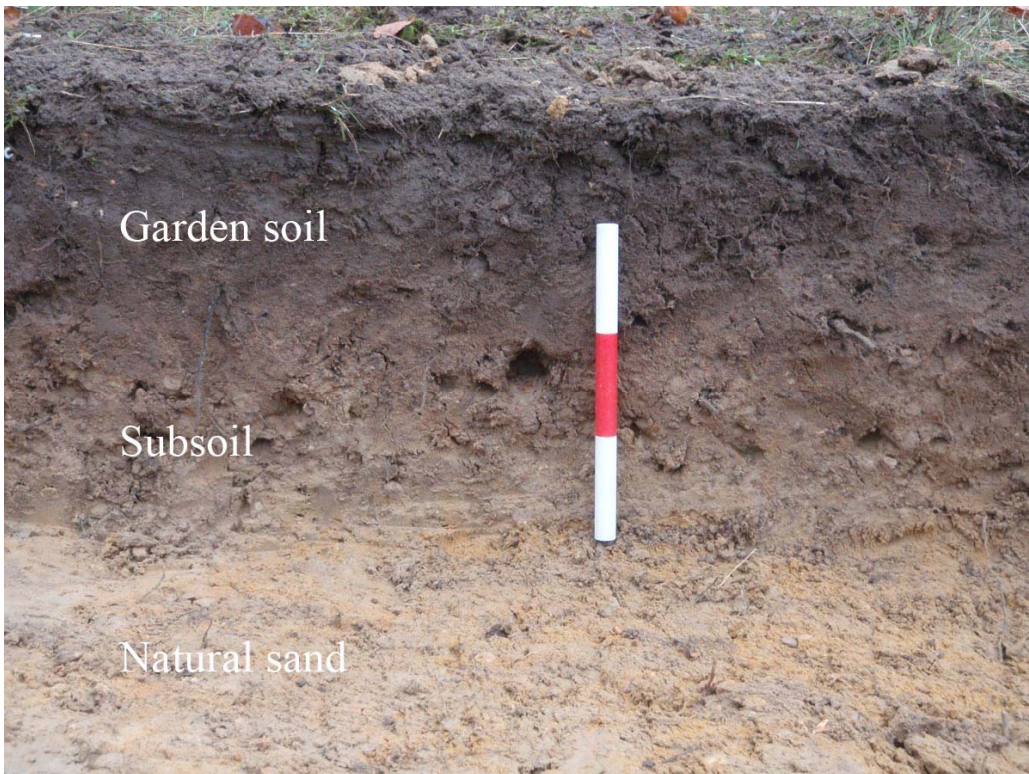
Plate 2. Typical section in Trench 1, looking east (0.3m scale)

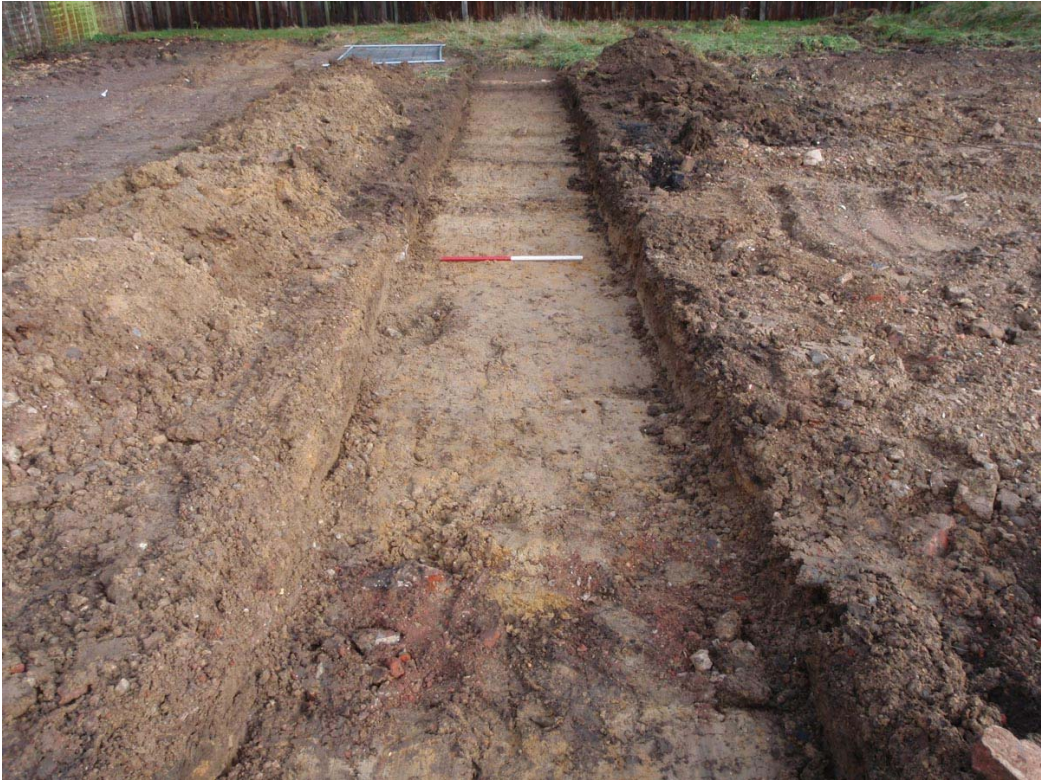
There were four modern, linear features in Trench 2, as shown on Plates 3 and 4, and Figure 2.

Near the centre of the trench was a land drain – a narrow trench (0.15m wide) filled with angular flint pebbles. This was probably an agricultural feature pre-dating the house.

Two linear features, 0.60m and 0.80m wide, were filled with mixed sand and brick/concrete rubble. They were probably service trenches associated with the house.

Plate 3. General view of Trench 2, showing modern features, looking NE (1m scale)

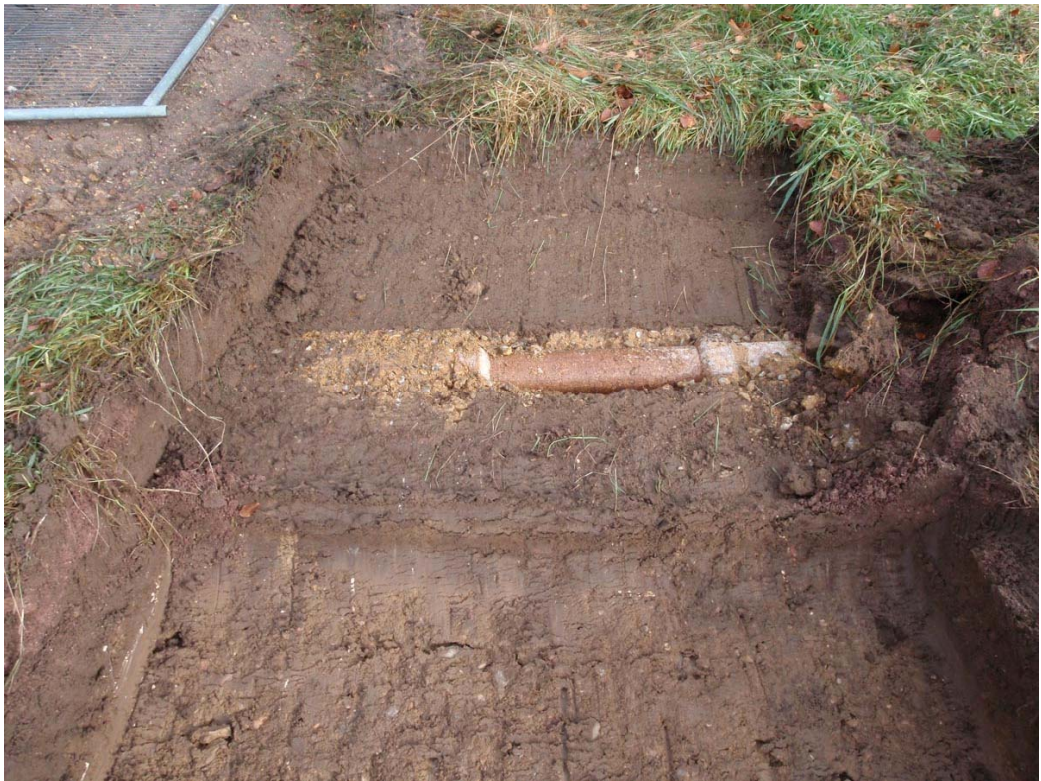
At the northeast end of the trench was a five-inch diameter ceramic drain, at a depth of only 0.20m below ground level. This was obviously associated with the recently demolished house.

Plate 4. Modern ceramic drain at the northeast end of Trench 2
