## 57-59 College Street BSE 290

### **Archaeological Excavation Report**

SCCAS Report No. 2012/180 Client: Mr & Mrs Mager

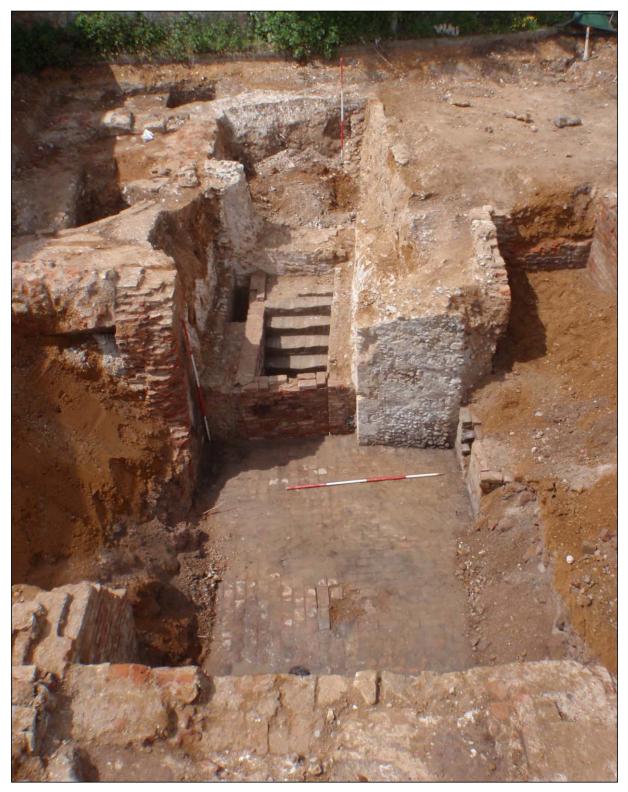
Plate 1. Cellar, looking west. The eastern lip of the cellar 0114 is in the foreground with the western corridor 0119 to the rear partly obscured by later cellar steps; other insertions include a set of steps to the right of the ranging pole and the spring of a brick arch to the left 0122. The flint wall behind the ranging pole is slightly proud of the original back wall and the flint is not set in regular courses suggesting it was a later addition or built in the newer tradition than the east cellar wall. 2x2m scale.

The earliest structural evidence from the site was of a cellar (PI. 1). The visible remains include the eastern wall of the cellar, 0114, and sections of the west wall, 0116, giving a span of c. 4.55m (15ft); the north –south dimension is uncertain; to the south the plaster face of wall 0114 was seen to continue behind the foundations of the later brick arches, 0122, (it could not be followed any further due to the proximity of the modern neighbouring property wall). The northern limit on the east side of the cellar had been removed to facilitate the northern expansion of the cellar in the post medieval period and was located during monitoring, which revealed a flint wall concealed beneath a later brick floor, 0115, (Fig. 3 and PI. 5). The minimum width of the main cellar therefore was c.3.3m (11ft). An interesting feature of the western cellar wall, 0116, is the slight angle it was built at with regard to the eastern wall; whether this was significant is impossible to say.

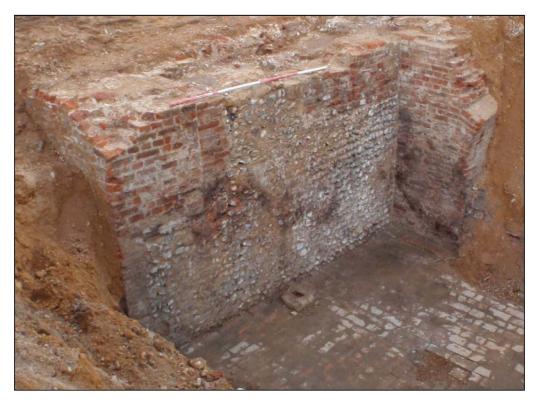
Plate 2. East wall of the cellar 0114, looking south. The northern edge has been finished with bricks where the early cellar wall returned for the post-medieval cellar steps. The Norman flint coursing is clearly visible and continues behind the later brick arch 0122 visible to the right of the picture. Although not in its original position, a padstone with a slot for a tenon can be seen against the wall and is matched by the ghost of a setting in the middle of the brick floor. 1x2m scale.

The east wall of the cellar, 0114, (Pl. 2 and Fig. 4) is 2.26m deep (from the top of the rough limestone laid across the top of the cellar to the base of the flint wall and the brick floor, a section revealed that beneath the later brick floor, below rubble, there was a clay floor (0091 and 0093 in Sections 13 and 12) the floor was also seen abutting the stump of the buried north wall and appeared over chalk; the clay also matched c. 0.4m of clay, 0117, beneath the flint face of the wall (Sec. 12 and Pl. 5) laid as a foundation for the flint wall. The additional 0.4m of clay gave a maximum depth of 2.46m to the cellar. North of the opening on top of the flint wall a crude line of rough limestone may mark the remains of the foundation from which the above ground structure was built. The flint wall, which was once concealed behind a plaster face that has largely fallen away, is in regular, individually laid, courses; this is a distinctly Norman characteristic

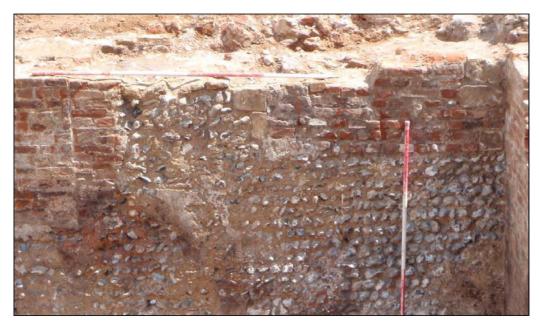
Plate 3. East wall 0114 detail. Showing *in situ* ashlar blocks in the centre of the picture indicating the edge of an opening 0118 later in-filled with bricks. Overlapping limestone rubble is visible beneath the horizontal ranging pole. The scale bars are at 0.5m.

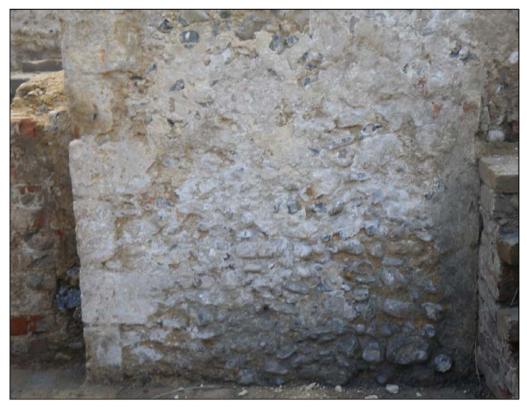
Plate 4. West wall 0116 detail. Looking west, the flint work is not in courses, unlike the eastern wall, and the block-work on the left of the picture is misaligned with the right angled corridor wall behind suggesting that they were not built at the same time. The chamfered finish to the wall on the right of the picture is a repair to the scar left when the returning cross wall 0115 of the cellar was removed.

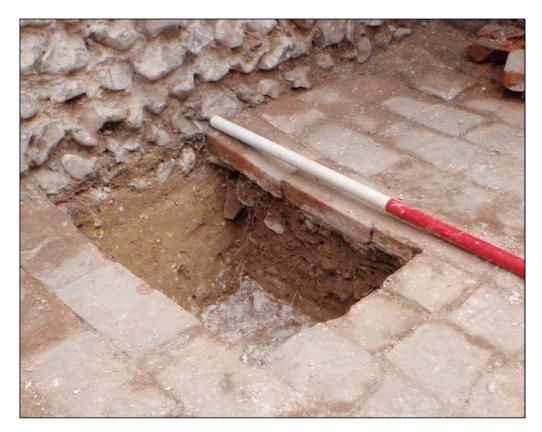
Plate 5. Sondage through floor. The clay foundation for the east wall 0117 is visible, also showing beneath a later tile floor are the remains of a clay floor 0093 laid directly over natural chalk. The scale bars are at 0.5m.

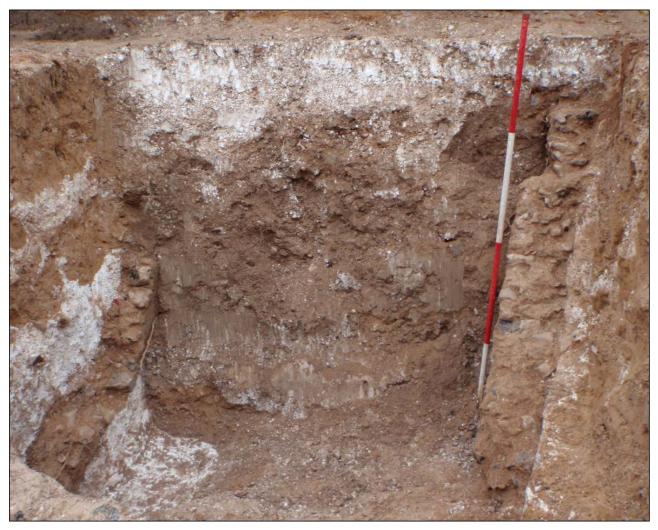
Plate 8. East end of the corridor 0119. The unexcavated east end of the corridor with surviving wall on either side; the wall on the south side is built from a chalk ledge. The depth of the floor is less than at the cellar entrance indicating a rate of descent into the main cellar. 2m scale.

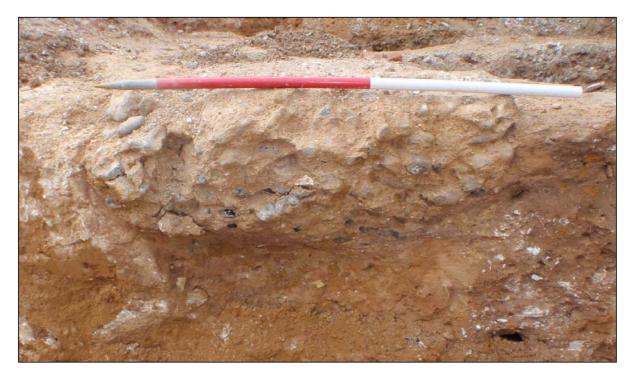
Plate 9. Pilaster buttress foundation 0120 facing north. Located behind the site of the missing south wall of the corridor. The brown fill with chalk to the right of the picture is the edge of probable cess-pit 0097. 1m scale.

A significant feature on the outside wall of the corridor on the south side and set close to the main building was the foundation of a pilaster buttress, 0120, measuring 0.9m (3ft) wide and 0.2m (7inches) deep; the foundation was built of packed flint and rubble with mortar. From this we can infer that an above ground structure was built of stone rather than timber.

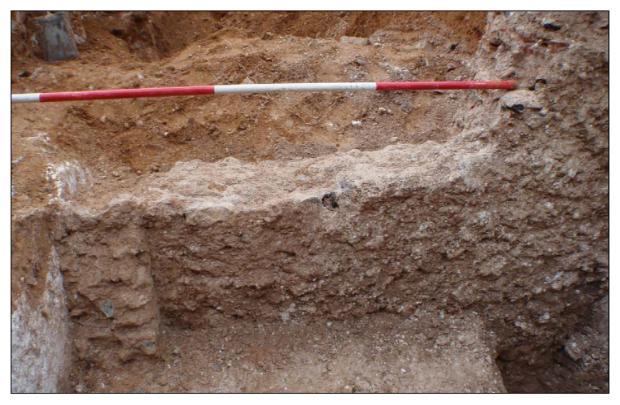
Plate 10. Inserted cross wall 0121. Blocking off the corridor leading into the main cellar (the wall was later punched through for a set of steps for a post-medieval building). The photograph is taken looking east into the rough back face of the cross wall. The scale bars are 0.5m.

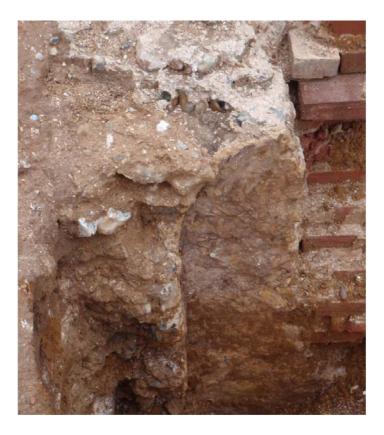
Plate 11. Looking west onto the top of the inserted cross wall 0121. Showing the impression of a wide flat 'Tudor' arch in the mortar.

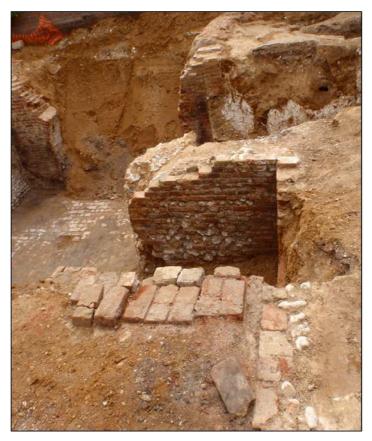
Plate 12. Looking south from north extension into the cellar. Two sides of an arch 0122 can be seen in the background separated by sand and gravel backfill. A later cross wall 0130 appears in the foreground.

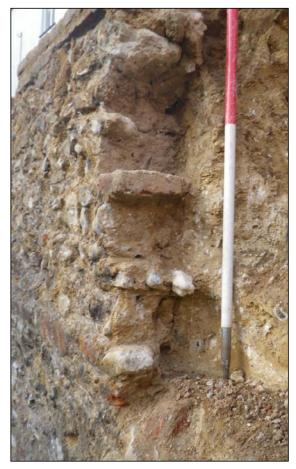
Plate 14. Detail of north wall 0125 fabric, showing brick and flint coursing. The scale bar is 0.5m.

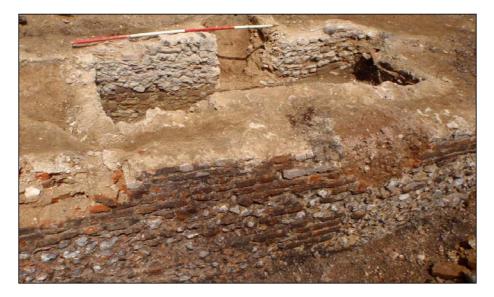
Plate 15. North cellar wall 0125. Not completely emptied, with contemporary cess pit 0066 behind. 2m scale.

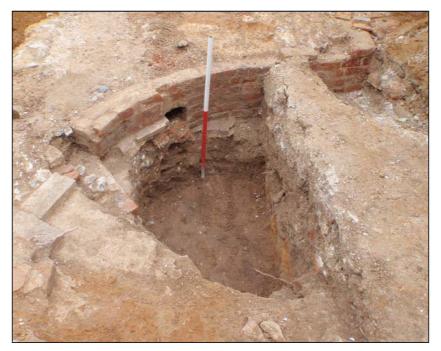
Plate 16. Looking south-east onto the top of spiral stairs 0132 into cellar. The entrance to the cellar was beyond the excavation but an opening is suggested by the moulded bricks in the top right of the picture. Medieval pit 0098 can be seen below the steps. 1m scale.

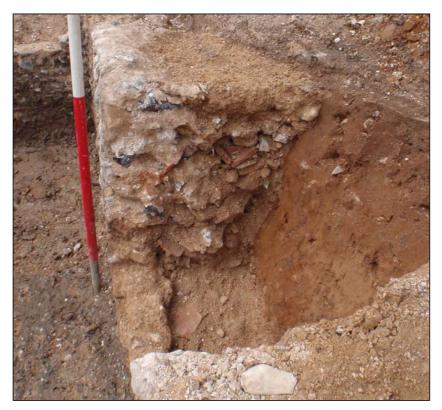
Plate 17. Looking west onto a section of the cess pit wall 0066. A largely flint wall with tile coursing can be seen with looser tile and flint packing behind. The scale bar is 0.5m.

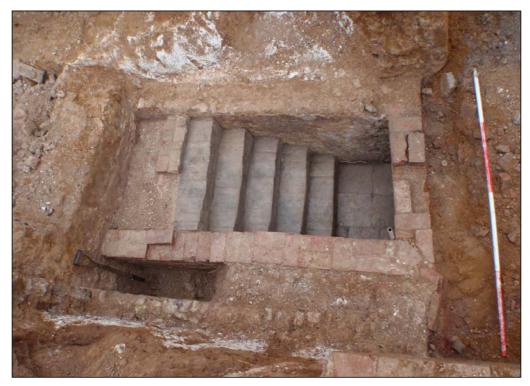
Plate 19. Lower course of internal steps. These were inserted through the early medieval corridor, with a later, 19th century, blocking wall 0133 on the right side of the picture. 2m scale.

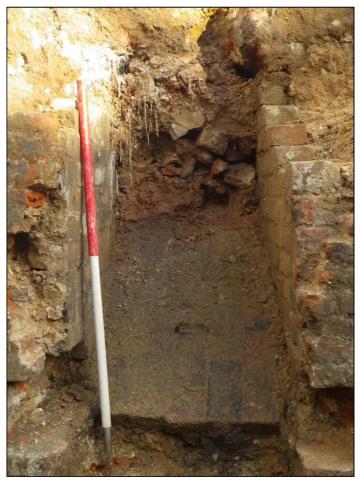
Plate 20. Coal chute 0131 inserted in the east wall of the northern cellar extension. 1m scale.

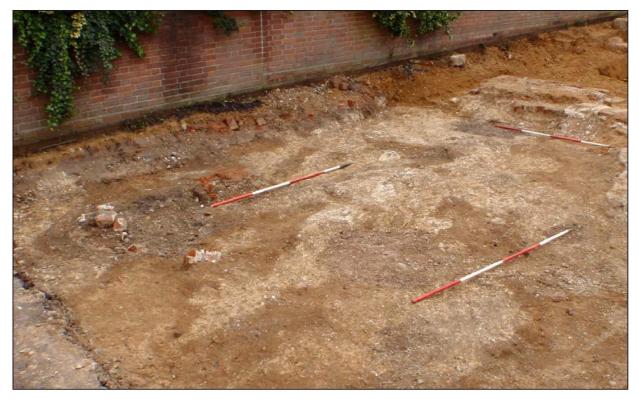
Plate 21. South-east corner of the site. The well can be seen on the left of the picture alongside the truncated surface of the natural subsoil. Pit 0050 is visible beneath the top right ranging pole. 3 x 2m scale.

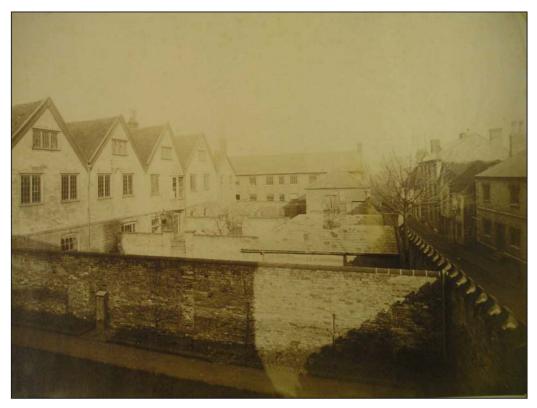
The photograph shows the buildings from the northeast and looks over the former boundary wall that ran along the western side of College Street. It seems likely that the buildings thought to have been the college were the structure whose gables faced the street. The building was used as stores, a dining hall and rooms for aged residents and able-bodied women. This photograph is one of a series of photographs probably taken shortly after the closure of the workhouse. The views of the buildings include a view from the south showing and internal divisions of the yards between the "college" and the boundary wall along College Street (ref. K511/476).

Plate. View of the workhouse (ref. K511/476)

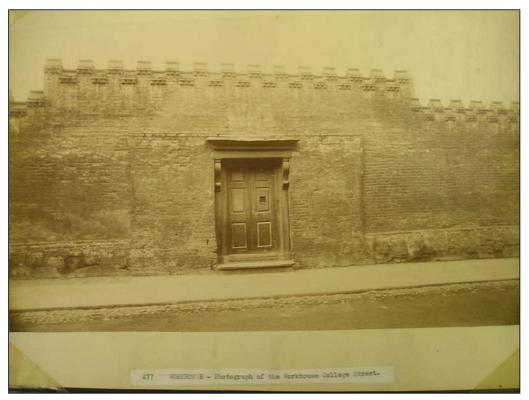
Plate. Entrance to the workhouse from College Street (ref. K511/477)

The view of the entrance on College Street (ref. K511/477) is of particular interest as it shows that the footings of the boundary wall was made up of stone rather than brick the wall appears to have been constructed at different dates with the doorway inserted at possibly the same date was the upper part of the wall.

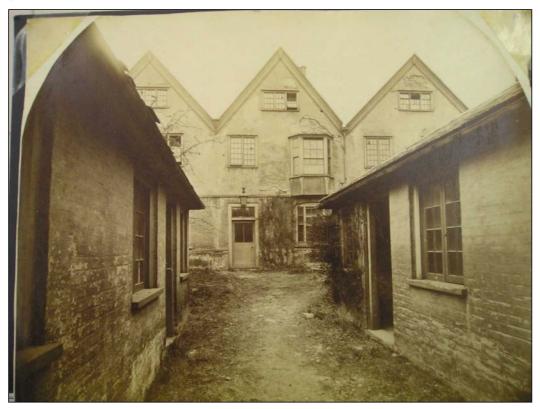
The view from inside the main entrance to the doorway and entrance passage of the College indicates that there was a slight upward slope from the road to this main building flanked on either side with later structures (ref. K511/478). Behind the building on the right hand side of this photograph and below a gable window on the College there appears to be an entrance to a cellar.

Plate. View of the main workhouse building (ref. K511/478)

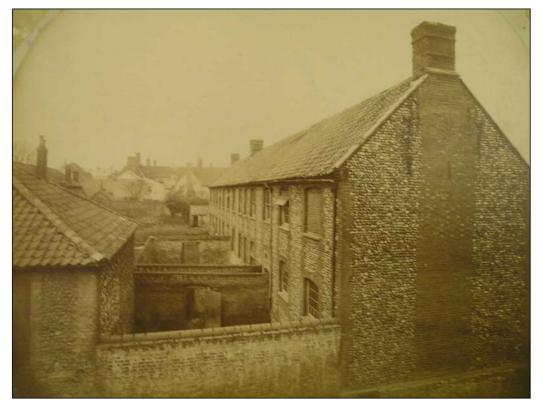
Another photograph (ref. K511/479) shows the buildings at the northern end of the site that have been recently converted into houses. Further photographs showing the internal arrangements of this building are in the planning files for 1999.

Plate. Buildings on the north side of the site (ref. K511/479)

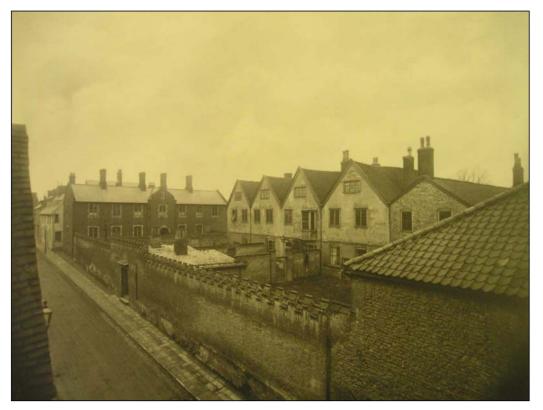
Plate. View of the workhouse from College Street (ref. K511/1101)

The published photograph (ref. K511/1101) has already described. These photographs have been copied for this report and combined with the sale plan show that much of the area behind the boundary walls has been free of later building.

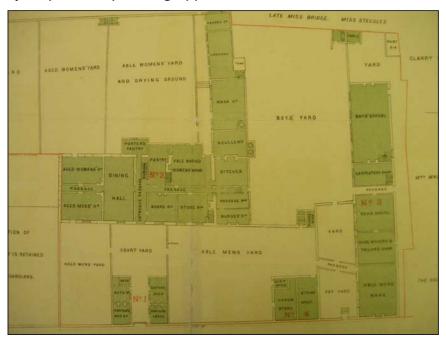
Museum at the record office in 1952. As in the case of most of these plans they have been detached from other documents. On the original plan the standing buildings are marked in green, the site boundaries are marked in red, as are the numbers that suggest that site when offered for sale was subdivided and sold in separate lots. Most of the buildings either side of the "Boys' Yard" to the north of this site are still standing. The main range including the "Boy's School" have been recently converted in houses and offered for sale. The condition of this building before its restoration was carefully recorded and a report presented to St Edmundsbury as part of a planning application in 1999.

Plate. Plan of the old workhouse, H. Lacy Scott 1884 map (ref. 373/4)

The original plan is at the record office (ref. 373/4). This was one of a number of printed plans and sale particulars of buildings in Bury deposited from the Moyse Hall

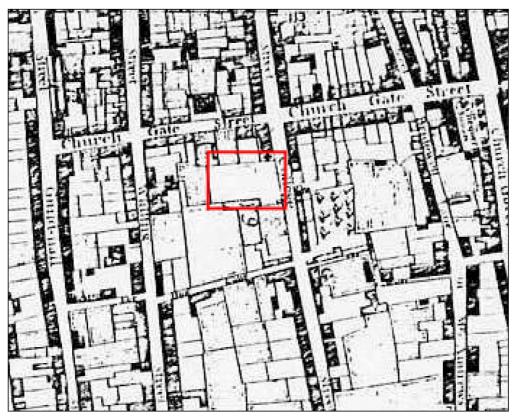
Further confusion as to the site of the college appears on Thomas Warren's 1776 map of Bury printed inside the cover of Margaret Statham's 1988 book. Those buildings shown in the photograph of the former workhouse are marked on his map with the number '9' and described in the legend as "The College". Warren also marks a site on the corner of Church Lane and College Street with the letter 'G' and this is listed as "Jesus College".

Figure. Extract of 1776 Warren Map, with development outline
