Clare Castle
Monitoring of masonry repairs
CLA 008

Archaeological Monitoring Report

SCCAS Report No. 2012/186

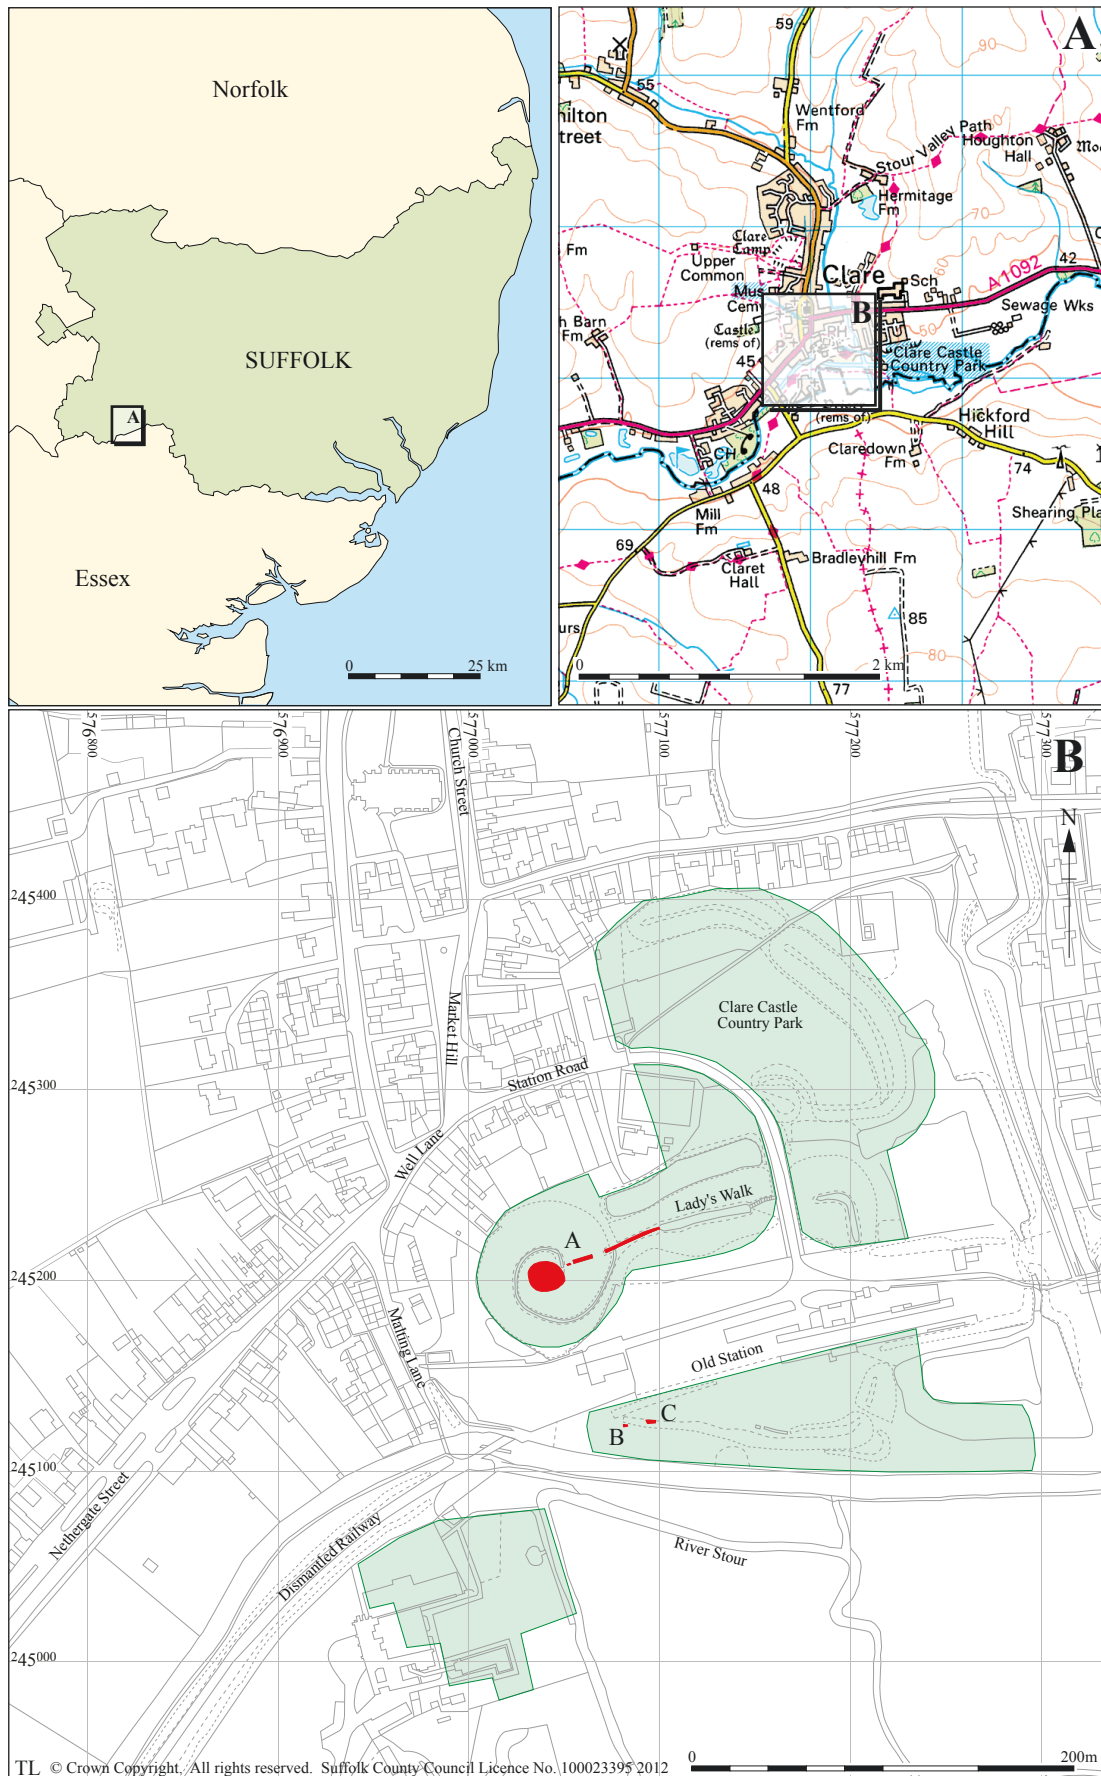
Figure 1. Location plan showing the area of the survey marked in red. The keep and upstanding bailey wall are labelled A and the detached sections of wall B and C

The location of two large blocks of collapsed wall on the south side of the bailey was also plotted (Fig.1 B and C) and photographed. These were completely obscured by ivy and barely recognisable as masonry. The intention is to bury the blocks and if so they will need clearing of ivy and additional recording.

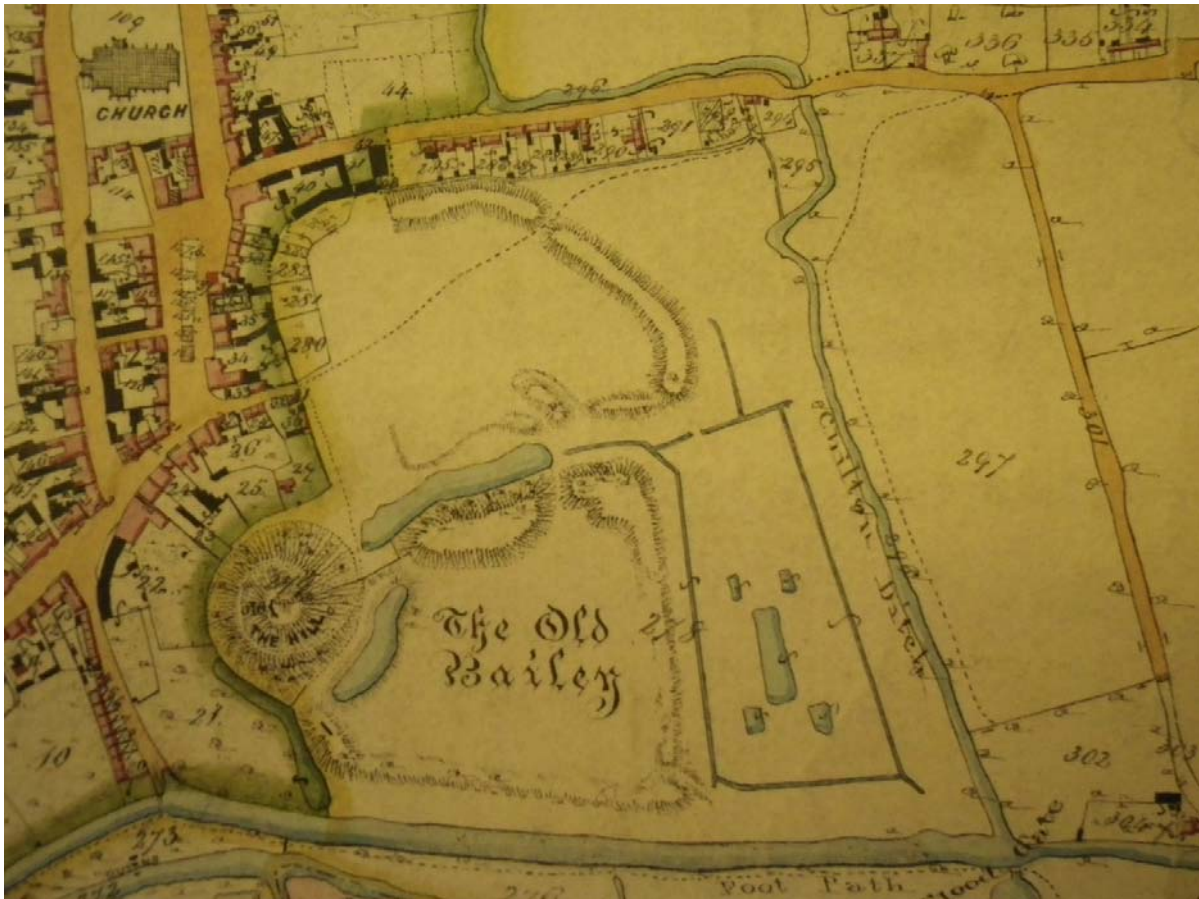
Figure 2. Clare Tithe map of 1846 with north at the top. An infilled moat and ditch are shown to the SE and SW of the motte respectively. The New Cut which powered the medieval priory mills runs parallel to the bottom of the map and probably utilised an existing ditch/moat that was part of the castle's defences. Rectangular fishponds are shown to the east of 'the Old Bailey'

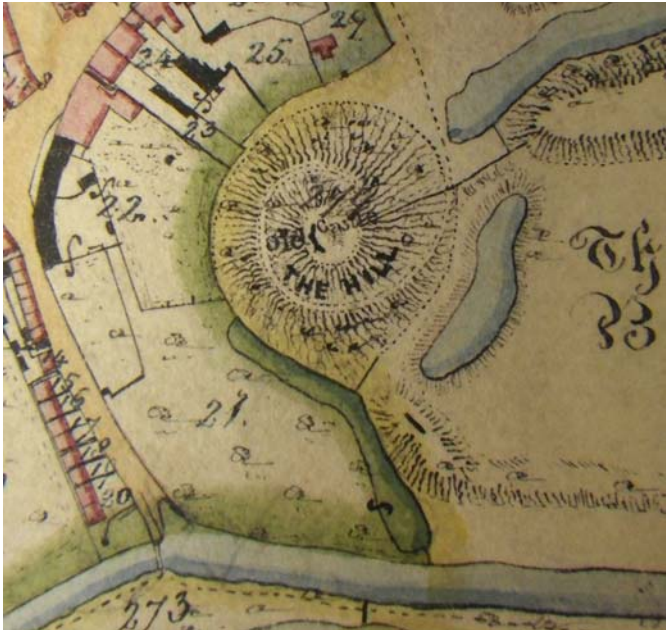
Figure 3 Tithe map detail. The open ditch, coloured green, is shown to the SW of the castle and is distinct from the water filled moats coloured blue. The green shading continues round to the north side of the motte suggesting the ditch once enclosed it fully but was infilled at the time of the survey. The ruined keep (with buttresses) and a short length of the inner bailey wall to the S of the motte are shown as thick black lines. The bailey north wall is shown as a thinner line

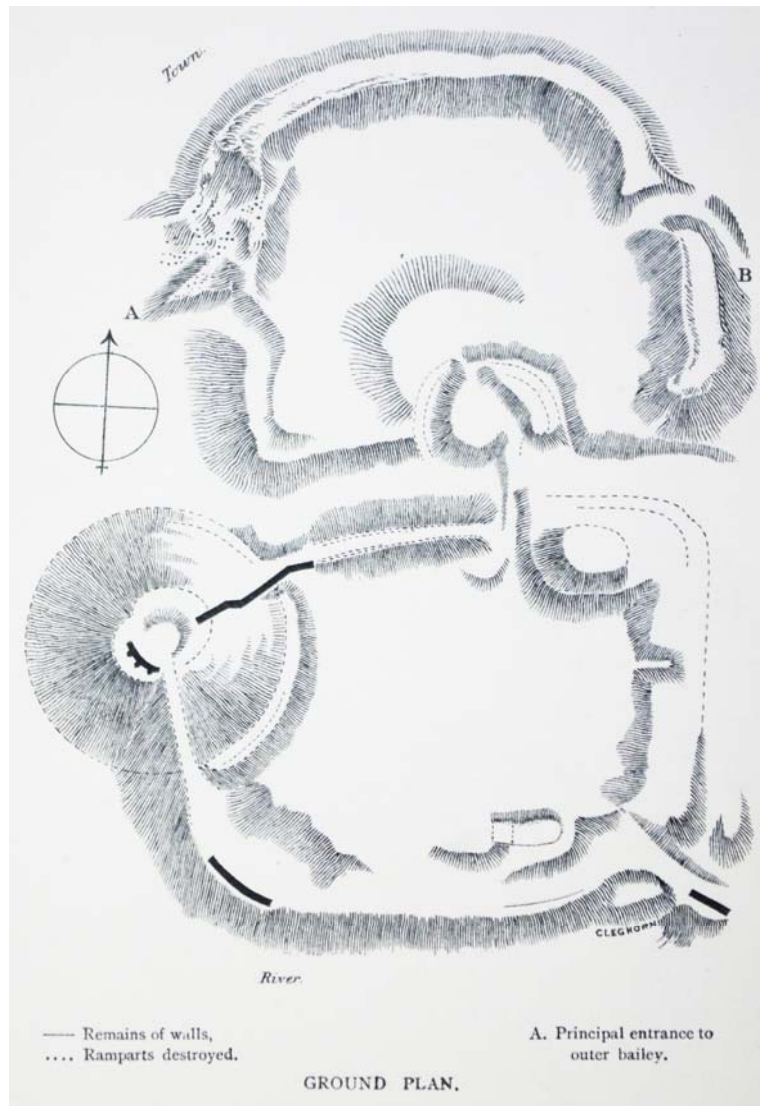
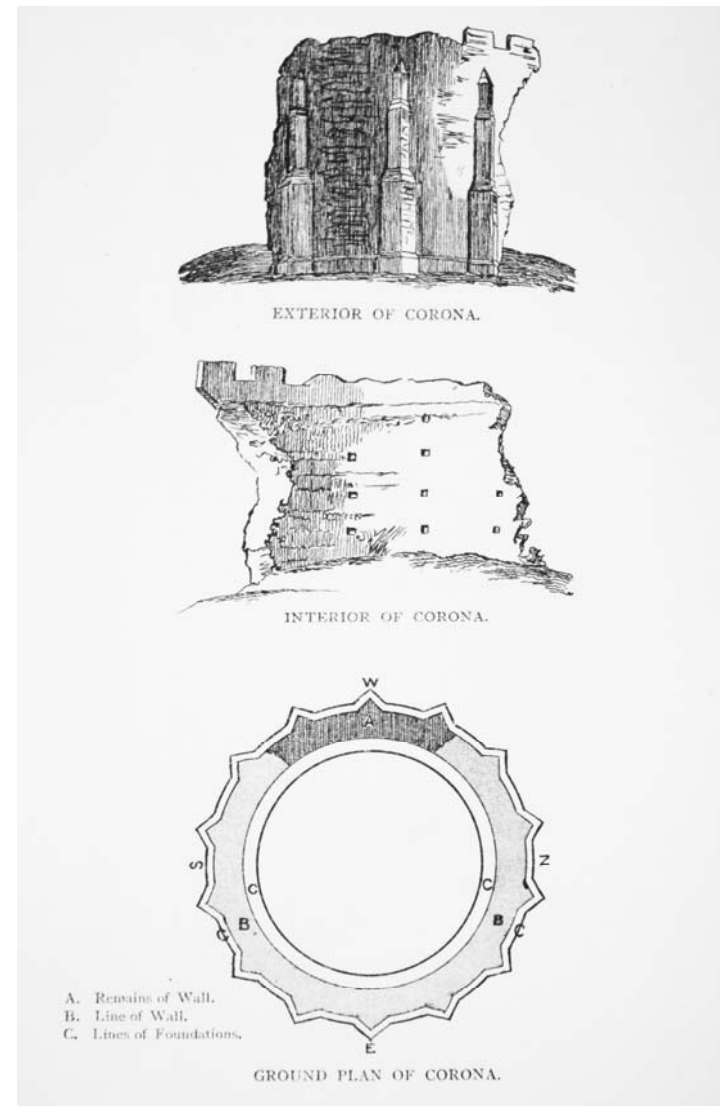
Figure 4. Plan and elevation of the castle complex and keep from a paper on Clare Castle by Samuel Tymms read in 1848 and published in PSIAH Vol 1 1895. The plan on the right shows the SW corner of the bailey wall still standing and the line of missing ramparts on the south side of the motte joining the keep at the current shear point. The keep remains are shown on the left largely as they currently stand; the parapet is better defined and shown with the remains of battlements that no longer exist.

The parapet wall is 400mm thick, narrower than that of the keep wall forming a narrow ledge at the top of the building. The parapet wall is truncated and there is no indication of the former height or levels of the merlins which are shown on antiquarian engravings

(Figs 4-8). Within the parapet, at the south end, is the bottom half of a smaller square-sectioned hole which pierces the full depth of the parapet just above the level of the top of the large beam settings (Pl. 5). This is thought to be a hole for a waterspout to discharge rain water from the valley/gutter at the junction at the base of the roof and parapet; examples of such holes were these were seen at Mettingham Castle where fragments of lead flashing from the lining of the valley were still in place. An alternative is that the hole is a 'putlock' for scaffolding, but this would imply that another full lift existed above the level of the roof a height that is not borne out by the evidence of the antiquarian engravings.

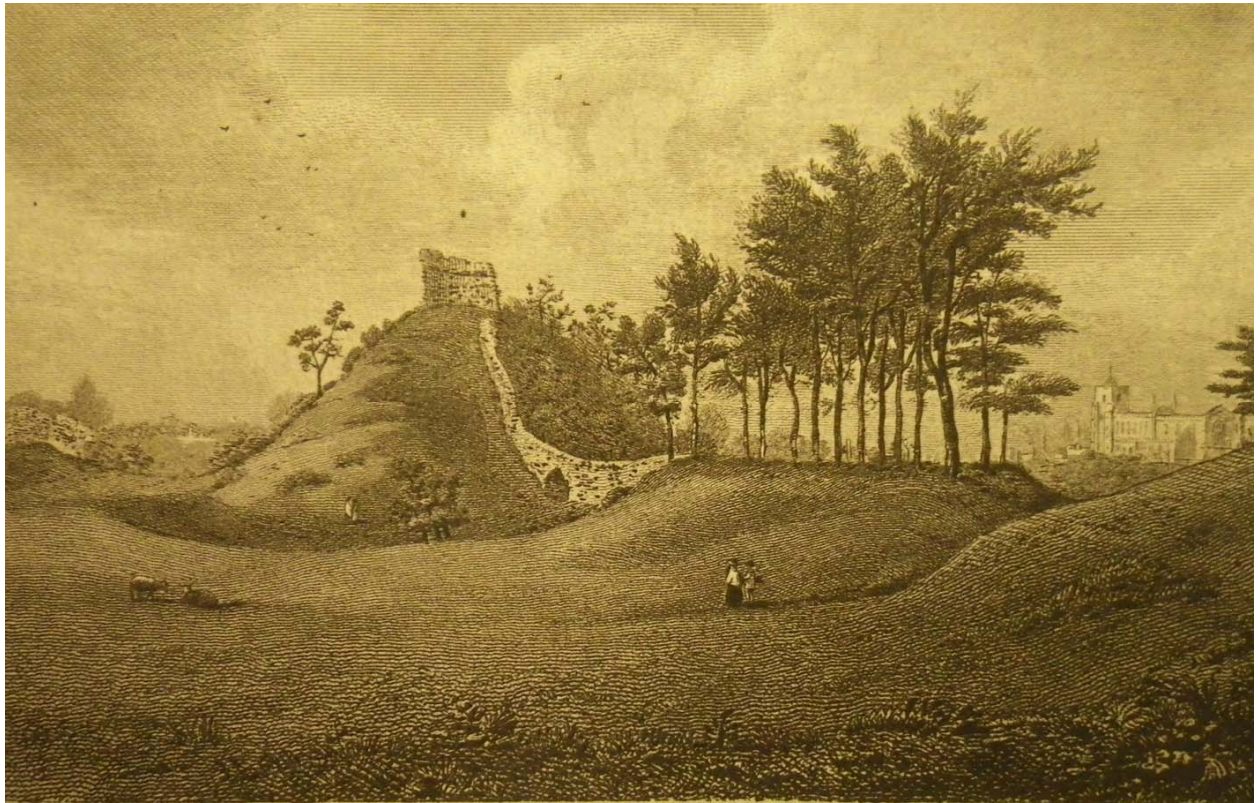
Figure 5. An engraving of Clare Castle, from a drawing by T.Higham, published in 1810. This seems to show remains of the curtain wall on the west side of the inner bailey still intact and rising up the motte (on the extreme left of the picture) and the earthwork in front of the mound (BRO ref 1511/67/10)

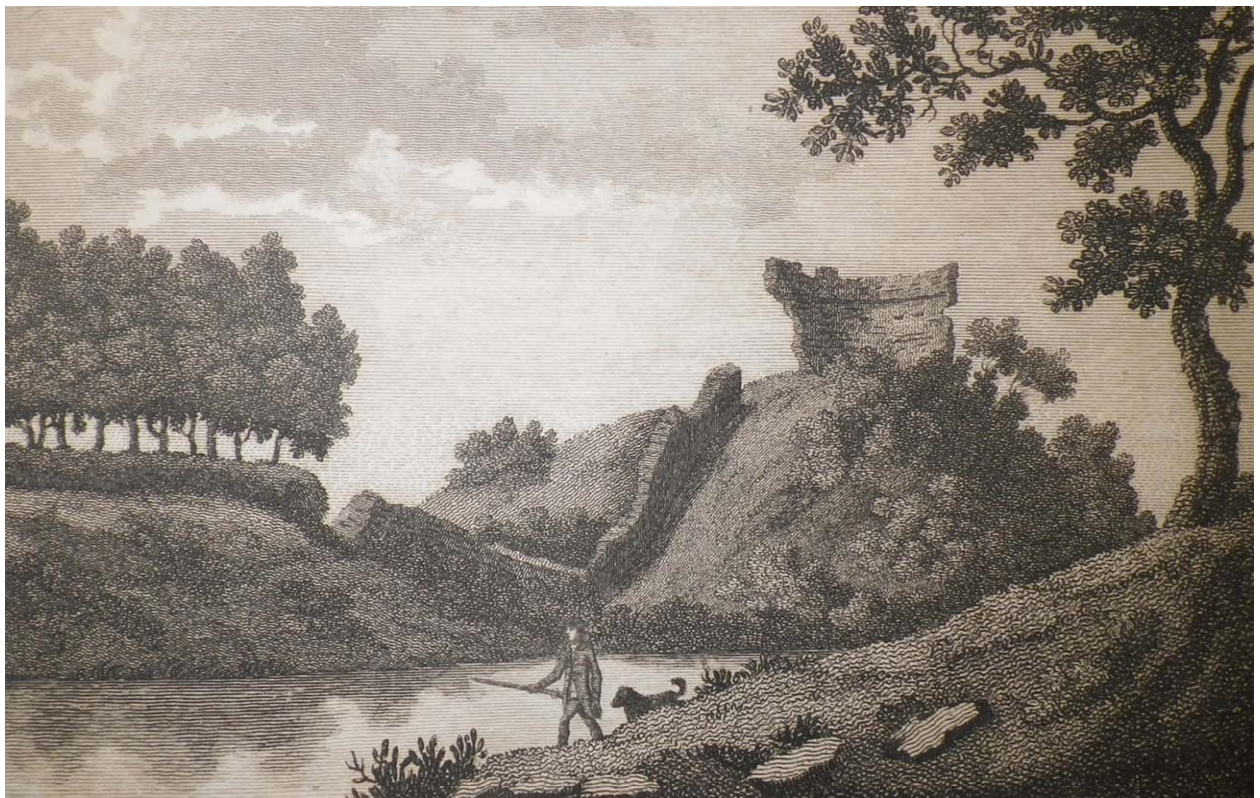
Figure 6. An engraving of Clare Castle by J Newton published 1787 (BRO ref 1511/67/13) showing clearly the parapet with crenulations and a row of putlock holes below

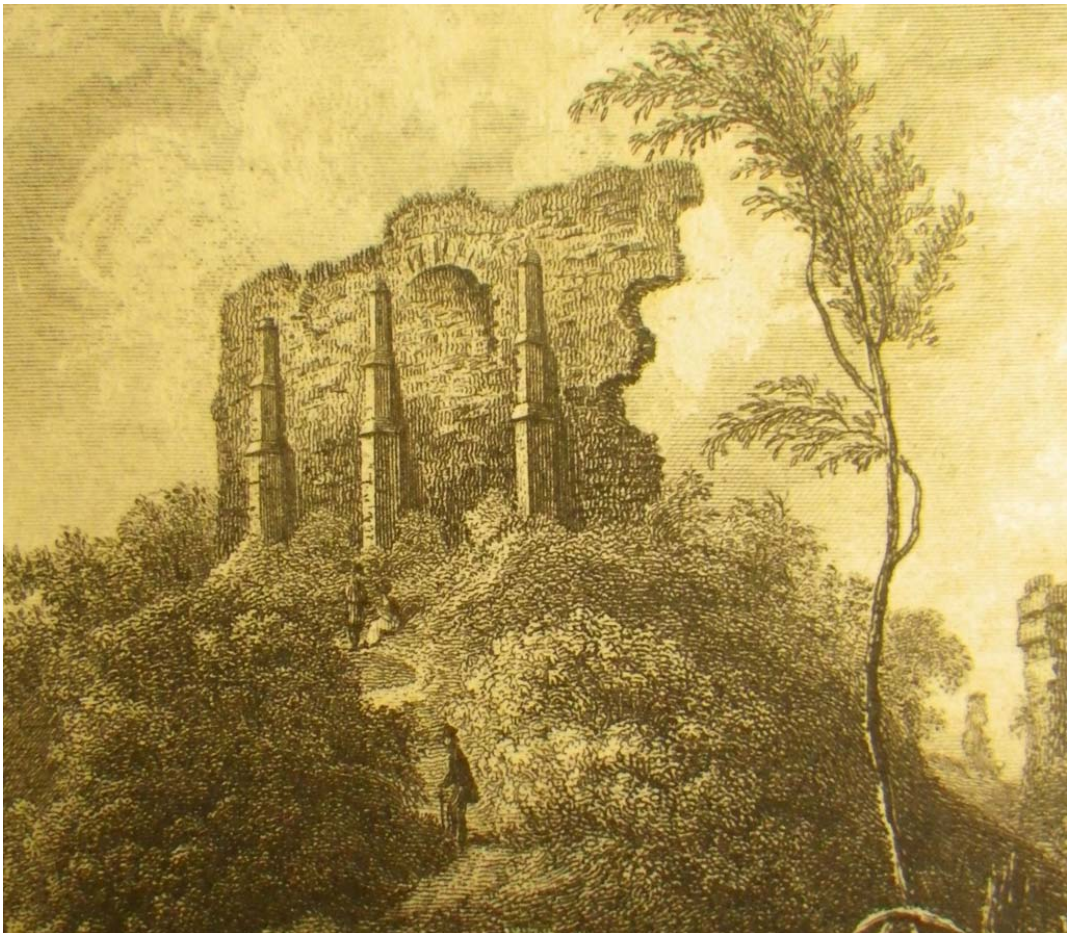
Figure 8. An engraving of the castle keep by J Haworth 1840 (Bury RO ref 1511/67/09). Note the arched feature between the buttresses, this is no longer visible on the exterior surface and was not identified within the core on the interior of the wall. The parapet is truncated with no indication of the crenulations

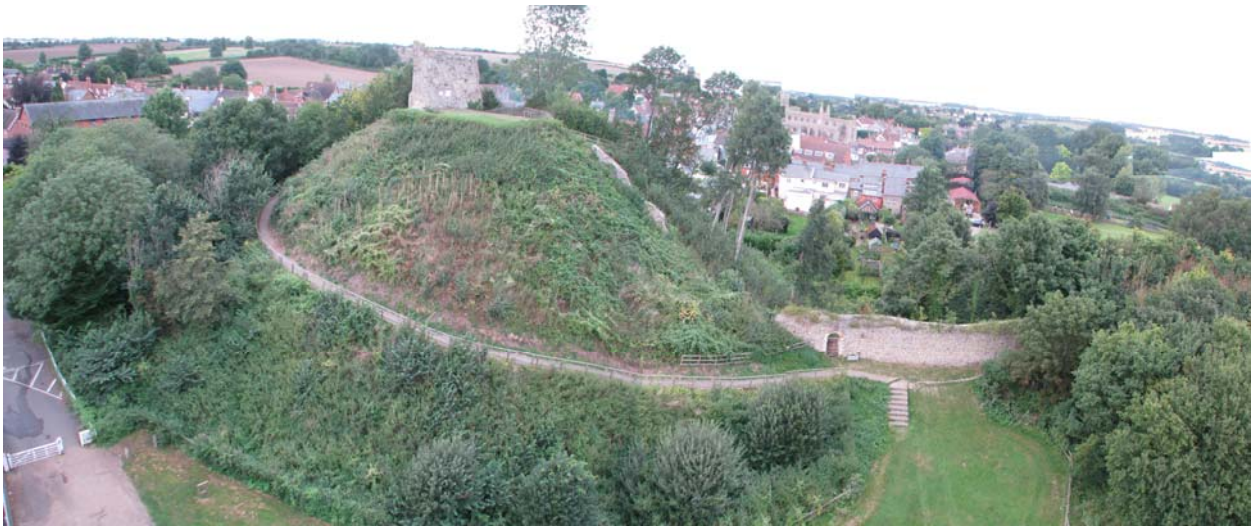
Plate 1. General view of the castle motte topped with the remains of the shell keep and the bailey wall running down the east side. The wall divides the inner bailey in the foreground of the picture from the outer (Higher View photograph).

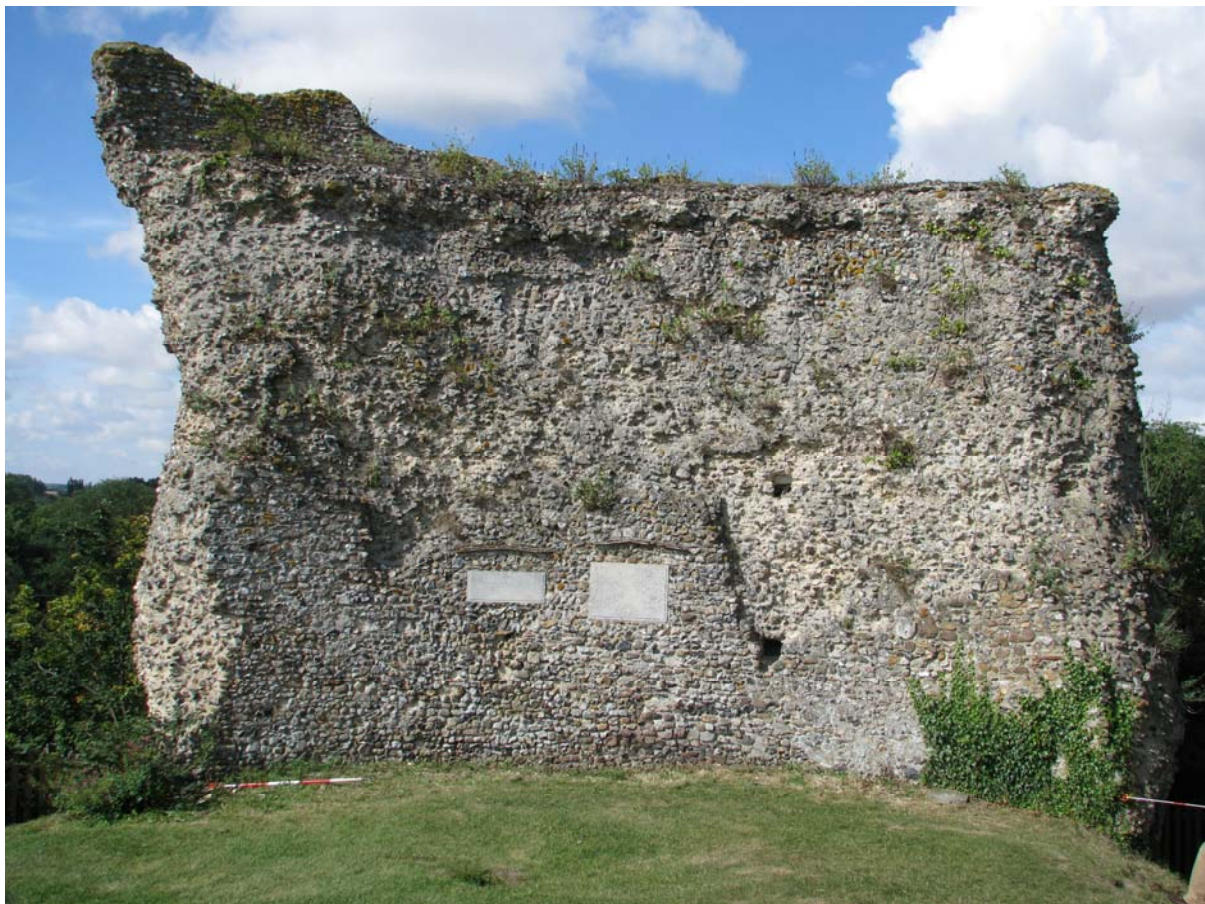
Plate 2. General view of the interior of the keep showing the condition of the monument prior to consolidation. The wall face has fallen away from a large section of the upper part of the wall exposing the wall's core. The remains of the parapet can be seen at the top of the wall to the left.

Suffolk County Council, the owners of the site proposed the removal of vegetation and the repair and consolidation of the ancient upstanding walls as part of the management of the country park. Repairs to the keep included:

- Reconstructing the interior face of the keep
- Capping the top of the wall with slabs to create a watershed
- Recreating part of the crenulations on the parapet and adding a flagpole

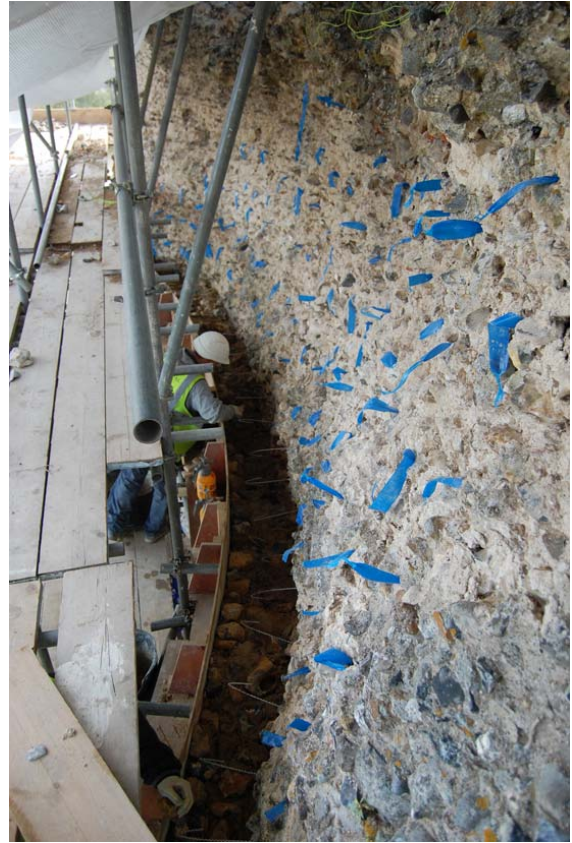
Plate 4. Building up the inner face of the wall behind curving timber formwork. The blue tags mark the stainless steel pins that help tie the flint face to the core

The new section of flint facing was to be raised on top of what remained of the existing wall face; this itself is a previous repair. The new work was to continue vertically the line of the existing wall face so that at the top of the wall the replacement facework was quite thick necessitating fixing into the core with stainless-steel ties. The reconstruction of the crenulations was informed by 18th century engravings (Figs. 4 and 6) and their positioning was guided by architectural clues surviving within the wall. The repairs to the bailey wall were limited to consolidation of the structure where necessary and capping with a rough-wracking to throw off water.

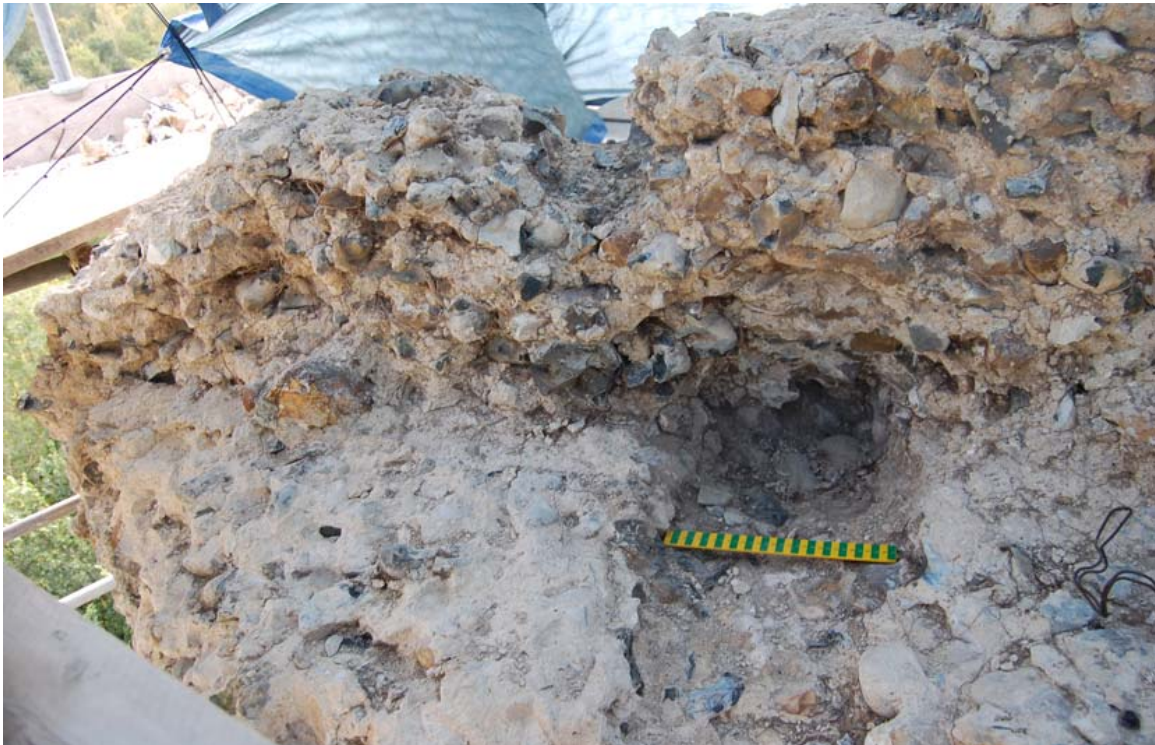
Plate 5. The scale lies within one of the beam slots set into the top of the wall to support the roof timbers of the keep buildings. The remains of the smaller hole which can be seen above it to the left, is thought to be for a water spout to discharge rain water through the parapet and outside the keep.

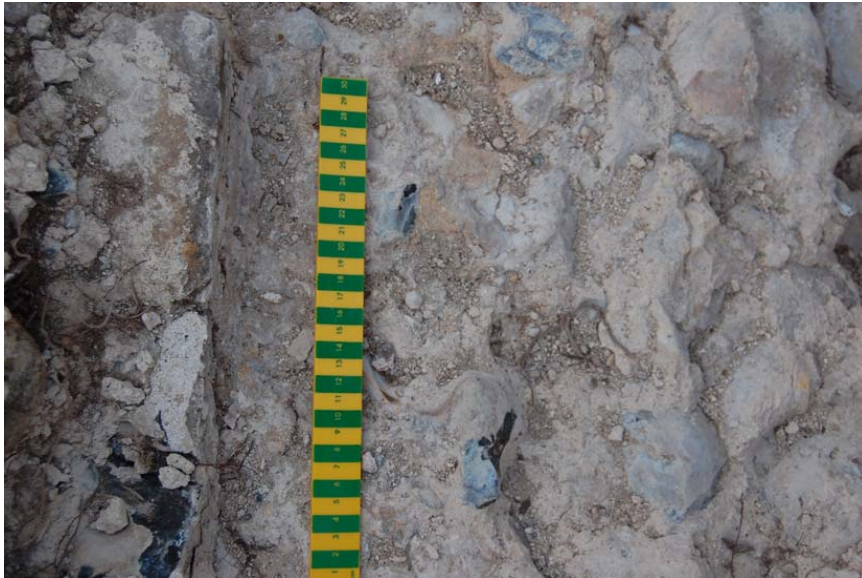
The keep wall survives to its full height and is topped with the stubby remains of a parapet. The top of the keep wall is finished with a smooth screed of mortar which meets and then follows up the short remaining inner face of the parapet to confirm that this was the wall's finished height (PIs. 5 and 6). Set into the top of the wall were four equally spaced channels which ran across the width of the wall like the radiating spokes of a wheel (Fig. 9 and PI. 5). The channels were the settings for large, square-sectioned, timber beams which would have carried the roofs of the buildings that lined the interior of the keep and/or a walkway inside the parapet. The channels were 300mm wide and 170mm deep (c.half the depth of the timbers they once contained) and originally they would have pierced the full depth of the parapet, although now they are blocked from the outside by subsequent re-pointing and repair. The blocking infill of the socket has a whiter, softer mortar and contrasts with the original fabric. There is a lift line just below the beam slot level and one just above, an interval of 550mm, suggesting that the topping off of the keep wall, the setting of the timbers and the starting of the parapet were all completed in one phase of work.

Plate 6. Looking down on the top of the keep wall showing the mortared screed finish and the face of the parapet wall to the left of the scale.

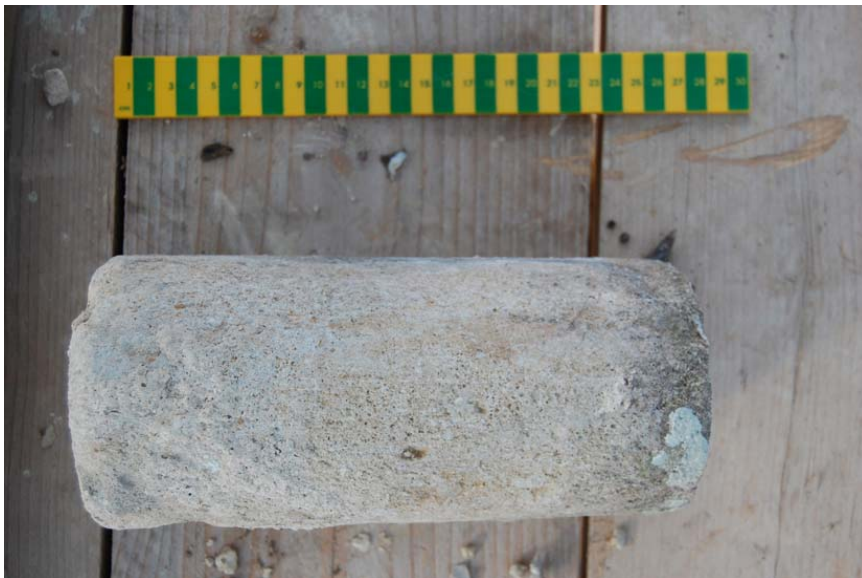
A section of a narrow cylindrical column in Barnack stone (PL. 7) was recovered from the core of the parapet; the column surface was undecorated and although not entirely diagnostic was not inconsistent with work of Norman masons and it is the only bit piece of fabric that could be attributed to this early date; the stone was photographed and re-incorporated into the wall during the rebuild.

Plate 7. Section of stone column, probably Norman in date, built into the core

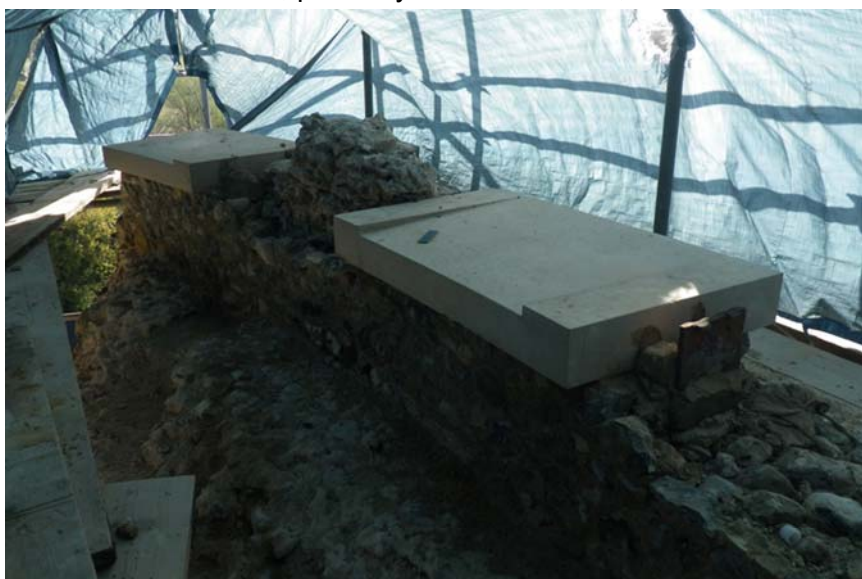
Plate 8. Limestone sills placed between the merlins as part of the reconstruction of the crenulations

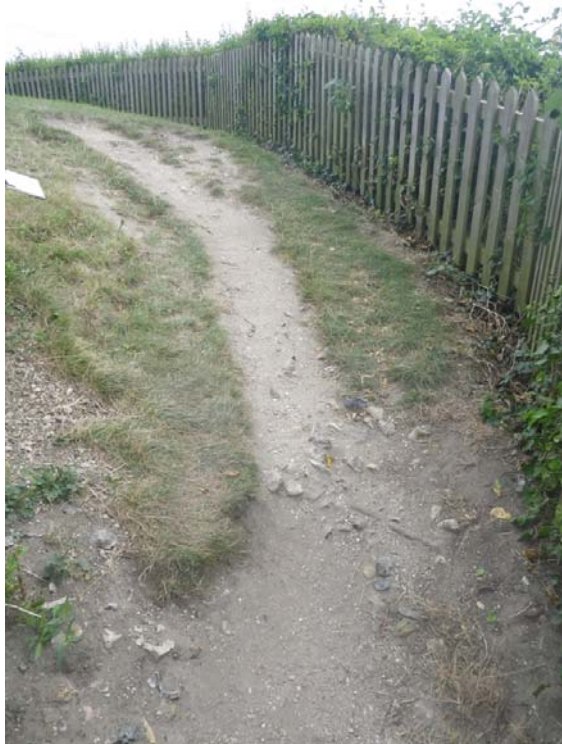
The ground level inside the curtain wall is higher than outside and sloping paths have been created around the walls ends. Erosion on the path has caused the buried remains of the keep to become exposed (PI.9) and the line of these gives a strong impression that the radius size of the keep is different to that of the motte platform and at both ends the wall line appears to be heading off the edge. The early antiquarian plans and engravings of the castle indicate that the western arm of bailey wall was attached to the keep on the east and south cardinal points. The bailey wall was attached where the keep remains terminate on the south side and the bailey wall's collapse may have be contributory to the creation of this shear point. The arc of the upstanding wall is not constant and flared/flattened out at the north end. This feature was also discovered by the builders when trying to establish a wall line for the reconstruction of the wall face.

Plate 9. Erosion to the path exposing buried flint foundations

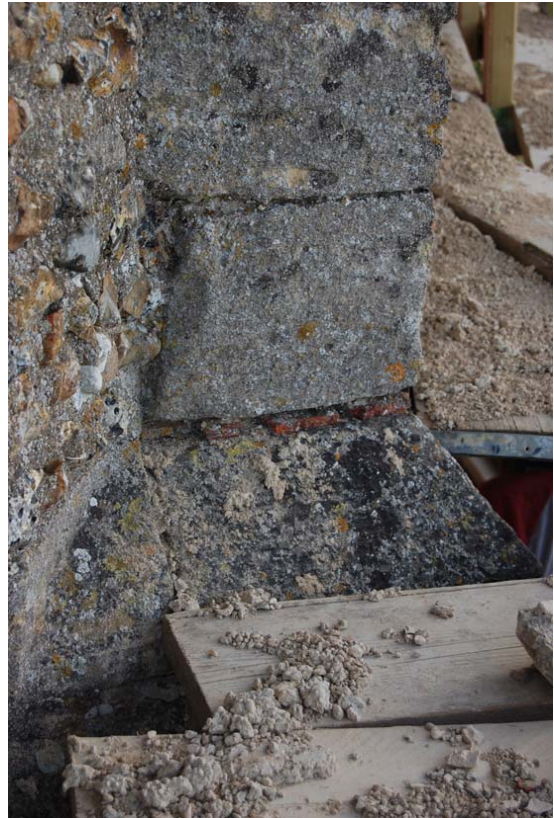
which date the quarries had stopped producing stone. The buttresses appear to be original to the construction of the wall and are integral with the wall face; stitched in with a mix of Barnack stone and clunch, the latter of which had decayed badly. There is evidence that some of the buttress stones have been re-set, as courses of post-medieval tiles have been inserted to recover the levels and stones were fastened together with internal wrought iron staples/ties set within the horizontal bedding joints (Pls. 10 and 11).

Plate 10. Post-medieval tile inserted into the joints of the buttresses

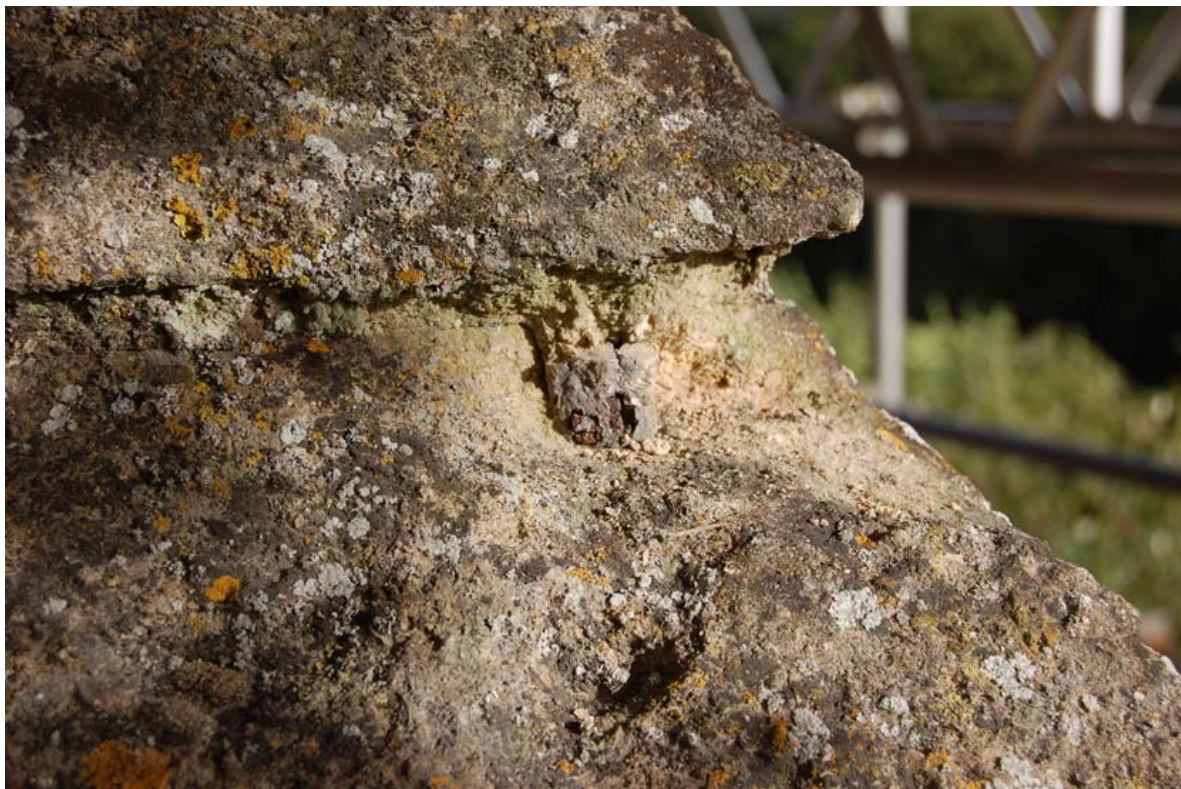
Plate 11. An example of the iron staples/dogs set into the limestone tying the buttress capping stones together.

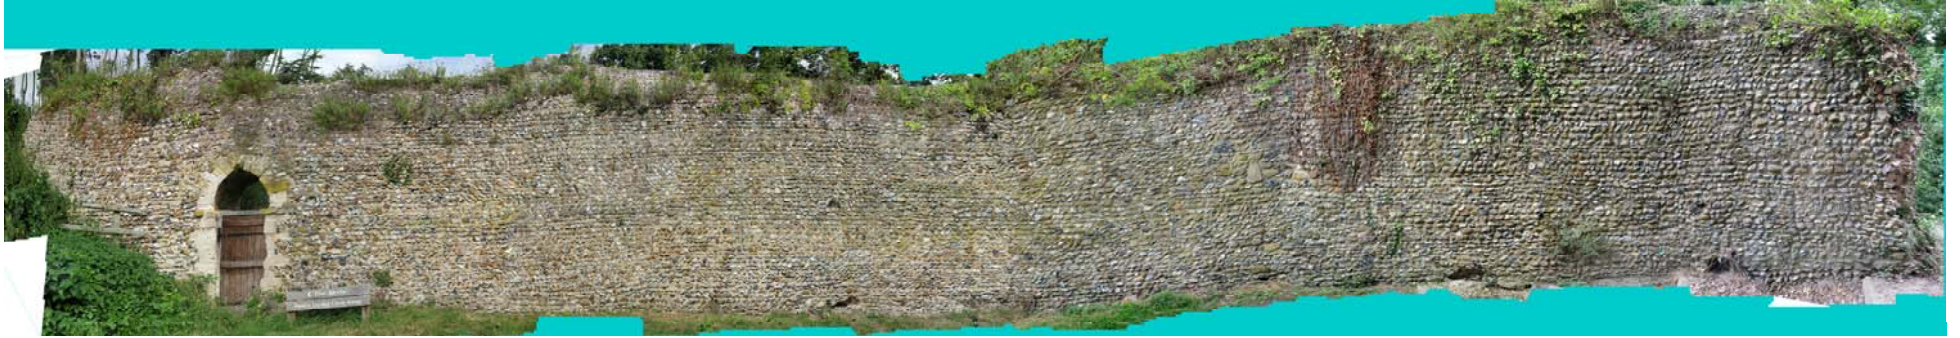
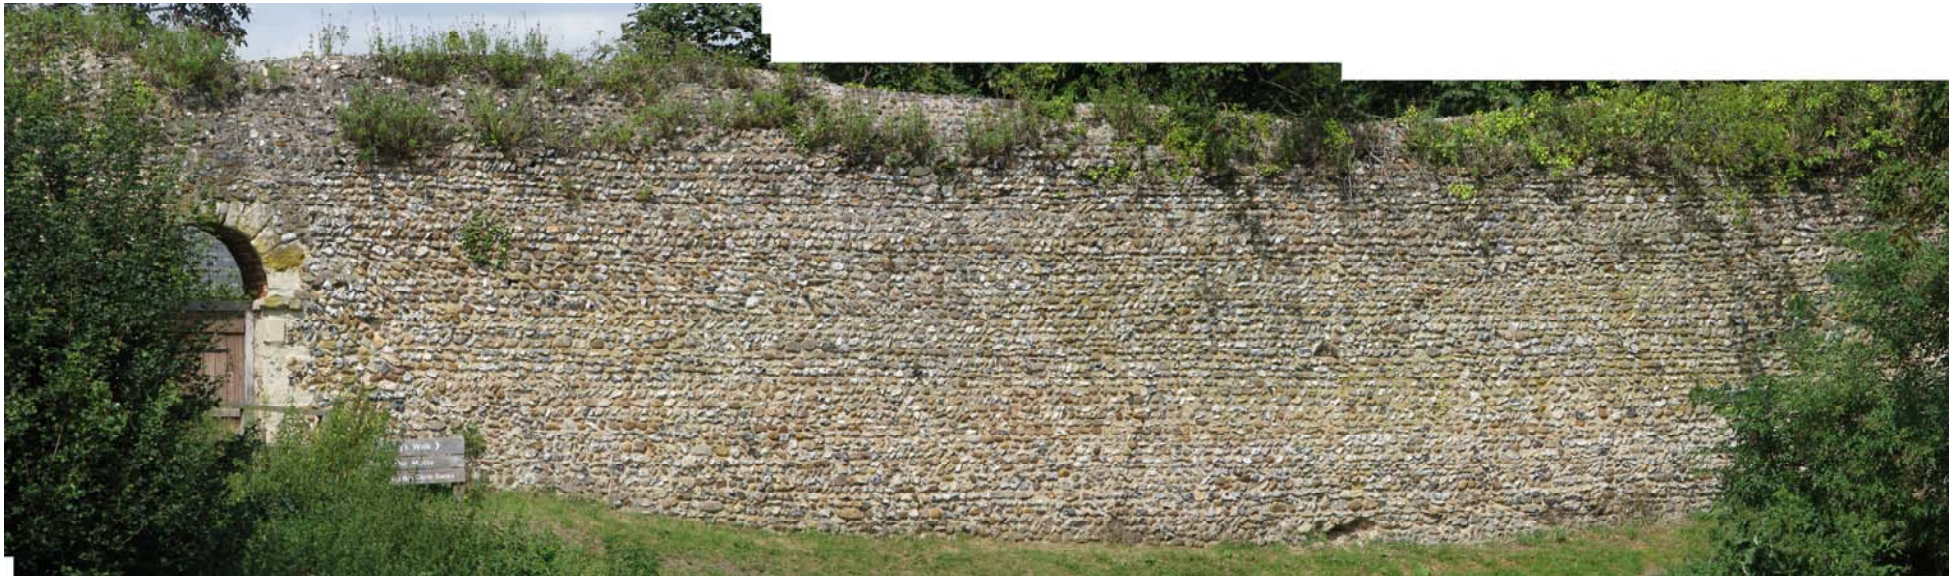
The remains of the bailey wall ran down the eastern side of the motte. It extends for c.51m and is sheared off at each end with a ragged break. These break points seem to be arbitrary and there is no indication that this is a coherent segment or that the terminals signify original openings. The wall is 4.3m tall and is constructed on a 1.6m high earth bank so that the wall top is 5.9m above the general ground level within the inner bailey. The wall follows the contours of a saddle dropping down from the motte before rising up again at its east end (Pl. 12).

Plate 12. The south face of the bailey north wall. It's is over 4m high and 50m long and built without supporting buttresses; it is a striking example of Norman wall building. The door on the left is a later insert the rusticated block work is a Palladian style and probably dates to the 17th-18th century (Higher View photograph).

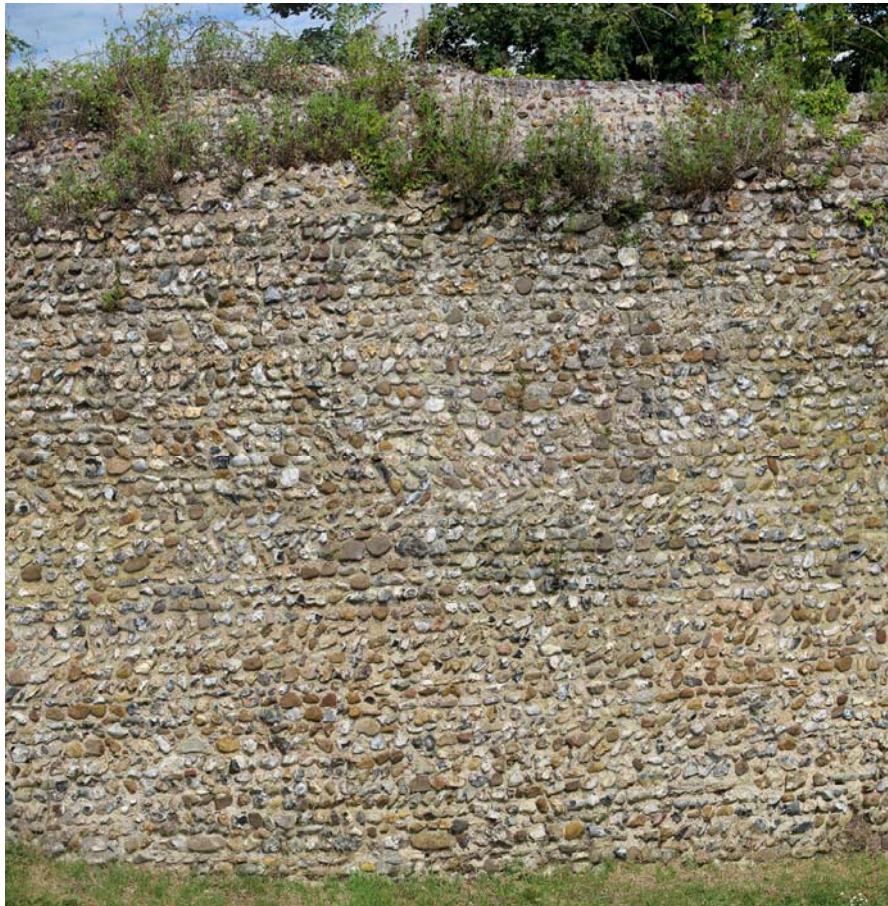
The wall is built of large sandstone cobbles and flint nodules; these are un-struck flints, cortexes intact, which were probably, collected from *stone-picking* the surrounding fields. They are laid in strong horizontal courses that follow the rise and fall of the wall's contoured course. Looking at the south face there is an impression that the wall is banded, divided by what appears to be string courses of flints which have been sorted for size and shape. The selected stones include, in some cases, elongated oval flints which have been laid in a herring-bone pattern. The 'string-courses' are evenly spaced bands at under 1m apart and presumably indicate building lifts (Pl.13). Herring-bone flint work is often attributed to Anglo-Saxon builders but it has been recorded by the author in the fabric of known Norman-date churches.

Plate 13. The flints of the bailey wall laid in strong horizontal courses that follow the rise and fall of the wall's contours. The flints appear banded, divided by 'string courses' of flints which have been sorted for size and shape and which include elongated oval flints which have been laid in a herring-bone pattern. The 'string-courses' are evenly spaced bands at under 1m apart and presumably indicate building lifts (Higher View photograph).

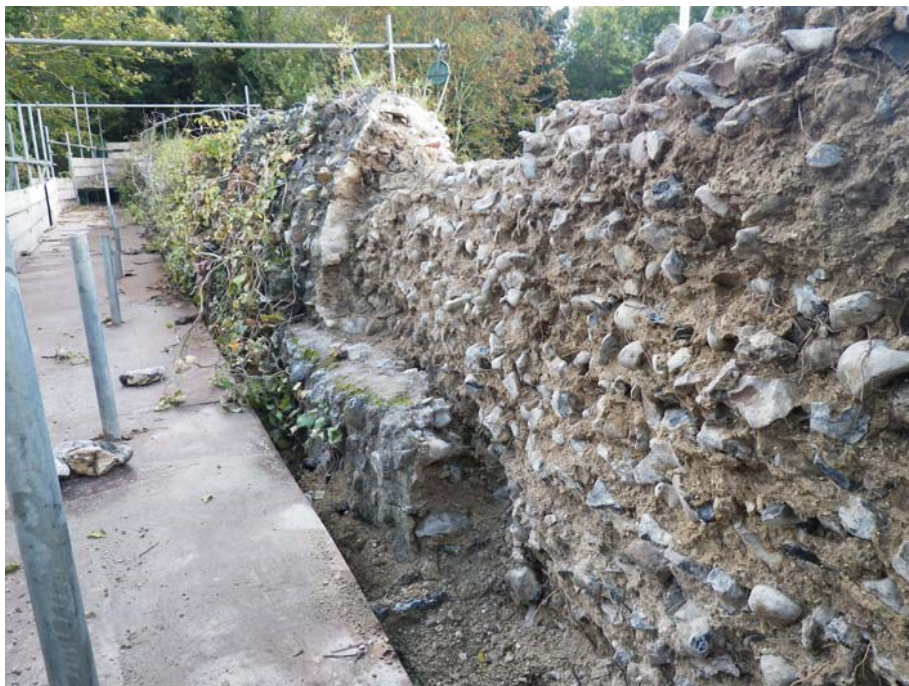
The entire visible face seems to be original Norman work which extends to within 1.5m of the top. The wall top is truncated and had been capped over with a 200mm thick cement based render to create a domed-shaped water-shed. The core of the wall beneath the cap was original but there was no indication of how the top of the wall was finished or how much of its height had been lost. The wall is plain, built without buttresses and there is no indication of original openings. It is beautifully constructed and remains vertical and flat.

Plate 14. Top of the bailey wall with concrete capping partially removed revealing the original wall core fabric beneath. North face of the wall looking east.
